BEINN THARSUINN  
TOPSOIL STRIP MONITORING  
AND STRATHRORY BRIDGE  
RECORDING  
DATA STRUCTURE REPORT

PROJECT 1996

carried out  
on behalf of  
Scottish Power

by  
Sarah Phillips

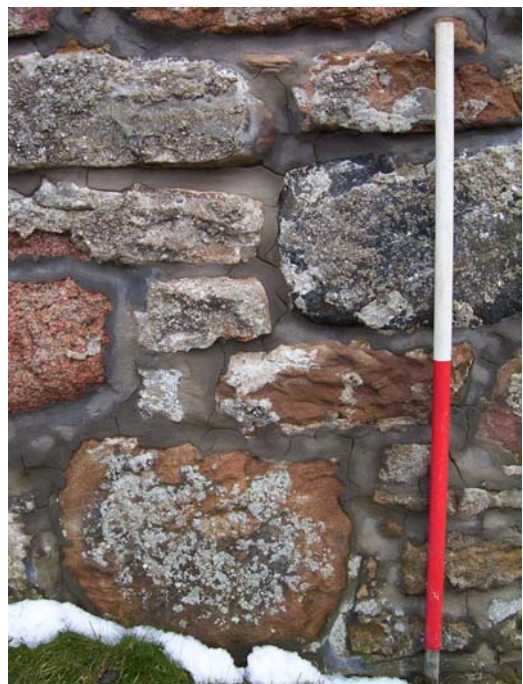
*Plate 6*

The fabric of the bridge consists of a variety of local stone including quartz and granite. Some of the stone may have come from the river as cobbles, which were split using heat. This may account for the flat-faced stones seen in the photographs (Plate 6 shows a detail of the stonework). Small quartz pebbles in a cement matrix remain in places attached to the face of the stonework. This suggests that the bridge originally was faced, with the facing being later removed or fallen off, to reveal the stonework beneath. Lime mortar was originally used as the bonding material for the stones of the bridge, but later re-pointing used cement. Large red sandstone blocks were used as capping stones along the top of the bridge (Plates 33 and 35). The bridge is not symmetrical as the two arches are not the same size and their construction differs. The Royal Commission on the Ancient and Historical Monuments of Scotland (Canmore database) suggests that the north arch has been rebuilt.

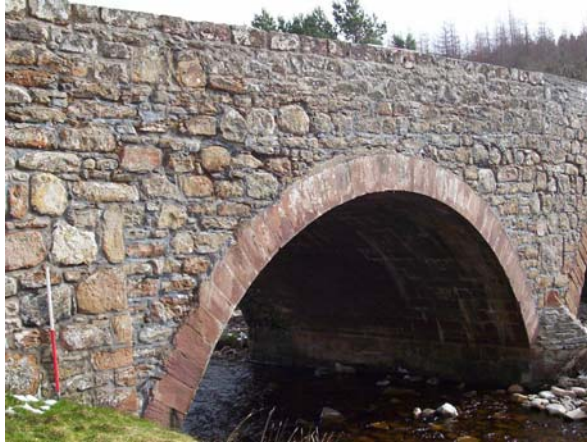
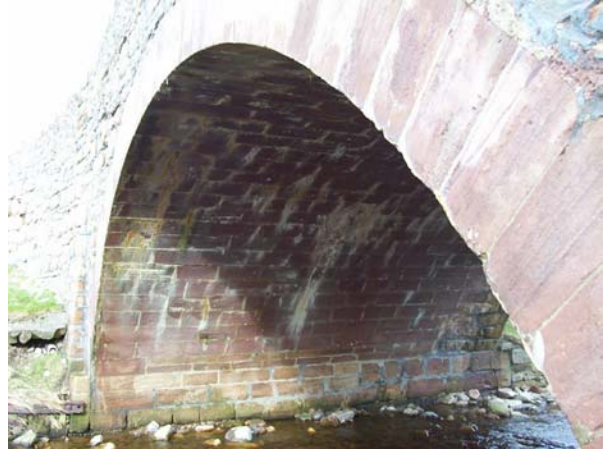
*Plate 7*

The north arch of the bridge has been constructed with uniform sized and shaped red sandstone blocks, although their length varies. The stones are well fitted and are in a clean condition. It is possible that this arch has been rebuilt. (Plates 7 and 8).

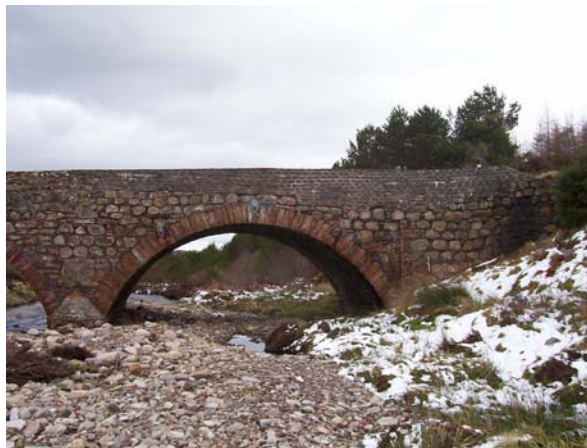
*Plate 9*

The south arch of the bridge is different from the northern arch. Although it is built in a similar manner using regularly shaped sandstone blocks, these blocks are not well fitted or are as neat in their finish or condition. The stonework on the south arch resembles the construction of the main stonework of the bridge. On both the east and west sides of the south arch there are three iron ties evenly placed along the top of the arch (Plates 9 and 22 with details in Plates 11 and 24). These ties are not found on the north arch.

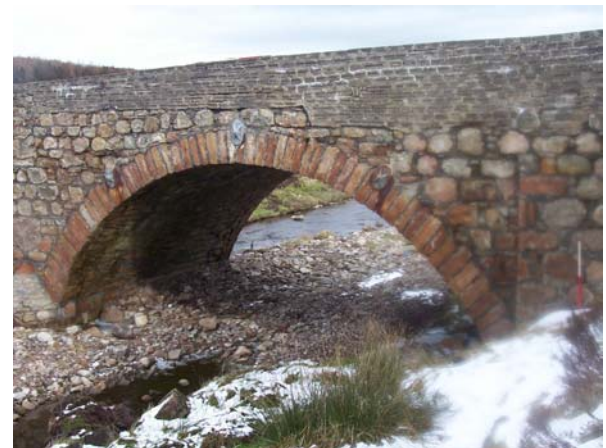
*Plate 10*

Repairs have been made to both the east and west sides of the bridge. The major repairs occur at the south end of the west side of the bridge on the body and along its top (Plates 10 and 39). The bridge has been repaired using blocks of quartz pebble concrete, grey in colour with cement as a bonding material. These blocks, measuring 0.45 m by 0.2 m by 0.18 m are rectangular and have a groove down either side (Plates 36, 37 and 38).

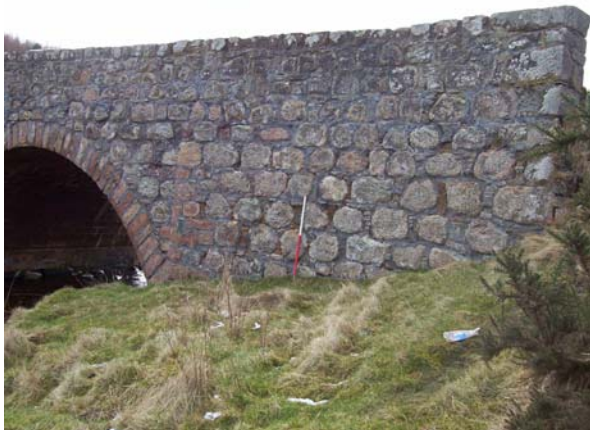
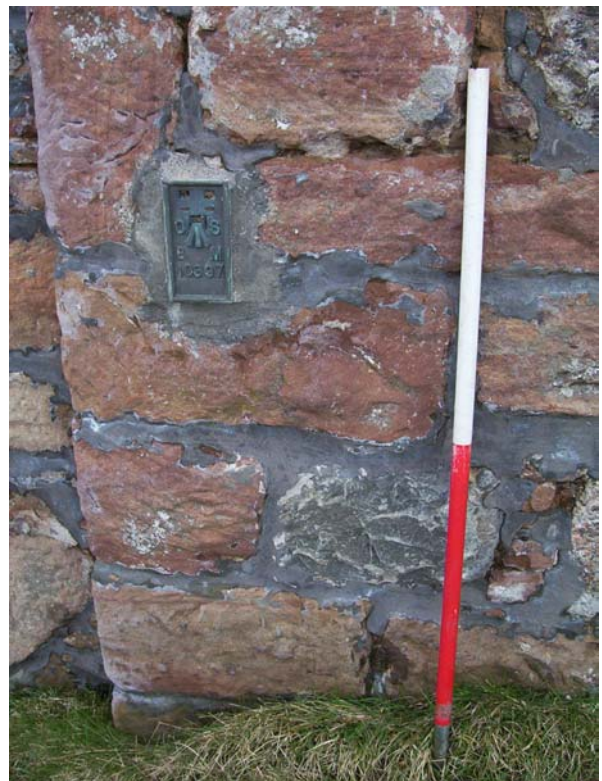
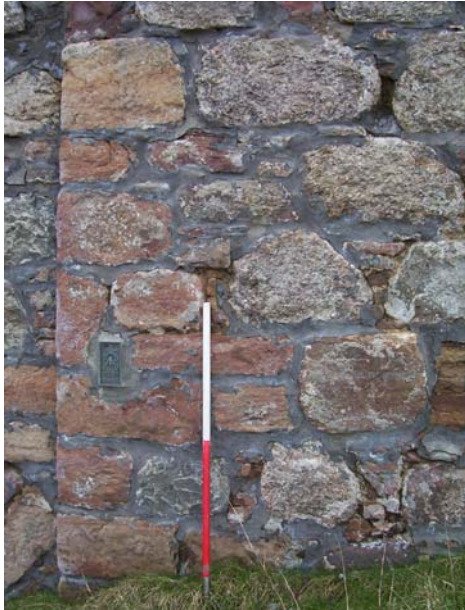
At the north end of the east side of the bridge there is an Ordnance Survey benchmark (Plates 19, 20 and 21).

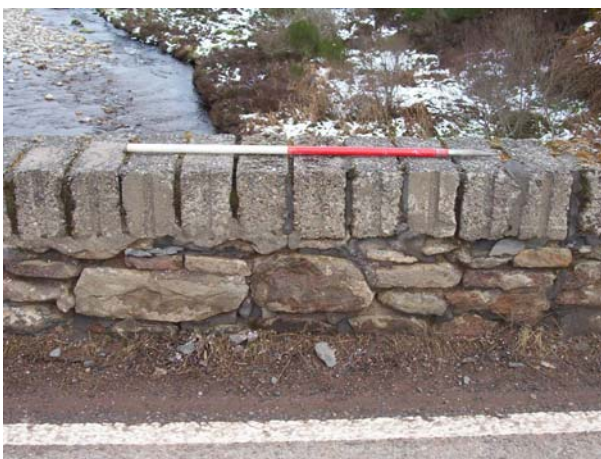
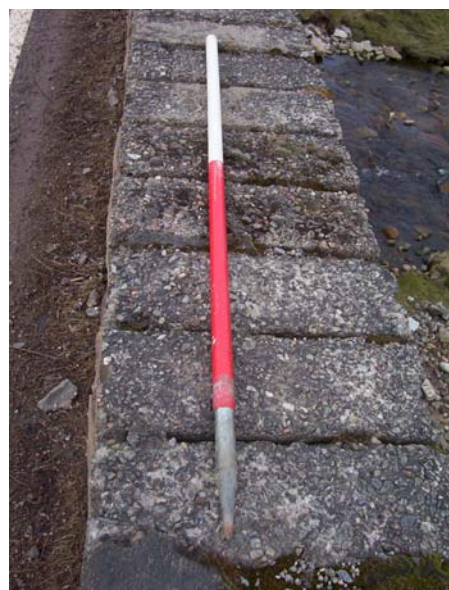
In the central part of the east side of the bridge some of the sandstone capping stones have been replaced with similar concrete blocks. These blocks have been laid on their sides (Plates 31 and 32).

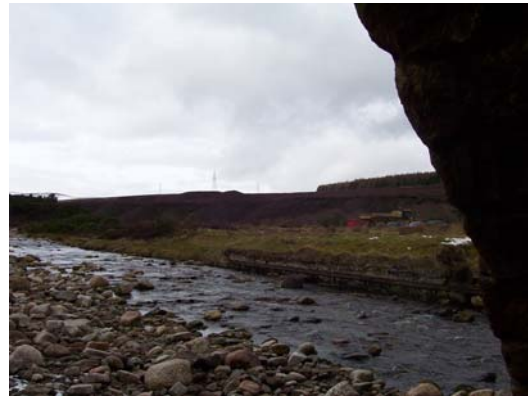
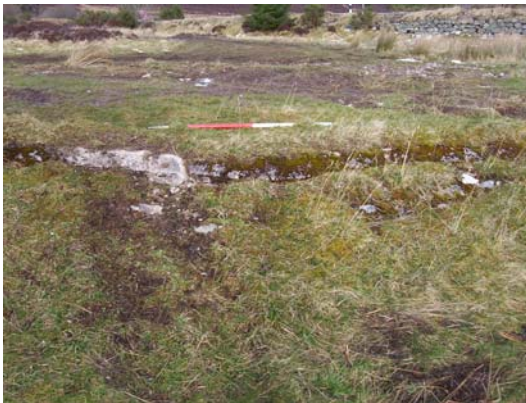
The banks north and west of the bridge have been augmented by a stone platform that slopes down towards the river (Plates 40 and 41 and architect's plan).

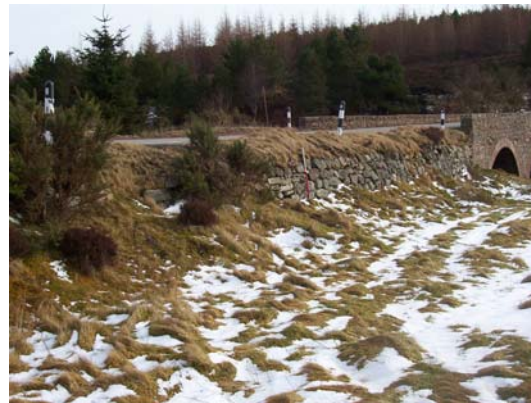
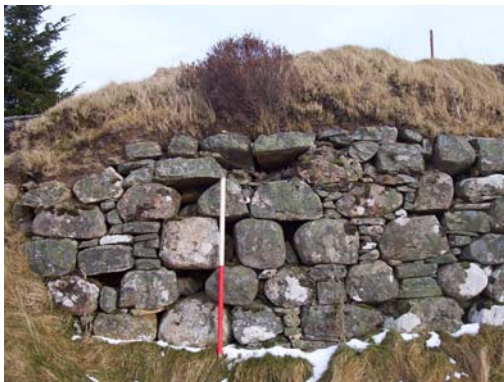
On the west side of the road running north to south towards the north end of the bridge there is a dry-stone wall (Plates 42 and 43). This substantial wall survives in places but in other areas the stones have been removed. The wall joins the north end of the west side of the bridge (Plate 44).
