Ref: 237/KGC

Military Road at Culachy, Fort Augustus.

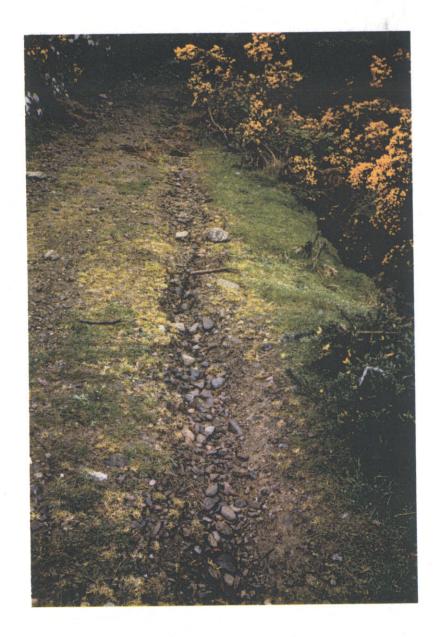
•3. Existing road surface with minor rutting. Ch 70

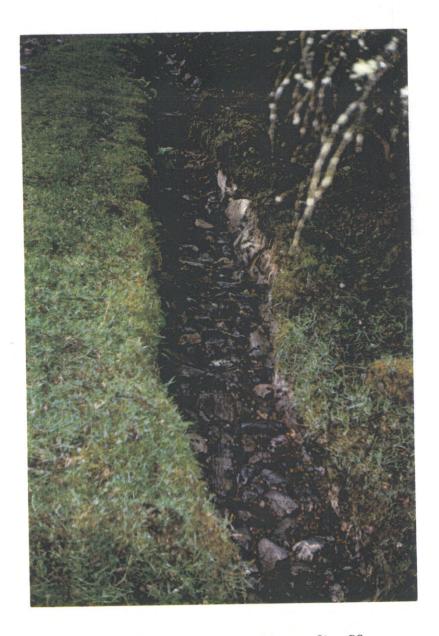
·4. Paved ditch in good condition. Ch. 90

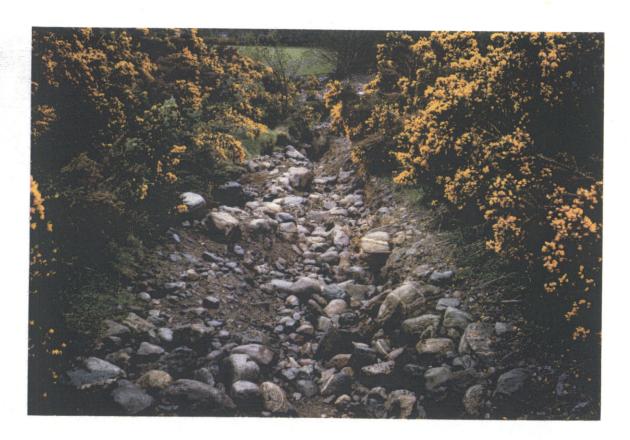
Looking downhill to public road. Showing road surface washed away and start of deep ruts.

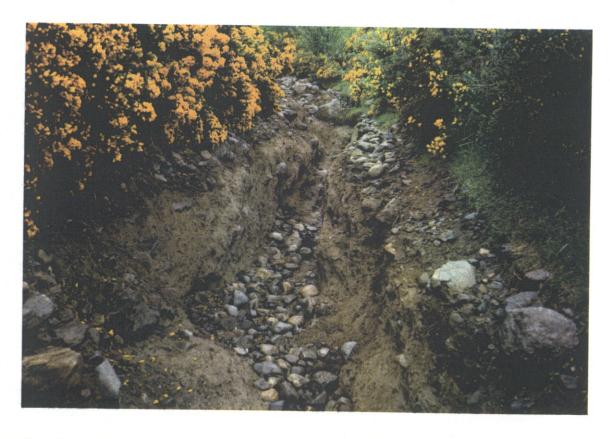
2. Deep ruts at Ch. 50
