Remedial Work Completion Report

The Corrieyairack Pass

at Culachy, Fort Augustus

February 2004

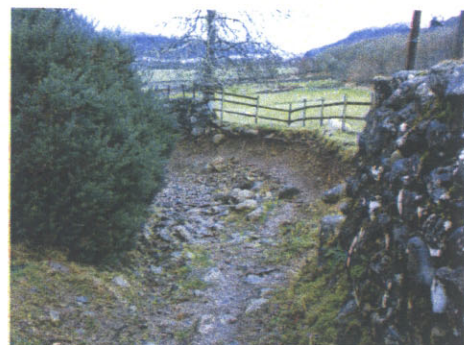
Wall collapse and washout

- **Wall repair.** Where the wall has been undermined or was in a state of near collapse, these sections have been structurally repaired.
- **Vegetation clearance** along the lower section has dealt with encroachment of scrub. The scrub has been completely removed, and trees that were influencing the drainage system have been removed or pruned.

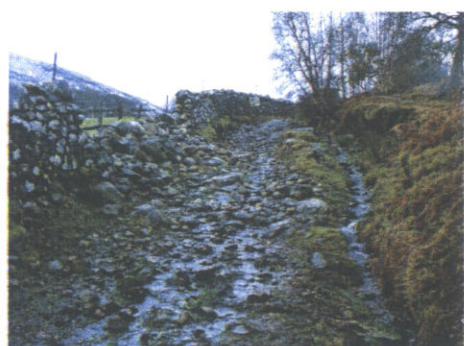
Wall collapse and washout
