CORRIEYAIRACK PASS

RESTORATION AND MANAGEMENT STUDY

DECEMBER 1997

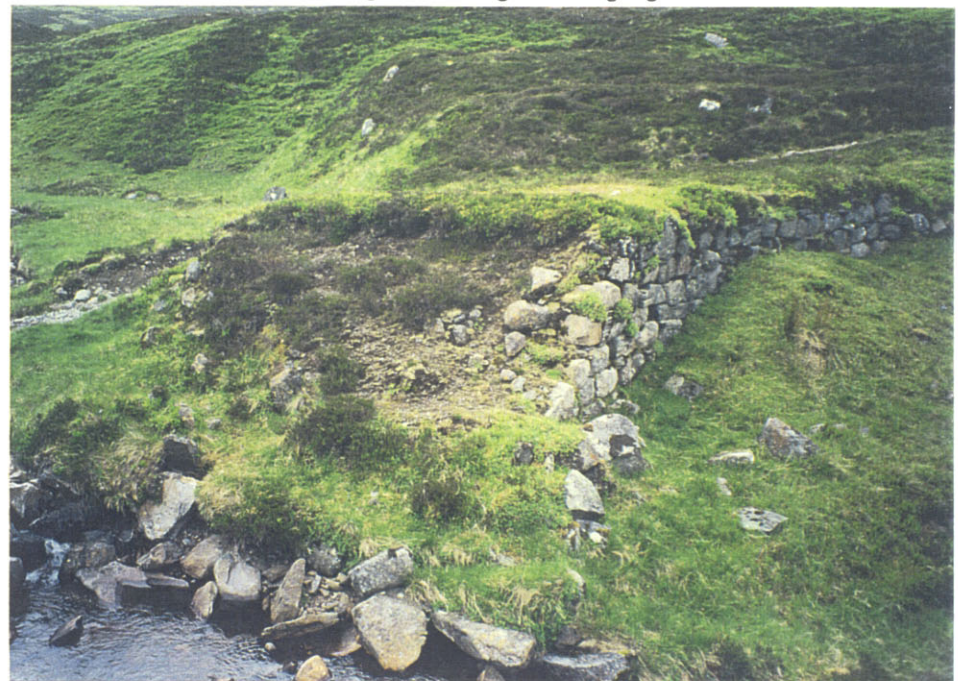
Bridge (remains of) at chainage 15.00

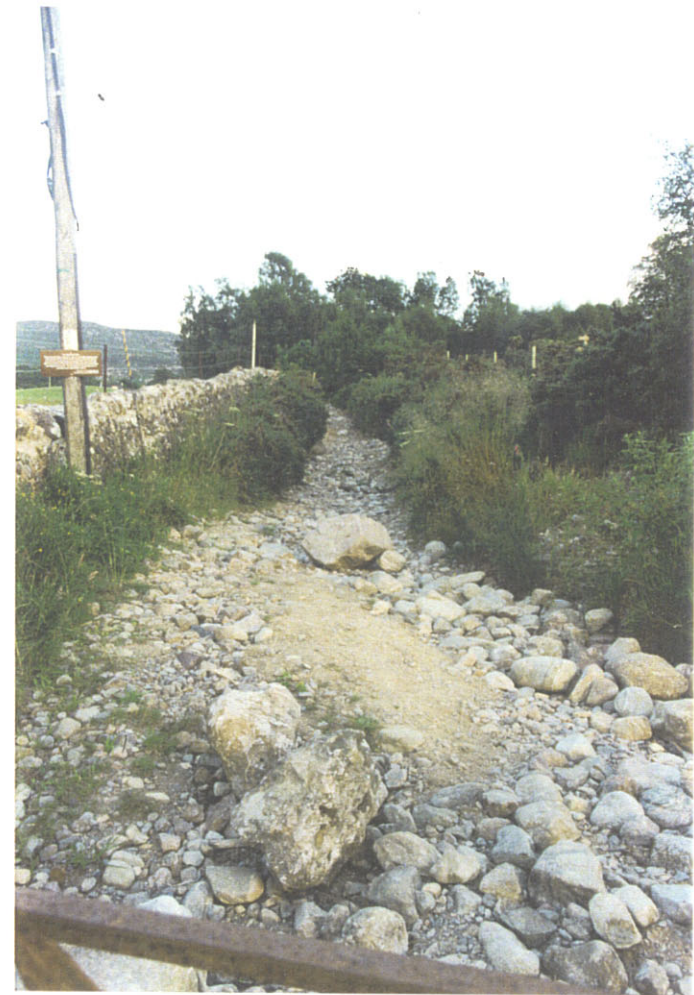
Wash-out of this section has occurred, apparently due to the collapse of a local dam.

Erosion at west end

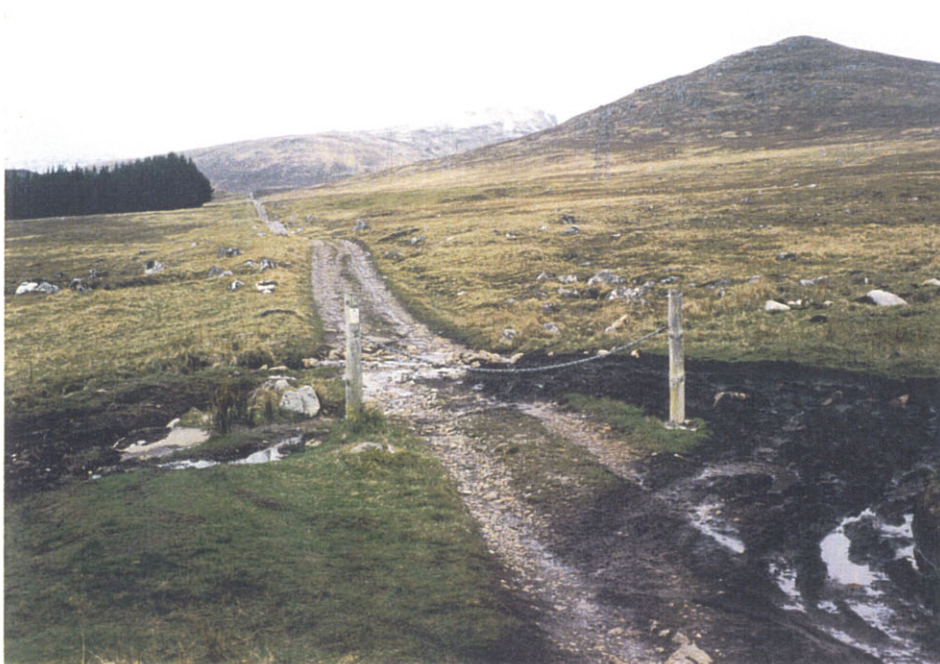
- iv) If the access to the Pass is to be controlled effectively, then protective measures will be required at each end. At the east end the present chain gate can easily be by-passed (see photo). To prevent this, boulders could be placed at close intervals to the next impassable point (a burn on the north side

East end showing lack of access control

and a bog to the south). In our opinion it would be best to control the access to the Pass at Bridge 7. This would be cheaper and more effective. Better signing is required. At the west end the present gate should be replaced with a new gate with steel posts securely concreted into the ground.

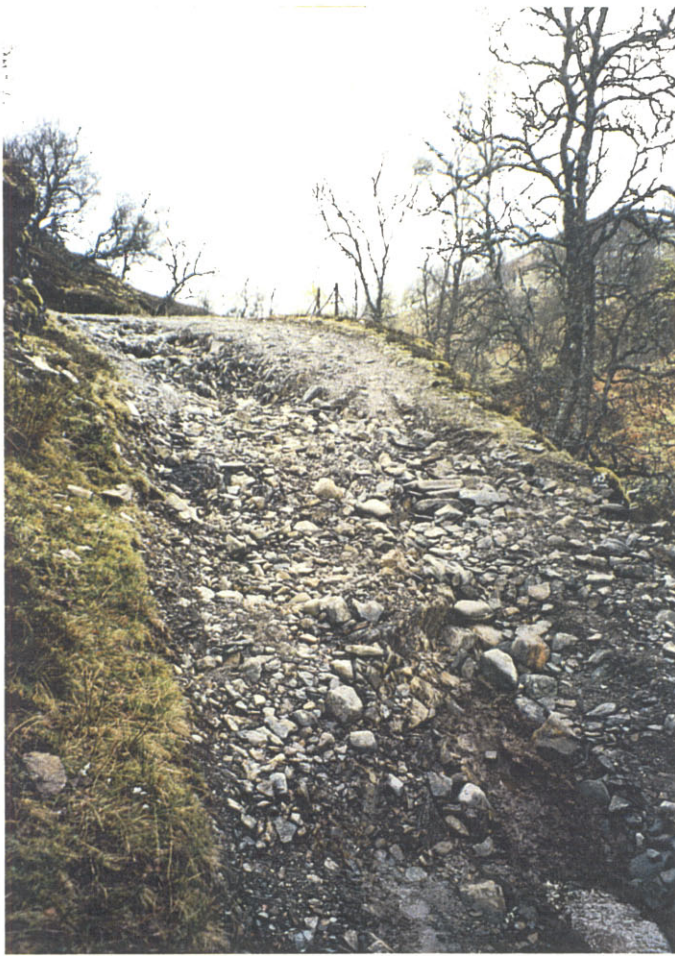
Severe erosion on hair-pin bend

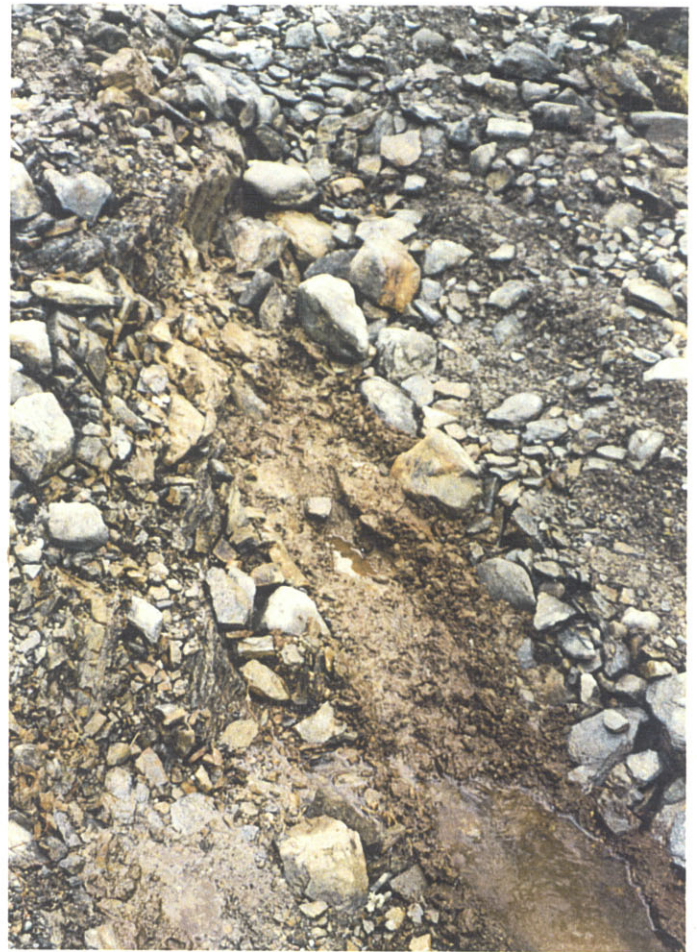
Damage by wheel spin

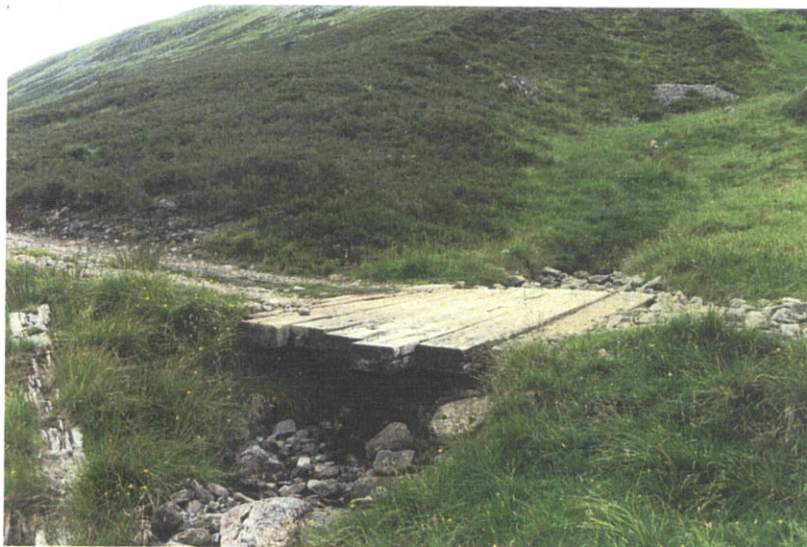
There are two sleeper bridges, both of which are in an advanced state of deterioration and are no longer serviceable.

Sleeper bridge

These are no longer serviceable and are in a deteriorated condition. They would require to be replaced with similar construction in timber.

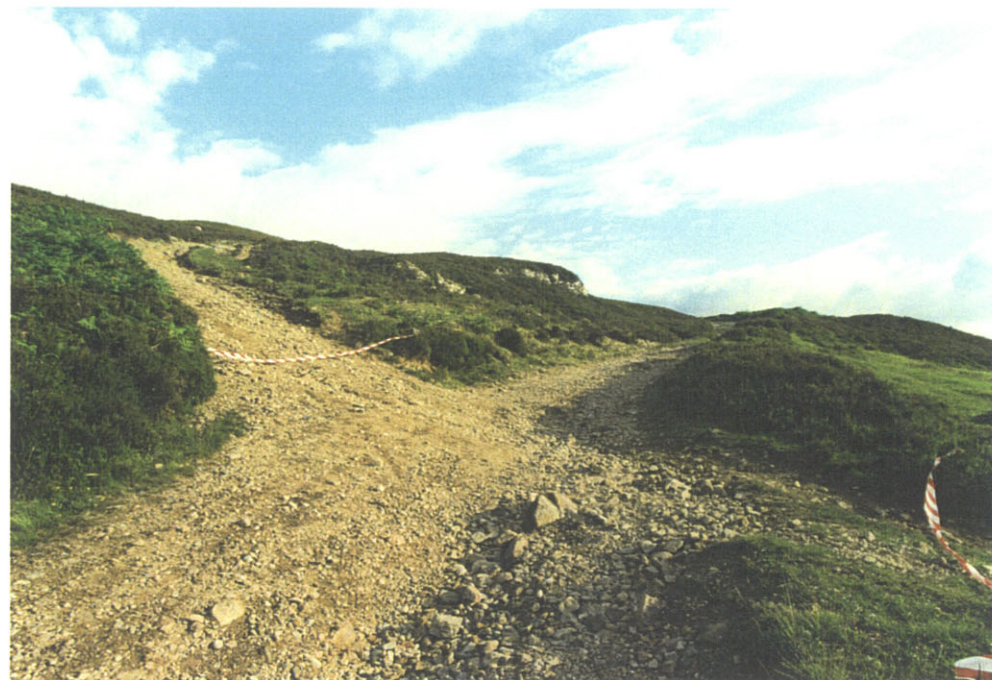
Damage caused by vehicles taking shortcuts

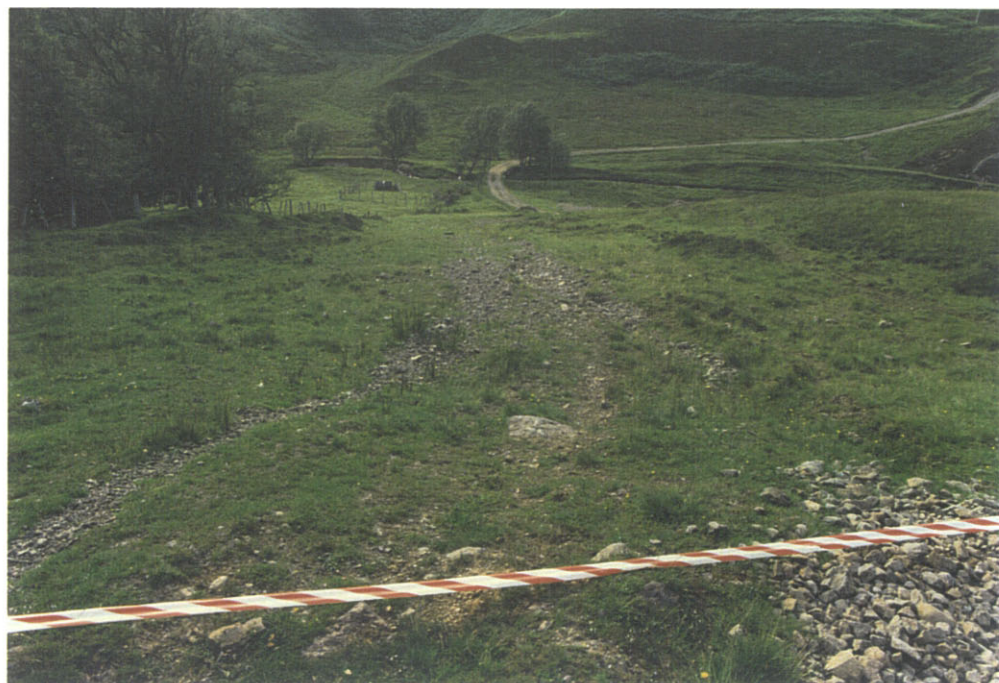
Wash out of material from road

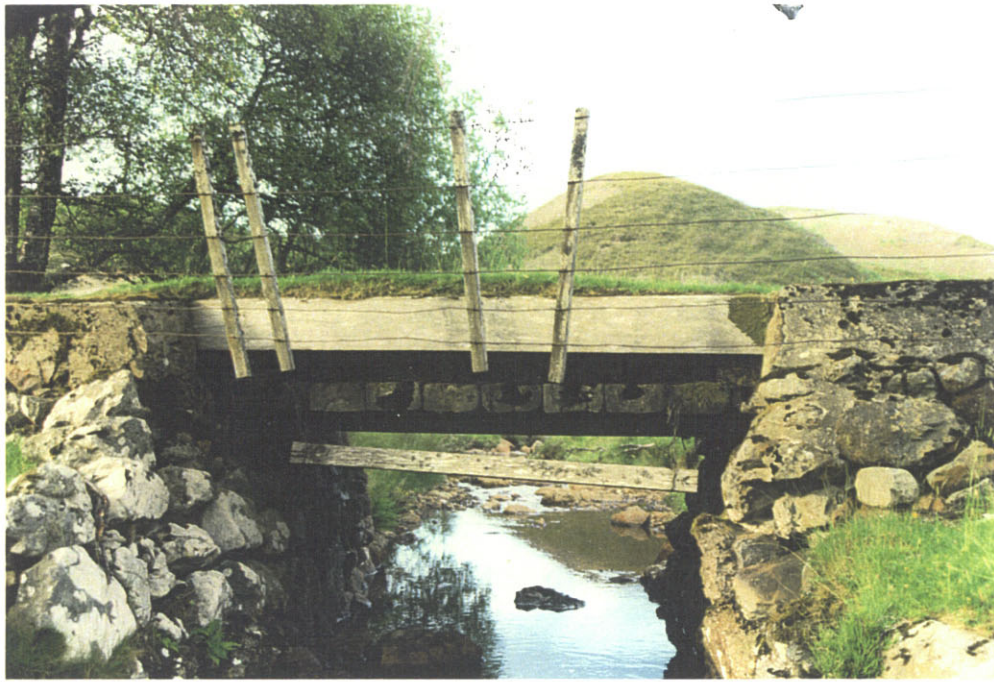
Bridge 1

The deck comprises three steel (railway track) beams with three layer timber grillage over. The abutments are constructed in random stonework. The abutments and training walls are serviceable. The deck is badly deteriorated. The timbers of the deck are rotted, the sub-structure main supporting railway lines are deflected and rusty. The abutments are substantially intact although pointing is defective and the odd stone missing.

Construct new bridge deck comprising steel beams with timber decking, abutments, training walls and wing walls to be repaired by hard pinning and pointing where necessary.

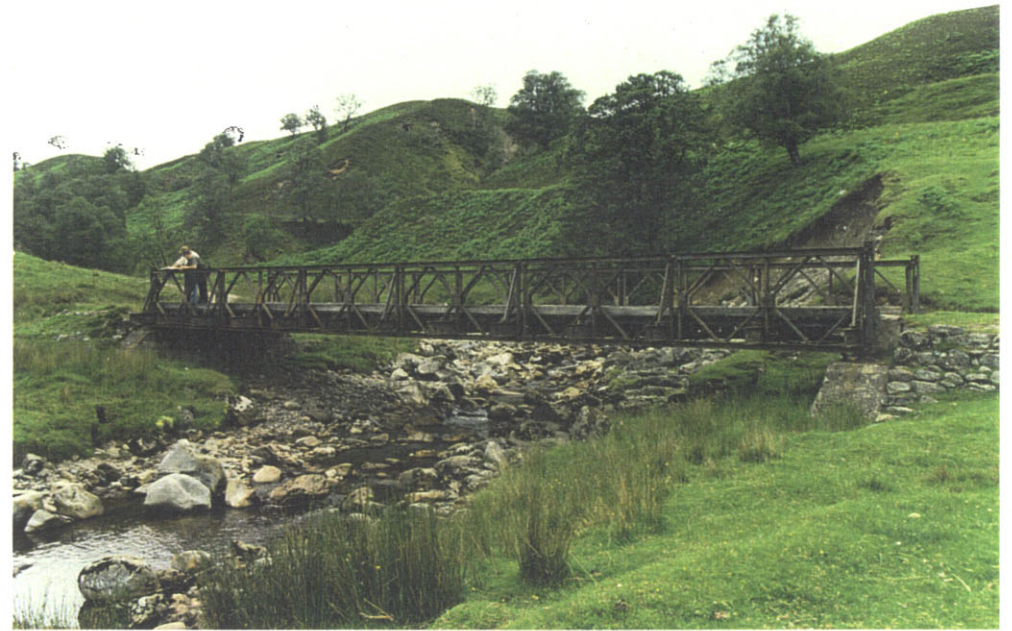
Bridge 2 is a relatively recent Bailie bridge which has been constructed within the last fifty years. The condition of the basic structure is sound but the paintwork is badly deteriorated. The main running surface is a series of timber slats. About 40 of these are rotted. The abutments are concrete and in sound condition.

Replace 40 timber slats to deck. Shot blast and repaint bridge to prevent further deterioration of the steelwork.

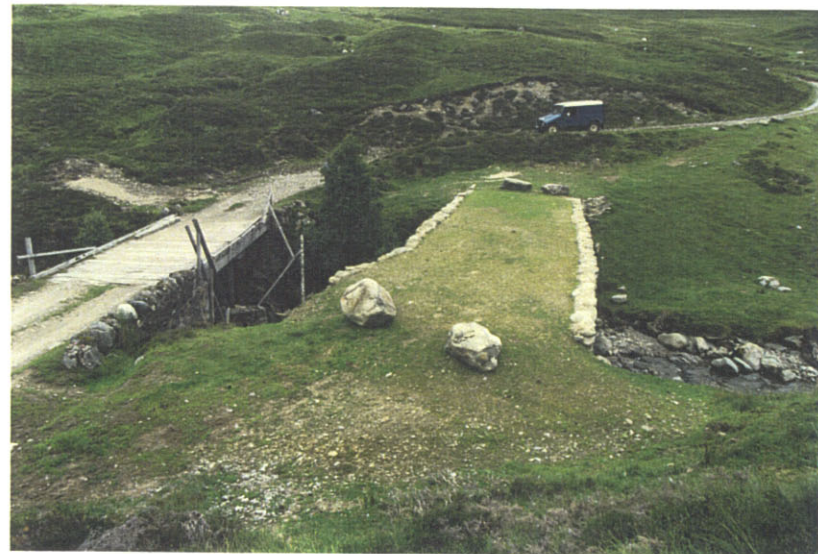
Bridges 3 & 4

This is a timber-decked replacement bridge with stone abutments to remove the traffic from the original bridge. There are four timber beams which are rotted at the east end and there is deterioration in the timber decking system and the railings have collapsed. There is a central prop comprising timber posts on a stone base. Temporary propping has been installed recently at the east end. The abutments and wing walls are constructed in random stone and have been pointed with cement mortar. Erosion is evident at the base of the west abutment. The abutments are repairable. The deck is no longer sound.

The abutments are in serviceable condition. The west abutment, however, requires to be made good at the burn bed level where erosion is taking place. This would be done by insertion of new stone which would be hard pinned and grouted into position. The pointing of the stonework should be made good generally by removing existing cement mortar and replacing with lime mortar. The bridge deck was originally single span with no intermediate props. The present deck is, in our opinion, unsound and no longer repairable. It is therefore recommended that a new bridge deck be constructed using steel beams with timber decking. The existing propping system to be removed completely from the bed of the burn. This will help to improve the water flow and reduce the potential for erosion on the abutment.

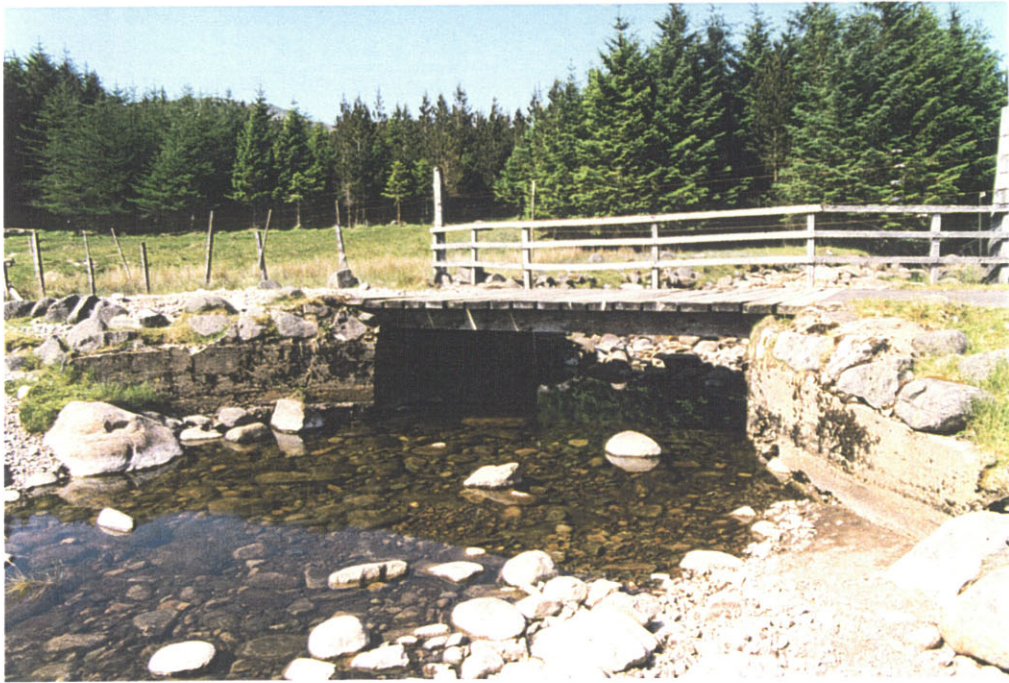
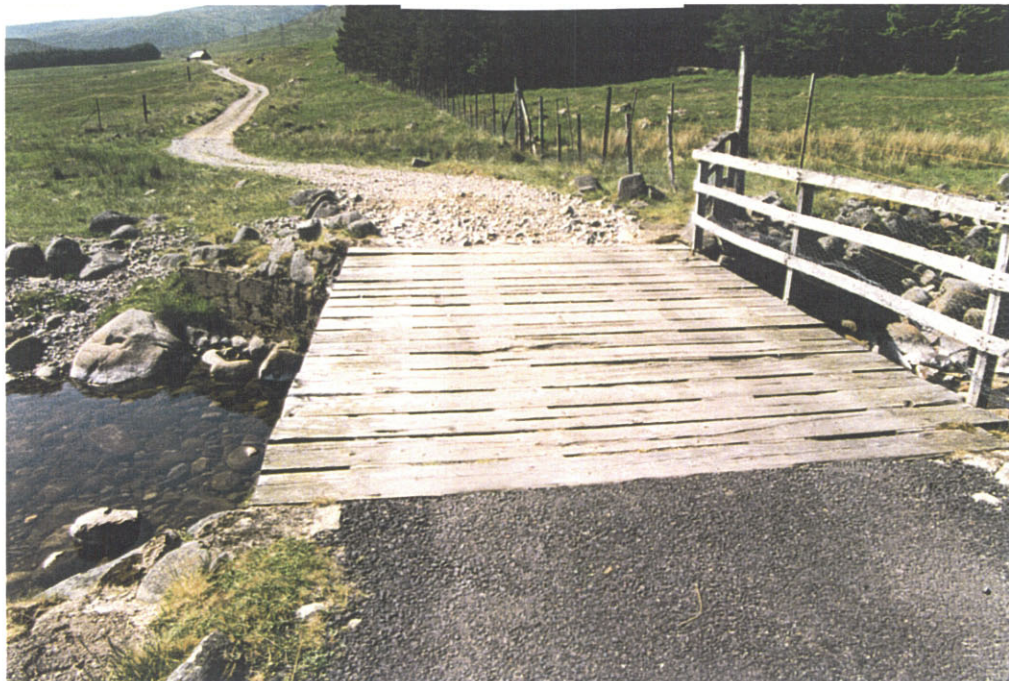
Bridge 7 is a timber beam bridge with slated deck and concrete abutments. Condition fair.

Make good cracks in concrete abutments and wing walls.

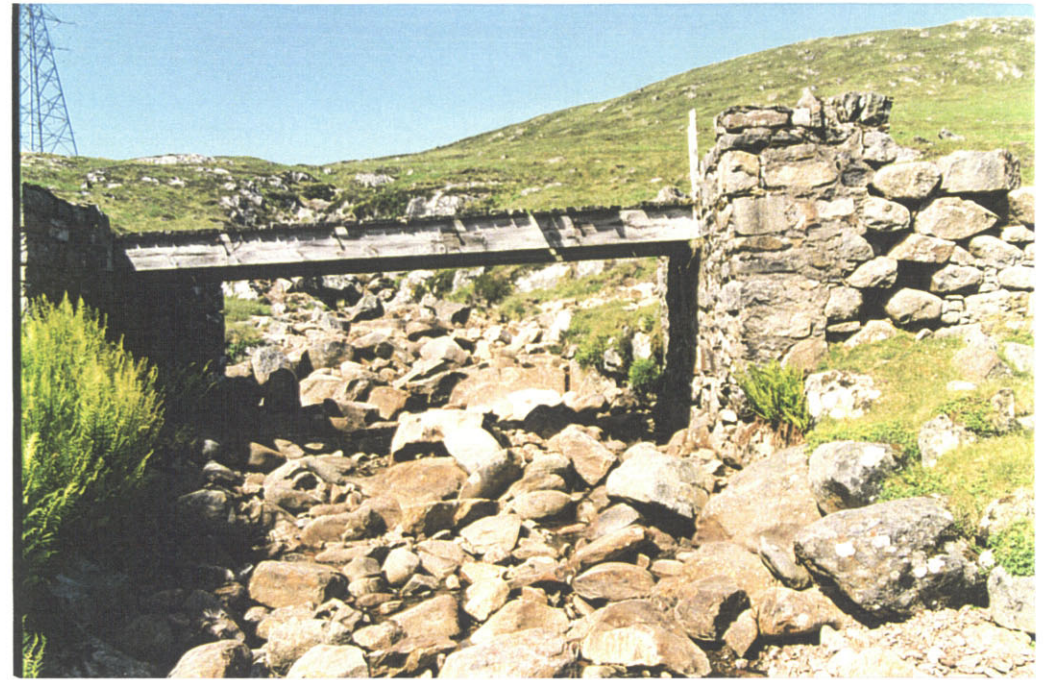
Bridge 5 is a timber bridge spanning between stone abutments. The light timber deck is badly deteriorated. The stone abutments are serviceable. The deck comprises three timber beams which are rotted. On top of these there are timber slats which are also in poor condition. The abutments are intact but pointing is defective.

The stone abutments are in serviceable condition. Local repairs, pinning and pointing should be carried out. The deck is no longer serviceable. It is therefore recommended that a new pedestrian bridge be erected on the existing abutments.

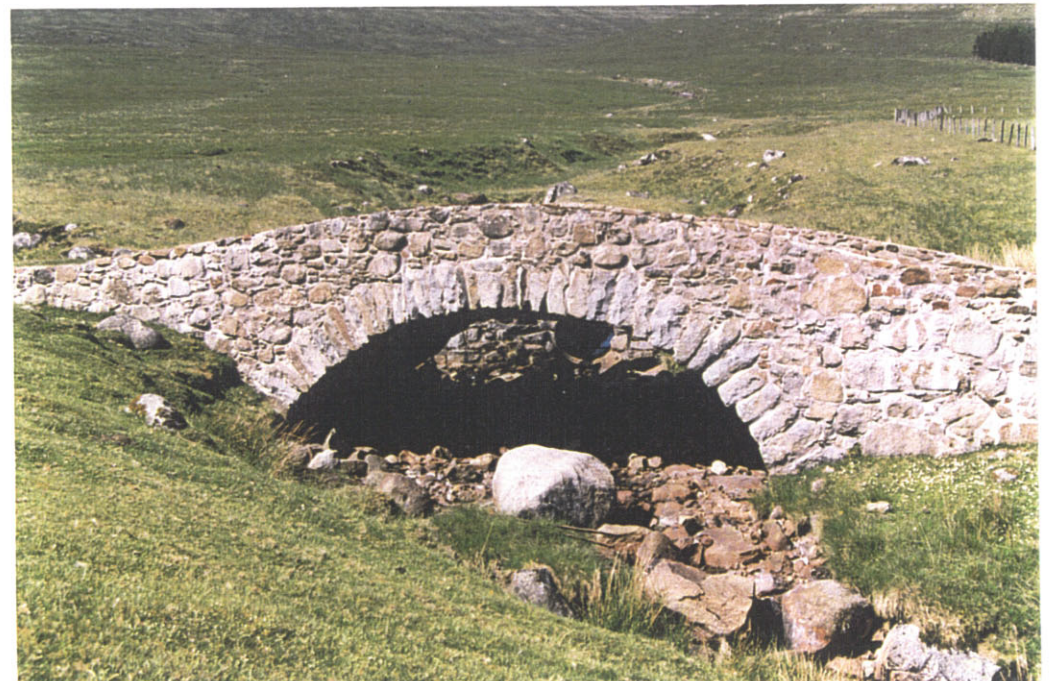
Bridge 6 is an original masonry arch Wade Bridge restored recently by APRS. Condition is fair but some erosion at base of wing walls noted.

Repair erosion to wing walls.
