**Condition survey
and outline assessment for
The Corrieyairack Pass**

at Culachy, Fort Augustus

January 2003

Condition Report on lower section of Corrieyairack Pass at Culachy.

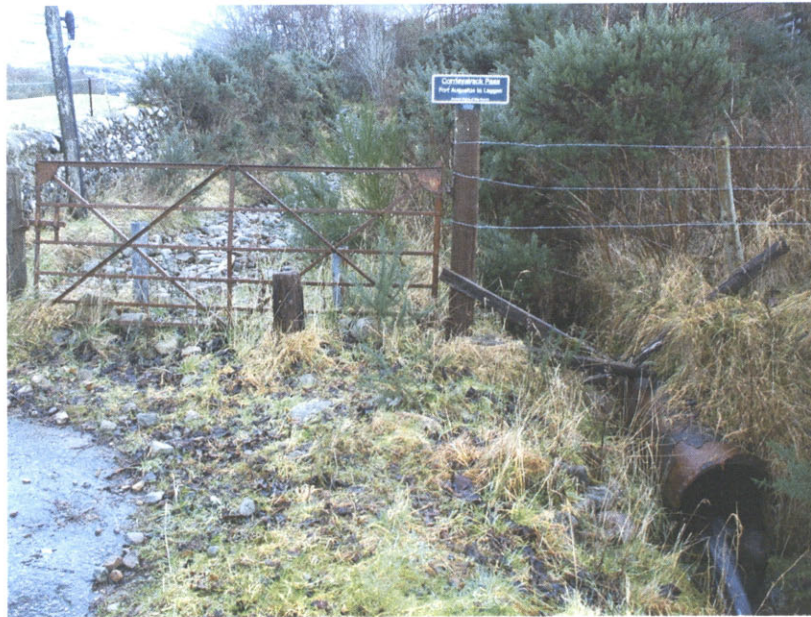
Ch0 – Culvert pipe and sign

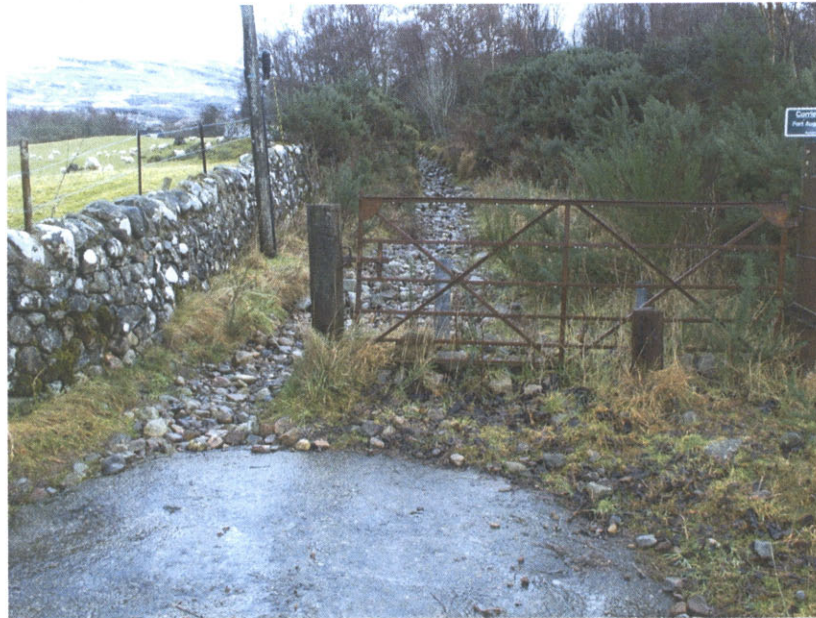
Ch 0 – Entrance to lower section. Gate and Bollards

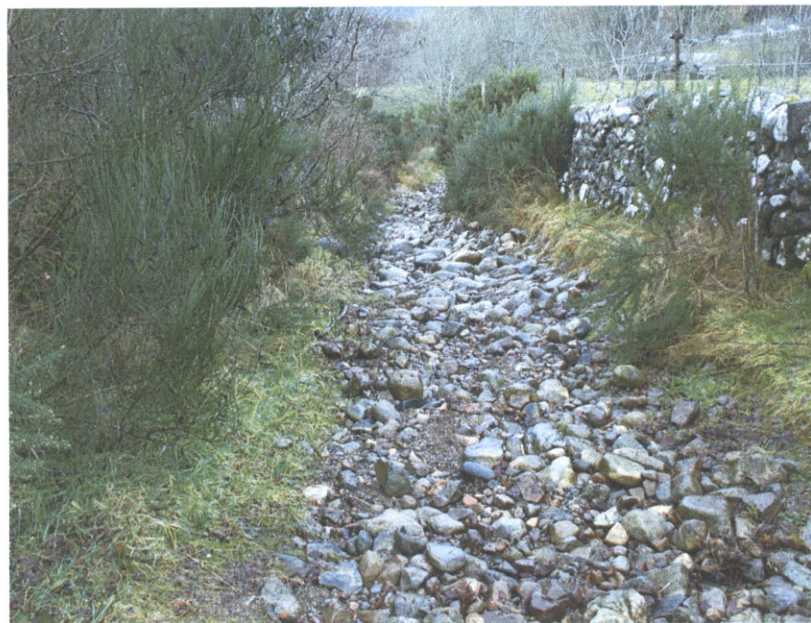
CH70 –Surface lower section

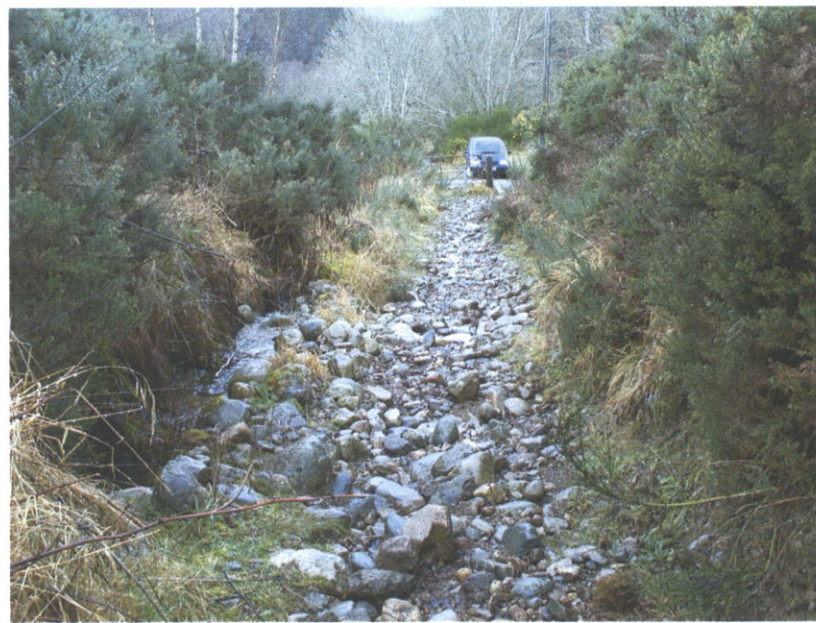
CH50 – Surface to lower gate

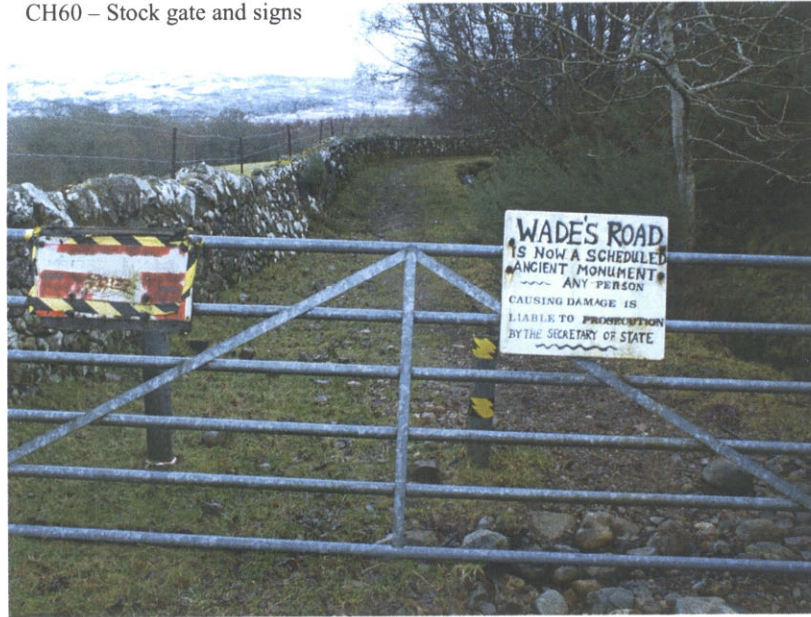
CH60 – Stock gate and signs

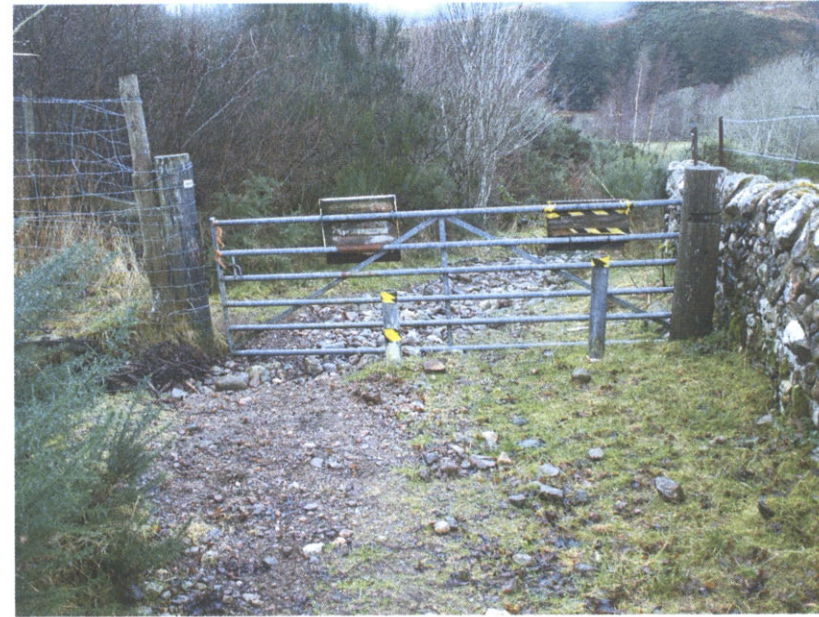
CH70 stock gate and bollards

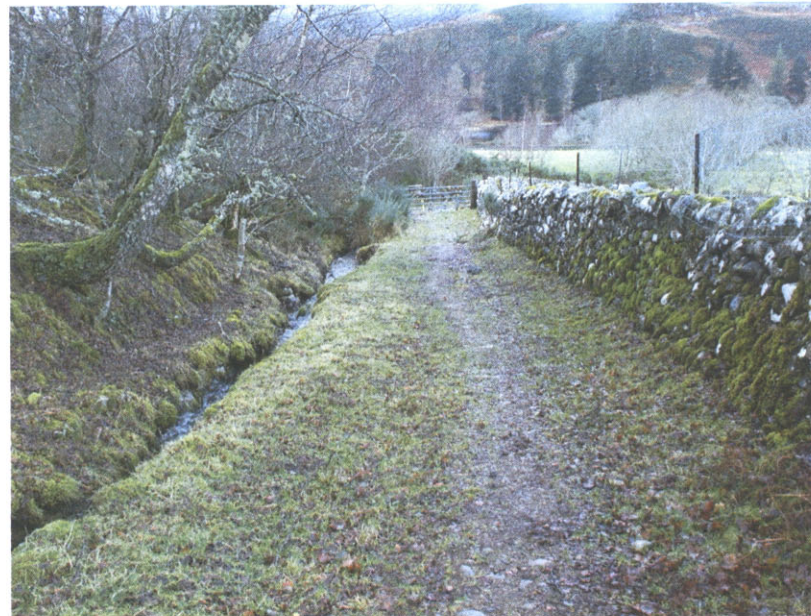
CH100 – section in good condition

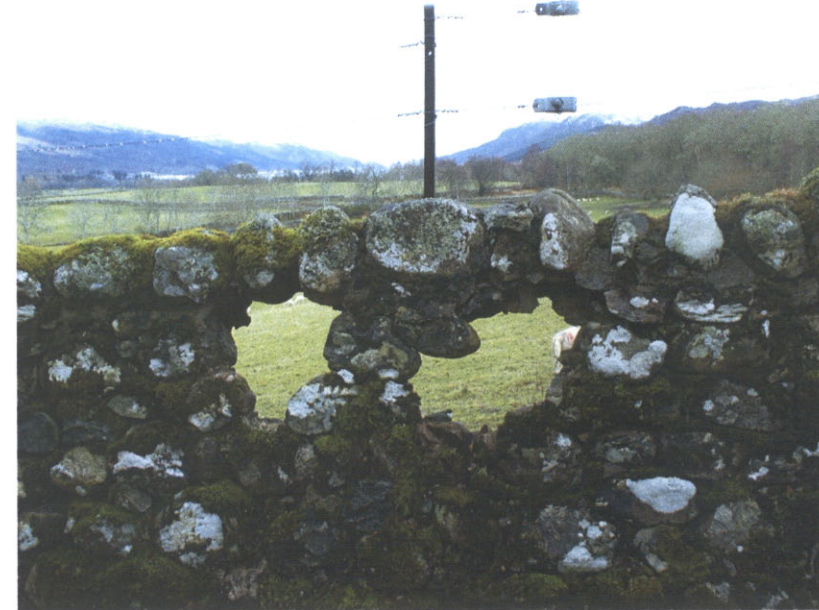
CH110 – wall collapse on field side

Wall repair. Where the wall has been undermined or is in a state of near collapse, these sections should either be demolished with the material used for infill and replaced by fencing, or structurally repaired in conjunction with the resurfacing work.

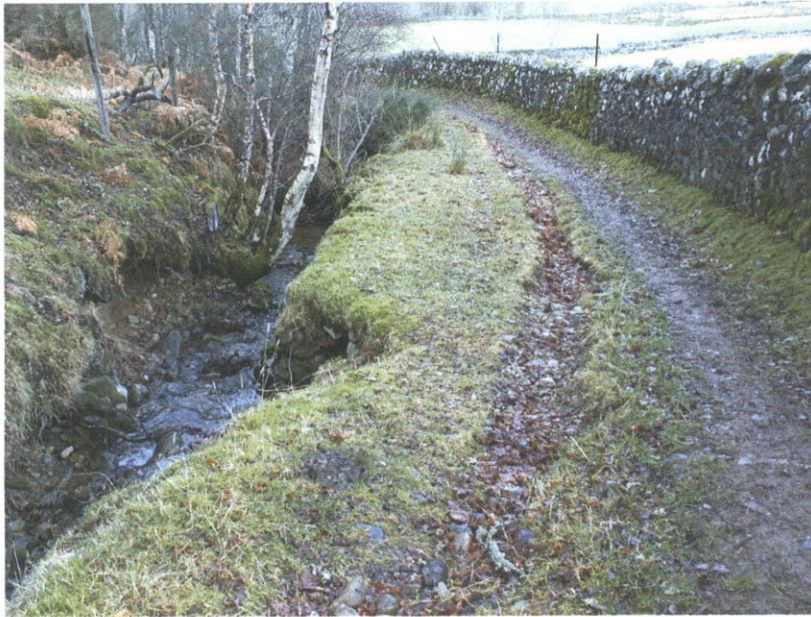
CH120 – minor ruts

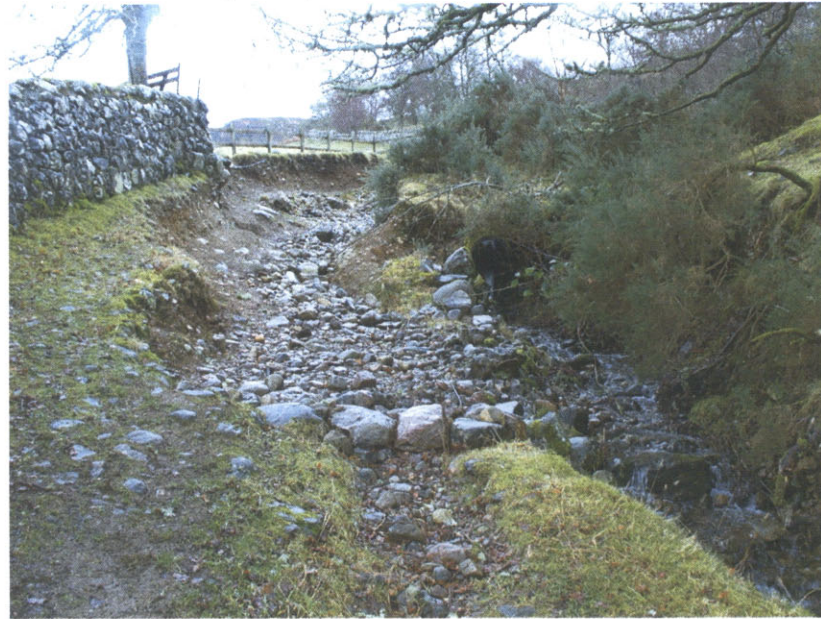
CH120 start of deep ruts – (See old photo 5)

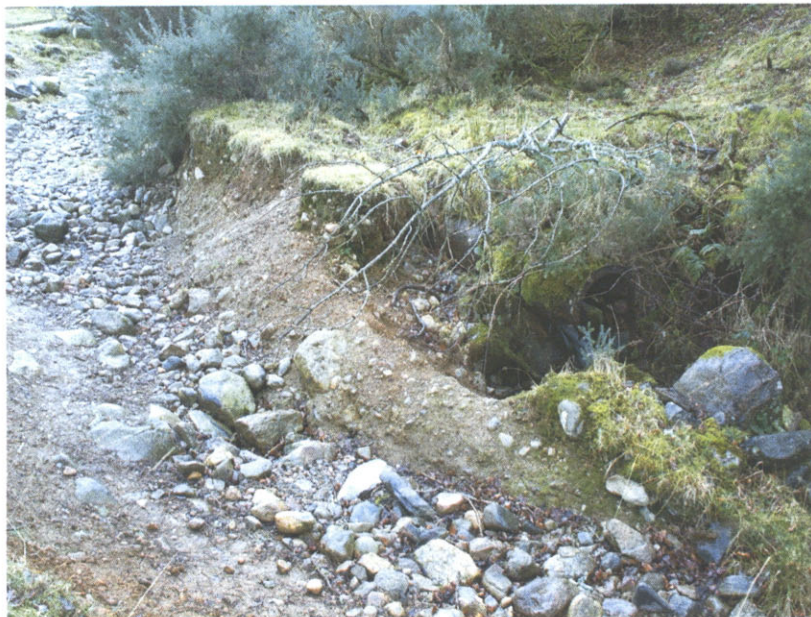
CH130 –End of Culvert pipe

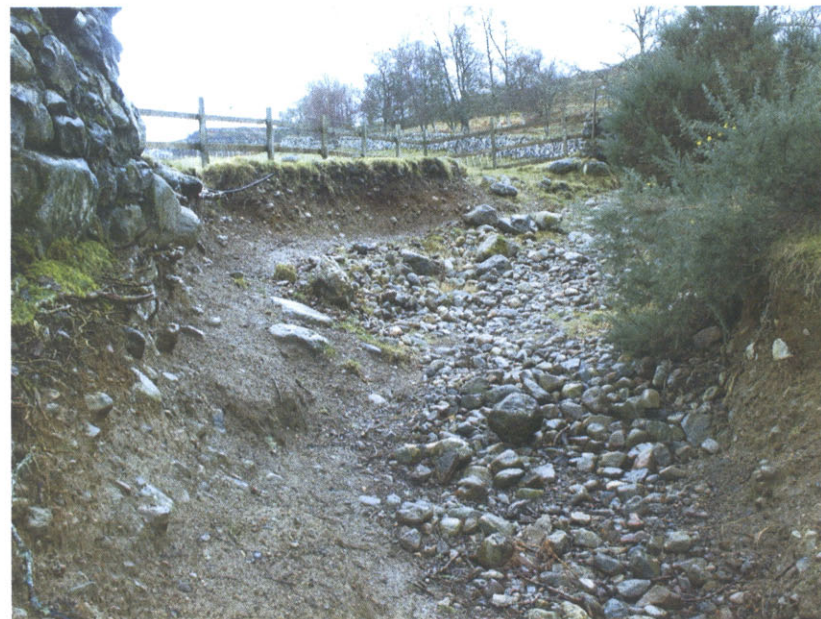
CH140 – Deep ruts

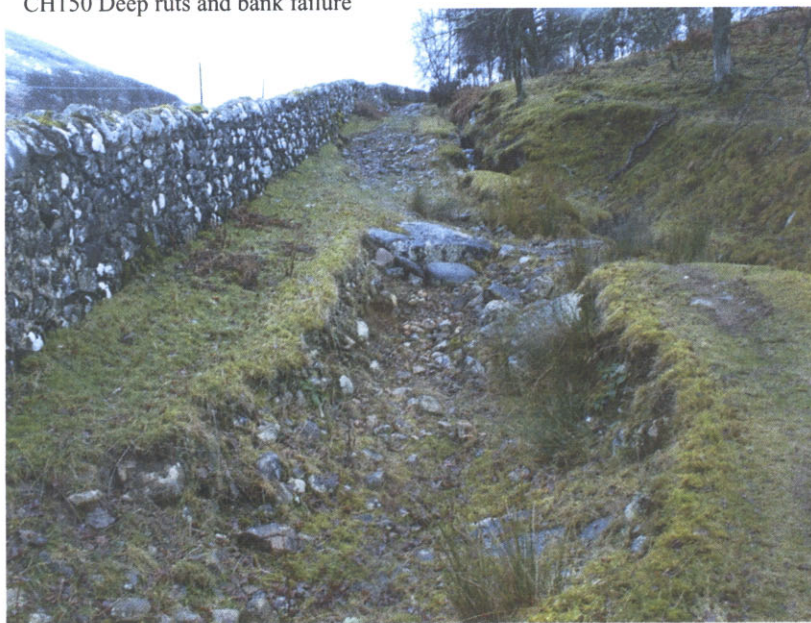
CH150 Deep ruts and bank failure

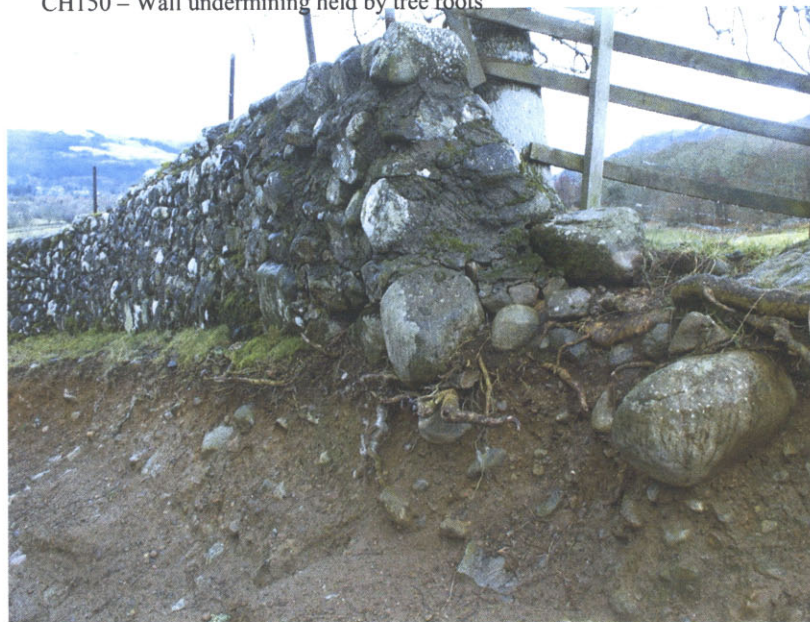
CH150 – Wall undermining held by tree roots

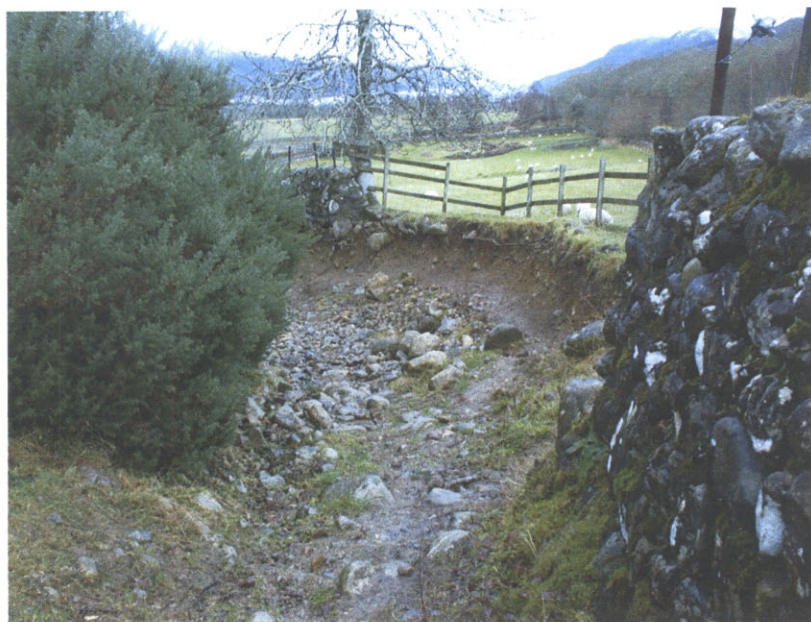
CH170 Washout and wall collapse (see old photo 6)

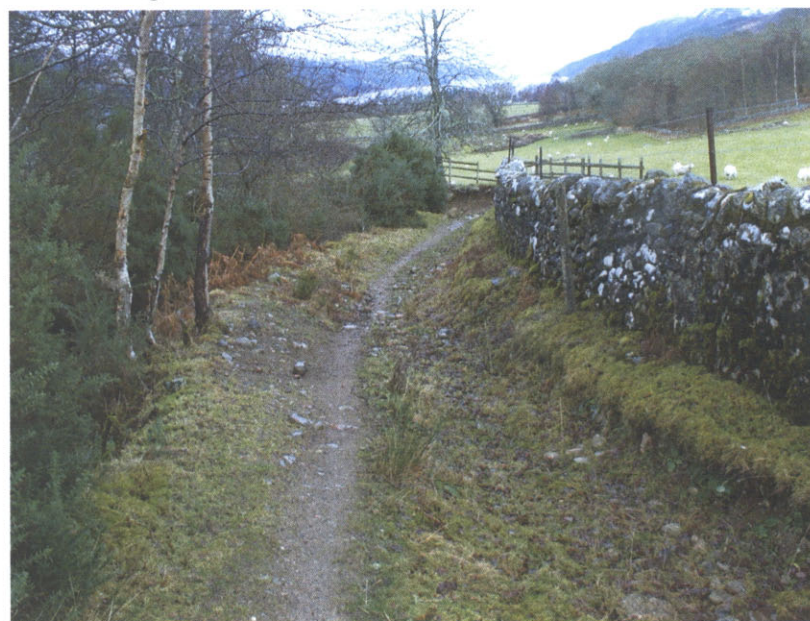
CH200 – re-growth on old washout

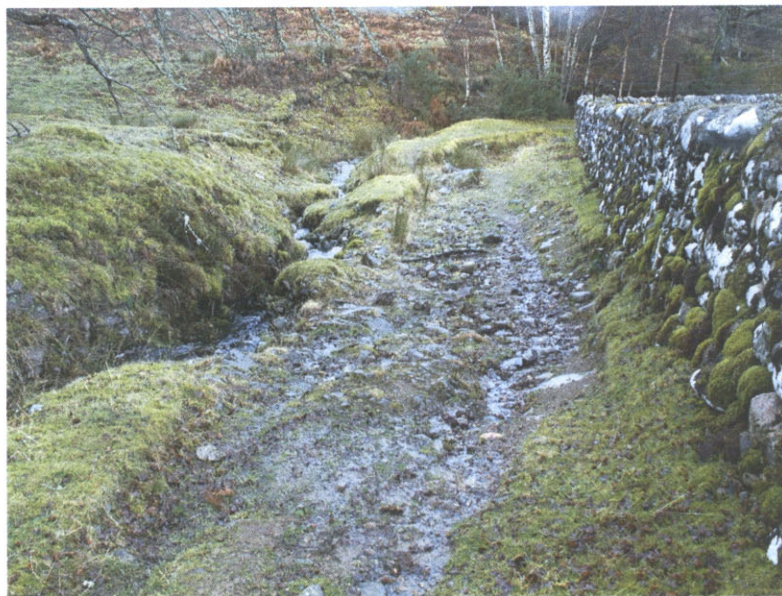
CH210 –rutting by outcrop

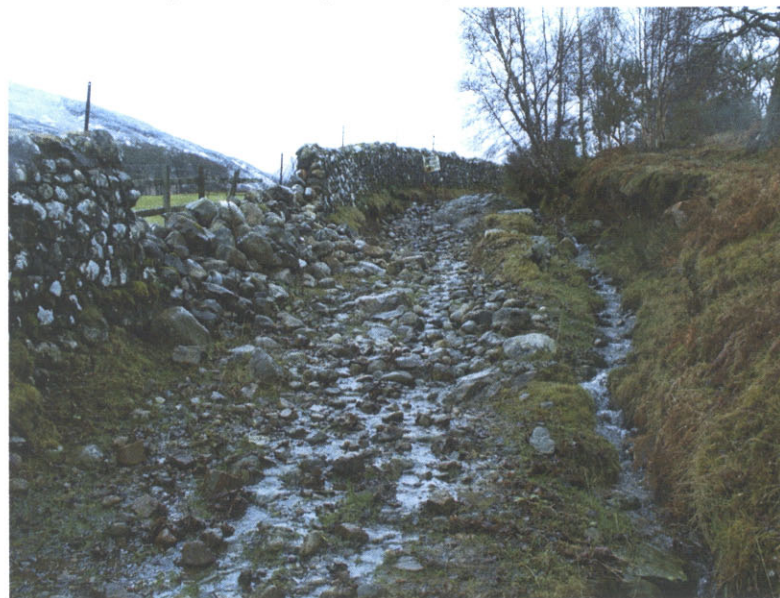
CH210 –rutting and wall collapse (see old photo9)

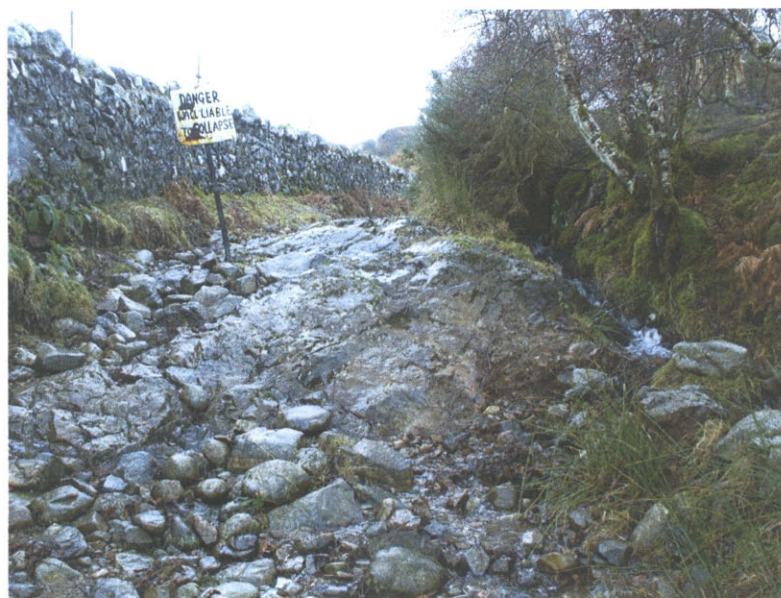
CH230 – Rock outcrop and sign (see old photo 10)

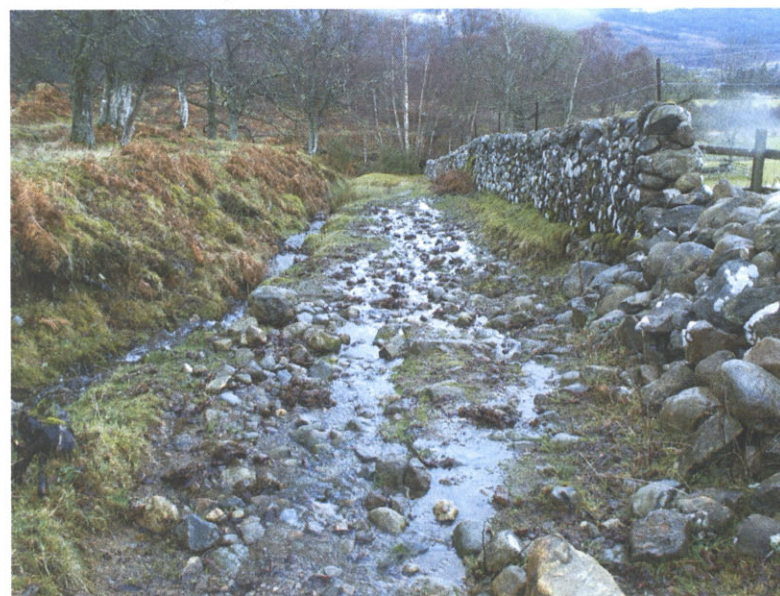
CH260 - Wall collapse

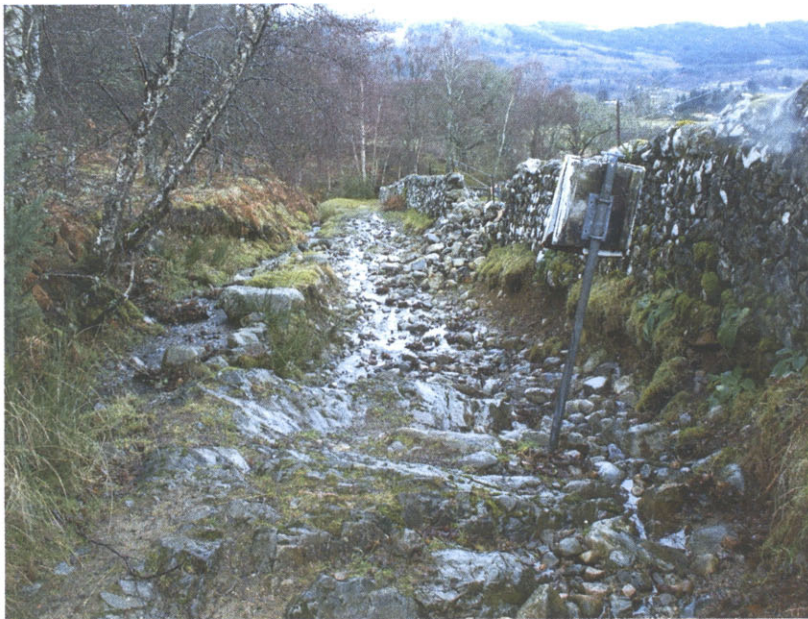
CH270 – Rock outcrop and wall collapse

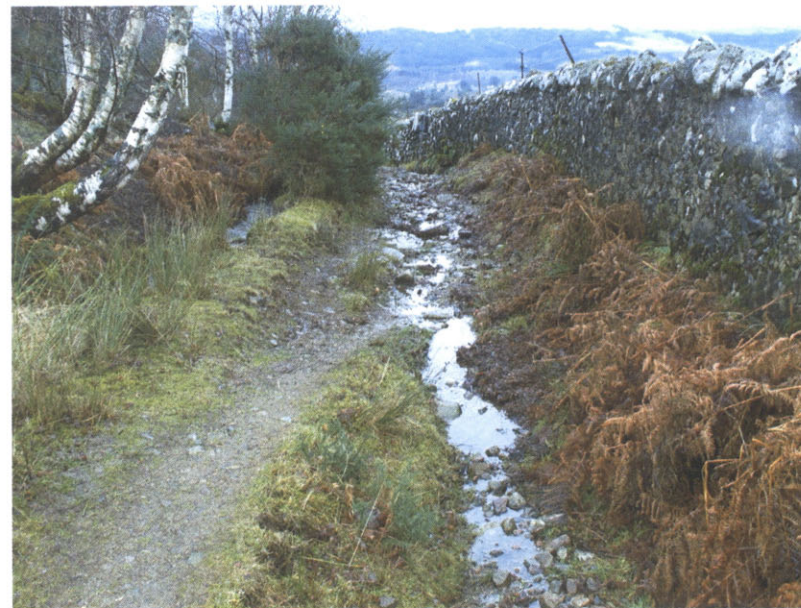
CH290 – Stream on path

Drainage. The drainage on this section should be redefined, upgraded or replaced.

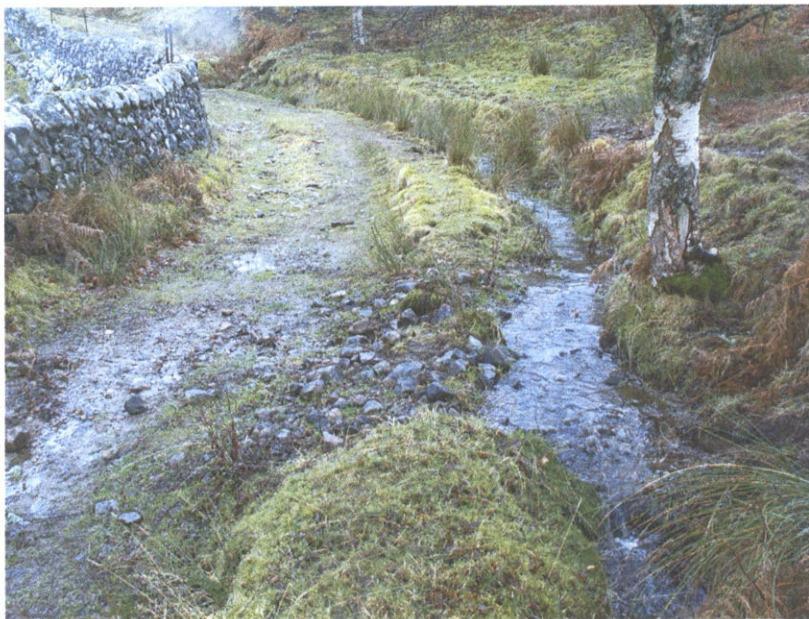
CH290 – Tree to remove from drain

Vegetation clearance. The lower section has seen a gradual encroachment of scrub reducing the width of the route to between 1.5 –2m in places. The scrub on the wall side should be removed, and trees that are influencing the drainage system should be removed.

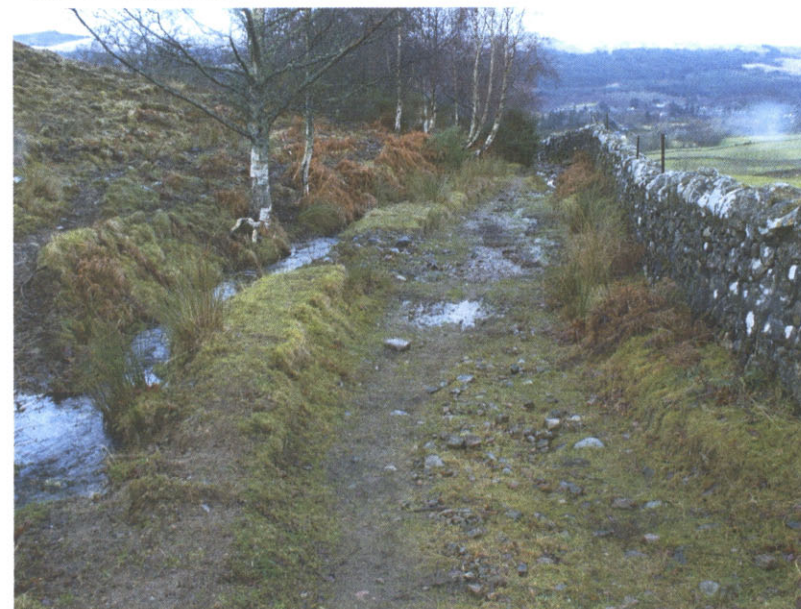
CH300- Bank failure

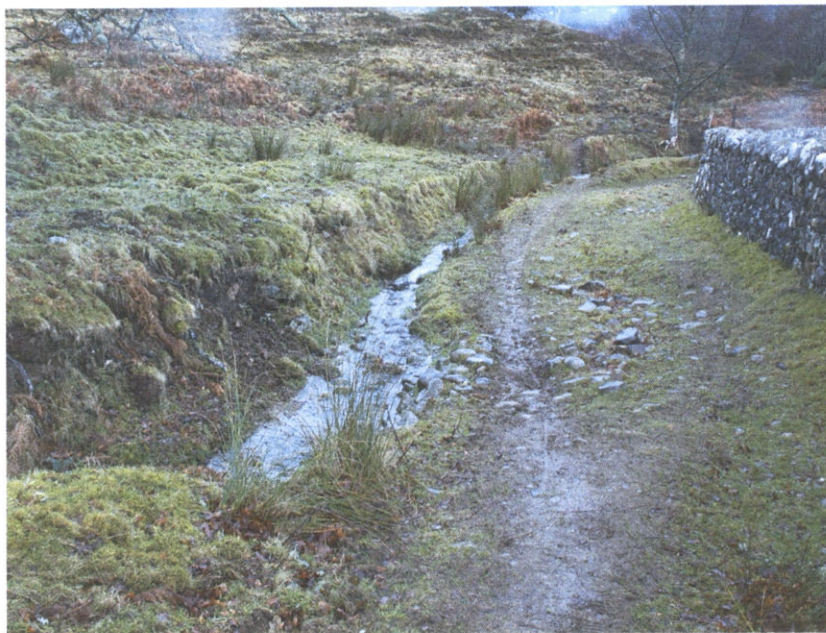
CH330 – Stream cutting cutting into path

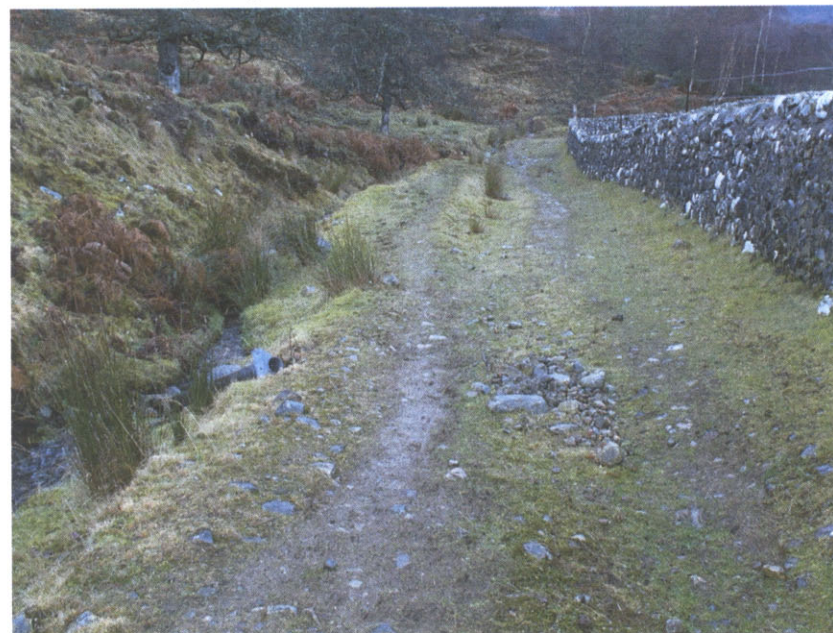
CH350 – Rutting on top section

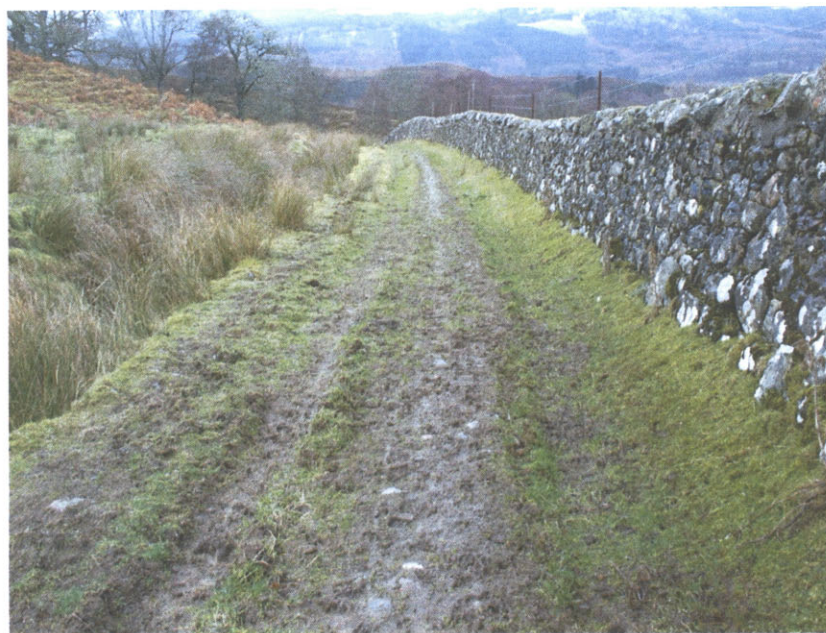
CH420 – top section mud on surface when wet

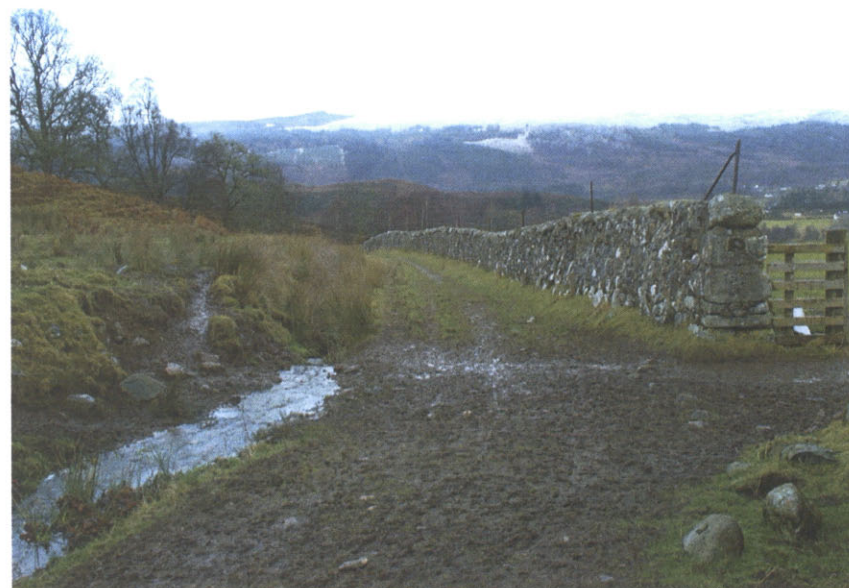
CH450 –Field access point

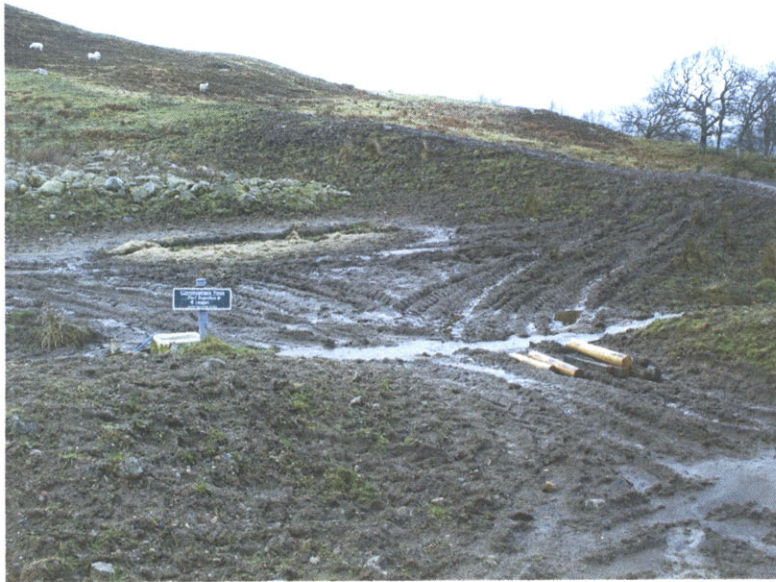
CH470 – Access to hill opp. Culachy access point

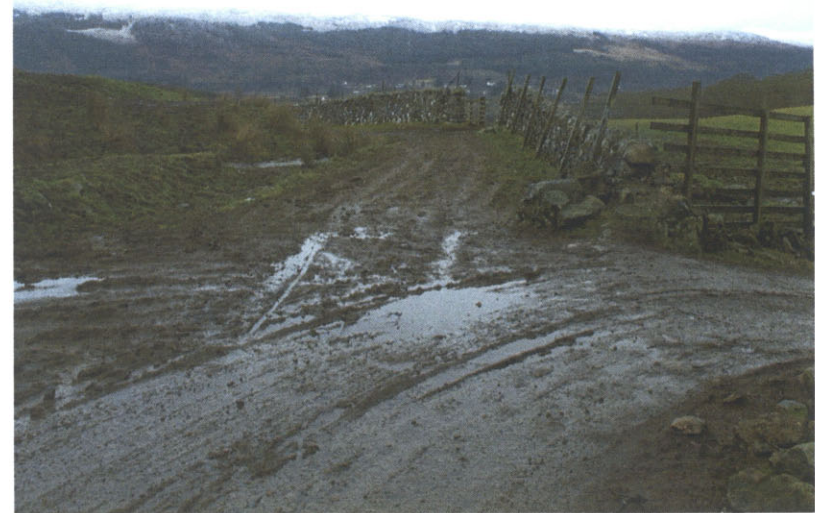
CH470 –Culachy access point

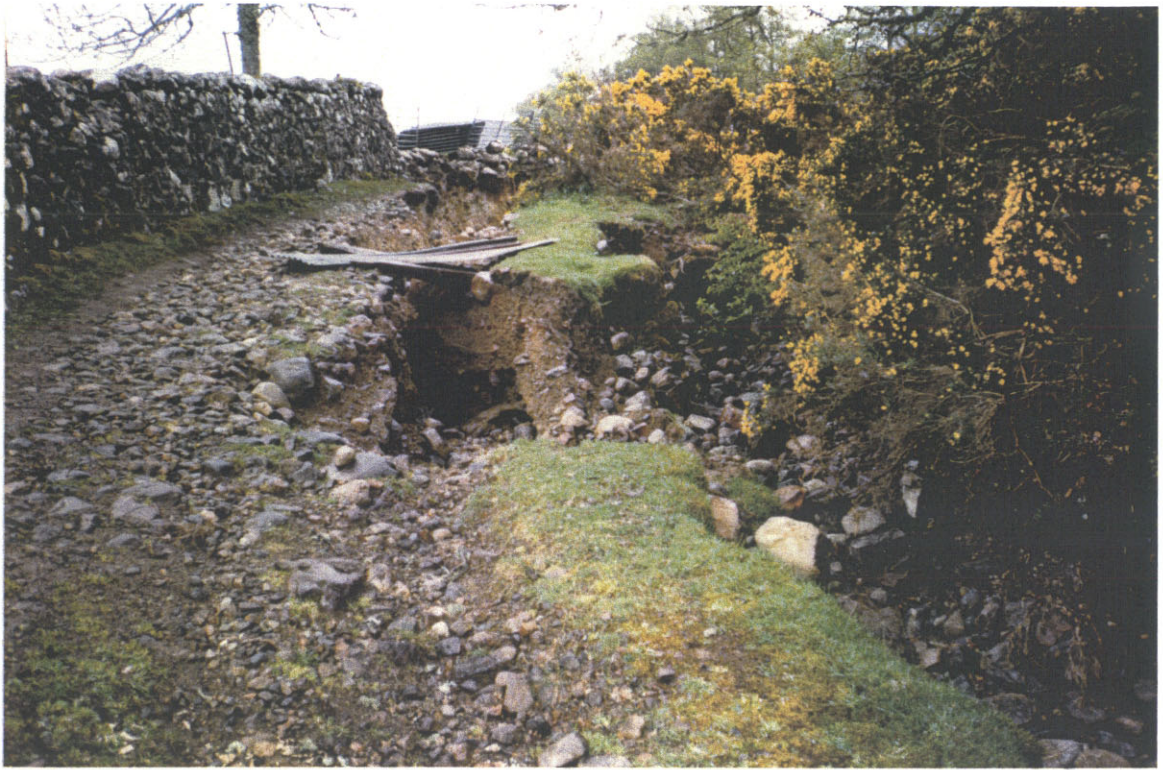
5. Ruts and ditch, at Ch. 130, looking uphill to collapsed wall.

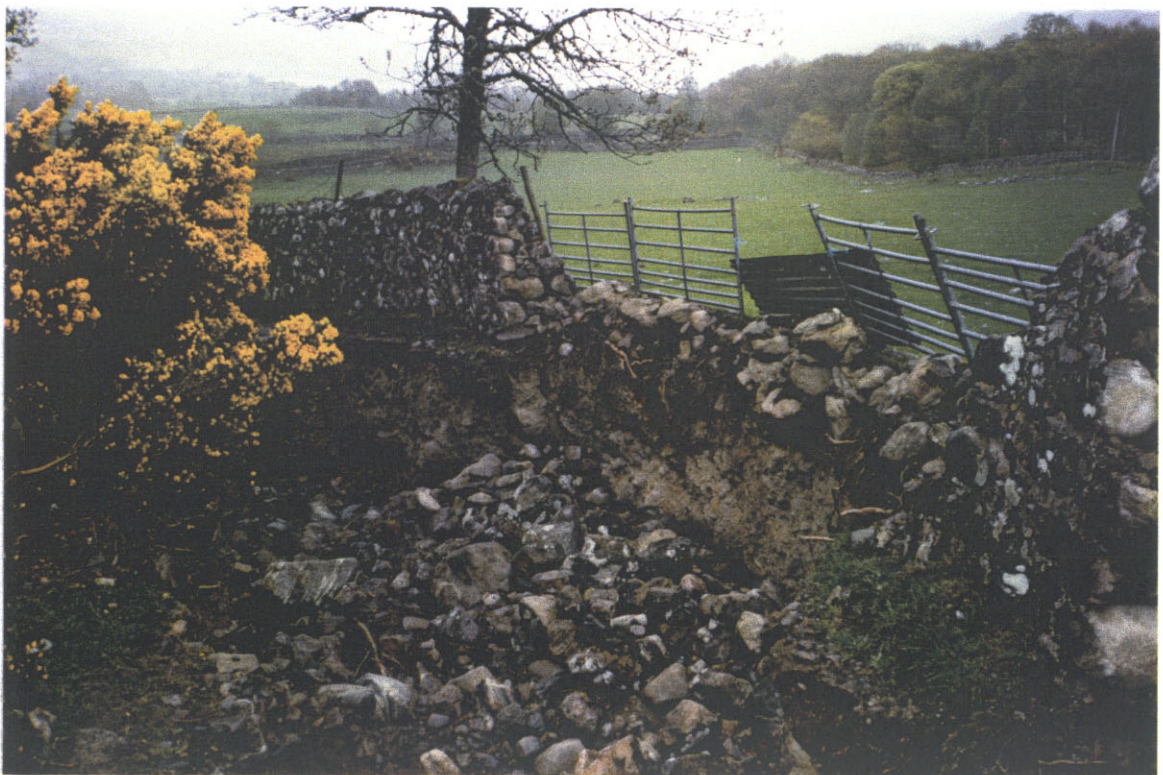
6. Collapsed wall at Ch. 150, looking downhill.

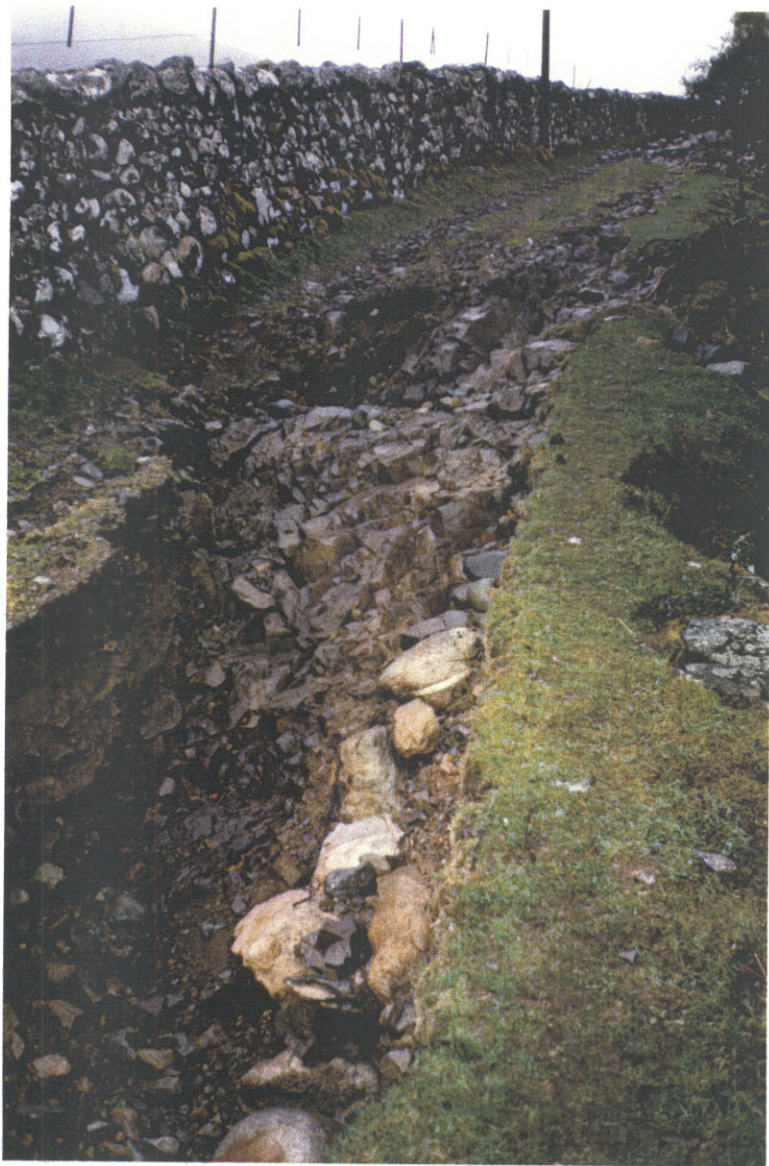
9. Washed out surface, with bedrock and rut, Ch. 210. Sides of ditch collapsed.

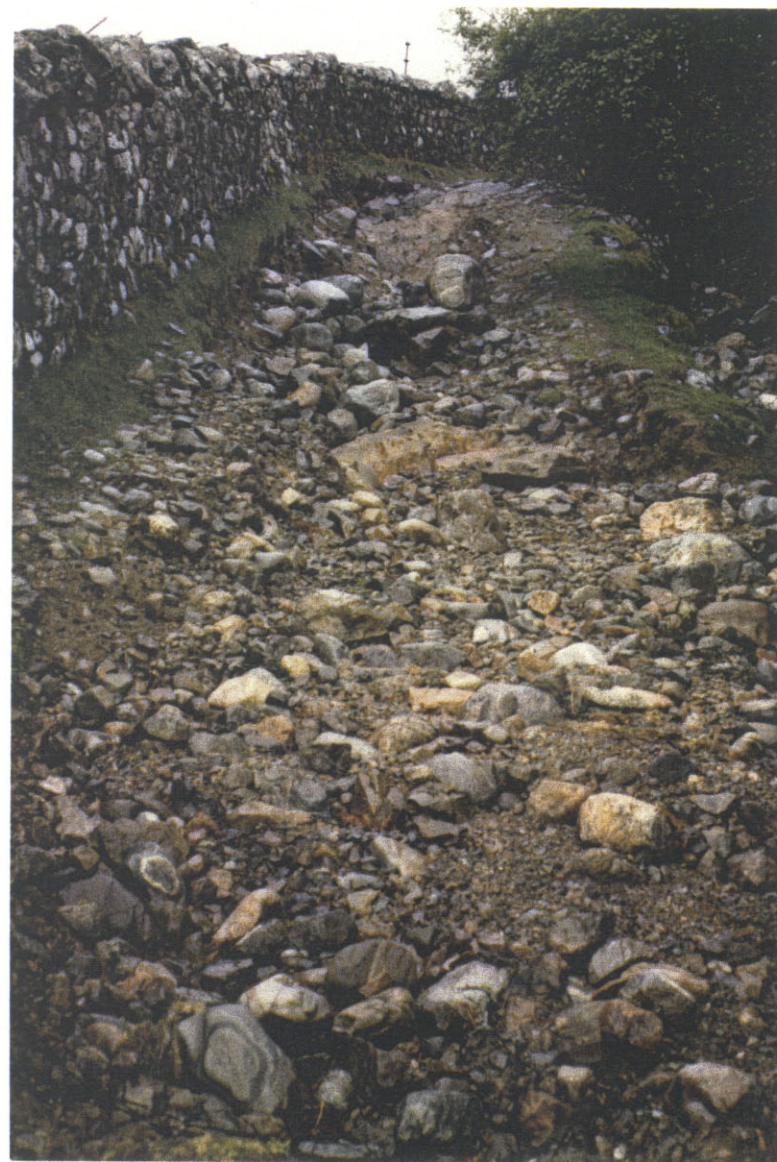
10. Washed out surface with bedrock showing. Ch. 230.
