#### **Military Road at Culachy, Fort Augustus**

#### **REPORT**

#### **Remedial Works After Flooding**

Ref: 237/KGC  
June 1993

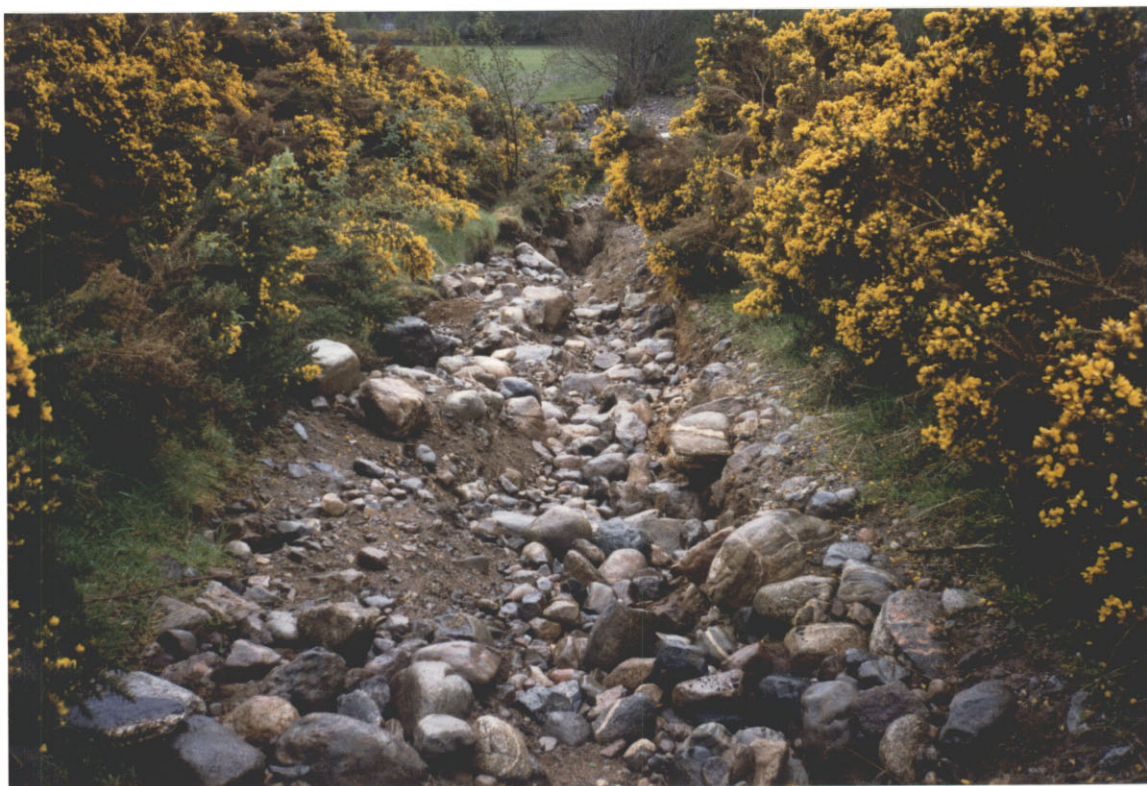
During severe rainfall, the drainage system had become choked and water had then run down the road. Several areas of the road have become gouged out forming channels up to 2.0 metres deep down the centre of the road. In some areas, most of the road surface had been washed away also.

1. Looking downhill to public road. Showing road surface washed away and start of deep ruts.

The work involved in remedial works to roadworks is largely self explanatory. Ruts require to be infilled with granular material up to formation level, and the surface reinstated.

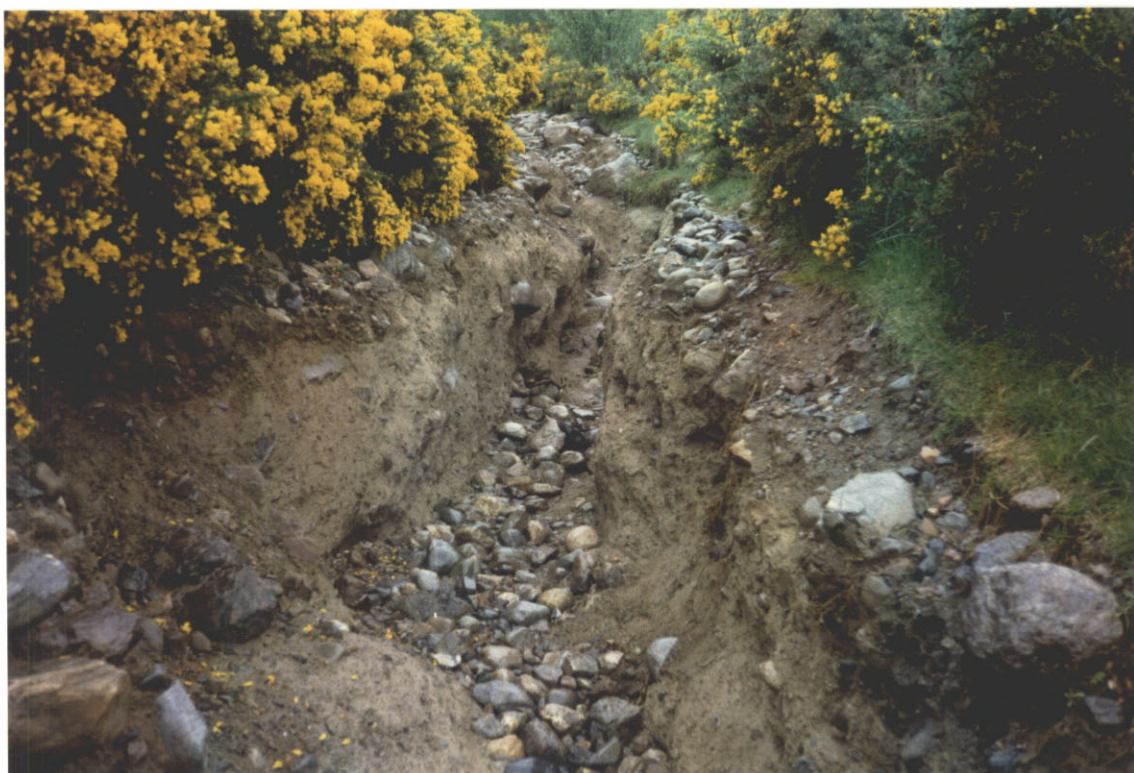
2. Deep ruts at Ch. 50

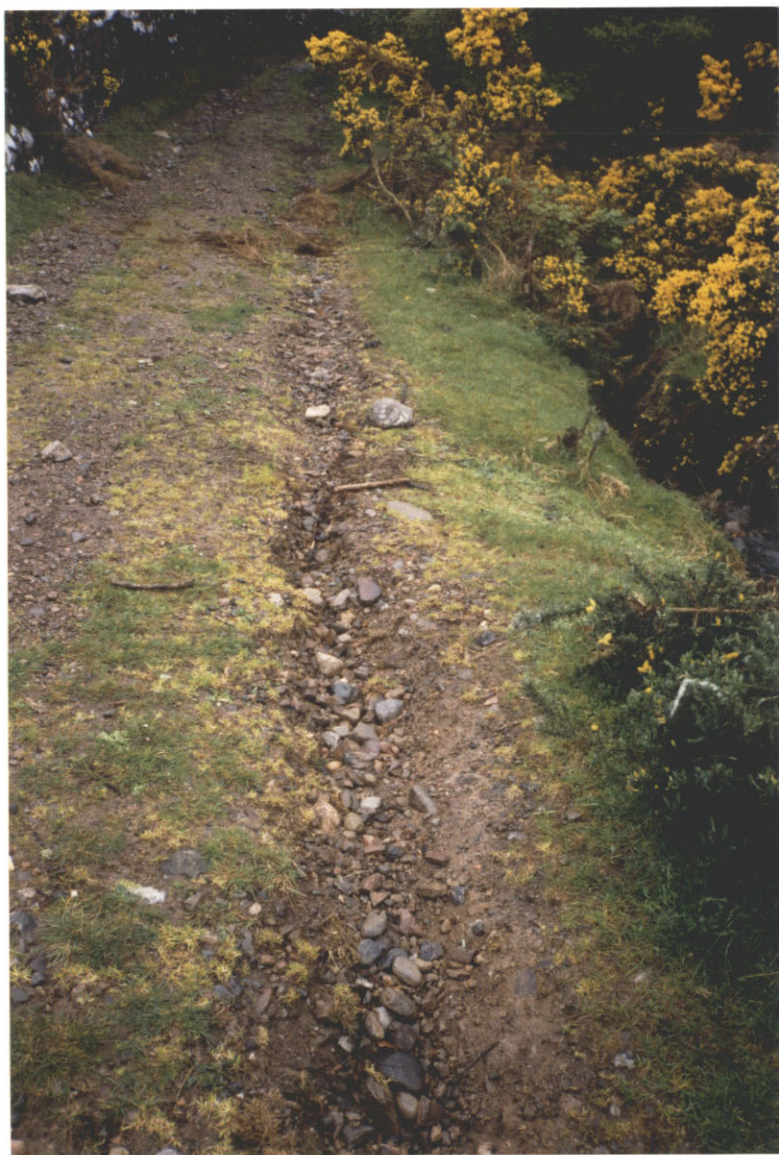
·3. Existing road surface with minor rutting. Ch 70

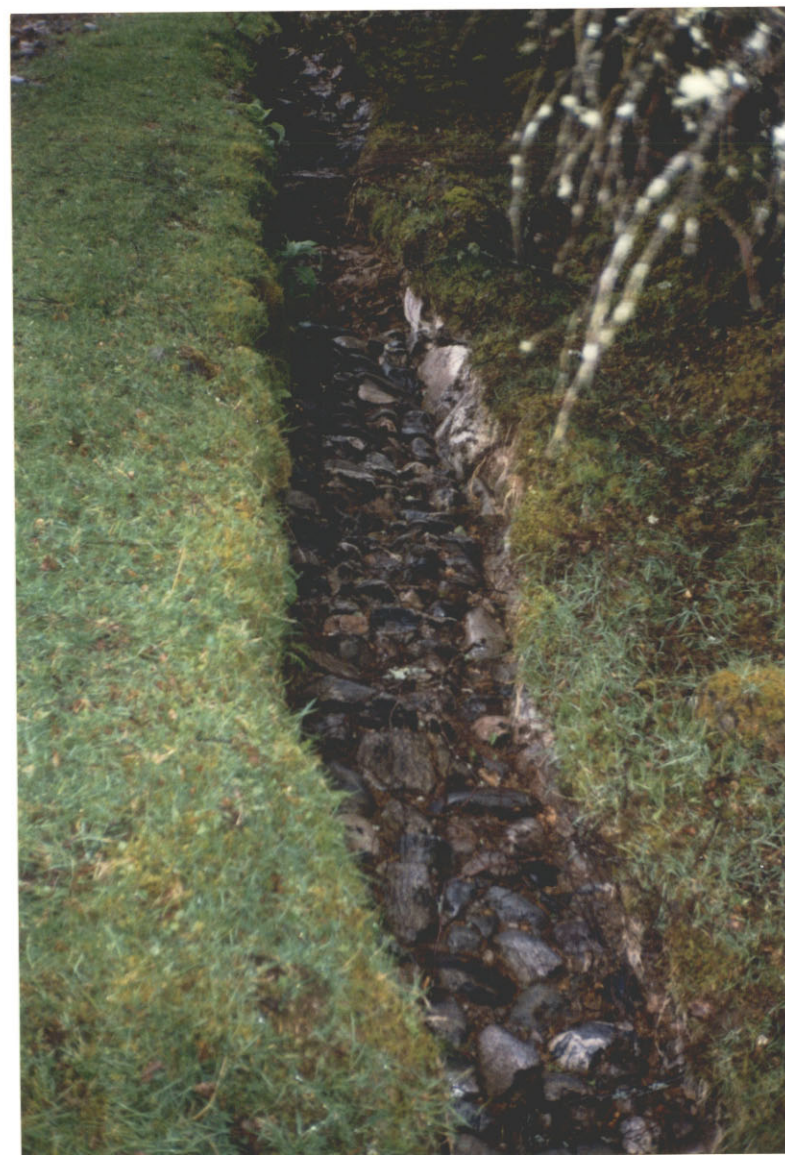
The ditch has been paved, both invert and sides and this is in satisfactory condition in some locations. In other places some of the sides of the ditches have fallen in, allowing scour.

·4. Paved ditch in good condition. Ch. 90

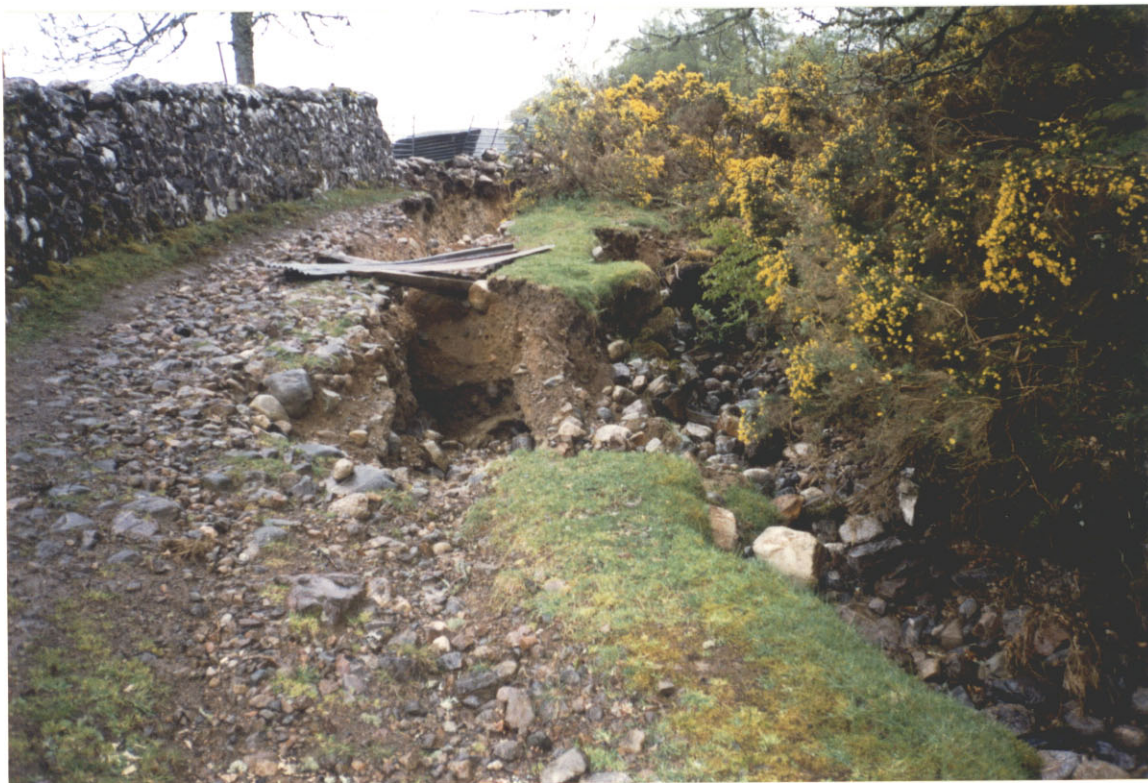
5. Ruts and ditch, at Ch. 130, looking uphill to collapsed wall.

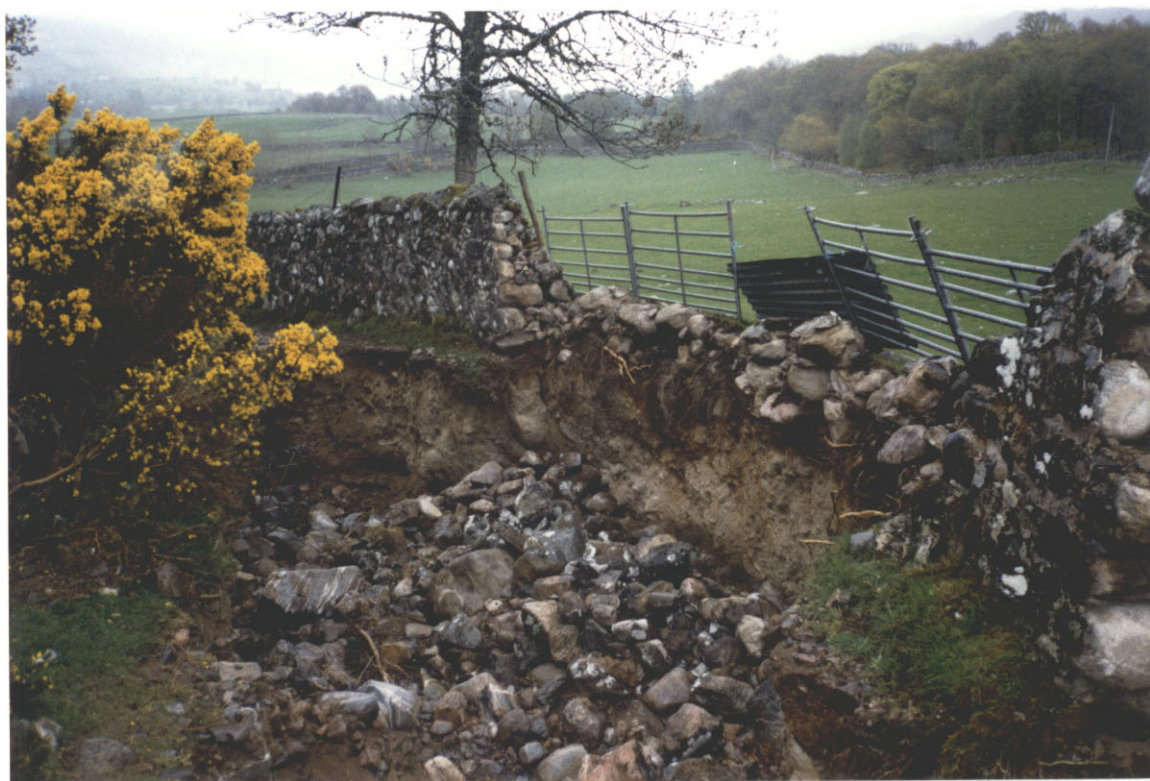
A dry stone wall is situated on the North side of the road, and at one location where the road had been washed out, this wall had become undermined and has collapsed.

6. Collapsed wall at Ch. 150, looking downhill.

Some sundry items are recommended to be carried out. The major item in this section is rebuilding the demolished section of dry stone wall. Other items include provision of a new gate at the public road, installation of some fencing and the provision of new signs at the public road.

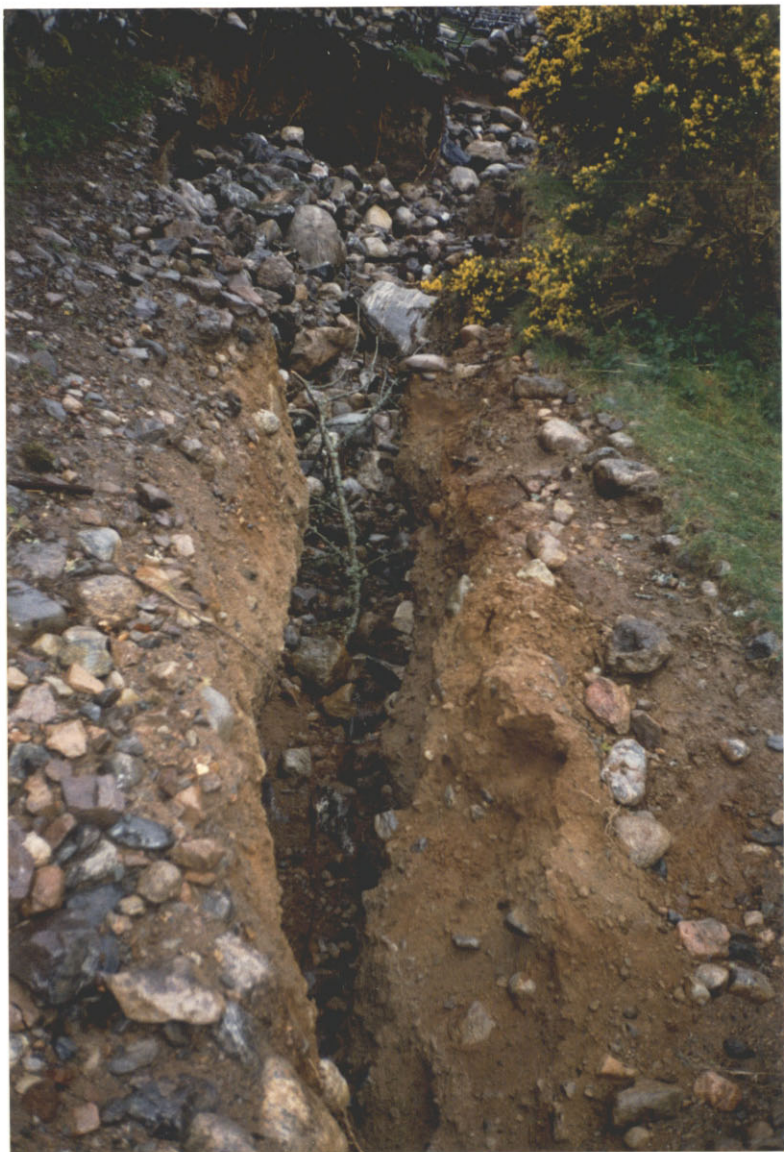
7. Deep ruts at Ch. 145, looking uphill.

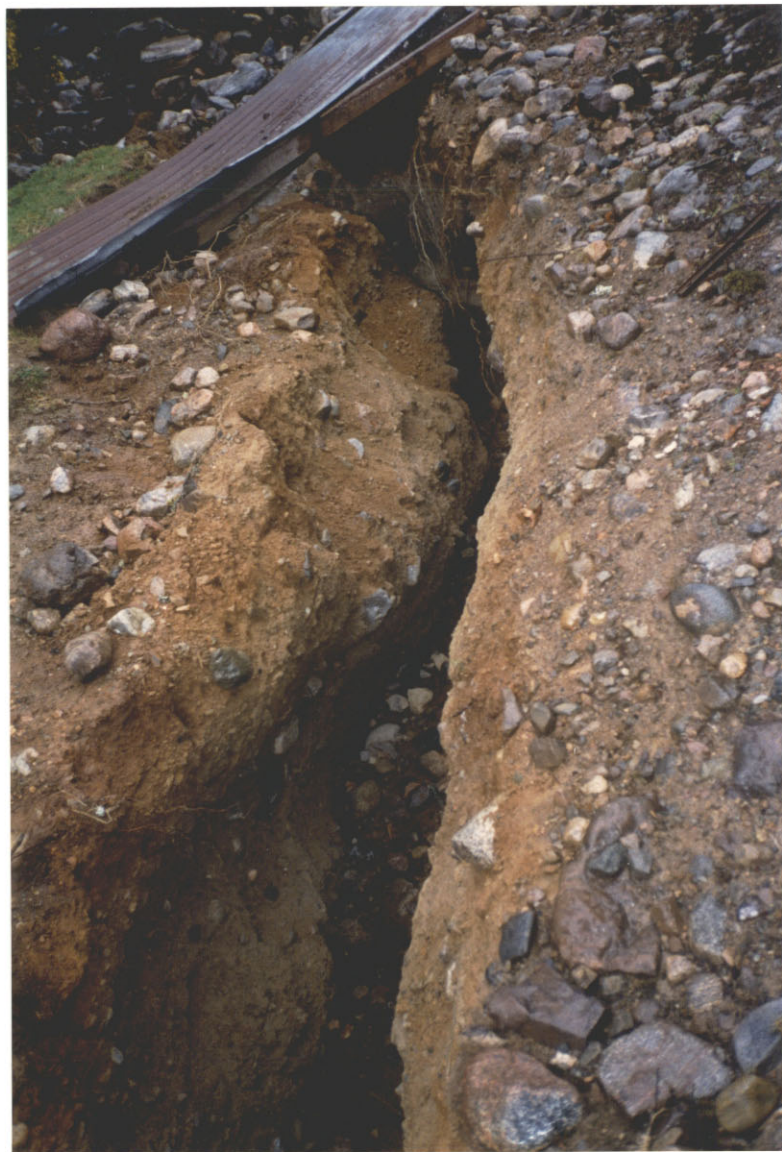
8. Deep ruts at Ch. 145 looking downstream.

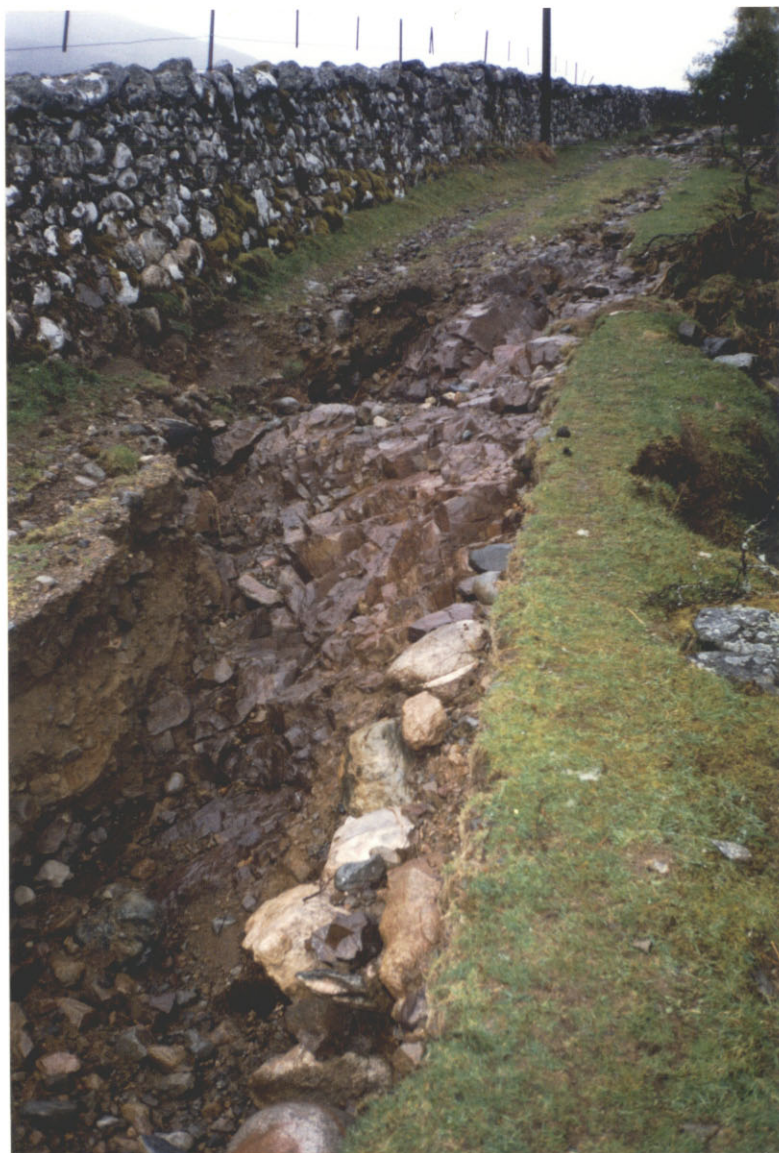
9. Washed out surface, with bedrock and rut, Ch. 210. Sides of ditch collapsed.

In order to overcome the existing difficulties we advise the replacement of the culverts with 500 dia. corrugated pipes, with the construction of associated headwalls. The ditch requires to be re-excavated in many locations and to be re lined in several places. The extent of the recommendations is noted on our Drawing No 237/2 at Appendix I.

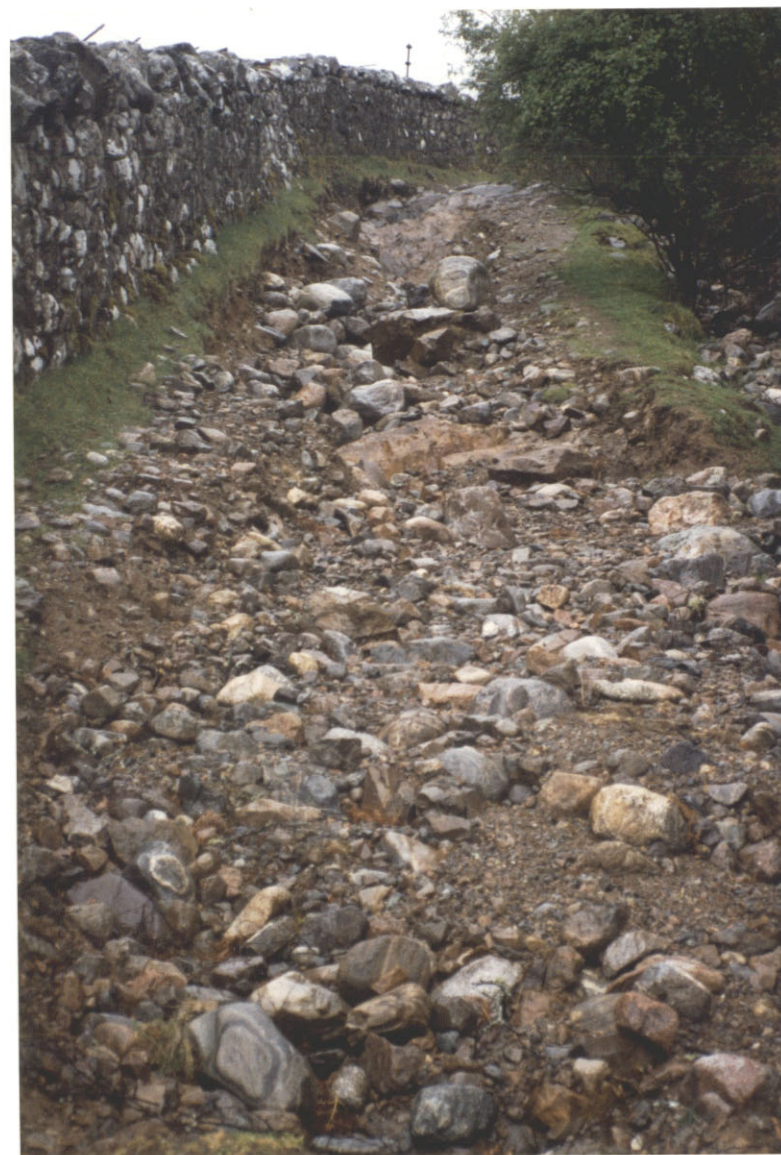
10. Washed out surface with bedrock showing. Ch. 230.
