Photographs and Observations

Survey carried out 12th October 2015

Photographic Survey:

Inchnadamph Lodge & Outbuildings

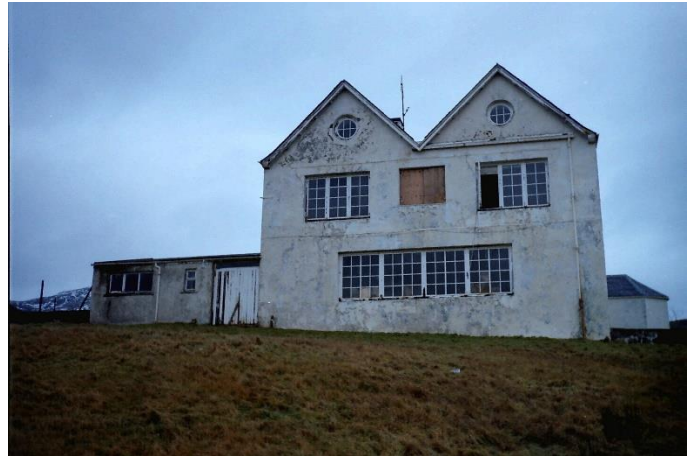
Historic photographs showing the extent of the damage from years of neglect when the Lodge building was originally purchased.

West Elevation 1994 – Facing A837

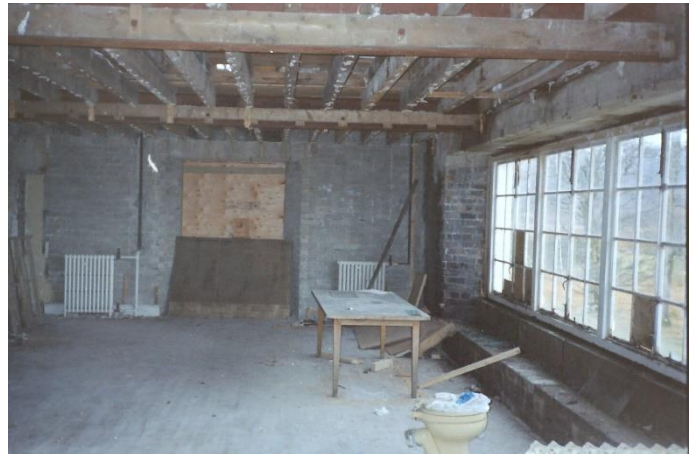
Dining Room Interior

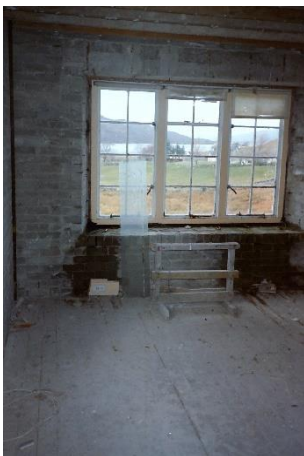
First Floor west facing bedroom

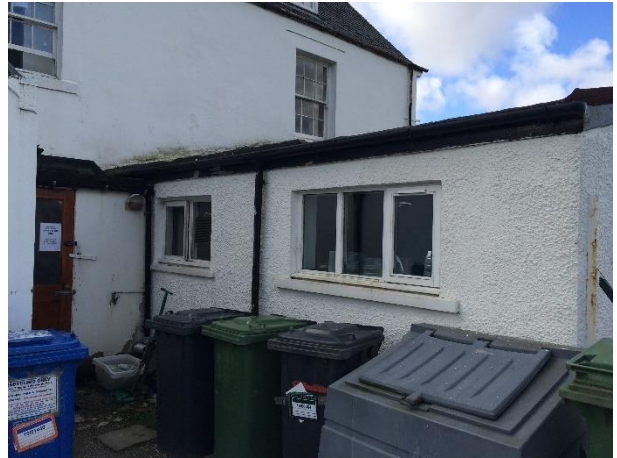
Photographs showing the existing extension to the north elevation. This is a garage which has been retained to serve as kitchens, however in spite of continual maintenance the building fabric is not up to current building regulations and the core materials are of a poor standard.

The extension originally a garage is construction from concrete block with roughcast. Internally minimum insulation and plasterboard lining. The roof is 3-ply roofing felt on chipboard and timber rafters with an internal plasterboard lining.

Lodge extension – East Elevation

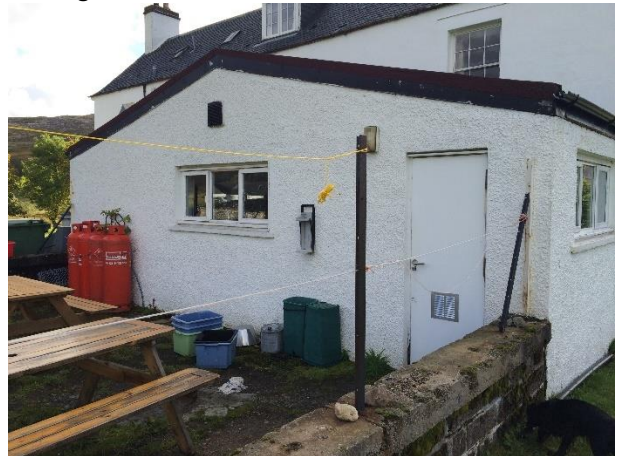
Lodge extension – North Elevation

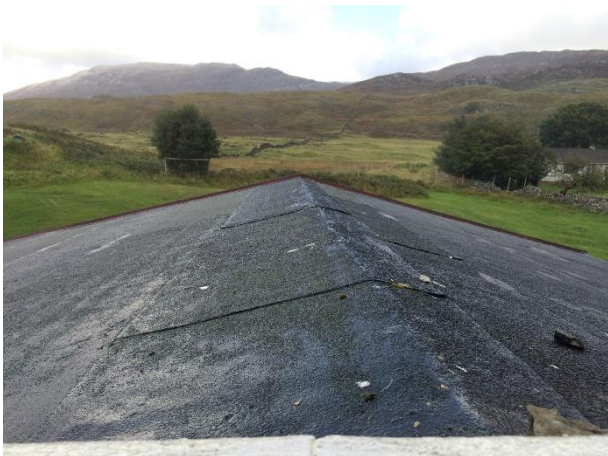
Roof to extension

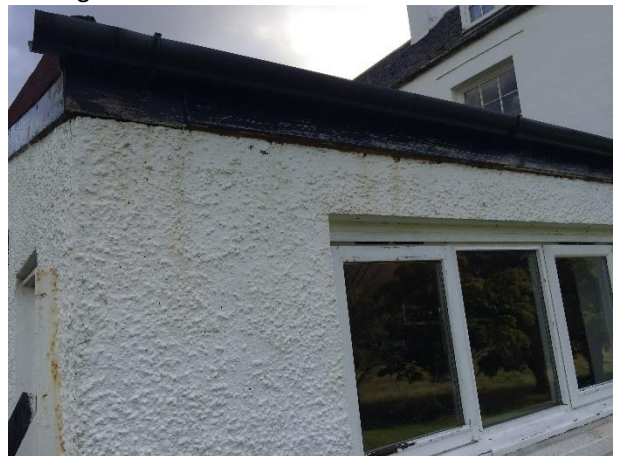
Lodge – North Elevation existing extension

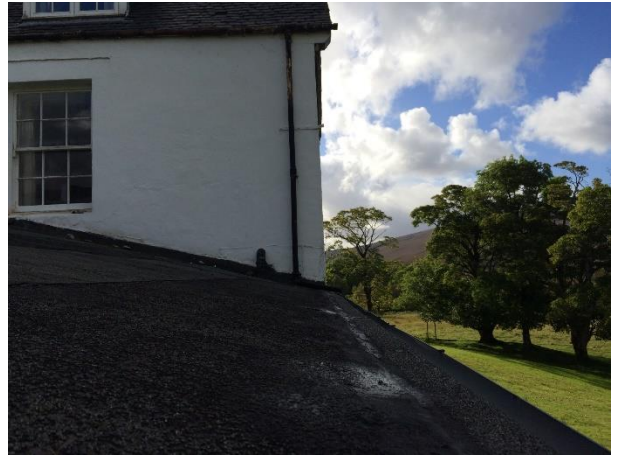
Photographs showing the existing extension to the north elevation. This is a garage which has been retained to serve as kitchens, however in spite of continual maintenance the building fabric is not up to current building regulations and the core materials are of a poor standard.

The extension originally a garage is construction from concrete block with roughcast. Internally minimum insulation and plasterboard lining. The roof is 3-ply roofing felt on chipboard and timber rafters with an internal plasterboard lining.

Lodge extension – Roof junction with lodge north side

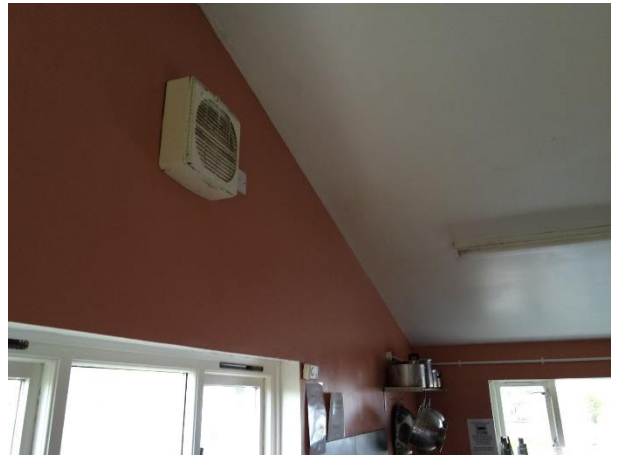
Lodge extension – interior

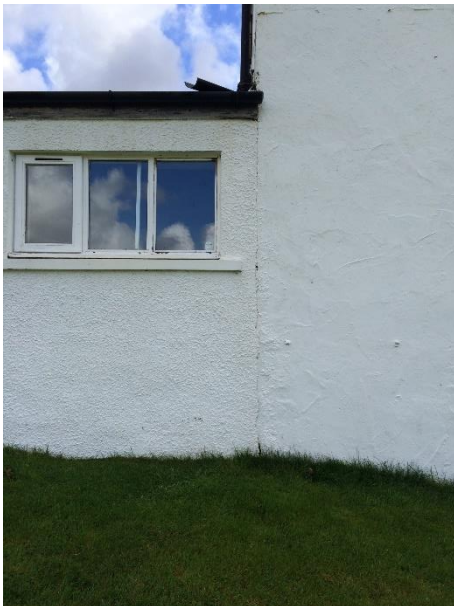
Extension – junction with lodge

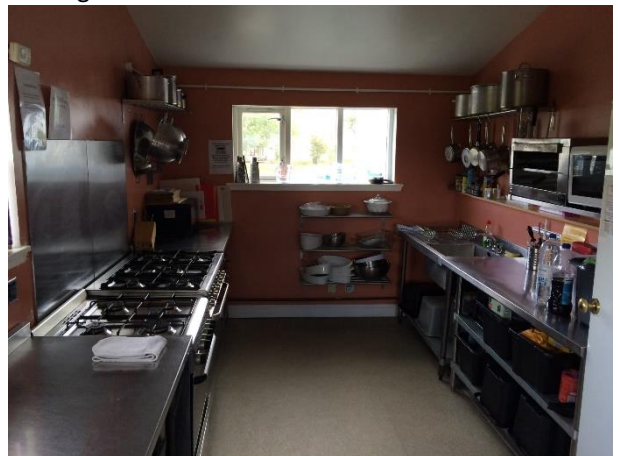
Extension - interior

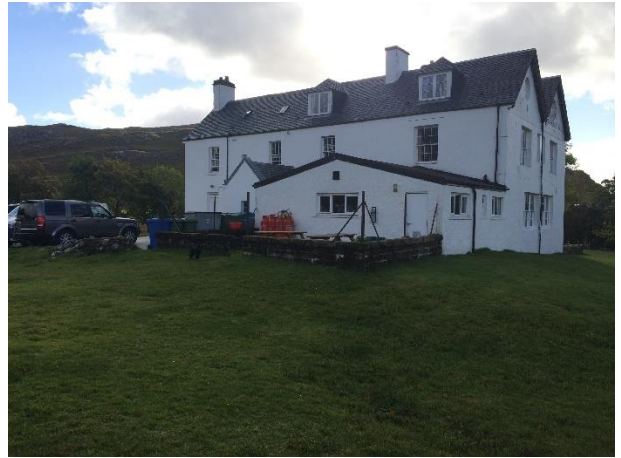
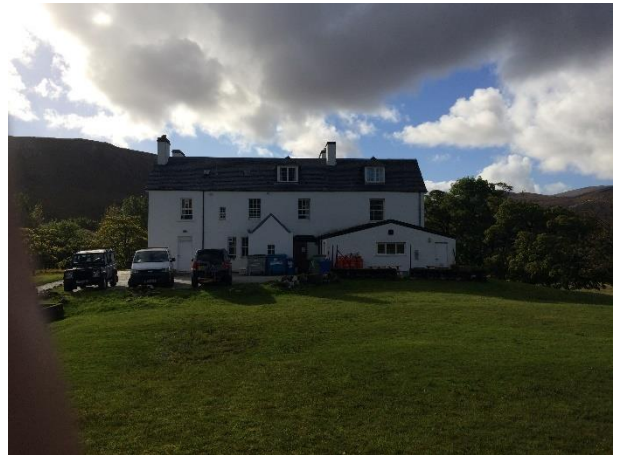
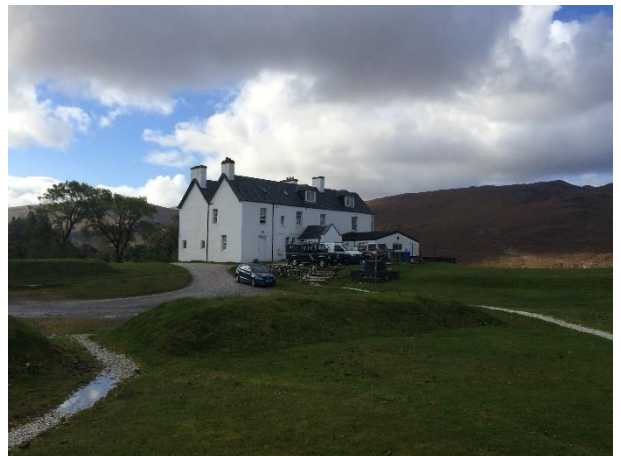
Photographs of the lodge extension to show its location and position against the lodge.

The wide and low proportion of the extension is unsympathetic with the lodge building. The extension is joined prominently extending the principal west elevation detracting from the existing proportion of the lodge and its double pitched 3 storey massing.
