Historic Scotland
Properties in Care
Minor Archaeological Works 2008-9

Urquhart Castle:
Archaeological excavation and
monitoring,
December 2008 & February 2009

HS PIC Index number: 90309
Project codes: HSCO-90309-2008-01
HSCO-90309-2009-02

24 March 2009
Kirkdale Archaeology

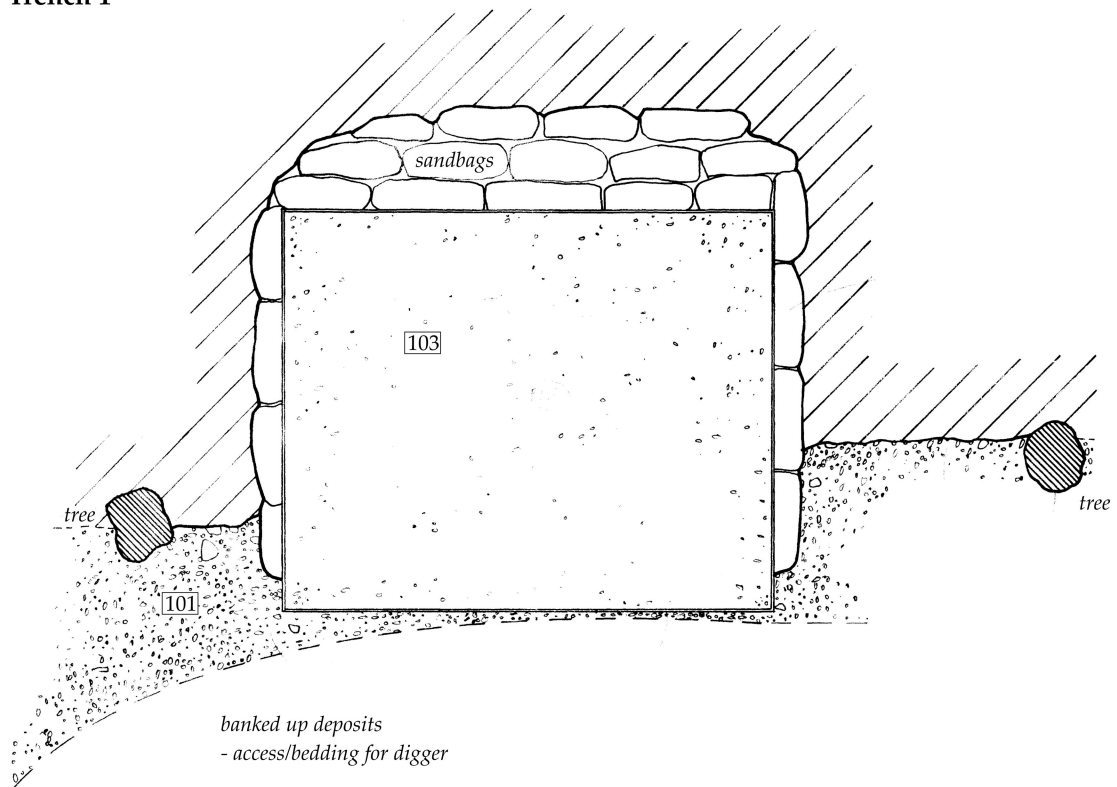
Trench 1

The cofferdam enclosed an area 2.08 m N-S x 2.58 m E-W. As the beach was sloping down from S-N, this required an excavated depth of 800 mm to the S while to the N it was only necessary to remove 400 mm. The presence of the trees to the E and W meant that there was a considerable amount of roots present within the trench; even though the sheet piles had severed many of them, they were still extremely difficult to move. The trench was photographed at various stages of excavation and a post-excavation trench plan was made. The upper 150 mm of the fill comprised **101**, voided, loose, yellowish brown sub-rounded pebbles <20 mm which had been continuously displaced by the cyclical action of the water at the shoreline. Below this was **102**, a very compact layer of similar pebbles in a yellowish brown sandy clay matrix held together by the numerous roots which had seemingly prevented the scouring action apparent in the layer above. The excavation reached its limit by exposing **103**, the top of a layer of compact yellowish brown sandy clay of indeterminate depth. The action of the loch had created a clean upper pebble layer, a mixed pebble and clay central layer and a clean clay lower layer. There were no features of archaeological significance encountered. Once excavated and planned,

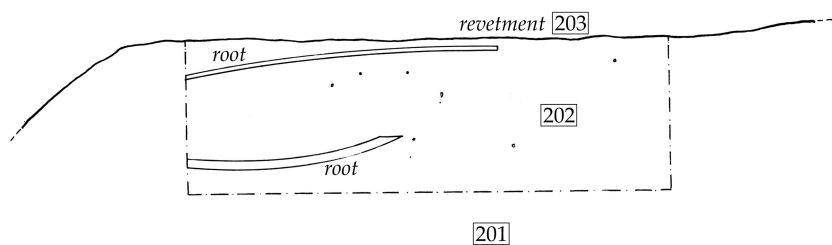
Trench 2

To provide a platform for access to the jetty it was necessary to de-turf an area 2.45 m S of Trench 1, 1.00 m N-S x 3.20 m E-W over an un-jointed sandstone revetment wall, **201**. A depth of only 80 mm was removed – this was not deep enough to expose the wall in plan. This exposed **202**, a layer of dark brown silt topsoil used to bed the turf; it was again heavily cut through with roots. The revetment itself, **203**, was up to 650 mm high and was formed of angular pieces of pinkish-grey sandstone (up to 300 mm across x 150 mm high), none of which were dressed. No mortar bonding was apparent. Apparently, this revetment once stood *c* 1.5 m higher, built by the local farmers in the mid-20th century as a livestock barrier. It was then reduced in the late 20th century so as not to obscure the view of the loch, and covered with topsoil and turf (pers. comm. HS staff member).

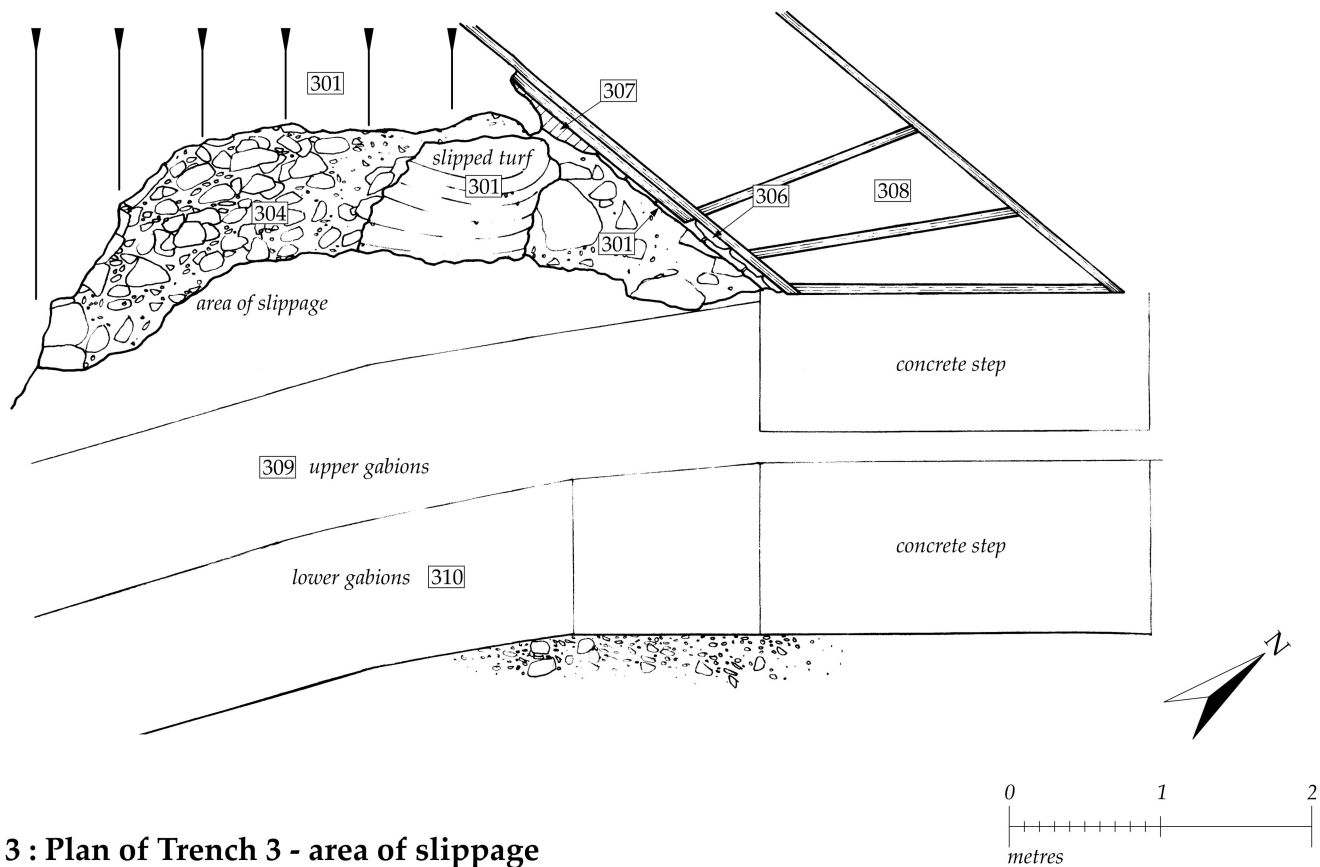
Fig. 3 : Plan of Trench 3 - area of slippage

Historic Scotland requested that a record be made of the area of slippage E of the Water Gate, at the foot of the slope separated from the loch by stone-filled Gabion baskets. This had exposed the S side of the stair and the slip comprised a roughly crescent-shaped area up to *c* 5.0 m long (N-S) and up to *c* 1.0 m wide (E-W) the exposed section was up to 800 mm high. The section comprised the turf, **301**, up to 80 mm thick over a 180 mm thick layer of moderately compact yellowish brown sand, **302**. The sand layer had been used apparently not only to bed the turf, but as a levelling layer over a compact (but cracking) layer of angular pink sandstone pieces (10-180 mm) bonded in a matrix of mid-brown silt, **303**. Below this was a layer (exposed to a depth of 200 mm) of voided pieces of angular pink sandstone **304**, 50-260 mm across, some pieces with a yellowish lime mortar adhered to their faces. This appeared to be a layer comprising material that had gathered as a result not only of the disintegration of the Gate and rampart walls but also as a result of deliberate stone robbing and shaping indicated by the varying size of the sandstone flakes and pieces.

problem appears to be that the sheer weight of the deposits on such a steep incline and wave action from the loch (given that they sit at this point on voided rubble) has caused slippage. An upper (309) and lower (310) row of stone-filled Gabion baskets between the break of slope and the shoreline are signs of efforts to reduce the water erosion.

The remedial work for the slippage is intended to include the replacement of the slipped bank with similar turf and topsoil, which should preclude the need to excavate the section by formal archaeological means. However, if intrusive excavation is necessary it should be carried out under archaeological supervision.

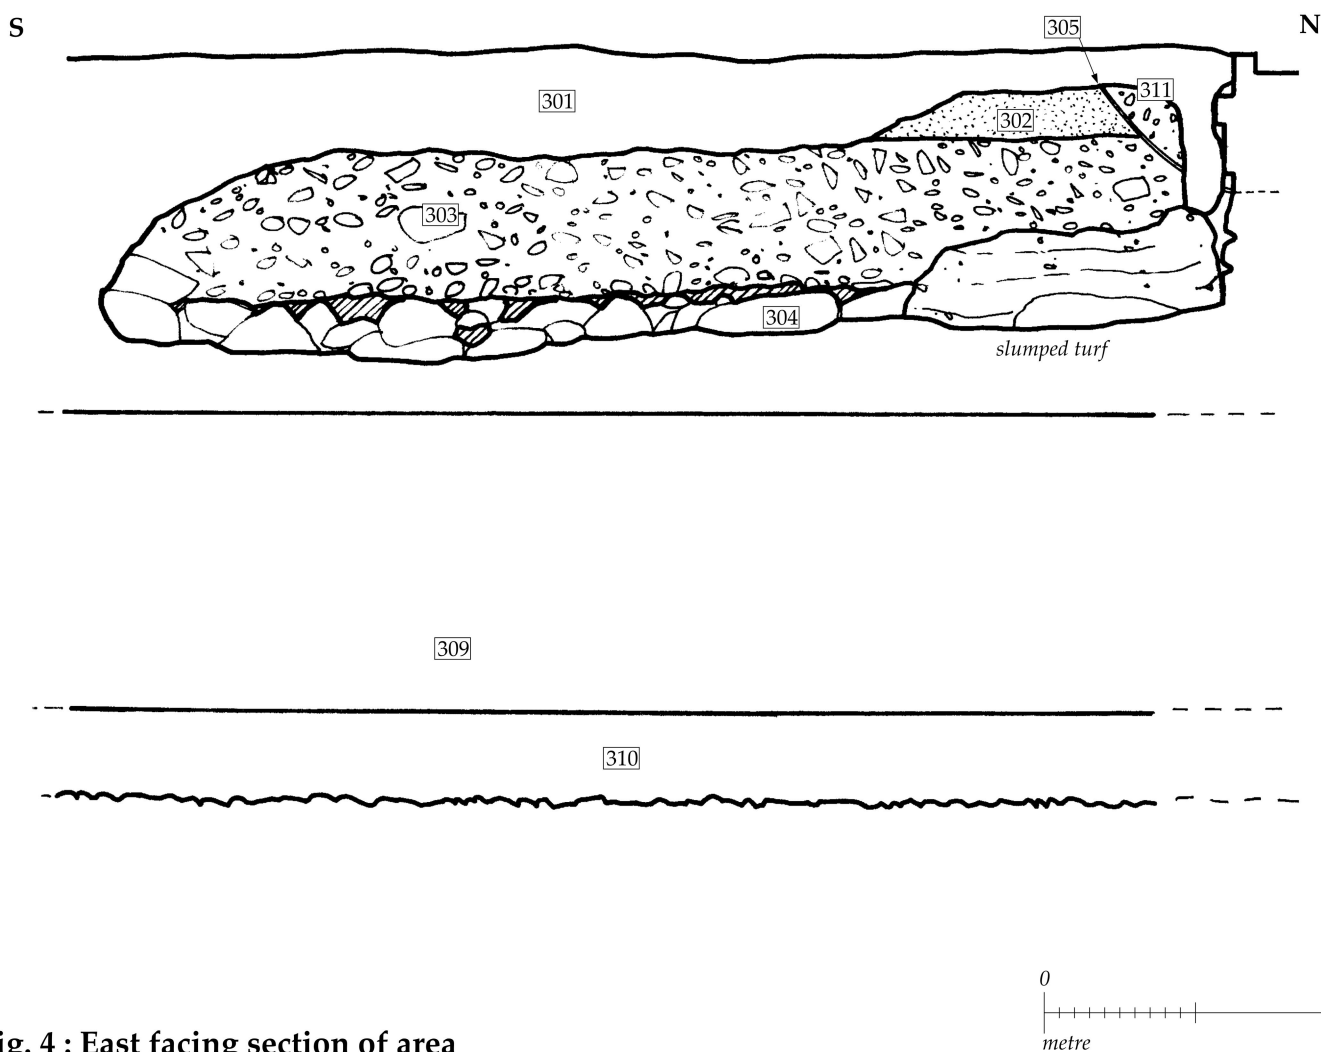
Fig. 4 : East facing section of area

The steps leading from the Water Gate to the shoreline appear to postdate the landscaping of the slope. A sloping cut (only partially exposed to the S of the stair), 305, truncates the slope make up and within it sits a deliberately laid rubble base, 306, of angular pink and grey sandstone pieces up to 300 mm across - this is 400 mm high where exposed. On top of this is a thin black Terram, 307, which beds the wooden-edged concrete steps, 308. To the S of the steps, the area between the steps and the Terram is backfilled with a mixture of silt and angular sandstone, 311, which is likely to be a re-deposited fill comprised of excavated material from 303.

The examination of the slippage at the Water Gate revealed modern landscaping overlying original deposits. Although the imported materials have been eroded and collapsed, they may have helped protect more significant deposits below them.
