Doire-
chlaigionn

Centred on NG
82575 54783

Doire-chlaigionn centred on NG 82575 54783

This settlement is situated on an E facing slope leading down to Ob Mheallaidh on Upper Loch Torridon and to the NE of the village of Shieldaig.

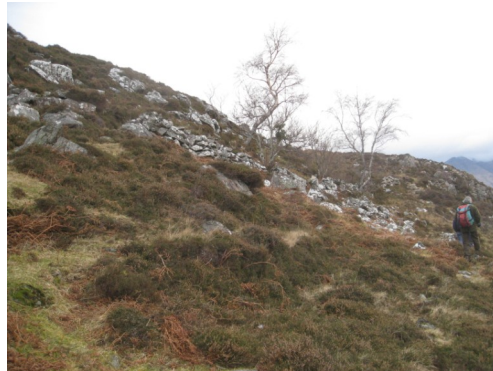
1. part of the head dyke

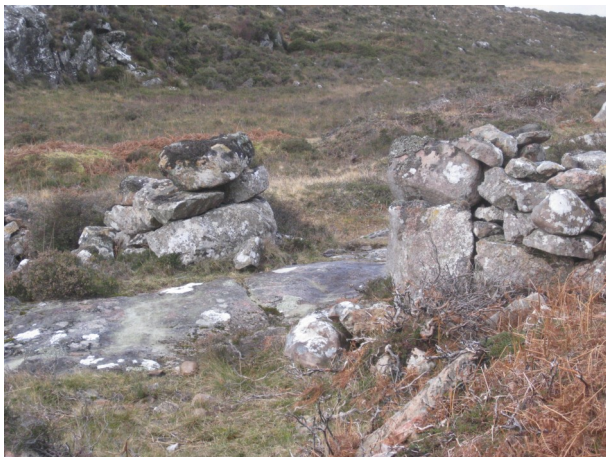
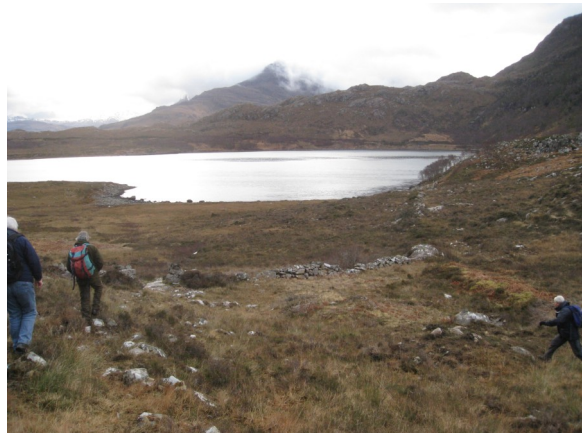
2. part of the head dyke with gateway. NG 82352 54357

There is a turf wall adjoining the stone dyke at this point.

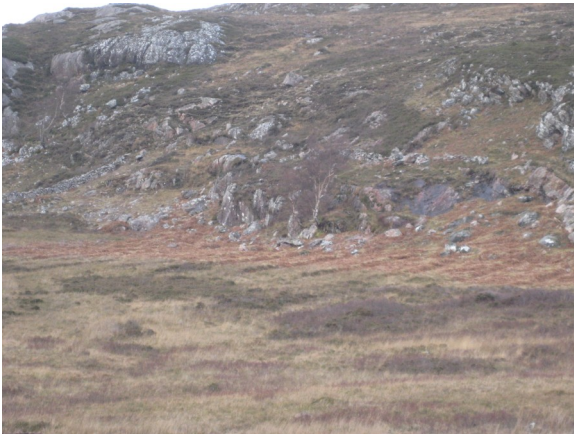
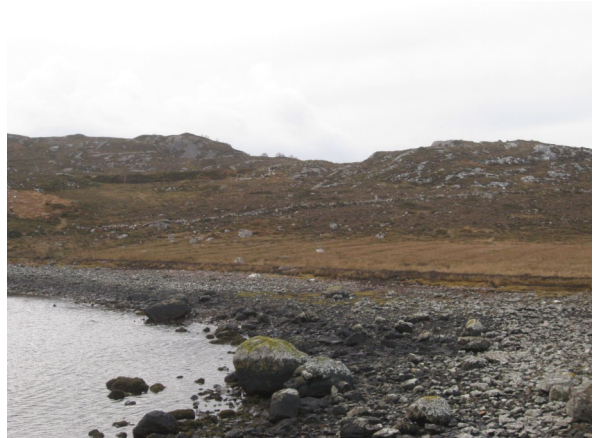
3. rigs/lazy beds NG 82408 54370 and 5. NG 82474 54443 In this area there are numerous rigs some stretching down to the sea.

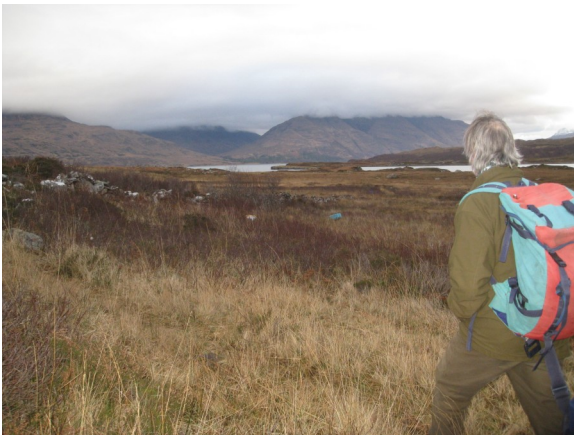
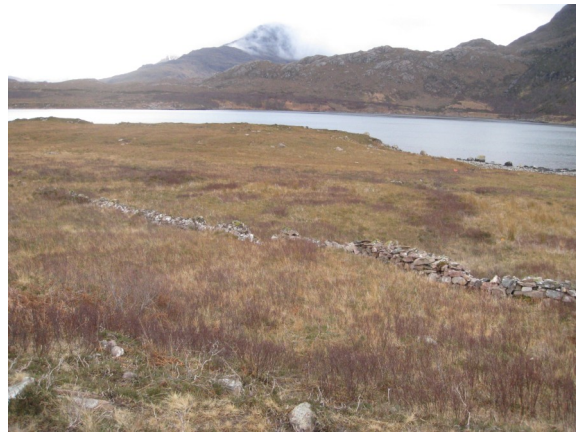
4. The walls continue NE across the area.

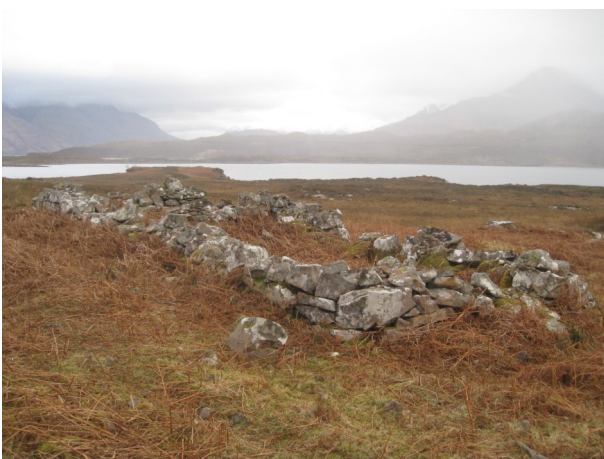
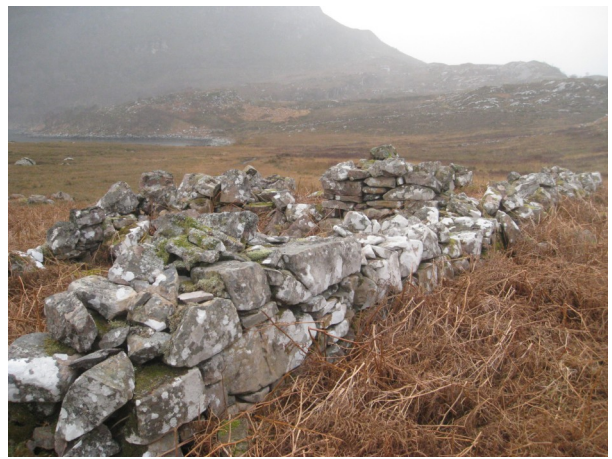
6. Two compartment ruin, probable house with byre. NG 82571 54516 elevation 9m. This ruin has an adjacent midden and the footings of two outbuildings. One end of the ruin is constructed with layered stones with the byre end crudely made. The walls are too low to see any evidence of windows and there is no evidence of a chimney.

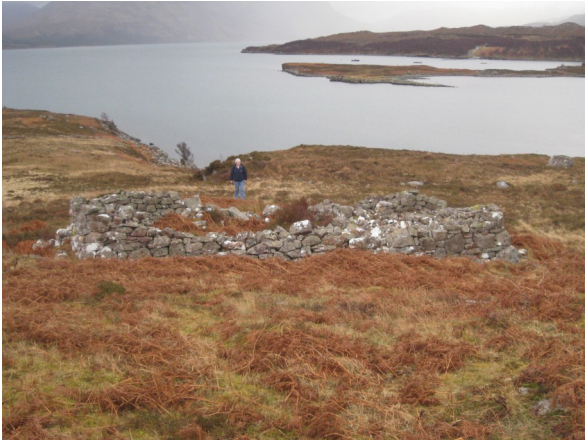
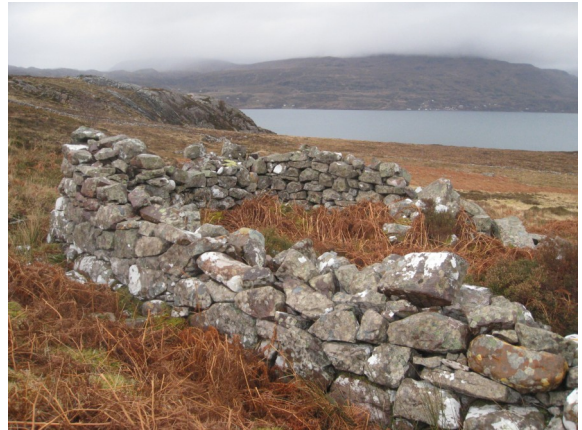
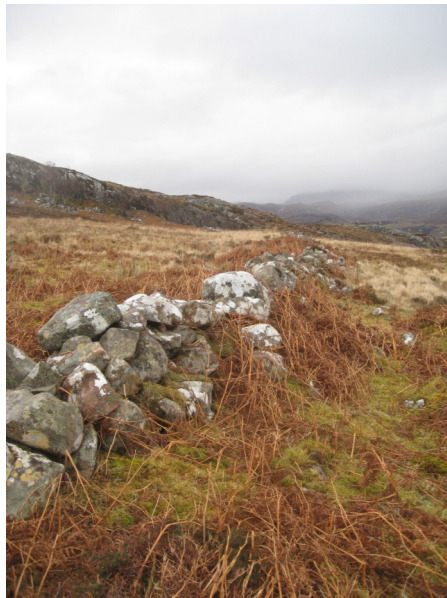
7. Ruin with a dividing wall and ditch to the rear. NG 82493 54681 elevation 19m Behind this ruin the head dyke continues to the N. The walls are made with chosen stone and boulders and there is no evidence of a chimney.

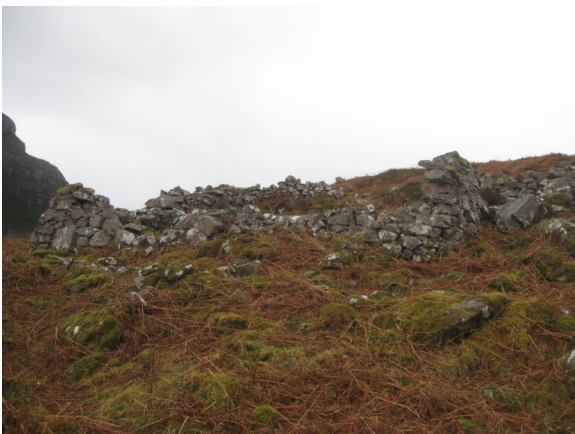
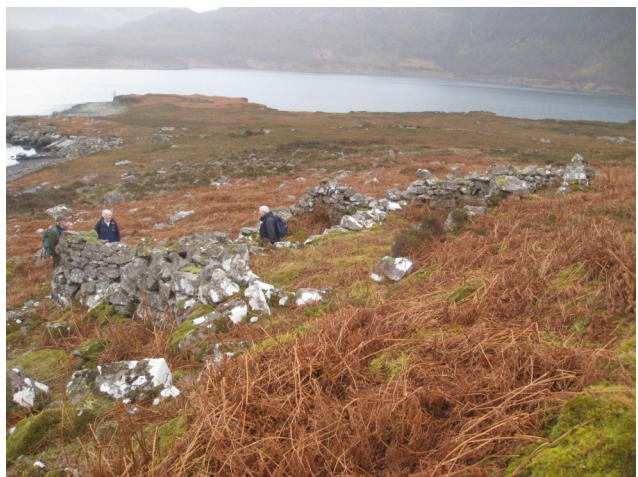
8. A ruin built into the slope with no obvious entrance. It is on two levels with possibly the upper layer being a garden, and the lower a byre. NG 82592 54677 elevation 16m. The walls are not well made, and have rounded corners. The lower level walls have evidence of partition/cruck slots.

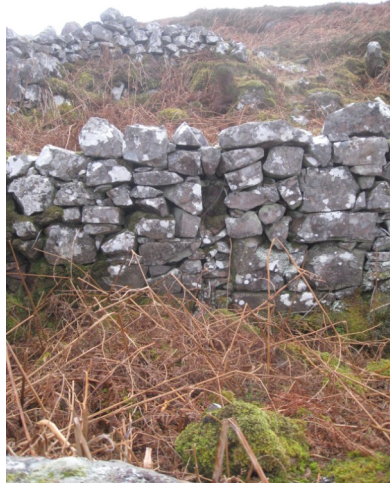
8. cont

Partition/cruck slot

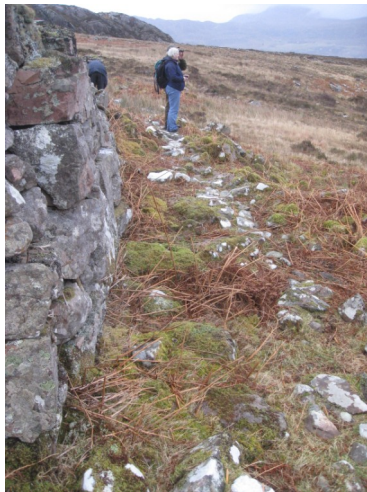
In front of the ruin is a stone pavement leading to the adjacent ruin (9) and down slope from this a small additional terrace.

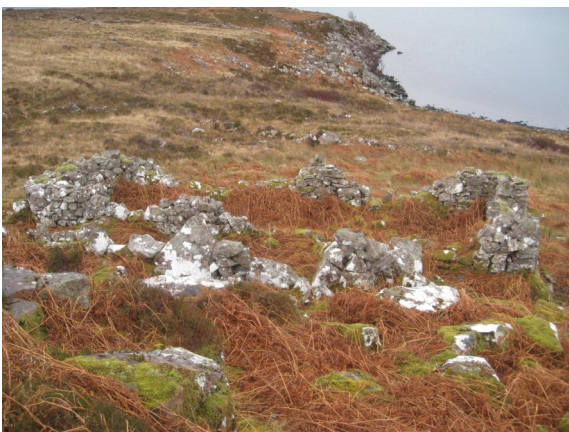
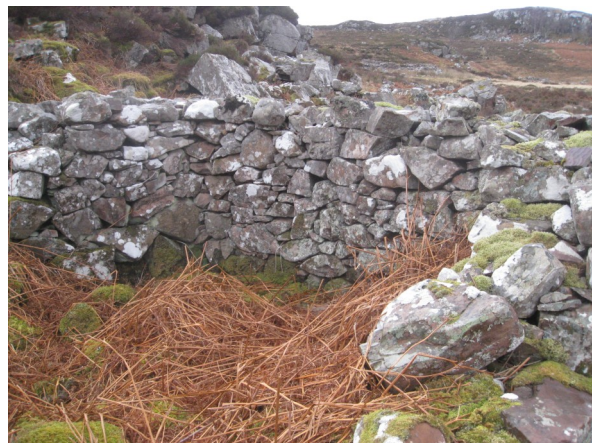
9. Ruin with two compartments, possible house and barn connected to 8. by stone pavement. There is a small building to the rear of it built into the bank. NG 82589 54697 elevation 17m. There is a definite entrance, and rounded corners but no evidence of a chimney.

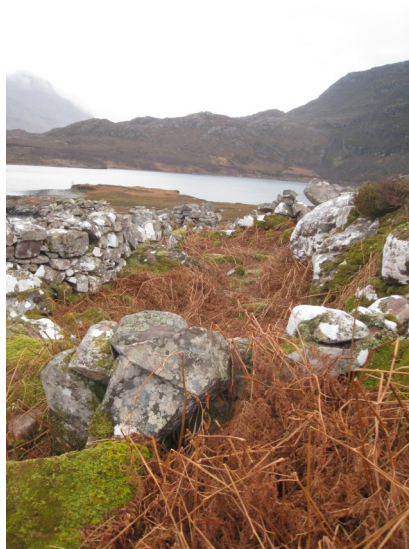
9. cont

Small building to the rear built into the slope.

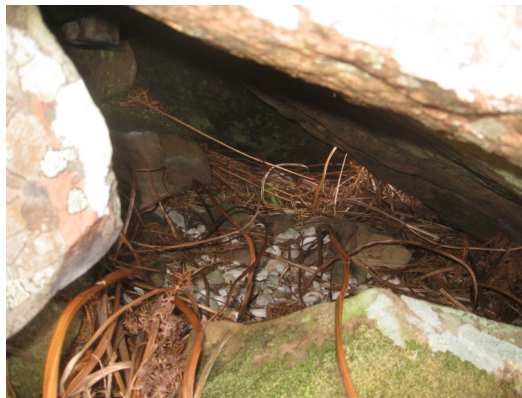
Just beside this ruin under a boulder there is a shell midden

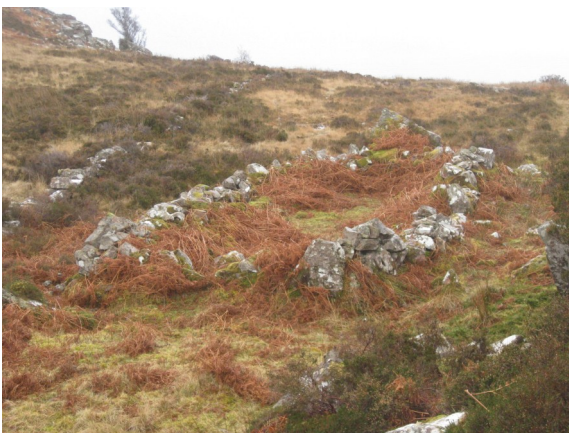
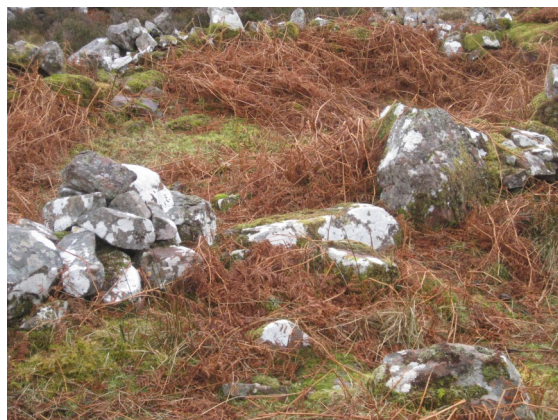
10. A roughly constructed one compartment ruin, probable barn/byre with entrance.
NG 82590 546 99 18m

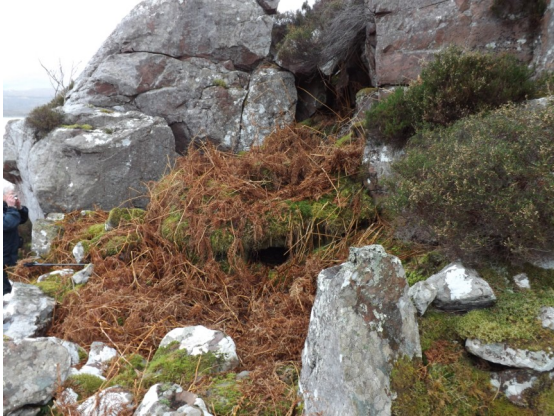
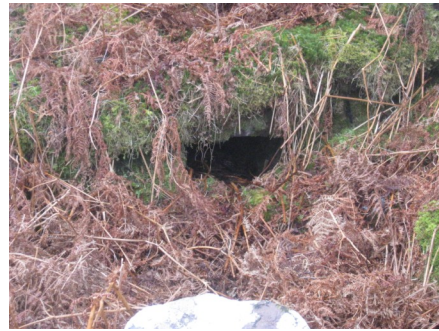
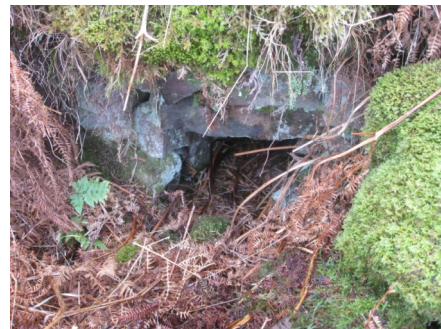
11. Corn drying kiln that is built into the crag. It has two flues into the bowl from the attached kiln barn, depending on direction of wind as to which would be used. The bowl s filled in with debris. NG 82545 54704 elevation 21m

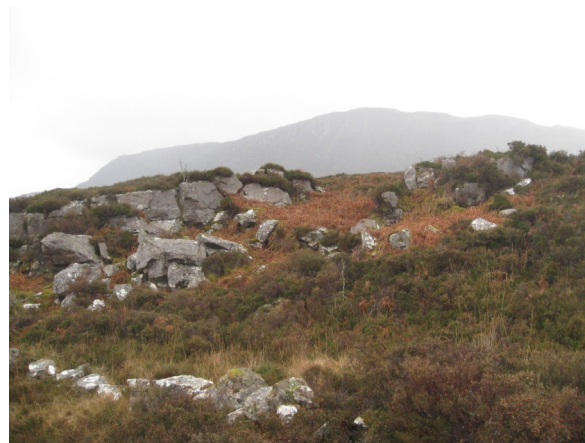
Adjacent to the kiln on the same slope there are two small terraced improved areas of ground.

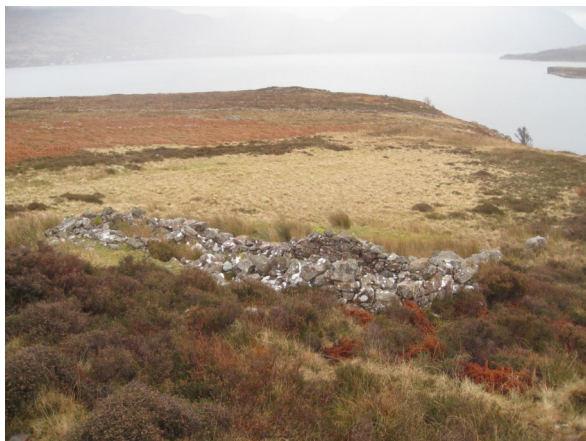
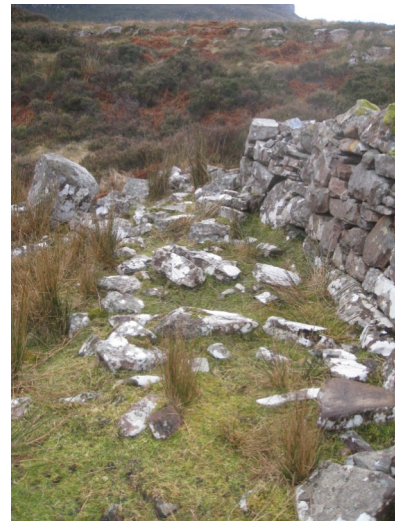
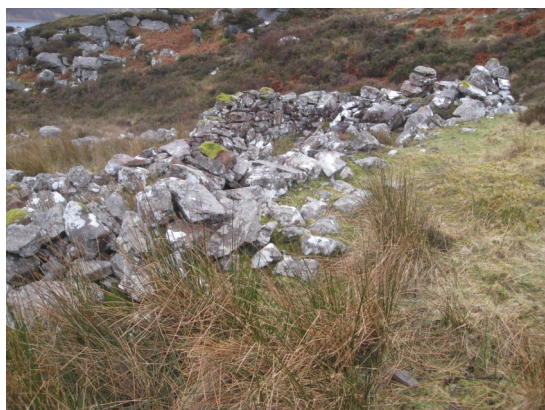
12. cont

12. A ruin with its rear wall built into the slope. It has a definite entrance, and the walls are well constructed with layered chosen stones. In front of the ruin is a stone pathway, and there is a platform built out from the path. A possible house. NG 82512 54728 elevation 30m

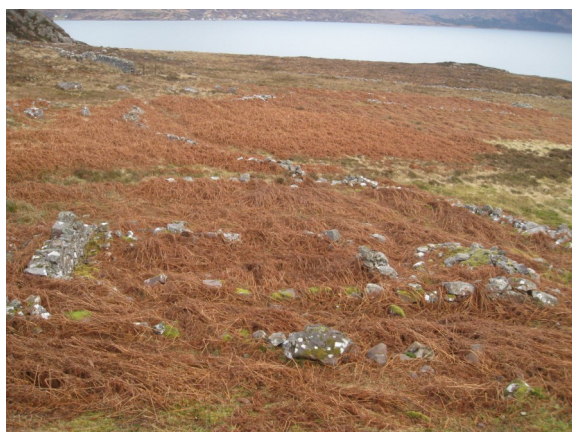
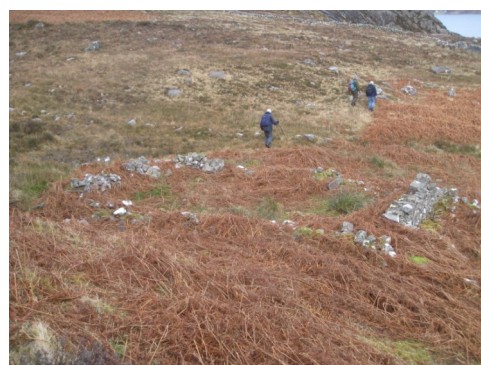
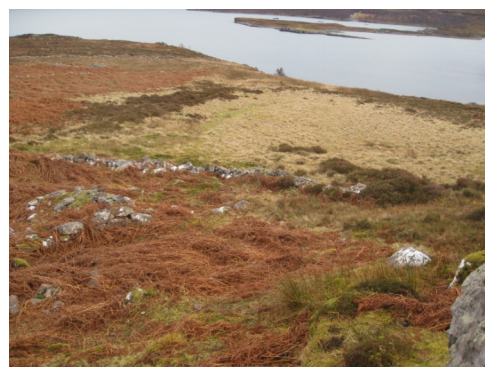
13. Ruin of a two compartment building with an enclosure attached at each end of the building. There is an add on uphill of the main ruin with its rear wall built into the slope. NG 82497 54751 elevation 26m. A probable house with attached barn/byre.

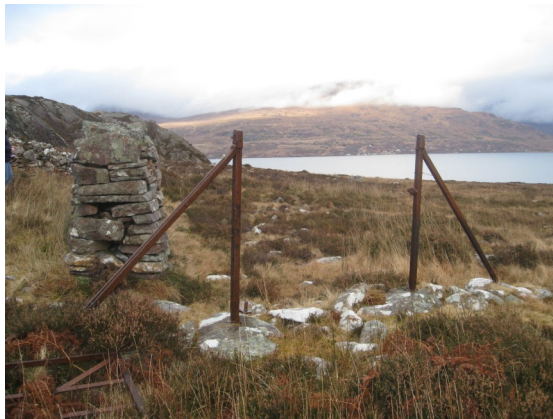
14. An iron gate way which is attached to the old estate boundary fence. NG 82524 54800 elevation 24m.

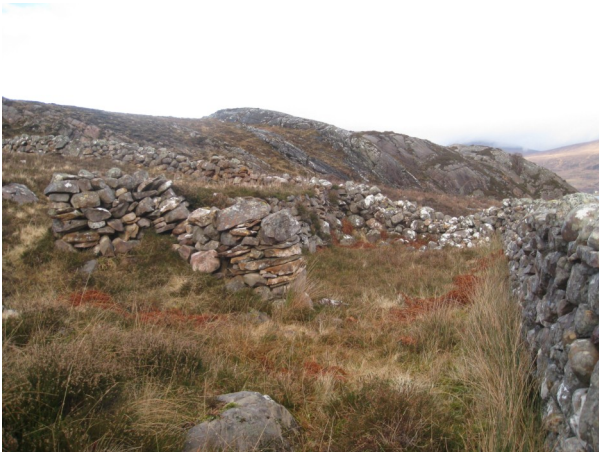
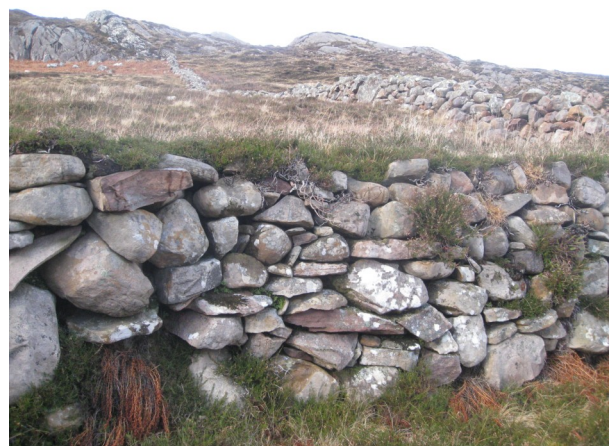
15. A known old sheep fank with its rear wall built into the slope and front wall part of a boundary wall. NG 82527 54821 elevation 28m

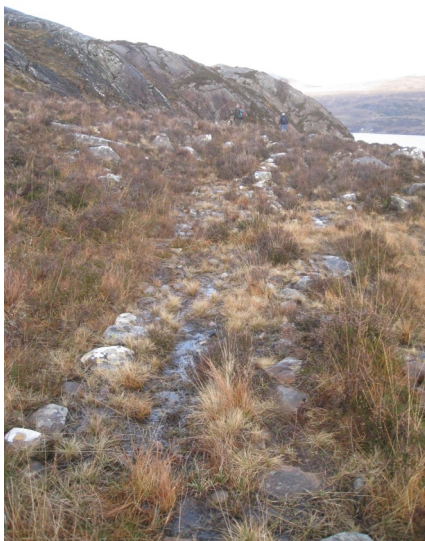
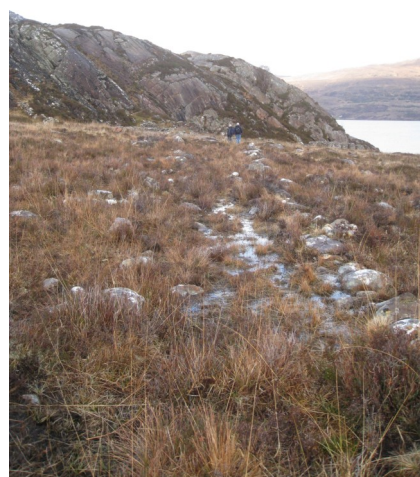
16. A stone track that leads from the iron gateway (14) in front of the fank, towards the houses at 17 and 19. NG 82534 54837 elevation 24m

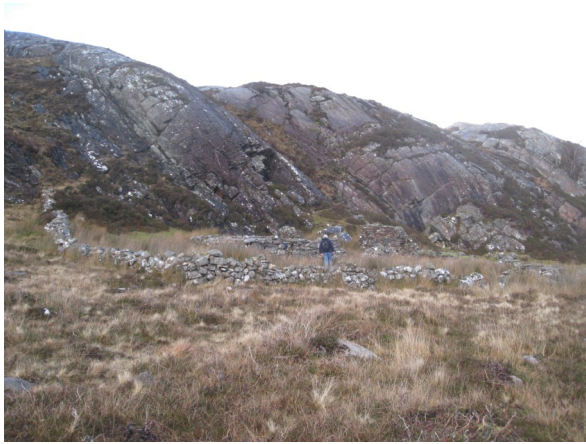
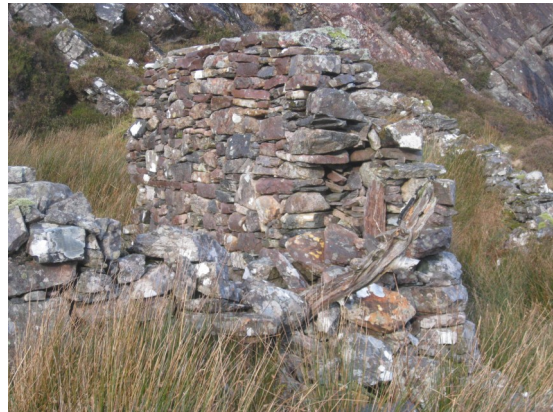
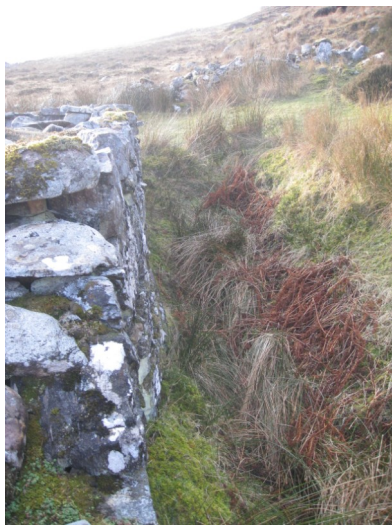
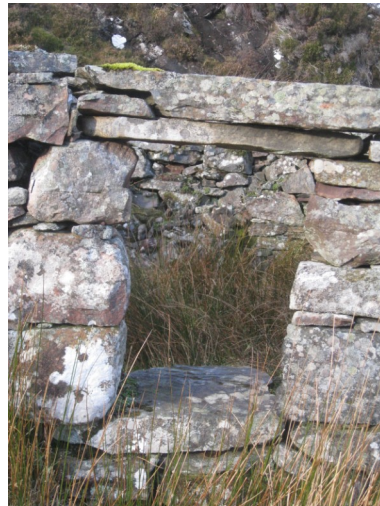
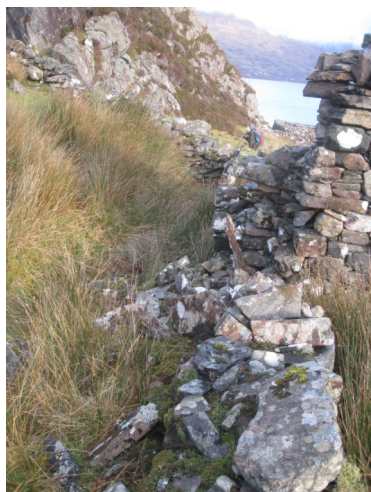
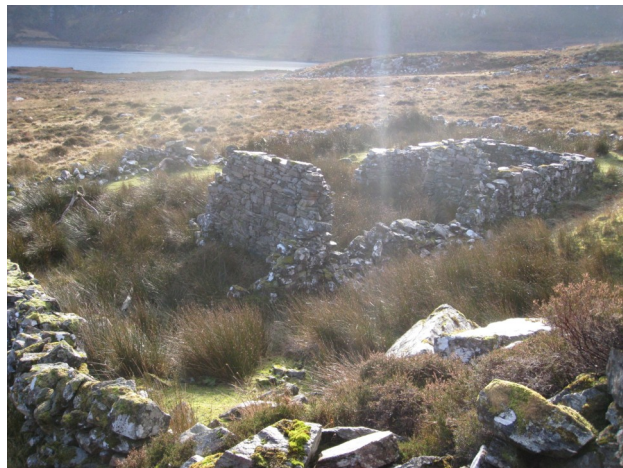
17. Ruined house with attached byre with byre drain. There are two rooms in the house. The whole building is surrounded by an enclosing wall which attaches to the crag under which the ruin lies. There is an E facing doorway and a window still evident, but no chimney. A ditch runs the length of the building to remove runoff from the crag .NG 82540 54903 elevation 23m.

A few metres uphill from the ruin are the footings of a small building NG 82540 54903
Elevation 23m

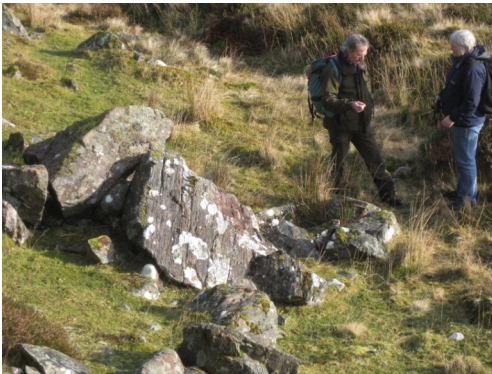
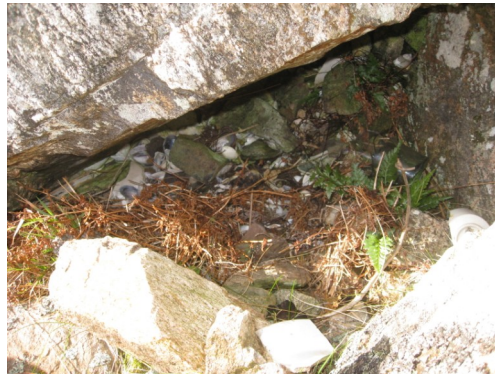
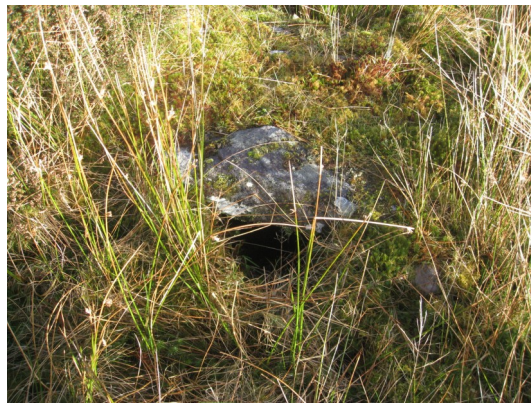
18. Wells. NG 82552 54926 elevation 19m This seems to be two adjoining wells from the same source, one being obviously later than the other. Beside the older well under a boulder is a dump full of old bottles, broken plates and shells. The later well can be accessed from a slab of rock from two sides.

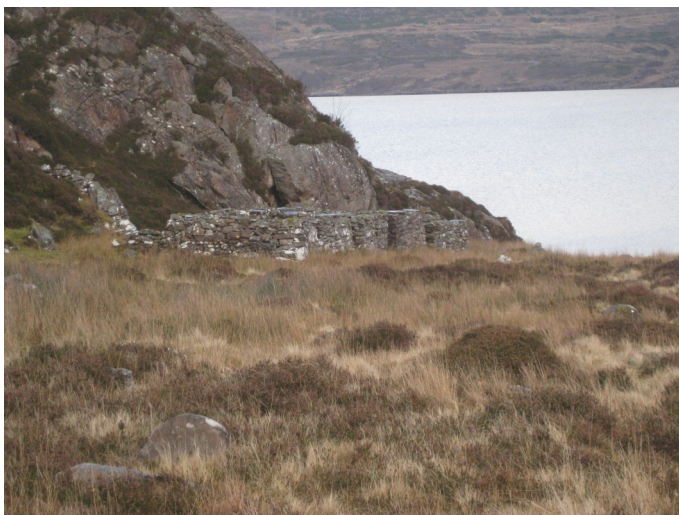
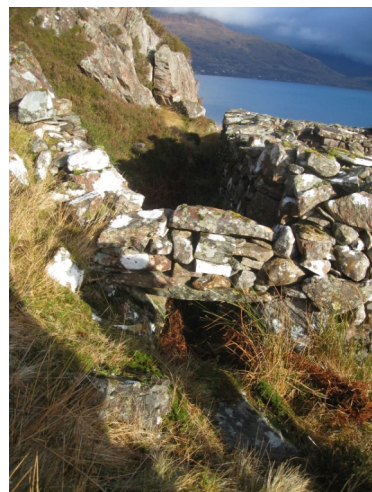
19. A substantial ruin lying under a rocky crag a few metres from 17. It is also enclosed by a stone wall that runs up to the crag and has an opening at one end of the building and a ditch running between the ruin and the crag. NG 82569 54943 elevation 18m.

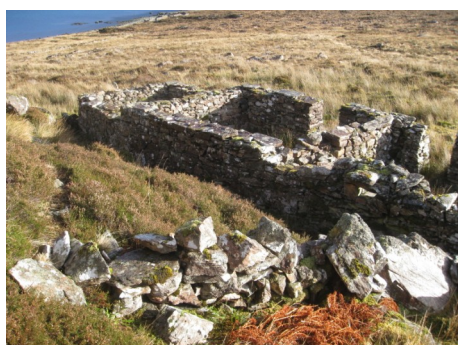
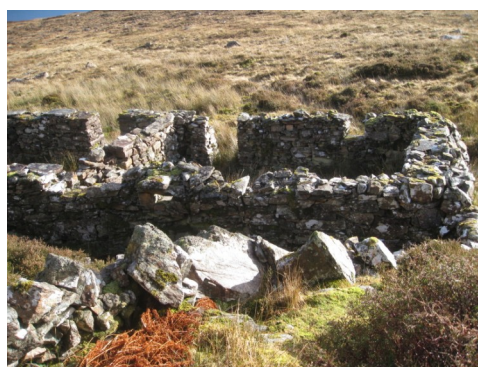
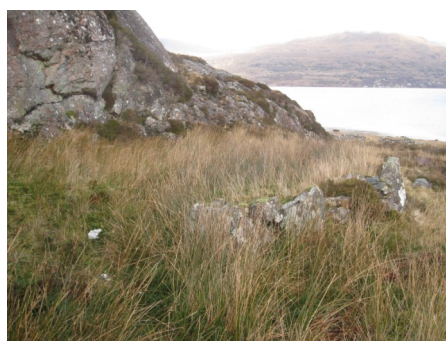
19. cont

In front of the house the drain containing the runoff from the adjacent well at 18 has a stone slab bridge over it and this drain continues on down slope towards the sea. There is a stone path in front of the building.

The building is well made with chosen and dressed stone that is layered. It has rounded corners and no evidence of a chimney, but a door and two windows. The main building has an added dividing wall which had a doorway that has been closed up. There is a cruck slot in one wall. A later byre with drain has been attached to the building and beyond this there is a terraced area.

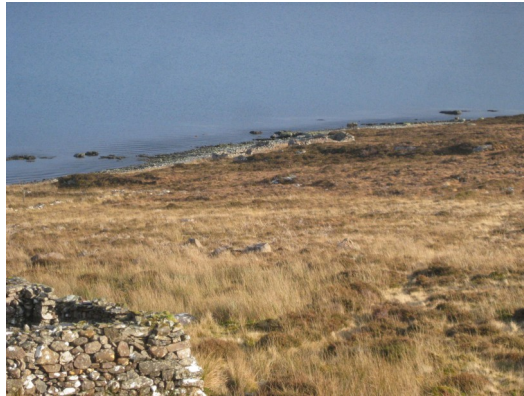
From 19. there is a clear view over improved ground down to the fishing bothies 22 and 23

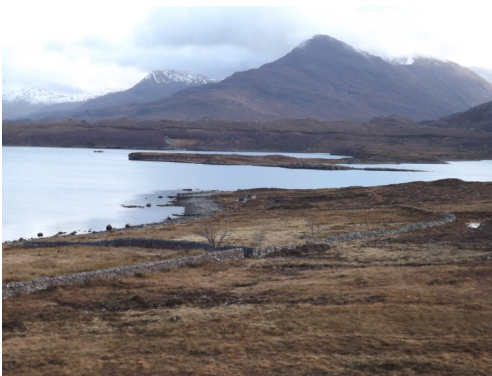
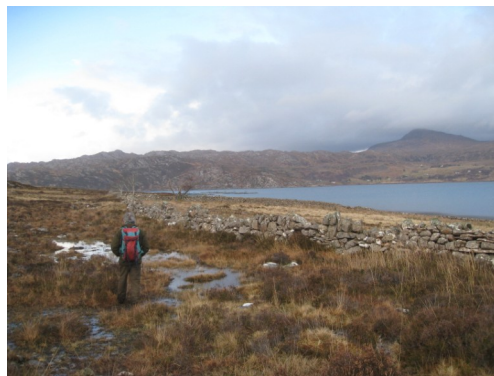
20. To the NW of these are the substantial walls of two enclosures which are accessed by a gateway NG 82616 54991 elevation 8m.

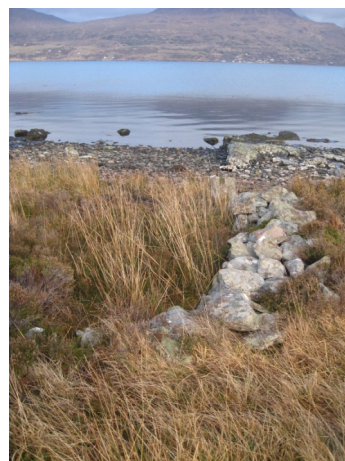
21. A stone jetty on the shore beside the fishing bothies. NG 82719 54996 elevation 4m

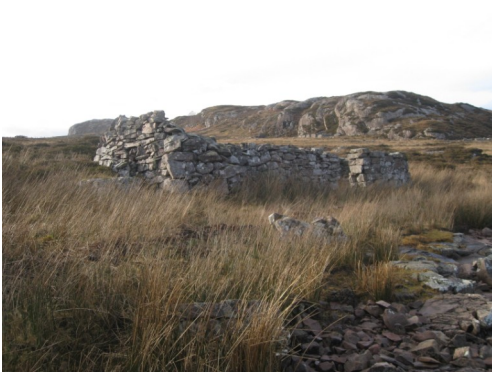
A few metres to the SE of the jetty lie the ruins of two fishing bothies 4m from the shore line.

22. NG 82749 54983 elevation 2m. This bothy is very narrow in width 2m. There is a lot of tumble in the ruin but a door, blocked windows facing the shore, and a small window in the gable end can be seen. There is a buttress against the external facing of this wall for support. The walls are of rough construction made with stones from the shoreline which naturally break in layers. A cruck slot is visible in one wall.

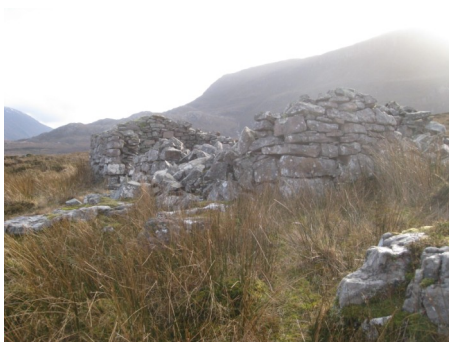
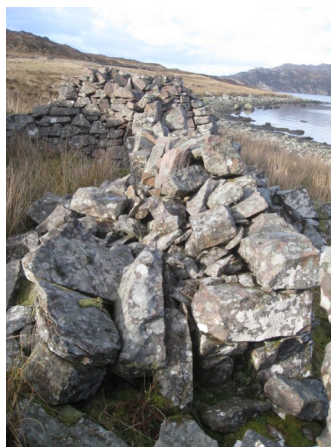
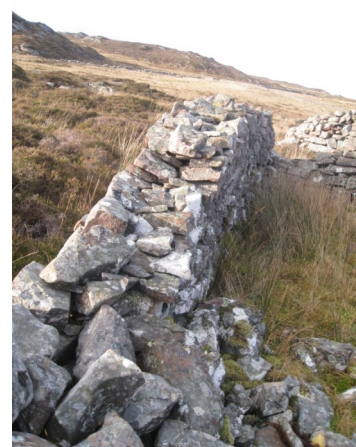
23. NG 82761 54975 elevation 3m. This second bothy is very tumbled and has a door but no windows.

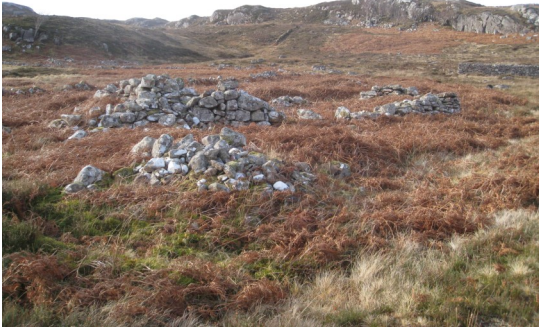
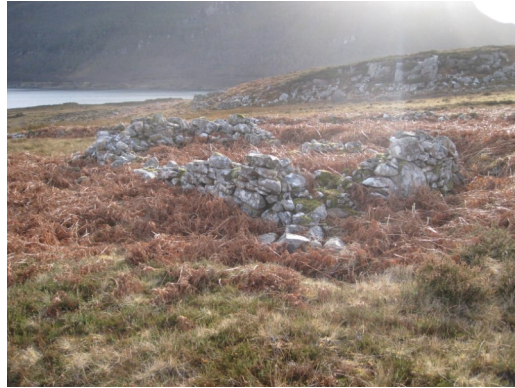
24. NG 82575 54783 elevation 20m. The ruins of a barn/byre in the middle of an enclosure with stone clearance piles close by. There is a ditch on two sides of the ruin to drain water away from the building.

Just to the N of this ruin are the remains of the estate iron fence which runs into a stone dyke leading over the hill.

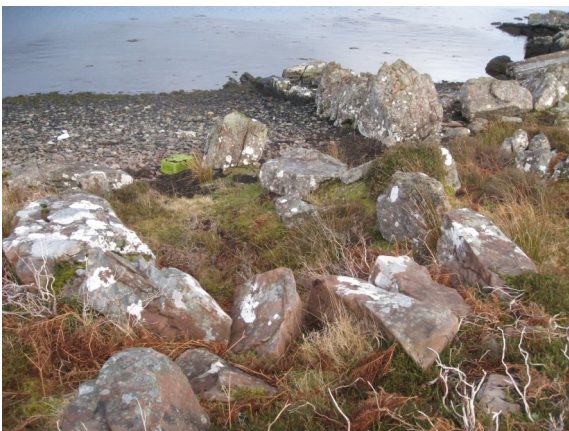
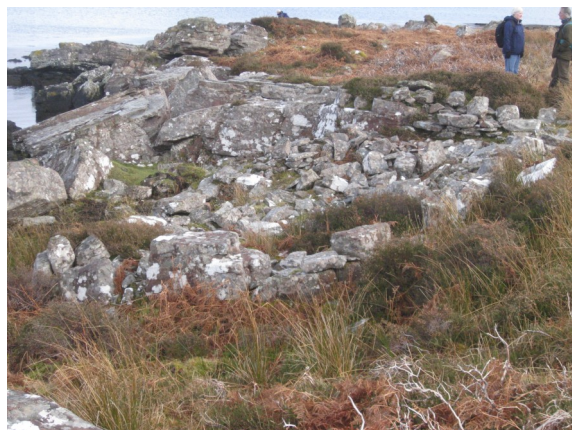
25. NG 82700 54632 elevation 3m. The ruins of a slipway and boathouse with cutting for a boat to be pulled up into.

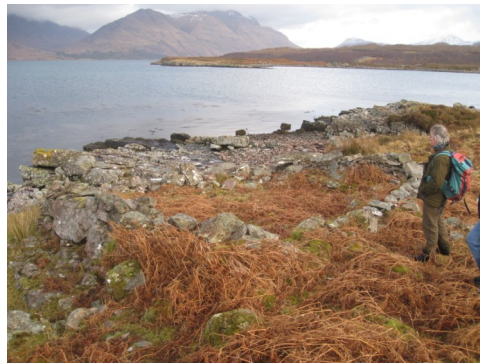
26. NG 82733 54627 elevation 4m A ruined fishing bothy by the shore with no door or window visible as walls are very broken down.

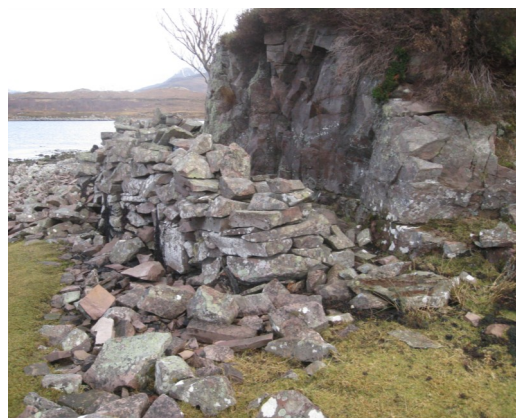
27. NG 82794 54578 elevation 3m A stone shelter or hide underneath a crag.

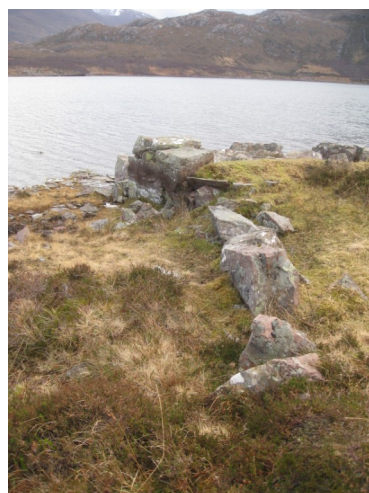
28. NG 82730 54525 elevation 3m A line of stones from top of shore rockface leading inland , purpose unknown.

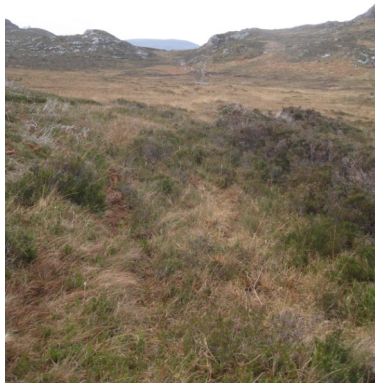
29. NG 82686 54470 elevation 6m The continuation of turf walls across the township where they end at the coast.

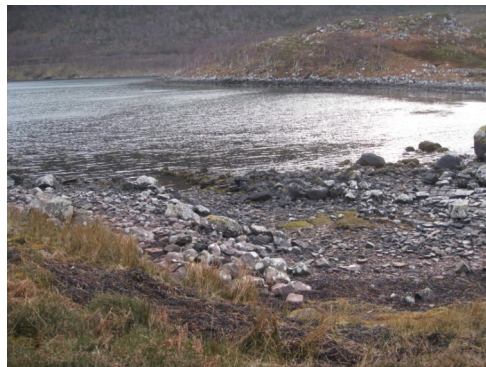
30. NG 82579 54359 elevation 3m A slipway

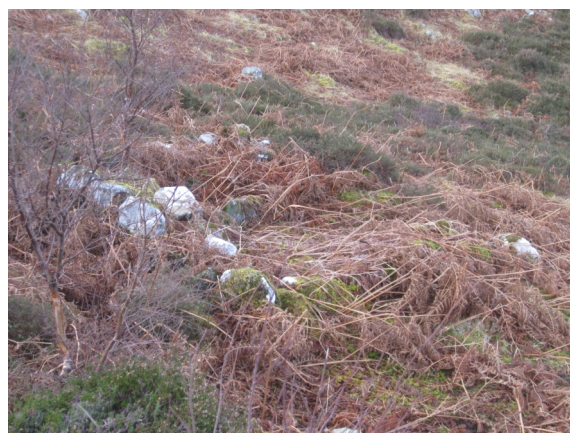
31. NG 82477 54221 elevation 9m. A terrace edged with stones

32. NG 82507 54211 elevation 12m. A small stone bothan 2x2m close to 31.
