## Archaeological Recording at 92-94 Academy Street, Inverness, Highland.

**Client:** William Gray Construction Ltd.

**Date:** 3 February 2015

**Planning Ref.** 13/03720/FUL

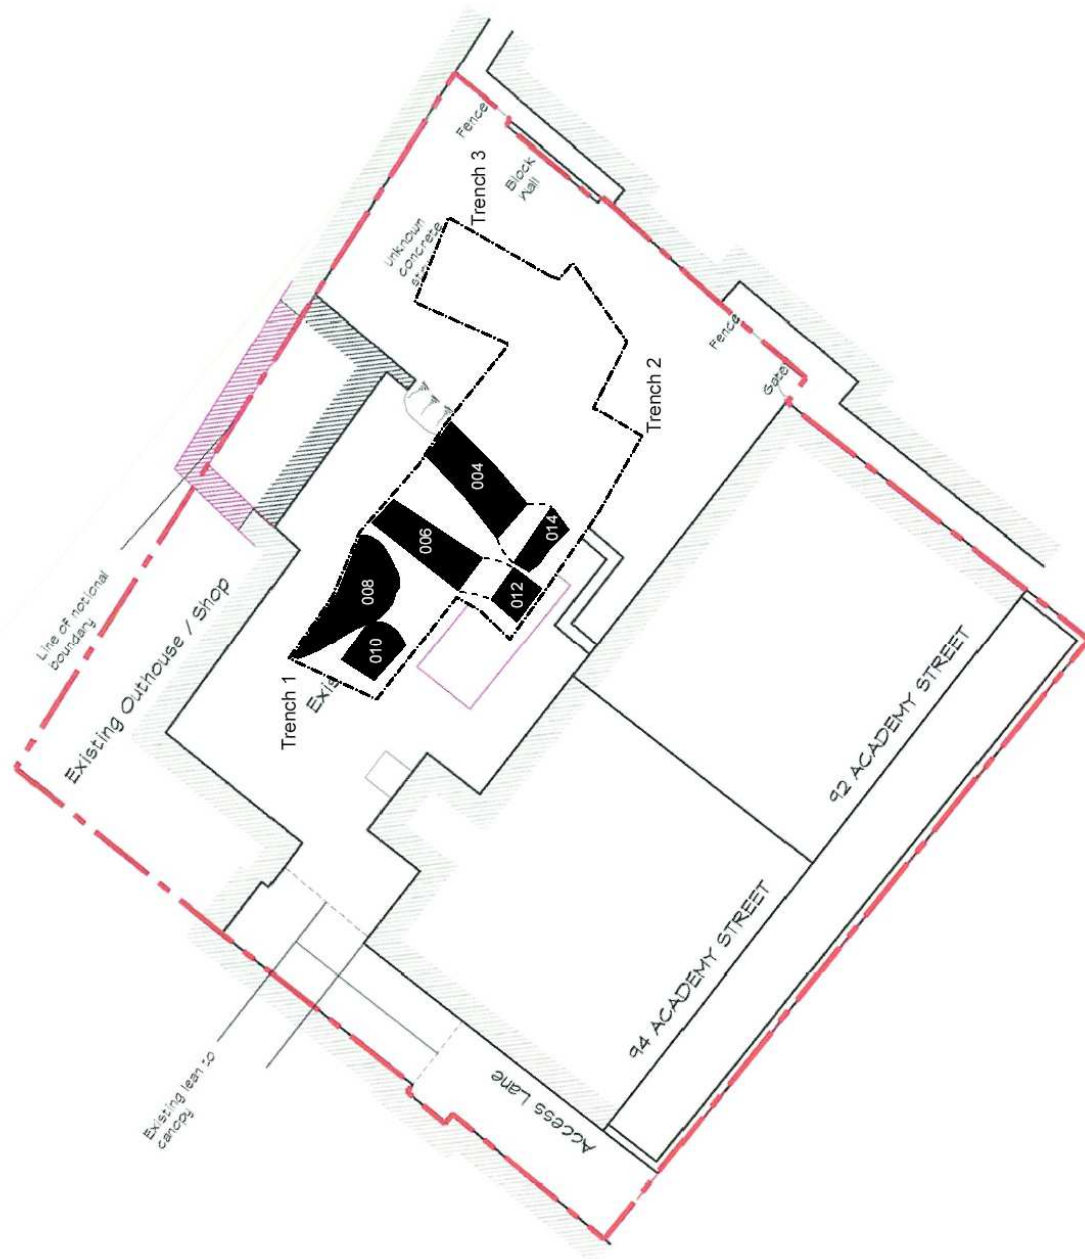
Figure 14 – Location of Evaluation  
© Rubicon Heritage Services Ltd.

No archaeologically significant features or artefacts were identified during the investigation. The basement at the frontage is likely to have removed any archaeology that predated the construction of the building. Therefore it is believed that the watching brief condition that is in place for the demolition phase of the development is sufficient and no further excavation is recommended. All recommendations made here are subject to approval by the Planning Authority Archaeologist.

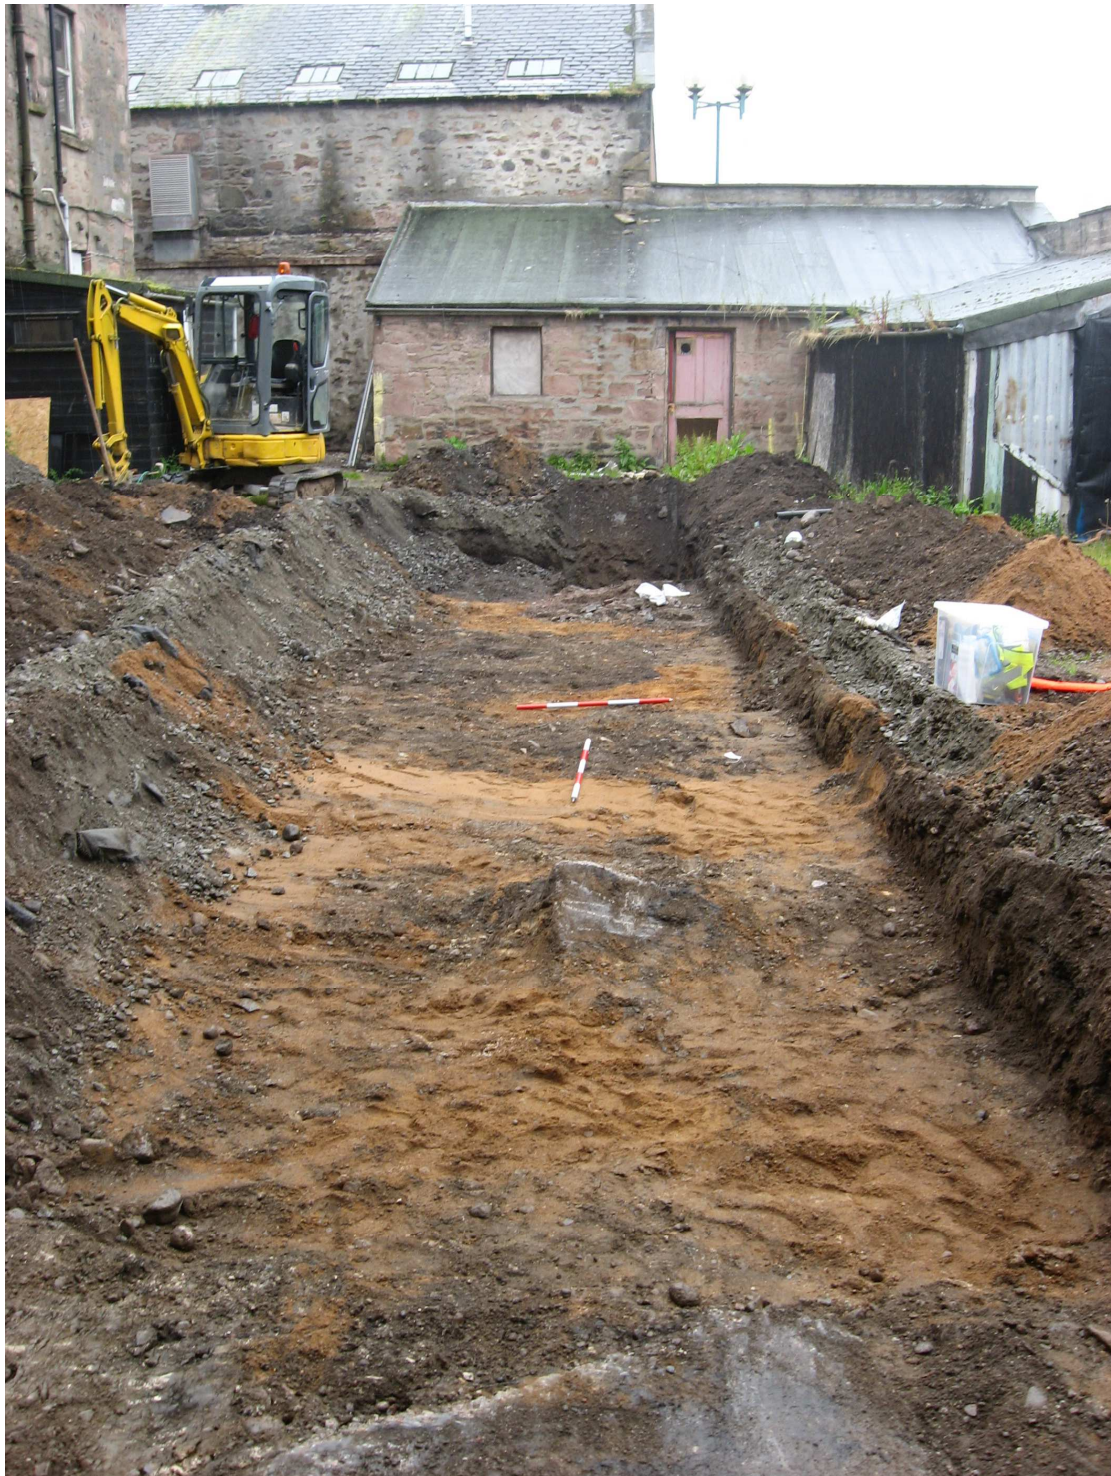
**Trench 1** was orientated NW–SE and measured 16.5 m long and 4 m wide. The modern hardcore surface (001) consisted of compacted stone fragments with frequent blocks of rubble mixed with mortar serving as a foundation. This was 0.5 m thick on average and sealed a thin layer (0.1m) of dark brown silty clay (002) which contained 19<sup>th</sup> century pottery. This represents the original ground surface on which the modern hardcore surface was constructed in order to provide a level carpark at

the rear of the property. Four negative cut features were sealed beneath this layer. All were cut into the natural geology. Linear feature (004) was aligned northeast to southwest and traversed the entire width of the trench. It had a sharp break of slope from the surface, gradually sloping sides and a gradual break of slope with the U-shaped base. It measured 1.45 m wide by 0.3 m deep. The single fill consisted of loose, mid-brown grey sand (003) which contained modern artefacts including metal and pottery – the pottery being 19<sup>th</sup> century in date at the earliest. A second similar linear feature (006) ran parallel to feature (004). This consisted of linear cut (006) aligned northeast to southwest with a sharp break of slope from the surface with a gradually sloping sides and a rounded base. It measured 2.6 m long within the trench by 0.19 m wide and was filled by loose mid-brown grey silty sand (005) with frequent stone inclusions. Pottery recovered from the feature is of 19<sup>th</sup> century date.

Plate 1 – View of Trench 1 during evaluation work facing W/  
© Rubicon Heritage Services Ltd.

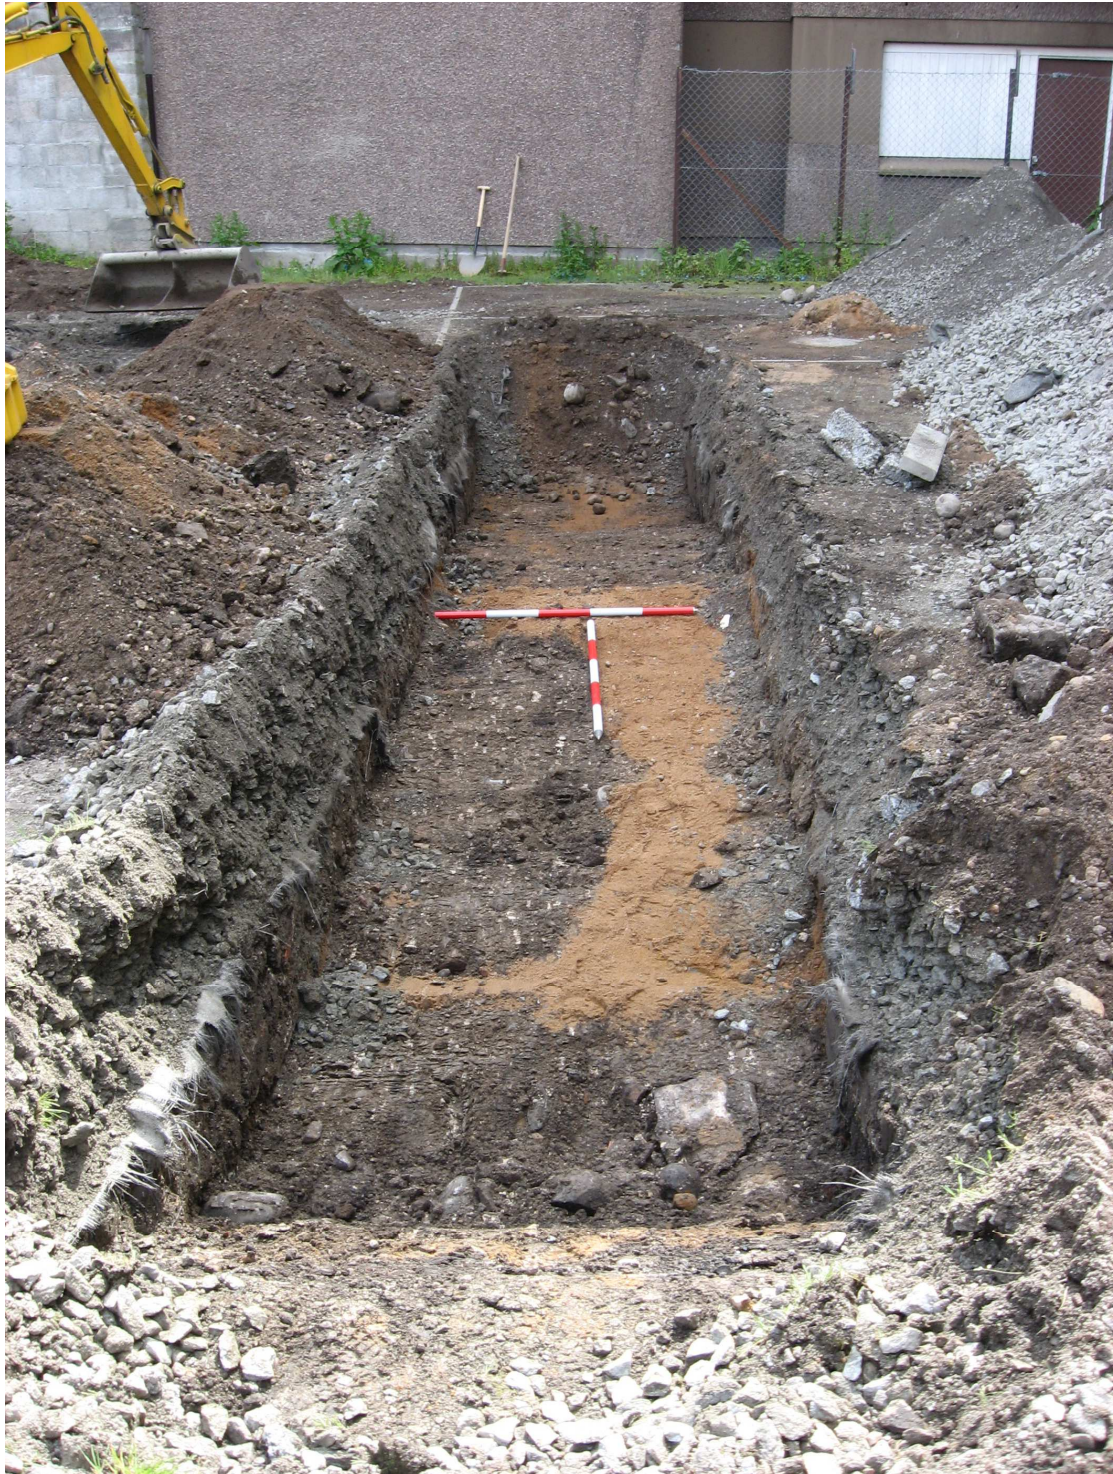
**Trench 2** was orientated NW–SE and measured 9 m long and 1.6m wide. The modern hardcore surface (001) consisted of compacted stone fragments with frequent blocks of rubble mixed with mortar serving as a foundation. This was 0.5 m thick on average and sealed a thin layer (0.1m) of dark brown silty clay (002) which contained 19<sup>th</sup> century pottery. This represents the original ground surface on which the modern hardcore surface was constructed in order to provide a level carpark at the rear of the property. Two negative cut features were sealed beneath this layer. Both were cut into the natural geology. A linear feature was identified at the northwest end of the trench. This consisted of a linear cut (012) which was 1.2 m wide and represented a continuation of linear feature (006) which was identified in Trench 1. The fill (011) consisted of loose mid brown grey gravelly sand which contained 19<sup>th</sup> century pottery. A second feature was initially identified as a pit but is more likely to represent the terminus of linear feature (004) which was identified in Trench 1. The cut (014) was 2.1 m wide and 0.31 m deep. It was filled by loose mid-brown grey gravelly sand (013) which contained modern artefacts and pottery.

Plate 2 – View of trench 2 during excavation facing E.  
© Rubicon Heritage Services Ltd.

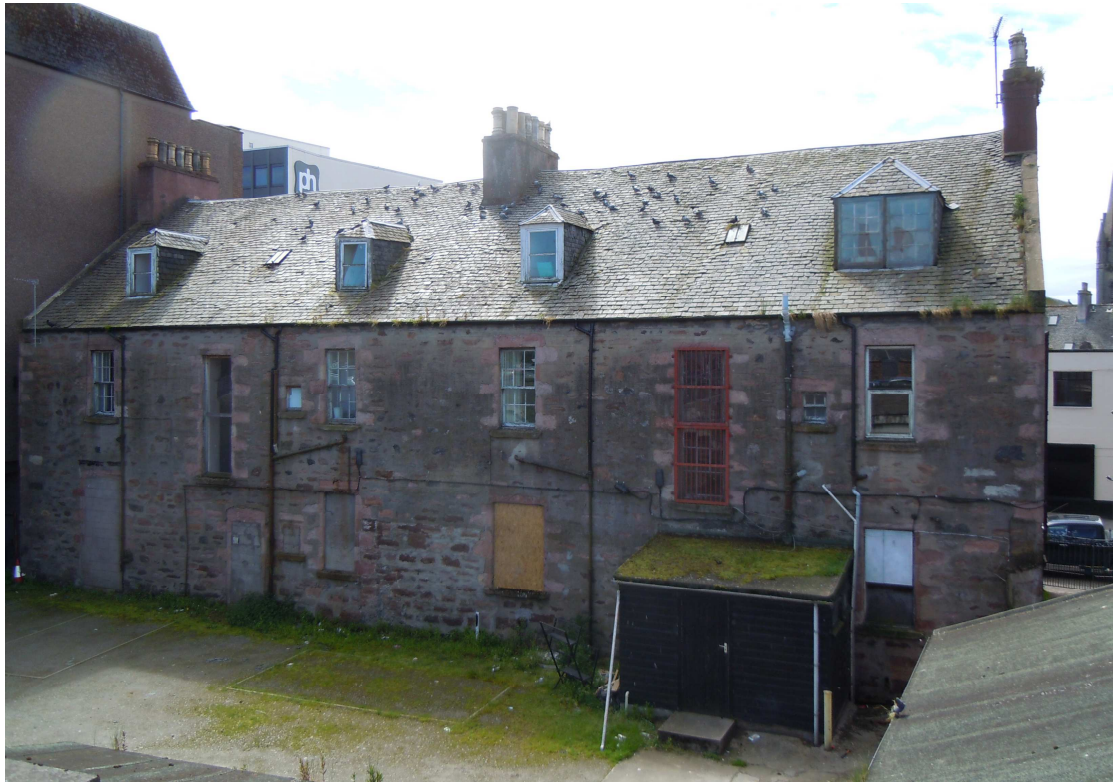
Plate 5 – View of rear of building (photo 3)

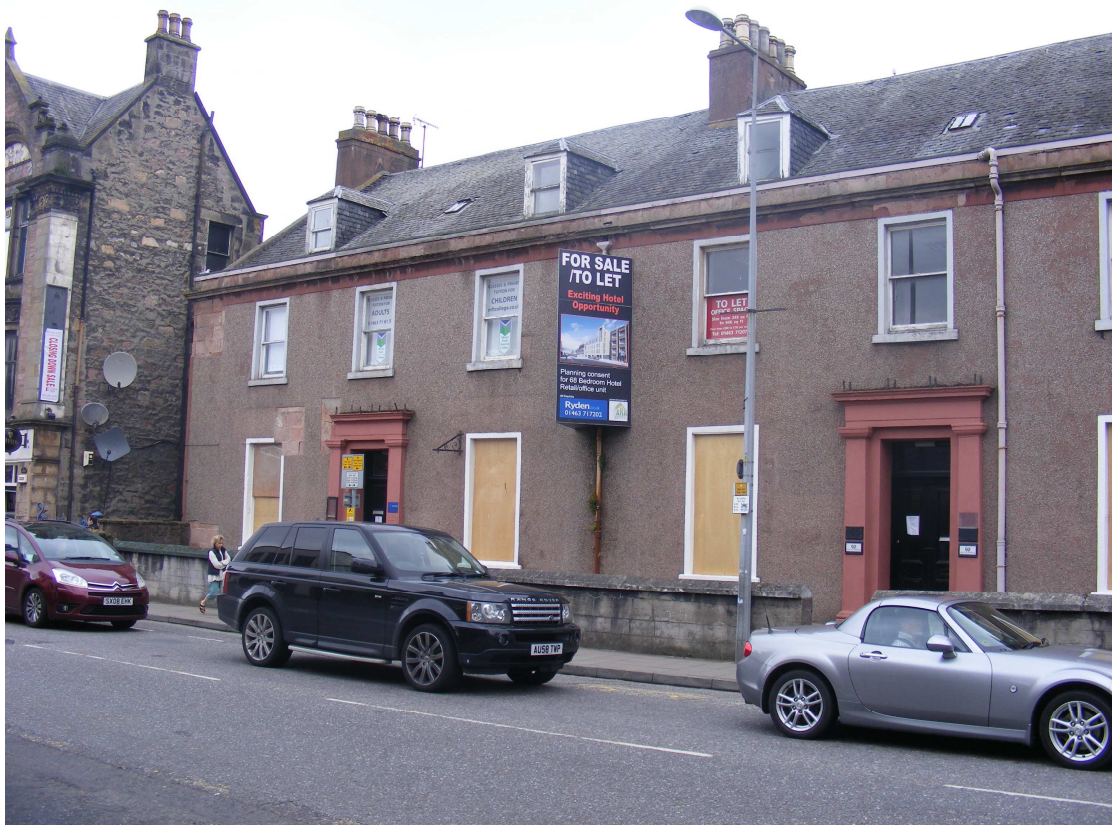
Plate 6 – View of front of building (photo 193)

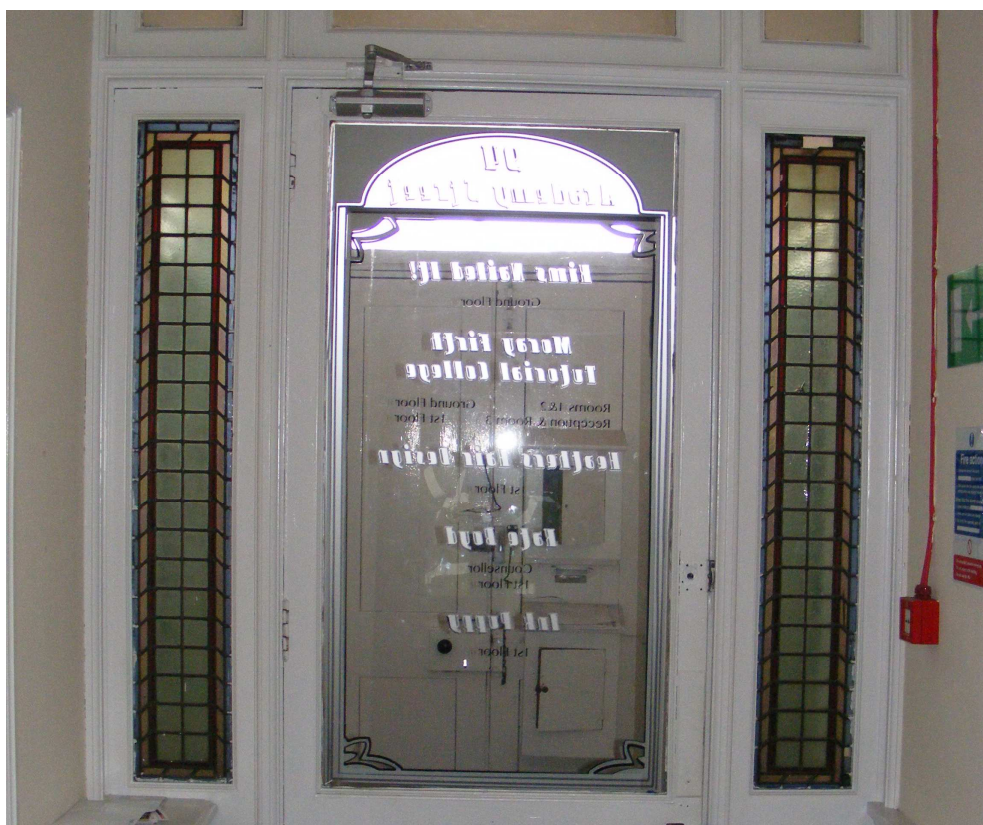
**1** – Lobby – Plain moulded cornicing, tiled floor (possibly late 19<sup>th</sup> century) with stained glass panels to interior door, possibly original (see plate 7). This interior door had modern plain glass. With modern suspended roof panels.

Plate 7 – View of stained glass in lobby of No.94 (photo 58)

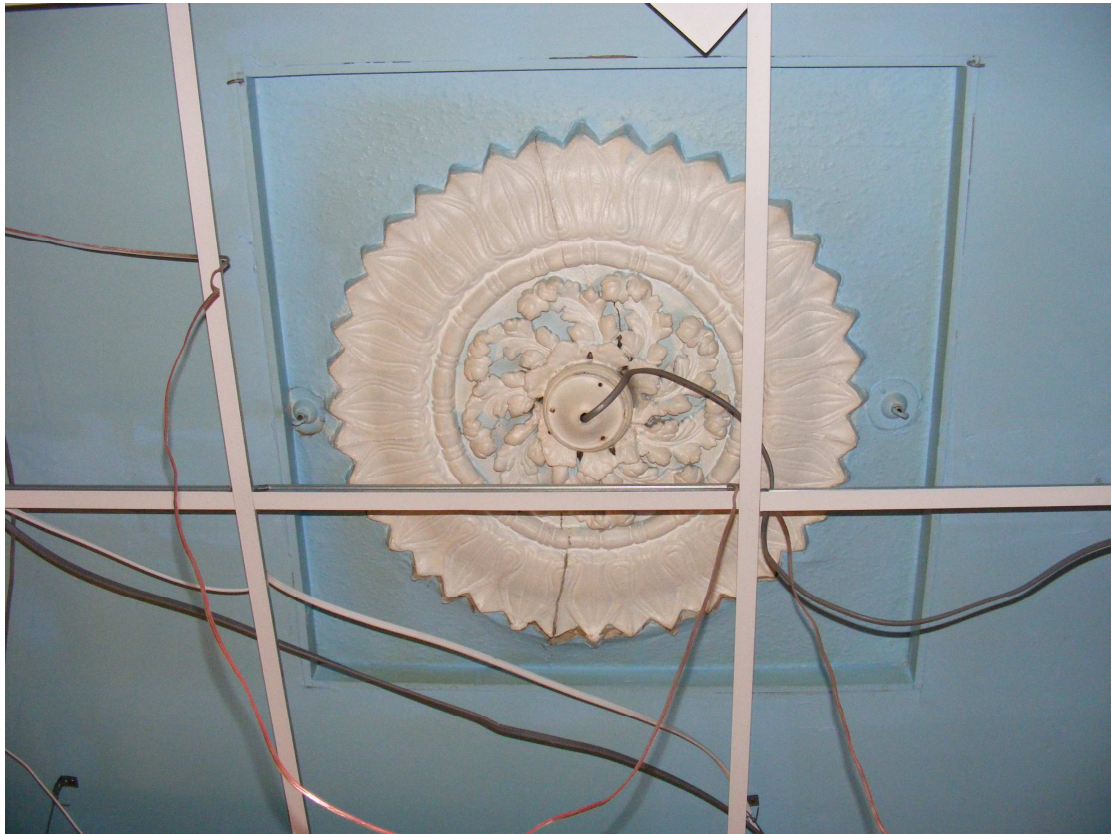
**23** – Front Room – No indication of Fireplace. Modern door to room, modern window. Decorated moulded ceiling revealed under modern suspended ceiling with central ceiling moulding in different style to that revealed in room 21. This was damaged by later insertion of lighting fitting but tow hooks may have been for earlier fittings, boxed frame around. Room larger than that in No.94 with recessed space on North wall and access to rear room differently set. Removal of plasterboard revealed fireplace of brown glazed tiles but no surviving ironwork. No other features revealed.

Plate 13 – View of centre moulded plaster room 23 (photo 267)

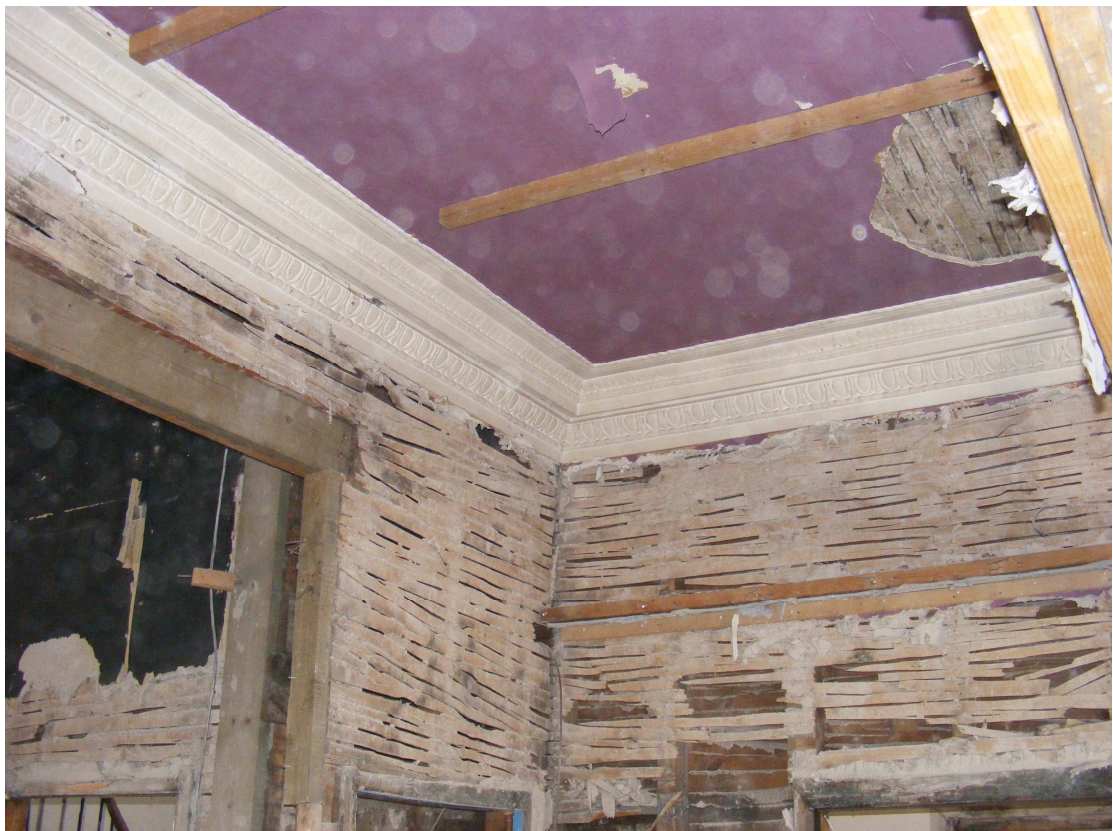
**3** – Front Room – Suspended ceilings (2) with modern light fittings, with modern plasterboard walls. Plain moulding around window frame. Modern wall between rooms 3 & 4. Subsequent removal of modern plasterwork revealed artistic moulded cornicing and a central piece plasterwork. Modern window. Removal of plasterboard revealed supporting steel beam in front of fireplace, which had been removed, though some brown glazed tiles were found behind brick indicating 2 fireplaces had previously been here. No other features revealed.

Plate 18 – View of moulded cornicing room 3 (photo 392).
