Glen Brown Woodland Creation Dorback Estate Archaeological Walkover Survey Report

AOC 70511

June 2021

On Behalf of:	Galbraith
National Grid Reference (NGR):	NJ 09811 18723 (centre)
AOC Project No:	70511
Prepared by:	Lindsey Stirling
Illustrations by:	Lindsey Stirling
Date of Fieldwork:	2 nd -4 th , 15 th -16 th & 22 nd June 2021
Date of Report:	25 th June 2021
OASIS No.:	aocarcha1-424845

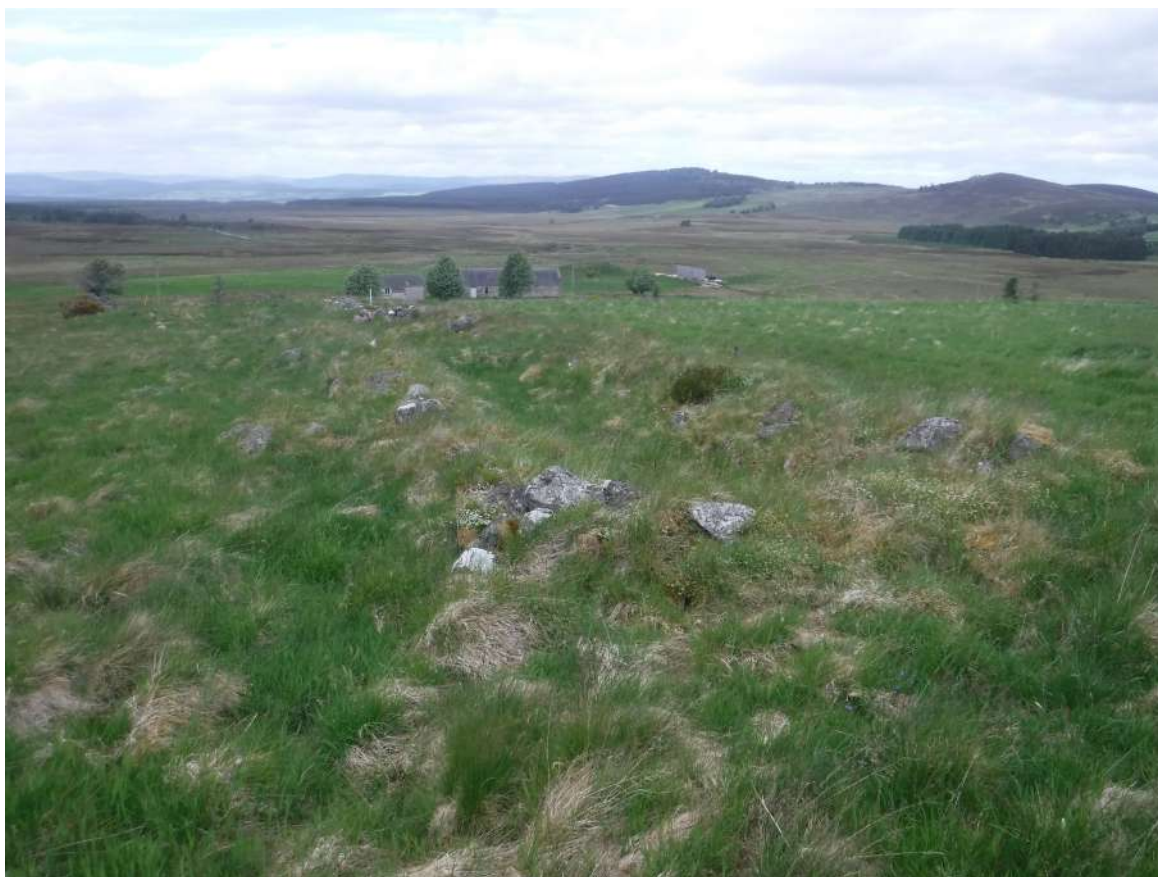
Plate 14: Degraded stone and turf structure 6a, facing NW

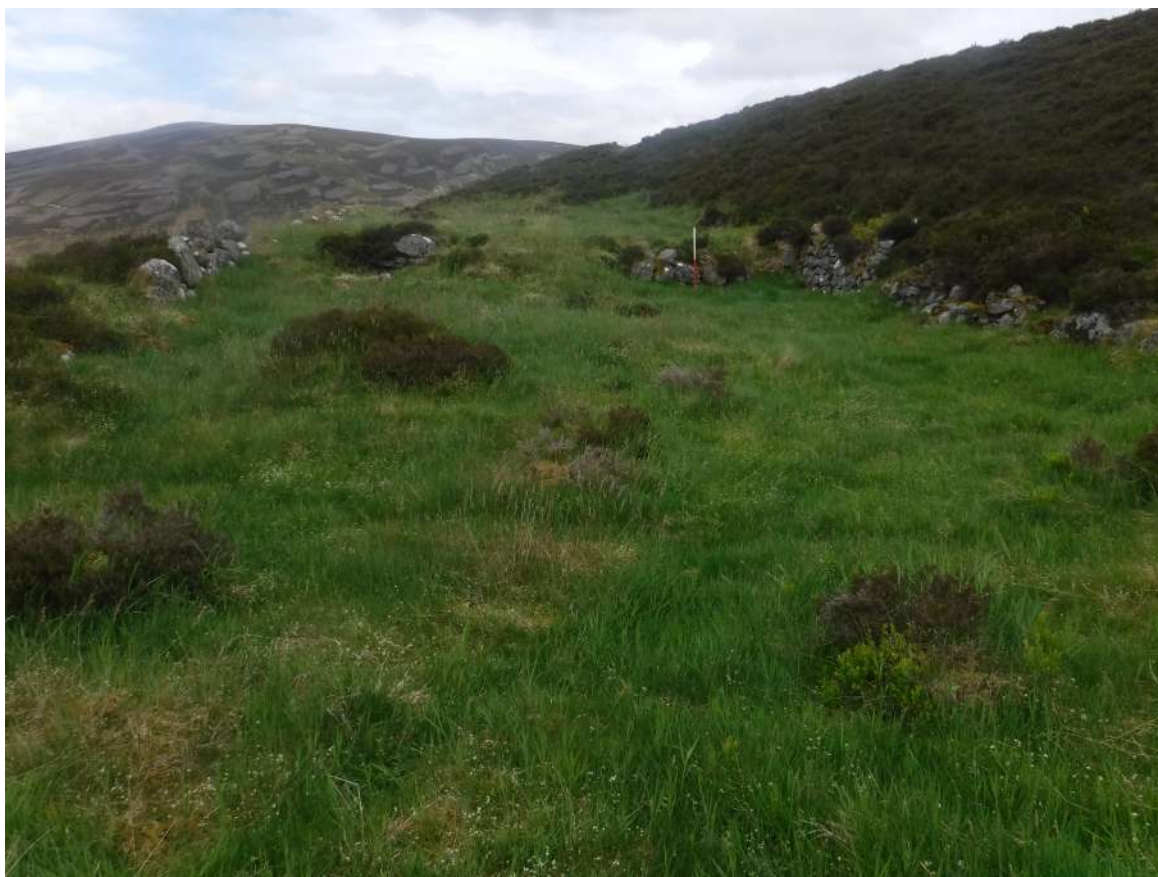
- 5.2.7 On the southeast edge of the improved ground stood a square stone enclosure (site 89) measuring 8-9m across and open to the south (**Plate 15**). It was constructed with a mix of coursed drystone and large boulders, revetted into the hillside on three sides. On the slopes above Sliabhclachd stood the degraded remains of a rectangular stone structure (site 7) measuring c.12m NNE-SSW by 3.5m internally (**Plate 16**). Its walls were double-faced and built with large stones and rubble, although stone collapse across the site meant that no entrance was visible. This building was depicted as roofed on the 1st edition OS map but was unroofed by the time of the 2nd edition, suggesting it was abandoned sometime between 1867 and 1900.

Plate 15: Revetted stone enclosure 89, facing NNE

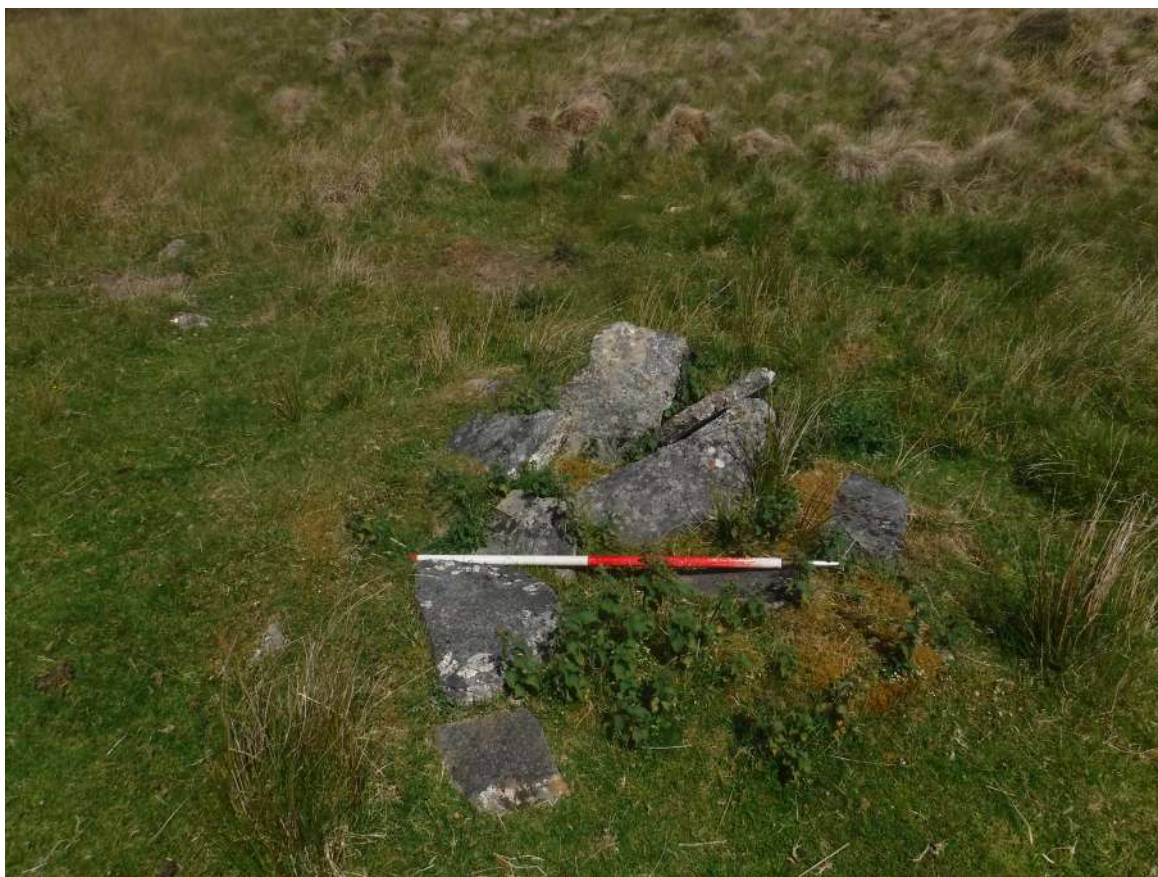
Plate 23: Circular stone structure 9c, facing NNW

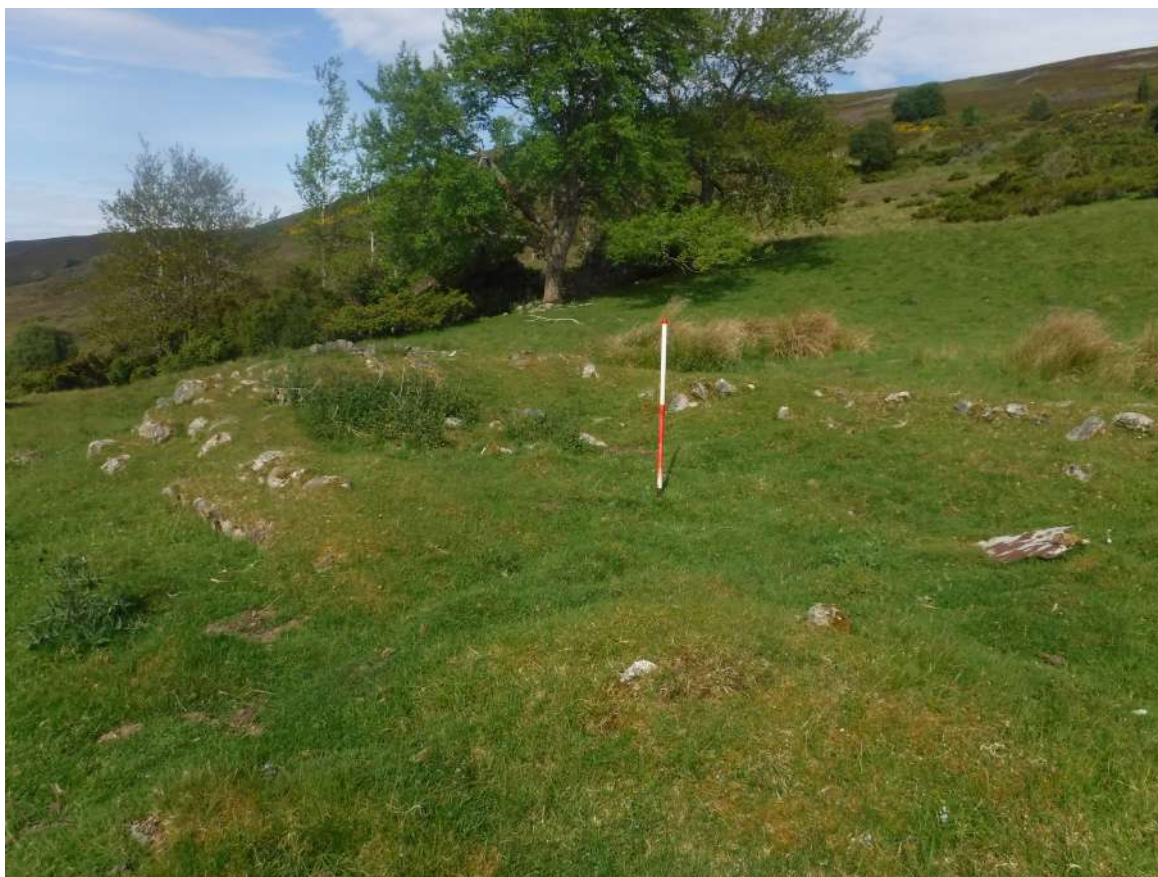
Plate 25: Degraded stone structure 10a, facing W

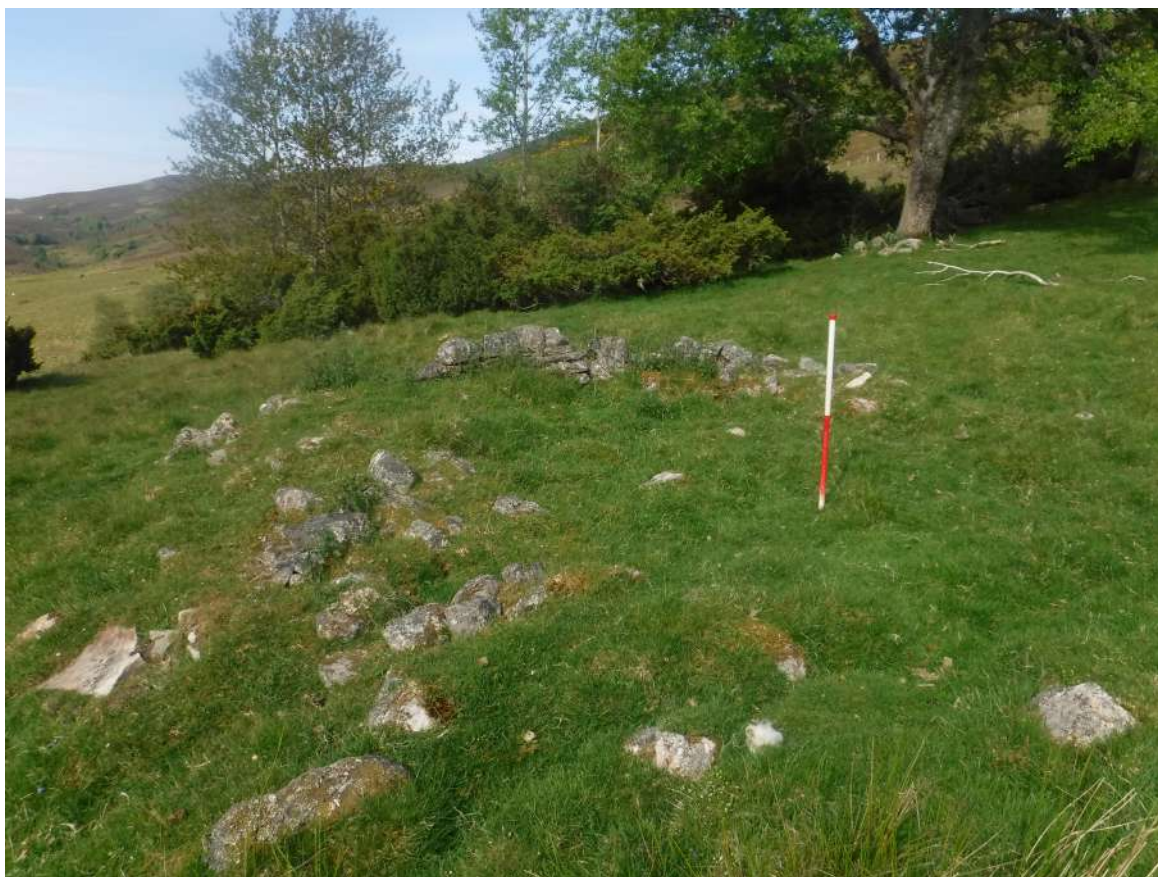
Plate 26: Degraded stone structure 10b, facing W

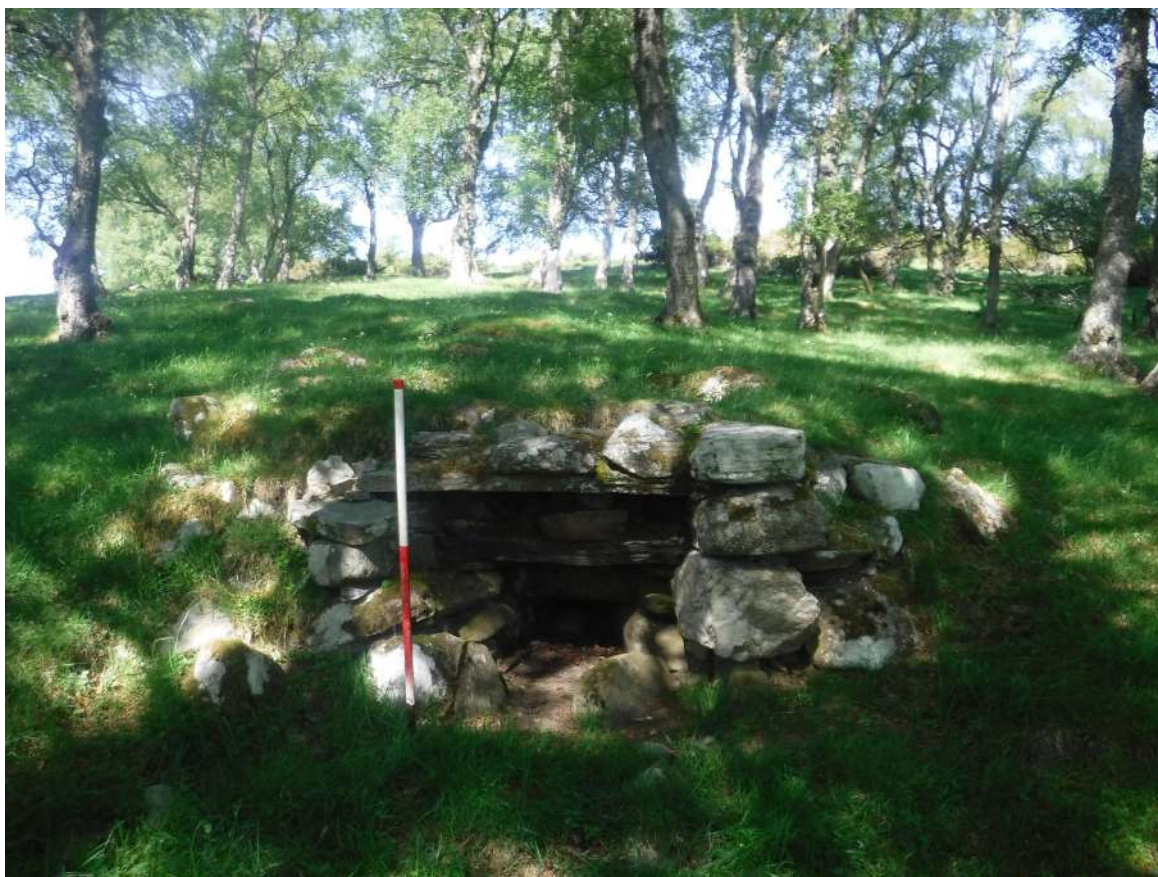
entrance and flue on the southeast side. The flue was capped by large lintel stones and stood to 0.9m high (**Plate 27**). The lime kiln is depicted on both 1st and 2nd edition OS mapping. North of the kiln were the very heavily degraded remains of a turf and stone pen (10g), L-shaped structure (10h) and attached sub-rectangular enclosure (10i). They were visible as low grass-covered, stony banks with several trees growing over the structures (**Plate 28**). These sites were not shown on any of the historical mapping, indicating settlement that was already in a heavily degraded state by 1867.

Plate 27: Ruinous stone-built lime kiln 10f, facing WNW

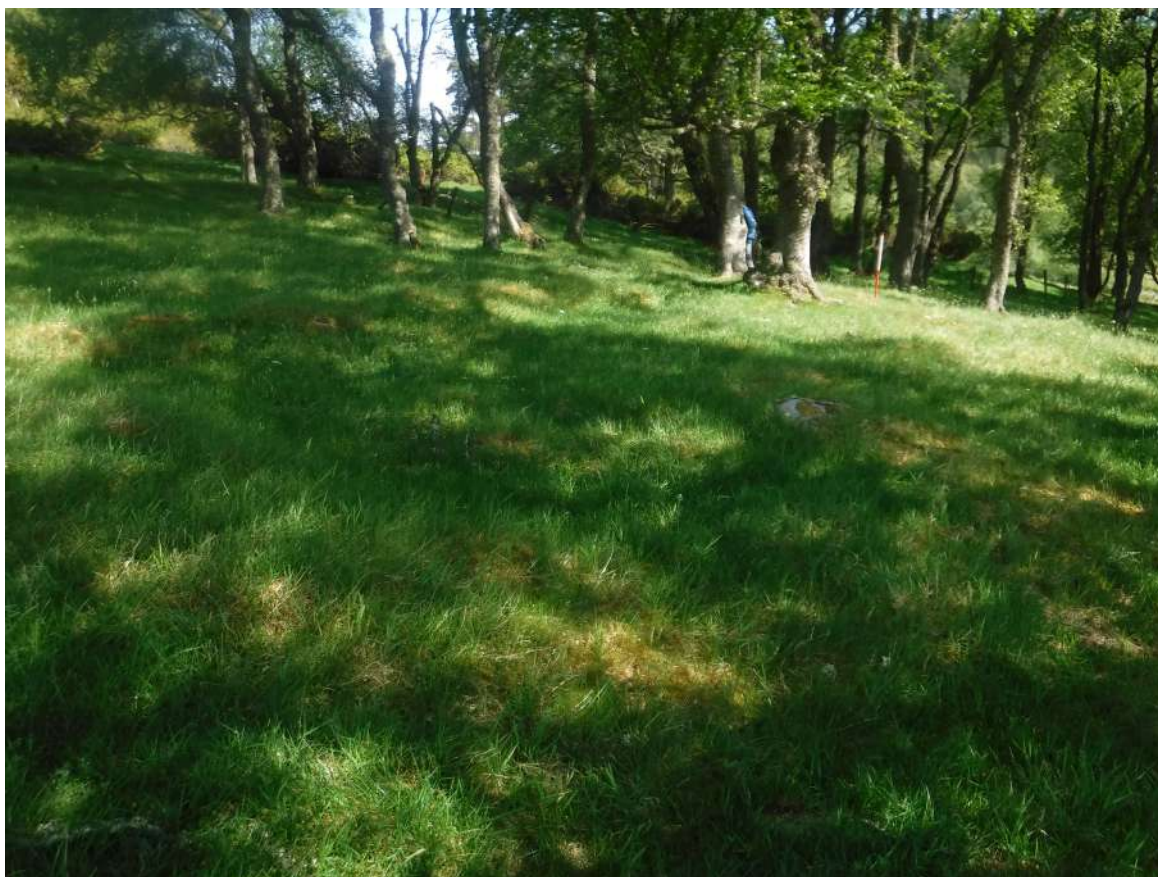
Plate 28: Very degraded turf and stone structure 10h, facing NNE

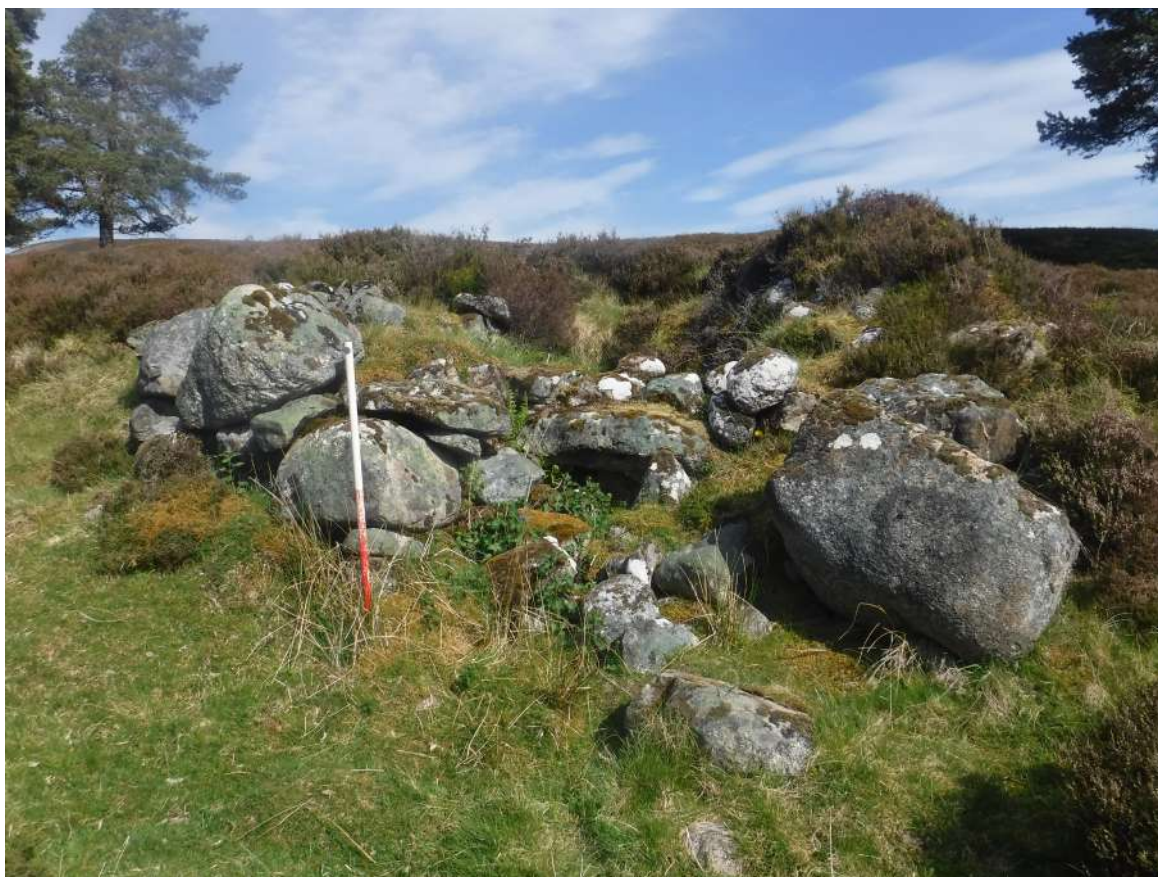
5.4.3 A circular lime kiln (13a) was located next to the stream on the west side of the settlement, measuring c.5m by 4m overall with an entrance and flue on the southeast side (**Plate 35**). The kiln was constructed with walls of large stones and boulders with a flat lintel stone capping the flue. The second kiln (13h) sat above the river on the east side of the settlement and comprised a kiln bowl and attached barn measuring c.11m NW-SE by 5m overall (**Plate 36**). The kiln bowl was at the southeast end and constructed with neatly coursed stonework. Both kiln sites survived as degraded stone structures under heather and grass. Lime kiln 13a is not depicted on historic mapping, suggesting it had gone out of use before 1867. The kiln barn 13h is shown as roofed on the 1st edition map but is no longer depicted by the 2nd edition map of 1900.

Plate 35: Stone-built lime kiln 13a, facing NNW

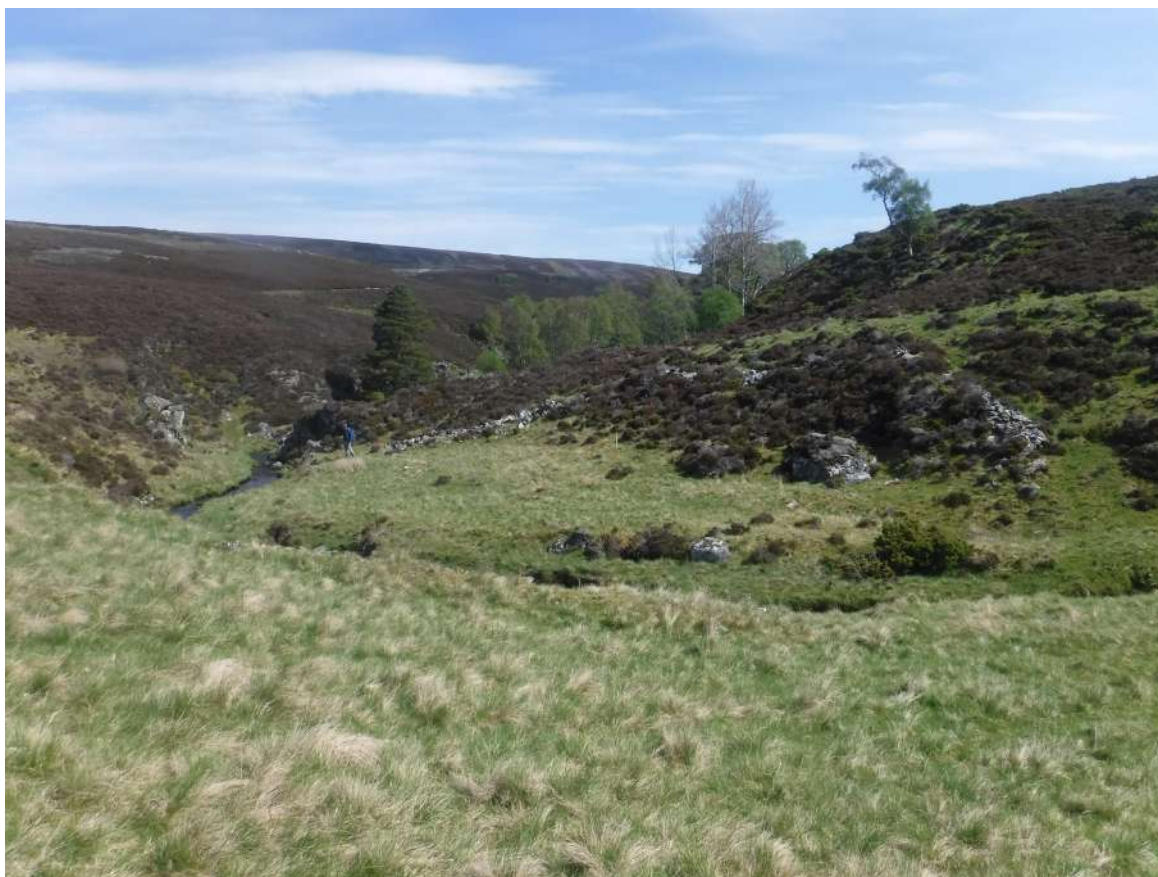
Plate 37: Degraded stone enclosure 14, facing NNE

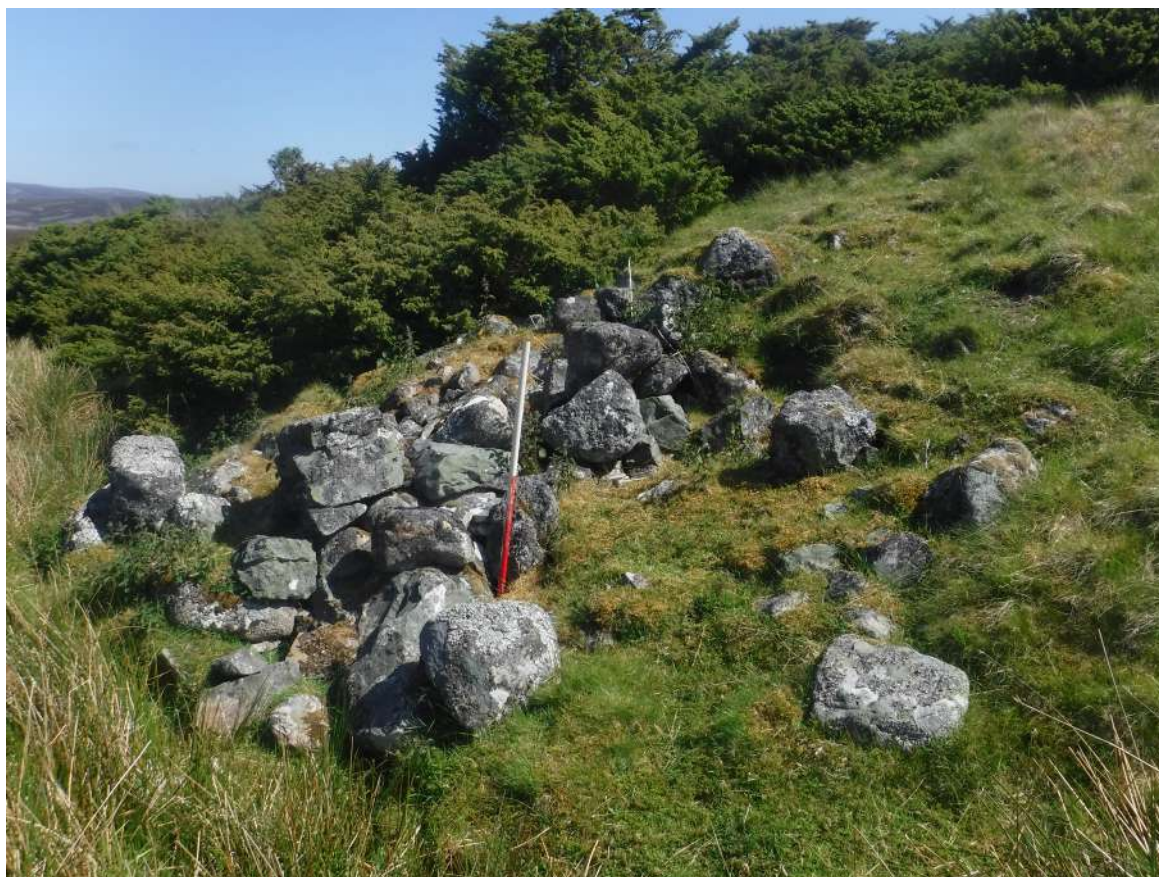
Plate 44: Degraded stone-built lime kiln 24d, facing NE

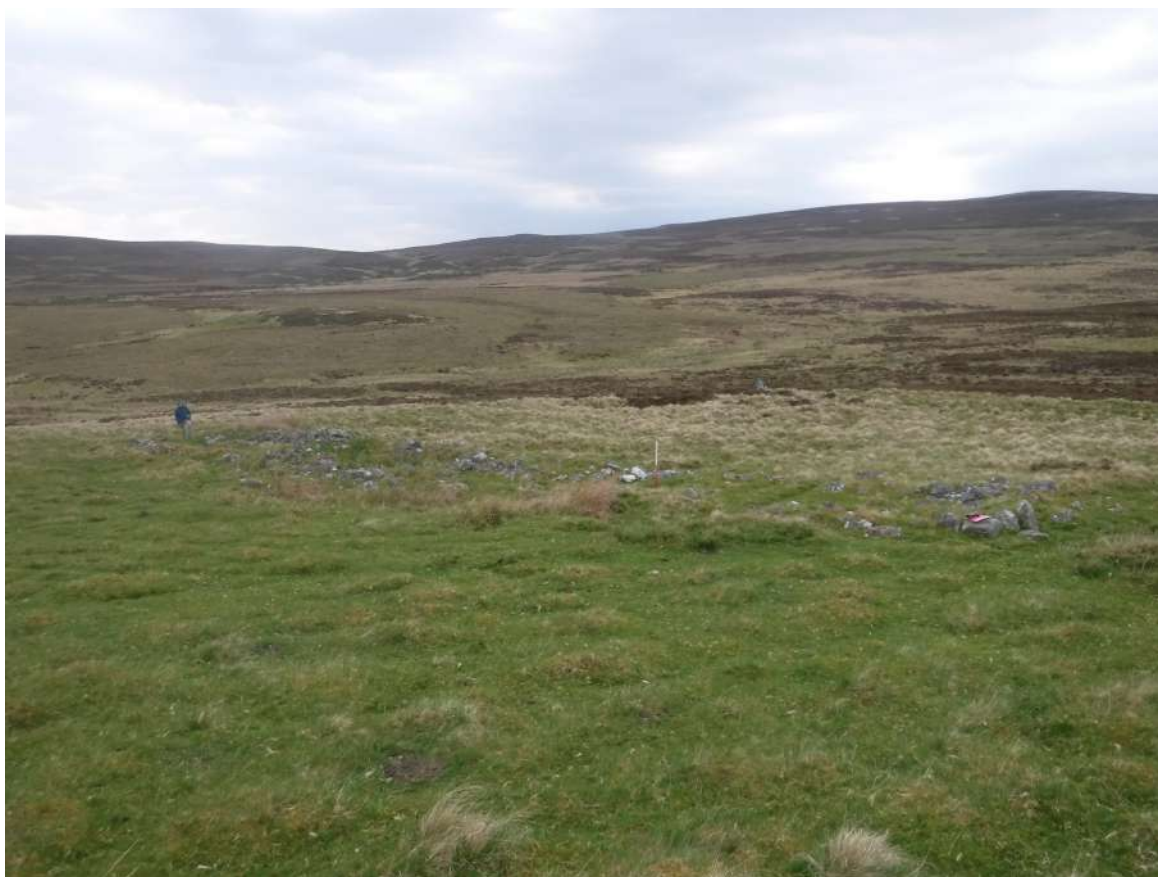
Plate 45: Degraded stone structure 21, facing W

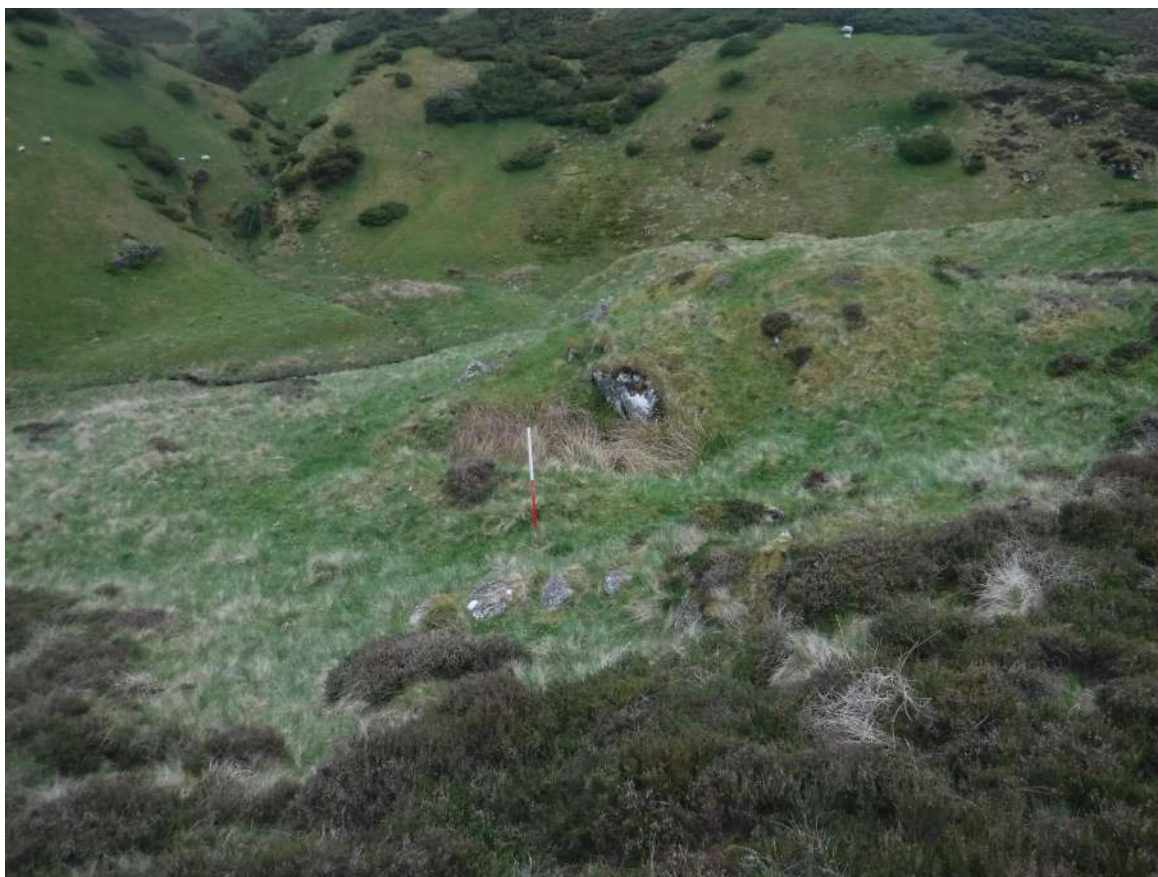
Plate 46: Degraded turf and stone structures 22a (front) and 22b (back), facing SSE

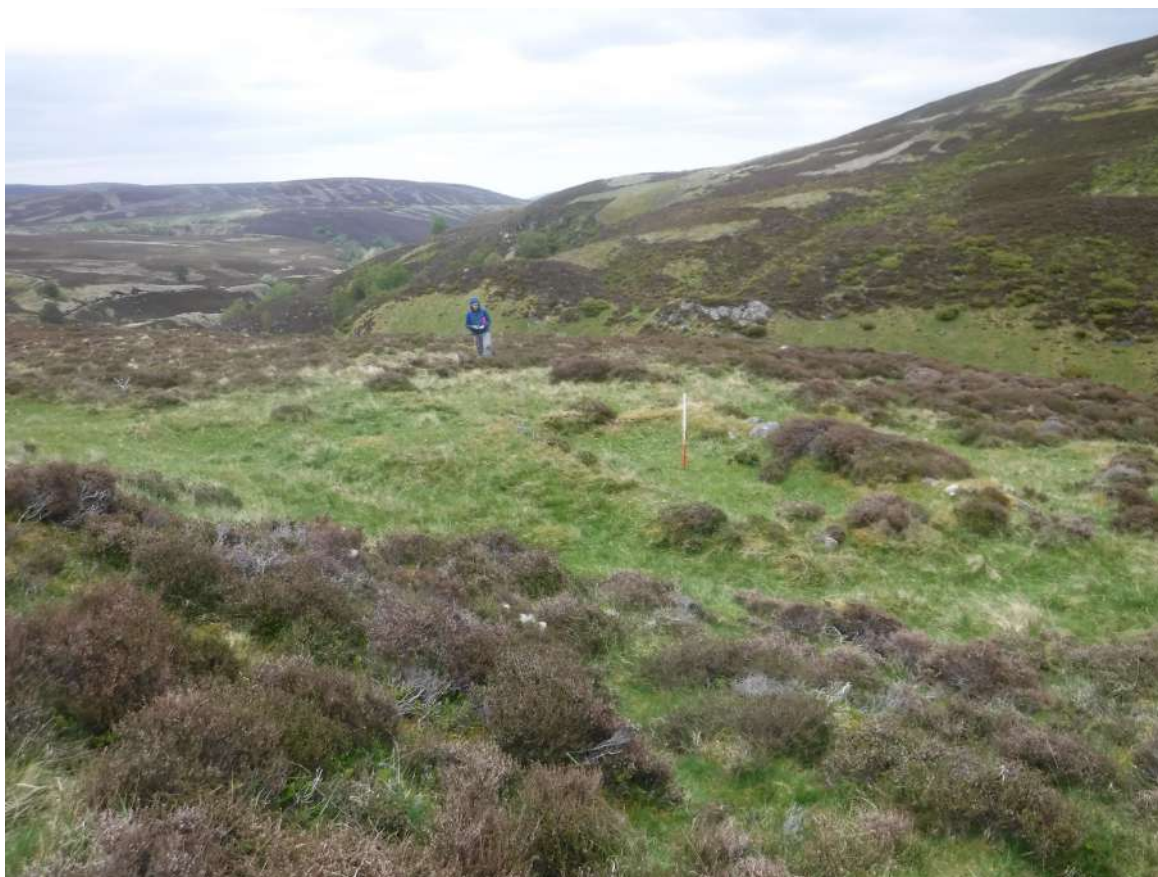
Plate 47: Degraded stone structure 20, facing NE

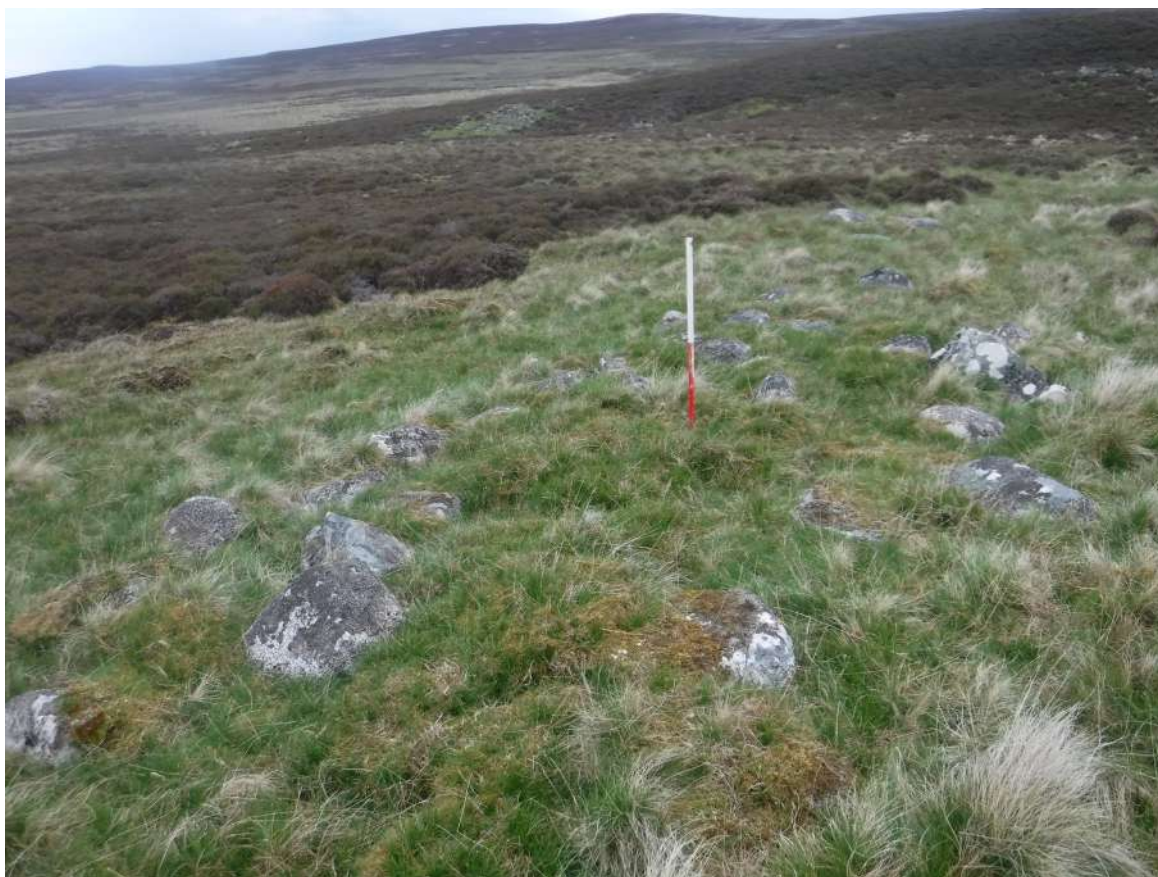
Plate 48: Degraded stone structure 53, facing WNW

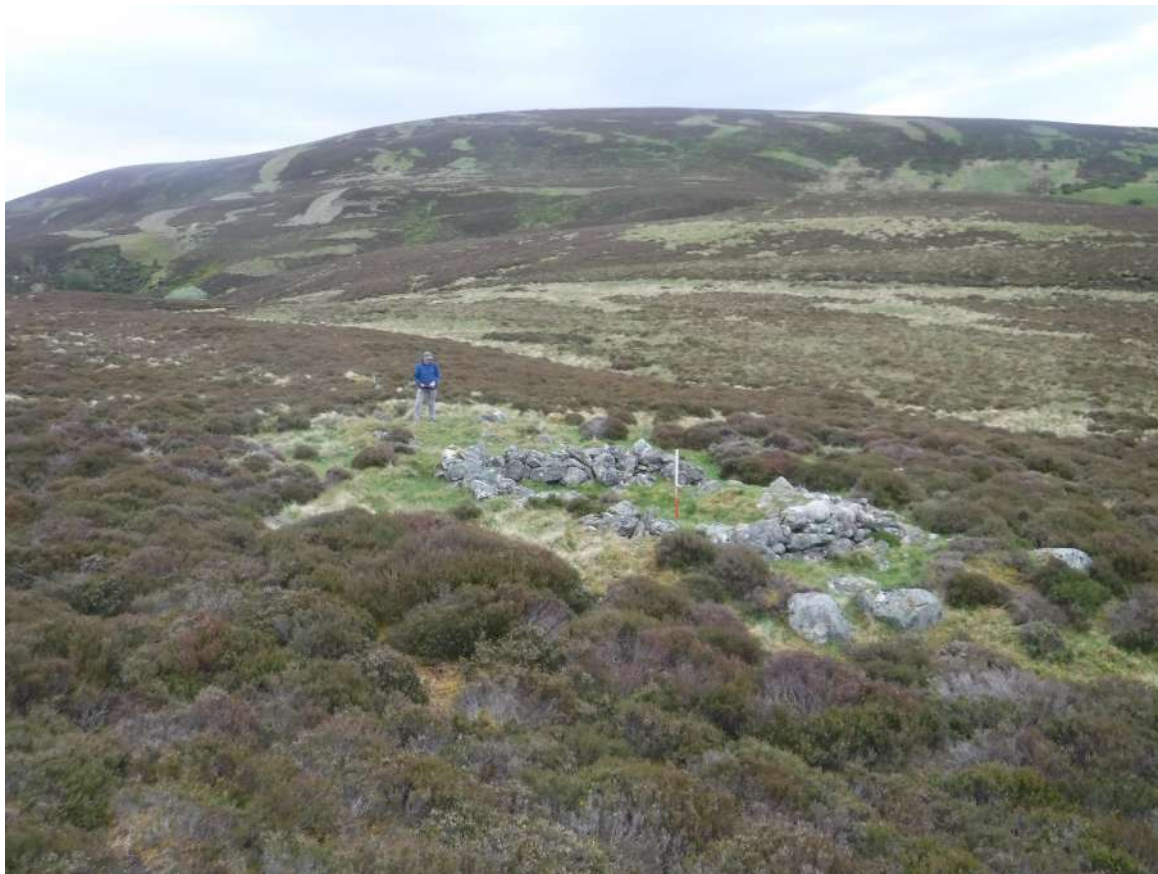
5.5.5 Site 19 comprised a probable multi-phase building, measuring c.14m NE-SW by 3.5m overall, with three internal rooms (**Plate 49**). The central room appeared to be a later structure, 4m by 2m internally, with an entrance on the southeast side and walls of double-faced stone and large boulders. The underlying walls of the larger structure were more heavily degraded. To the southwest, stood the remains of a stone-built lime kiln (site 54) revetted into the slope with

Plate 49: Degraded stone building 19, facing E

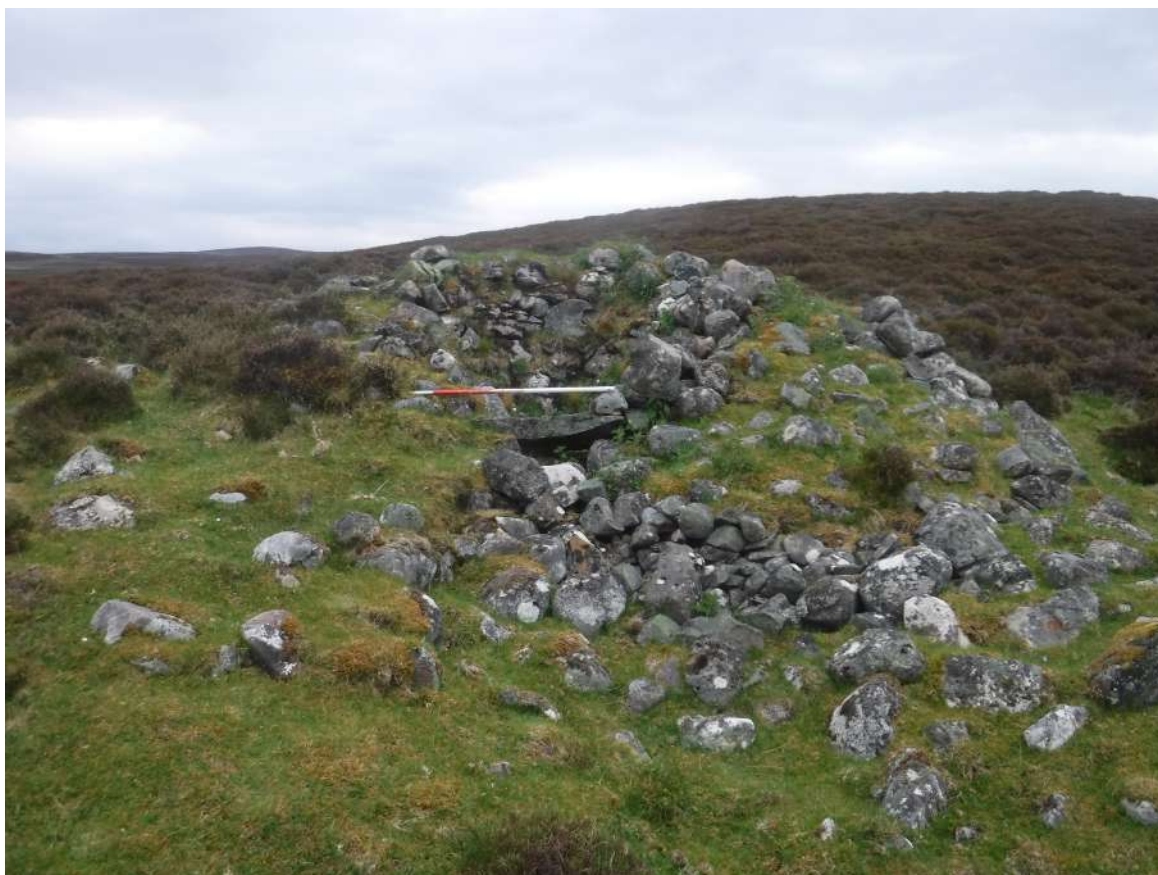
Plate 50: Degraded stone-built lime kiln 54, facing NNW

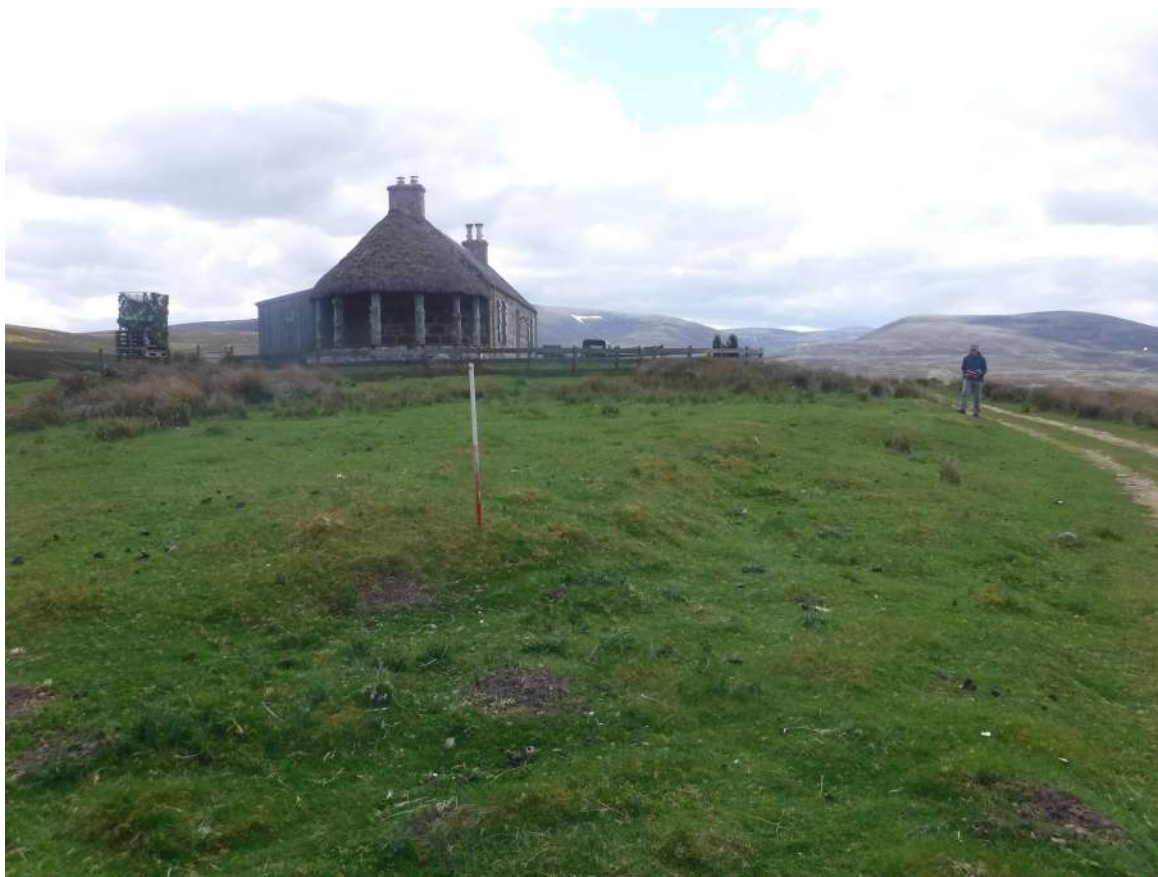
5.6.1 Fae is the southernmost area of settlement within the survey area, centred around a renovated cottage (site 29a) which is still in use by the estate. On the north side of the cottage were the very heavily degraded footings of an L-shaped structure (29b), surviving only as very slight raised banks under the grass with a short section on wall face visible on the northwest side (**Plate 51**). An enclosure (29c) was also present on the north side of the cottage, with walls mostly built of loose rubble banks with the west side formed by a later drystone dyke (**Plate 52**). An internal very degraded revetment wall may indicate the remains of an earlier enclosure wall. Both 29a and 29b appear to correspond to roofed structures shown on the 2nd edition OS map revised in 1900, which are in a different arrangement to earlier structures shown on the 1st edition map. The enclosure 29c is shown on both historic maps.

Plate 51: Very degraded footings 29b with renovated cottage 29a behind, facing S

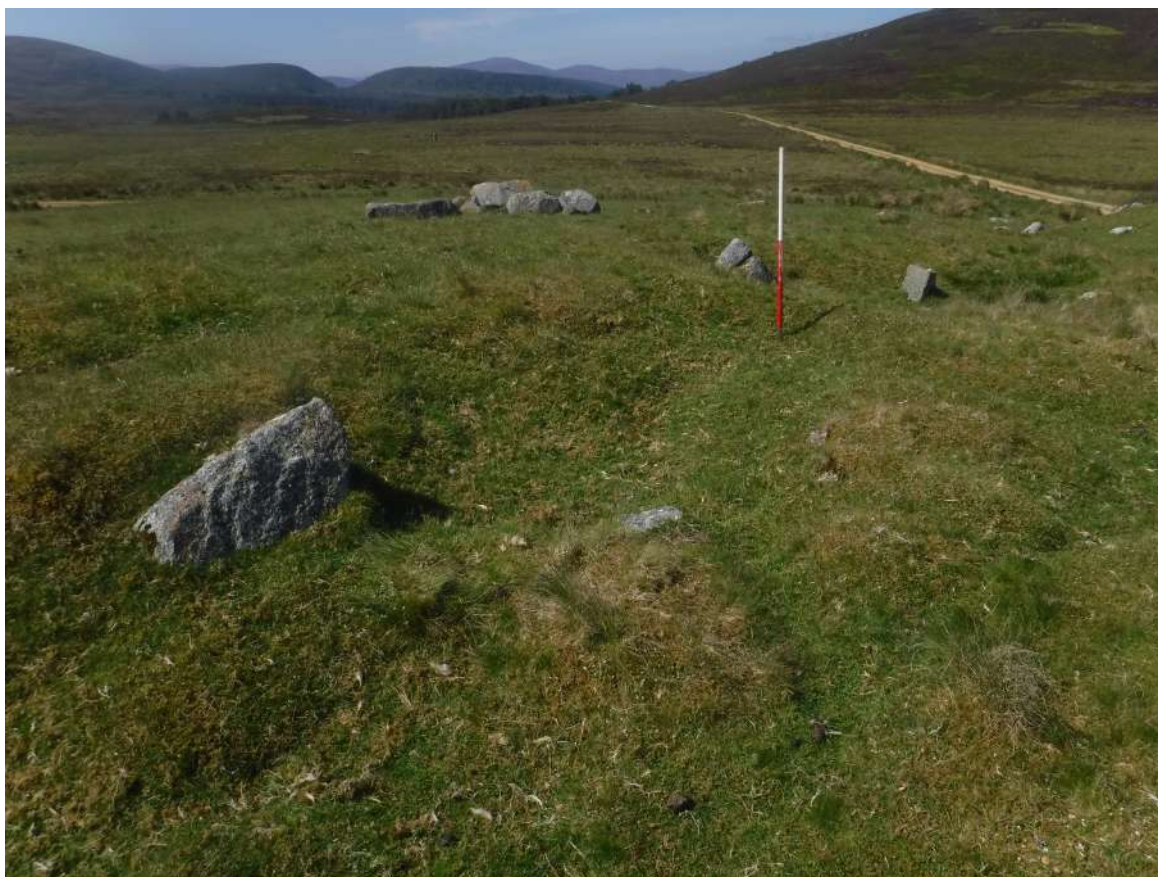
Plate 59: Degraded turf and stone structure 27d, facing SW

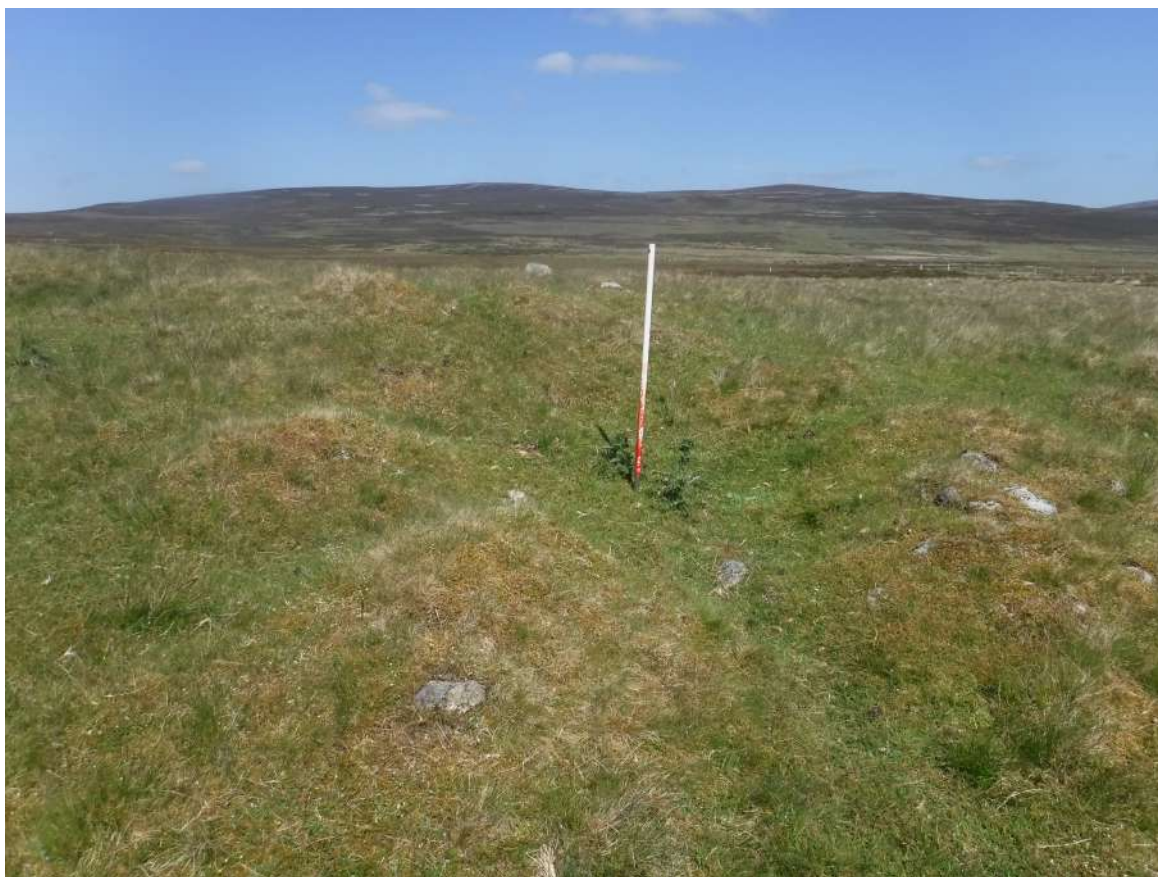
Plate 60: Degraded possible grain kiln 27e, facing NE

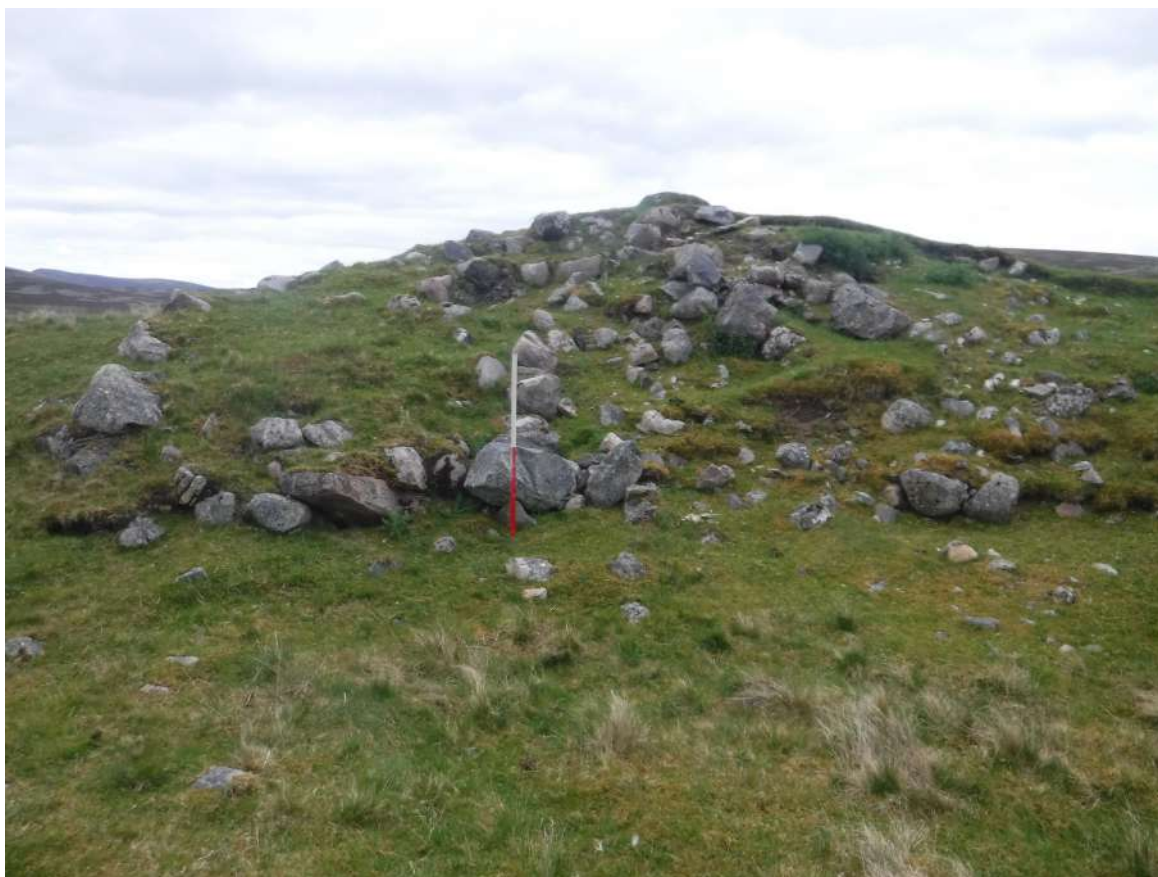
Plate 61: Heavily robbed lime kiln 25, facing NE

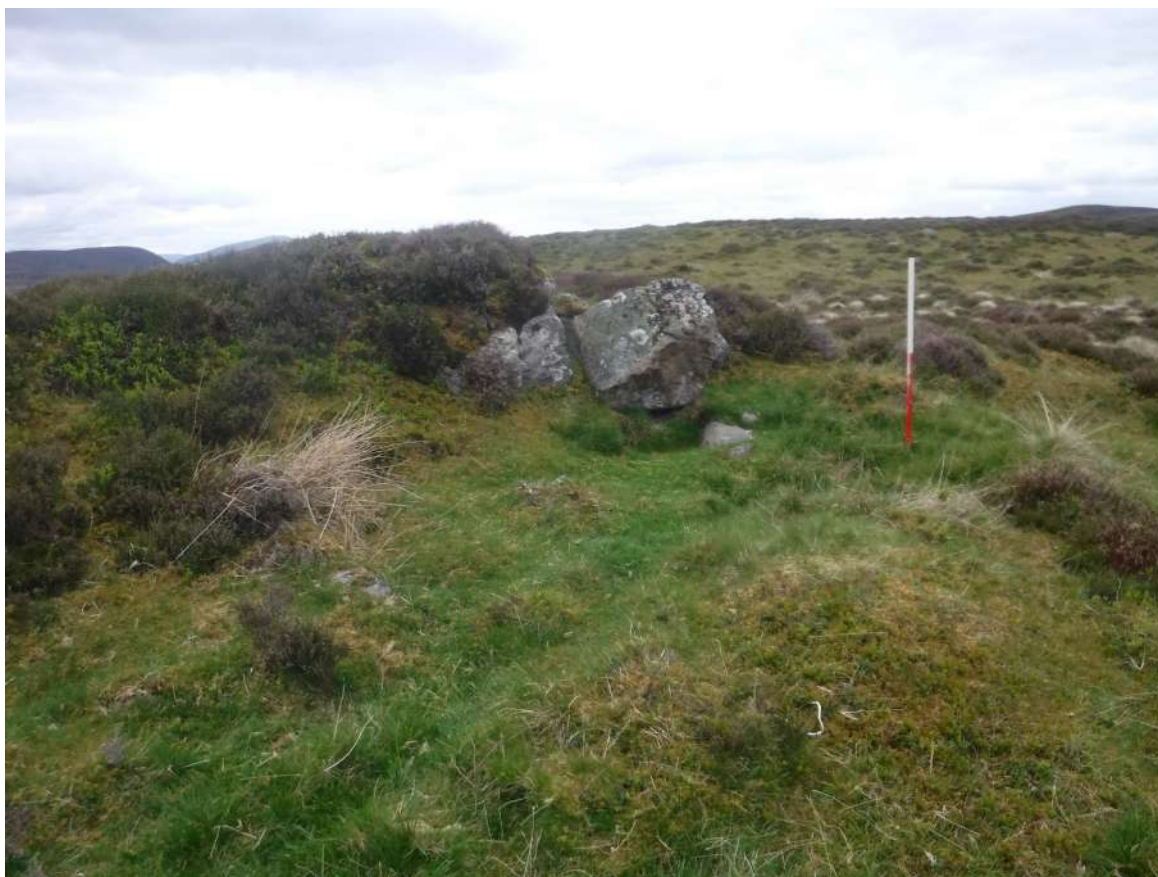
Plate 63: Degraded turf structure 32, facing W
