Glen Brown Woodland Creation Dorback Estate Archaeological Walkover Survey Report

AOC 70511

June 2021

On Behalf of:	Galbraith
National Grid Reference (NGR):	NJ 09811 18723 (centre)
AOC Project No:	70511
Prepared by:	Lindsey Stirling
Illustrations by:	Lindsey Stirling
Date of Fieldwork:	2 nd -4 th , 15 th -16 th & 22 nd June 2021
Date of Report:	25 th June 2021
OASIS No.:	aocarcha1-424845

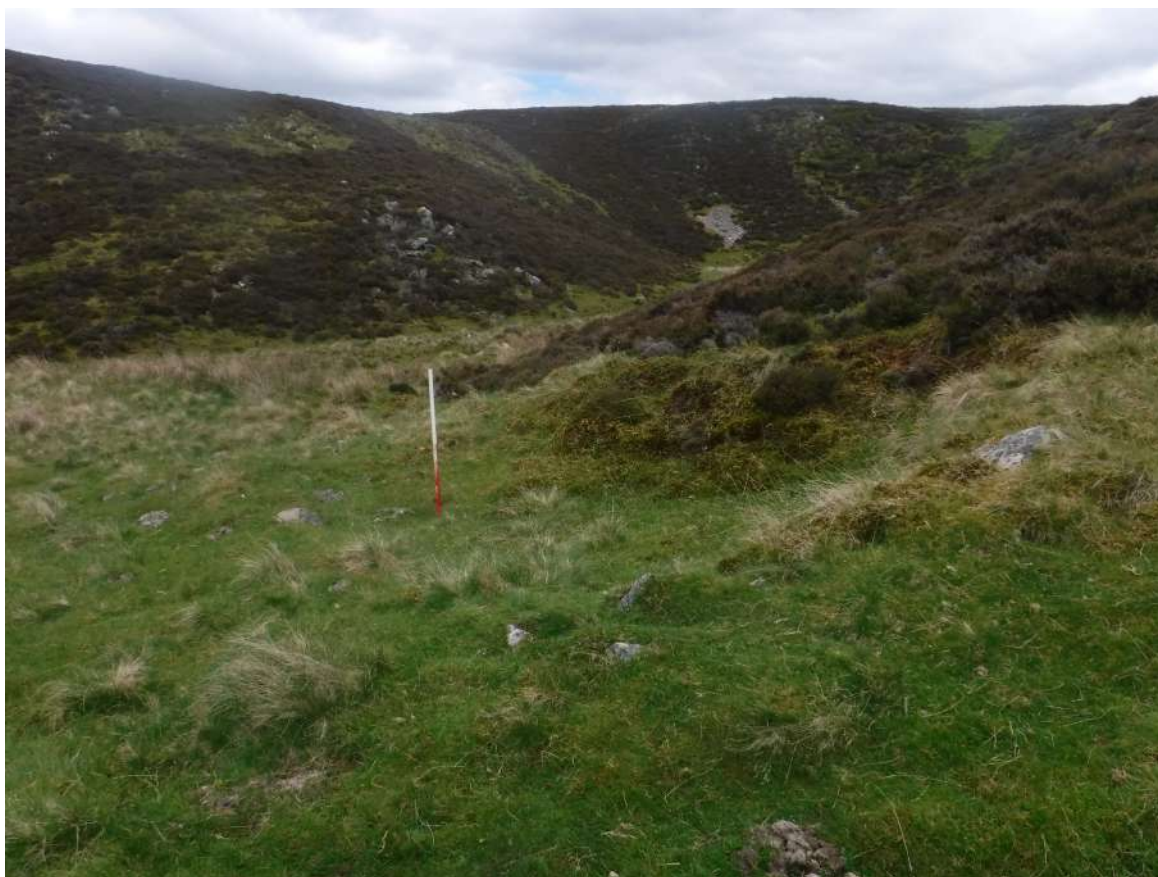
Plate 64: Degraded turf structure 35, facing E

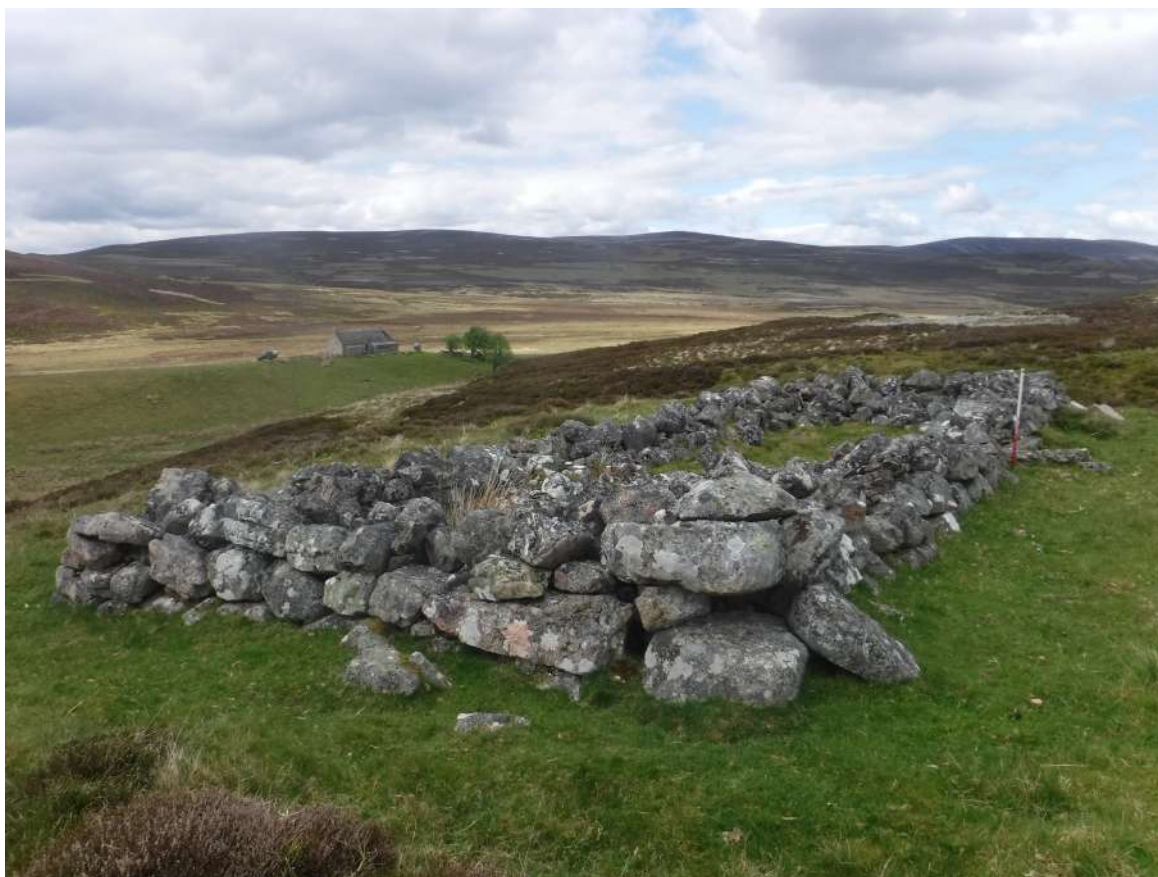
Plate 66: Degraded stone structure 34, facing NNW

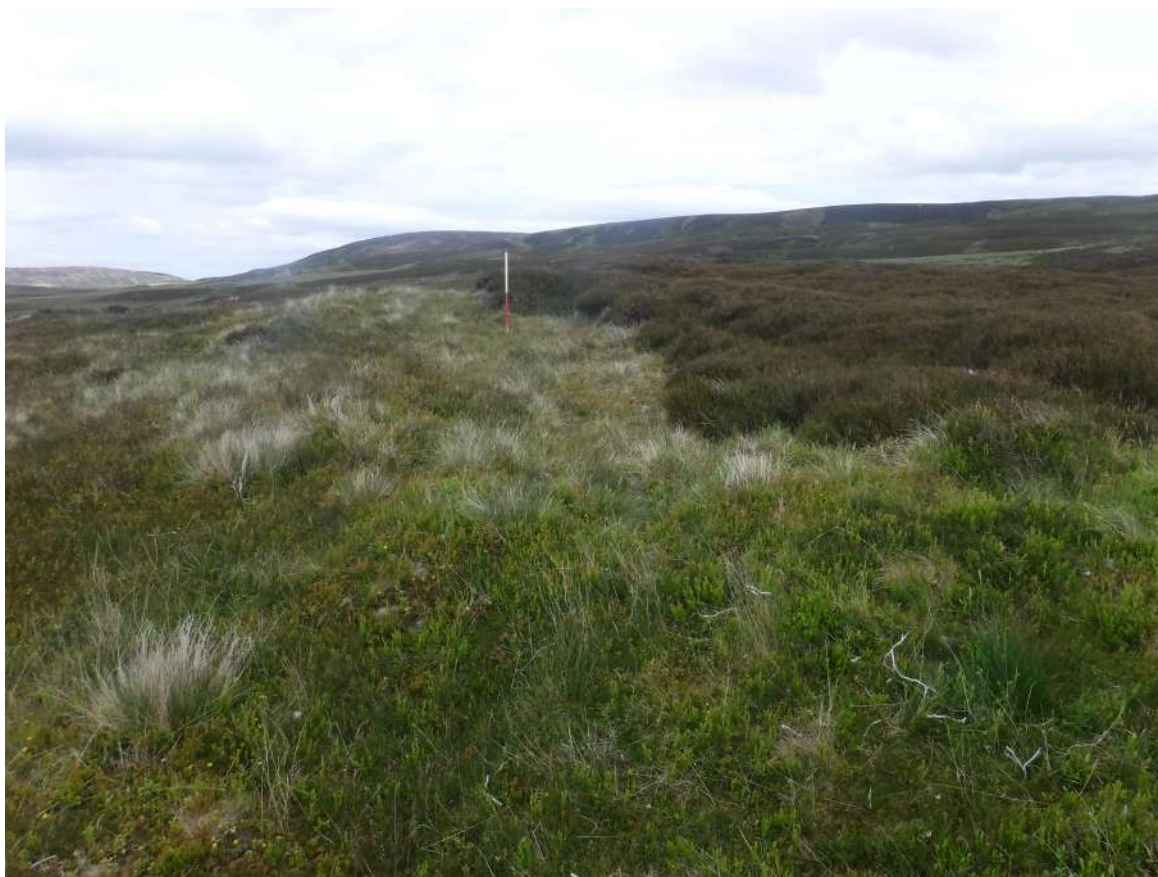
Plate 67: Degraded turf structure 91, facing NE

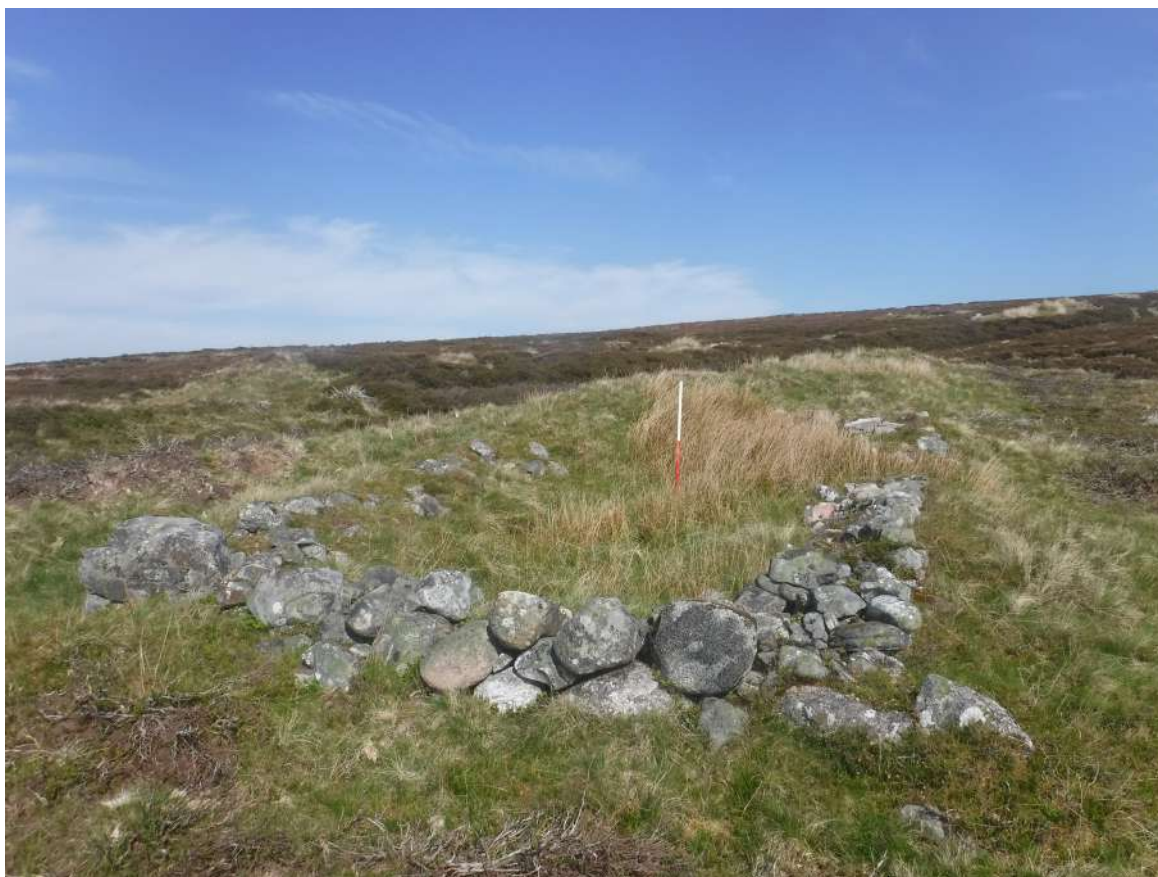
Plate 69: Degraded stone structure 23a, facing NW

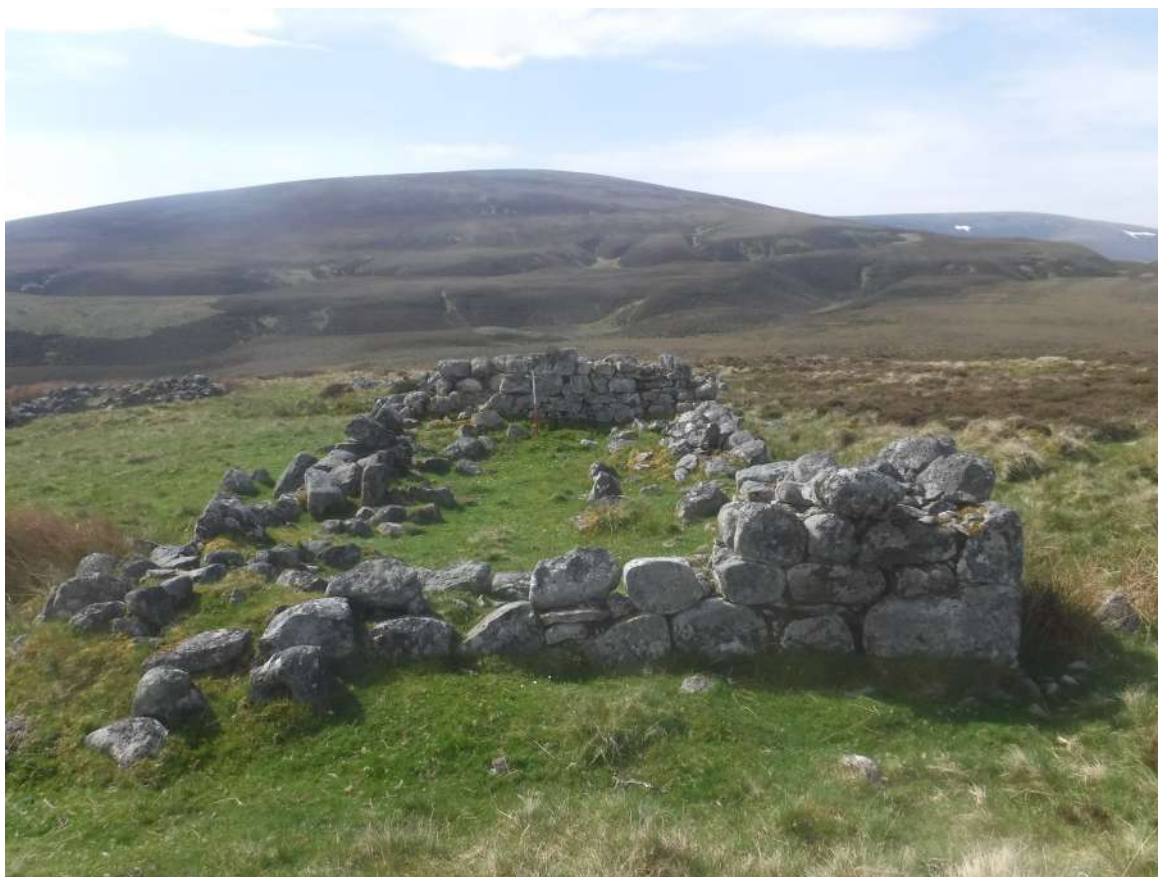
Plate 70: Ruinous stone structure 23d, facing S

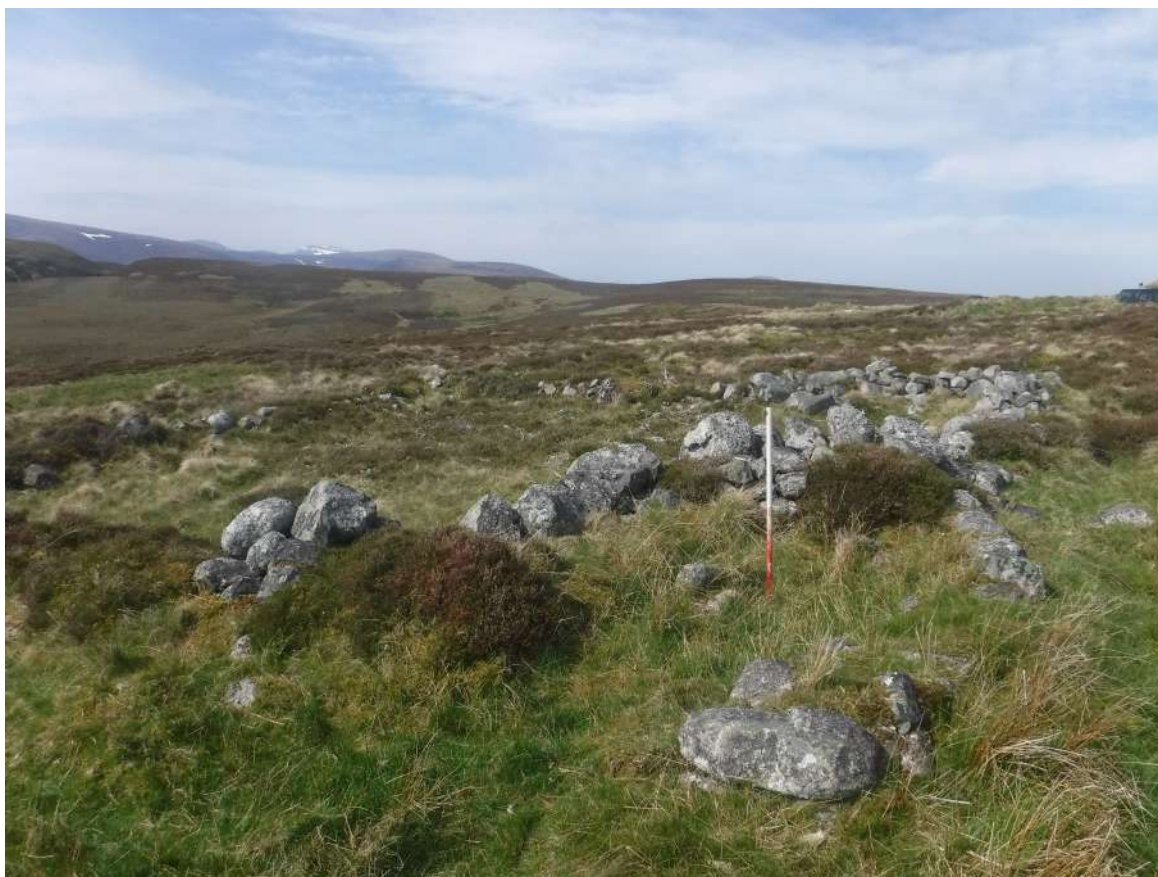
Plate 74: Degraded stone enclosure 23i, facing S

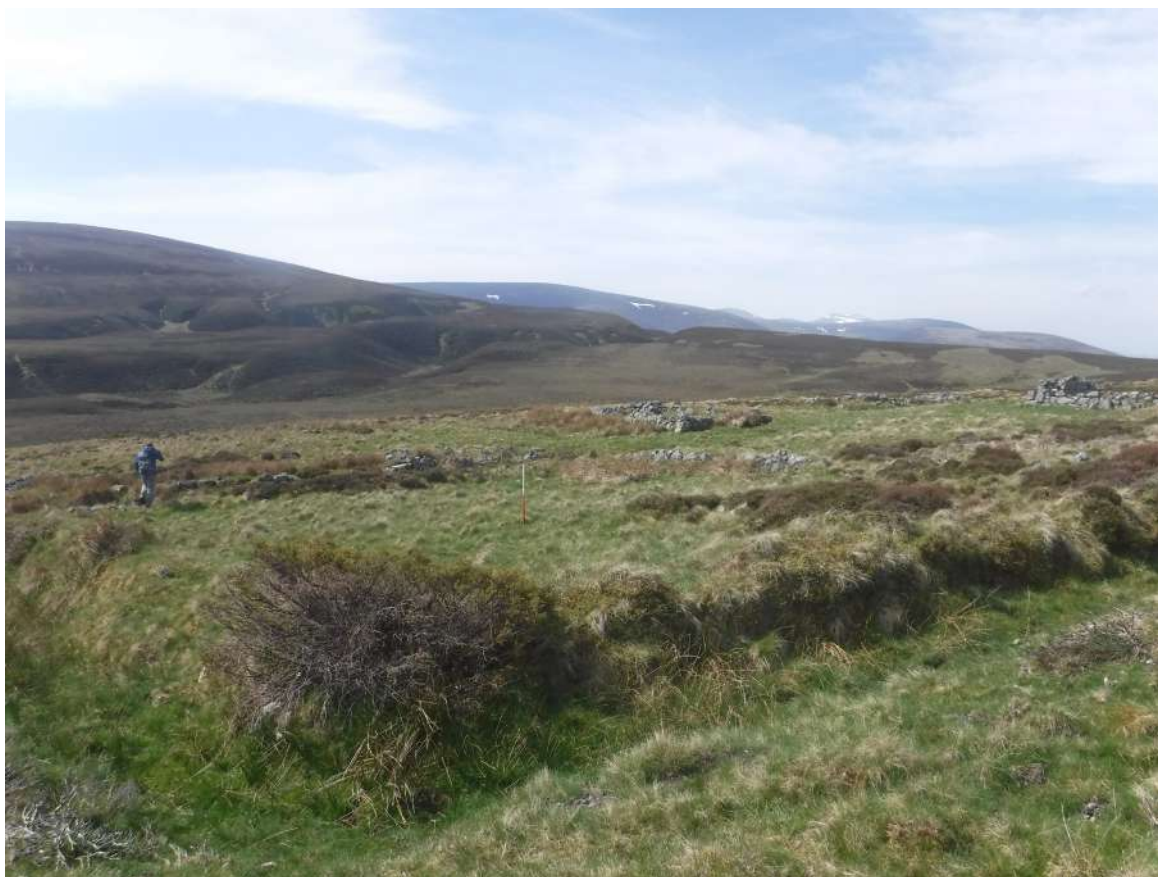
Plate 75: Degraded turf structures 23c (front) and 23b (back), facing SE

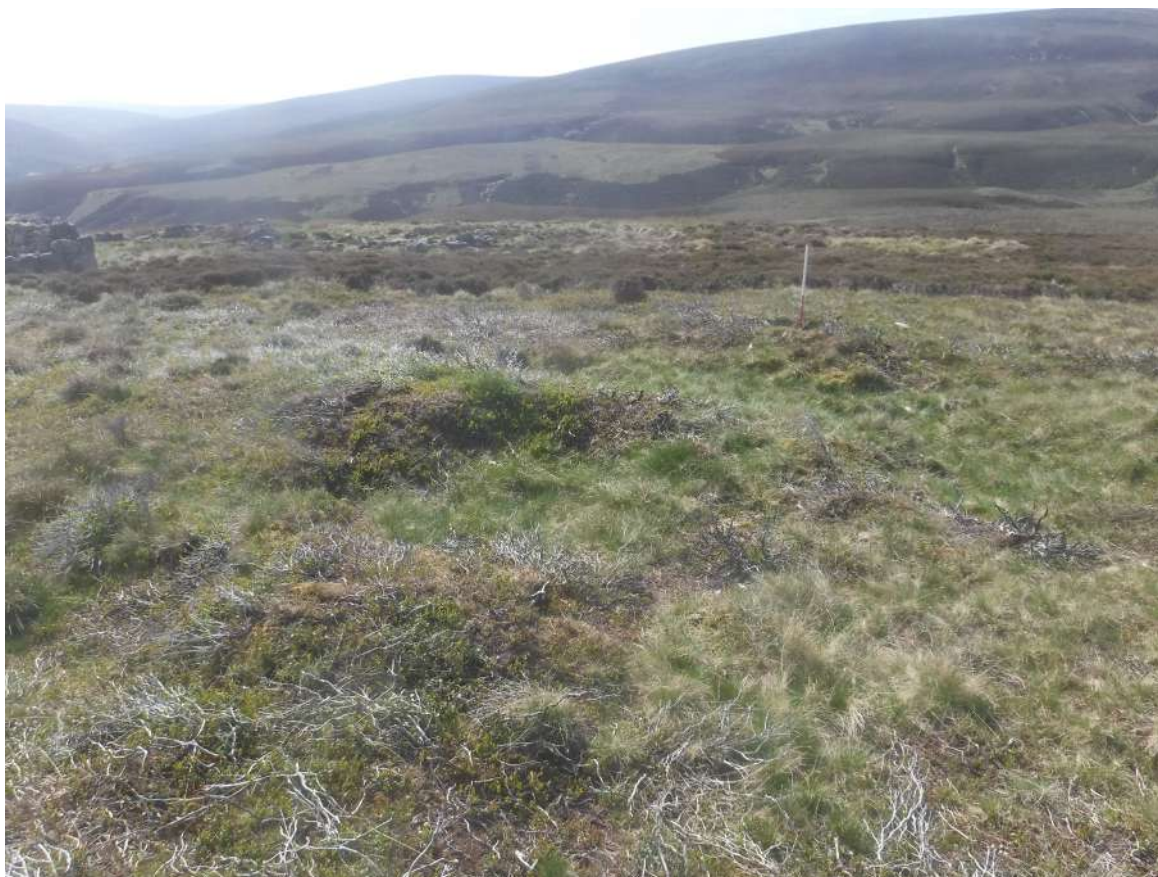
Plate 76: Ruinous stone-built lime kiln 23j, facing N

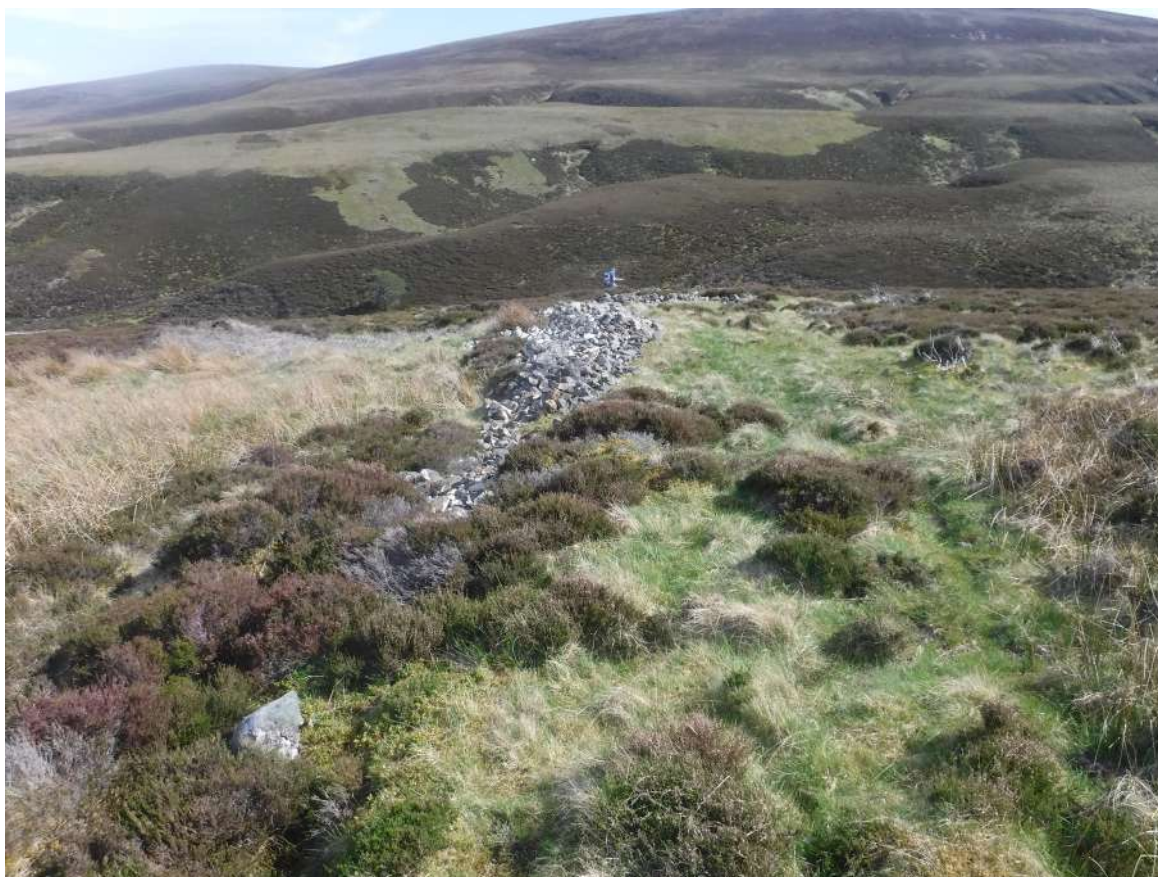
Plate 78: Degraded stone structure 44, facing N

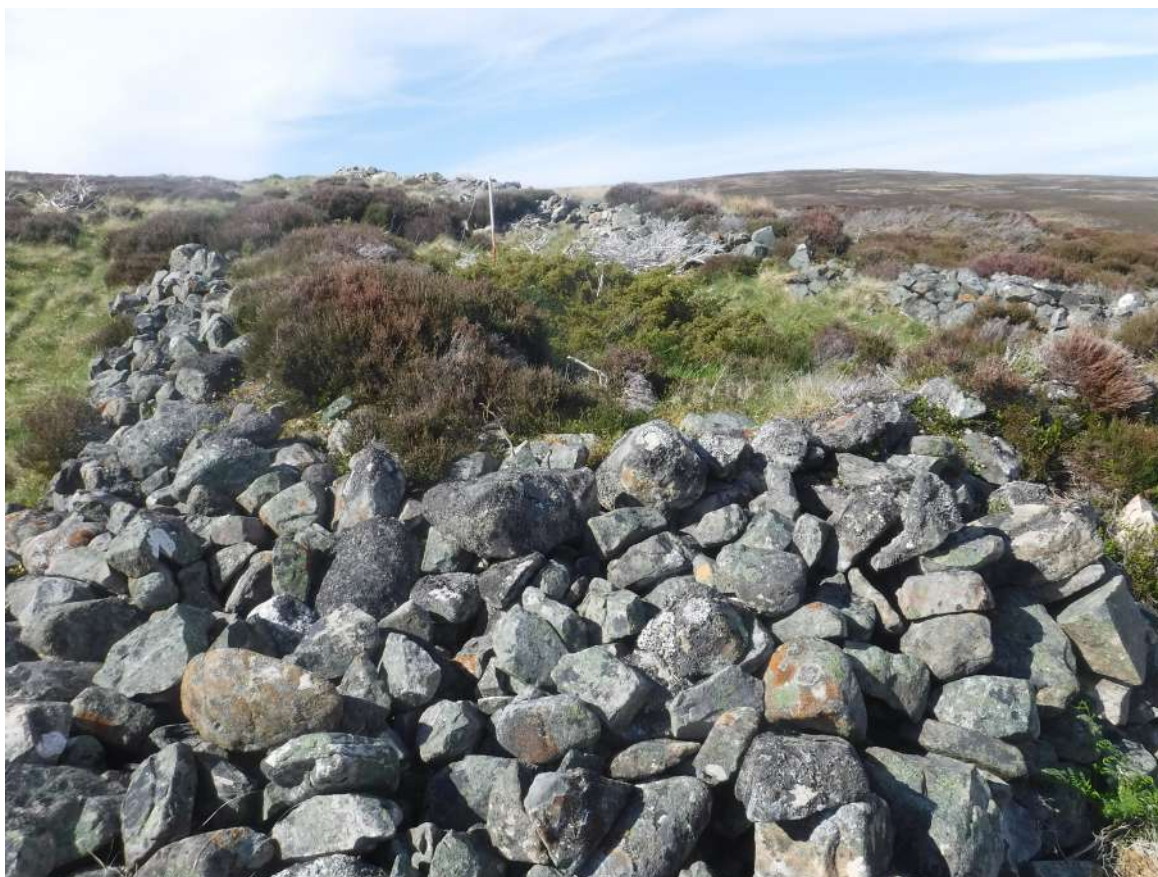
Plate 79: Ruinous stone building 15a, facing NW

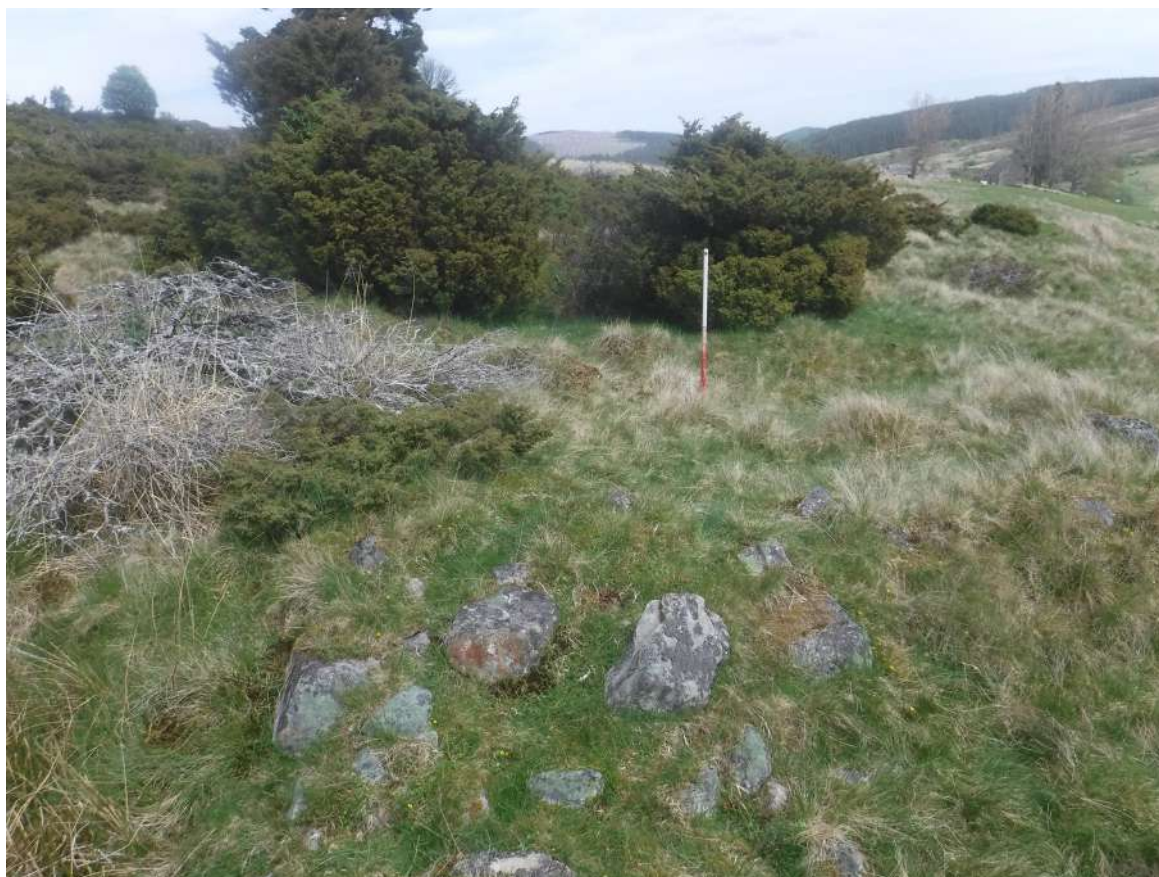
Plate 86: Degraded stone and turf structure and enclosure 38, facing NE

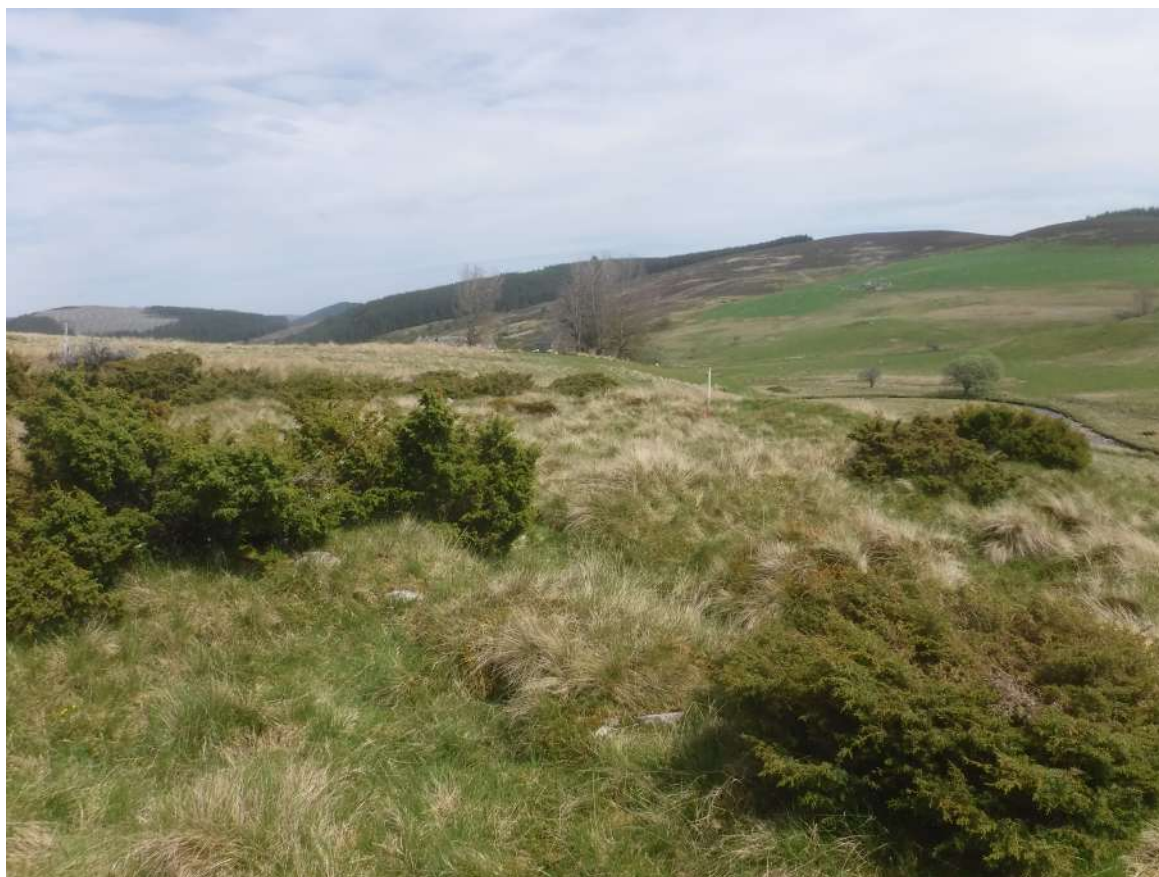
Plate 87: Degraded turf shieling hut 17c, facing NNW

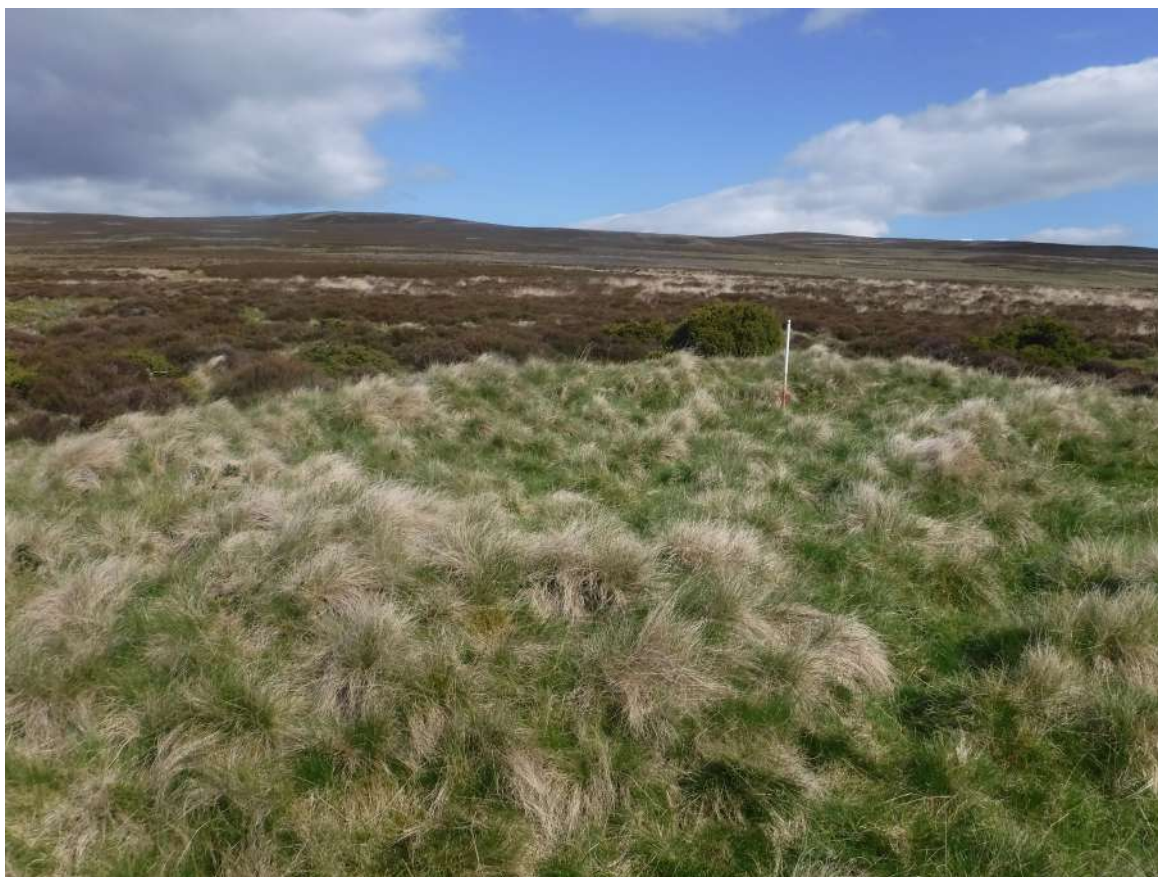
Plate 88: Degraded turf shieling hut 17e, facing NNW

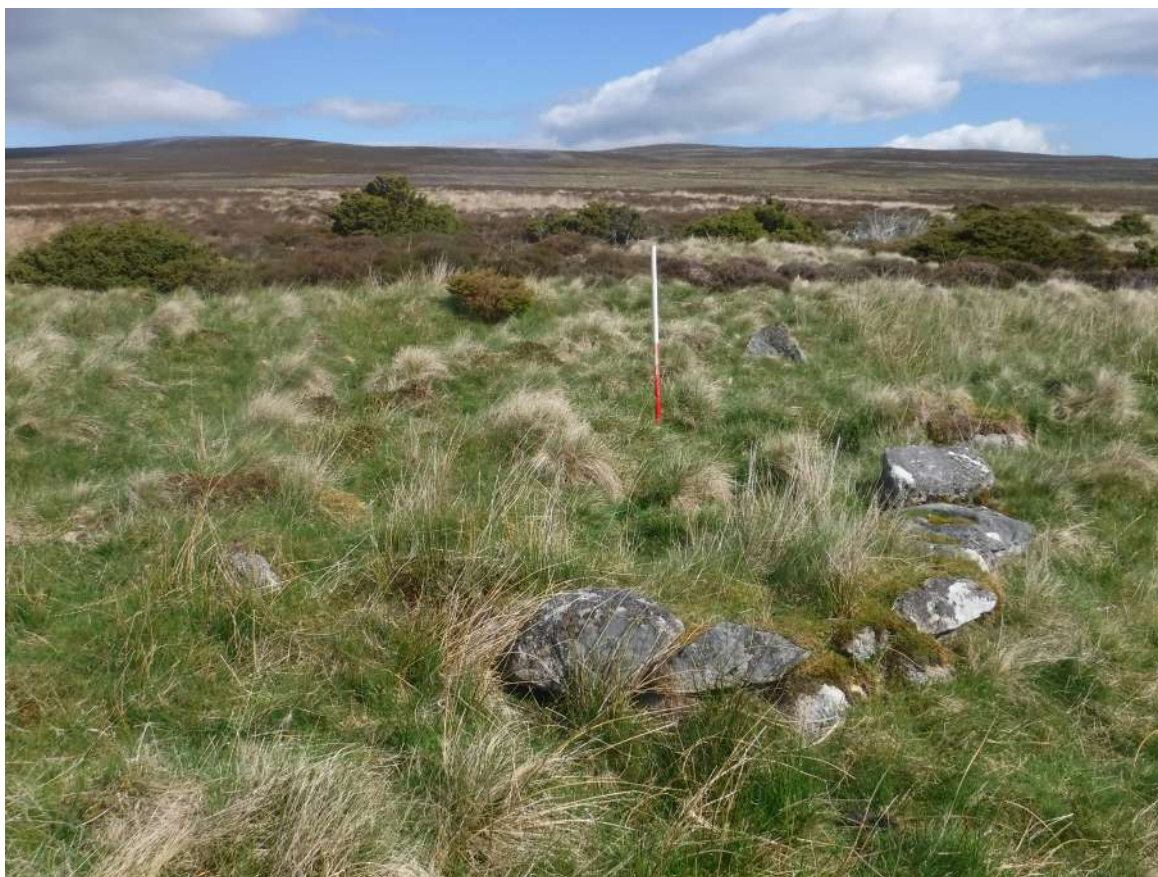
Plate 89: Degraded turf shieling hut 16, facing W

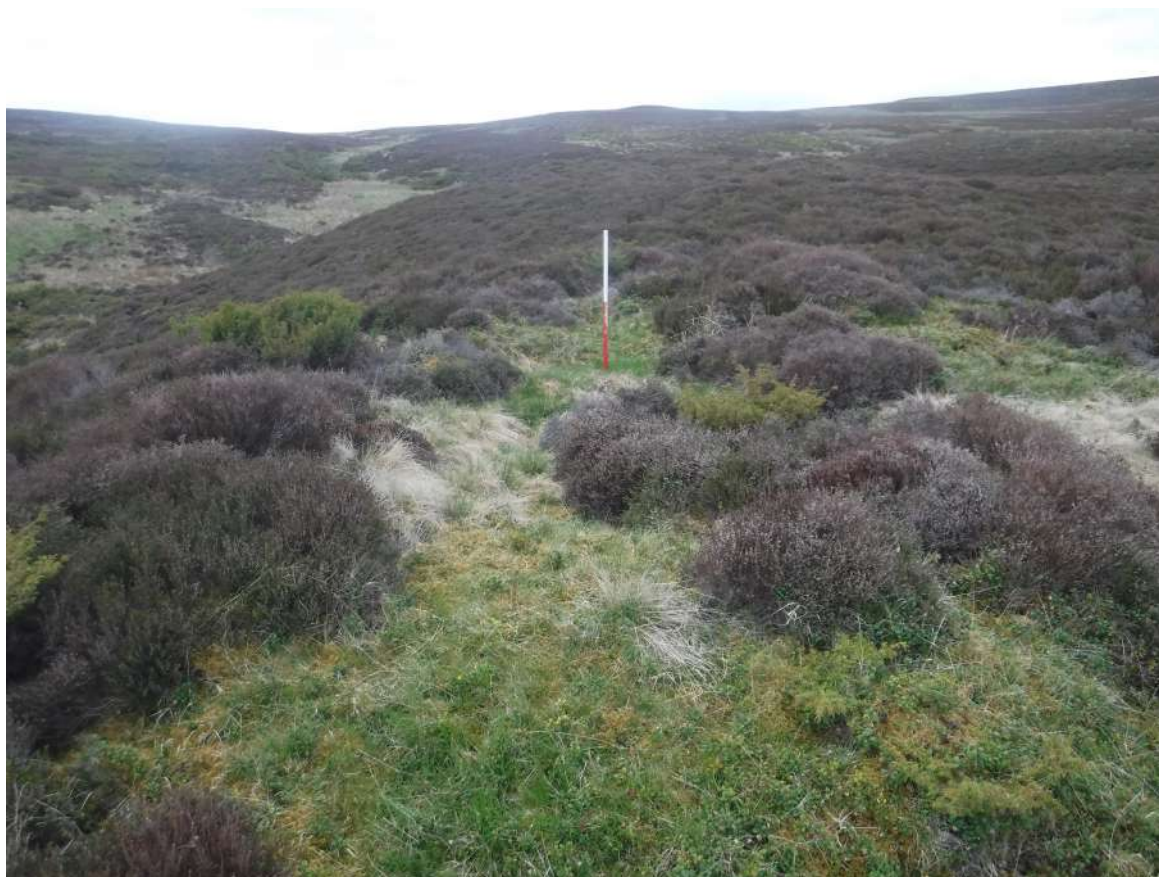
Plate 90: Degraded turf shieling hut 18, facing SW
