Dalmore Distillery Watching Brief

DSR and Recommendations

HAS Report No.	DMD22-004
Site Code	DMD22
Client	Blyth & Blyth Ltd
Planning Reference	22/02146/FUL
OS Grid Reference	NH 66710 68747
Date	11/09/2024
Author(s)	Karen Kennedy
Approved by	Lachlan McKeggie

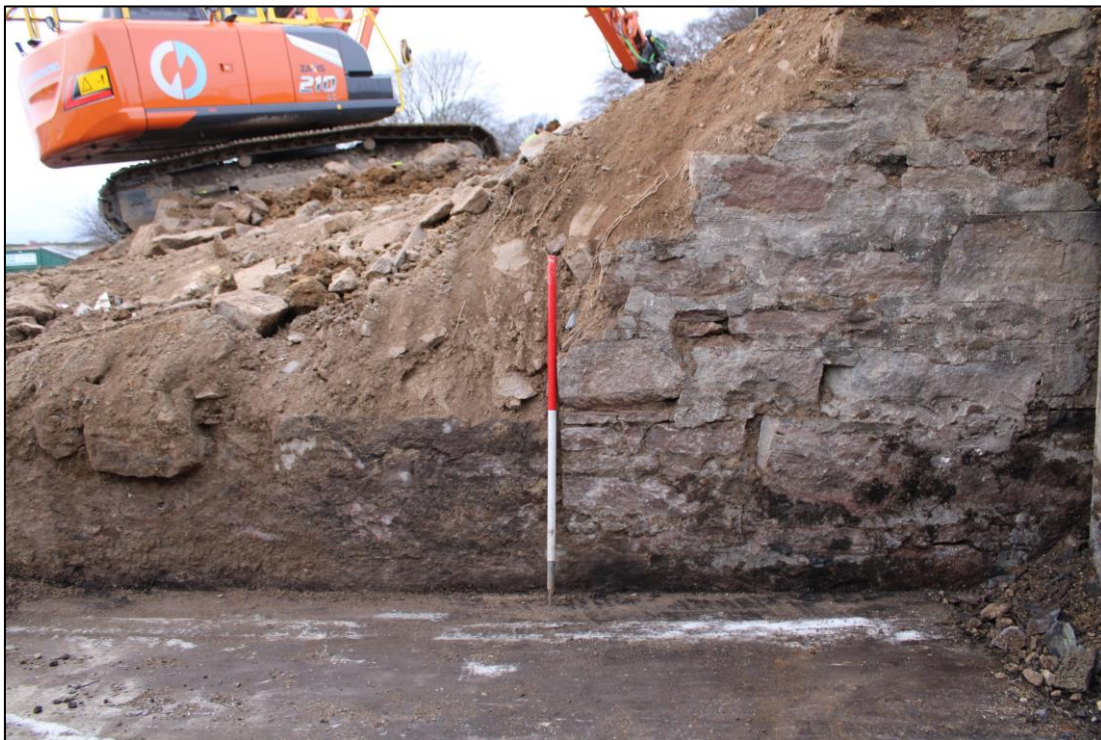
The east entrance road re-route comprised 234sqm and was rectangular in shape, running west to east along the southern extent of the east entrance (Figure 14). It was on a very steep slope (Figure 15). The area excavated varied between 0.4 and 10m in depth covering the slope to the south of the current access road. The slope was filled with rubble containing worked stone, bollards, concrete, etc mixed with a grey brown sandy silty topsoil (005). During excavation what remained of the exterior of the eastern wall of one of the distillery's warehouses was exposed [006] (Figure 16). This is one of the warehouses which are visible on the second edition OS map surveyed in 1904 and the more recent OS map surveyed in the mid 1950's. The wall was built with large, rectangular worked stones, bonded with a creamy coloured mortar. Further excavation revealed the top 1m of the interior of the north wall of warehouse 1 [007]. This was built with small rectangular shaped worked stones of grey and pinkish colour with black marks where the rubble was situated against the wall, this wall was also bonded with mortar (Figure 16). To the east of the exposed wall, between warehouses 1 and 2 a concrete slab [008] was revealed (Figure 17). This was covered in a layer of slates which may indicate that either a small roofed building was situated here at some point or be part of the remains of the original warehouse. Whilst the archaeologist was onsite the contractors did not think it was necessary to dig any deeper into this rubble filled topsoil, although at a later date it was decided that all the rubble would be removed but it was agreed that an archaeologist was not required to watch this excavation as it was only demolition rubble being removed. The contractors sent photographs taken during this excavation (Figure 20). According to the contractor onsite the rubble was dug out to a concrete base which was not penetrated before they started building up the area with clean stone. The height of the wall was approximately 3.5m.

Figure 16: Photo 5168, exterior of east wall of warehouse, facing west, 1m scale

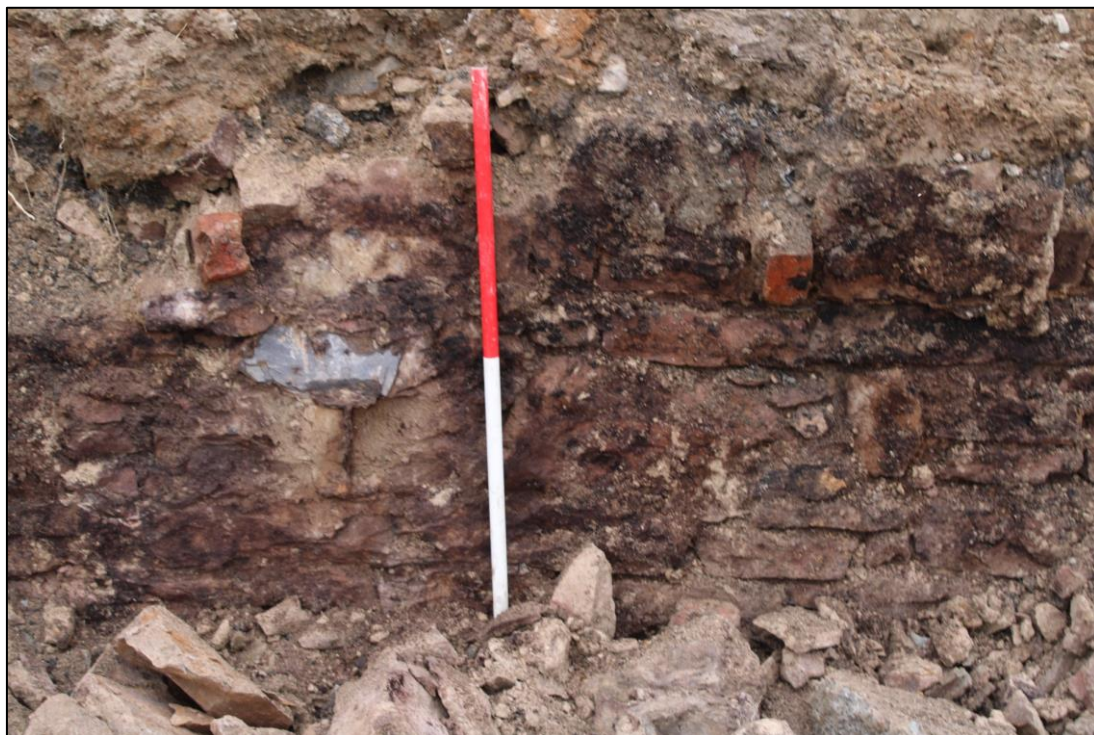
Figure 18: Photo 5177, showing north wall of warehouse, 1m scale

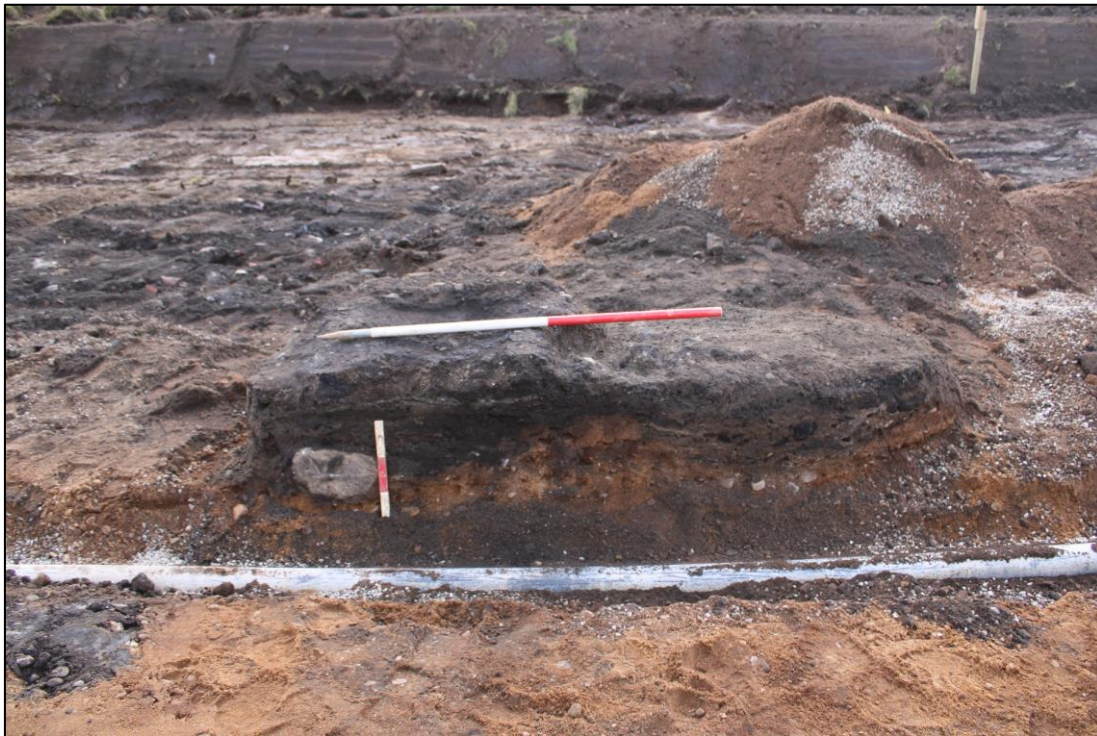
The watched area comprised 350sqm and was roughly rectangular in shape running north east to south west along the south of the Shore road, just to the east of the turning circle. The depth of the excavated area varied between 0.4 and 1.2m. The topsoil (009) in this area comprised a mid brown-grey silty loam with few small stones. The southern part of the watched area was filled with rubble and degraded concrete which went into the natural subsoil (Figure 21 and Figure 22). This subsoil (010) consisted of yellow-orange sandy silt with few gravel sized stones. The south east corner was a creamy yellow clay with few small rounded stones. Towards the centre of the watched area a small patch of black tarmac (011) (Figure 23) remained which overlay a layer of concrete/hardcore (012). It is most likely that this is the remains of an earlier road surface. This was likely disturbed by the now unused plastic drain covered in a pea sized gravel which ran to the north of the tarmac patch.

Figure 23: Photo 5205, facing south, showing patch of tarmac (unused drain in foreground), 1m and 0.3m scales

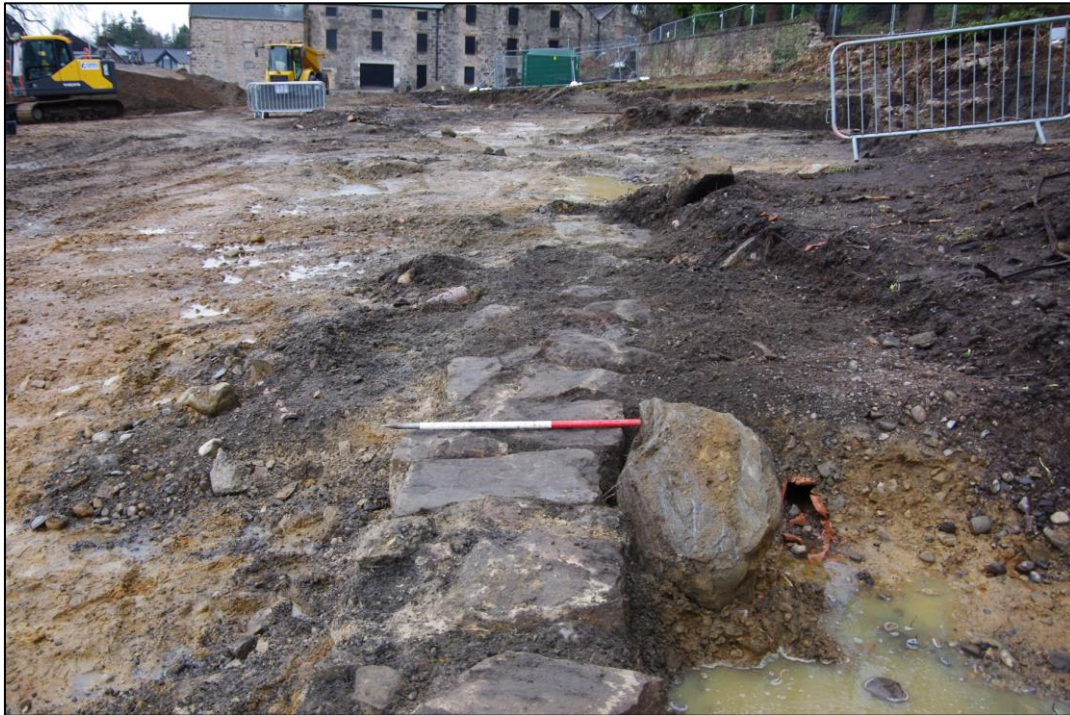
Ten structures, a culvert, cobbled surfaces and a garden wall were excavated within the garden area (Figure 24). These included the foundation remains of two walls, structure 3 [022] and structure 5 [030] which both consisted of large flat angular stones of various sizes filled with smaller stones and were built onto the natural subsoil. The surviving remains of structure 3 [022] (Figure 25) measured 7m in length and 0.45m in width, it's remains were only one course high measuring up to 0.45m in height. It was constructed of large flat local stone with smaller stones used as infill. The remains of structure 5 [030] (Figure 26) were smaller but built with the same construction method

onto the natural subsoil (014), measuring only 3.5m in length by 0.87 in width. Only one course survived to a height of 0.35m.

Figure 25: Photo 6578, Structure 3 facing north east, 1m scale

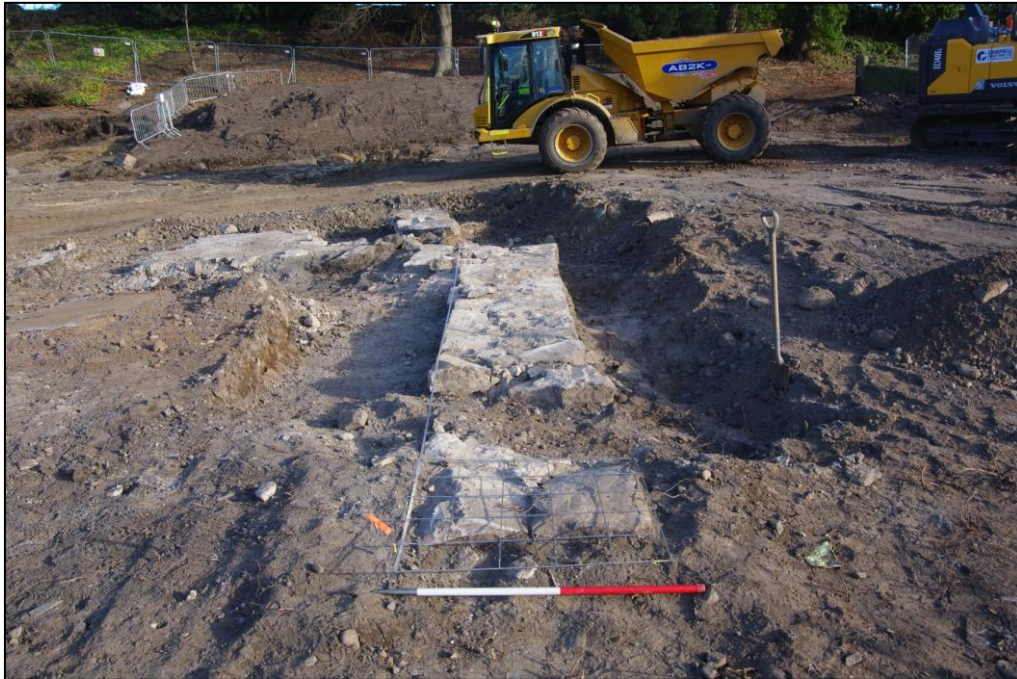
These comprised the wall of Structure 1 [15] which measured 6.1m in length and was 0.85-1.5m wide. The structure survived to a single course and was 0.4m in height. The remains consisted of large angular flat stones with smaller stones as infill. The wall/structure appeared to have been robbed out particularly towards the south end where some of the stone was missing (Figure 28 and Figure 29).

To the west of structure 1 [15] and to the east of structure 23 [16] was the remains of Structure 21 [85] which was also constructed of large angular stones with smaller stones as infill. This also survived to one course and was bonded with mortar. It measured 1m by 1.08m.

Figure 29: Photo 6530, Structures 1, 21, 22 and 23, facing north, 1m scale

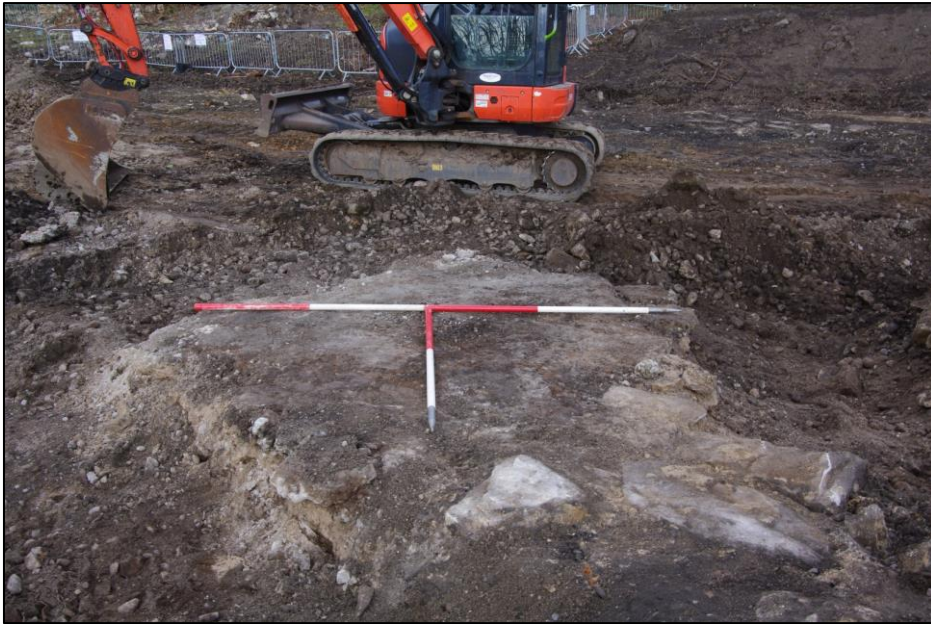
Directly to the west of Structure 21 was a concrete pad, Structure 23 [16] which was very degraded at the edges and ran south west to north east (Figure 30). The remains of this measured 6.8m x 6.25m, it was 0.4m deep and contained small gravel sized rounded stones which overlay a layer of imported large gravel (31). This concrete pad may have been the internal floor for Structure 21 and/or 22 but it was very difficult to say for sure as the edge of the concrete on all four sides is very degraded.

Figure 30: Photo 6503, structure 23, facing north west, 2m and 1m scales

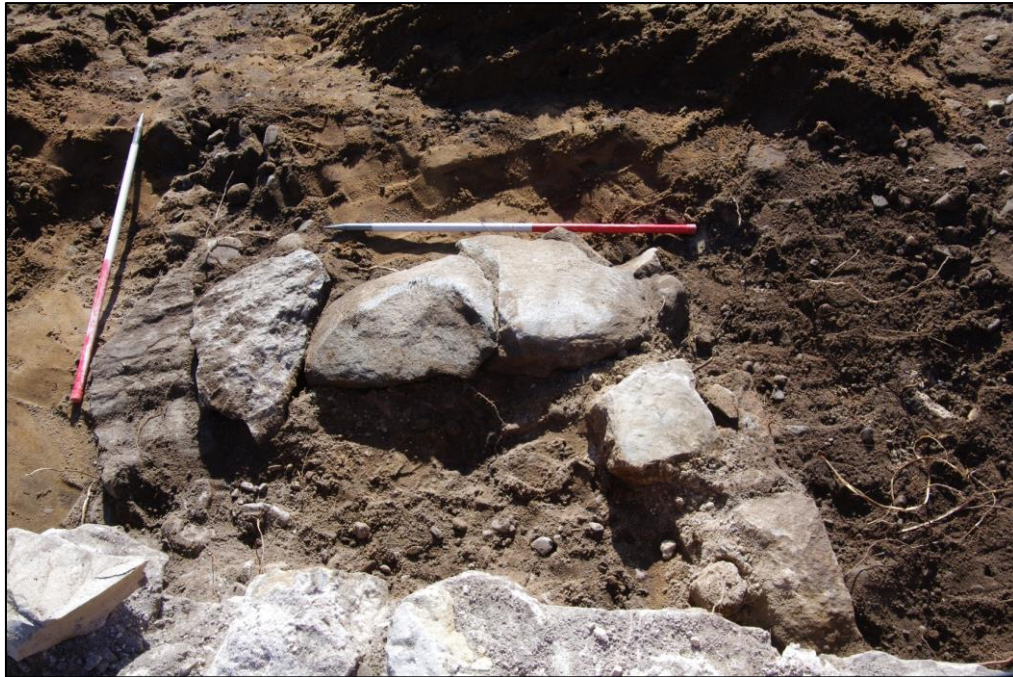
Figure 34: Photo 6549, Culvert [18] facing south, 1m scales

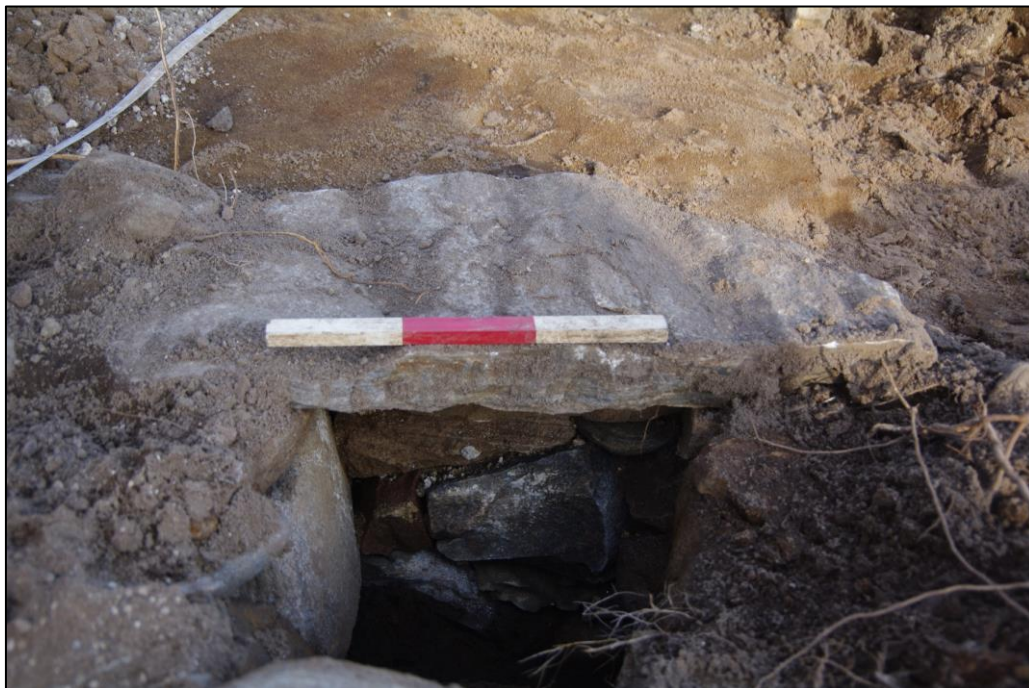
Figure 35: Photo 6559, West facing section of Culvert [20] joining culvert [18] to the south of structure 2, facing east, 0.3m scale

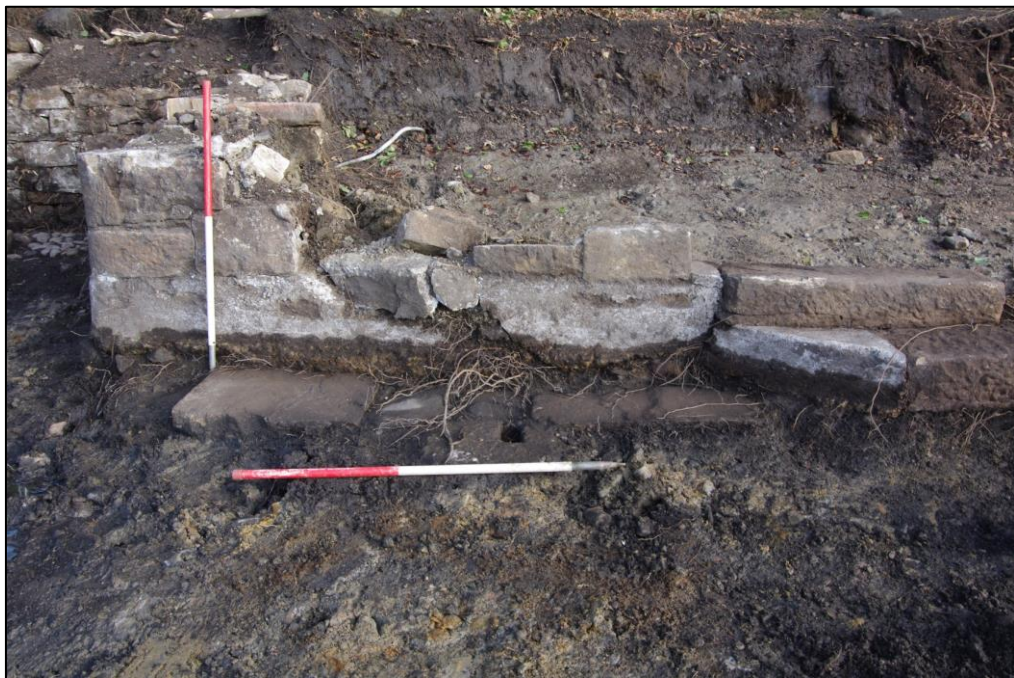
A single skin stone wall [32] continued east from the curved external eastern corner which contained what appeared to be steps (Figure 40). Immediately to the south of this wall were several flagstones [33]. Abutting the outside of [32] was a small orangey yellow concrete pad [34] containing a stakehole which in turn abutted the south edge of the flagstones.

Figure 40: Photo 6650, Structure 4, facing north showing [32], [33] and [34]

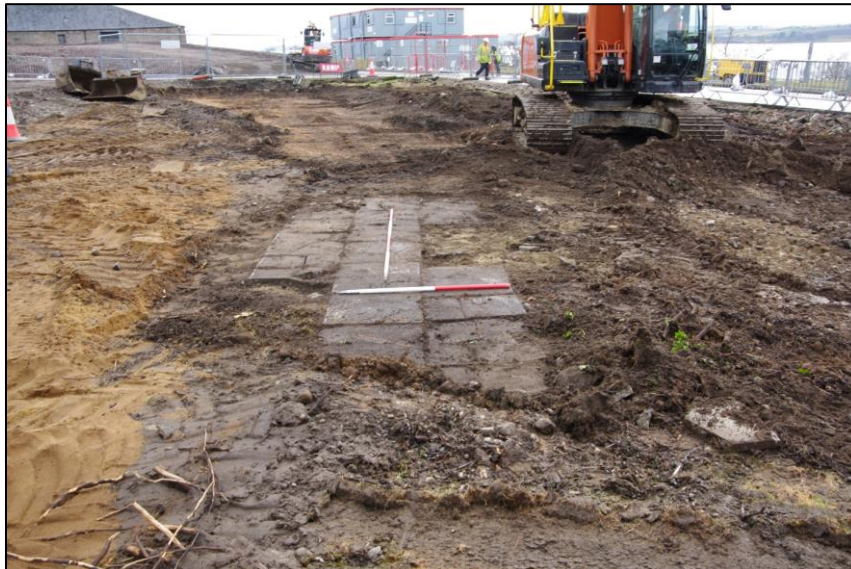
The suds pond was situated to the north of the Shore road and to the south east of the garden area. It was roughly oval in shape and was orientated west to east. The watched area here was 119sqm. The topsoil was a mid brown grey sandy silt with few rounded and sub angular stones (37) and varied in depth between 0.45m and 0.60m. The subsoil (38) was a yellowy-orange sandy silt with frequent rounded gravel in parts. A cut for an electricity cable could be seen running south east to north west across this area. To the west was an area of demolition containing rounded medium sized stones and stone shatter. The only feature noted was the remains of a garden path/slabbed area [39] made up of precast concrete slabs (Figure 46), this was outwith the excavated area.

Figure 46: Photo 6681, remains of garden path [039] facing south east, 2m and 1m scales

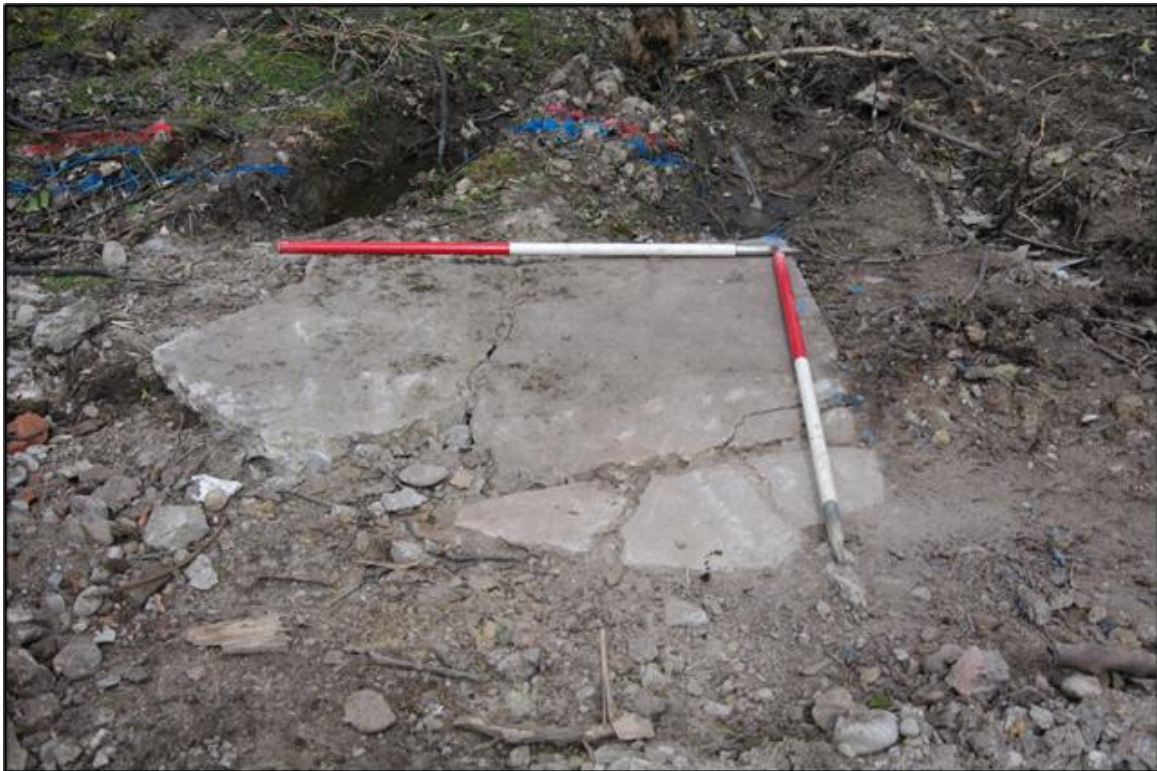
This was a very degraded smooth grey concrete pad [045] (Figure 50) and measured 0.7m by 1.6m. It was situated to the east of structure 11 and west of structure 14.

Figure 50: Photo 6723, structure 9, facing north east, 1m scales

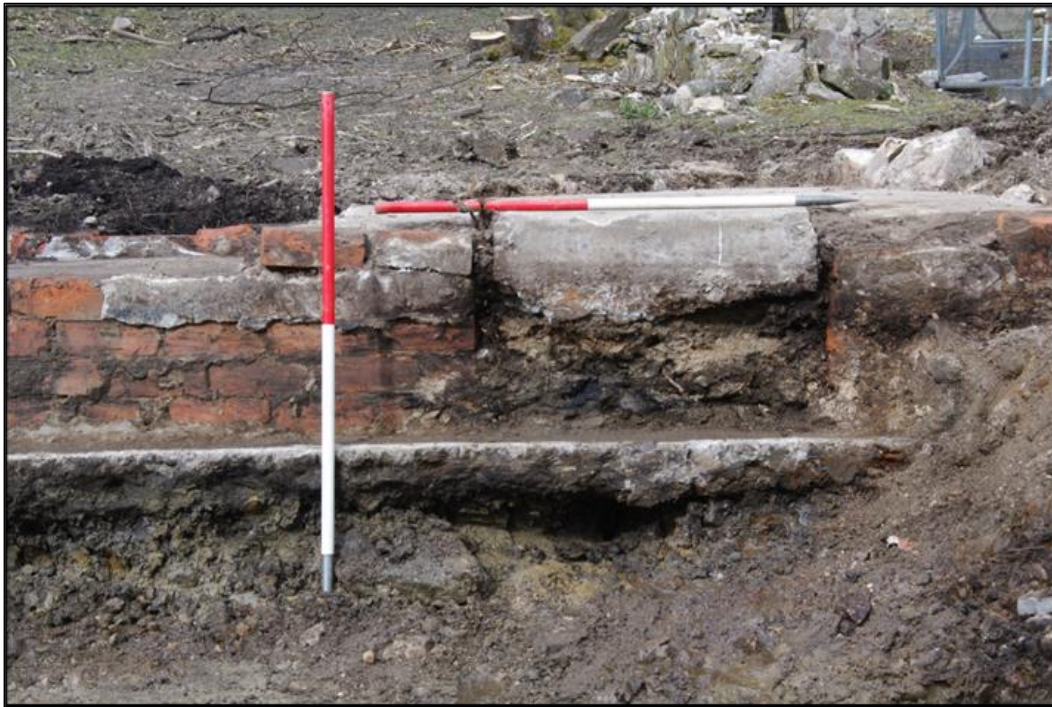
Structure 13a measures 2.15m by 2.47m and is similar in nature to structure 11 although more complete. It ran west to east and was rectangular in shape. It comprised 6 dark grey brown precast slabs [50] each surrounded by red bricks [96] with a metal ring in the centre of the interior edge (Figure 51). There was also a gap which ran between the two rows of slabs. The soil in this gap and on top of structure structure 13a was a very dark brown black humic soil (80) which was very wet. Structures 13a and 13b appeared to be one structure. Structure 13b was a smooth grey concrete pad [50] measuring 2.5m by 1.97m which overlay [93]. [93] consisted of 5 courses of brick work and was bonded with a creamy coloured mortar. The mortar remains in patches on the southern extent of the structure. These bricks underlie both structures 13a and 13b. Towards the eastern side of structure 13b the concrete continues over the front of the structure for a 0.8m, this section had no bricks underlying it. This may have been a step into the structure. Underlying the bricks was a layer of pale grey concrete [94] which was 0.18m in depth and ran under both structures and sat directly onto the natural (Figure 52).

Figure 52: Photo 6751, south facing section of structure 13b

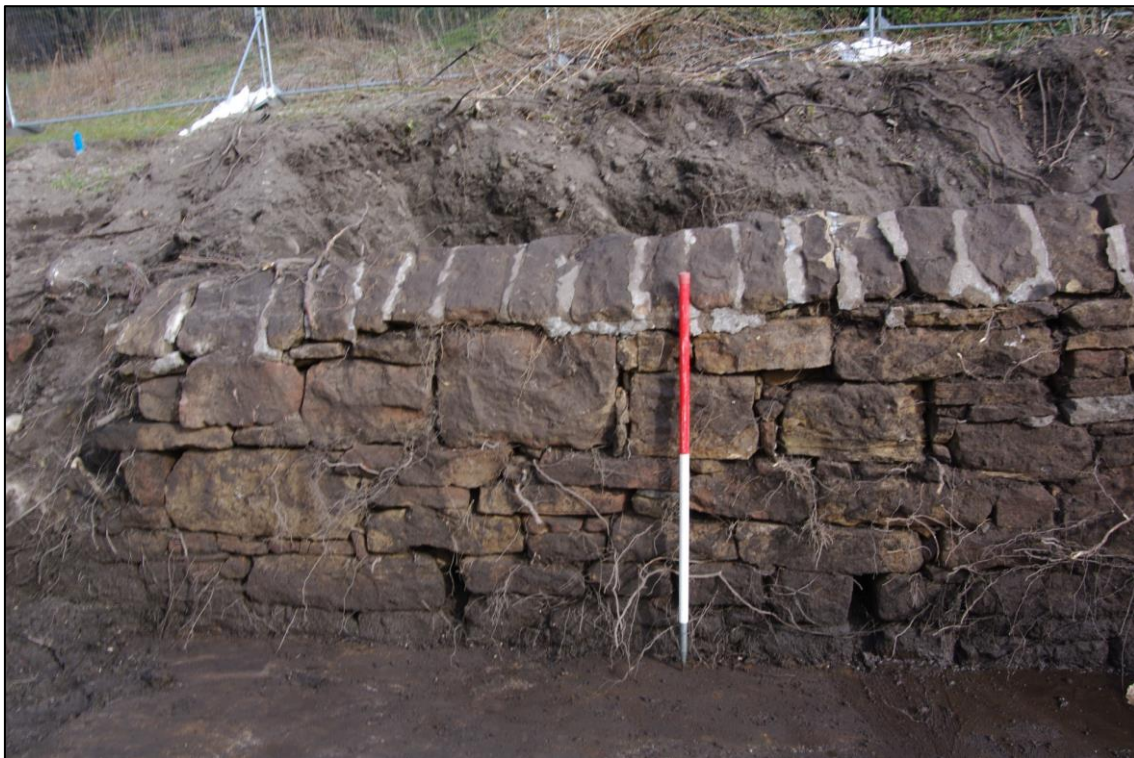
Figure 54: Photo 6763, South facing elevation of north wall of structure 15 [51], showing gaps in lower course of stone, 1m scale

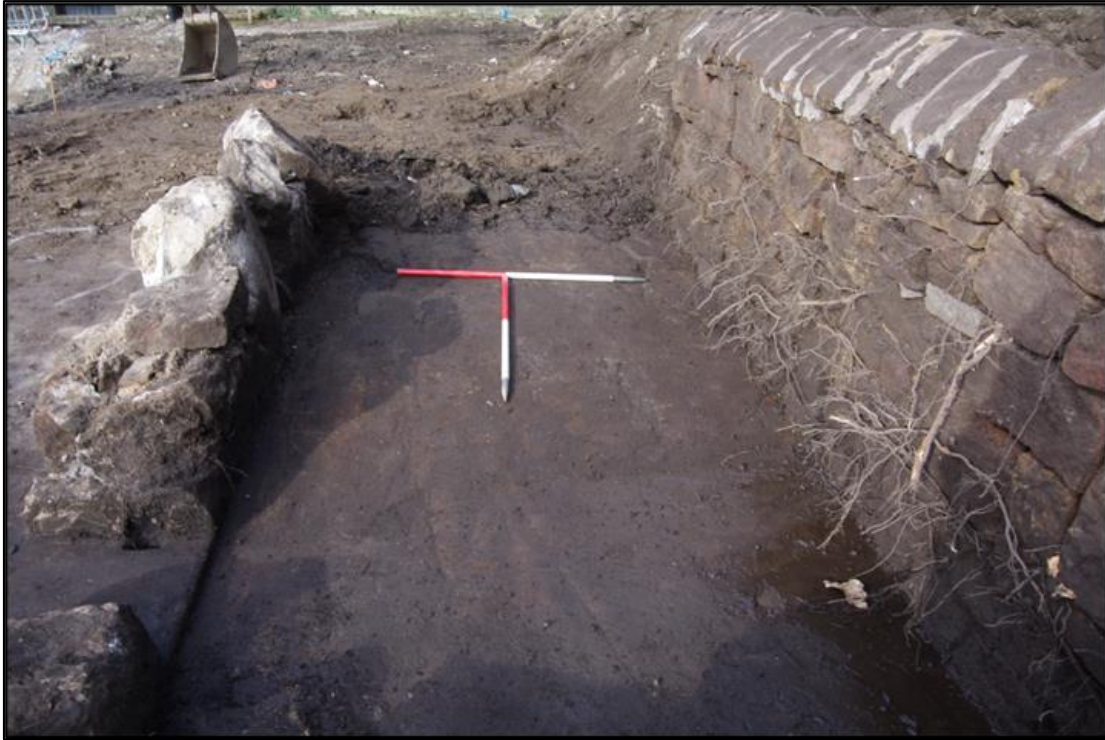
Between these three walls ([51], [52] and [53]) was a concrete floor [54], this abutted these walls and measured 4m in length by 1.9m wide. The western end of this concrete slab was very degraded and from the amount of loose large stones in this location it is likely that at some point a wall stood here enclosing the structure (Figure 55)..

Figure 55: Photo 6759, Structure 15, facing west. 1m scales

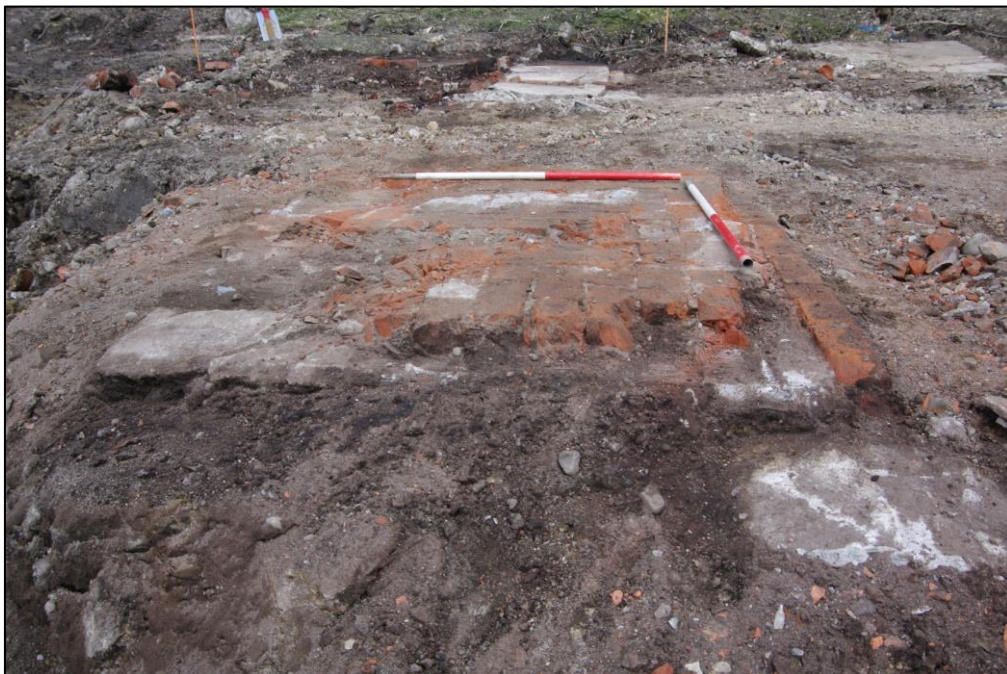
Structure 10 was a red brick [43] platform (Figure 59) which was built on top of a layer of flat stones [83] of various sizes which formed the base of a structure measuring 1.6m by 1.75m. The bricks were quite degraded on the outside edges but some remaining mortar was visible.

Figure 59: Photo 6717, Structure 10, facing north, 1m scales

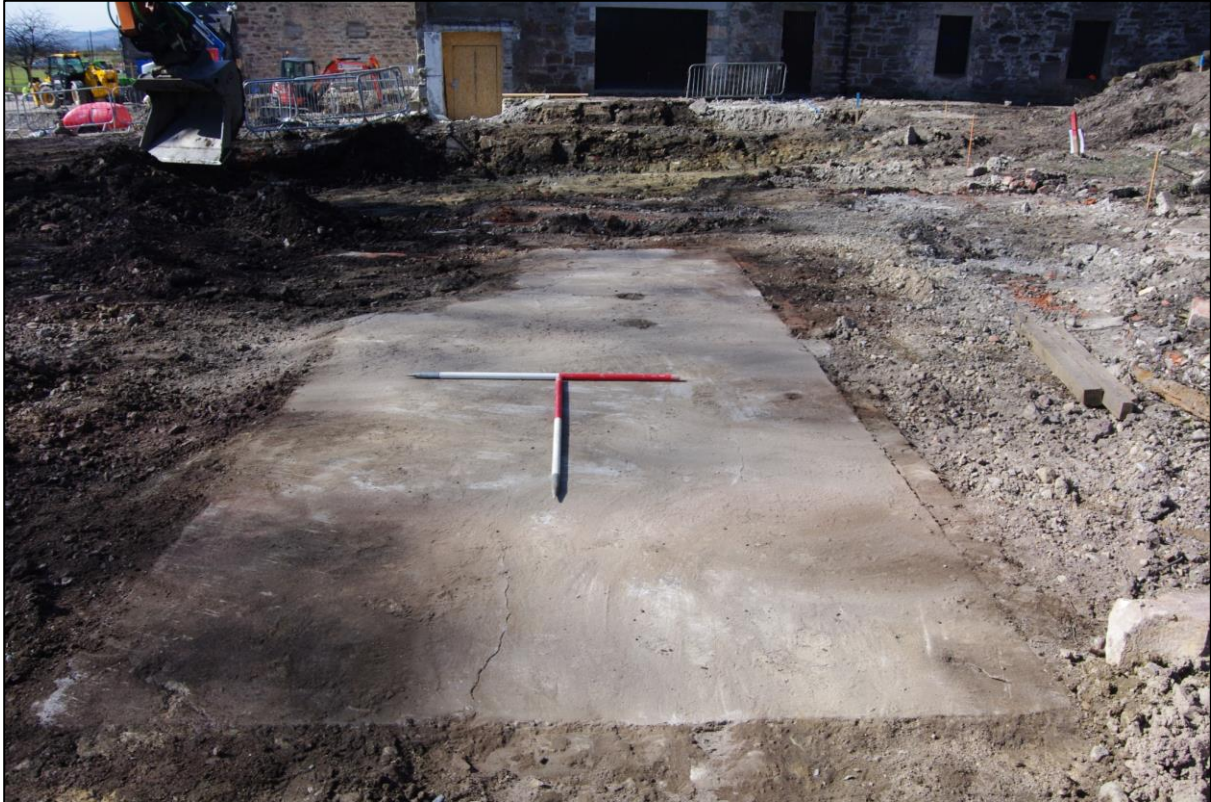
To the east of Structure 10 was structure 8, a smooth grey concrete pad [41] measuring 5.5m by 2.72m (Figure 60). The south west corner of which was quite degraded. To the north and west of the structure a single row of bricks [47], some of which were identified as Hunter Brora bricks (Figure 61) were noted. Hunter Brora bricks were being produced between 1914 and 1949⁹. These bricks ran along the western edge adjoining the northern part of the western edge of Structure 12 (Figure 62) which was also a concrete pad [45] measuring 2.5m by 2.76m. The concrete appears to be quite degraded around the edges particularly in the southern edge.

Figure 60: Photo 6699, Structure 8, facing west, 1m scales

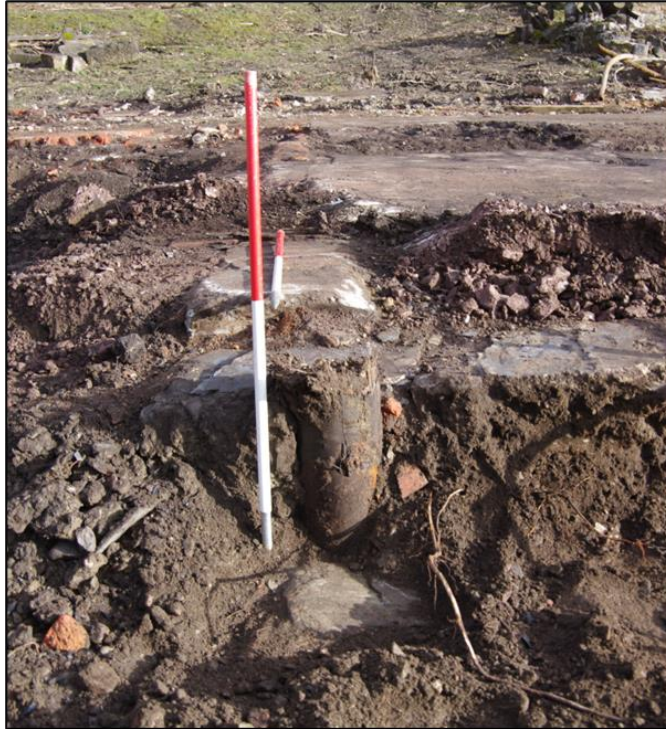
Figure 63: Photo 6735a, Structure 12a, facing north showing modern post, 1m scales

Structure 12a [48] appeared to have been two concrete foundations to the south and west of structure 12, part of which came away with the digger (Figure 63). These were concrete built foundations, the top of which was covered in a layer of slate. These foundations appeared to run under structure 12. To the south western edge of the structure there was also a wooden post sitting on a flat stone pad (Figure 63).

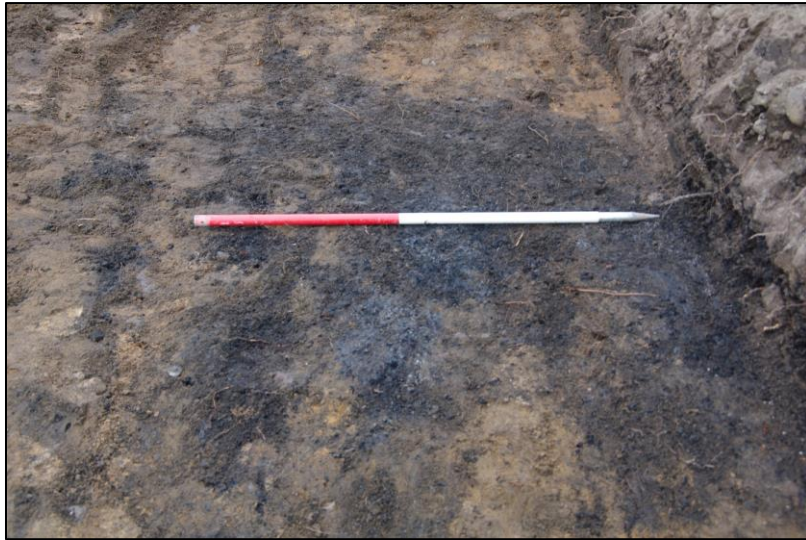
To the south of the watched area a spread of black coaly material (042) mixed with topsoil with some larger pieces of coal visible in the section of the trench (Figure 64). The remains were very shallow and contained several pieces of modern ceramic. This may be related to the coal store which was located to the north.

Figure 64: Photo 6707, Coaly spread (042) facing east, 1m scale

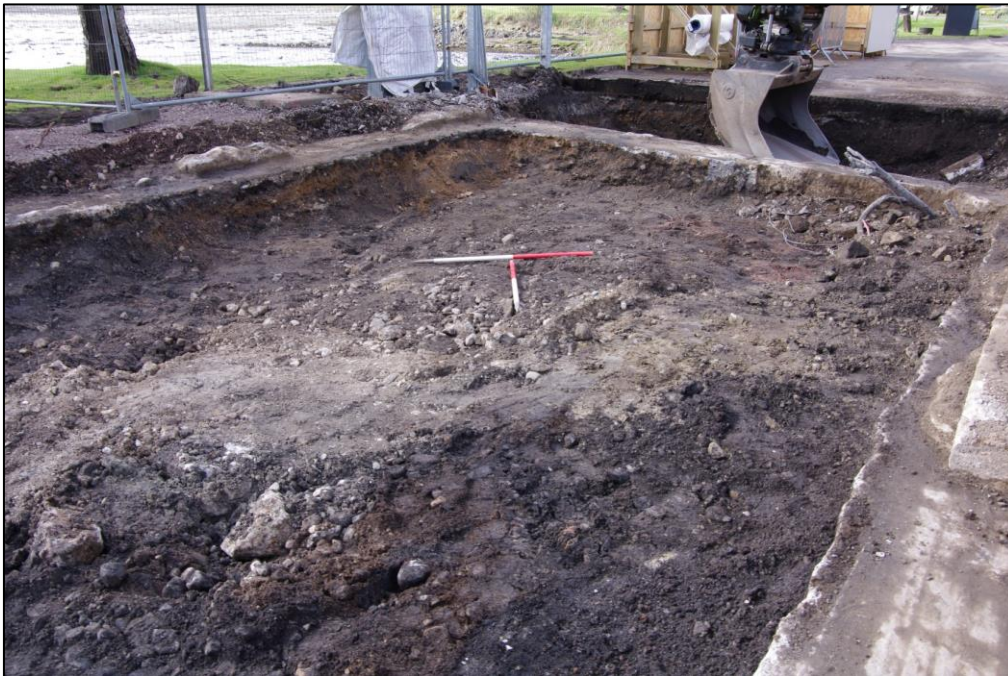
To the west end of the Shore Road trench, the south, west and north foundation walls of an old substation (structure 19) were uncovered (Figure 72). They were constructed of a pale grey smooth concrete [61] with breeze blocks [75] on top of the northern wall at the western end as well as in patches on the southern wall (Figure 73). The lower part of a downpipe remained on the southern wall, 2 metres from the eastern edge. Another drain for a downpipe was visible on the outer edge of the northern wall. To the north of the structure was a patch of topsoil mixed with what appeared to be oil, presumably from a leak at the substation. There were also patches of stones and mortar within the structure.

Figure 72: Photo 6837, Structure 19, facing south-west, 1m scales

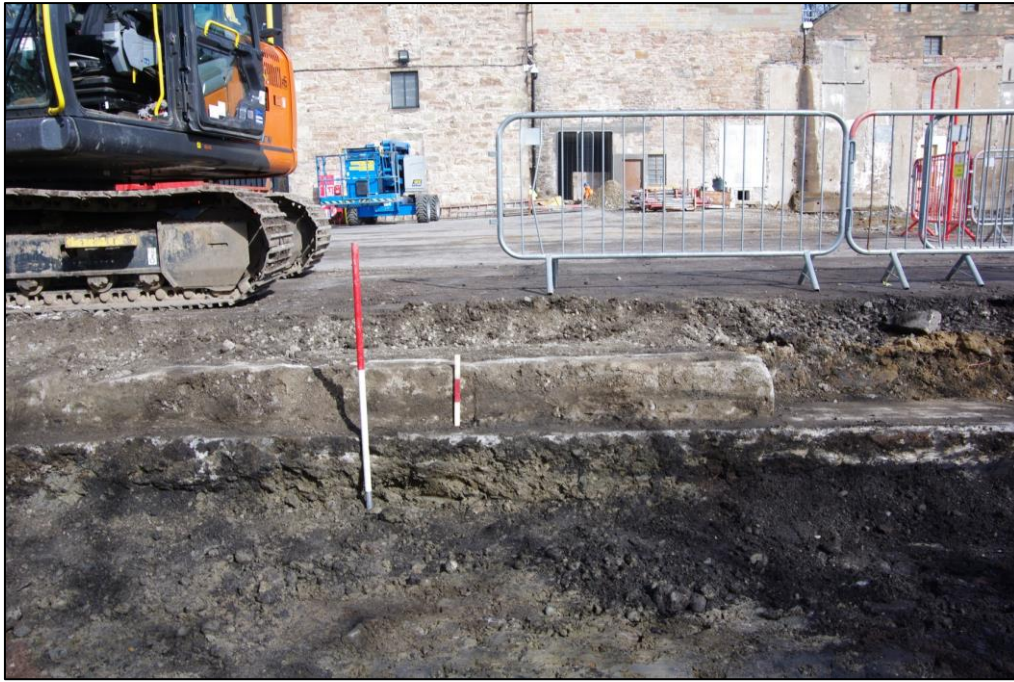
Figure 73: Photo 6827, northern wall of structure 19 showing breeze blocks, 1m and 0.3m scales
