**A Measured and Photographic Survey of
Archaeological Features to be affected by the
Proposed Hydro-Electric Scheme at Loch Poll,
Assynt, Sutherland.**

**HIGHLAND COUNCIL
ARCHAEOLOGY SERVICE**

A Measured and Photographic Survey of Archaeological Features to be affected by the Proposed Hydro-Electric Scheme at Loch Poll, Assynt, Sutherland

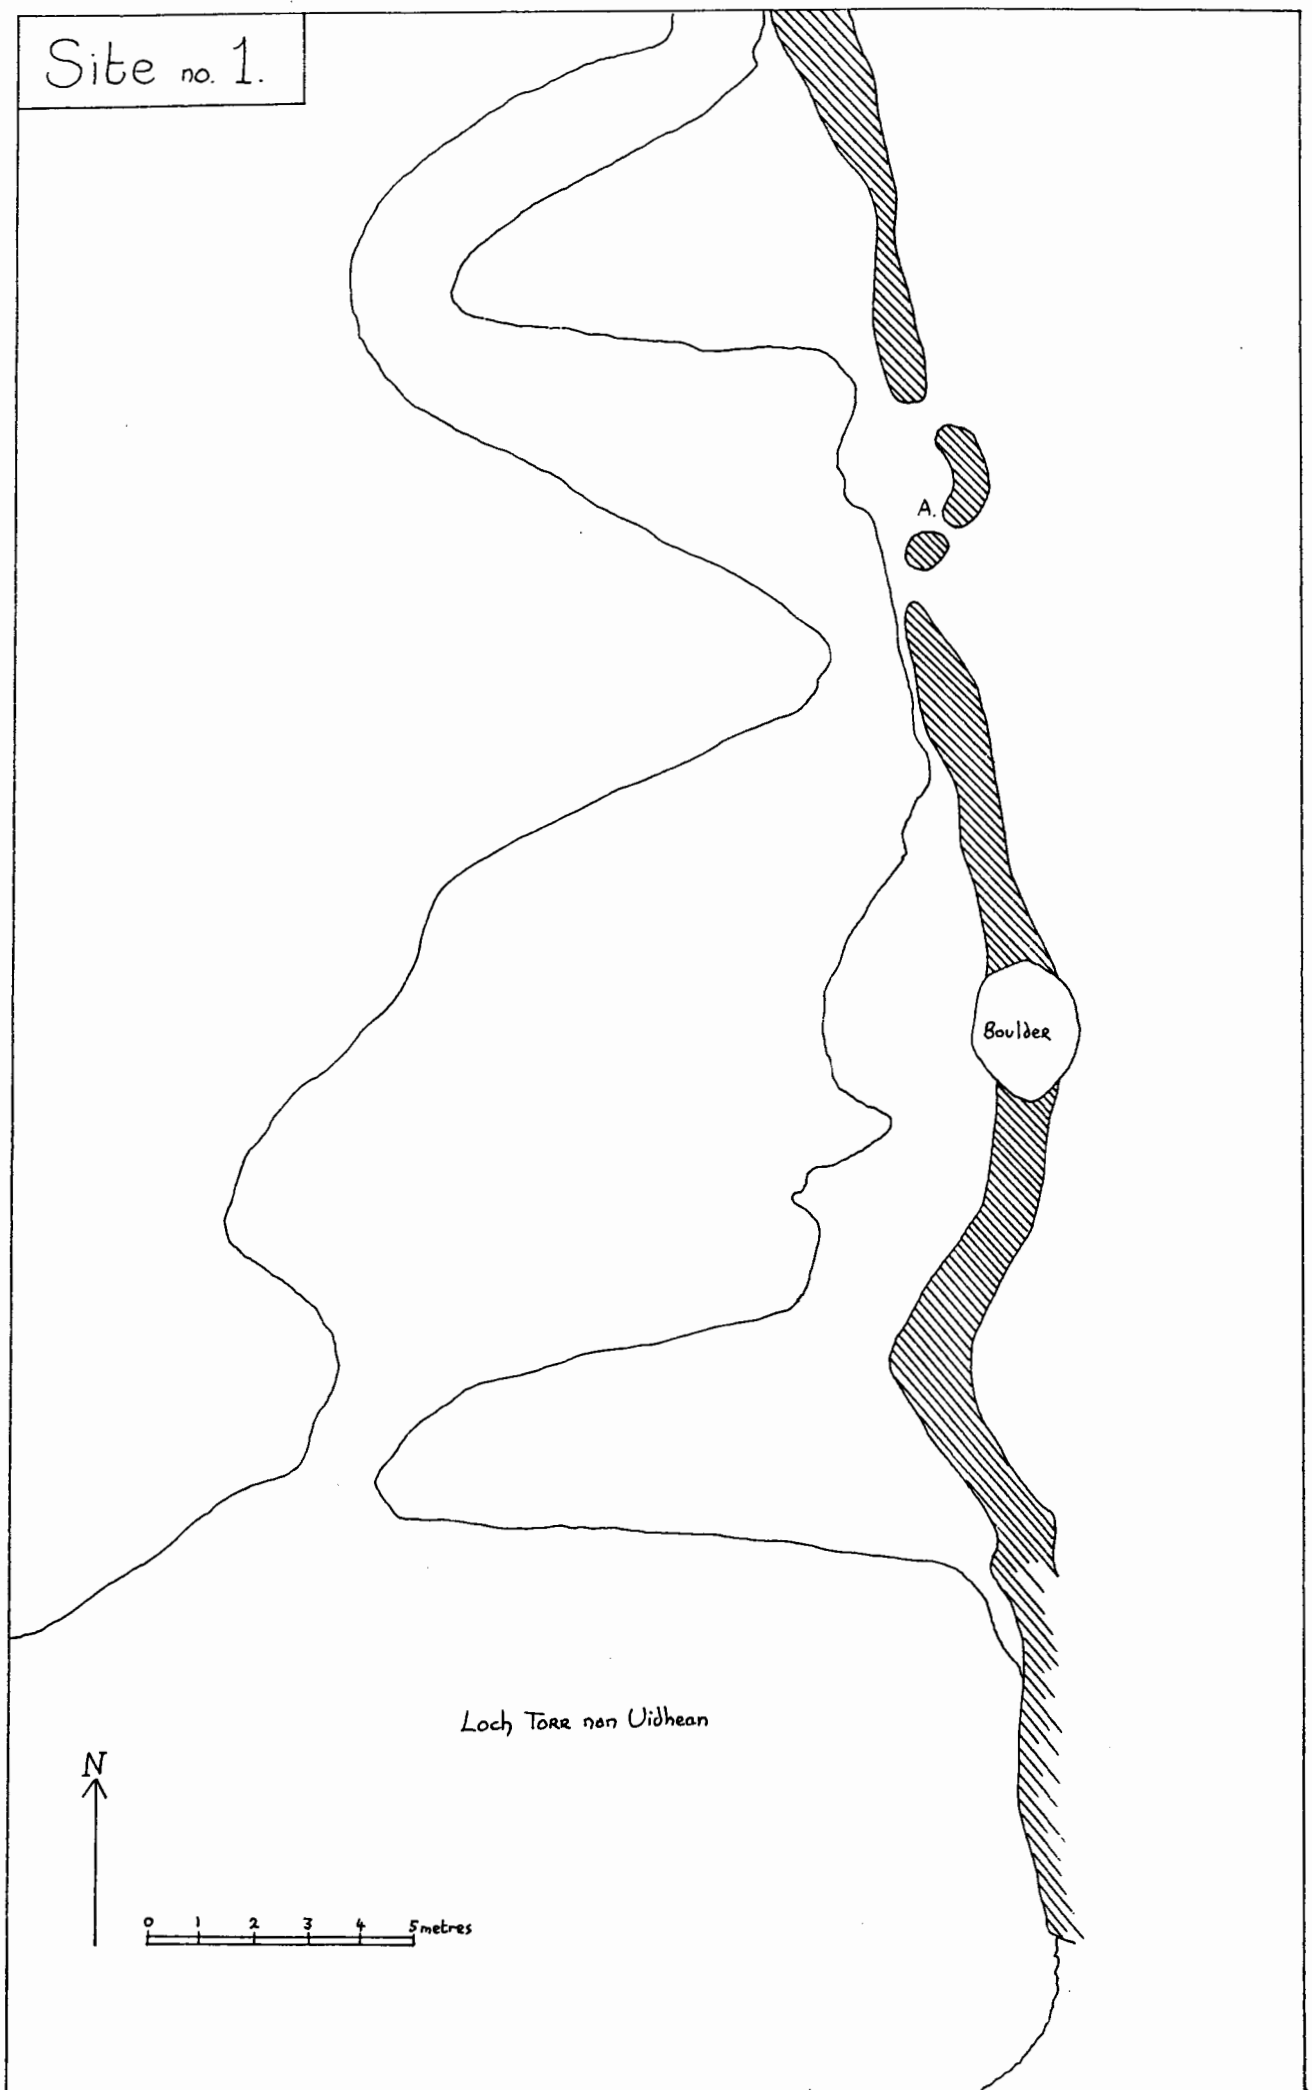
Site no. 1.

It is intended that the present water level of Loch Torr nan Uidhean will rise by 2m. The lower stretches of the dyke and all of the retaining wall along the loch shore will be completely submerged, while higher stretches of the dyke will be partially submerged and will begin to deteriorate as the turf washes out of the dyke.

A turf and stone dyke following the entire length of the east bank of the burn and extending 6m. as a retaining wall along the east shore of Loch Torr nan Uidhean. The dyke stands 1m. high in its best preserved stretches, reducing to low clumps of heathery turf at its worst. it is overgrown along its entire length with a thick growth of heather except at its northernmost point as it meets the shore of Loch Torr na-h-Eigin where the turf is bare and eroded. The retaining wall is of stone and does not rise above the natural height of the bank above the shore.

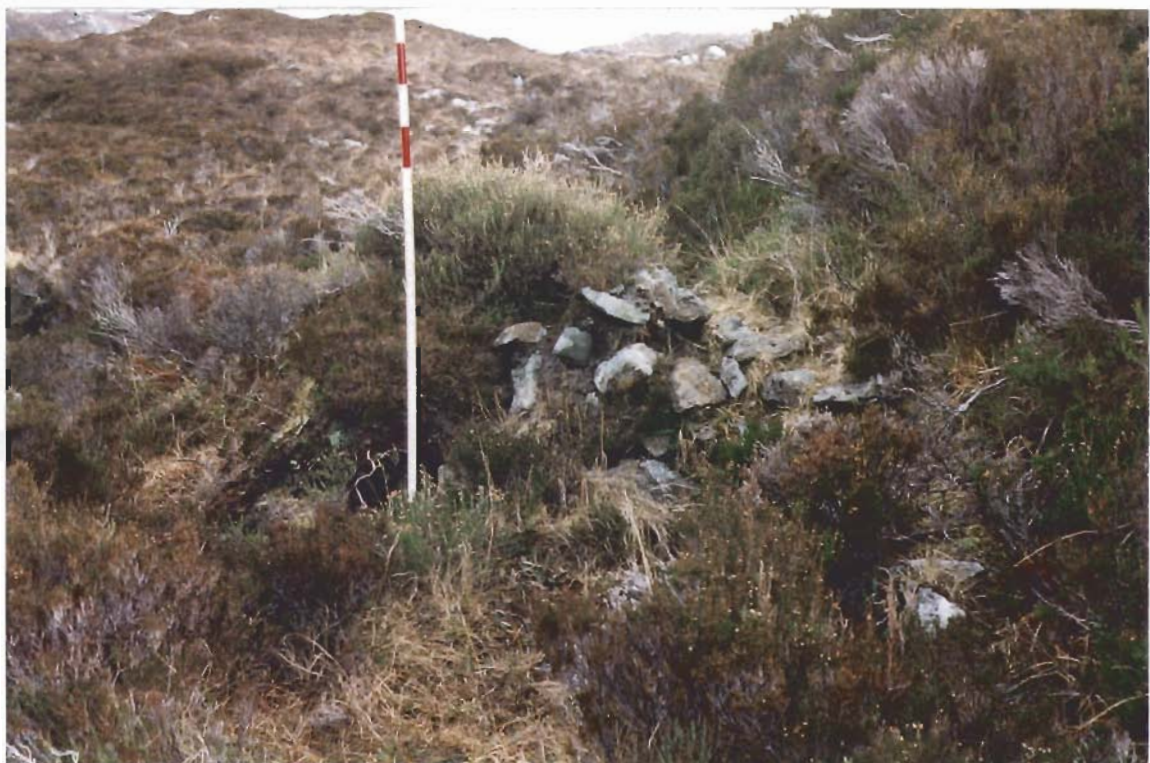
SITE NO. 1 Photograph No. 4

Detail of dyke, marked A on ground plan, view to North East.

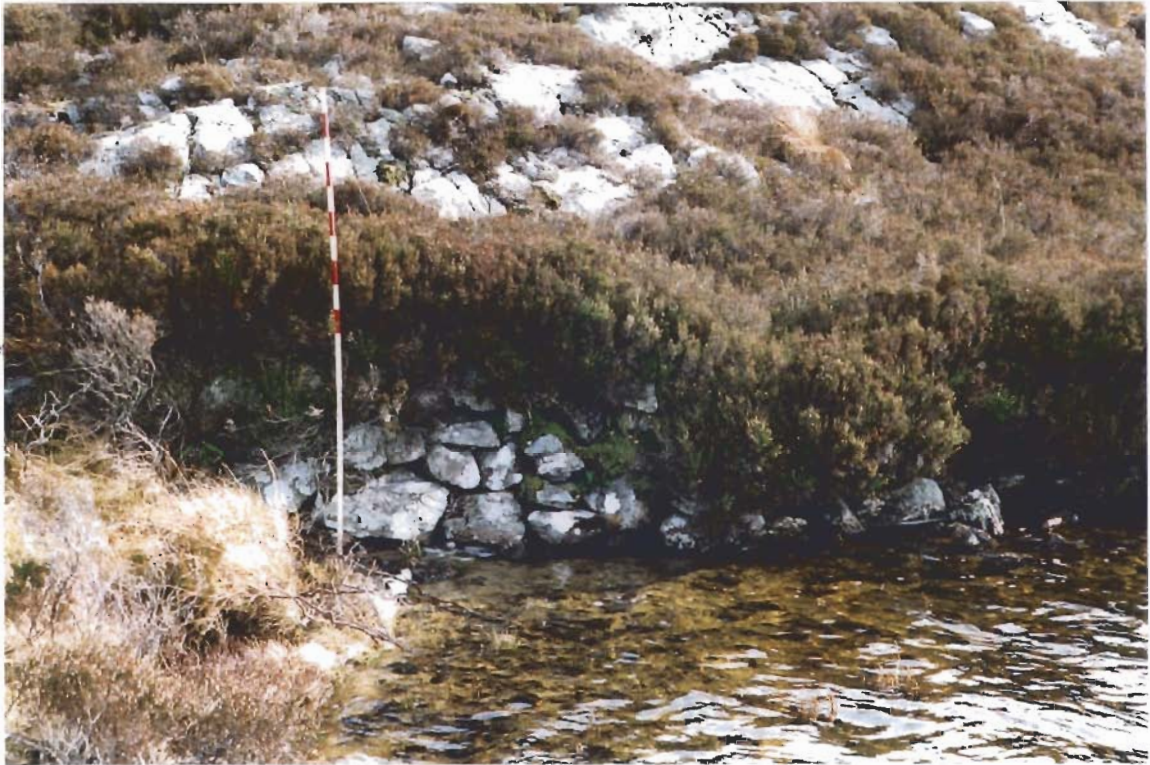
SITE NO. 1 Photograph No. 5

Retaining wall along shore of Loch Torr nan Uidhean, view to East.

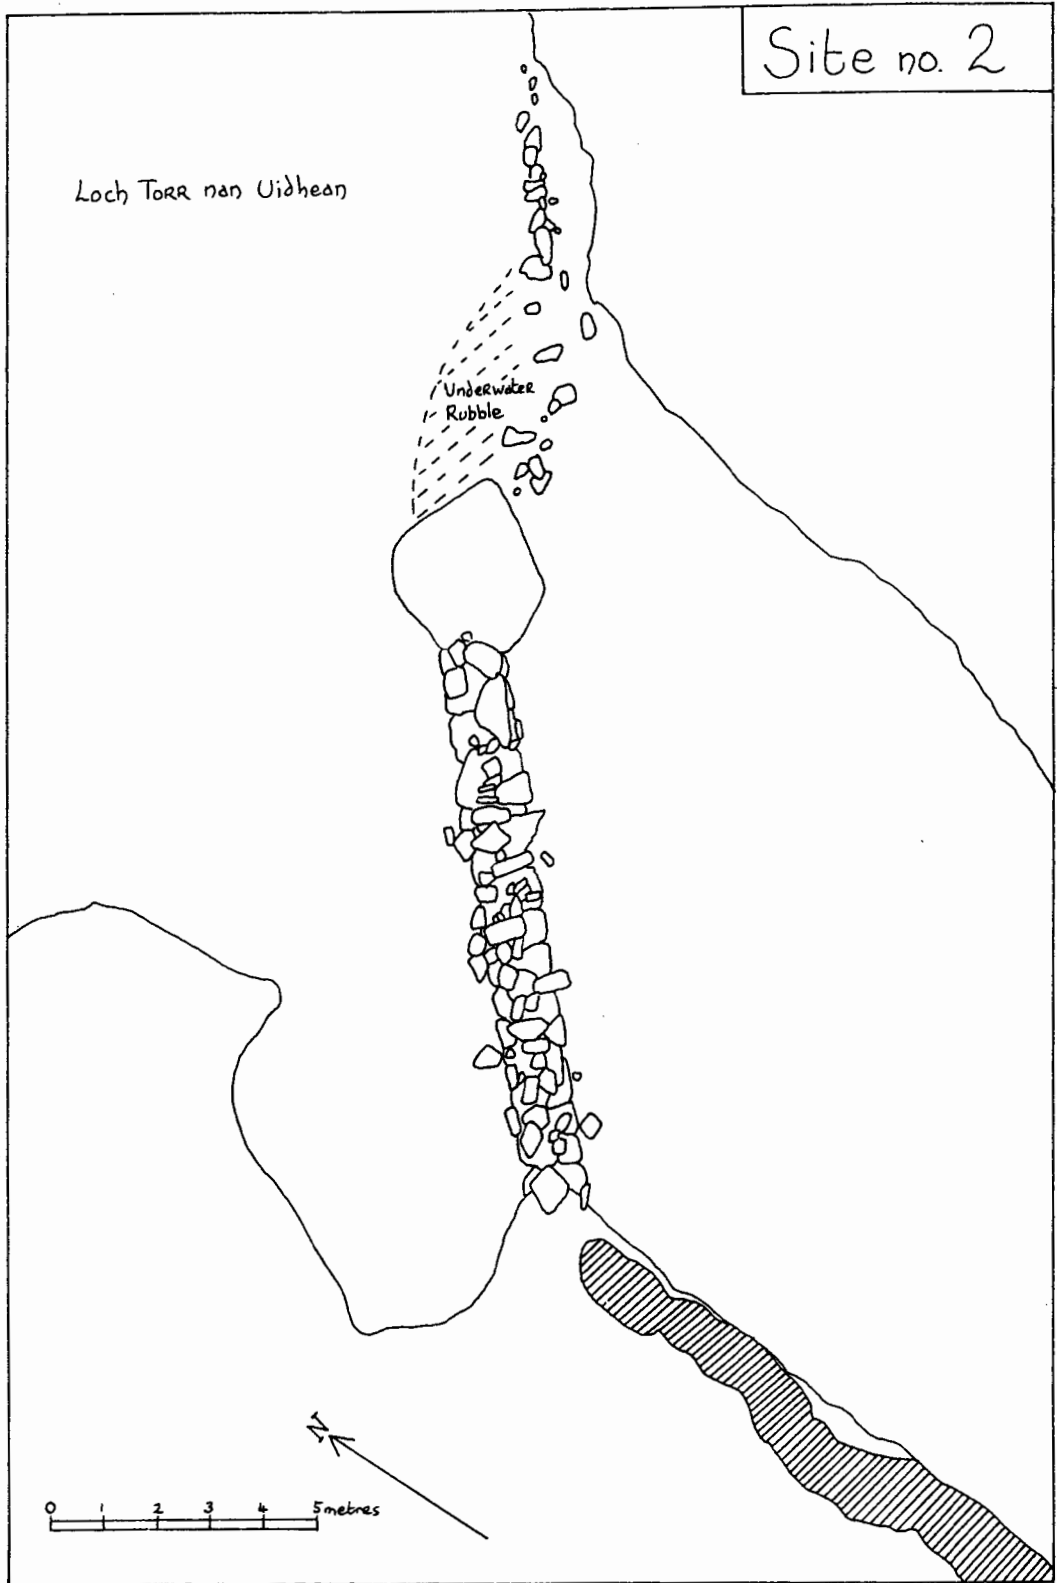
Site no. 2

As the burn leaves the loch it is broad and shallow in a steep sided valley before narrowing and dropping steeply towards Loch na Loinne. This broad and shallow stretch has been effectively dammed by rubble fill and walling, making use of a natural rocky island midstream. Running west of this island to the shore is a low rough wall of originally three courses of large stones with rubble fill. The base of the wall, now standing in silt, is a double row of carefully placed large stones. Most of the top, single row of stones has now been lost. As this wall reaches the shore it attaches to a low stone and turf dyke which turns south and continues along the bank of the burn.

To the east of the island, below water level can be seen piled rubble extending into the loch for up to 1m. beyond which the loch bottom is considerably deeper. Only a few stones break the surface here to provide irregular stepping stones. As this dam approaches the eastern bank there is a section of stones set upright to provide a more substantial barrier. There are some traces of this eastern bank of the burn being strengthened or steepened by walling, with a clear section approximately 20m. downstream.

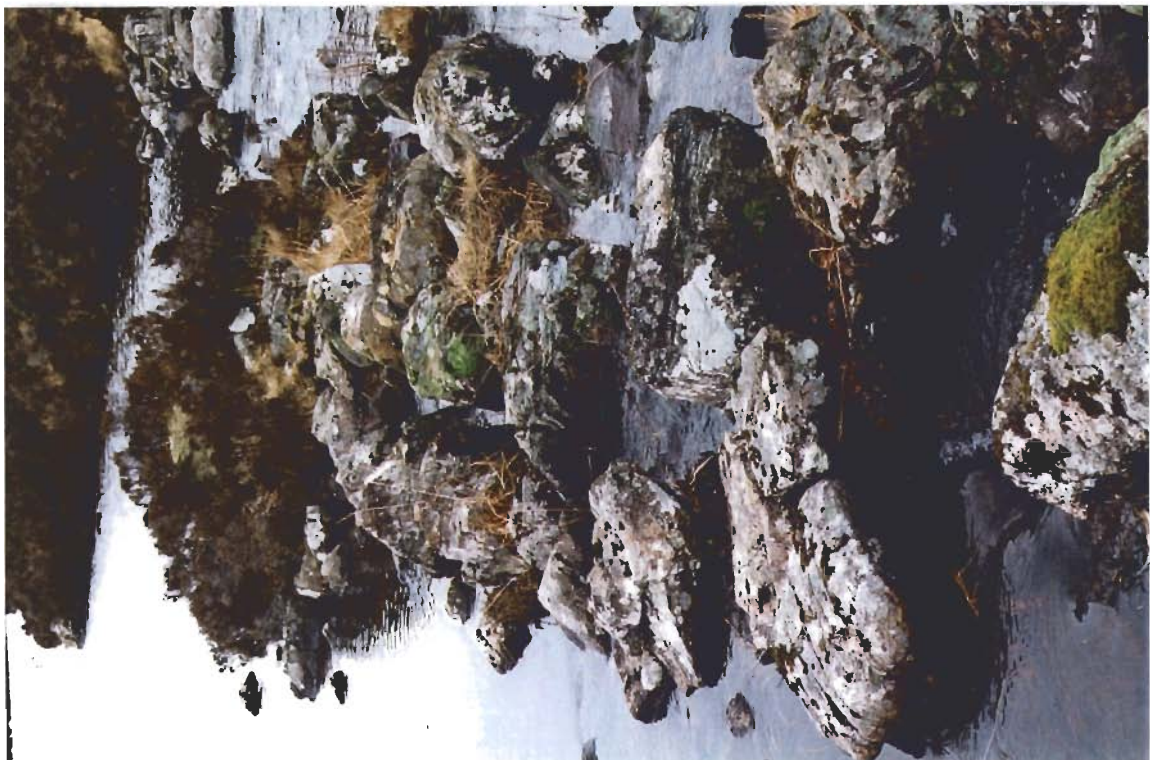
SITE NO. 2. Photograph no. 6

Wall demolished to show double row of stones at base

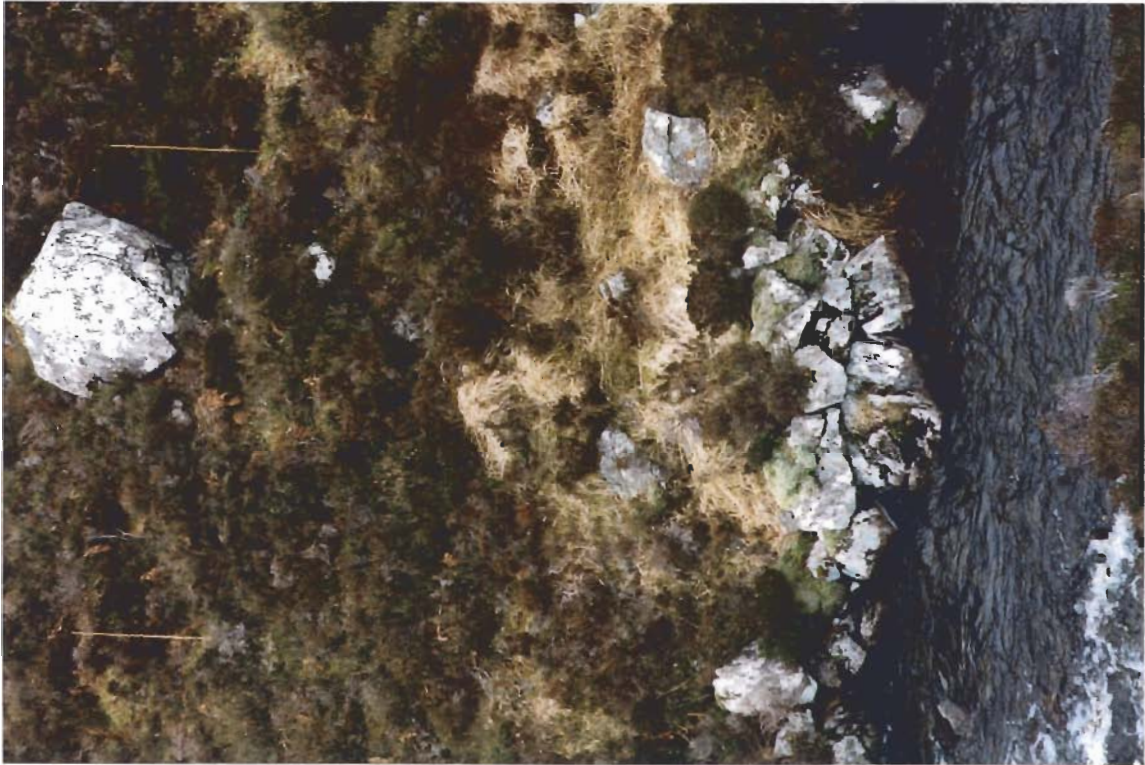
SITE NO. 2 Photograph No. 7

Retaining wall on the East bank of the burn approximately 20m. South of the main feature. Canes indicate the proposed location of the dam

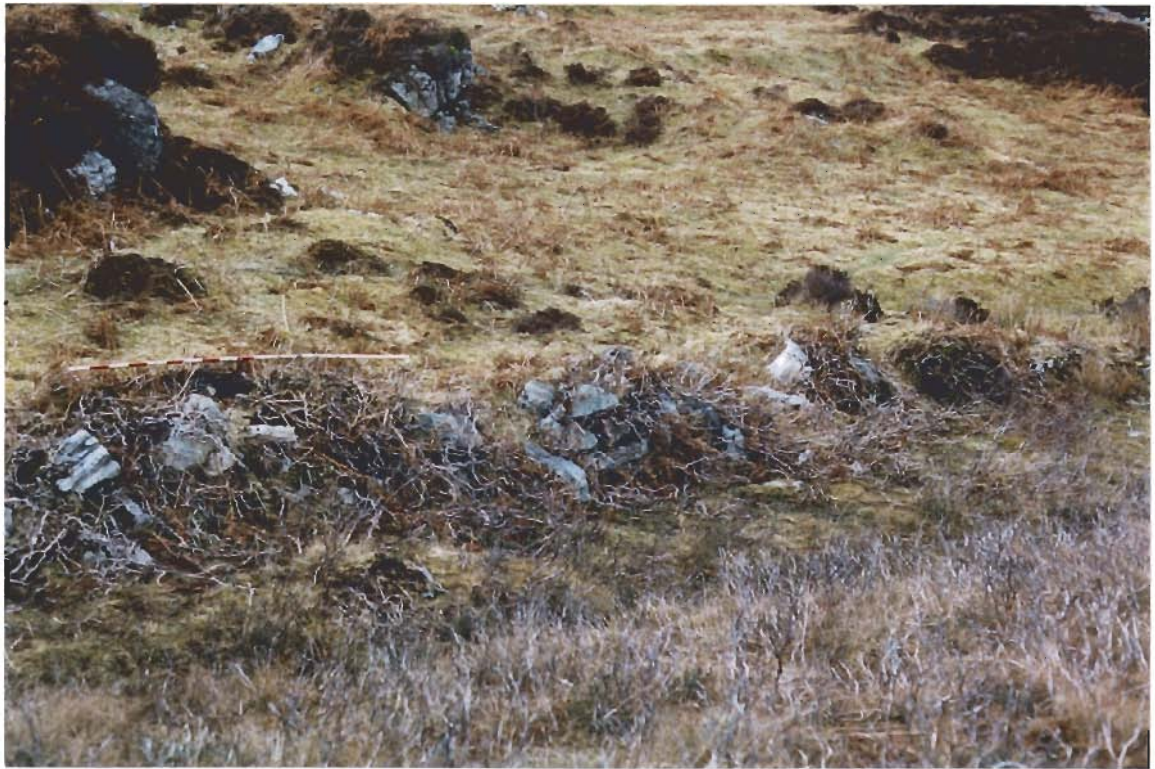
SITE NO. 3 Photograph No. 5

Detail of eroded section of dyke, view from South

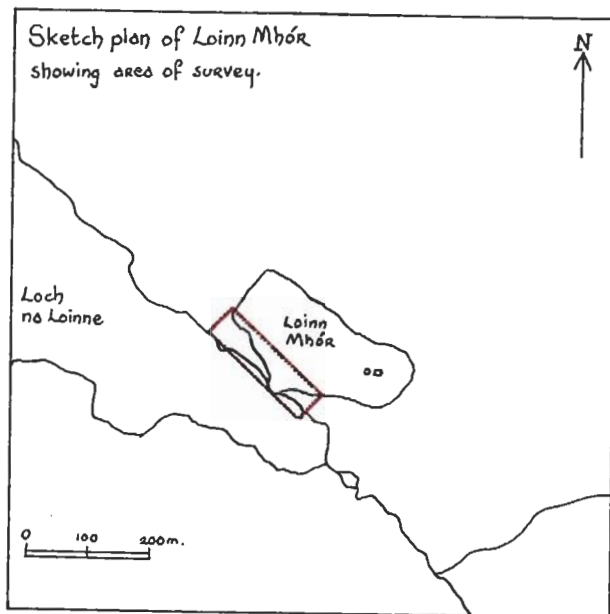
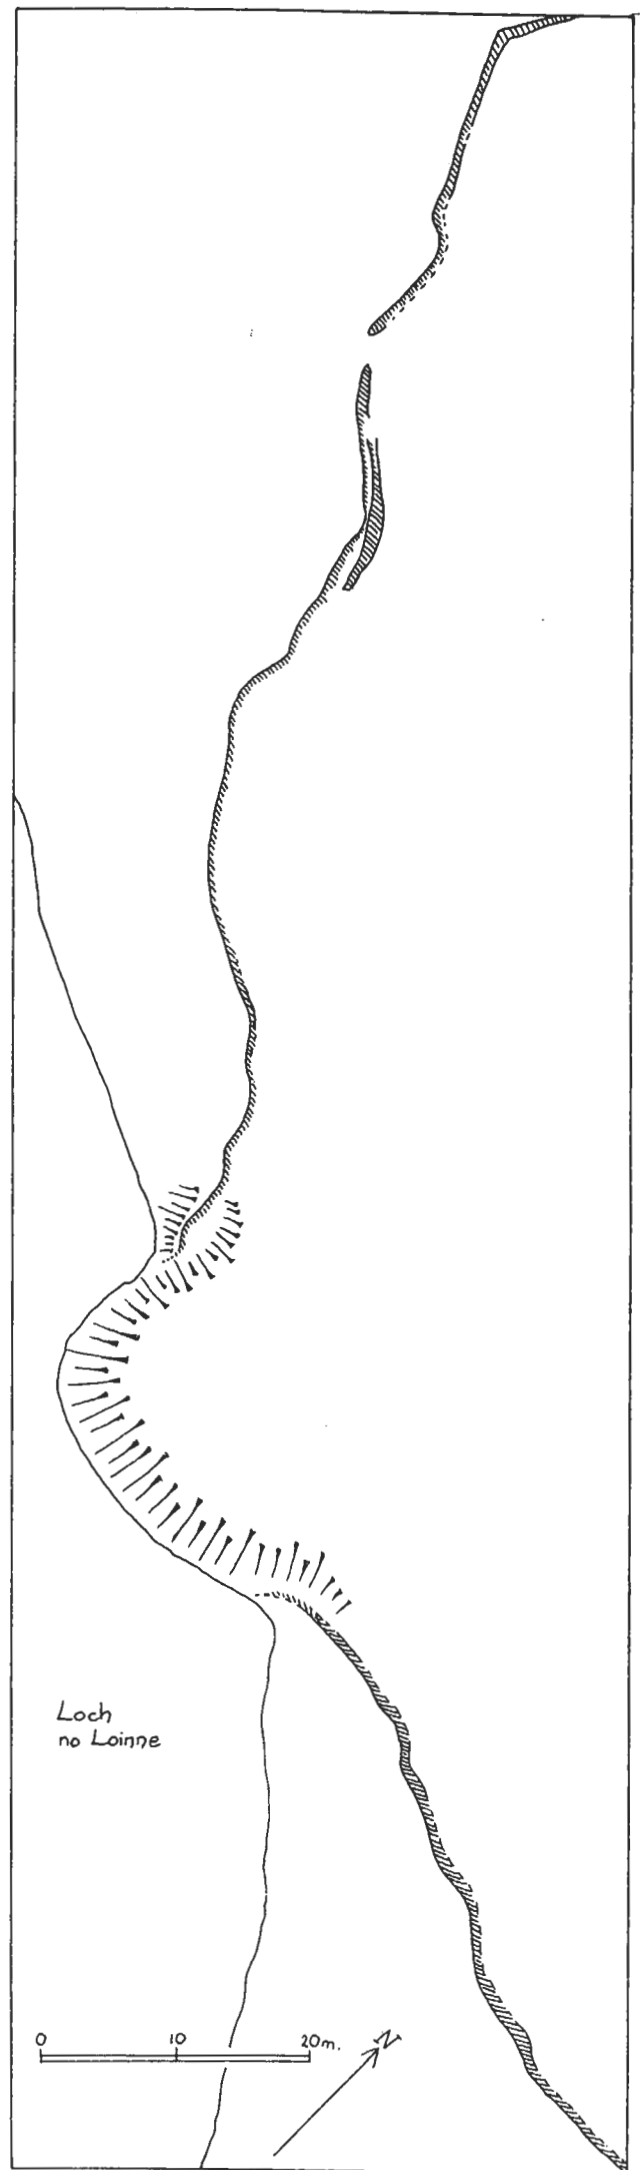
Site no. 4

It is proposed to raise the water level of Loch na Loinne by 2m. and this will submerge or partially submerge the lower stretches of the enclosing dyke of the settlement. The dyke is of stone and turf construction, and will be considerably damaged by submersion as the turf erodes out. The dyke was surveyed along the length which, it was estimated, would be fully or partially submerged, running from a point to the west of the settlement where the dyke turns a sharp corner to run uphill at a right angle to the shoreline.

The dyke is of turf and stone construction and is eroded in many stretches, visible at worst as only a retaining bank rising 0.5m. Along the higher stretches to the west the wall stands up to 0.8m. above the ground level outwith the dyke. There is no appreciable improvement in the land or vegetation within the settlement. From both east and west burns or ditches run down along the outside of the dyke but are separated at the shoreline by a rocky knoll which has been utilised as a natural barrier. The dyke runs into this knoll at shore level from both directions, at this point it is eroded to a rubble of small stones.

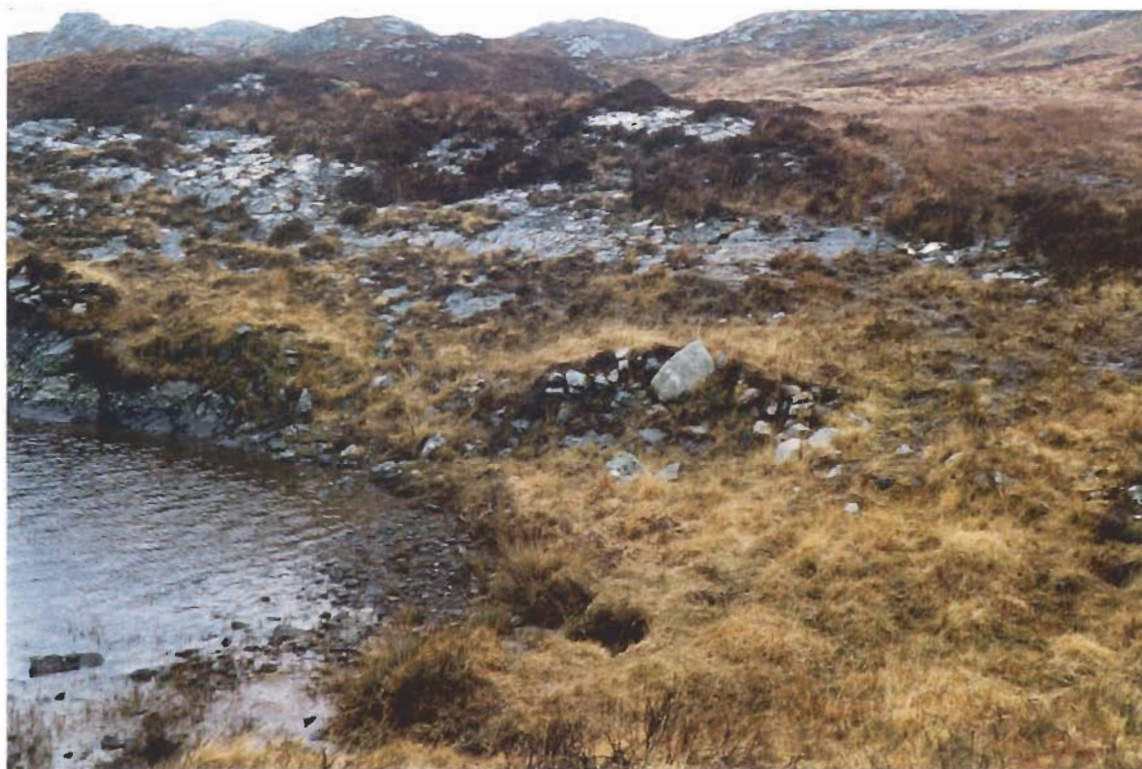
SITE NO. 4 Photograph No. 3

Detail of eroded section of eastern stretch of dyke as it abuts onto rocky knoll

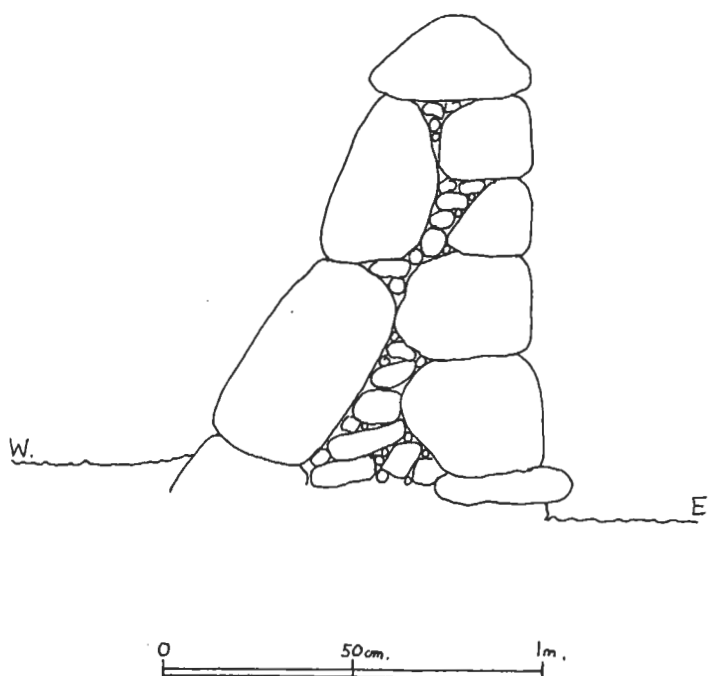
2. Cross-section of dyke at A.

The dyke stands on average 1.3m. high, with the ground level slightly higher by up to 0.1m. on the inside. The outer face of the wall is very nearly vertical but there is a pronounced batter on the inner face, the stones of the inner skin being placed at an angle to conform to the slope of the face. The wall runs out into the loch for a distance of 2m., terminating untidily with fallen stones underwater.

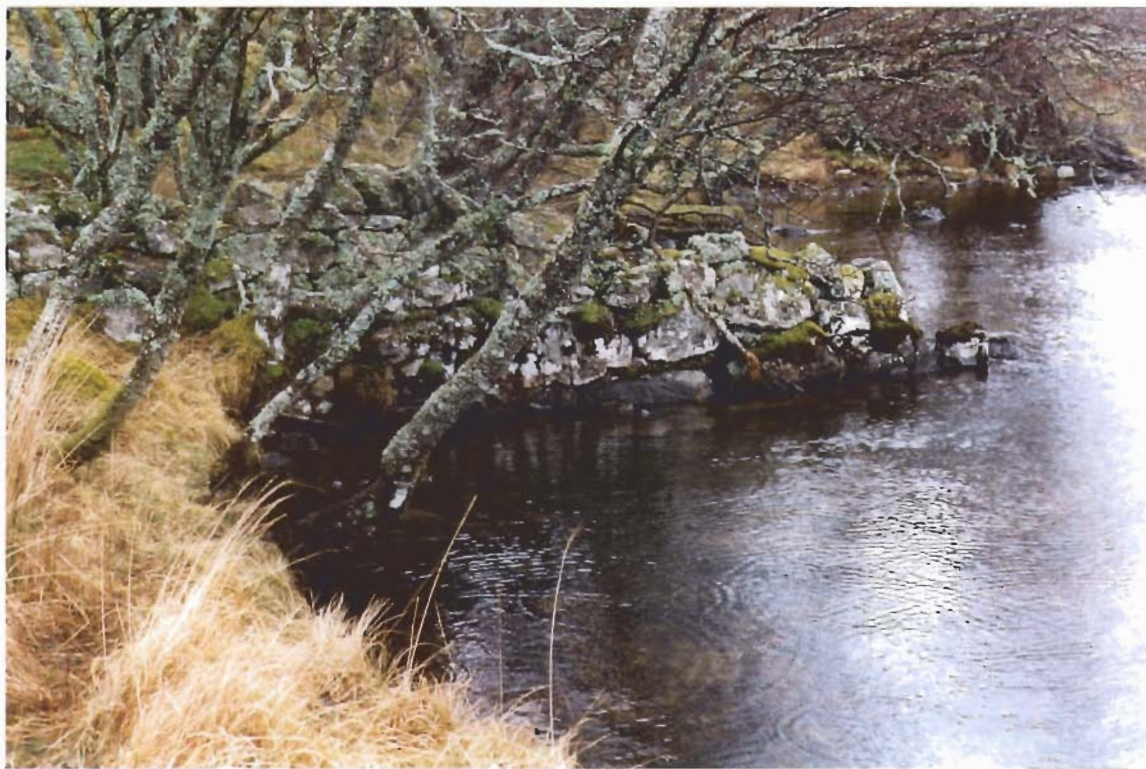
SITE NO. 5 Photograph No. 5

Section of dyke extending into Loch na Loinne, view from South East

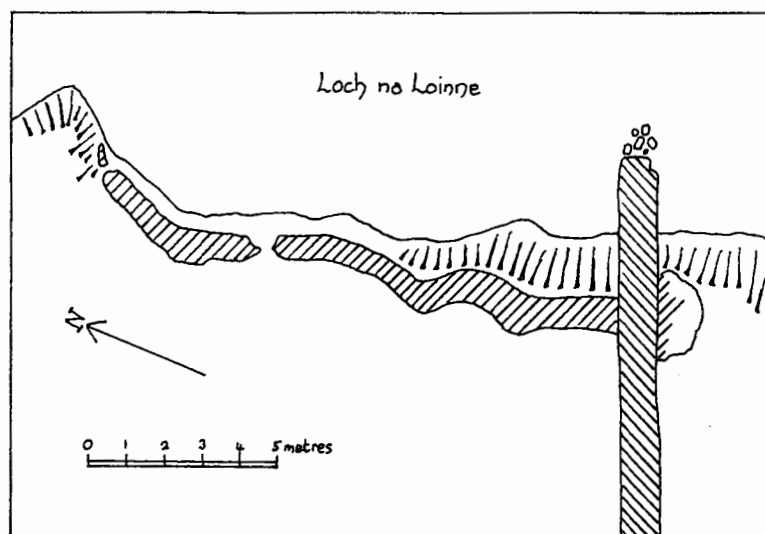
Site no 6

The ground falls steeply to the loch at this point and only about 6m. of the dyke will be submerged by the proposed 2m. rise in water level of Loch na Loinne. Close examination revealed the remains of an older dyke running along the shore and crossed over by the more recent dyke. This is of stone and turf construction and will be completely submerged. It was surveyed along its entire visible length.

The post-clearance drystone dyke is of the same dimensions and general construction as at site no. 5, but is less uniformly built as it drops steeply to the shore. The 2m. of wall extending into the loch is poorly constructed and tumbled. The older dyke running along the shoreline is low, at most 0.3m. high and broken into turfy mounds and runs only from the drystone dyke to a sharp rocky outcrop to the NW. Apart from a rubble pile abutting on to the drystone dyke, there is no visible trace of this dyke to the SE. The drystone dyke clearly passes over the top of the older dyke.

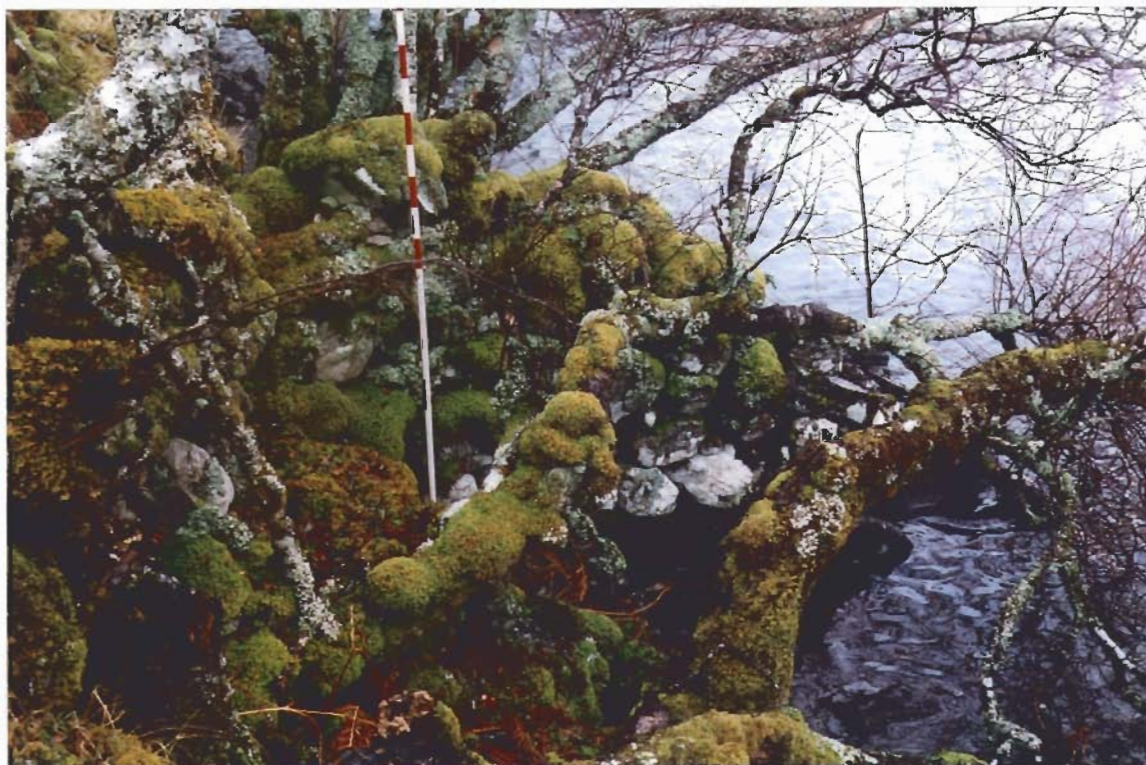
SITE NO. 6 Photograph No. 2

Section of dyke extending into Loch na Loinne, view from South.

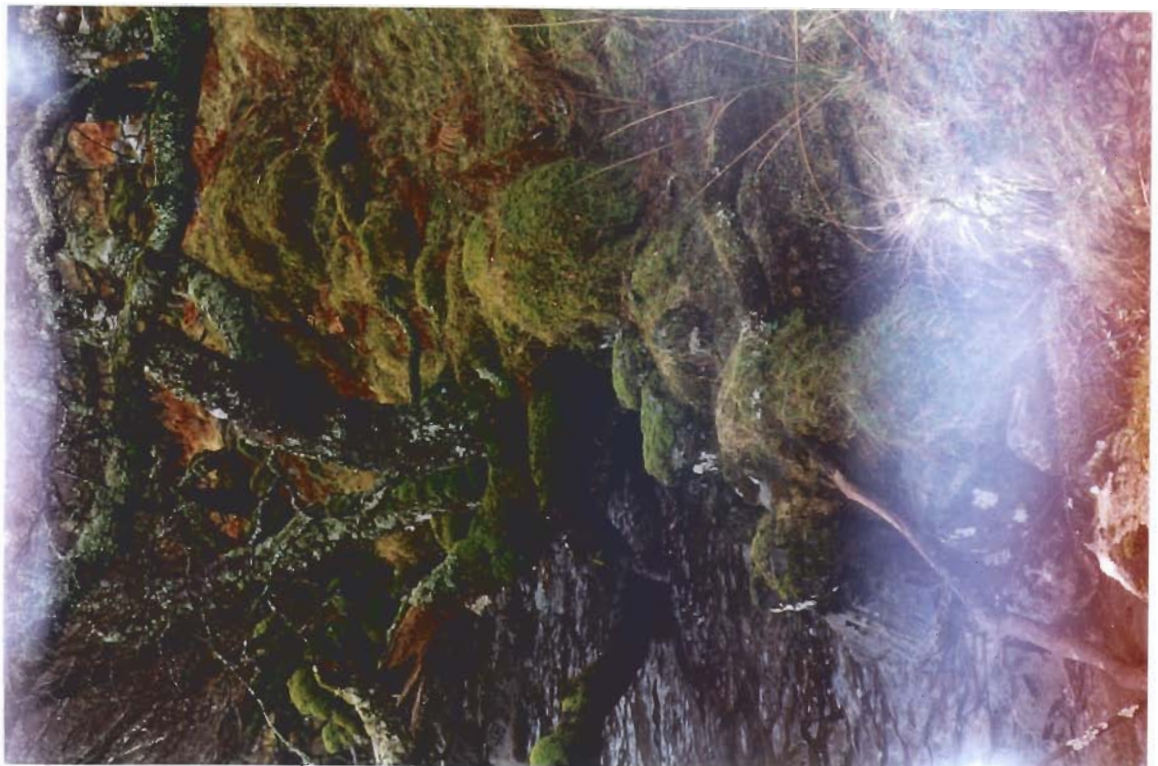
SITE NO. 6 Photograph No. 4

Earlier dyke following the shoreline, view from the North

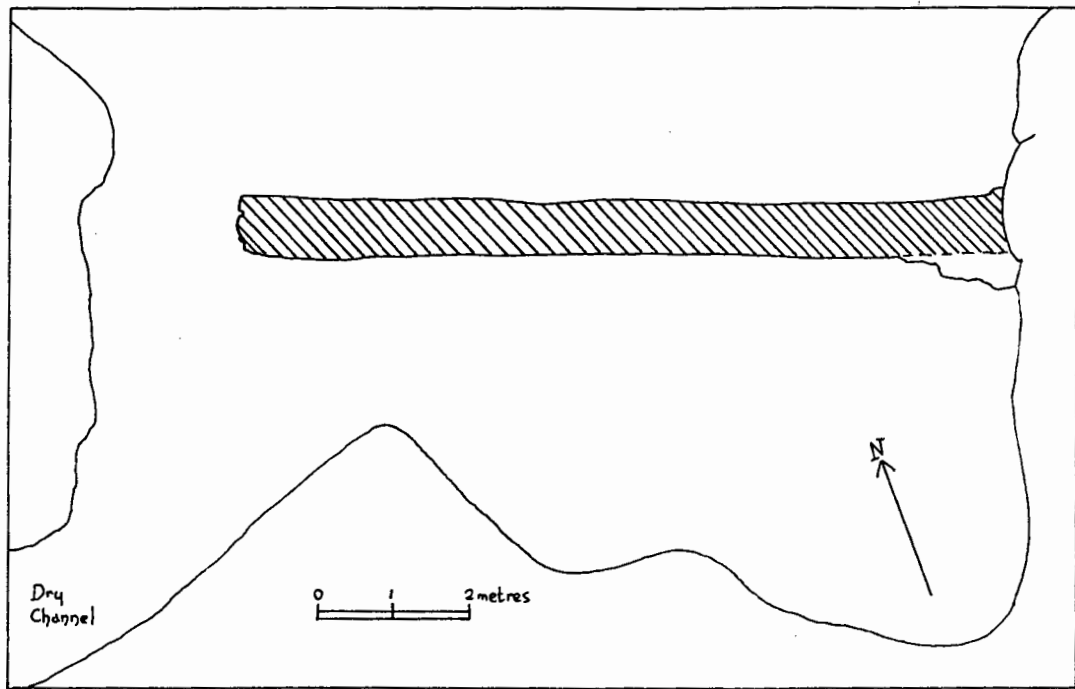
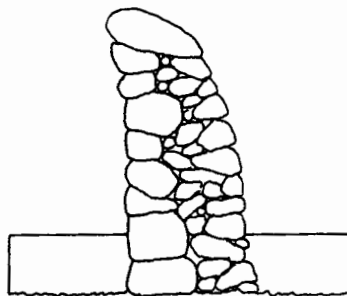
Site no. 7

Where the river flows out of Loch na Loinne it passes a rocky outcrop on the south bank then appears to have originally divided into two channels to flow around a second knoll. The SW channel is now dry but there is a shallow pool 12m. by 4m. SW of the main flow of water, cut off by a drystone wall measuring 10m. in length. It was originally thought that the wall cut off the pool completely, but the lack of rubble underwater in the 2m. gap suggests that this was not the case and that the wall was intentionally incomplete. Although looking well built, the wall proved fragile and has presumably only survived by not being rubbed against by livestock, but the flow of water along its northern face appears to have caused subsidence. The wall now has a distinct lean to the NE. Only on the NE face were stones regularly placed at the base, this face was presumably more carefully constructed to withstand the flow of water but the SW face is of roughly piled rubble. There are very few tie stones. The wall stands in 0.4m. of water with a height of on average 1.4m. above the present water level. The SW end of the wall abutts onto the vertical rockface of the small knoll.

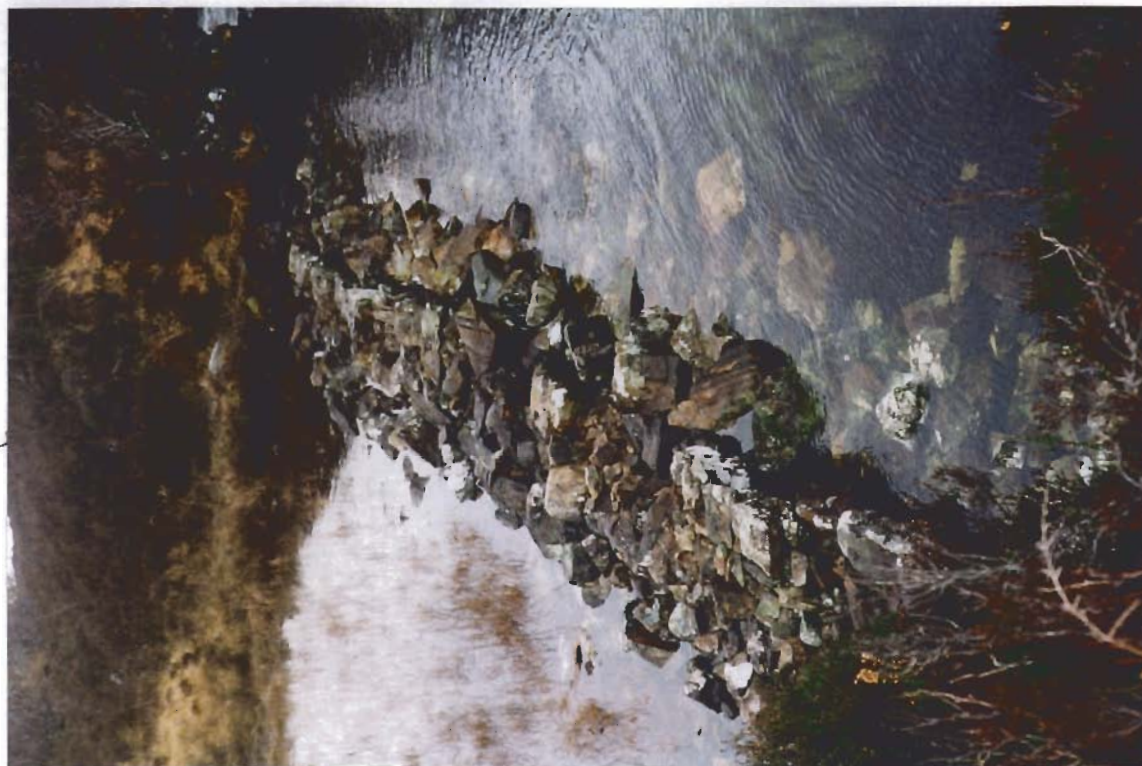
SITE NO. 7 Photograph No. 3

Wall after demolition, showing row of stones laid at base on northern side. View from
North West

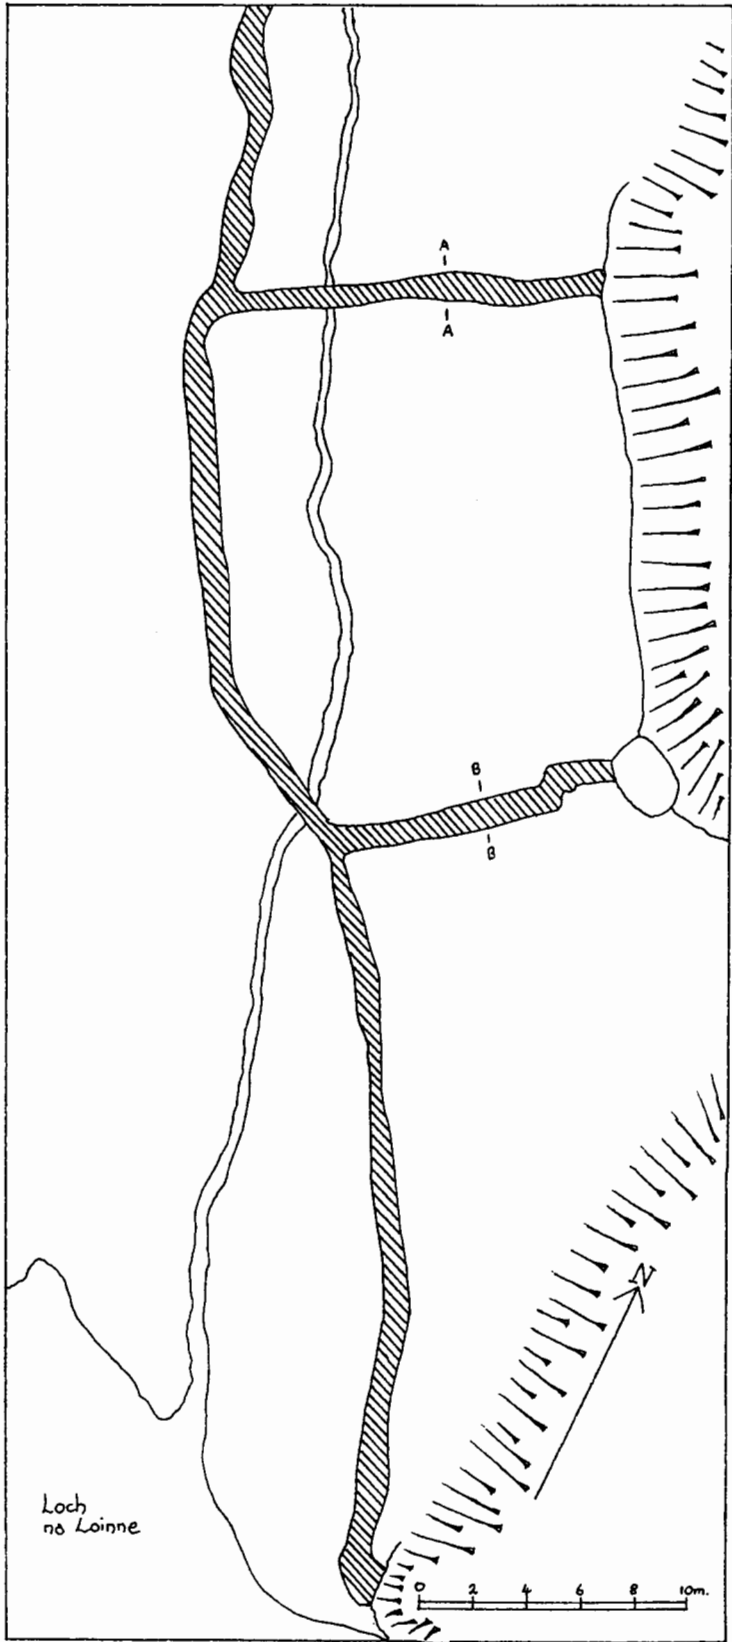
Site no. 8

The lower lying sections of the main dyke and the two enclosure dykes will be submerged by a 2m. rise in water level of Loch na Loinne, and being of stone and turf construction will deteriorate as the turf erodes out. The area of the survey included the complete enclosure and as far up the dyke as it was estimated would be affected by the rise in water level. The higher edge of the enclosure will not be submerged and the two terminals of the dykes will remain visible as points of reference.

The beginning of the main dyke curves slightly eastwards to abutt onto the vertical rockface at this point of the valley side but generally runs SE-NW, crossing the burn at the enclosure to run up the west side of the valley. It is of stone and turf construction, thickly overgrown with heather, and stands on average 0.8m high. The two enclosure walls are stonier and eroded with no covering of vegetation and stand on average only 0.5m. high. The enclosure is roughly rectangular, with no obvious entranceway. The burn passes through the enclosure and passes under the dykes with no apparent construction of culverts. The enclosure walls rise at an angle of 30 degrees to terminate at the rockface which forms the NE edge of the valley.
