438/SKL

An Archaeological Watching Brief at Torvaig, Skye

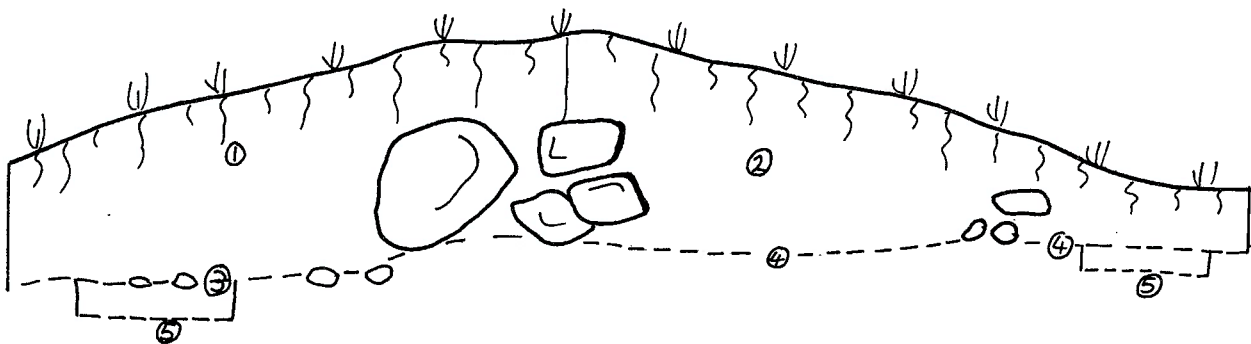
Trench 1 Southwest facing Section through East wall of large Enclosure Scale 1:20

A small trench was cut across the entrance to the large enclosure, as it was considered that the substantial wall here might mark a building. The size of the trench and the poor weather conditions handicapped results. From the OS maps it is possible that remains of a building were seen, but no convincing floor level was seen. The stones seen in layer (4) were interpreted as the surface of the **B** horizon, being similar to exposures at the road side.

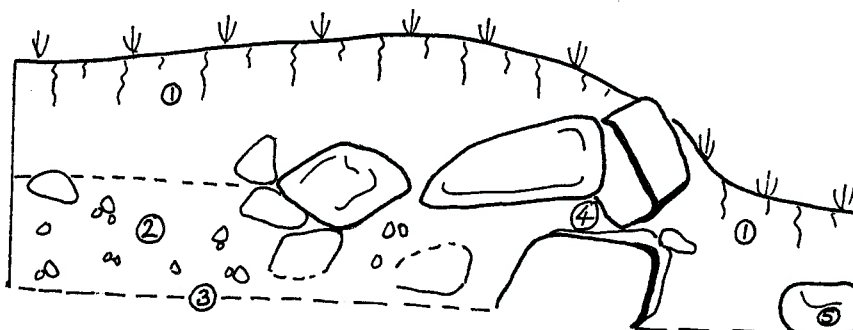
Trench 2 East facing section through south wall of Enclosure on east side Scale 1:20

These were cut as shown on the edge of a shallow terrace. This was revealed to be a stone revetted wall defining an area of presumed arable ground. Faint linear furrows observed here between 3 and 5 metres apart are thought to be the remains of cultivation ridges. No finds were recovered and the torrential rain prevented a detailed examination of the soils. Sections were drawn of the excavated features as shown overleaf. From what was observed the stone-free nature of the soil would be consistent with arable cultivation and there clearly had been a build-up of soil against this wall. The quality of the soil was poor and heavily panned, though

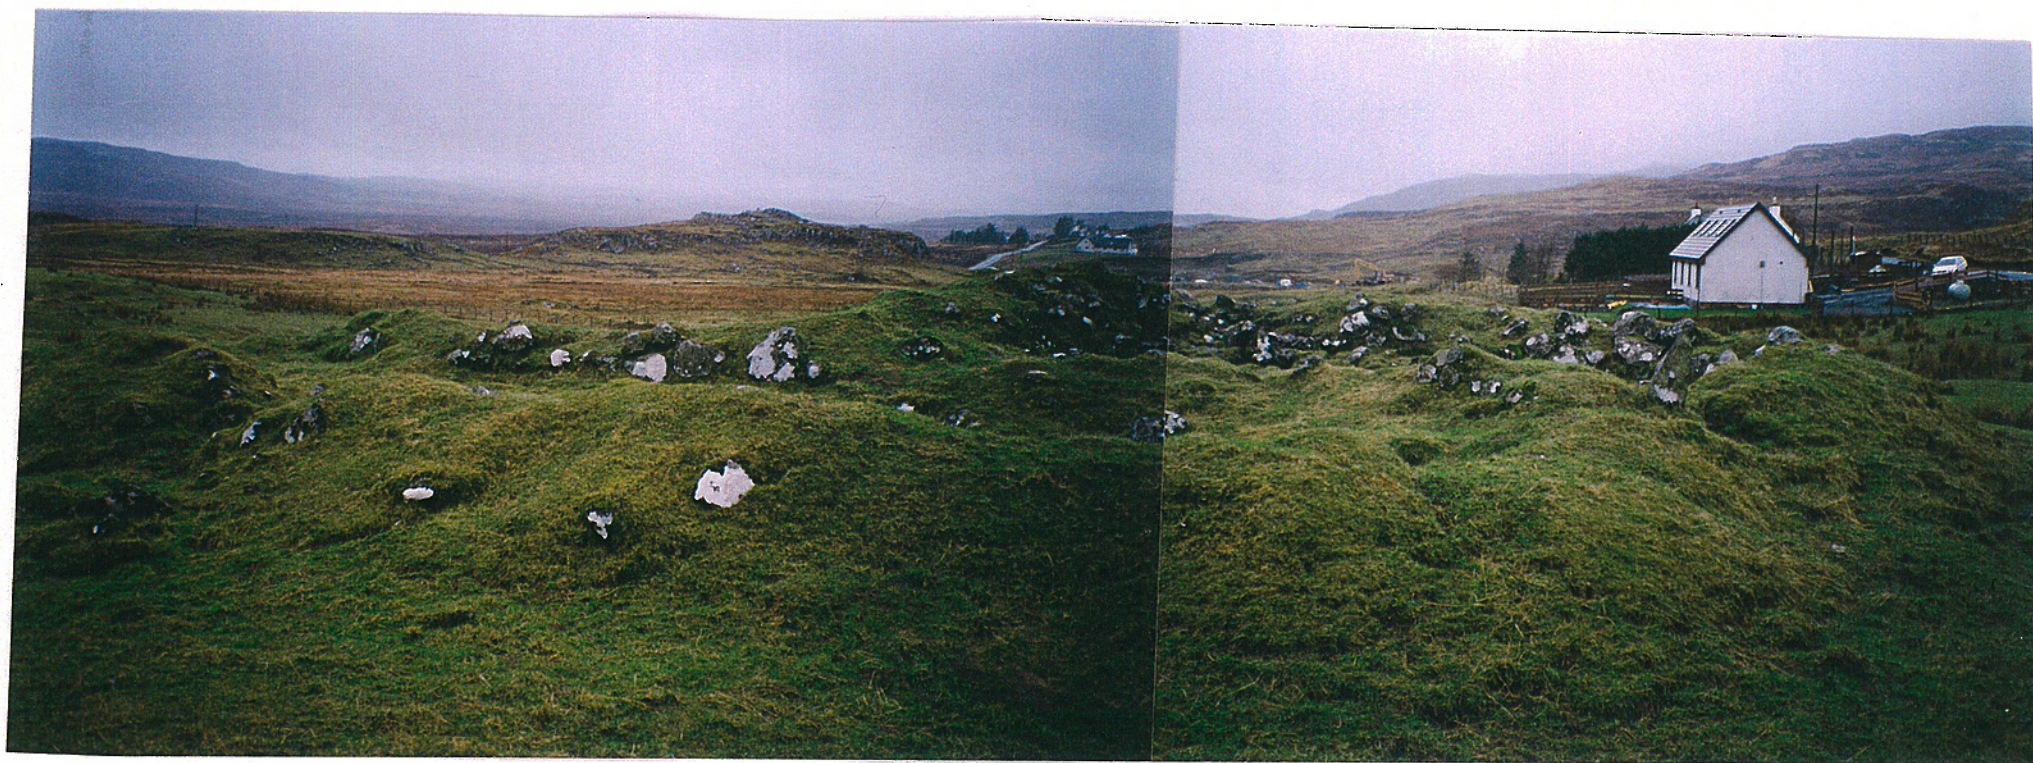
Fig 2 **Looking west at house site with Dun Gershader and modern house in background.**

The surviving building, as seen on Fig 3, is a substantial ruin 4m by 11m and has a well-preserved enclosure 6m by 5m on the north west side. The building shown to the south west on Fig 1, has now been demolished and appears to have been of a more modern construction. Though not shown on the earlier OS maps, it is likely to have been built and occupied in the 18th century.

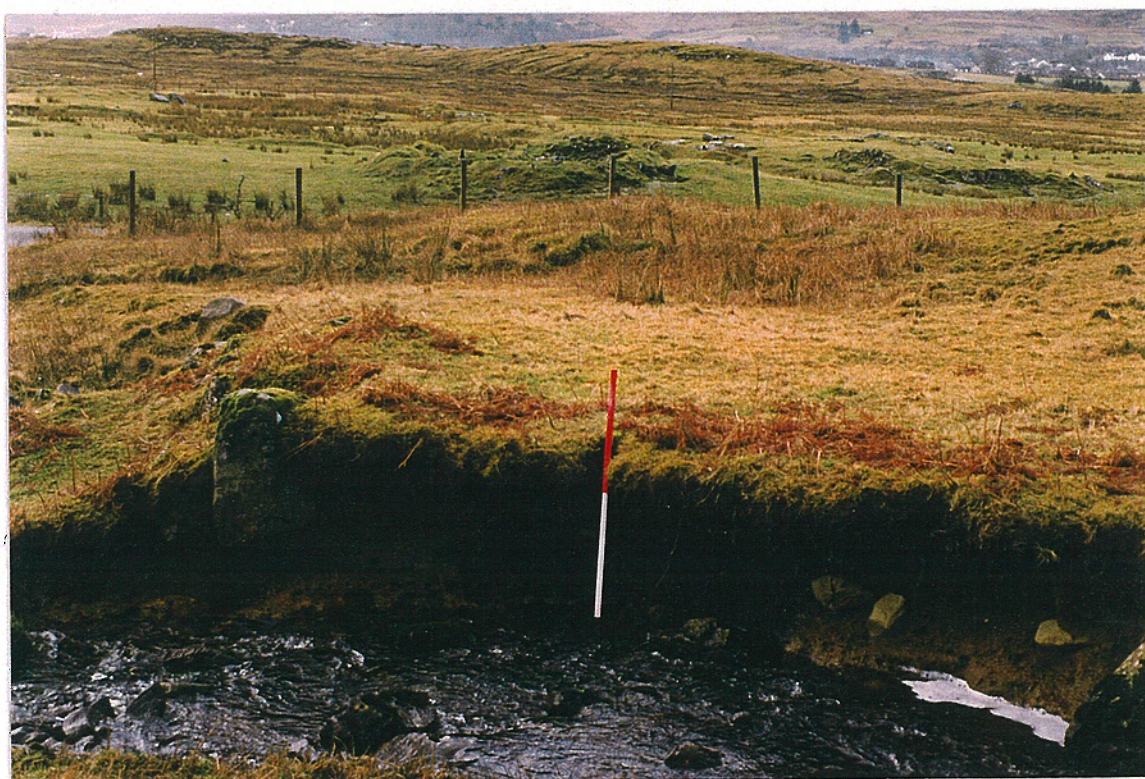
Fig 3(ii) Looking south past burnt mound on Martaig Burn to site of house.

On the opposite side of the road to the pipe cut, on a sharp bend of the Martaig Burn at NG 4939 4521 are the remains of a burnt mound [*see Fig 3(i)*]. It measures 0.2m high by 1.2m wide and is capped by a more recent structure/terrace. It was not examined in detail but probably dates to 2-3,000 years ago. It was perhaps contemporary with *Dun Gershaider* and

was the only evidence for prehistoric occupation in this immediate area.
