Camster Windfarm, Near Wick, Caithness Archaeological Photographic Survey, **Desk Based Assessment** and Walkover Survey

Report No. 1797

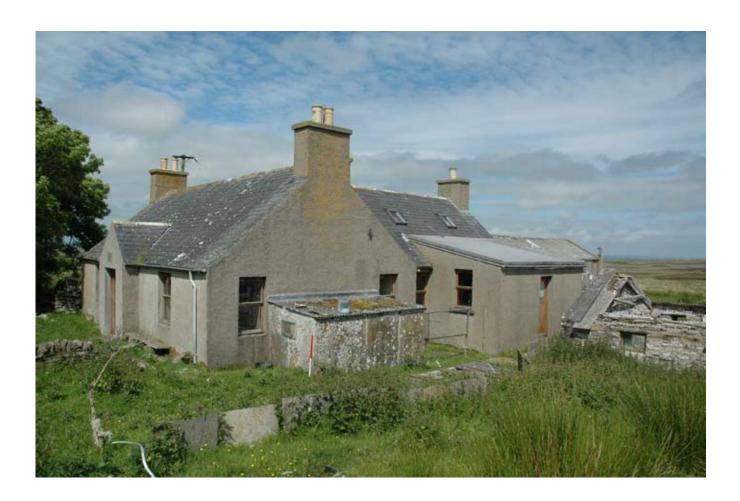
- 3.1.1 A comprehensive photographic survey was undertaken of the standing buildings at Badlipster (NGR: ND 2470 4921). Badlipster comprises a house, a byre and three outbuildings. The house is a linear cottage with a pitched roof, and has a pitched extension to the north with a lean-to extension on its east side. The house is stone built but entirely harled so it is unclear whether it was built in a single phase or extended after the initial construction. A stone plaque dated 1894 is located above the main door. The house has a garden to the rear bounded by drystone walls.

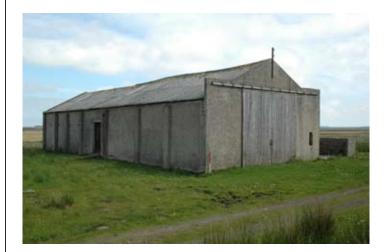
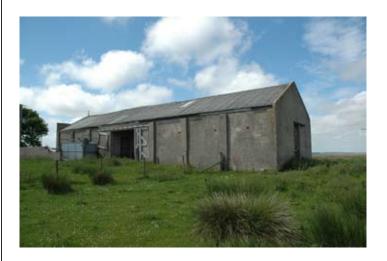
- 3.1.2 The byre, to the north-east of the house, is a later building. It is built of breeze blocks and has concrete floors with drainage and stalls for livestock. A sheep dip and shower are situated on the side of the byre.

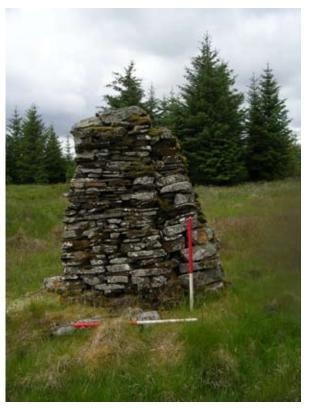
Fig 6. Site 5

- 3.4.1 A marker cairn of probable modern origins overlying a ring of stones (5) was identified in the DBA and visited during the walkover survey (Fig. 6-7). The cairn was found to be in a good condition and situated within a forestry clearing. While a possible hut circle was recorded in the NMRS in 1959 and 1972 as a ring of stones, the hut circle was not recorded on the Ordnance Survey First Edition 6" map (1877) nor in the RCAHMS Inventory of 1911, suggesting it is not an antiquity. There are now no visible remains of this ring of stones.

- 4.4 Buffer zones around Site 5 and a previously unknown cairn at Site 63 will be erected using high-visibility durable fencing. Tree felling within the buffer zone at Site 5 will be monitored and undertaken in such a way as to not affect the site.

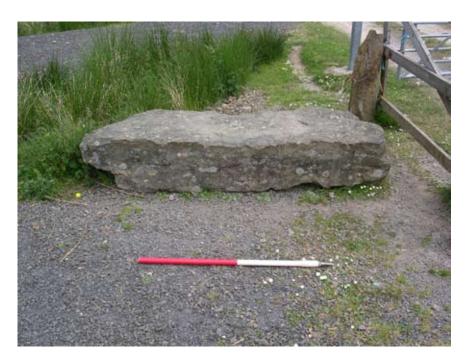
Fig 9. Site 58

- 3.4.6 A large stone (58) was located in a supine position next to the gate and picnic area for the Camster forestry access track (Fig. 9). Information from the HER suggests it may be the remains of a gate post or possible standing stone, although as it has been removed from its original location these postulations cannot be proved. It is not situated within the forested area and as such will not be affected by tree felling works, although further mitigation may be required during any track improvement or gate widening works.

- 4.8 Site **58** lies adjacent to a gate and picnic area on the existing access track. The gate is not going to be widened and therefore no further work is recommended.

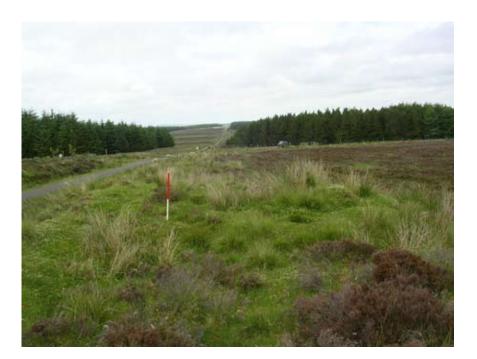
Fig 10. Site 59

- 3.4.7 Two low amorphous mounds (**59**) situated to the east of the Watten to Lybster public road (Fig. 10) were visited. Both mounds lie outwith the forested area and are not situated near to any proposed development elements and as such will not be affected by the development.

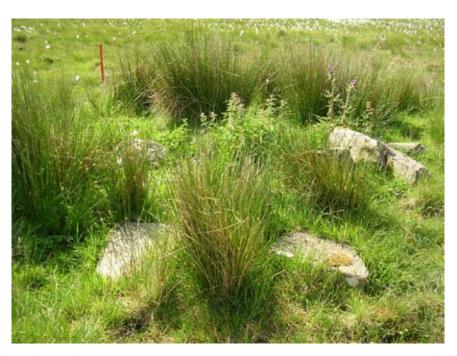
Fig 11. Site 63

- 3.4.11 A group of roofed and unroofed structures and associated field boundaries and enclosures (63), seen on the 1st Edition OS map, was visited and found to comprise three roofed and inhabited/in use structures as well as a collapsed section of drystone walling and a number of probable clearance cairns (Figs. 11-12). The site is situated outwith the forestry and alongside the proposed access track. The majority of the features at Site 63 will be unaffected by the

- proposed development, although a clearance cairn lies close to the proposed access track into the development site, adjacent to Achairn Cottage.
- 3.4.12 The walkover survey identified the remains of a derelict stone built structure measuring 7.5m by 4m and surviving up to 2.5m in height (64; Fig. 13). This building lies outwith the forestry area and is of a sufficient distance from the proposed access track that it will not be affected by the development.

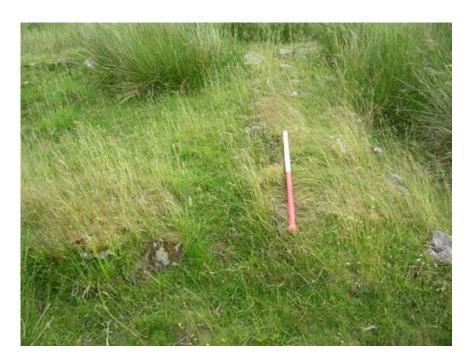
Fig 14. Site 65

- 3.4.13 An enclosure and a length of field wall (65) depicted on the 1st Edition of the OS 6-inch map was identified in the DBA. The walkover survey found the site to consist of the largely collapsed and overgrown remains of a two-roomed drystone structure with an adjacent possible wall/enclosure (Fig. 14). These features lie outwith the forestry area and are of a sufficient distance from the proposed access track that they will not be affected by the development.

- 4.5 Sites **64**, **65** and **67** will be unaffected as the existing road will be used and will not need any upgrading. No further work is recommended.

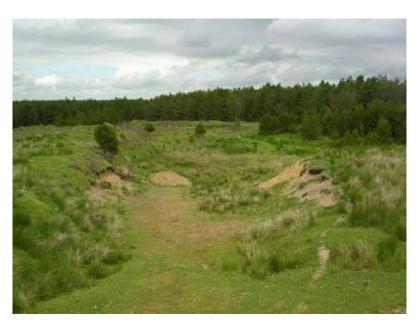
Fig 15. Site 66

- 3.4.14 The remains of a quarry site (66) consisting of two overgrown spoil heaps/upcast piles was identified during the walkover survey (Fig. 15). Site 66 was one of several quarries, all modern and presumably related to forestry activities, seen within the area. Site 66 occupied a gap within the forestry plantation and is unlikely to be affected by any felling works due to its position and nature.

- 4.6 Sites **7**, **59** and **60** are under no threat from any elements of the development. No further work is recommended.
- 4.7 Site **66** is a quarry in open ground. No further work is recommended.

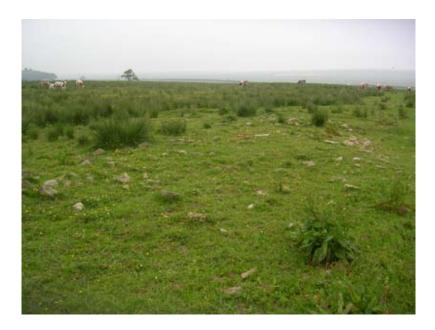
Fig 16. Site 67 stone spread

- 3.4.15 A small area of rig-and-furrow cultivation abutted by a bank and ditch with two irregular stone spreads situated to the east (67; Figs. 16-17) was identified during the walkover survey. The remains most likely represent the remains of a small-scale field system and the land is now used as rough pasture. These features lie outwith the forestry area and are of a sufficient distance from the proposed access track that they will not be affected by the development.

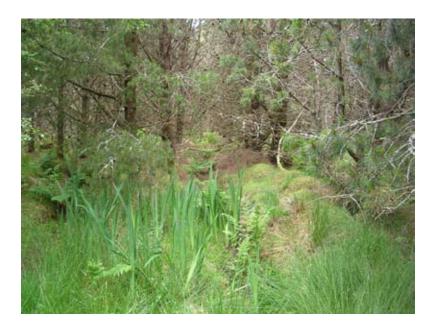
Fig 18. General shot of forestry furrowing

- 3.3.3 The majority of the survey area was very densely afforested (Figs 18-19). There have been two rotations of commercial forestry within the development site since the 1970s, and the existing furrows are extensive, deep, and are likely to have had a detrimental effect on any archaeological remains present. The existing furrows measure up to 1m across and 1m deep.
