## Osedale Water Main Isle of Skye

## Desk-based Assessment and Walk-over survey

<b>Report No.</b>	HAS100904
<b>Site Code</b>	HAS-OWM10
<b>Client</b>	Scottish Water
<b>OS Grid Refs</b>	NG 3338 4214 NG 2488 4594
<b>HCAU / Planning Ref</b>	N/A
<b>OASIS</b>	highland4-82966
<b>Date</b>	17/09/2010
<b>Author</b>	J Wood

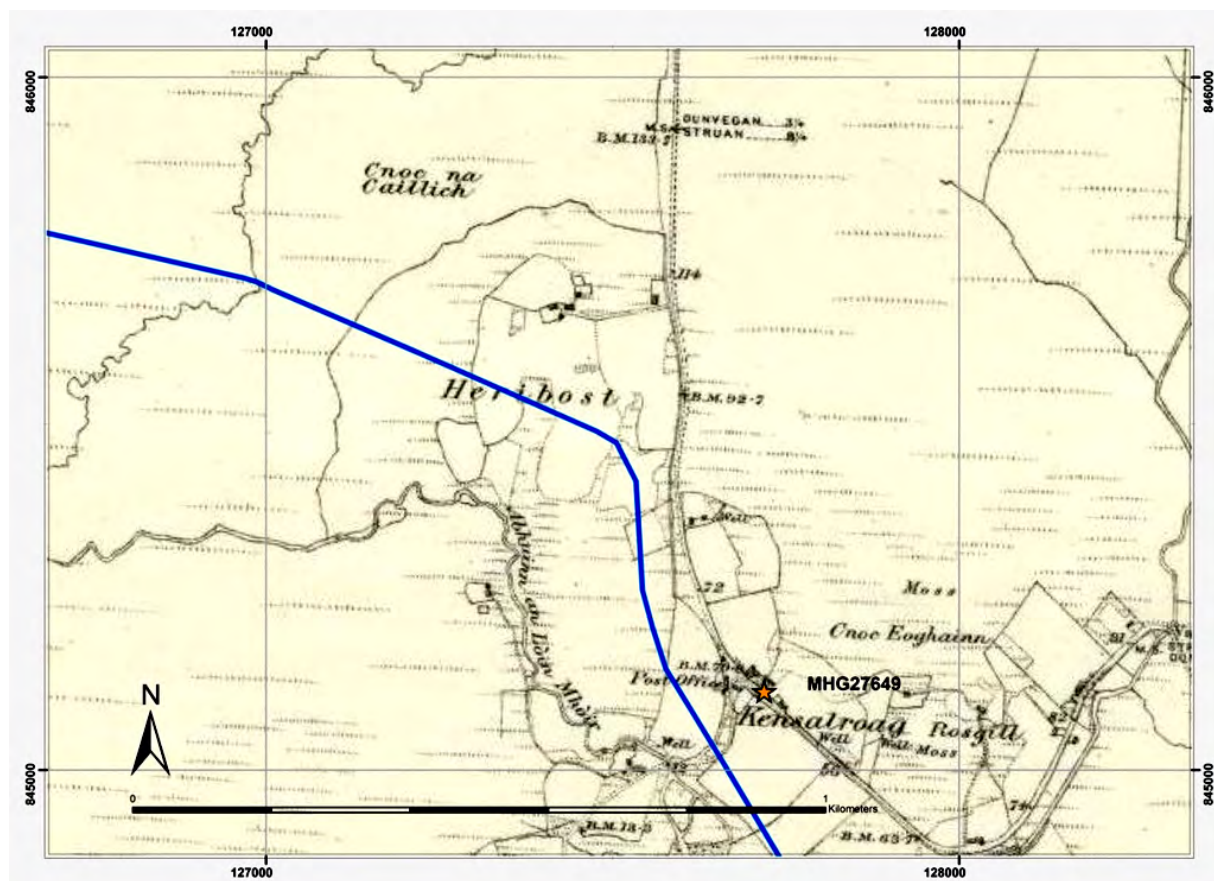
**Figure 3 Heribost Township 1877: Water main line superimposed**

A crofting township, comprising eleven roofed buildings and one unroofed building was noted on the 1st edition of the OS 6-inch map (Inverness-shire, Isle of Skye 1881, sheet xxi). Seven roofed buildings, one of which is a church are shown on the current edition of the OS 1:10560 map (1968).

The water main will cross this area; no visible structures appear to be directly on its proposed line, but a watching brief is advised here as there is a possibility that buried archaeology could be present.

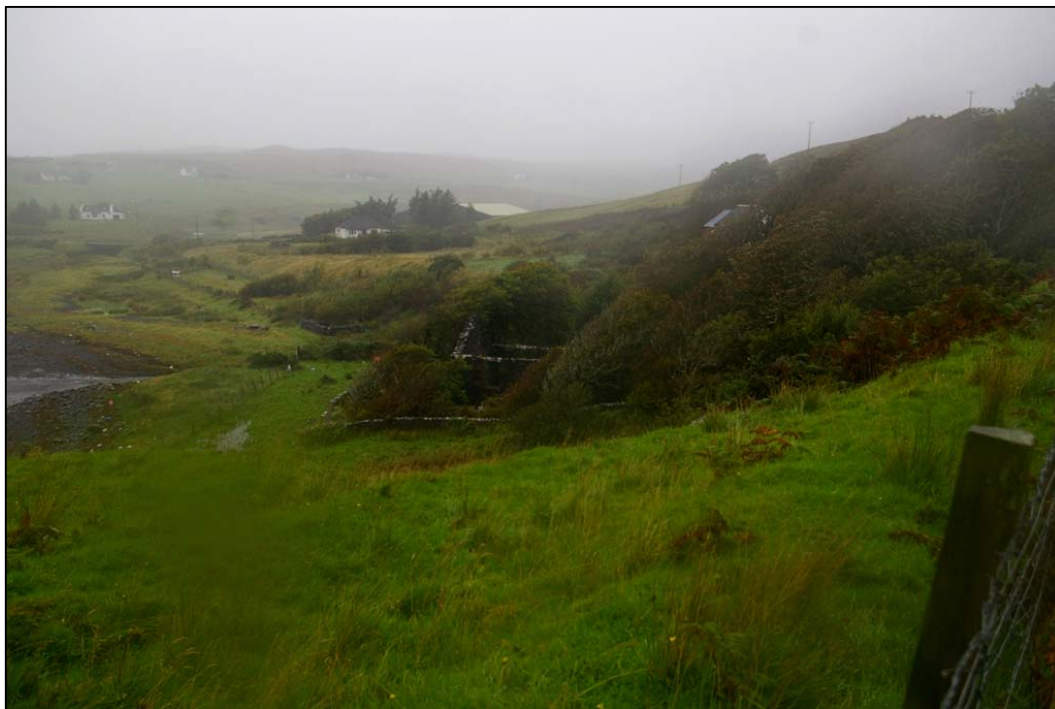
**Plate 1 St John's Chapel**

“Built 1843. Roofless, but in good condition; within a burial-ground which is still in use”<sup>10</sup>.

This will not be affected by the water main.

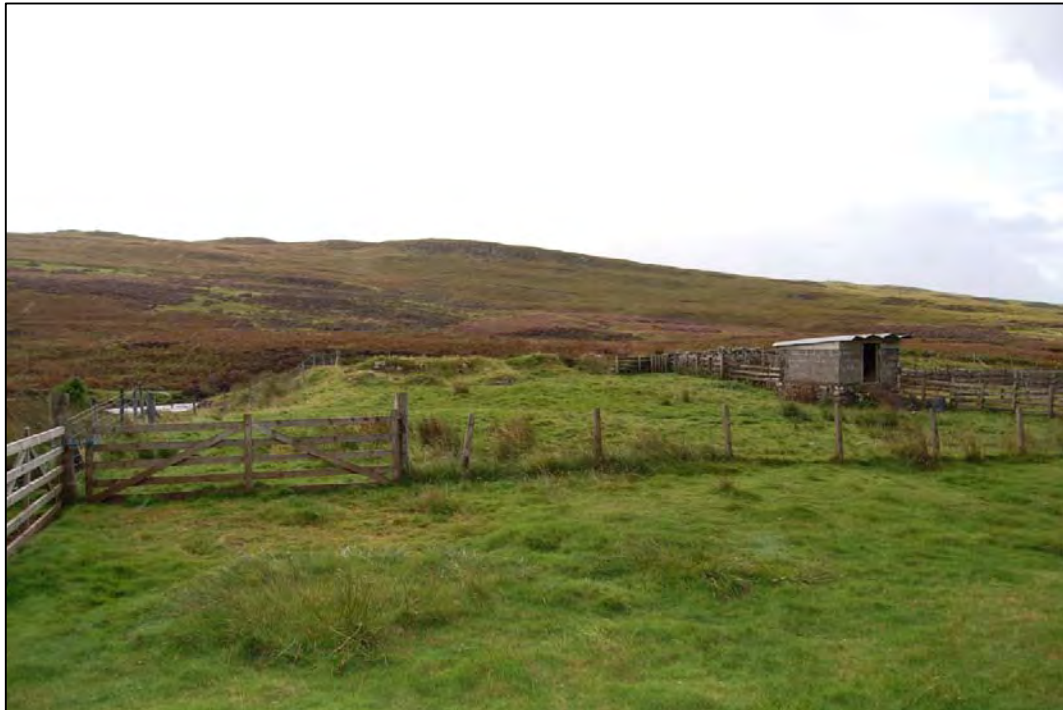
**Plate 2 Sheep fank and building footings - Osdale farm**

This lies on the opposite bank of the river and should not be affected but machinery and vehicles will be kept clear. Two buildings are shown on the north side of the river. This site is now occupied by a sheep fank (plate 2, below).

The water main will not affect this site.

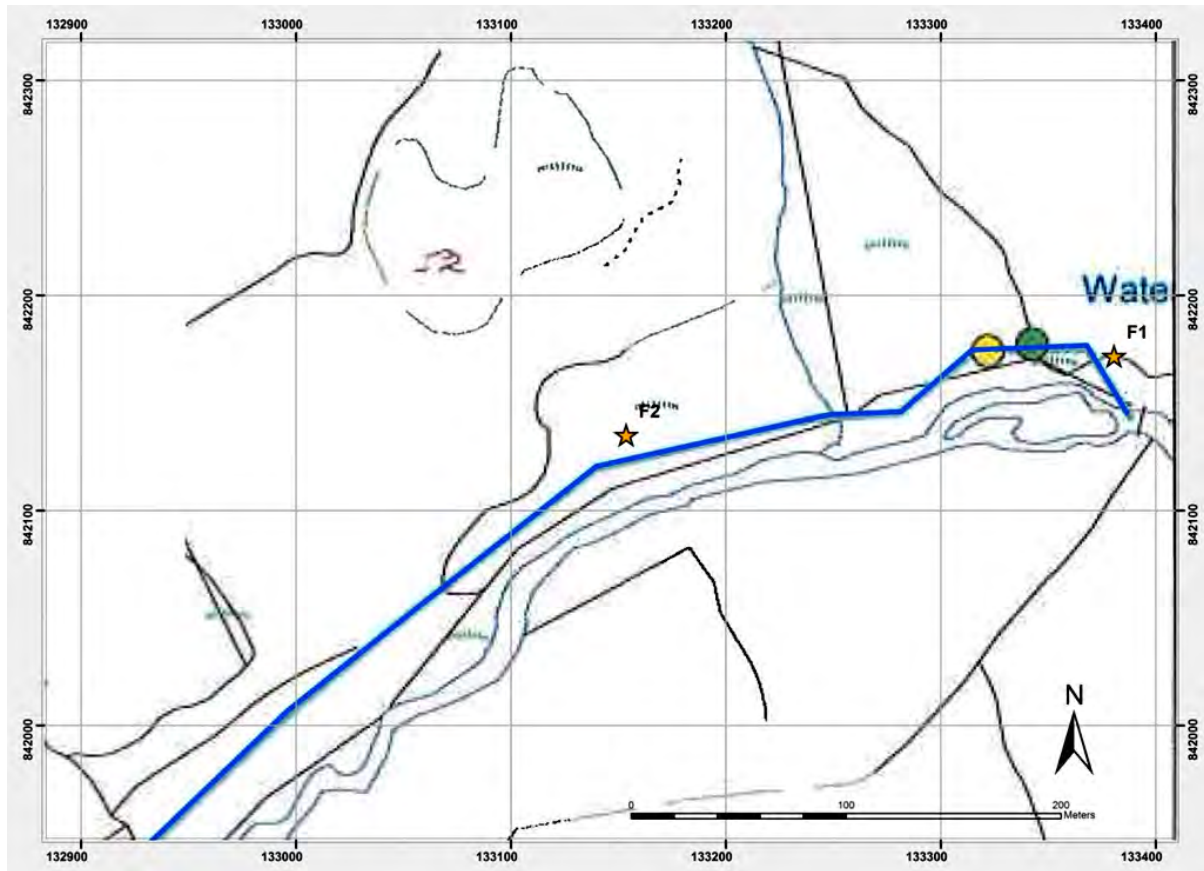
**Figure 6 Features 1 and 2**

A substantial stone and turf dyke was noted running approximately east-west just north of the proposed weir. This is marked on the Scottish Water drawings, but it is not shown on the first edition 1:10560 OS map (see Figures 5 and 6 above). It has not been recorded in the archaeological records and is undated.

An area of ridge and furrow cultivation was noted (See Figure 6 and Plate 4). This does not appear on the 1877 Ordnance Survey map (Figure 5). The water main will pass along the edge of this; no mitigation is proposed here.
