Coastal Assessment Survey Inner Moray Firth

Inverness to Dingwall

**MORAY, BEAULY AND CROMARTY FIRTH
COASTAL ASSESSMENT 1998**

Report No. 446

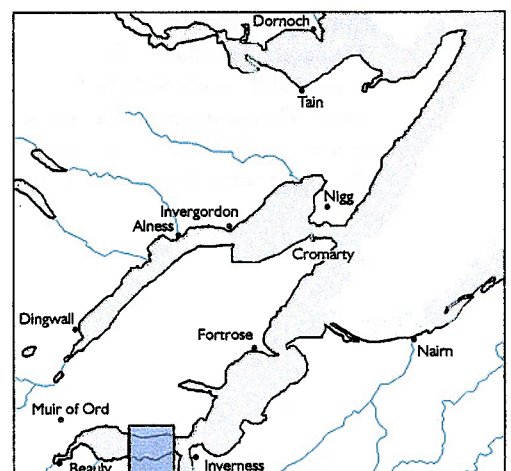
Map 1: EROSION

Backshore well vegetated with an eroding saltmarsh at the HWM caused by scouring in storm conditions. Mud and shingle are exposed on the tidal flats.

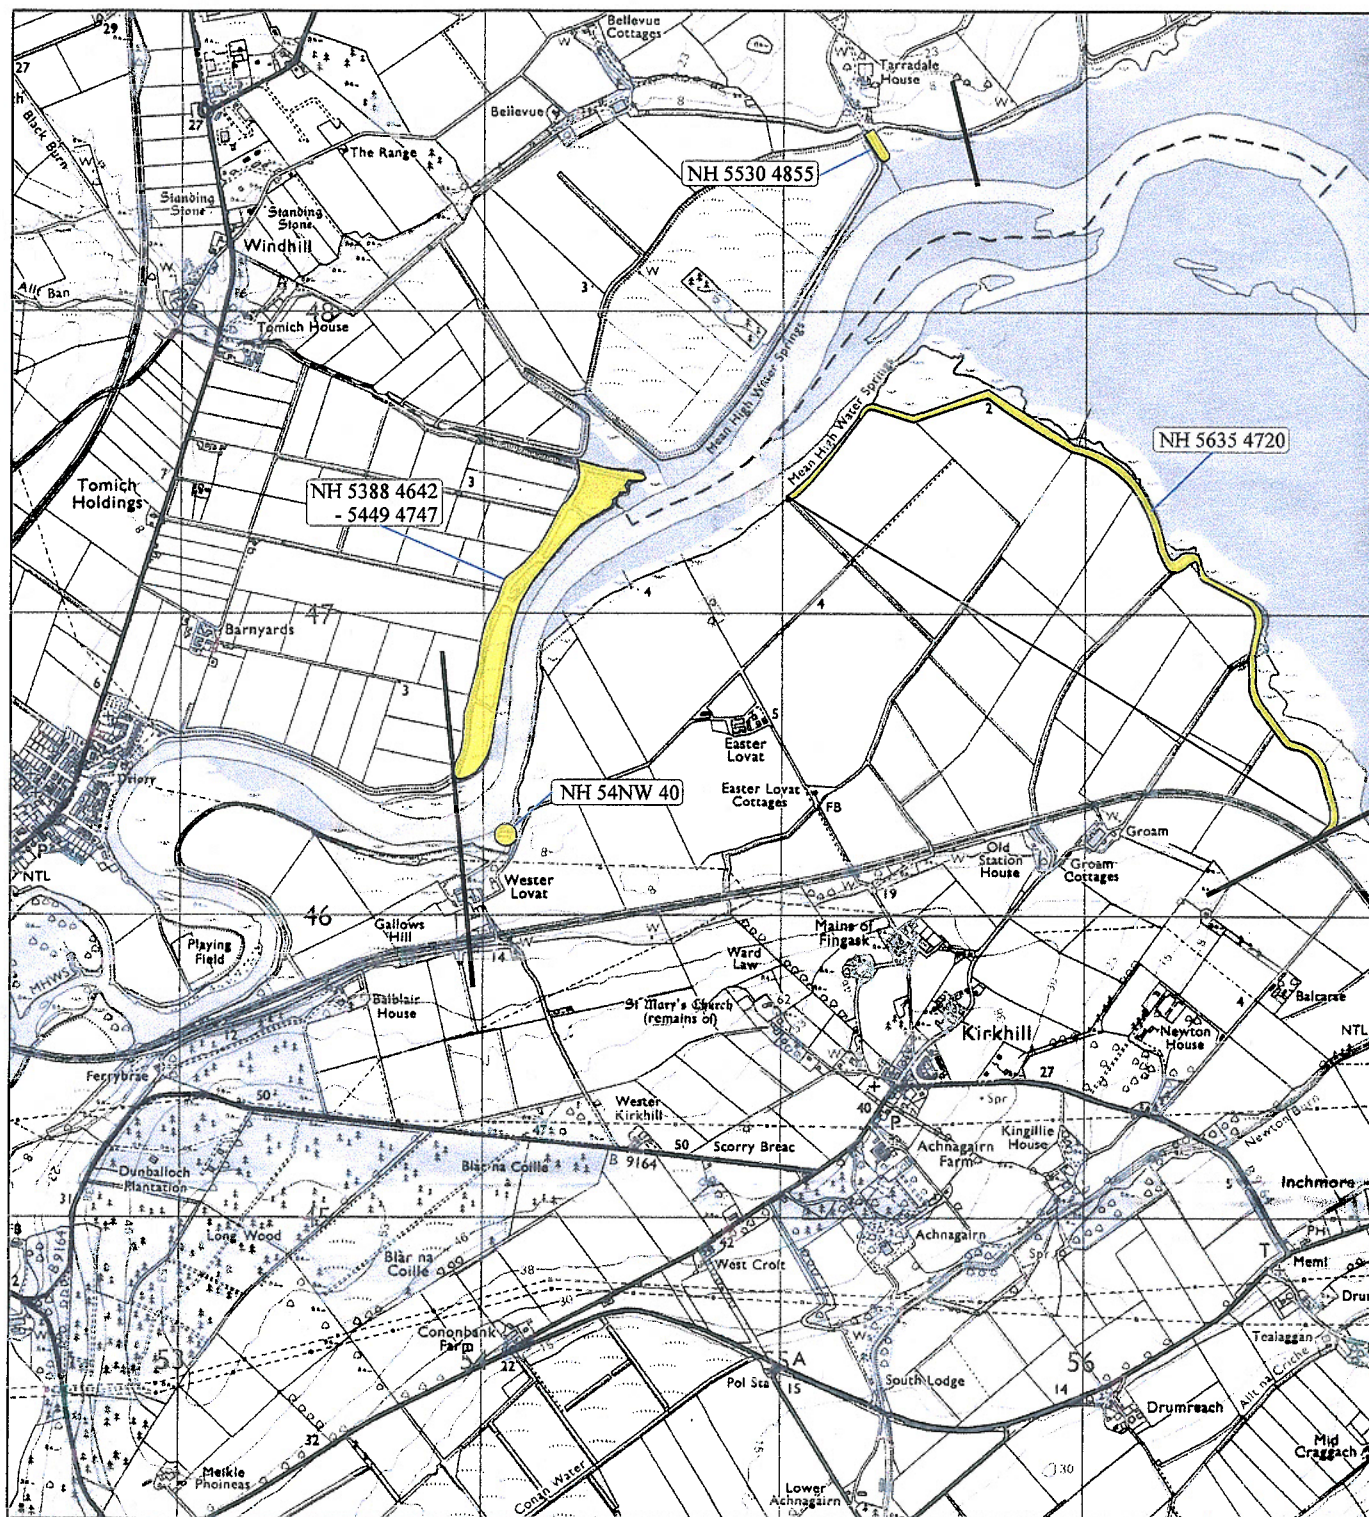
MAP 3: BALCARSE TO TARRADALE HOUSE

Erosion class: Owing to the sheltered position of this section of estuarine coastline the condition of the low shore is stable and accreting. Estuarine mud is the dominant feature of the foreshore with isolated patches of shingle in parts. Some slight degradation of the carse clay platform is ongoing but recession of this low cliff is at the present only slight. Undercutting is leading to collapse but the fallen material is not being transported and appears to form a lower step of vegetation. It is the vegetation that is rendering stability in what is considered to be a fairly low wave energy environment.

In the hinterland archaeology the Redcastle, a 17th/18th century tower house and designed landscape, is reputed to stand on the site of Ederdour erected by William the Lion in the 12th century AD. Today the castle is part of a large working estate and is in a poor state of repair. Off shore from the castle is the Redcastle intertidal crannog. The site is a complex Iron Age structure with at least two phases of construction and appears to have been constructed during a period of lower water level. A series of piles at low water mark near Corgrain Point are the remnants of a wooden fish trap, which requires survey and monitoring.

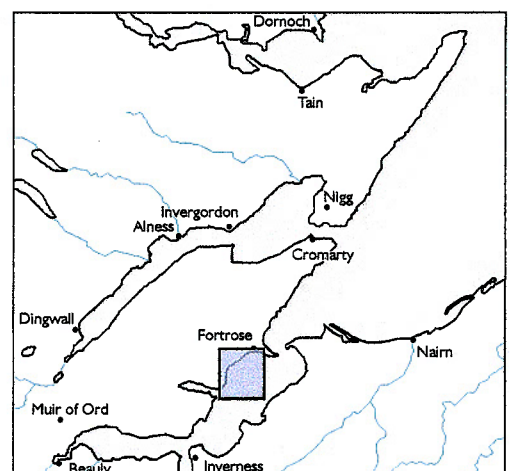
MAP 8: EROSION

Sandy beach with stable conditions.

Shingle banks are stabilised by vegetation. Stable conditions prevail. A c.50m section of erosion has occurred on the neck of the pier at Avoch and is now defended by rubble. Turf behind has been scoured by wave action. On the whole conditions are stable.

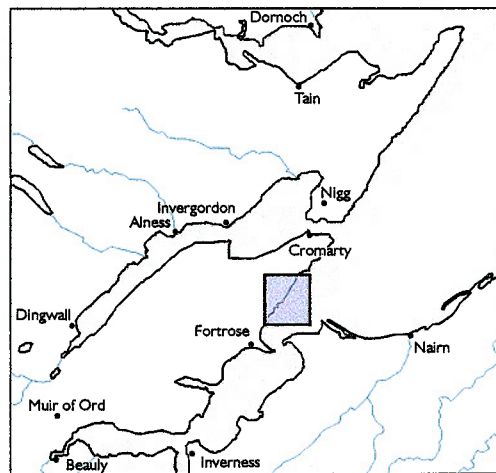
MAP 10: EROSION

The coastline is irregular and incised at the base by scouring of boulders at the base of the cliff. Exposed to easterly gales erosion is constant on the foreshore albeit slow.

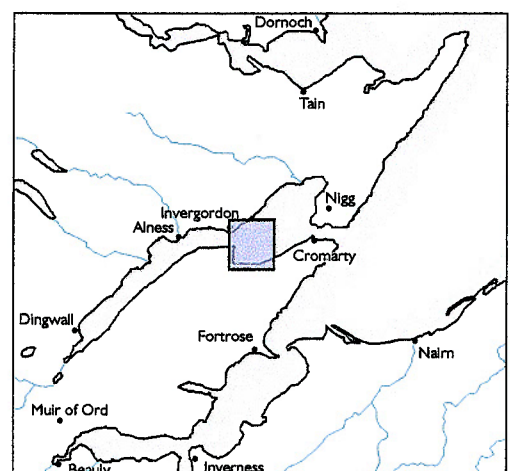
MAP 13: EROSION

A cobble beach overlooks accreting mud flats. Raised beach deposits at the backshore are stabilised by saltmarsh. At the present there are no indicators to suggest that conditions are not stable.

Sea defences guard Newhall Point. Cobble and sand is banked up at the HWM. The foreshore is accreting with mud flats extending to about 1.5km.

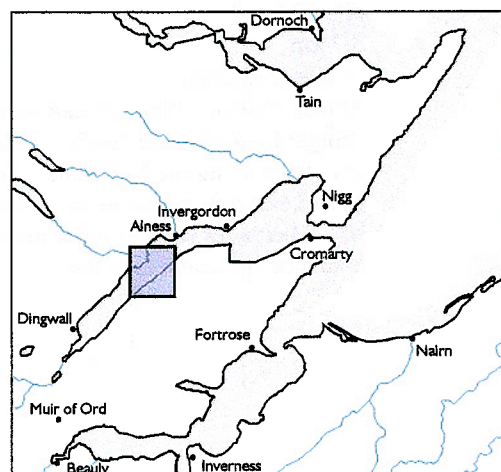
MAP 15: EROSION

The build up of shingle and cobbles at the MHWMS suggest that conditions are stable with a sandy beach towards the LWM. There are no indicators to suggest conditions are not stable.

This unit of coastline consists of cobbles and shingle banked at the HWM. Slight erosion is occurring along the MHWMS where marine gravel outcrops or where vegetation is poor. The beach becomes sandier offshore but there is no evidence for active erosion.

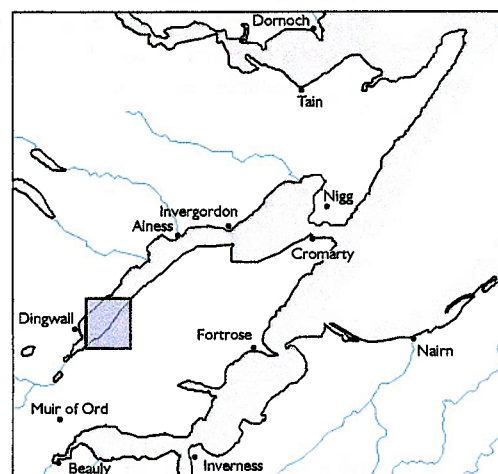
MAP 16: EROSION

Rubble deposition at the coastal edge attempts to limit the damage from erosion behind the cobble MHW. Mud flats are extensive and show signs of accretion mid way from the shore.

Accreting mud and sand on the foreshore with channels exposed at the LWM. Shingle build up suggests stable conditions.

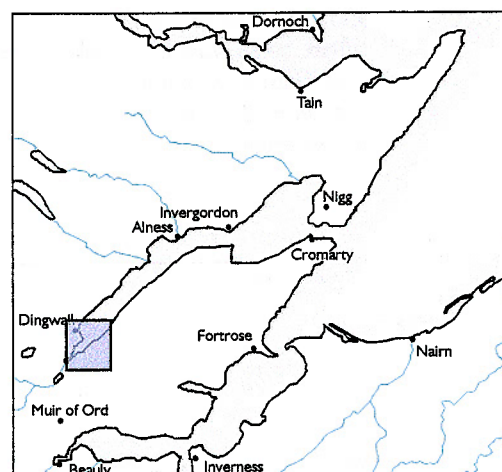
MAP 17: EROSION

2. URQUART to north of TIGHNAHINCH
NH 576 584
1km
Definitely Accreting
Irregular unit of coastline with accreting mud flats. Shingle is banking up at the MHWL suggesting that conditions are relatively stable.

8. DINGWALL HARBOUR towards north east DINGWALL
NH 559 590
2km
Definitely accreting
Saltmarsh and flood defences traverse this unit of coastline. Mud is accreting on the foreshore.
