SCHEDULED ANCIENT MONUMENT MANAGEMENT PLAN

**Truderscaig deserted township, hut circles
& clearance cairns**

Name of Monument: **Truderscaig deserted township, hut circles & clearance cairns**

Scheduled Ancient Monument Number: **2512**

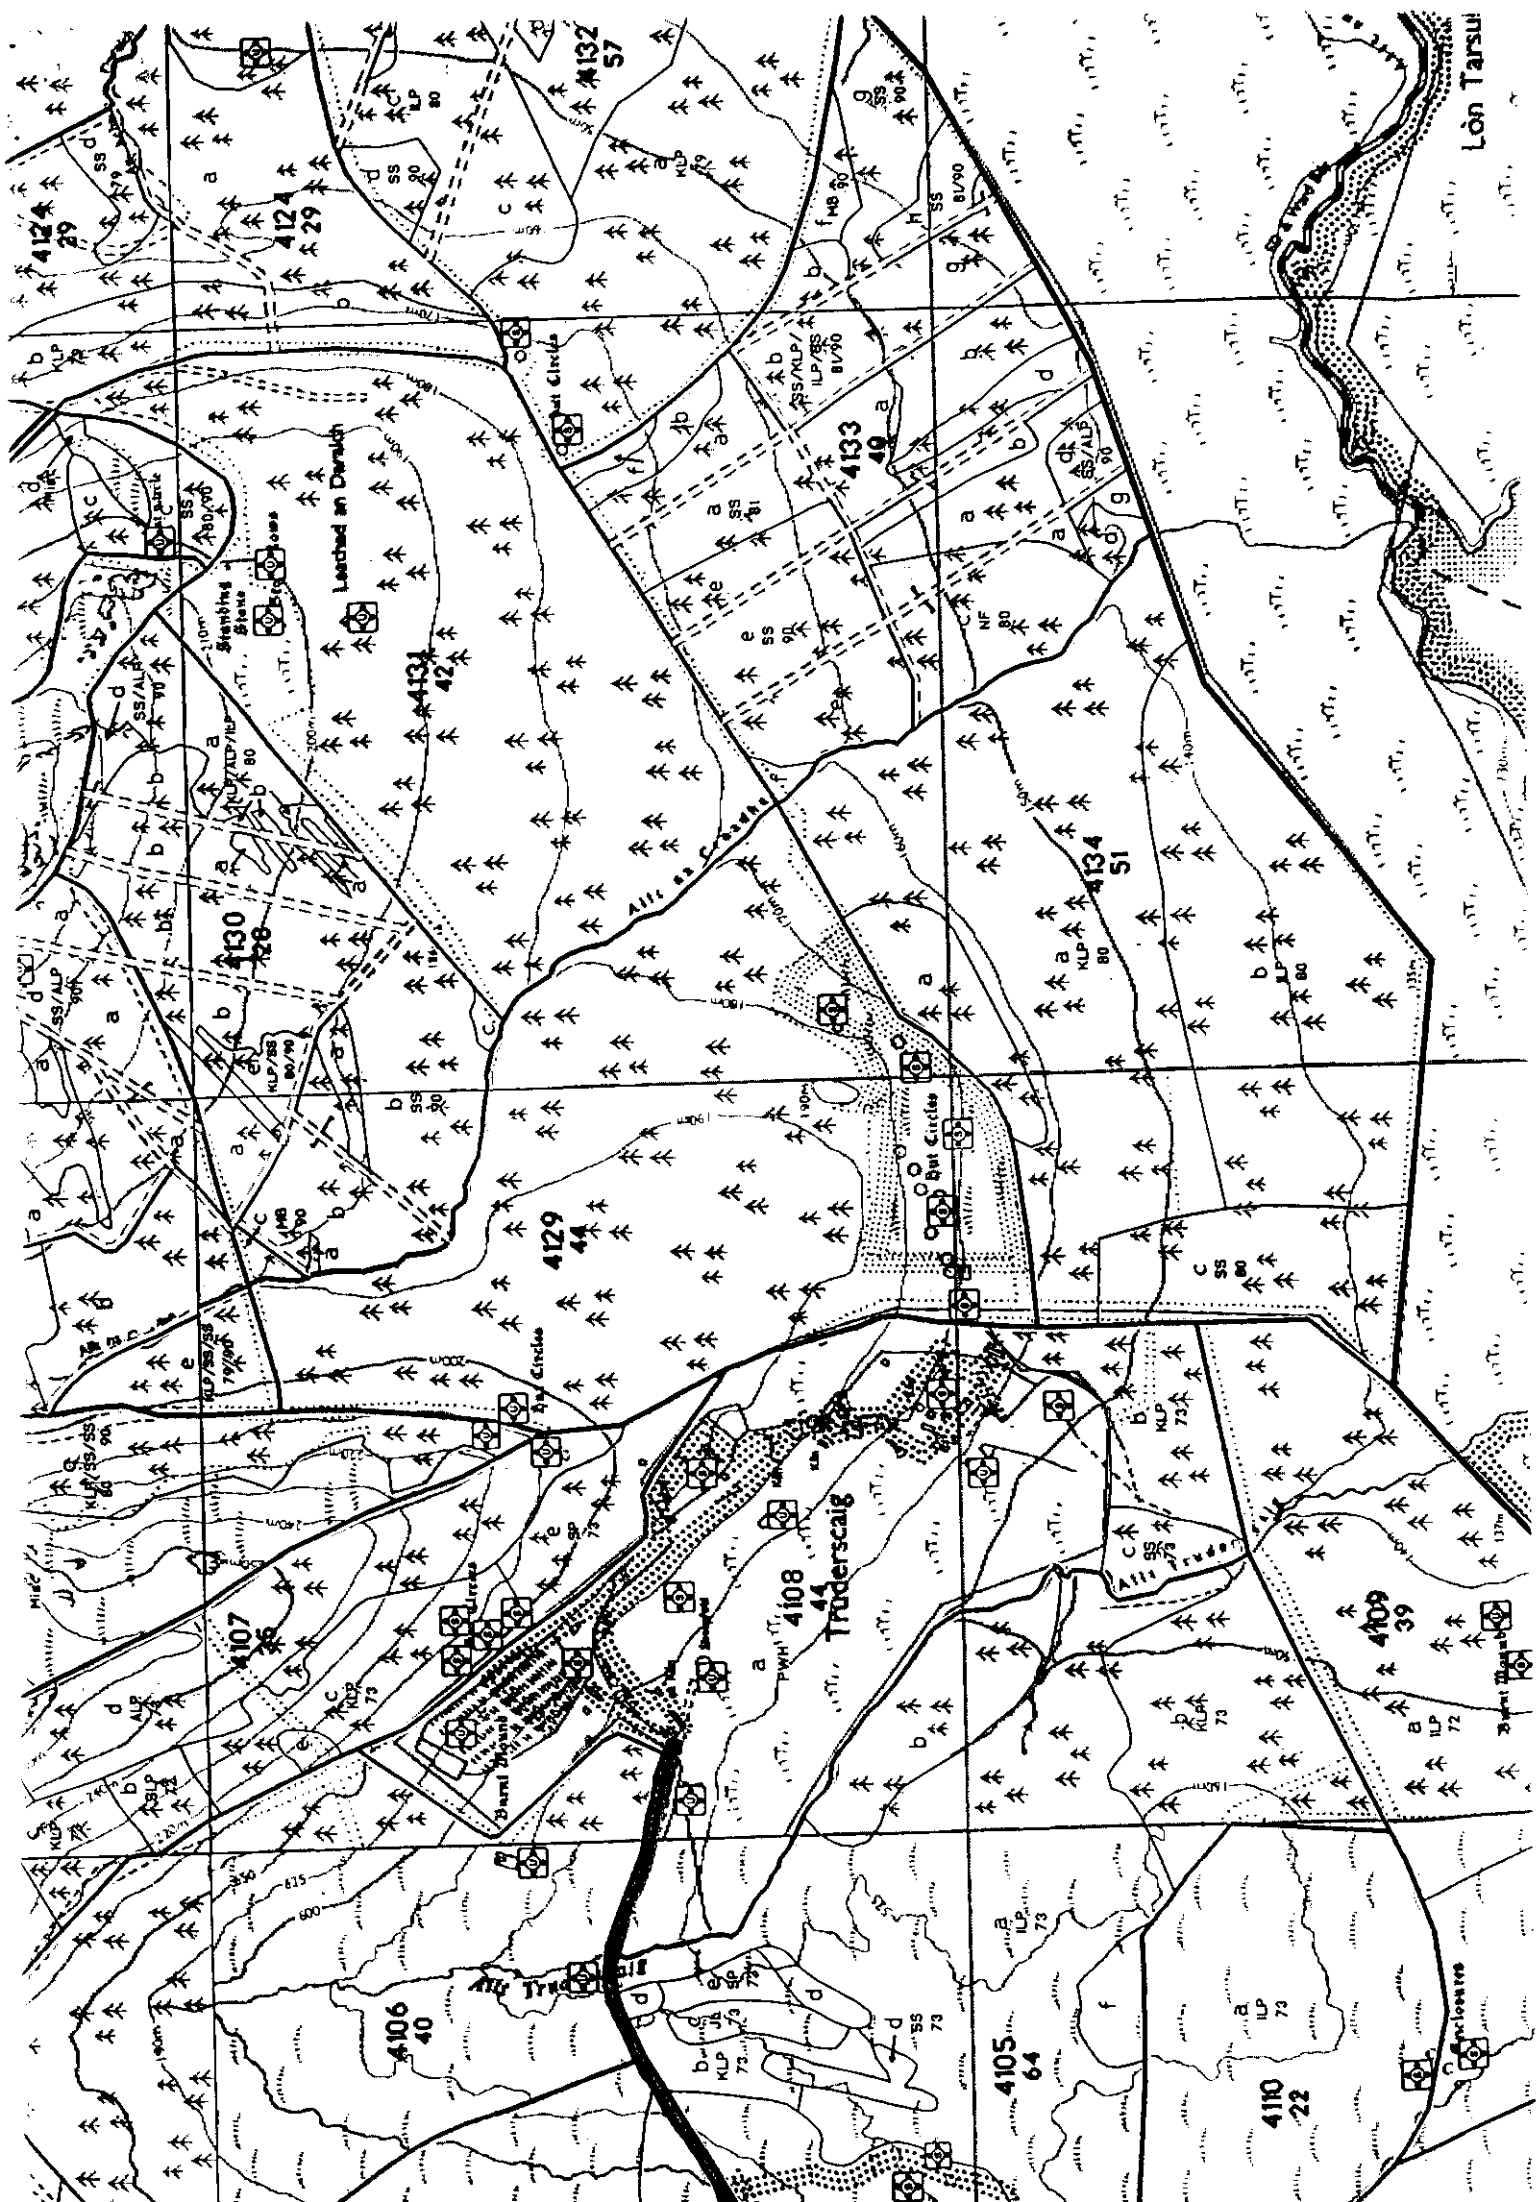
Appendix 3 Site access map

Public access will be improved by provision of waymarking and maintenance of a clear track to the site. (Appendix 3)

10. To allow public access at all reasonable times to the Scheduled Area. An access route will be way-marked as shown on the attached map extract (Appendix 3). This route will be checked annually to ensure it provides adequate guidance and access.
