CROMAL MOUNT, ARDERSIER (Grid ref NH 7822 5556)

Preliminary Report on the Archaeological Assessment,  
29-30 September 1989.

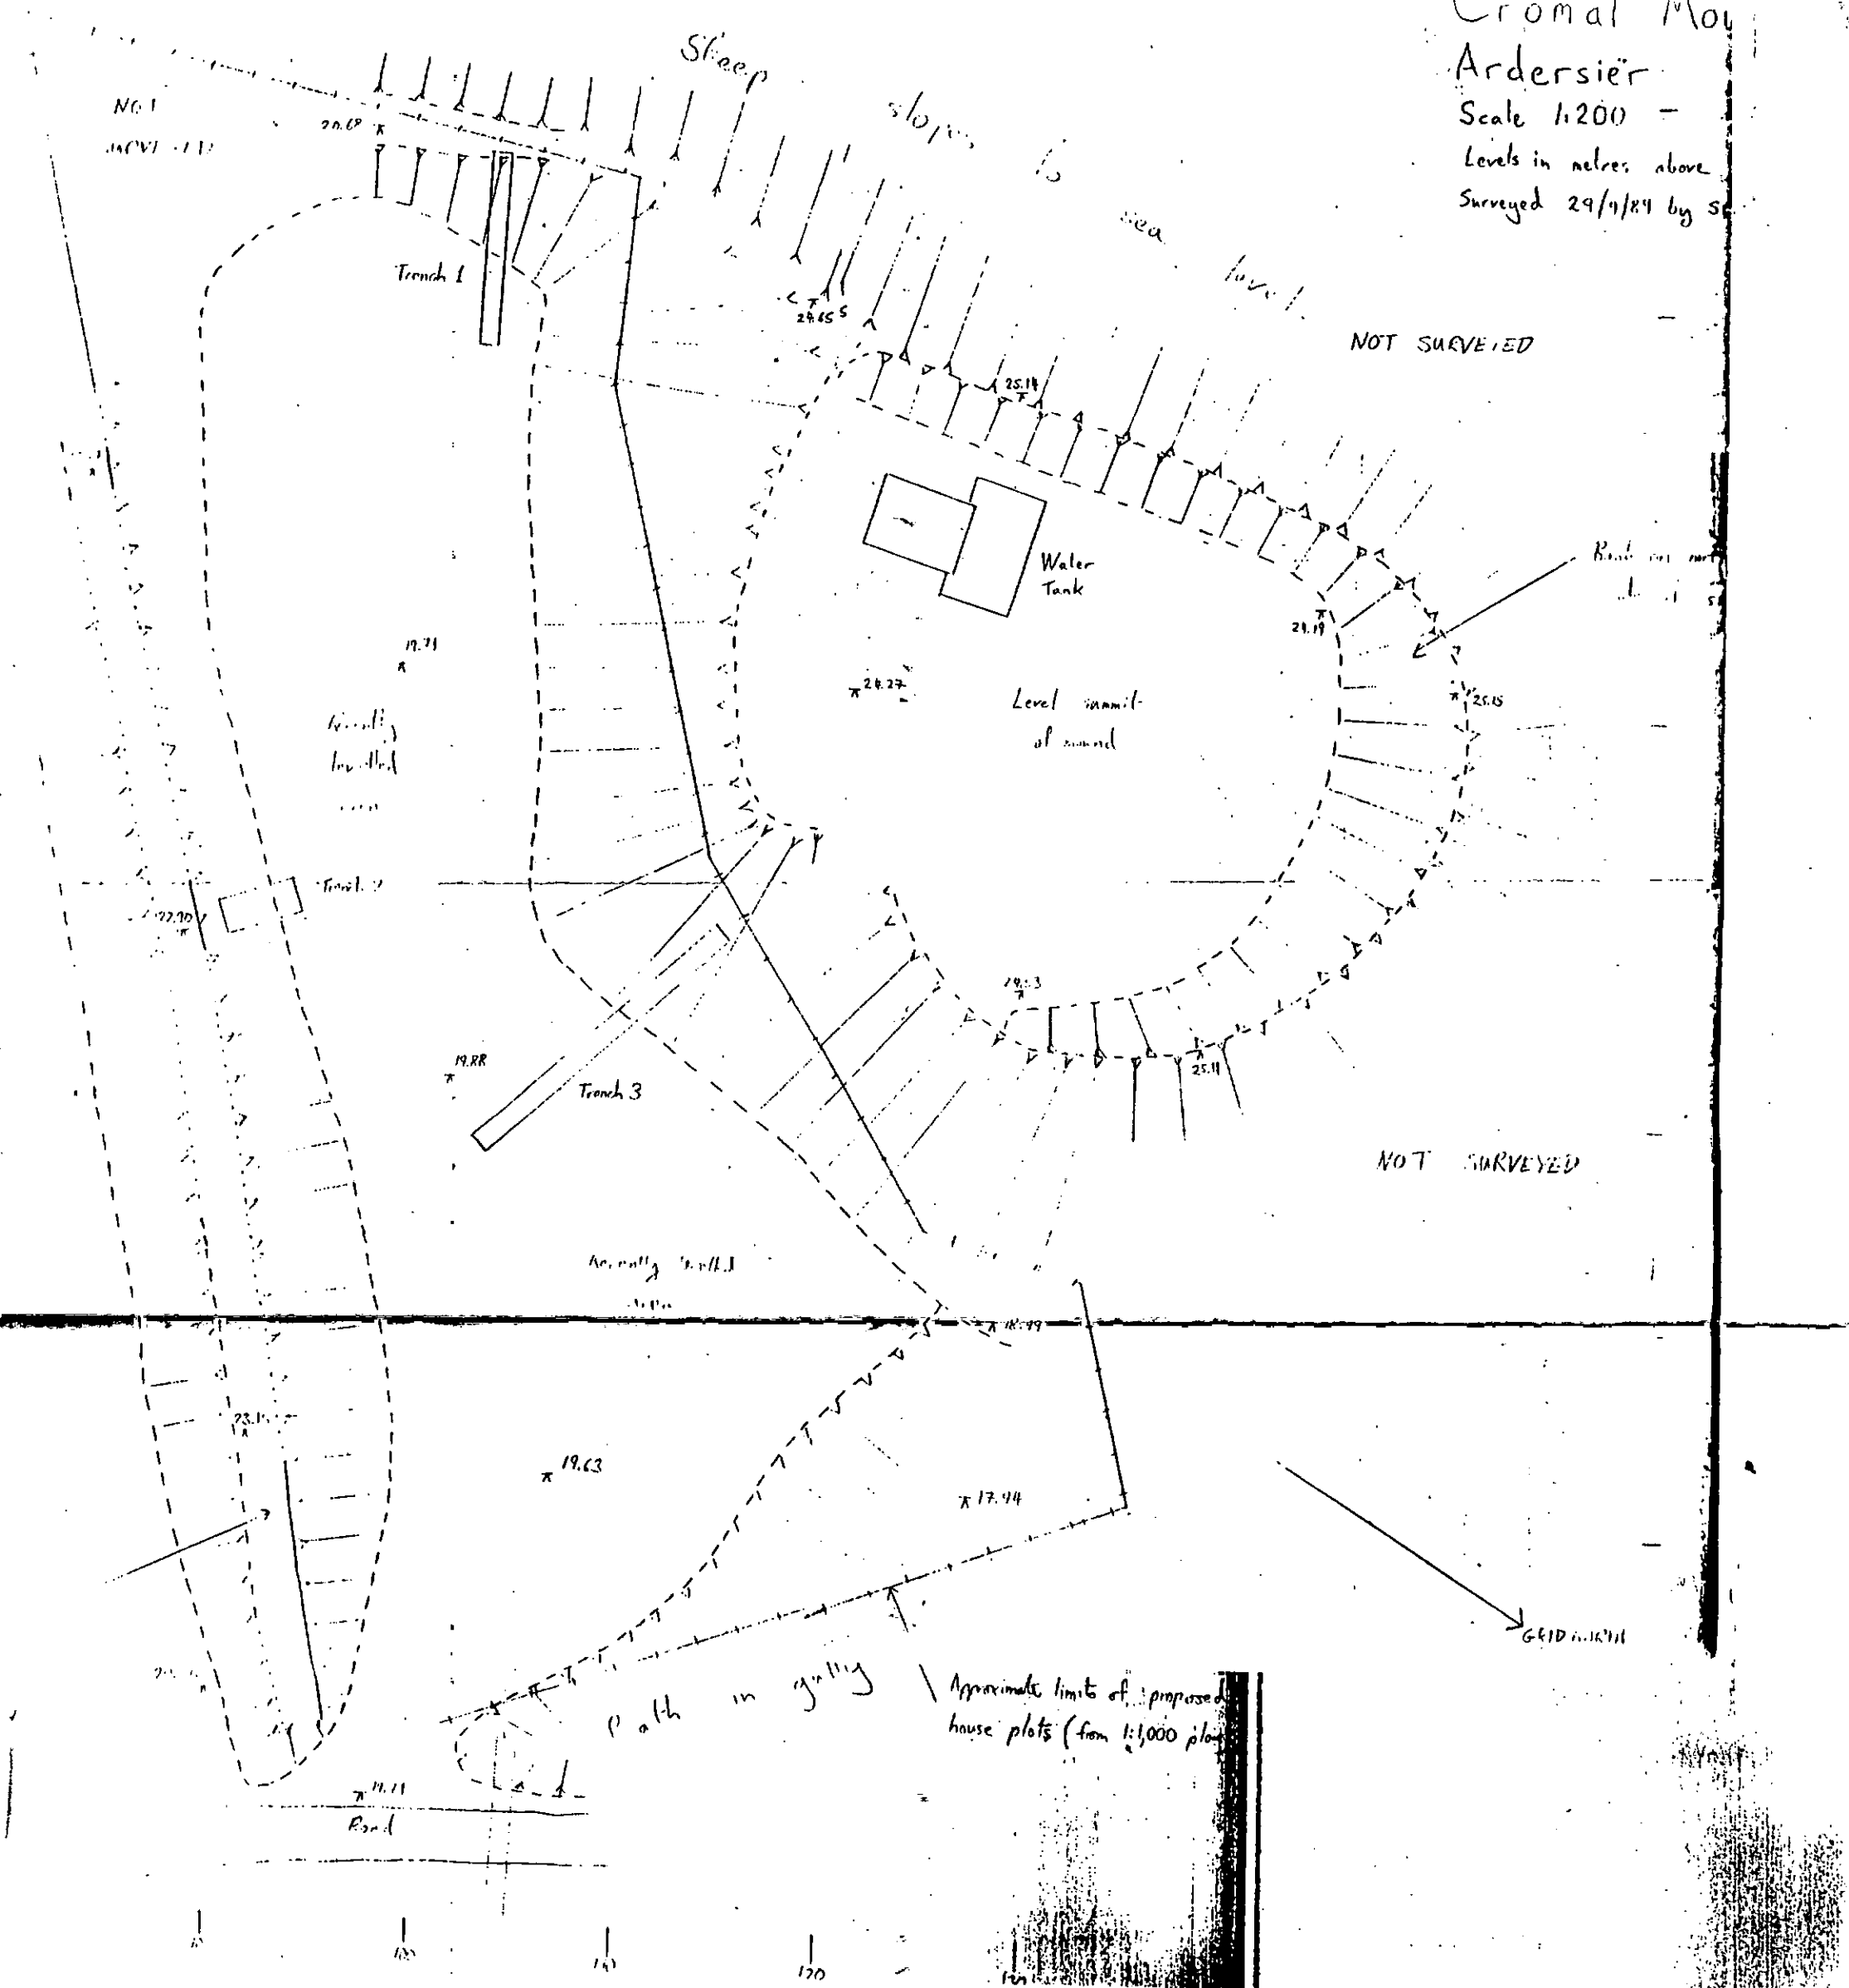
Surveyed 29/9/84 by S

The site was partially surveyed and levelled using an EDM at a scale of 1:200. Dense, tall gorse made a complete survey impossible but the main elements of the site were plotted. The survey was not located on the national grid or related to Ordnance Datum.

Three trenches were excavated by JCB using either a 3 ft toothed bucket or a 5 ft toothless. These were selected to examine the nature and stratigraphy of the various features in the area affected by the planning application. They are located on the site plan:

Trench 1: Section of apparent bank linking the main bank to the mound.

Trench 2: Section of main bank and stone dyke.

Trench 3: Section of mound and adjacent levelled area.
