**Report of Archaeological Watching Brief
September 15th – 27th 2003
Corrieyarrack Pass, Inverness
NH 374/071 - NN 462/961**

Client: Scottish and Southern Energy Plc

This report is for an archaeological watching brief conducted for Scottish & Southern Energy Plc by the author for a project of reinstatement works on the Corrieyarrack Pass, Highland.

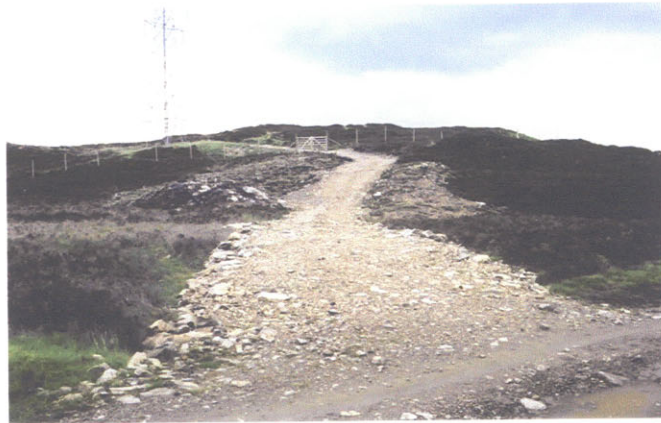
1 – Access Point to Pad 1

Top: View of access road before work commenced.

NH 37609/04931 to NH 37784/04974. Former access road to pad 1 for length of 85m. Road narrowed to 3m, especially at access point. Edges of road narrowed, turfed and seeded.

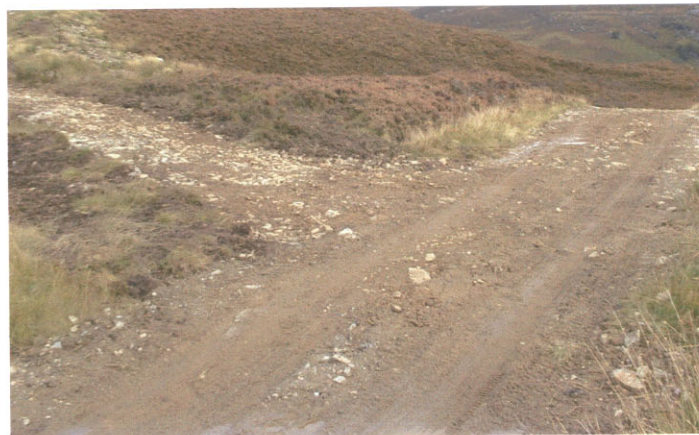
Centre: View of access point upon restoration.

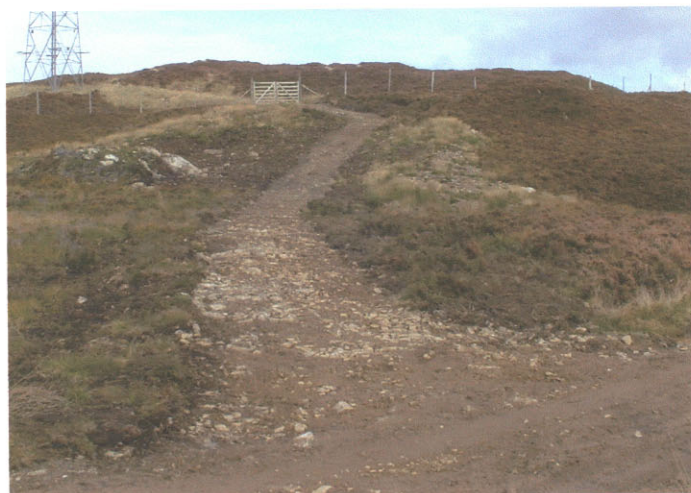
Below: View of road upon completion of work.

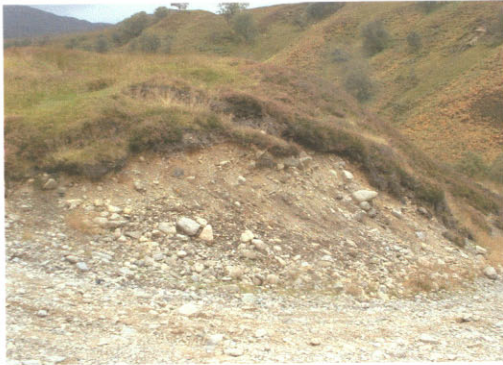
2 – Corner above Bailey Bridge

Left: View of corner before restoration.
Right: View of new installed cross drain.
Centre: View of corner after restoration.
Below: View of new drain facing E.

NH 38994/00724 – Work involved restoration of bank of corner which continued flooding was causing further erosion. A new box drain was installed replacing an existing wooded drain that had become blocked, with a new drain for 20m inserted to carry water away from the corner that is being undermined. Material from corner taken and put down on road, area spot turfed and seeded.

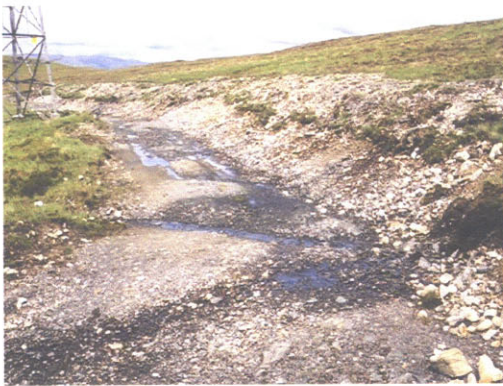
Top left: View of access road before restoration.

A – NH 39551/00262 to NH 39543/00309 - existing access point to pad 3. Material taken from south side and graded back into 'natural' slope. Are spot turfed and reseeded.

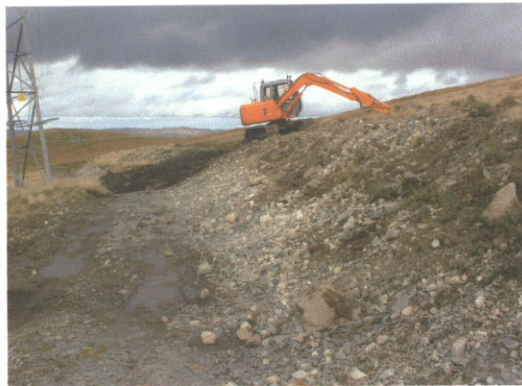
Top right: View of work in progress.

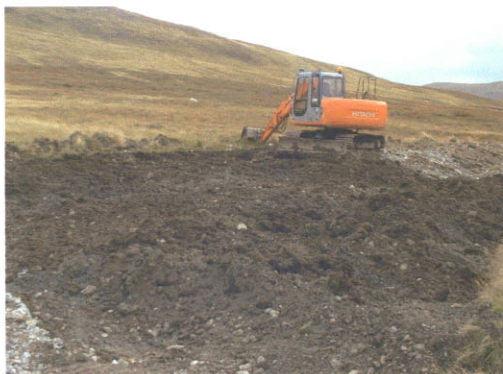
Bottom left: View of work in progress.

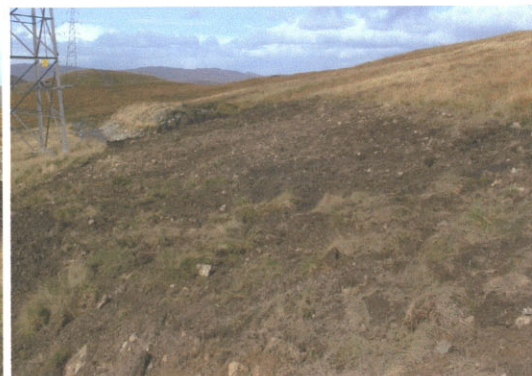
Bottom right: View of site upon completion.

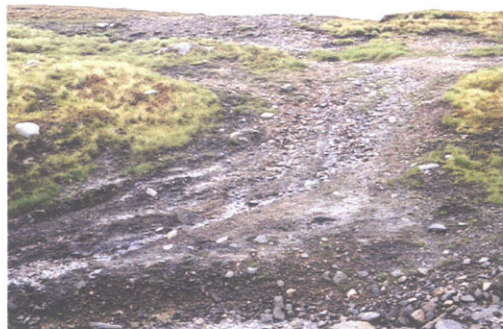
Left: View of access point before restoration.

B – NN 40331/99505 - existing access point used in July 2002 for Optic cable works with burrow pit. Burrow pit landscaped with material from edge, spot turfed and seeded.

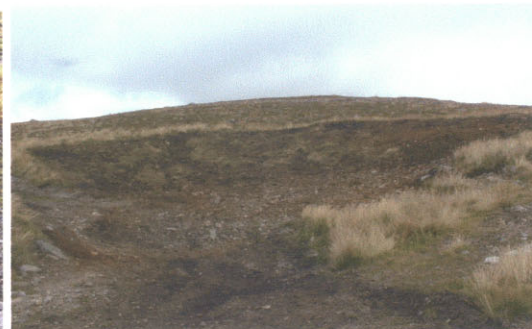
Right: View of site upon completion.

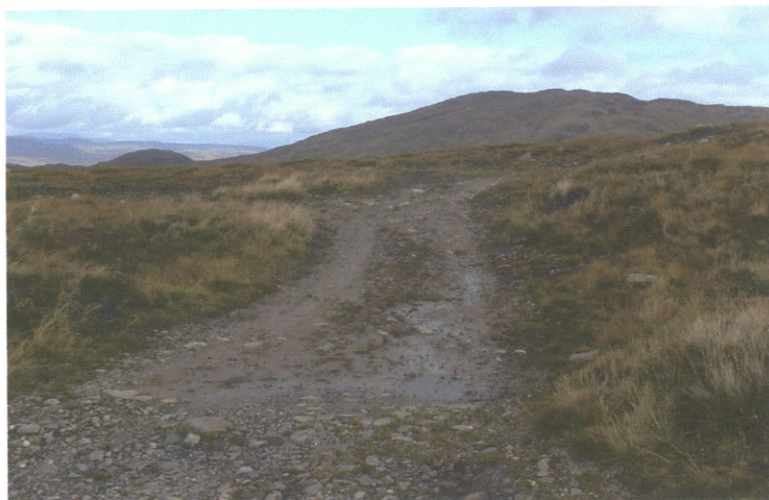
C – NN 41096/98863 – existing access point used in July 2002 for Optic cable works. No work carried out as still in use by Estate.

Below: View of site September 2003.

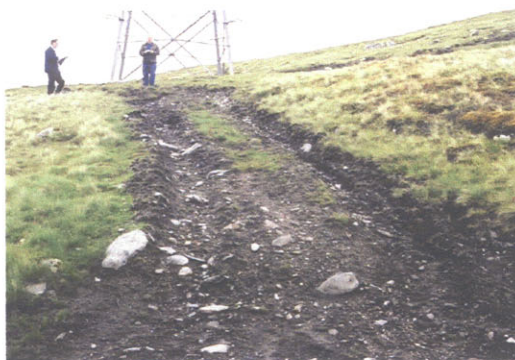
4 – Access Point

Left: View of access point before restoration.

NN 41219/98753 – area landscaped with straight edged bucket and reseeded.

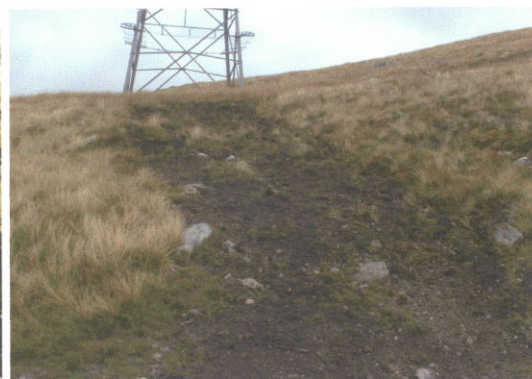
Right: View of site upon completion.

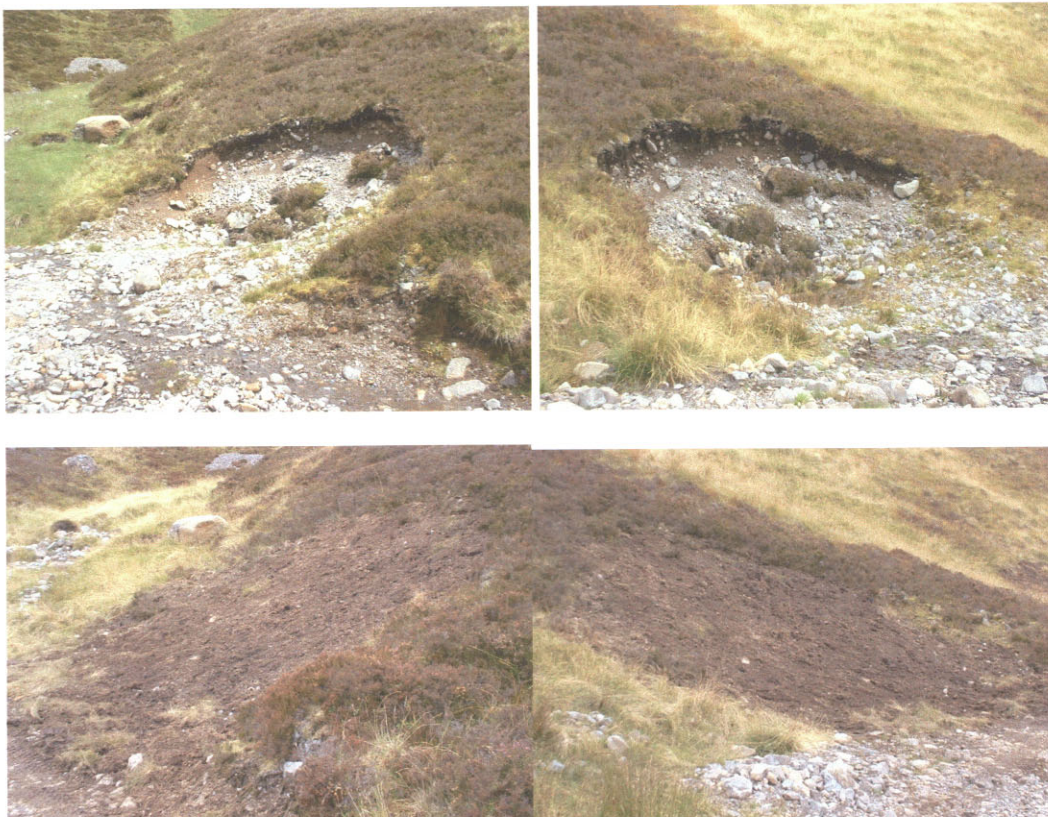
Top left: View of burrow pit before restoration facing NE.
Top right: View of burrow pit before restoration facing SE.
Bottom left: View of site upon completion facing NE.
Bottom right: View of site upon completion facing SE.

A – Burrow Pit – NN 44258/97654 – burrow pit by east side of road. Material from pad used to infill hollow, raked and seeded.

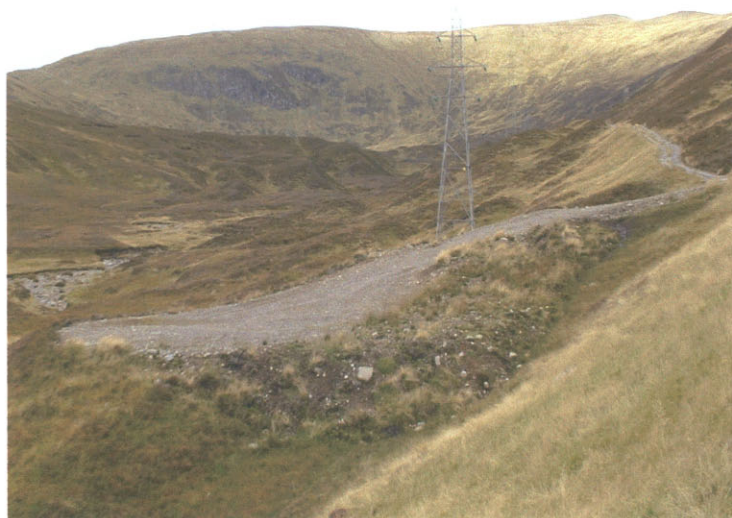
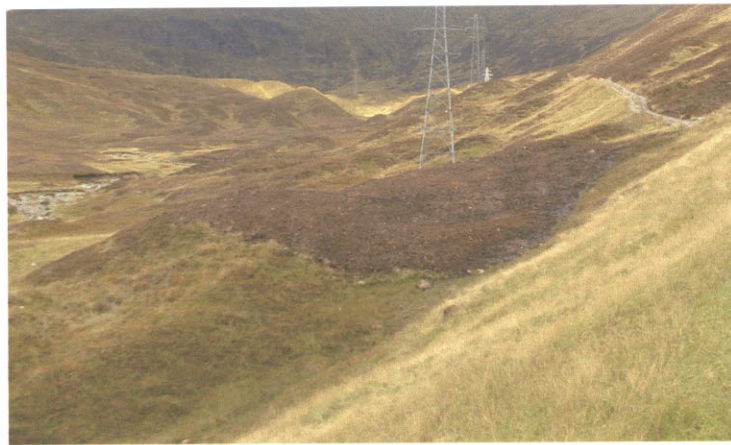
Top: View of pad before restoration.
Below: View of site upon completion.

B – Pad – NN 4425/9759 – pad number 4 – material around used to reform 'natural' knoll. Area spot turfed and reseeded.

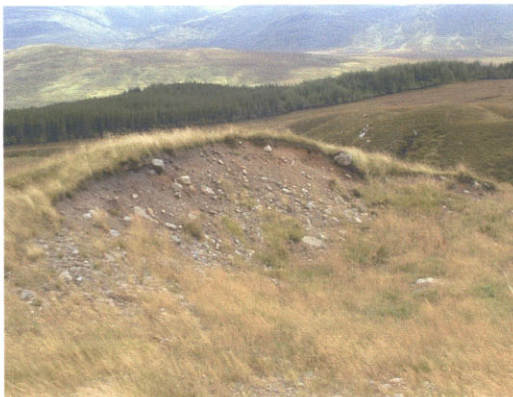
Top left: View of site before work started.

NN 4485/9644 – material from edge including turf taken to grade bank, area spot turfed and reseeded.

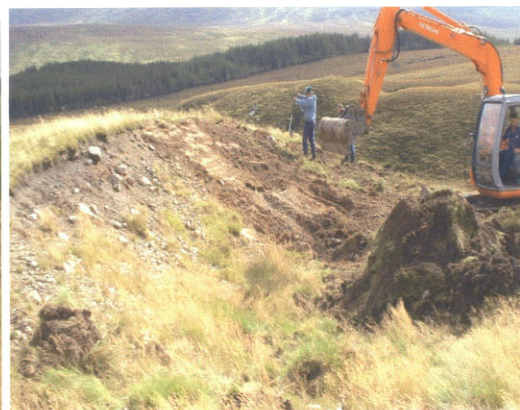
Top right: View of work in progress.

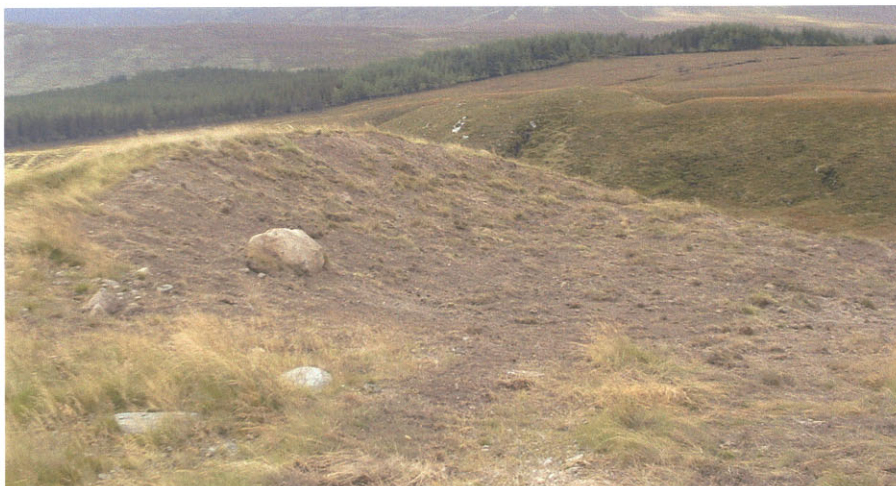
Bottom: View of site upon completion.

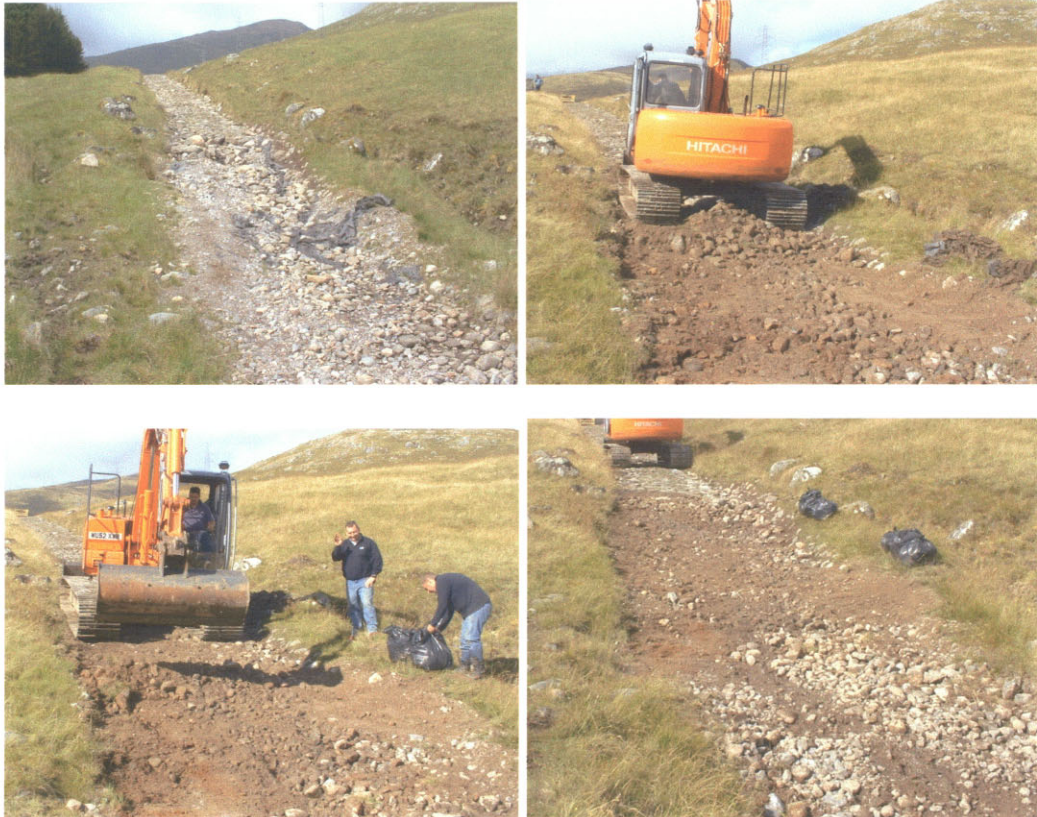
7 – Road at Melgarve

Top left: View of road before removal of terram.

Top right: View of machining in progress of regarding material.

Bottom left: Grading of road and removal of terram by hand.

Bottom right: View of road upon removal of terram.

NN 45973/96186 – washed out material graded with straight edged bucket by back-acting machine, with terram removed by hand.
