# **New House on Croft 5, Balmeanach, Glenhinnisdal, Isle of Skye**

## **Archaeological Recording and Evaluation**

Planning Ref.: (SL-07-147)

AALS Report No. 184

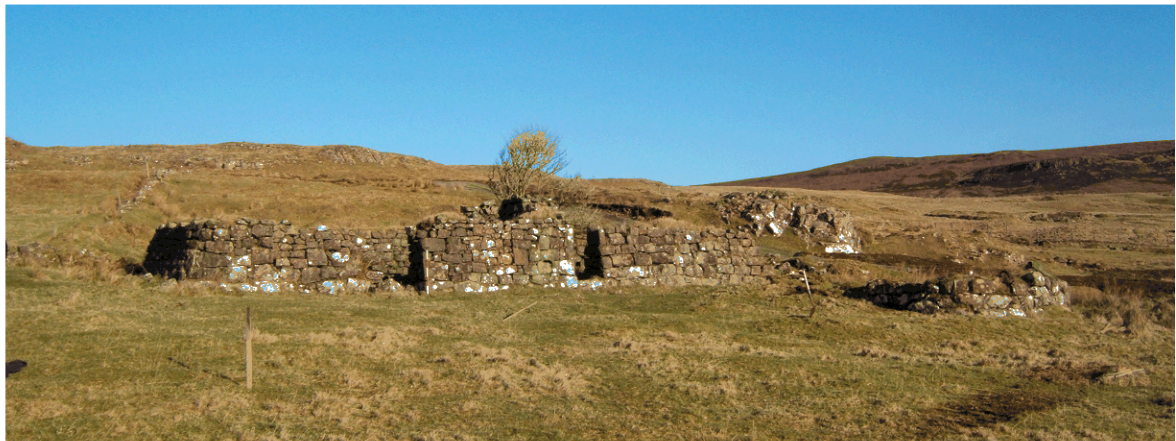
Illus. 1 : The development site viewed from the south.

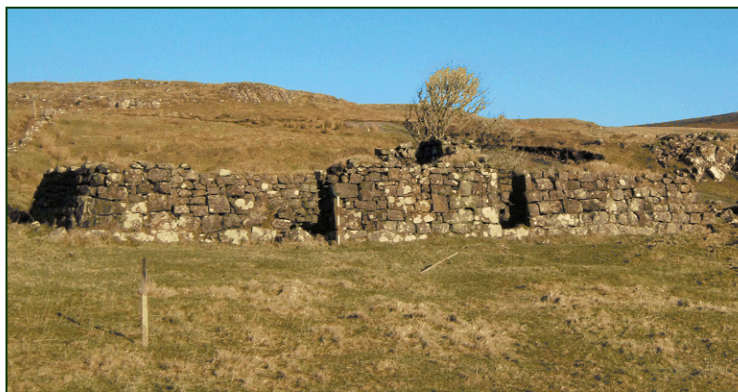
Illus. 5 : The House/Store/Kiln-barn complex viewed from the south. Scale = 1 meter

The house faces to the SE, it is stone built and of one build with the store and kiln-barn. It measures 7.40m by 3.80m internally with gable ends 1000mm thick and side walls 900mm thick. Remains of poor quality lime based mortar can be seen between the wall-stones. The walls are round cornered externally and square cornered inside. The north and south walls and west gable wall generally stand to their full height of 1.60 meters, the east gable stands to 1.90 meters with the upper part collapsed into both the house and store. This mix of gable types indicates that the roof was hipped at the west end. The east gable contains a central fireplace measuring 900mm square and 600 mm deep. The flue rises vertically through the gable. A centrally placed door and two windows, (one either side of the door), survive in the south facing wall. The door opening measures 1100mm wide the windows 700mm wide inside and out by 1200mm high. Both windows are now blocked by dry stonework perhaps indicating that the building was used as a sheep pen after it lost its roof. The NW corner of the house has collapsed.

The store faces to the SE, is also stone built and of one build with the house and kiln-barn. It shares its west wall with the east wall of the house. The store measures 5.30 by 3.80 meters internally. The north & south walls are 900mm thick, the east wall, which it shares with the kiln-barn, is only 600mm thick. The walls of the store stand to wall plate all round (circa 1.60 meters). A door opening 900mm wide lies in the south-west corner. A large tree is growing in the centre of the west end of the store.

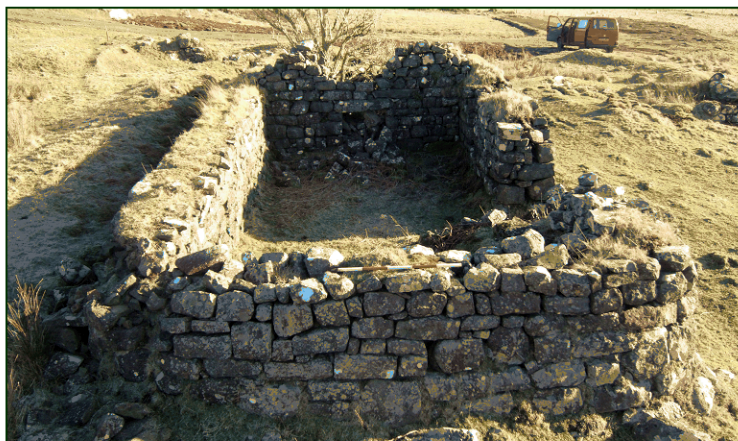
Illus. 6 : The house viewed from the west end. Scale = 1 meter

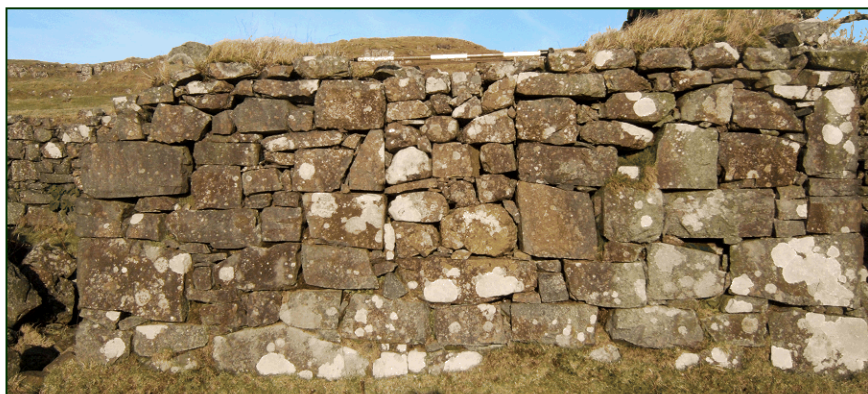
Illus. 7: The blocked window to the east side of the house door. Scale = 1 meter.

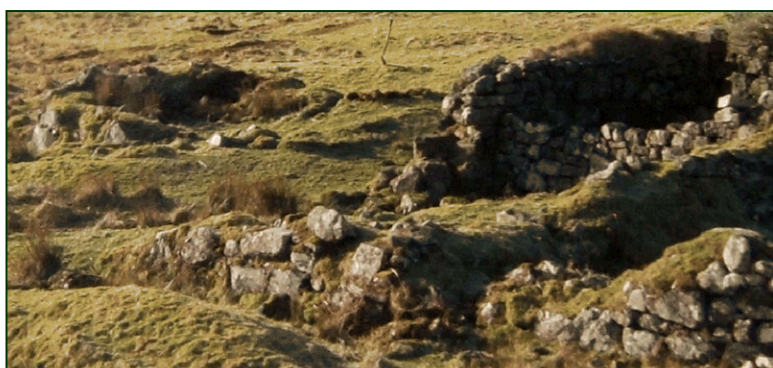
Illus. 8: The kiln-barn and byre viewed from the north-east.

The kiln barn is also stone built and is of one build with the house and store. The western end of this structure is preserved to wall plate height, the remainder is reduced to foundation level. Internally the kiln-barn measures 5.75 by 3.60 meters, with side walls and end gable 900mm thick. Due to the ruinous state of this end of the building it is not possible to say if it was hipped or gabled, however the reduced thickness of this gable (900mm) may indicate a hipped gable end. Set within the north-east corner of this building is a grass covered, stone built, platform which is now part covered with debris from the collapsed east gable. This platform which measures 3 meters long by 1.40 meters wide has a circular hollow 1.20 meters in diameter at its east-end.

This platform has been interpreted as a corn-drying kiln. Access to the kiln barn is via a 2.50m wide door opening, the footing of which are just visible in the ruinous south wall.

The byre, which lies immediately to the south of the store, is reduced to just a few courses of grass covered stonework. This structure measures 6.40 by 4.40 meters over walls circa 800mm thick. The walls appear to be stone faced with a rubble-stone core and nowhere stand to more than 800mm high. A possible door opening lies 1000mm from the north end of the east wall. Immediately to the east of the byre, and fronting the kiln barn, is a small enclosed yard surrounded by low earth banks. There are degraded openings into this yard on the east and south sides.

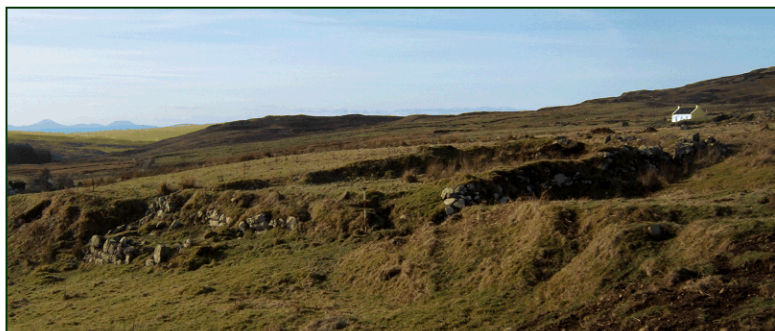
Illus. 9: The kaleyad viewed from the east.

The kaleyad which lies some 11 meters to the south-east of the byre is almost playing card shaped measuring, at maximum, 17 meters north-west to south-east by 10.20 meters north-east to south-west. The walls of the kaleyad are 1 meter thick and consist of earth built banks with a stone facing to the outer side. A shallow drainage ditch runs around the west, north and east sides of the kaleyad. A stone-faced entrance 1 meter wide lies in the centre of the north-west facing wall (facing the house). There are no discernible features within the yard. Attached to the outer face of the south-east wall, and visible in illus. 9 & 10, is a revetted platform or perhaps a small enclosure which measures 5.25 meters by 2.40 meters overall.

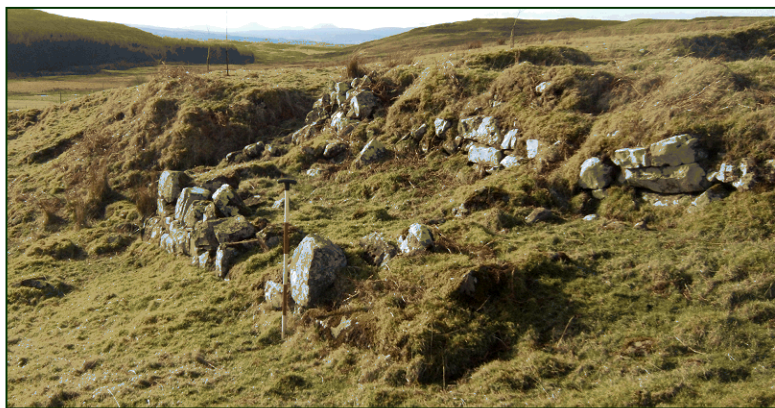
Illus. 10: The platform/enclosure attached to the south-eastern side of the kaleyad.

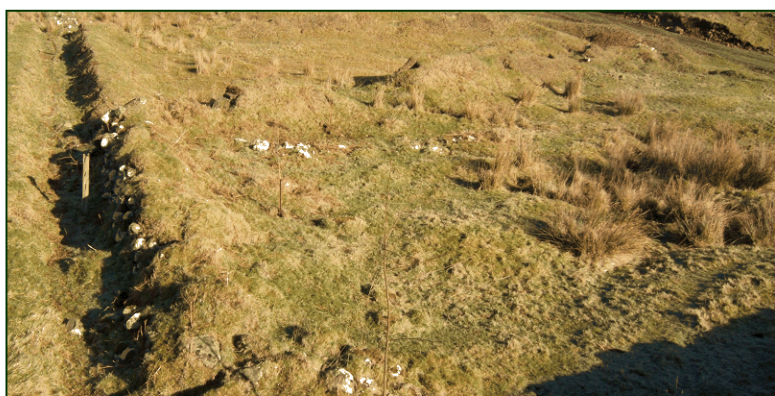
Illus. 11: The stackyard and attached enclosure lying adjacent to the croft boundary.

A stackyard, which measures circa 26 meters by 20 meters, lies immediately to the north of the house/store/kiln-barn complex. This yard is enclosed by a stone faced earth bank circa 1.20 meters wide which still stands to a maximum of 1.20 meters high. Degraded entrances circa 2.meters wide lie in the east and north facing sides. Two, stone-based, stack stands circa 3.00 meters in diameter, lie in the north-west corner of the stackyard. A number of other raised platforms of uncertain use lie within the stackyard. A small enclosure, with an entrance on its east side is attached to the north side of the stackyard. The enclosure dyke is constructed entirely of earth and measures a maximum of 600mm high and 1.30 meters wide at the base.

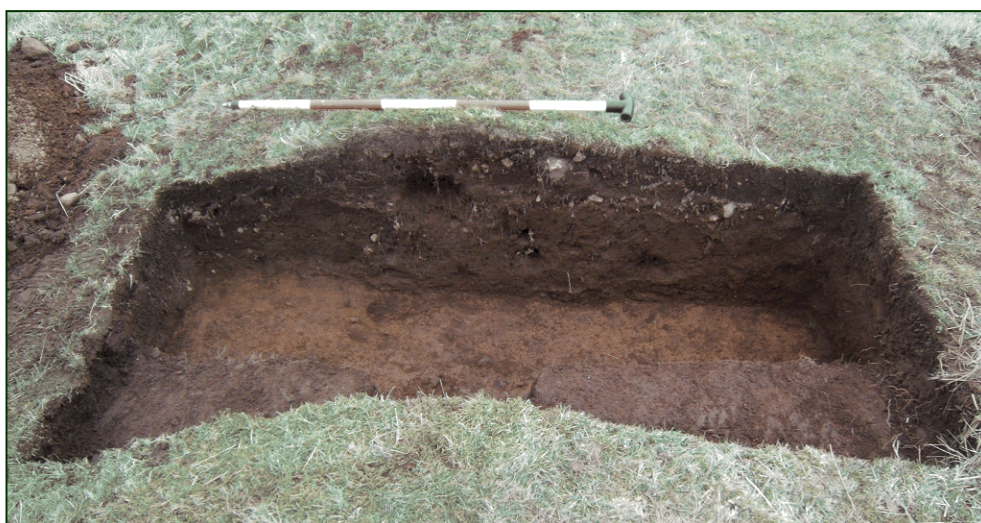
Illus. 13: The eastern section of Trench Hin.01. Scale = 1 meter

Illus. 14: The eastern section of Trench Hin.01

A 1 meter by 2 meter trench was placed across the most prominent part of the yard earthwork exactly 4 meters from its western end. Three contexts were recorded in the trench:

- Context 1.01 A black/brown friable loam containing few stones.
- Context 1.02 A brown, compacted loam containing few stones.
- Context 1.03 A very compact, orange, clayey subsoil containing iron pan and small Stones.

Context 1.01 appears to be a dump of redeposited topsoil that has been placed on the top of C.1.02, a former, and now buried ground surface. The single find - the upper part of a mould blown wine bottle - provides a terminus post quem for the deposition of the bank. The mould blowing of glass bottles was not invented until 1860\*, placing the deposition of this bank of earth at no earlier than 1860. The bank butts up to and therefor post-dates the byre.

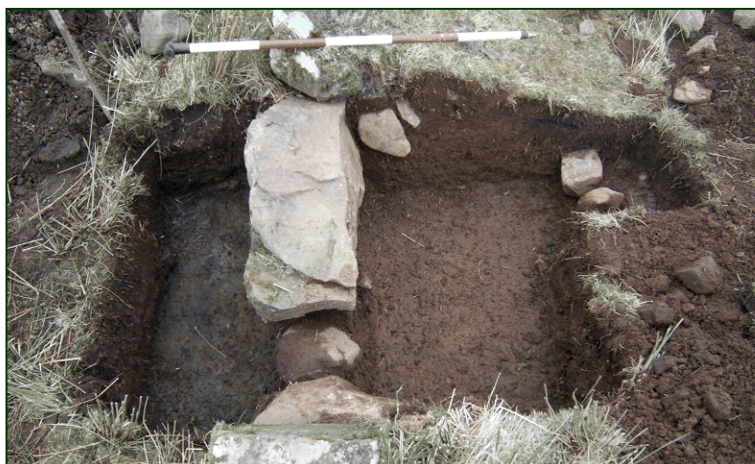
Illus. 15: The north-east section of Trench Hin. 02. Scale = 1 meter.

Illus. 16 & 17: Plan and NE section of Trench Hin. 02

A 1 meter by 2 meter trench was placed across the north-west wall of the kaleyard 1.5 meters to the south-west of the entrance. Five contexts were recorded in the trench.

- Context 2.01 A friable black/brown loam containing few stones.
- Context 2.02 A compacted black/brown loam containing few stones. Retained by a stone facing on its north side and a single boulder kerb on its south side. A very thin layer of coal dust separated this context from Context 2.01
- Context 2.03 A black, gloopy, peaty earth containing iron pan stains.
- Context 2.04 A buff/brown compacted loam containing few stones.
- Context 2.05 The local dolomitic bedrock.

Context 2.02 appears to be a thrown up bank of topsoil that has been faced with large stones on its north side and retained by a kerb on its south side. Below Context 2.02 is a small strip of pre-bank ground surface, (Context 2.04) which has been preserved by the later feature. To the north, outer side, of the stone-faced bank is a drainage ditch that has been cut down to the bedrock. This ditch has gradually filled with a wet peaty deposit (Context 2.03). The fragments of green mould blown glass bottle once again provide a terminus post quem (1860) for the construction of the bank and therefor the Kaleyard. The stoneware marmalade jar from a primary position in the drainage ditch, (mid 19<sup>th</sup> to early 20<sup>th</sup> century), corroborates this date.

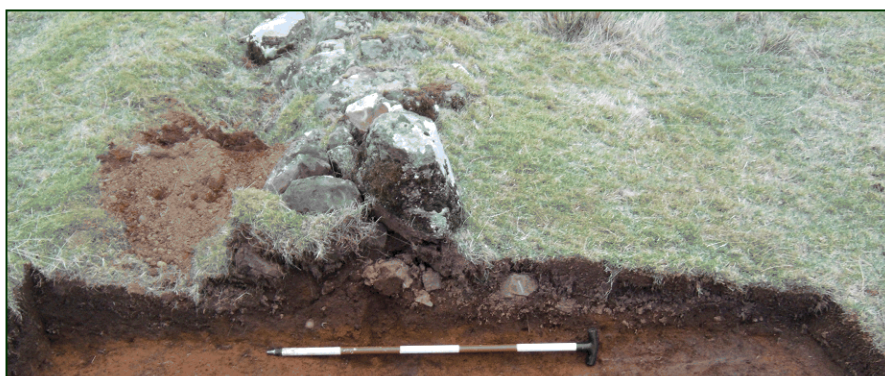
Illus. 18: The northern section of trench Hin.03. Scale = 1 meter.

Illus. 19: The northern section of Trench Hin.03.

A 2.80 meter by 1.00 meter trench placed across the line of the western croft boundary. This trench was cut by an excavator with a 1.00 meter wide straight edged bucket and then cleaned by hand. Five contexts were recorded in the trench.

Context 3.01 appears to be a low, marker bank constructed of stones and soil which has been thrown up on an existing and now buried ground surface (C.3.04). Subsequently plough soils have accumulated on both sides of the bank (Contexts 3.02 & C.3.03).

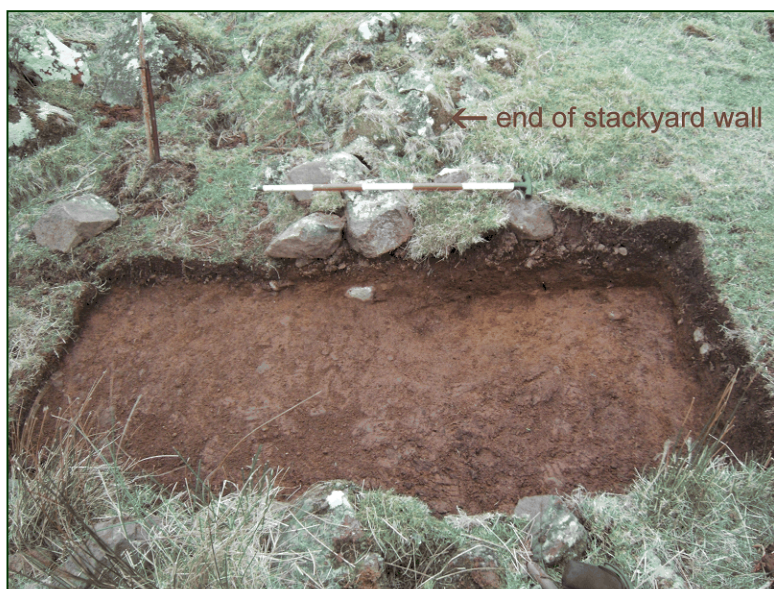
Illus. 20: The north-west section of Trench Hin.04. Scale = 1 meter.

Illus. 21: The north-west section of Trench Hin. 04

A 2.50 meter by 1.00 meter trench placed across the point where the stackyard boundary appears to abut the north-west corner of the house/store/kiln-barn complex. The line of an oil feed pipe is due to cut the boundary at this point. This trench was also cut with an excavator and cleaned by hand. There were no finds from this trench. Two contexts were recorded in the trench:

The stackyard enclosure wall does not appear in this trench. Context 4.01 represents a continuous build up of loam over time. The corner of the house has then collapsed on to this surface. On closer examination the stackyard wall can be seen to end 2 meters from the corner of the house creating a gap allowing access to the stackyard.

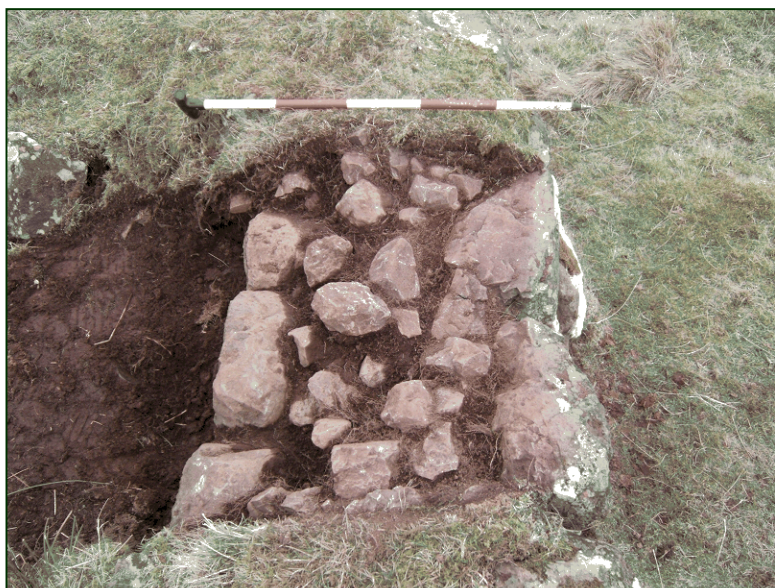
Illus. 22: The cleaned section of byre wall viewed north to south. Scale = 1 meter.

Illus. 23: Plan view of excavated section of the byre wall .

A 1 meter square cut to allow cleaning of a section of the byre wall without disturbing the remains. Two contexts were recorded.

The wall of the byre is 850mm wide and well constructed having two faces of part dressed dolomitic stone with an earth and stone filled core. The midden, which overlies the remains of the wall, contains pottery and glass with a possible date range circa 1<sup>st</sup> quarter of the 19<sup>th</sup> C. (Pearlware and Spongeware) through to 1<sup>st</sup> quarter of the 20<sup>th</sup> C. (Inkbottle). It would appear that the byre was in ruins and being used as a convenient rubbish dump prior to the abandonment of the farmstead. The 1903 OS map (see illus. 3) which shows the byre as roofless adds weight to this assumption.
