Archaeological Report

Halcro, Bower Caithness

Report No.	HAS080301
Project code	HAS-HCB07
Client	N Clyne
Planning Ref	CA-06-663
Date / revision	15 June 2008
Authors	Paul Humphreys and John Wood

A watching brief was carried out on site clearance and excavations for foundations, services and drainage at Halcro, Bower, Caithness. No archaeological finds or features were identified and no further work is recommended.

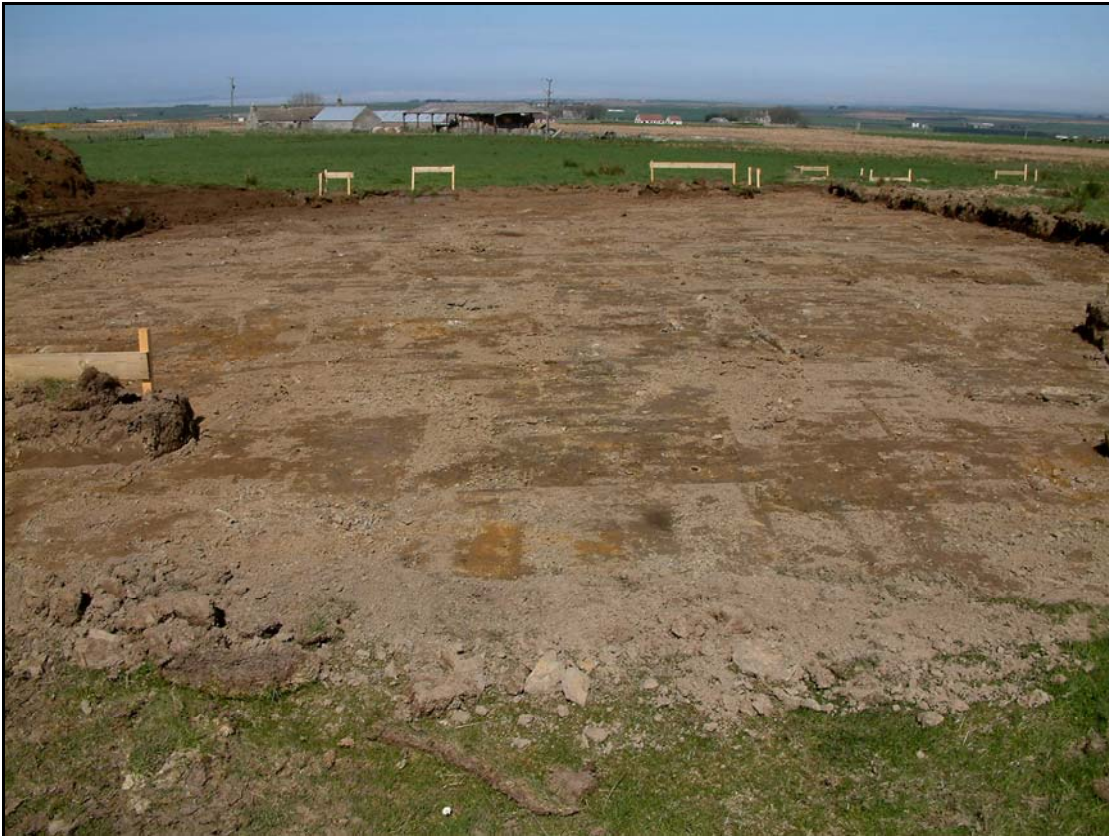
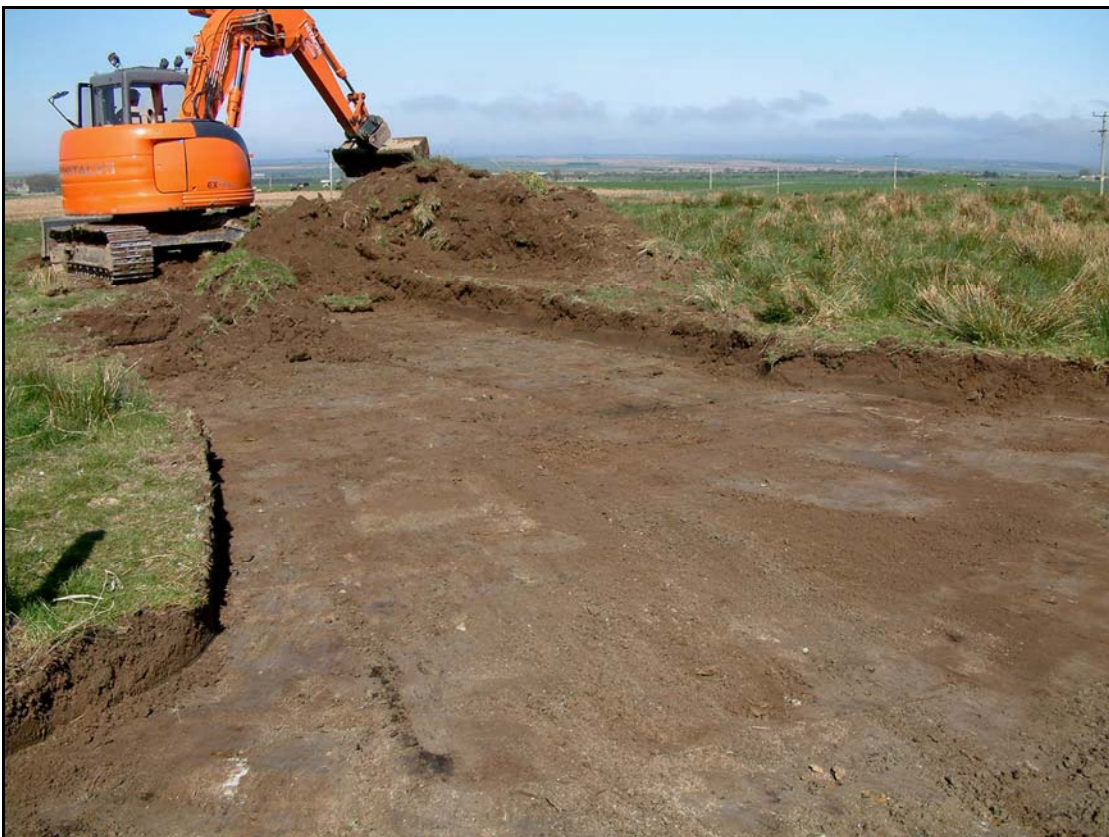
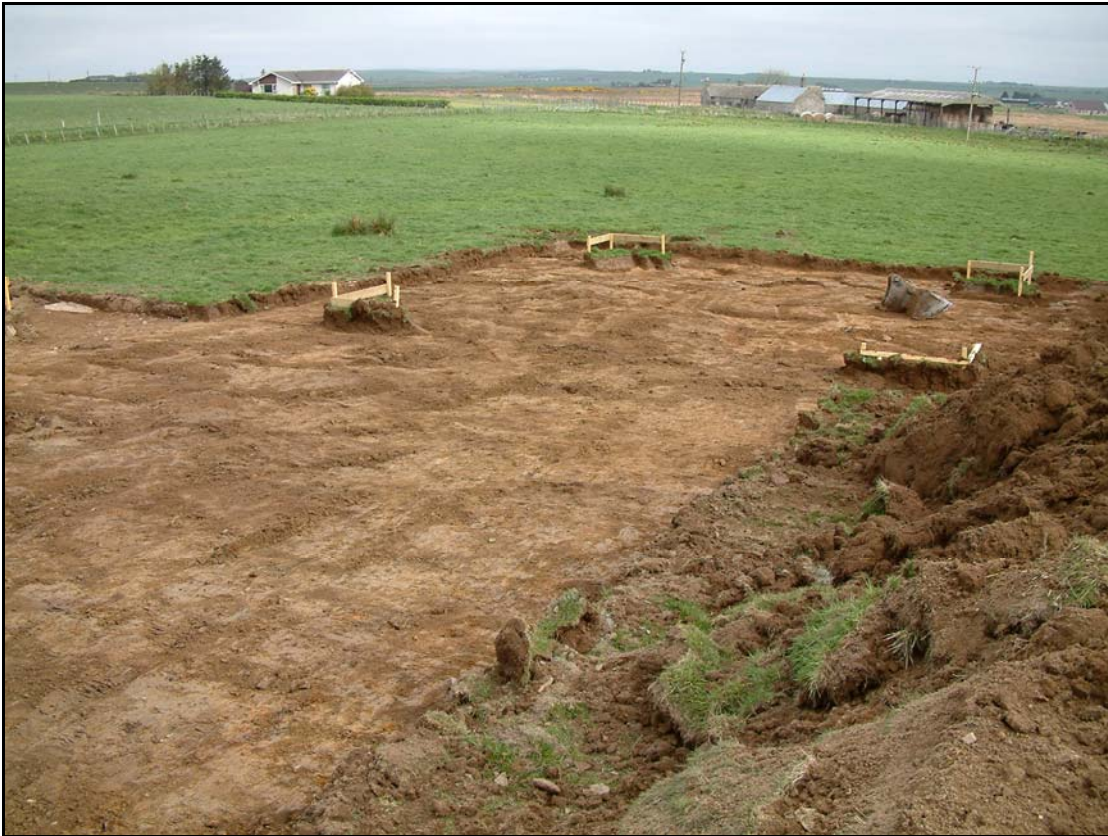
The observed site preparation work included the removal of the top soil over the area of the house base, workshop base and driveway (plates 1, 2 and 3). The revealed soil profile over the stripped area comprised 20 to 30 cm of top soil overlying oxidised till (plate 4) containing occasional cobbles and large slabs all of glacial origin. Conversation with the farmer confirmed that the land had not been ploughed for many years and there was no visible evidence for modern or ancient ploughing in the exposed till surface.

Photo No.	Notes	Taken by	Date
1	Stripped house area	PDH	30/04/2007
2	Stripped drive area	PDH	30/04/2007
3	Stripped workshop area	PDH	30/04/2007
4	General soil profile	PDH	30/04/2007
5	Slab detail	PDH	30/04/2007
6	Slab detail	PDH	30/04/2007
7	Colour change	PDH	30/04/2007
8	Dark flecks	PDH	30/04/2007
9	Foundation trench looking north	PDH	01/05/2007
10	House foundations looking south	PDH	01/05/2007

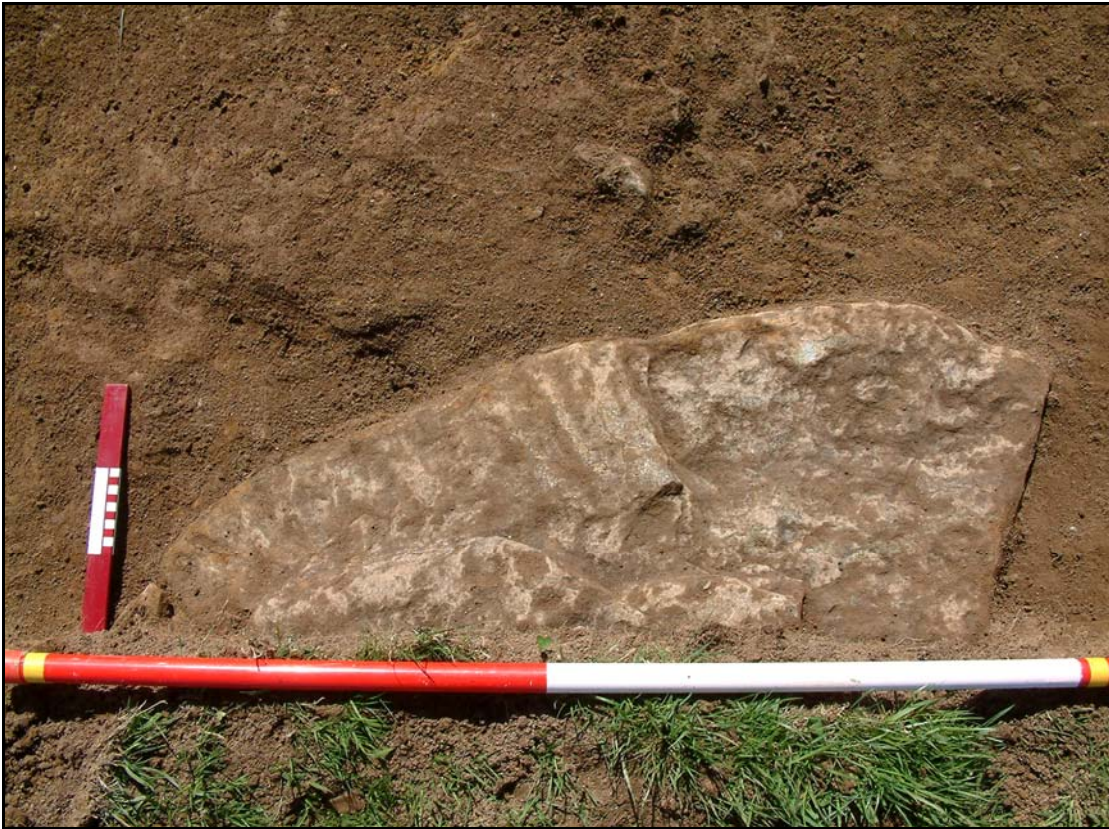
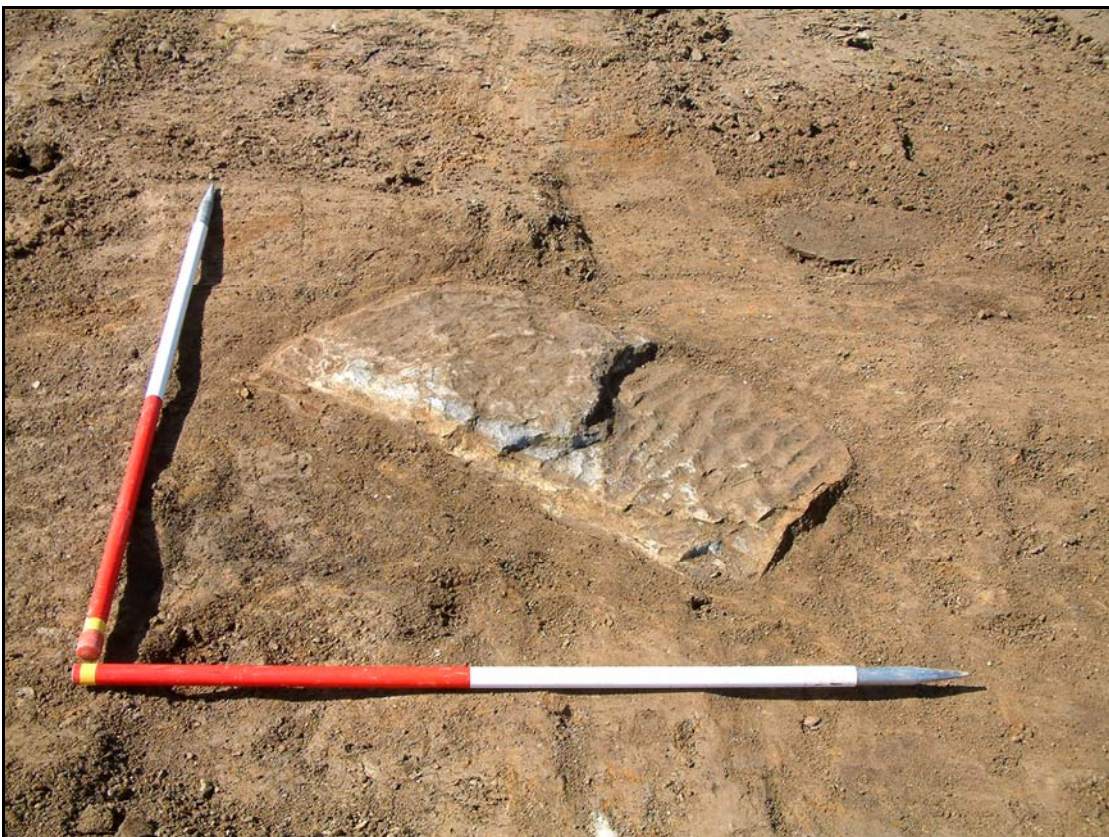
Two flat slabs, high in the soil profile on the till surface, were investigated (plates 5 and 6); no cut or other soil disturbance could be detected and they were interpreted as having no archaeological significance.

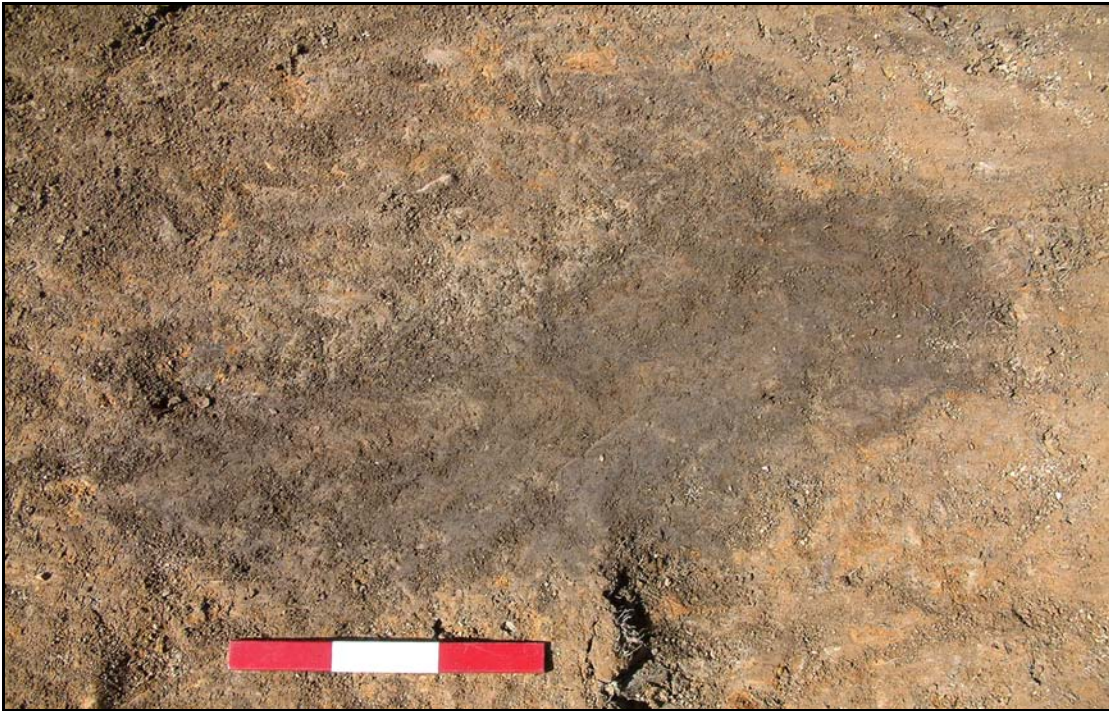
Plate 7

A small discrete area of colour change on the till surface was also investigated (plate 7). It lacked the coherence of form that might have indicted an anthropogenic interpretation. An old animal burrow was the most likely explanation.

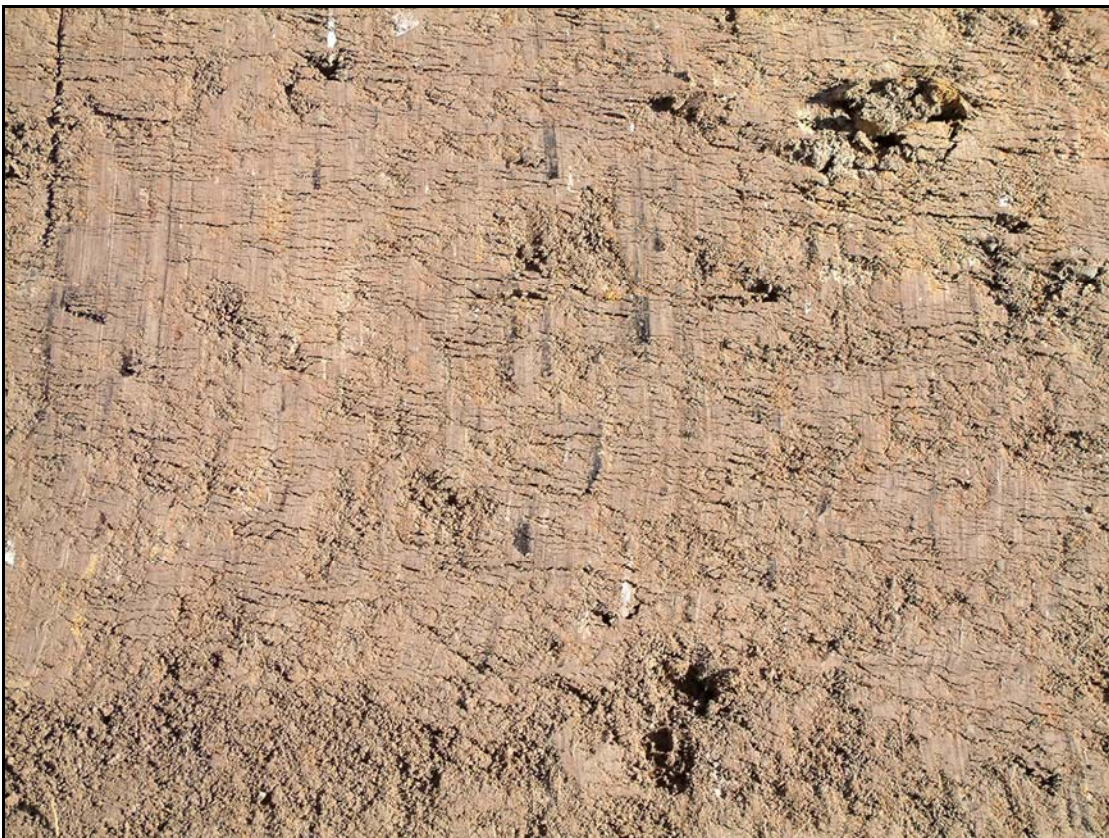
Plate 8

Dark flecks (plate 8) on the till surface and in the soil section that had the superficial appearance of organic matter or charcoal proved, on close inspection, to be derived from decayed oil-shale that occurred in elsewhere on the site as large fragments.

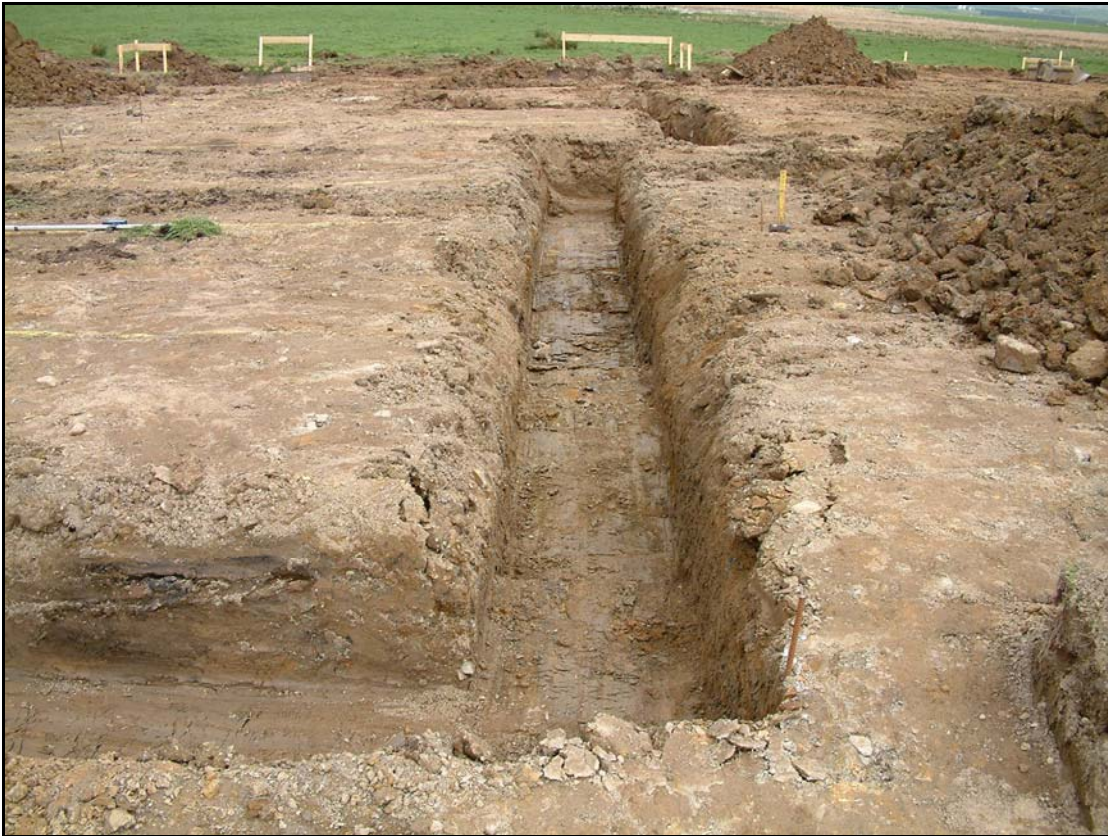
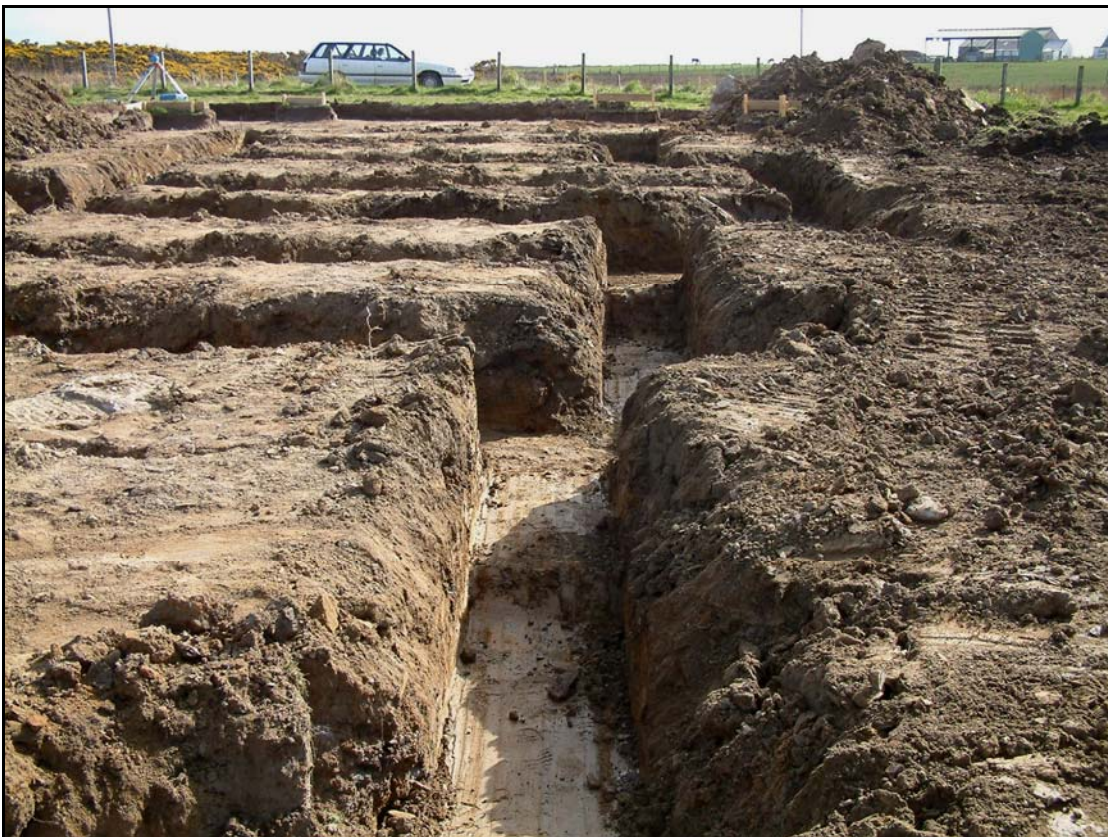
The percolation test pit demonstrated that the thickness of the till at least 2 metres; it contained occasional large boulders and slabs of glacial origin. The cutting of the building foundation trenches indicated that the nature of the till was uniform over the site. There were no indications of anything of archaeological significance (See Plates 9 and 10 above).
