## *Archaeological Evaluation at*

*new housing development - east of Invergordon Golf Course,  
Planning Application RC-06-1153,  
Highland Council Archaeology Unit brief 03/09/07  
Aspire Project UID HH 2008/07*

**Report on Archaeological Evaluation east of Invergordon Golf Course, Planning  
Application RC-06-1153, Aspire Project UID HH 2008/07**

**Archaeological Evaluation at housing development east of Invergordon Golf Course,  
Planning Application RC-06-1153, Aspire Project UDI HH 2008/07,  
as detailed in a brief by Highland Council Archaeology Unit (03/09/07).**

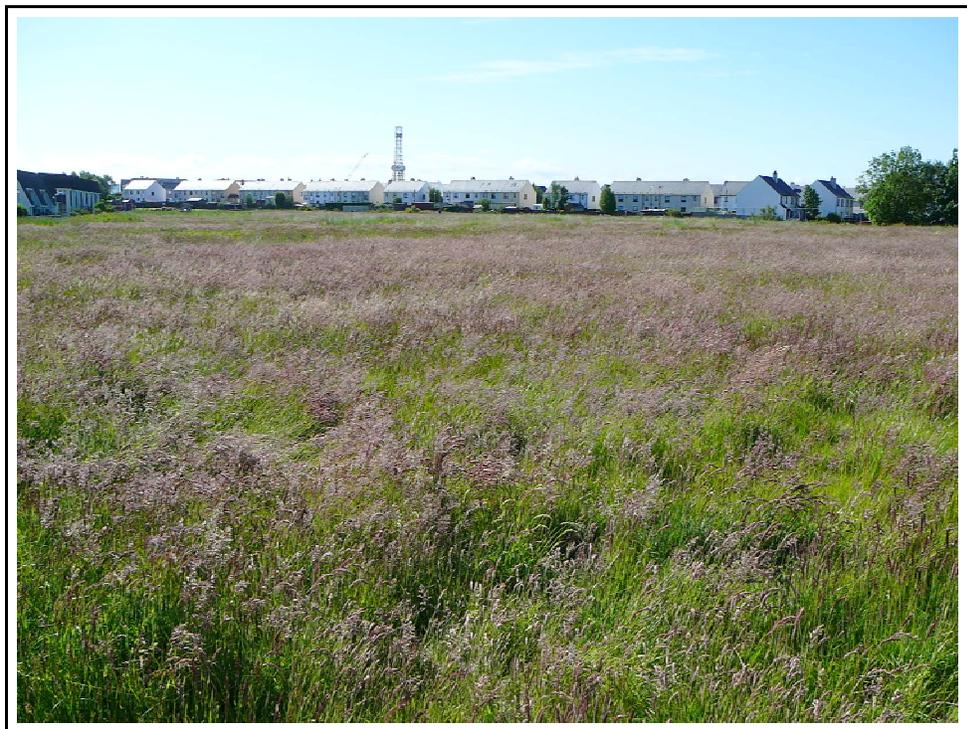
**Figure 6 - photograph 1 ( also CD photos 1-7)**

The area of the development is a single fallow field, covered (June 24<sup>th</sup> 2008) in a thick, rank growth of grasses which obscure the ground surface apart from where paths have been worn. There are no traces of the former golf green. To the NW, the field is open to the present golf course, behind mature trees. To the east and SW, the area is bounded by modern housing developments, while to the west it is separated from the housing by a row of mature trees behind a ditch. Many of these mature trees are likely to be relics of the original 18<sup>th</sup> century plantings.

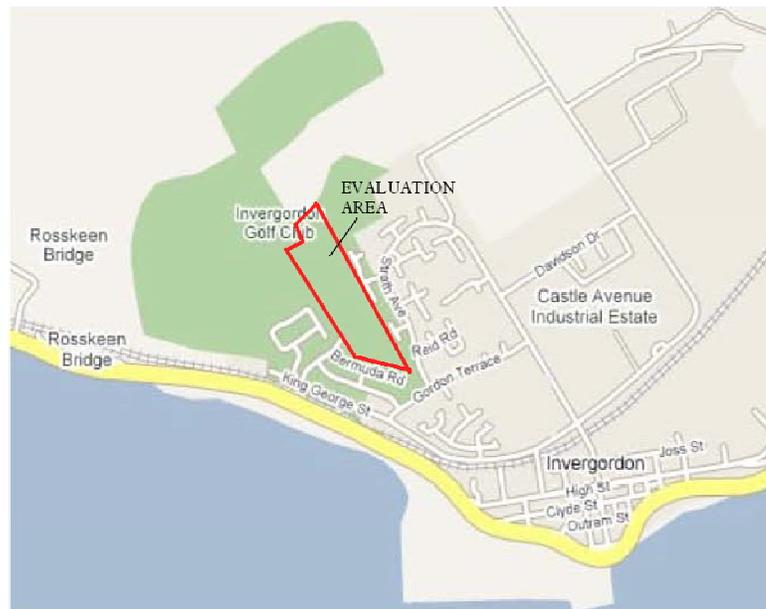
**Figure 7 : Invergordon golf course and development site**

The area of the development is now a single fallow field which apparently formed one long fairway of the golf course with a green (of which there are no traces) at the southern end. To the NW, the field is open to the present golf course, behind mature trees.

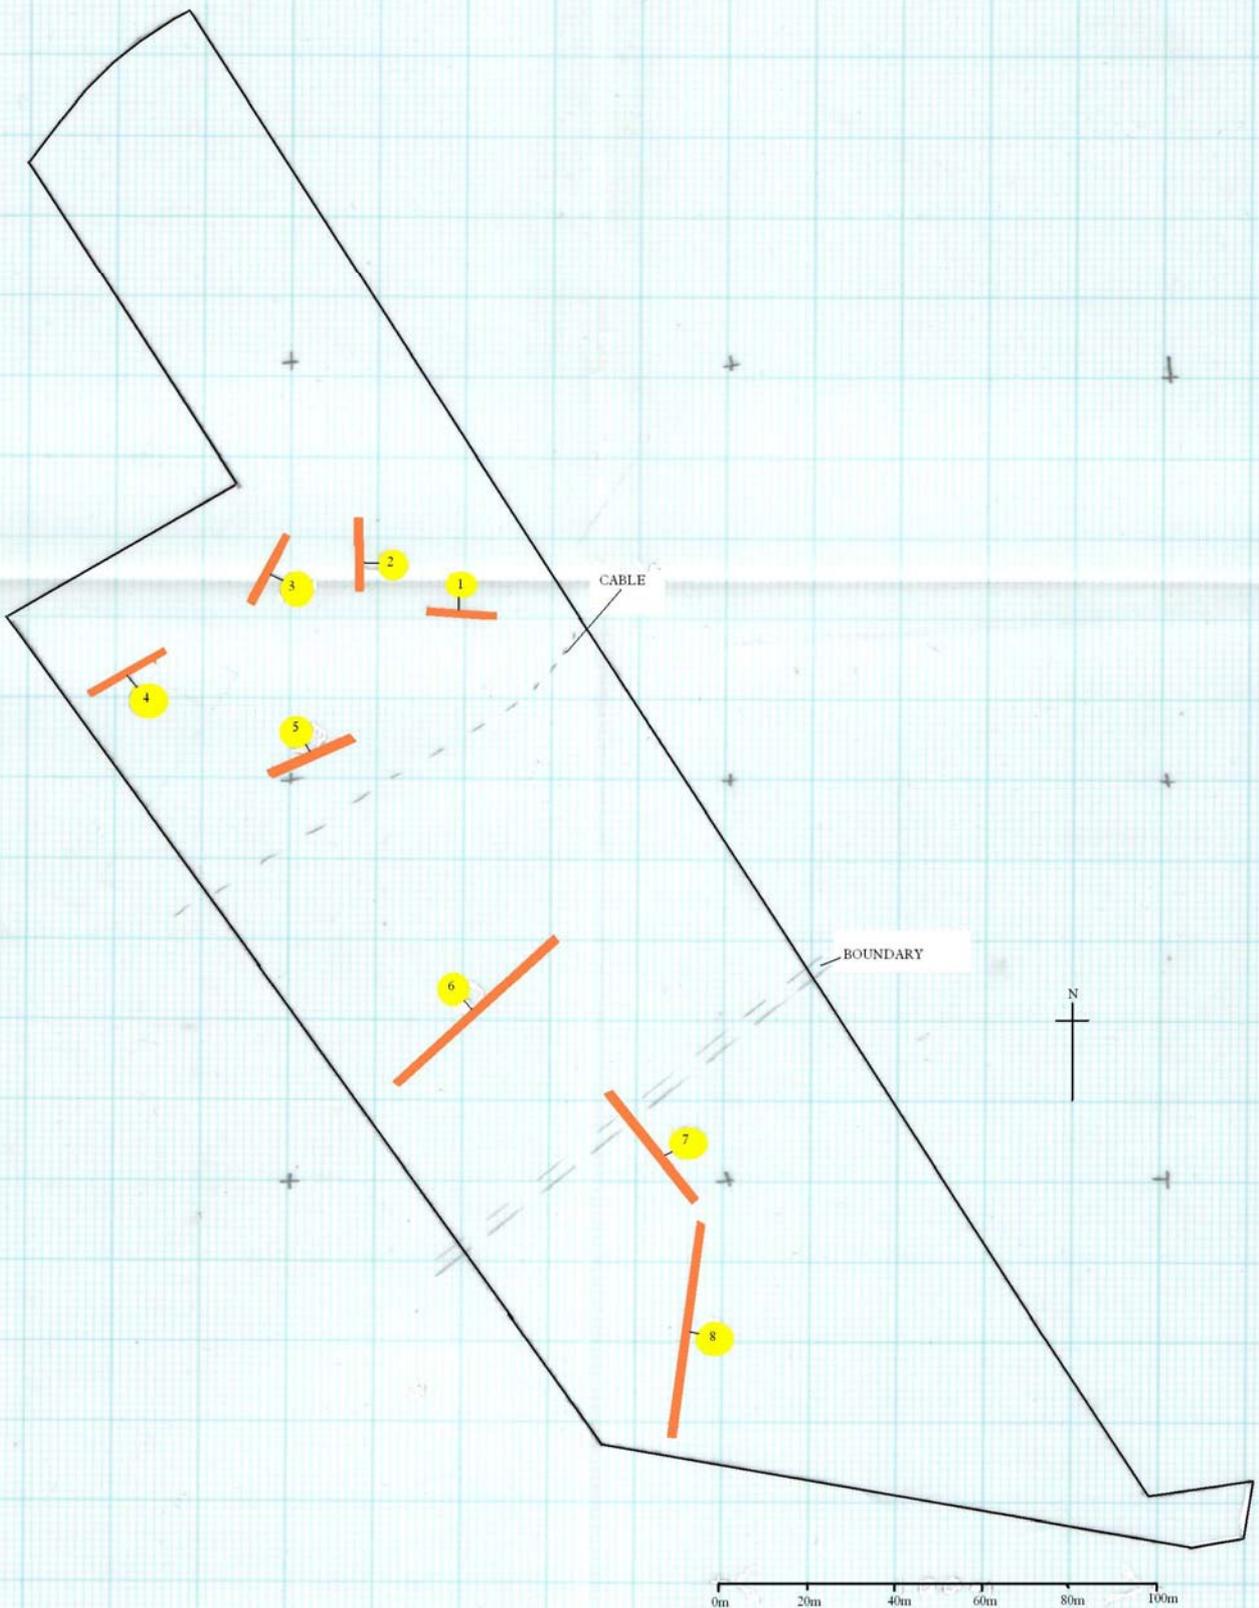
The development area corresponds to the two west fields of the four adjacent square fields south of the castle. The 1<sup>st</sup> edition Ordnance Survey map of 1880 shows the boundary between the two west fields as double-dyked, with trees along the boundary and up the west side of the north field. Its east boundary is the former avenue and to the SW is the Beech Wood. To the west is a row of mature trees behind a ditch which was investigated in trench 4. Crossing the area from ENE to WSW is a slight linear depression which corresponds approximately to the field boundary recorded by Roy and the 1<sup>st</sup> edition OS map. This was investigated in trench 7.

The 5% trial trenching was carried out on 24.6.08 in sunny and dry weather conditions. The on-site contractors provided a back-action JCB equipped with a straight edged bucket for trench digging. Eight trenches were investigated in order to get good spatial sampling of the site and to investigate certain possible features. The results are as follows:

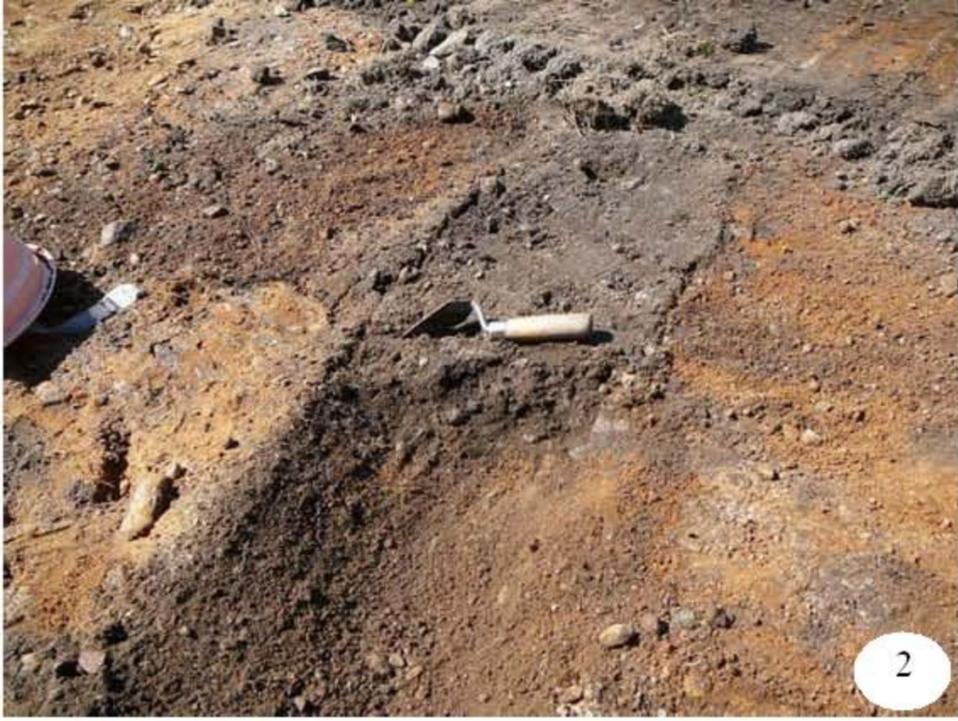
At NH 69917 69256 a shallow cut infilled with dark soil was noted (Report photo 2 ; CD photos 14-17). This was aligned ENE-WSW and measured 450 mm across at its widest point. The cut was a shallow scoop, 150 mm into the subsoil. The trench was extended east to investigate the cut, but it was found to be no more than 2m in length. It was concluded that this was a shallow ditch removed by deep ploughing. No other features were found in trench 2 or its extended area east. The dark fill, although slightly darker than the overlying topsoil, contained no inclusions other than gravels typical to the subsoil

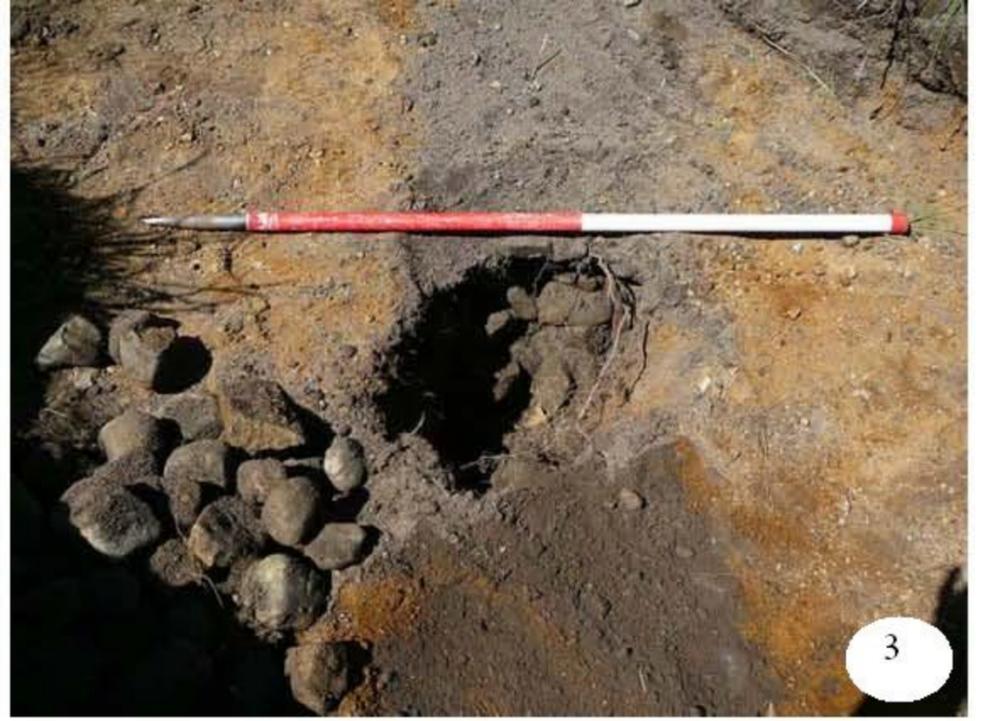
At 2m from the west end of this trench a filled cut into the subsoil was noted, measuring 400 mm in width, aligned 280°. A section across the feature revealed it to be a straight-sided vertical cut, back filled with topsoil to a depth into the subsoil of 300 mm, below which were packed a number of cobbles (Report photo 3 ; CD photos 20-24). This would appear to be a typical although crude drainage ditch.

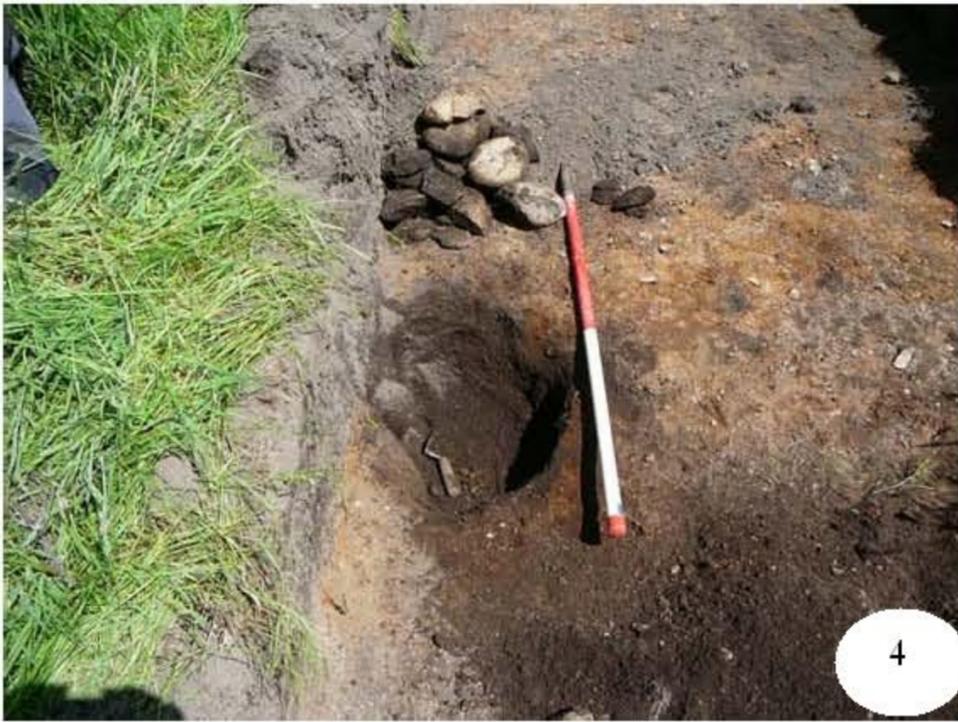
At NH 69929 69132, in the north section of the trench, a small circular cut was noted. The visible part was 550 mm in diameter and it appeared to be roughly circular. The cut was excavated, revealing a steep-sided pit to a depth of 150 mm below the subsoil surface, infilled with cobbles in a dark soil matrix (Report photo 4 ; CD photos 25-30) It was concluded that this was most likely to be some form of sump associated with drainage

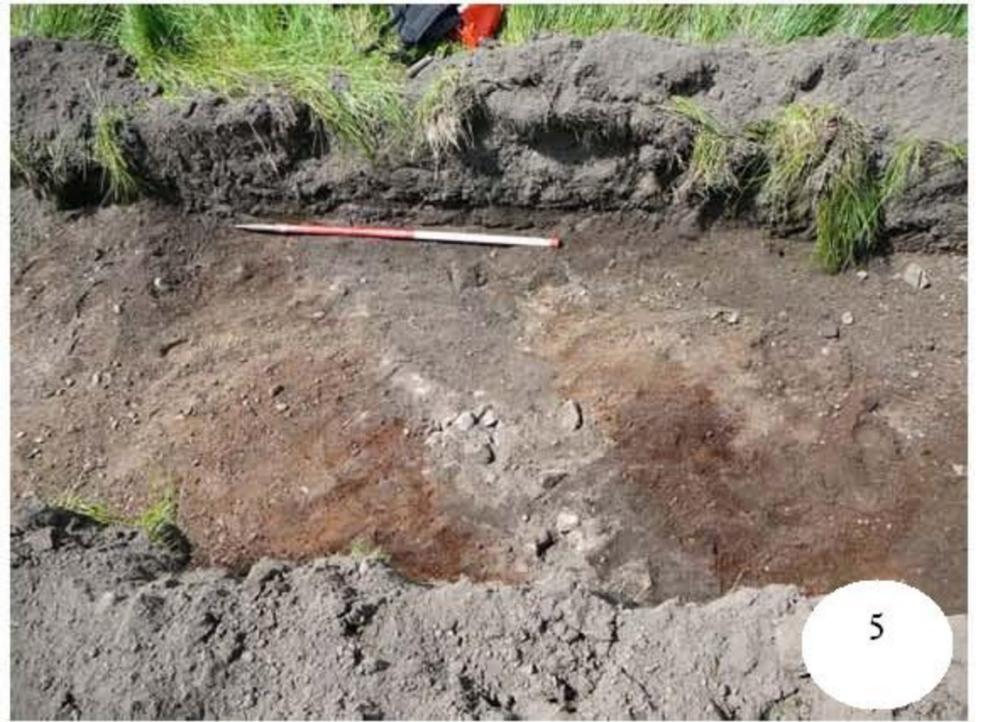
At NH 69975 691137 a land drain, aligned 280° and 400 mm in width, infilled with small stones (Report photo 5 ; CD photos 31-32)

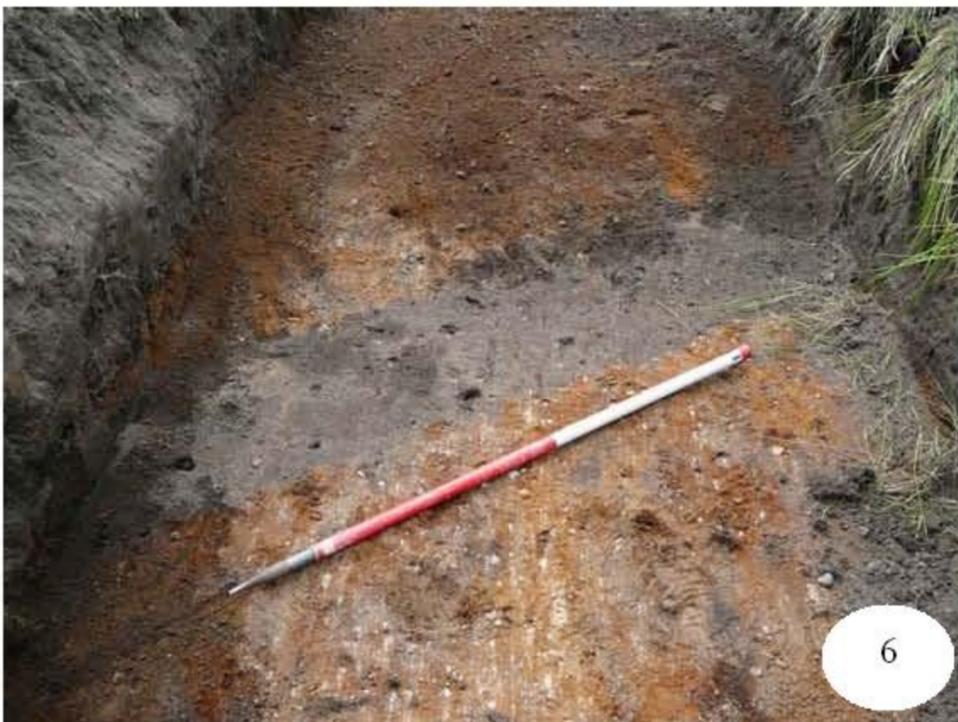
At NH 69935 69138 a land drain aligned 285° (Report photo 6 ; CD photos 33-34)

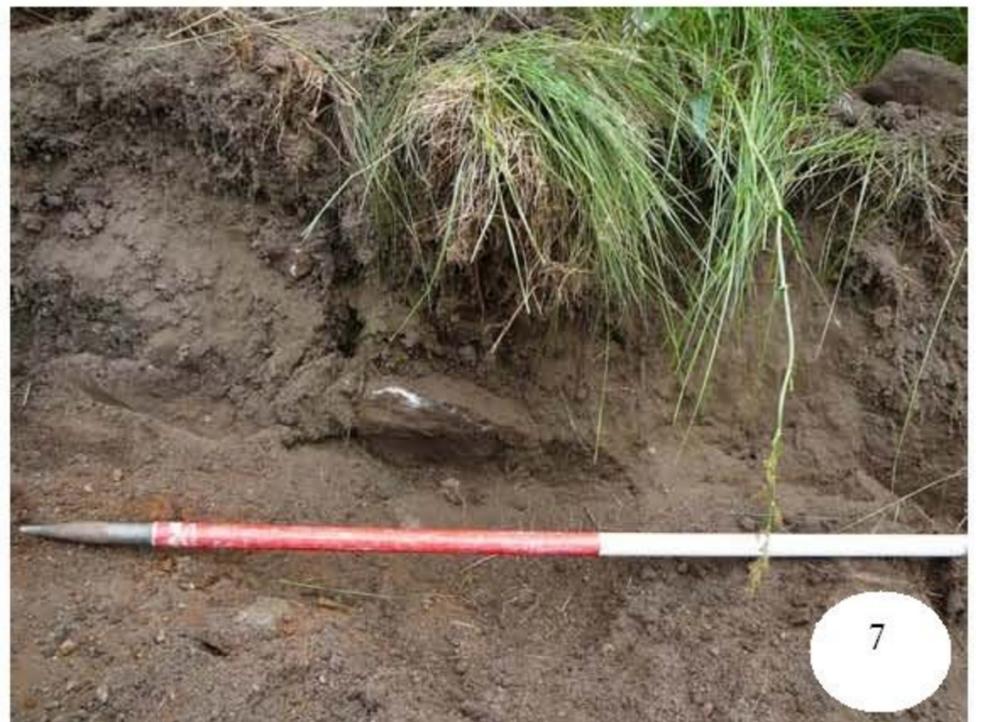
Dyked, ditched boundary: This feature proved to consist of two rubble dykes, between which were two infilled ditches separated by an area of pale sandy soil. The rubble dykes were represented only by a few large stones at the lowest course (Report photo 7 ; CD photo no. 35) and some stones had obviously tumbled into the ditches. The pale earth separating the two boundaries showed no signs of a constructed surface which might have suggested a roadway and is likely to differ from the surrounding topsoil in colour and inclusions only through lack of cultivation. No tree roots or stains from former roots were noted, although trees are recorded on the early maps, suggesting that the trees were grubbed up some time ago. Located at NH 69978 69117

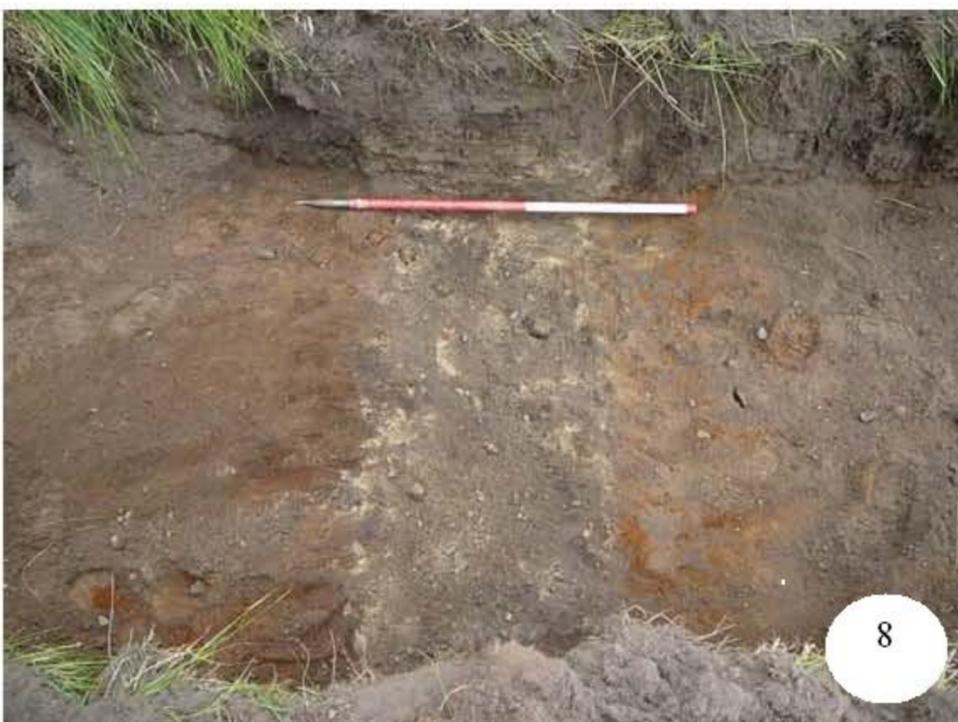
At NH 69990 69107, a land drain: this differed from features 3,5,6,7 in being cut through the topsoil (Report photo 8 ; CD photos 36, 37) as well as the subsoil, and being infilled with a very compacted pale yellow, stony soil. It measured 700 mm at the top of the cut, 300mm below ground surface and 600 mm across at the subsoil surface. The cut was not excavated fully due to constraints of time and the compacted nature of the fill (Photo 38), but as it must have been inserted after the field was last ploughed to full depth of the topsoil, it was concluded that this is a relatively recent feature, possibly associated with the golf course.

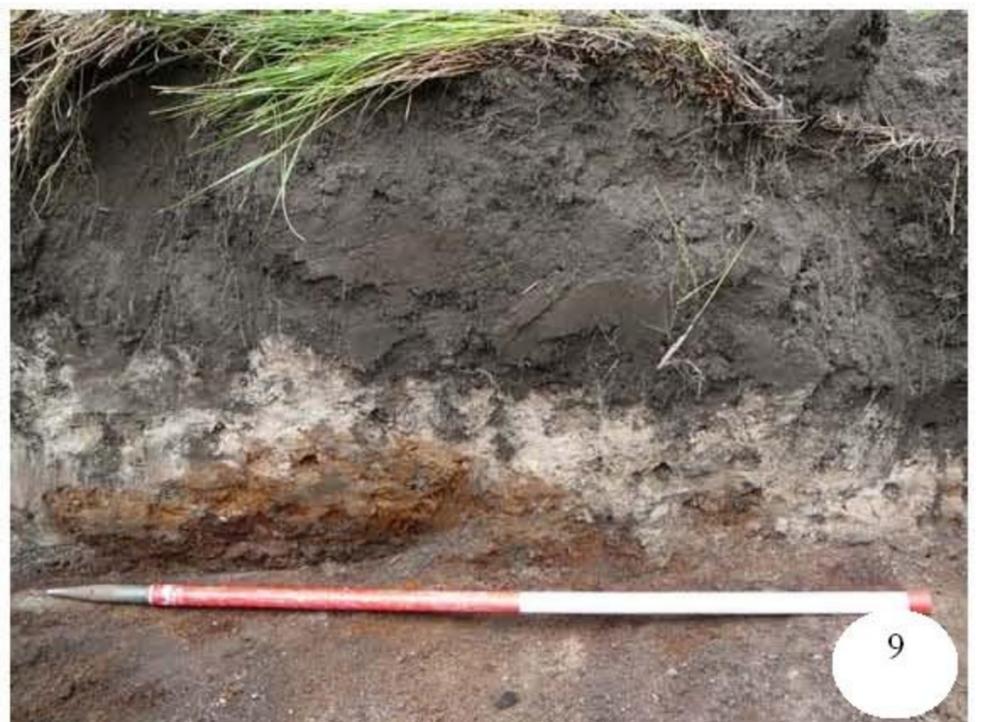
From NH 69993 69068 to the south end of the trench, a pale sand deposit, to a maximum of 200 mm deep, was noted (Report photo 9 ; CD photos 39-40) in some places it clearly lay between the topsoil and the subsoil, while elsewhere the stratigraphy was unclear, possibly due to the insertion of a land drain (CD Photo 41) in the form of a clay pipe, 800 mm deep and aligned 330°. The sand deposit had the appearance of imported material, and as this is at the approximate location of the golf course green, this was interpreted as being associated with the construction of the green.
