# EILEAN DONAN CASTLE

ARCHAEOLOGICAL  
EVALUATION

**ARCHAEOLOGICAL EVALUATION**  
EILEAN DONAN CASTLE  
ROSS-SHIRE

SITE CODE: LDC08  
REPORT CODE: FAS2009 416 LDC342  
NGR: NG 8812 2583  
MONUMENT No. 7575

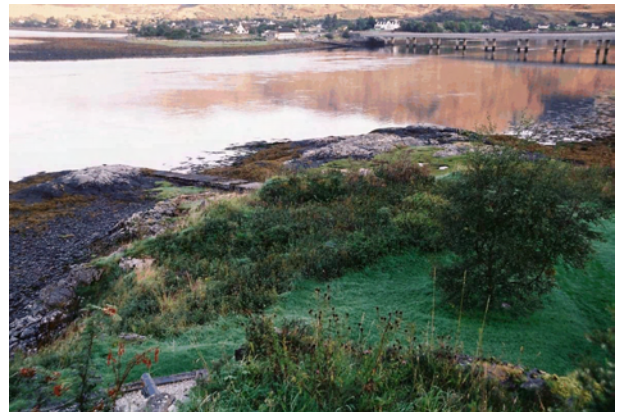
**Plate 2** Structure 1, pre-excitation, looking north

At the onset of the evaluation, the tower (Structure 1) was covered with dense vegetation; specifically grasses, ferns, and roses. Once clearance of this vegetation was underway, it became clear that much of the surviving earthwork of the tower consisted of rubble wall core, with the external and internal elevations having been robbed or eroded. As such, total removal of the vegetation was likely to result in significant damage to the structure, and so rather than threaten the structure further, the vegetation was cut back in order to reveal the layout of the tower, and surviving elevations were photographed where possible.

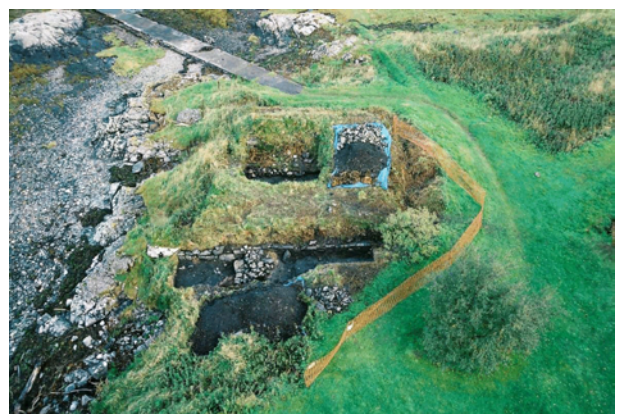
**Plate 3** Structure 1 from above, after vegetation clearance, looking north

The exercise allowed the position of the walls (F1 C1023) to be clearly defined, and their layout surveyed and updated (Plate 3). Visible elements of stonework at the northeastern corner of the tower hinted at the

possibility that this was the location of an adjoining wall, or the springing of an arch.

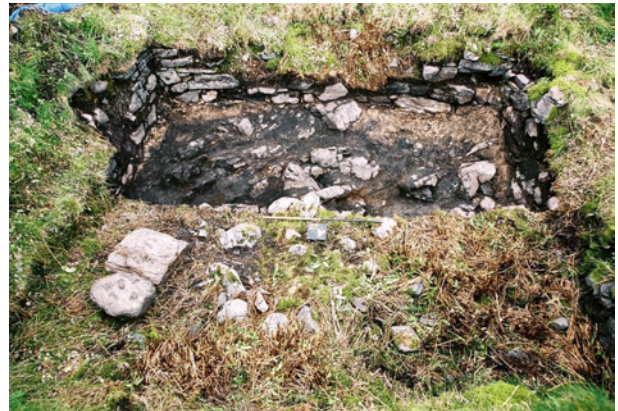
**Plate 4** Intervention 3 - post-excavation, looking south (scale 1.0m)

Intervention 3 involved the archaeological excavation of deposits within the tower itself. At the outset of the investigation, the tower was found to contain irregular rubble which was overgrown with moss and vegetation. The southern half of this backfill was removed, to characterise the sequence of deposits present, being an area of 3.8m x 1.8m. The earliest deposit to be encountered within the trench was the natural bedrock of the island, which formed an irregular surface within the tower (Plate 4); bedrock across the whole of the island was allocated C1025.

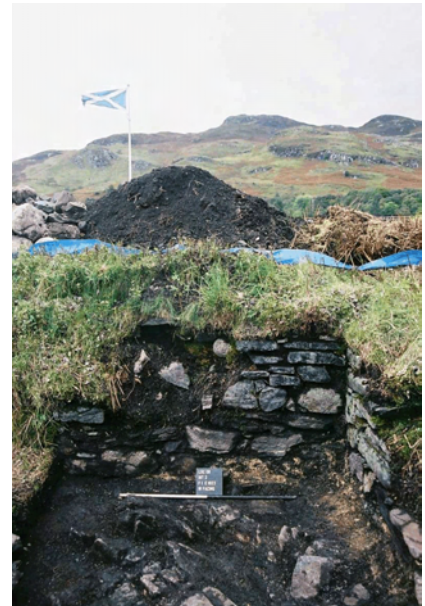
**Plate 5** Structure 1, internal west-facing elevation (scale 1.0m)

The walls of Structure 1 (F1 C1023) had been constructed directly over bedrock, with stones keyed into the undulating topography (Plate 5). Excavation within the tower allowed the full extent of the surviving internal elevations of the southern half of the structure to be recorded using rectified photography (Figure 4). Abutting the base of the internal elevations, a firmly compacted mortar deposit was recorded (C1024), but not excavated further (Figure 5; see Plate 5). This deposit represented bonding material that had eroded from the walls of the tower, during its structural collapse.

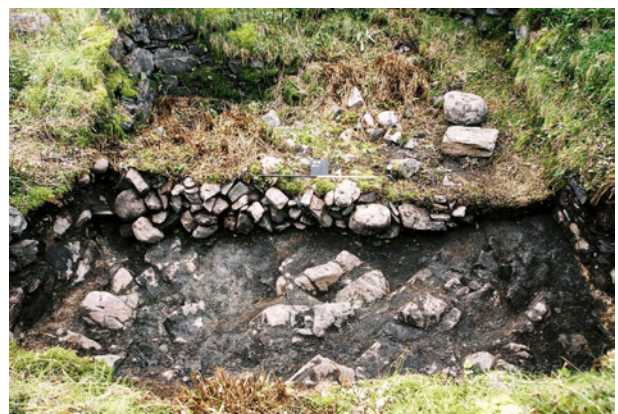
**Plate 6** Intervention 3 - south-facing section (scale 1.0m)

Sealing the mortar deposits, and infilling the tower, was a deposit of large rounded and angular boulders, of varying geology, with rare slag inclusions (C1022). This deposit measured a maximum 0.70m in depth, infilling undulations in the natural bedrock (Figure 6; Plate 6). C1022 does not necessarily represent *in situ* collapse, the stones do not show ordering to this effect, but may have been dumped within the building at a later date. The deposit was covered with moss and vegetation that had occupied much of the tower.

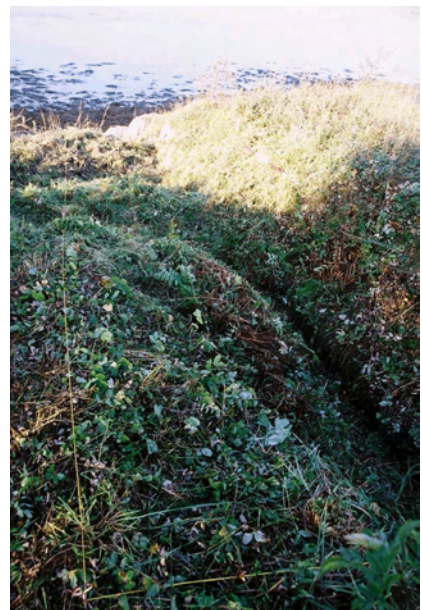
**Plate 7** Intervention 4 - pre-excavation, following clearance

rowan tree. Prior to the evaluation, this area was heavily overgrown with nettles, brambles and roses. Following clearance of vegetation, a steep, north-south slope was exposed, indicating that deposits had already been removed from the area adjacent to the tower itself (Plate 7).

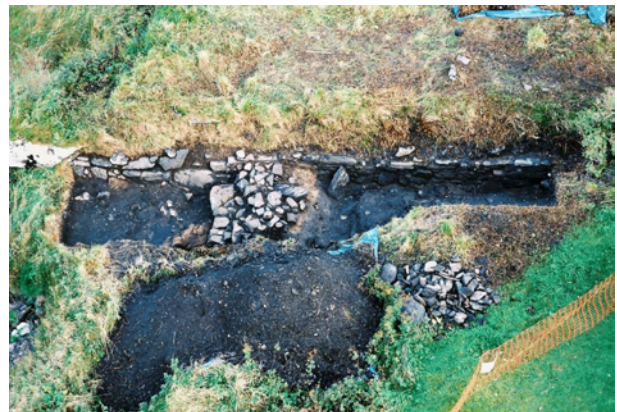
**Plate 8** Structure 1, external south-facing elevation

Constructed over bedrock, the external face of Structure 1 (F1 C1023) was exposed for the full length of the intervention, but survived only to a maximum 0.70m high (Figure 7; Plate 8). The irregular stonework suggested that the lower courses at least were initially below-ground foundations.

Abutting the tower, a section of north-south wall was revealed; this feature had been defined during the topographic survey and allocated F2 (Figure 8; see Plate 8). The wall was badly truncated to the east and west, and only one course of the outer elevation survived, at the western side of the wall (Plate 9). The remainder of the wall survived only as rubble core, with layers of compacted yellowish-brown mortar. Severe root disturbance had removed much of the bonding material from between these stones. As a result, the full extent of the wall could not be determined, although the results of the topographic survey suggest a wall width of 2.75m. A possible steep-sided cut to the immediate east of F2, preceding F28, may represent an episode of partial robbing of the eastern edge allocated C1046 (Figure 9).

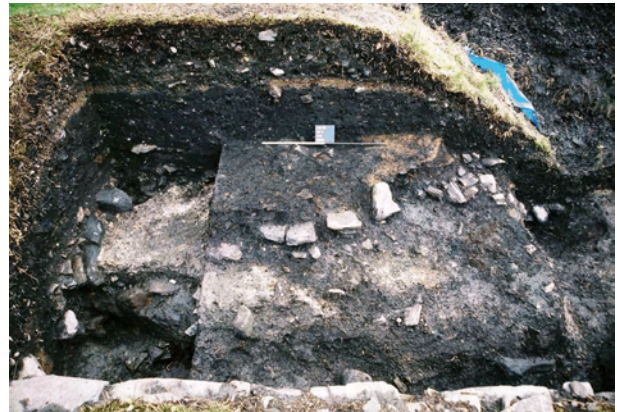
**Plate 10** Intervention 4 - showing C1033, looking south (scale 1.0m)

Also overlying bedrock (C1025), a deposit of grey clay was defined (C1046); the relationship between this deposit and C1034 was not ascertained within the excavated area. This clayey layer formed preparation for a well-defined mortar floor (C1033). Although only exposed in plan in the eastern sondage of Intervention 4, C1033 and underlying C1046 were observed within the cut of later feature F28, extending towards the remains of wall F2 (Plate 10). A compact layer of mortar extending beneath F2 may represent part of the same sequence, although the matrix of the deposit was quite different. The presence of a mortar floor has been used to infer that this area would have been a roofed internal space.

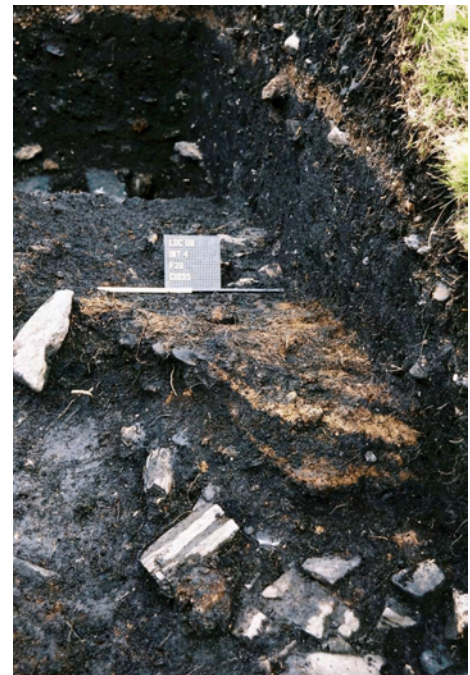
**Plate 11** Intervention 4 - F29 C1035, looking west (scale 0.5m)

southern edge of Intervention 4 (see Plate 10). The feature, allocated F29 C1035 was characterised by alternating deposits of orange clayey silt and charcoal, visible against the cut of F28 (Plate 11). A number of stones, also visible in the cut of F28 may represent hearth make-up. F29 was recorded *in situ*, but not further excavated following initial definition and recording leaving the remains intact for future investigation.

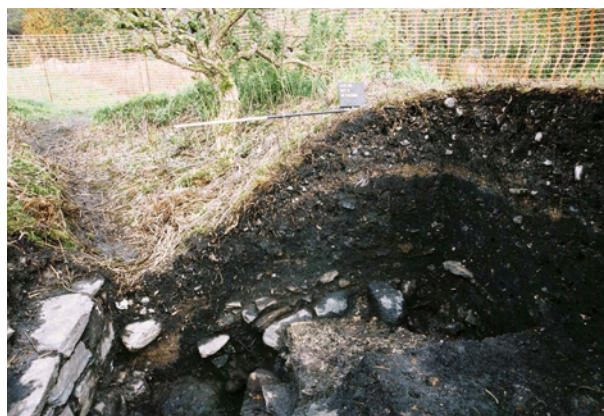
**Plate 13** Intervention 4 - west-facing section (scale 1.0m)

west-facing sections, however, suggested a more complex sequence of backfilling, and C1001 was subsequently recorded as a sequence of three deposits (C1041 to C1043)(Plate 13). C1043 was allocated to the earliest deposit within the base of the cut and extending over C1044, and consisted of a well-defined dark greyish-brown to black sandy clay, flecked with charcoal. Over C1043, a distinct deposit of yellowish sand was recorded (C1042), which had also slumped into the cut adjacent to the wall F1. Over C1042, was a layer of very dark grey clayey silt, with gravel and slag inclusions (C1041). This directly underlay the modern topsoil (C1001).

The sequence of deposits would suggest that the feature was gradually backfilled, through the slumping of upcast, and subsequent deposition of sand and soil. The finds from the backfill (allocated C1001), cover a broad date range. The slag inclusions from the backfill of F1 are likely to derive from the medieval deposits through which the trench had been excavated. Further finds of early date included iron nails, and a 13th- to 14th-century copper-alloy brooch (Plate 14). A small assemblage of ceramic has been dated to the 19th century, including a single fragment of clay pipe of 18th- to 19th-century date. More recent inclusions indicate a later date for the final backfilling of the feature, including a 20th-century glass bottle base, fragments of 19th- or 20th-century fire grate, and a 'Sqezy' bottle of early 1960s design (Plate 15).

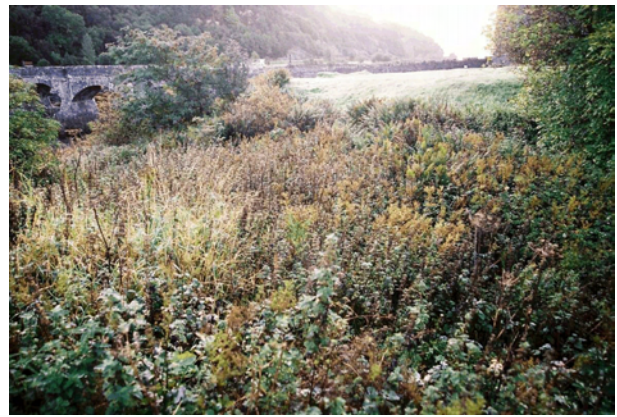
**Plate 16** Intervention 5 - pre-excitation

Intervention 5 was situated approximately 15m to the east of the northwest tower, and was positioned to investigate the northern stretch of curtain wall in this area, and the character of the midden on which the flagpole is positioned. This area was formerly overgrown with fern and nettles (Plate 16). Intervention 5 was excavated to a maximum safe depth of 1.30m (4.36m AOD); natural bedrock was not encountered.

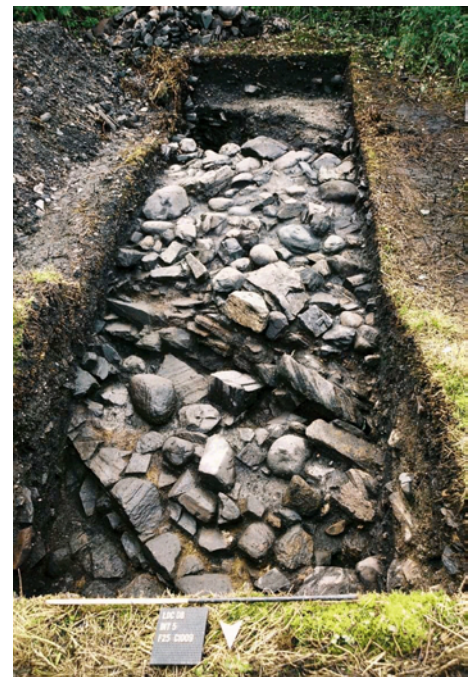
**Plate 17** Intervention 5 - F25 C1009, looking south (scale 1.0m)

C1032 was seen to extend beneath the foundations of wall F25, which dominated the intervention (Figure 12; Plate 17). The wall was constructed with regularly laid stone (Plate 18) and a clay-bonded rubble core; the remains measured *c.*4m wide in total. A coarser, sandier matrix at the northern edge of the wall suggested that it had previously been harled or mortared.

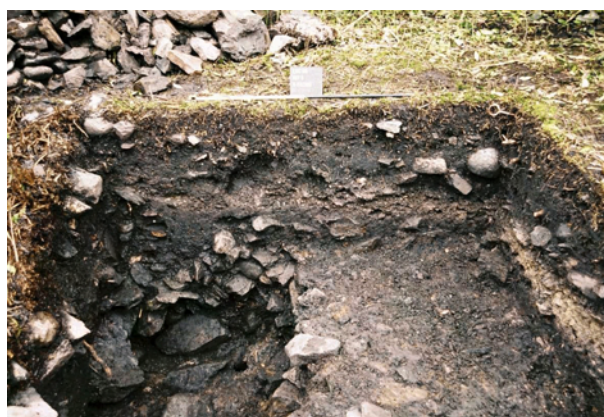
**Plate 20** Intervention 5 - north-facing section (scale 1.0m)

To the south of Intervention 5, overlying C1032, a sequence of layers was identified which appear to represent occupation activity (C1028, C1027) and a deliberately laid floor surface (C1012)(Plate 20). These deposits were physically separated from the wall by the excavation of wall-chasing trench F26 (see Figure 12 and 13), but it seems likely that they would have been associated with this structure.

C1027 was allocated to a thin, charcoal rich lens overlying C1028, which contained flecks of burnt animal bone, and fragments of a copper alloy ring. C1027 was fine-mesh sieved in its entirety (= 10 litres) and produced hammerscale, calcined animal bone fragments and a small lead token bearing a faint scratched cross. These deposits had been sealed by a layer of pale brown gravel (C1012), representing the construction of a surface or path (see Plate 20).

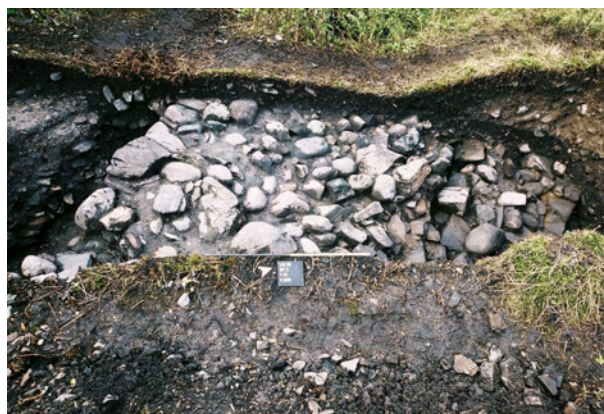
**Plate 21** Intervention 5 - east-facing section (scale 1.0m)

F25 had been levelled before the accumulation of the overlying buried topsoil (C1007), which also sealed the surface (C1012). C1007 pre-dated the early 20th-century, and formed a more gradually sloping surface onto which the mortar-rich make-up of the midden had subsequently been deposited (Plate 21).

The midden, which was defined during the topographic survey as F4, is a large mound on which the flagpole currently stands. The make-up of the midden was investigated in the northern part of Intervention 5, and recorded in the east-facing and south-facing sections (see Figure 13 and 14; see Plate 21). Two deposits were observed; the earliest (C1005) was a loosely-compacted mortar dump, which contained occasional large fragments of mortar and stone (including a piece of vitrified rock). A few fragments of well-preserved animal bone were collected, identified mainly as cattle bones, with a single goat/sheep bone. A thin, slag-rich deposit was encountered (C1002), which had been

deposited over the mortar deposit; this did not extend across the whole of the area. This produced modern glass and ironwork. It is assumed that the midden represents mortar which was cleaned from medieval building material, before its reuse in the 20th-century reconstruction. Following deposition of the midden material, a layer of topsoil had accumulated across the mound, representing the current ground surface (C1000).

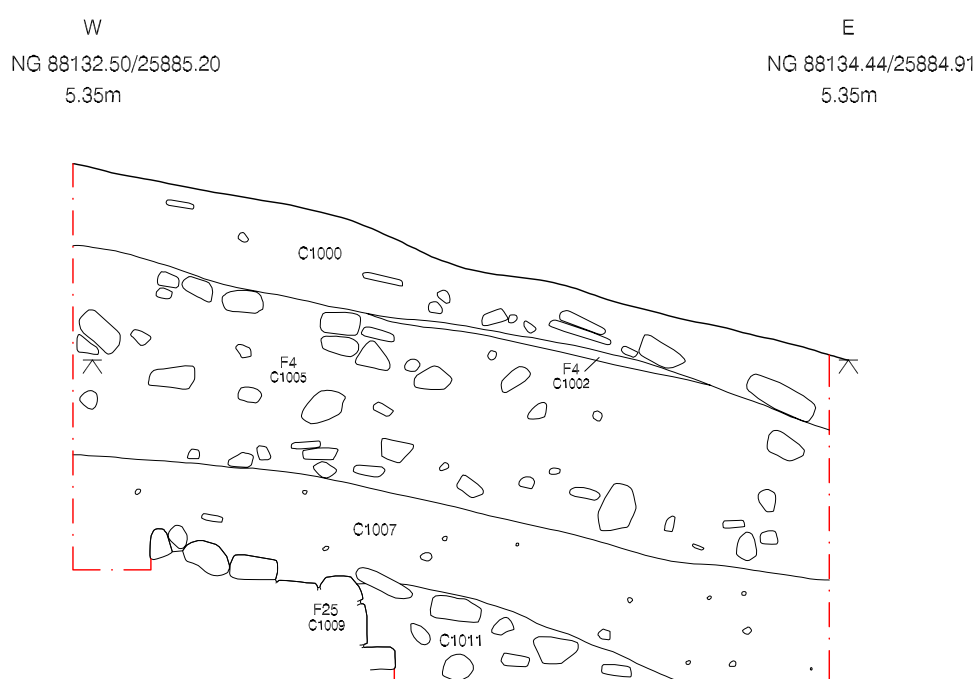
Figure 14

Intervention 5 - south-facing section

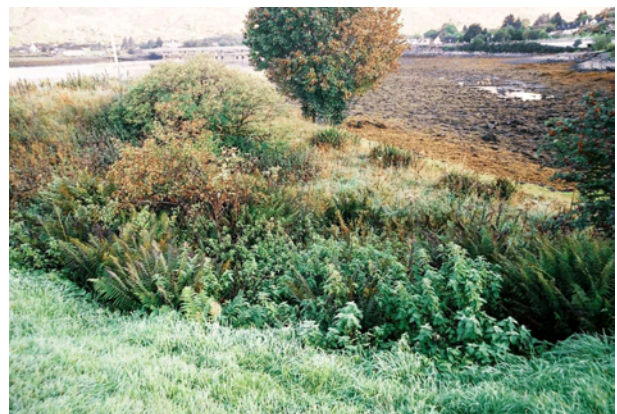
**Plate 24** Intervention 6 - pre-excavation

Intervention 6 was situated *c.*8.0m to the east of Intervention 5, and measured 6.0m x 2.0m, orientated NE-SW. The trench lay in an area previously overgrown with vegetation, sloping steeply down towards the shore of the island (Plate 24). The intervention aimed to investigate the presence of a possible tower in this location, in addition to characterising the survival and layout of the curtain wall and any associated deposits. The trench was excavated to a maximum depth of 0.70m at its southwestern end, at which point the rubble matrix of the walls made further investigation unsafe. A 1.0m wide sondage was further investigated at the northeastern end of the trench, reaching bedrock at 2.85m AOD.

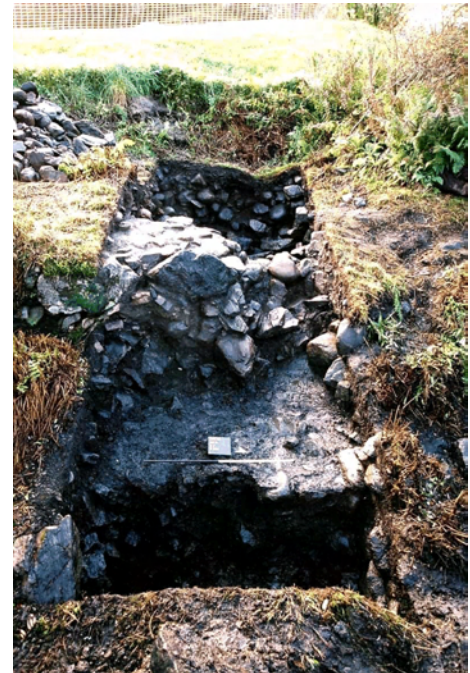
**Plate 25** Intervention 6 - F7 C1014, east-facing elevation (scale 1.0m)

site, and allocated F7. The full extent of wall F7 was not observed within Intervention 6, and the feature appears to be have been truncated by later activity.

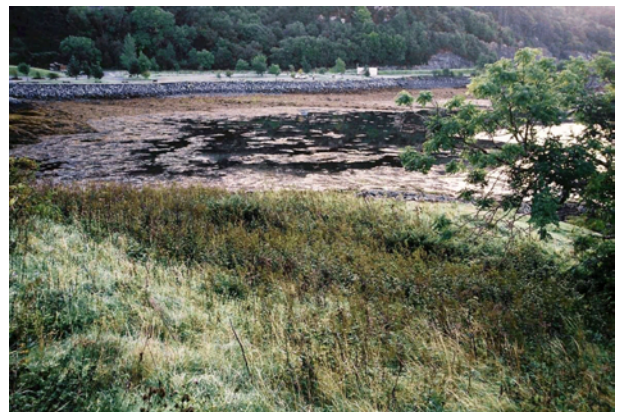
**Plate 29** Intervention 7 - pre-excavation

Intervention 7 was located on the southern side of the island, and was positioned to investigate the curtain wall, and a possible tower in this location; the trench measured 6.0m x 2.0m. Previously, this area had been overgrown, although parts of the southern elevation of the wall were visible amongst the vegetation (allocated F8 during the topographic survey)(Plate 29). Intervention 7 was excavated to a maximum depth of 1.20m (2.96m AOD); natural bedrock was not achieved.

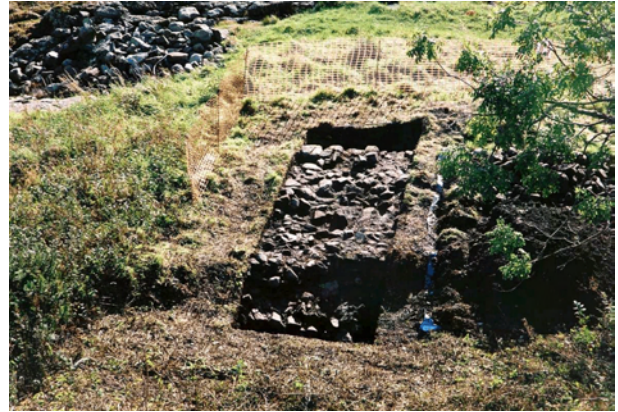
**Plate 30** Intervention 7 - F8 C1019, looking south

Overlying C1039, and spanning most of the trench, was the stone-built curtain wall, allocated F8 C1019 (Figure 19 and 20; Plate 30). The wall in this area was much wider than the visible earthwork had suggested, measuring 5.0m in total width. The wall was well-constructed, with regular elevations formed from boulders, and a clay-bonded rubble core (Plate 31). Fragments of vitrified rock were observed within the make-up. The well-preserved southern elevation was gently battered, and survived to a height of 1.20m; its lower extent was not achieved, and it seems likely that the structure was constructed directly over bedrock. The elevation to the north was more fragmented, with a possible return to the east, and appeared to have been constructed over a rubble foundation layer.

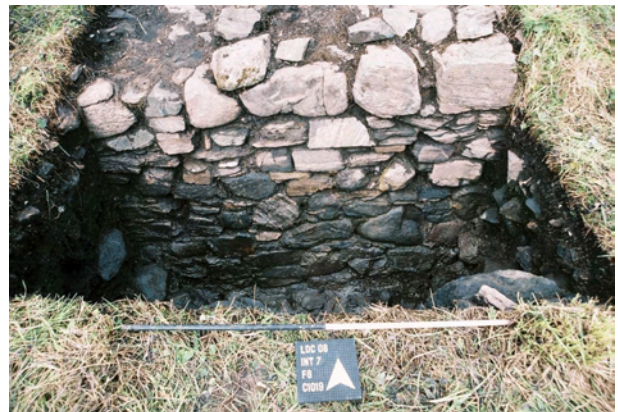
**Plate 31** Intervention 7 - F8 C1019, south-facing elevation (scale 1.0m)

The evaluation demonstrated that the apparent curve in the curtain wall, visible topographically, did not reflect the layout of the buried remains (see Plate 31). The curving feature may be a remnant of field boundary, as seen on the eastern side of the island, or possibly a topographic feature caused by later clearance of stone from this area. The northern elevation of the wall ran in a more direct NE-SW direction.

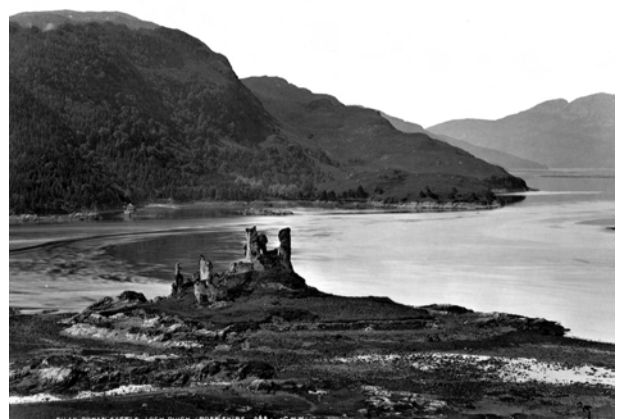
**Plate 32** Pre-1908 view of the castle (GWW E1606)

The midden, representing mortar presumably removed from rubble before reuse, contained very little of antiquity, and was well-defined stratigraphically. This feature is not visible on historic photographs prior to reconstruction, but can be seen to have developed after the onset of reconstruction (Plate 32 and 33).

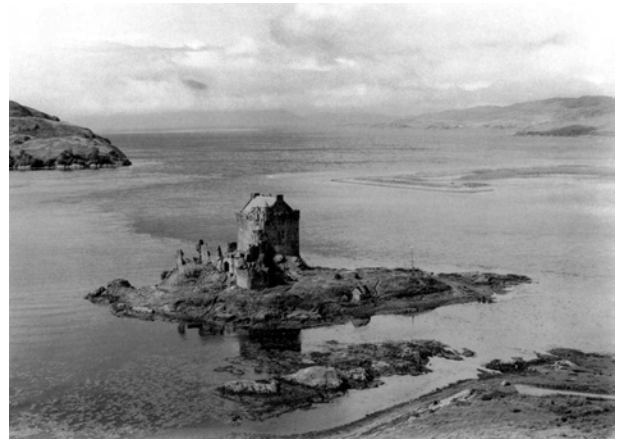
**Plate 33** Eilean Donan during reconstruction, 1929

provide access to the shore. Historic photographs and illustrations depict Farquhar's hut on the foreshore close to this location, and this may have formed part of remodelling during his occupancy (see Plate 33).
