**The Report
Of a Project to Identify, Survey and Record
Archaeological Remains at Rogie, Ross-shire
February 2008 – May 2009**

**The Report of a Project to Identify, Survey and Record
Archaeological remains at Rogie, Ross-shire
carried out by the North of Scotland Archaeological Society,**

February 2008 – May 2009

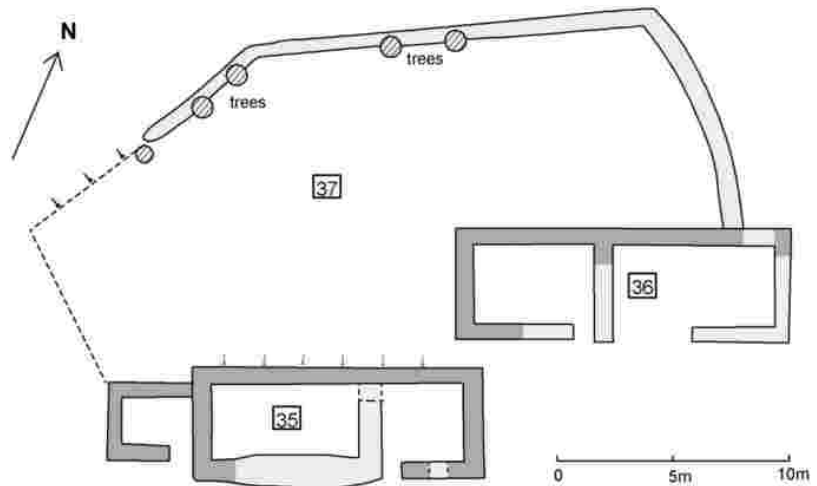
GR NH 4416 6007 sites 35 - 37

Upper Rogie - North East settlement
(schematic plan only)

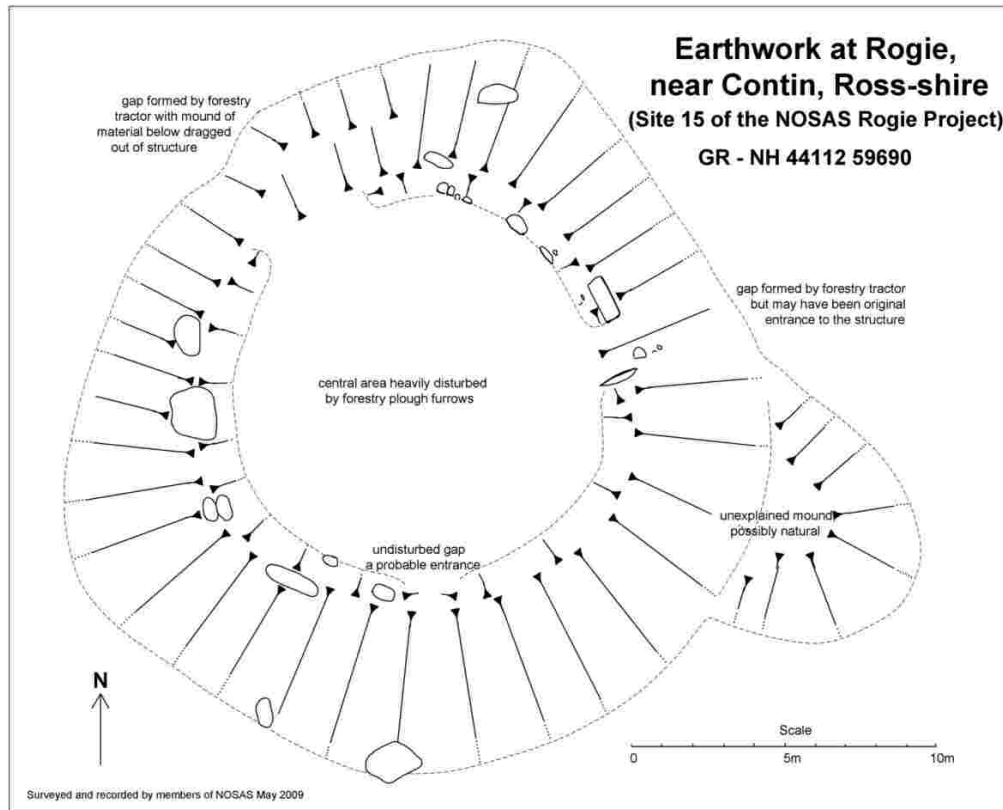
The massively walled circular structure No 15, see drawing on page 18, could be the remains of a dun, and that would place it in the Iron Age. No hut circles from the Bronze Age were found in the project area, but several are known on the west side of the Blackwater, opposite Rogie.

15 Ringed earthwork/Possible Dun - NH 44112 59690 A raised circular feature with an encircling bank which contains large stones, some of which may be in-situ boulders. The internal diameter of the feature is c12m. The bank is 1-1.5m high externally and generally 0.3-0.5m high internally. It has a spread of 2 - 3m. There is a possible entrance, c2m in width in the eastern arc but this may have been caused by heavy forest machinery. The whole site has been grossly trashed by tree planting, felling and reploughing, with furrow marks across the internal area. See plan

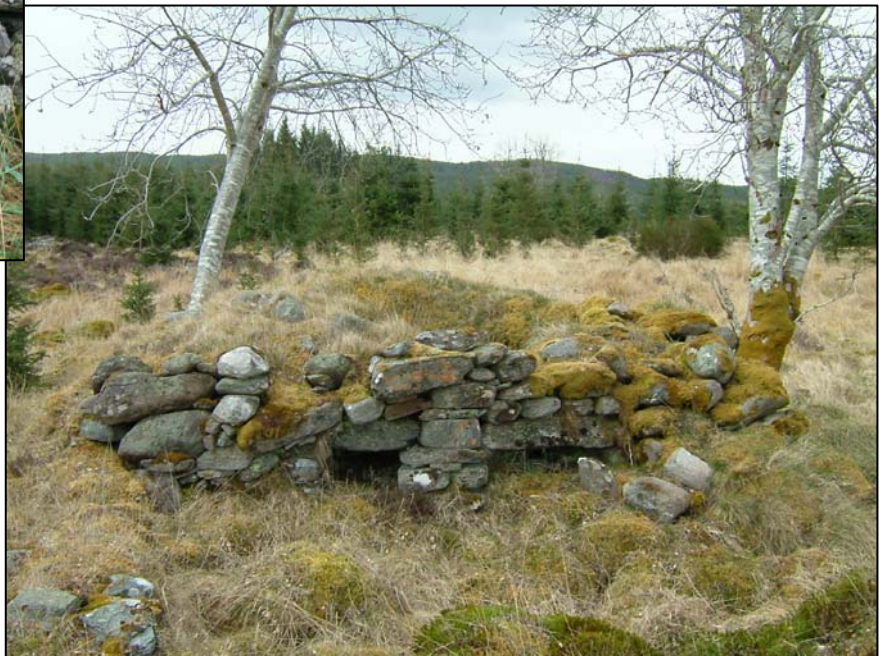
Figure 3. Unusual corn drying kiln, site 43, with 2 flues at North settlement

43 Kiln and barn (figure 3) - NH 44009 60135 Aligned E-W this structure has an overall measurement of 7m x 3m. The kiln is well preserved and of dry stone construction, it is generally 1.6m high. The bowl has a diameter of 1.8m and it is 0.5-1m deep although there is some tumbled material inside. Unusually there are two flues in the straight west face which is 1.1m in height. The south one appears blocked although it can be probed to a depth of 0.9m, it has an aperture of

1m width x 0.3m height externally, narrowing to 0.3m width x 0.1m height. The north flue is 0.5m wide, 0.2-0.4m depth and 1m in length.

Externally there is an abutting feature on the SE side of the structure, this takes the form of a rising ramp of large stones, this may have been steps up to the top of the kiln.

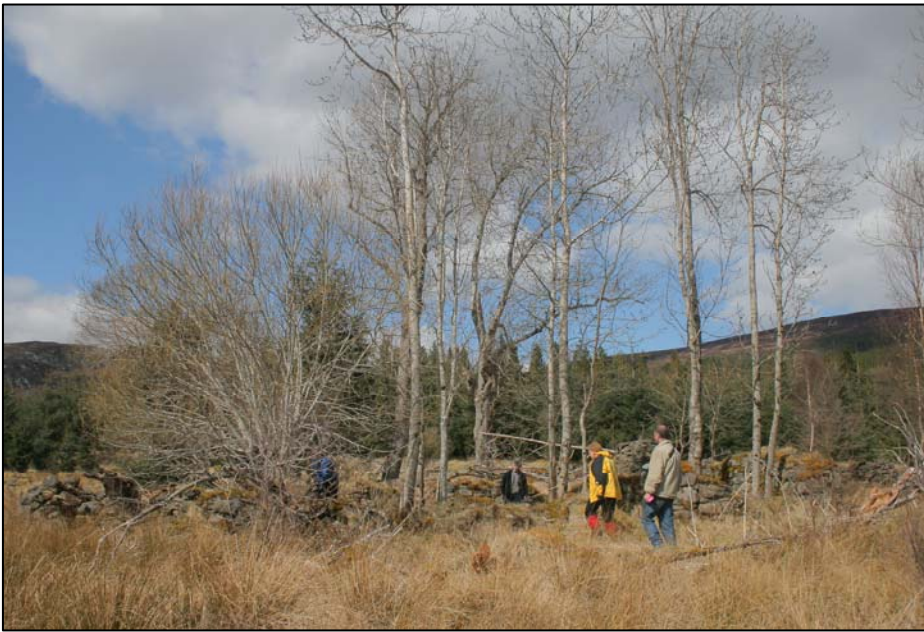
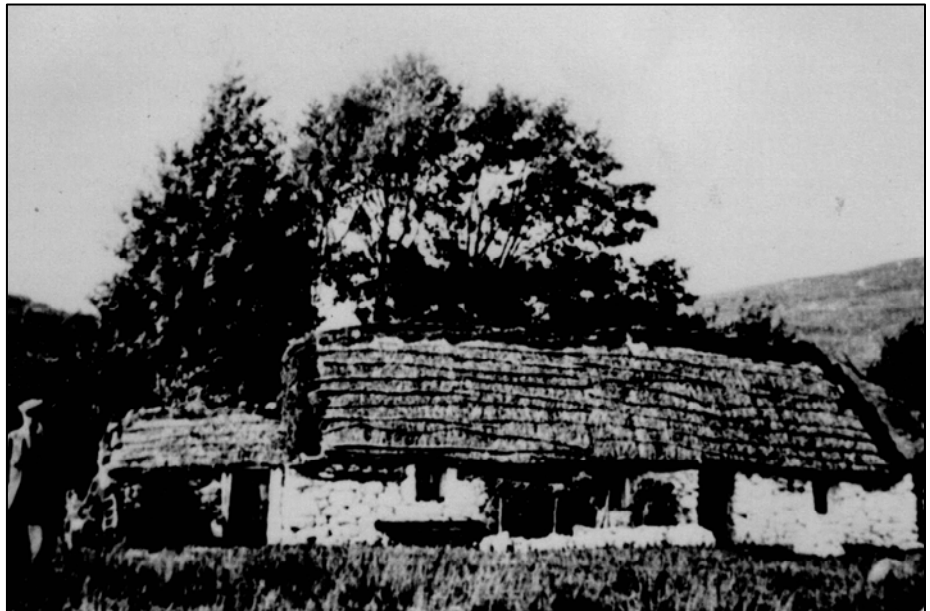
Figure 6. Site 35, Macqueens croft as it is today, 2008 and Figure 7. below as it was c1920 with James MacQueen himself beside it. (Unable to trace source of photo)

This building is thought to be MacQueens croft. A photograph taken in the 1920s, has been reproduced in this report, *Figure 7*, page 25.

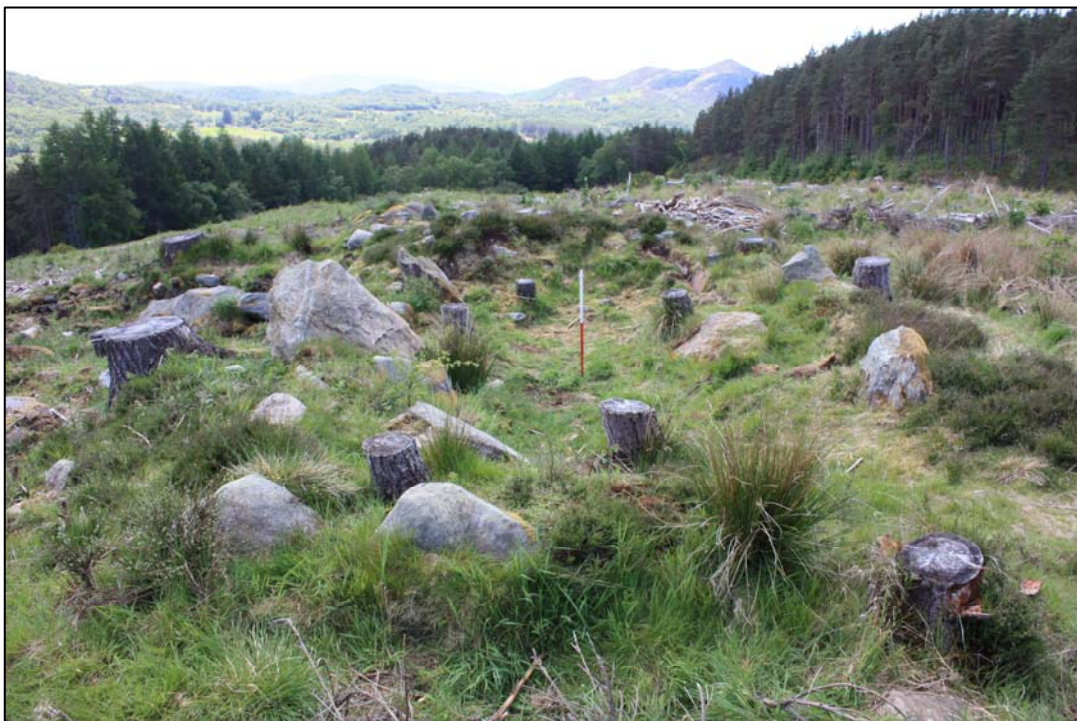
Figure 8. The "Mystery" building, site 45, viewed from the east

45 Building (figure 8) – NH 43870 59711 The remains of a small but substantial building occupy an exposed but commanding position on the summit ridge of a prominent knoll. The area of the knoll and the structure itself have been grossly disturbed by forest operations with felling, mounding and replanting having recently taken place. The underfoot conditions are extremely rough and hazardous.

The building measures 20m x 14m overall. The main axis is NE-SW and there are 2 compartments to this part of the building, but there is also a third compartment on the east side, see drawing. All the walls of the building have been solidly constructed of earth, rubble and large boulders. Their remains are generally 0.5m to 0.8m high and between 1.5m and 2m thick and even 3m in some places.

The west compartment measures 5m x 3.5m internally and there is an entrance 1.3m wide in the SE wall. The NE compartment measures 7.5m x 3m internally, again there is an entrance in the centre of the SE wall. There may also be an entrance into the east compartment at the west end of this SE wall, but an opening at the NE corner has probably been made by forest vehicles gaining entry. The SE compartment is aligned at right angles to the other two and is 4.5m x 3.8m internally. It has an entrance in the NE wall. The building sits on a revetted platform 25m x 15m, the SW side of which has been built up considerably with large boulders.

The building is a bit of a mystery. It is quite unlike any of the other buildings in the surrounding dispersed township. The fact that it has such a commanding position may be significant, as may the fact that it is reasonably close to the ringed earthwork, site 15 and a segment of wall, site 46, which lies just 100m to the NE

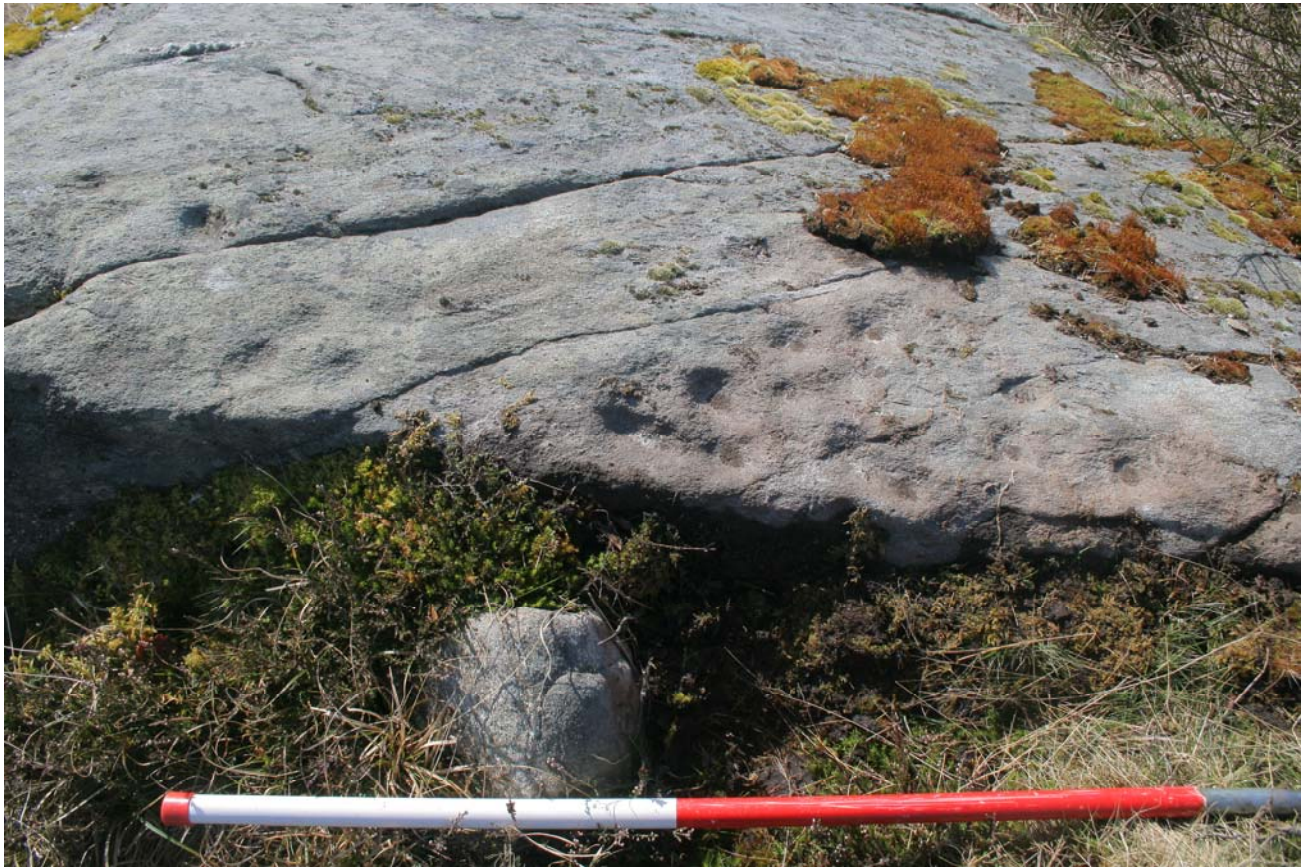
Figure 9. Cup marked outcrop 18

18 Cup marked outcrop (figure 9) – NH 43960 59808 A linear outcrop of rock on the SE side of the summit of a prominent knoll has 22 cups on it. Most of the cups are along the upper edge and are quite worn.
