ROSS & CROMARTY ARCHAEOLOGICAL SERVICES

Glenfeshie Estate Woodland Restoration Scheme

Desk-based Assessment and Walkover Survey

| RoCAS Report | 2011-08/GWR11 |

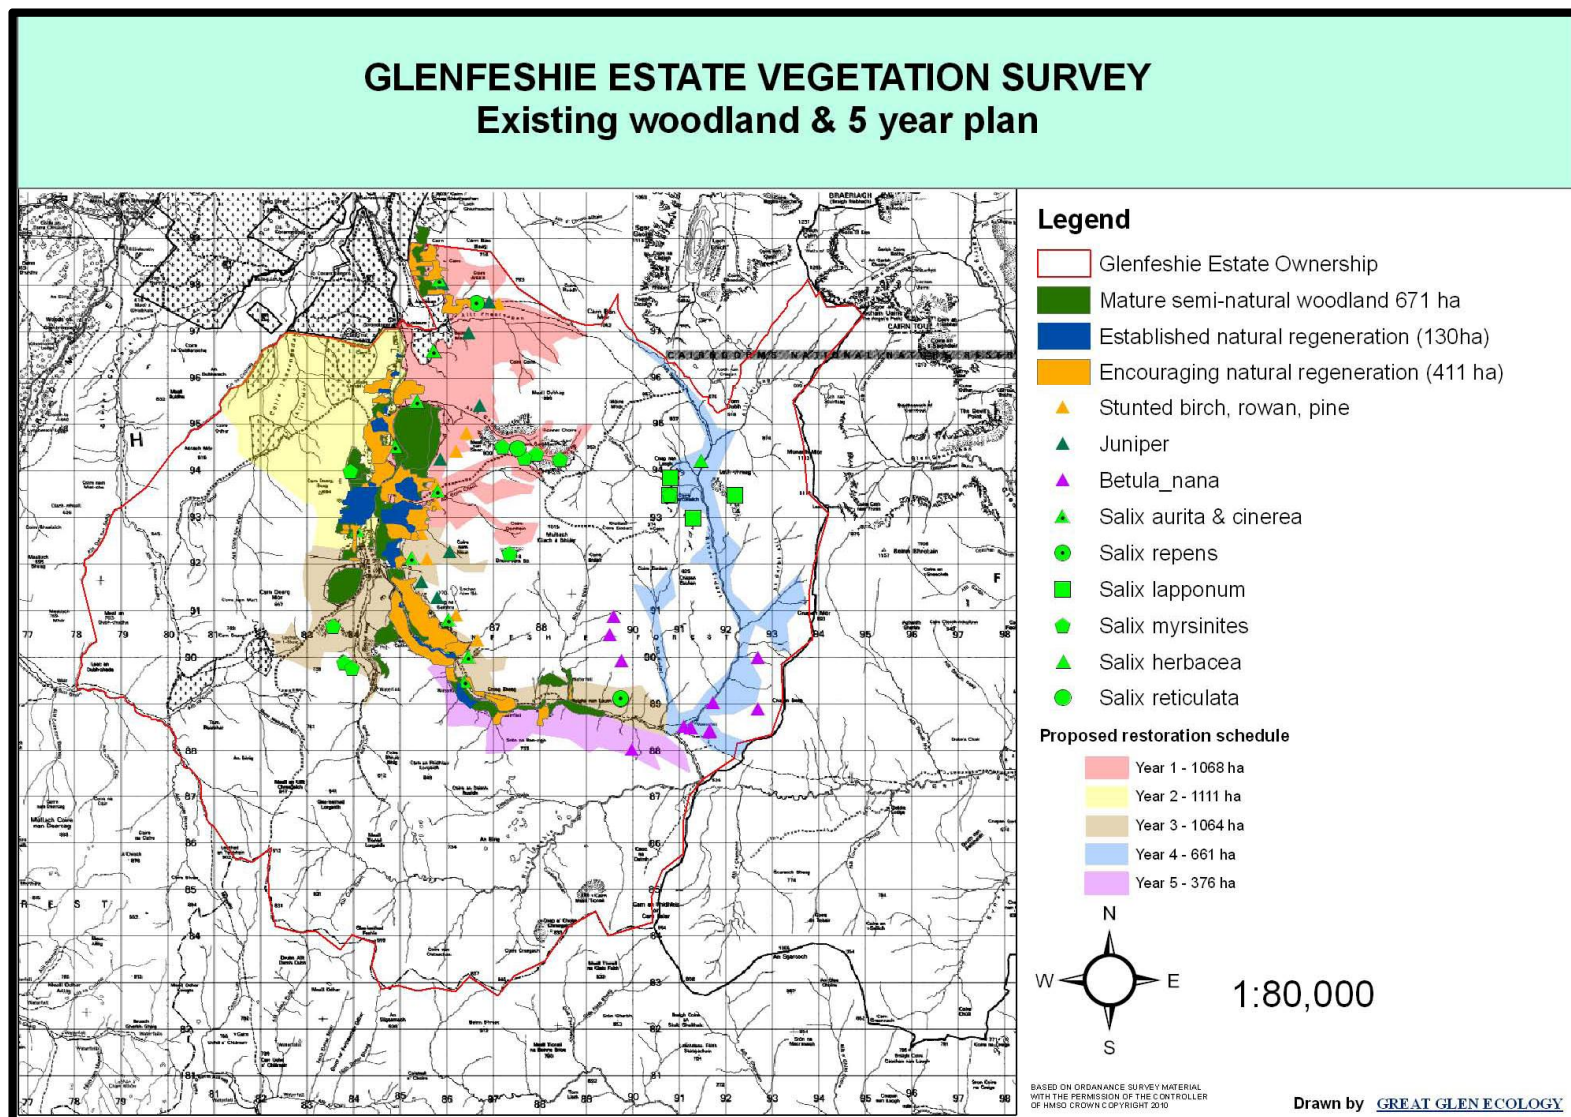
Figure 2: Location of the existing regeneration and planting areas¹³

The woodland restoration scheme will take place over five years and will cover a total area of 4,280 hectares; this will complement the existing mature semi-natural woodland of 671 hectares. In addition, there are 130 hectares of established natural woodland regeneration with a further 411 hectares where natural regeneration is being encouraged. The existing areas of woodland and proposed regeneration and planting areas are shown divided into five zones in **Figure 2**.

A rapid walkover survey of the planting areas (**Figure 2**) was undertaken on 8, 23, 24, 28-31 March and 8 April 2011. Additional tracts of Forestry land were covered during the survey, as per the request of Scottish Woodlands Ltd for the purpose of management planning. The extra areas included four tracts to north of the Year 2 planting scheme and two tracts to southwest of the Year 3 planting scheme. The outline of the entire area assessed is shown in the location map in Figure 3.

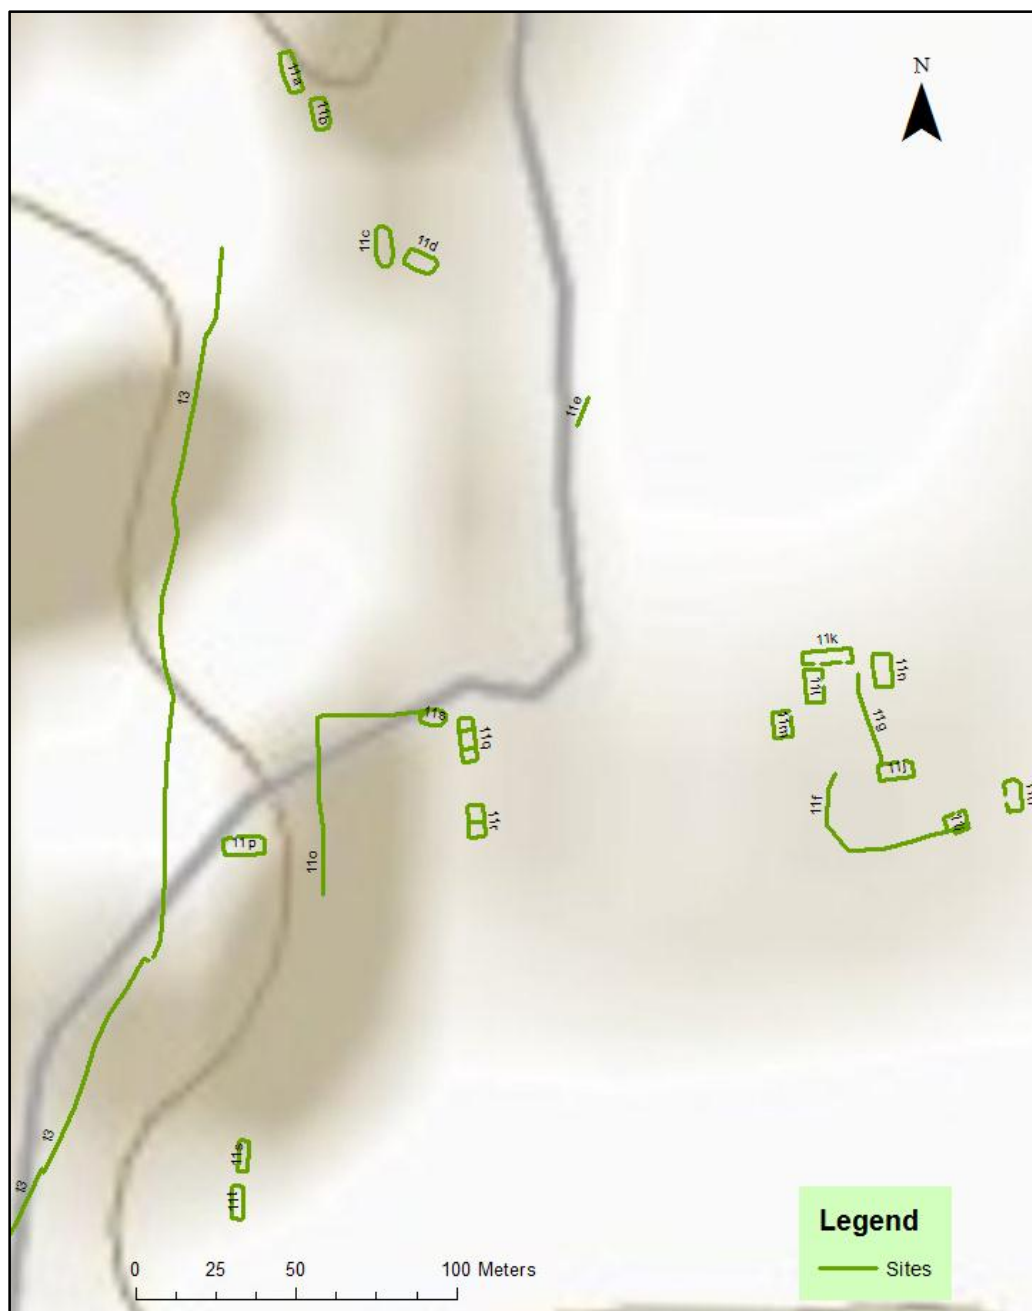
Figure 4 Ruigh Fionntaig settlement (Site 11)

Most of the new sites recorded during the survey pertain to Post Medieval settlement and many of them are related to previously surveyed settlements. This is the case at Ruigh Fionntaig (**Site 11**), where new sites **Site 11o**, **Site 11p**, **Site 11s** and **Site 11t** are a turf enclosure and three further subrectangular drystone houses or house-byres associated with the rest of the settlement at Ruigh Fionntaig (**Figure 4**).

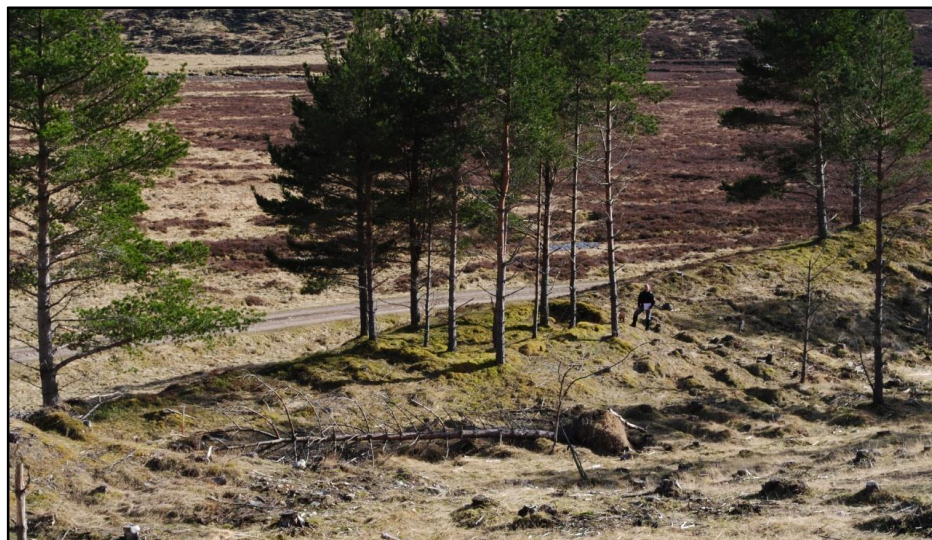
Plate 1 Site 11s and Site 11t: two structures built into an esker ridge SW of Ruigh Fionntaig

| No. | Site name | Site type | HHER No. | Description | Alignment | Category | Impact zone (m) | Condition | Period | Height OD (m) | Easting (centre) | Northing (centre) | Photo No. |
|---|---|---|---|--|---|---|---|---|---|---|---|---|---|
| 11s | Ruigh Fionntaig | House | - | Set into an esker and planted over in trees is the grass- and moss-covered remains of a rectangular stone/turf house measuring 11m N-S by 4.5m over walls 1m wide and 0.5m high | N-S | 2 | 10 | Very degraded | Post Medieval | 440 | 284162 | 791581 | 26, 27 |
| 11t | Ruigh Fionntaig | House | - | Set into an esker and planted over in trees is the grass- and moss-covered remains of a rectangular stone/turf house measuring 12m N-S by 5m over walls 1m wide and 0.5m high | N-S | 2 | 10 | Degraded | Post Medieval | 440 | 284161 | 791557 | 26, 27 |

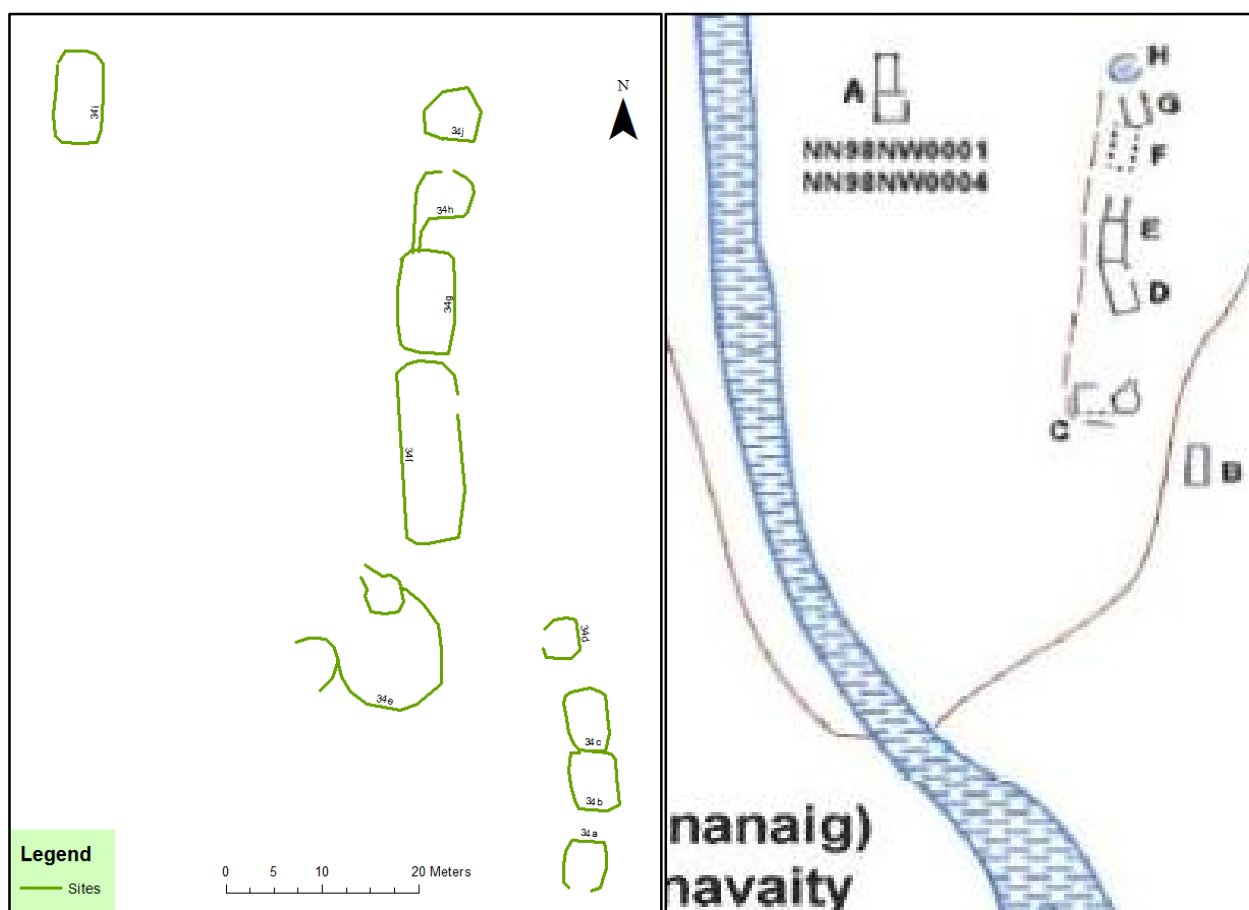
At *Stronavaity* (**Site 34**), the surveyors' interpretation of the structures differed to that shown in the previous record (**Figure 5**).

Figure 5 Stronavaity settlement as recorded during the present survey (left) and previous survey (right)²³

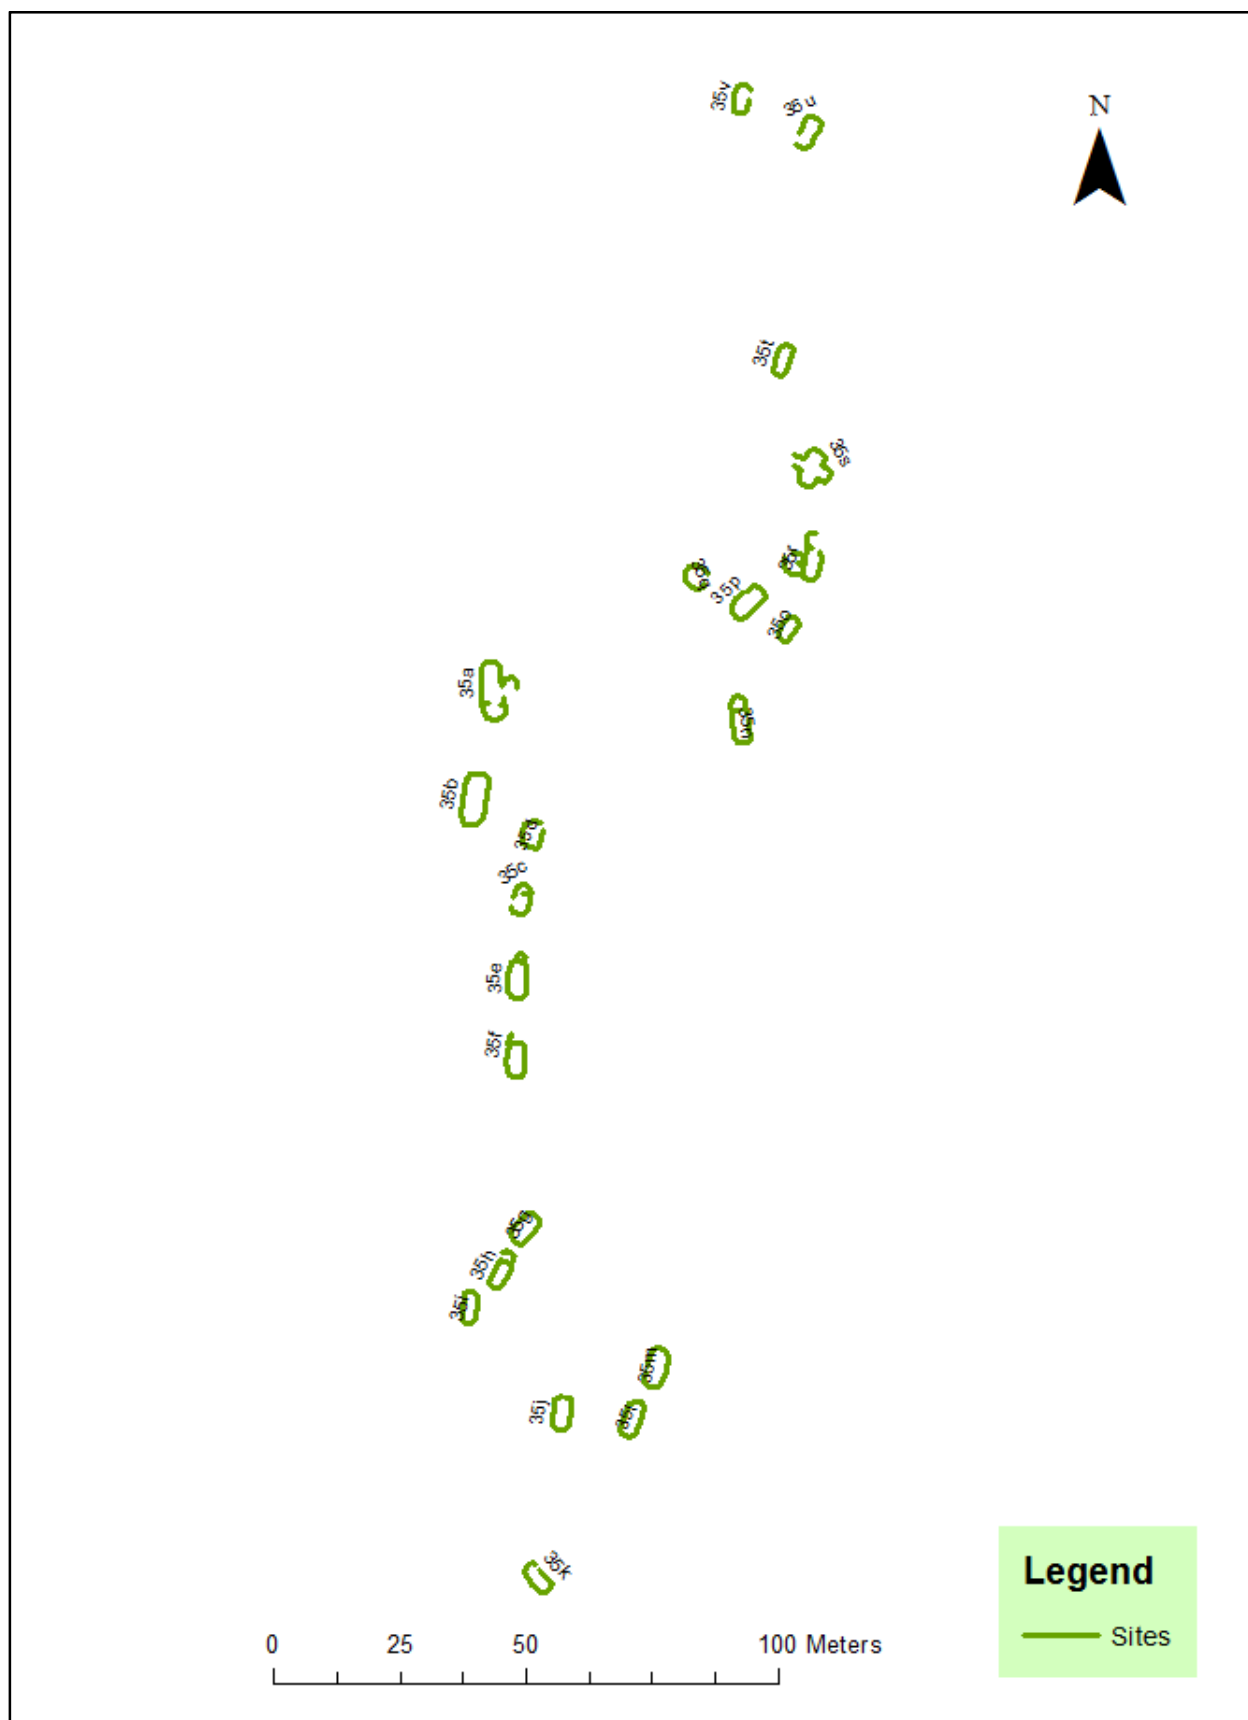
Twenty-two new shieling structures were surveyed and recorded along the Allt Coire nam Mart (**Figure 6**), south of the Allt Mor and Coire Fhearnasdail. These structures comprise ruinous heather- and grass-covered stone and turf structures of varying shapes and sizes along the east and west sides of the burn (**Plate 2**). The two northernmost structures had been much mutilated by previous machinery operations, although the other sites appear to have remained undisturbed. Differences in condition and construction of the shielings may indicate that there have been multiple phases of building and use of this site. Further description of individual structures is recorded in Appendix 1.

Figure 6 Site 35: Allt Coire nam Mart shieling settlement

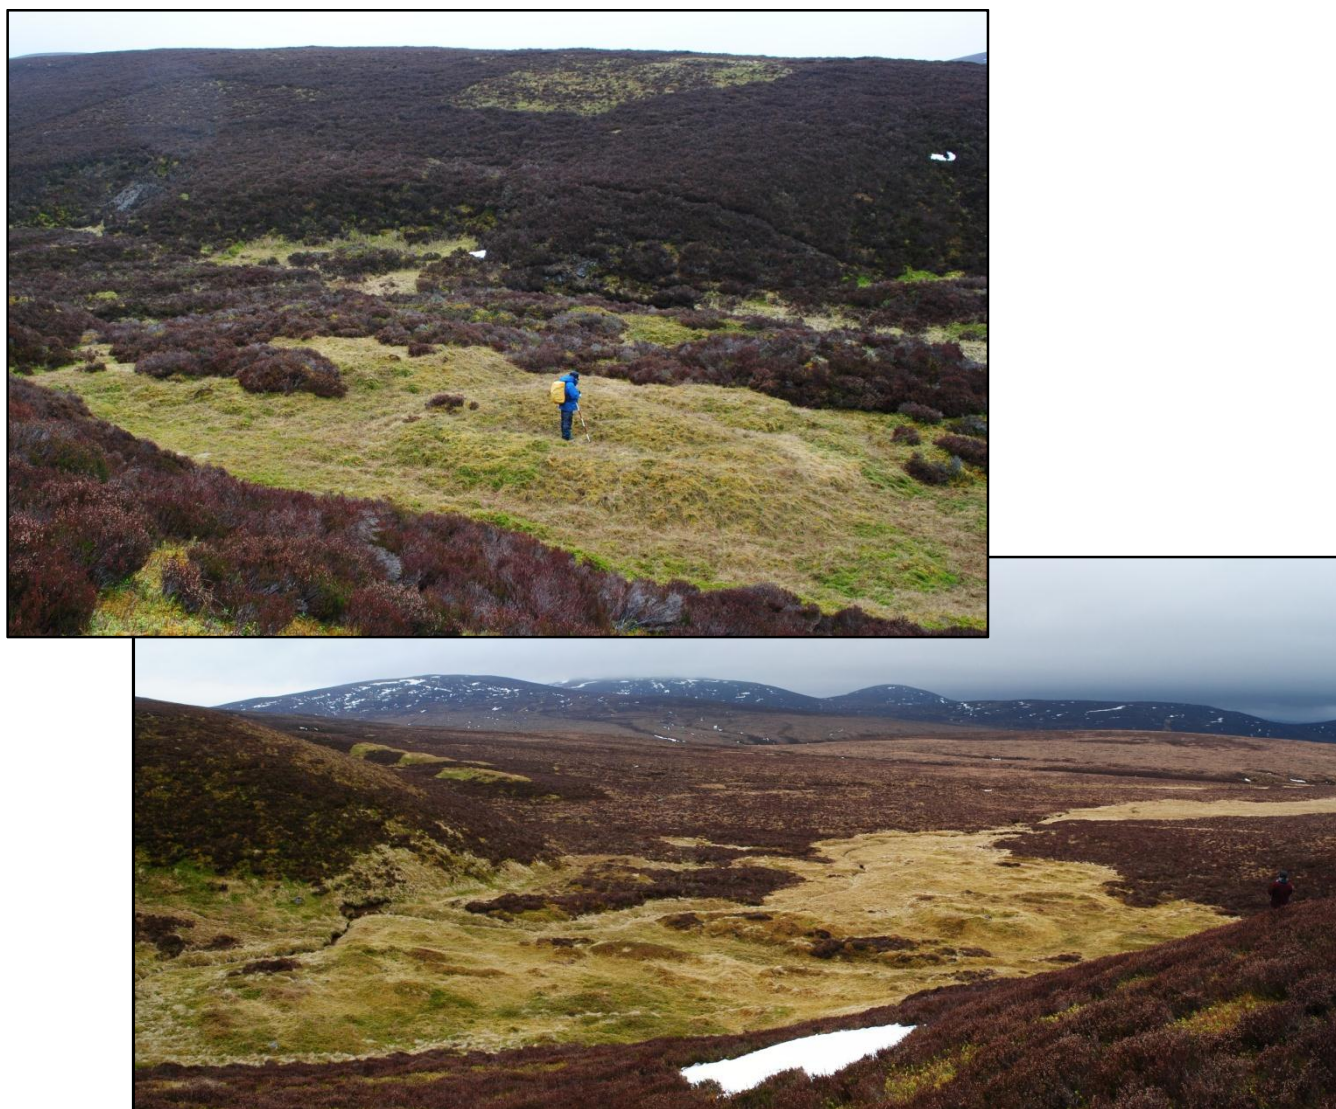
Plate 2 **Site 35t shieling structure at Allt Coire nam Mart (top left) and Site 51: Shieling settlement outside of the survey area**

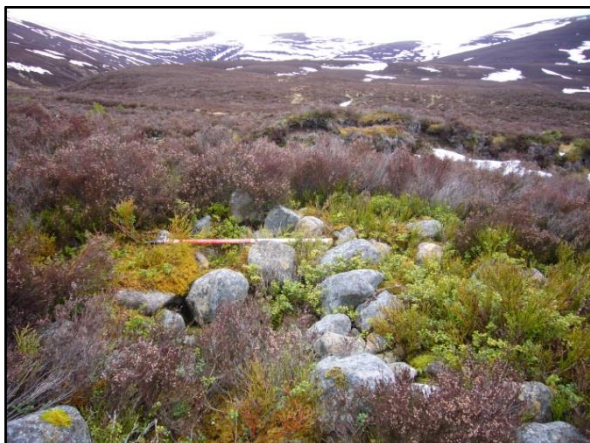
A rough, much degraded circular structure of drystone (**Plate 3**) was recorded alongside Allt Fhearnagan and has been interpreted as a possible still. It was located well upland to the east of settlement remains along River Feshie. The remote and hidden location of the site would support this theory.

Plate 3 Site 49: Possible still at Allt Fhearnagan

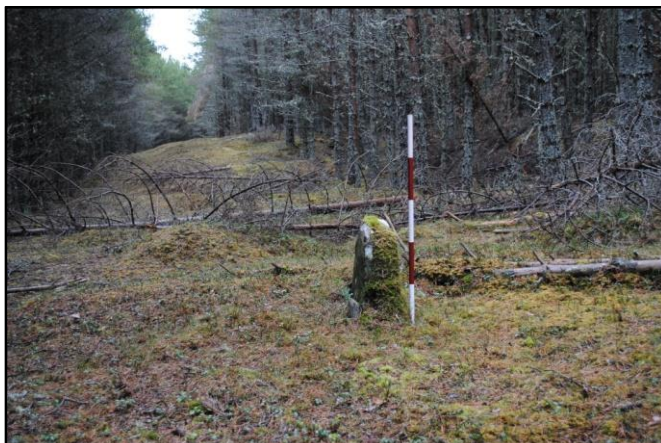
Two additional, much degraded shieling structures were also recorded at **Site 38** along the south end of Coire Fhearnasdail and another possible shieling, **Site 7**, was recorded on the east side of the Allt Mor. They appeared to have been mostly washed out by river flooding and hillslope erosion.

Plate 4 Site 7: upright marker stone

| No. | Site name | Site type | HHER No. | Description | Alignment | Category | Impact zone (m) | Condition | Period | Height OD (m) | Easting (centre) | Northing (centre) | Photo No. |
|---|---|---|---|--|---|---|---|---|---|---|---|---|---|
| 7 | Allt Mor | Shieling | - | Moss-, heather, bracken-covered possible turf shieling located to E side of Allt Mor; structure is very degraded, probably measured 2.5m in diameter with walls surviving to 0.3m high and spread to 1m wide | N-S | 2 | 10 | Very degraded | Post Medieval | 426 | 282817 | 796081 | - |

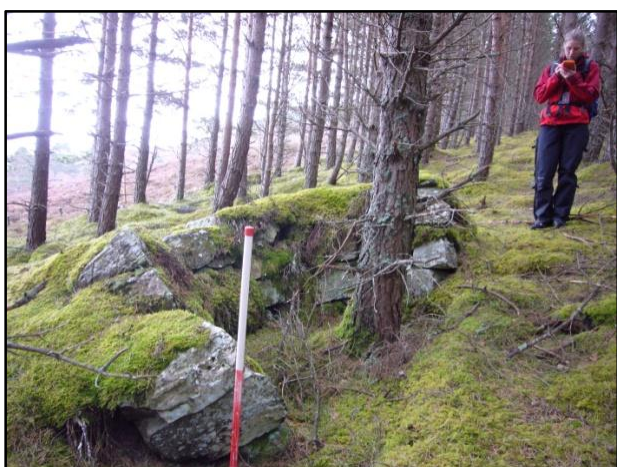
Plate 5 Shooting butt in Site 4

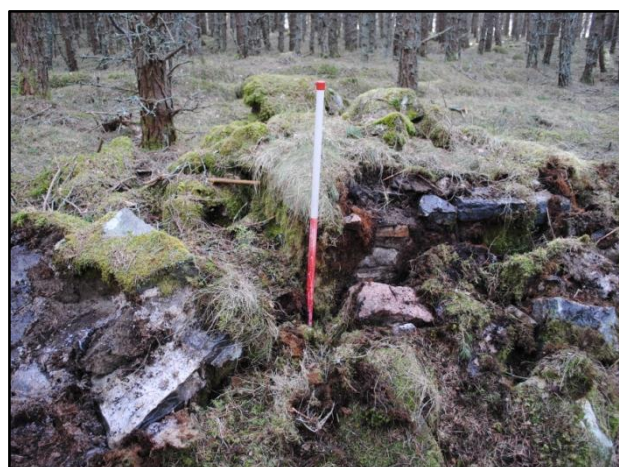
Plate 6 Site 2: WWII-era building ruins

| No. | Site name | Site type | HHER No. | Description | Alignment | Category | Impact zone (m) | Condition | Period | Height OD (m) | Easting (centre) | Northing (centre) | Photo No. |
|---|---|---|---|---|---|---|---|---|---|---|---|---|---|
| 2 | Druimcallich | Building | - | Remains of a demolished, moss- and grass-covered square mortar/stone building measuring 3m by 3m and surviving up to 0.75m high | N/A | 2 | 10 | Degraded | WWII? | 320 | 284735 | 798046 | 1-3 |

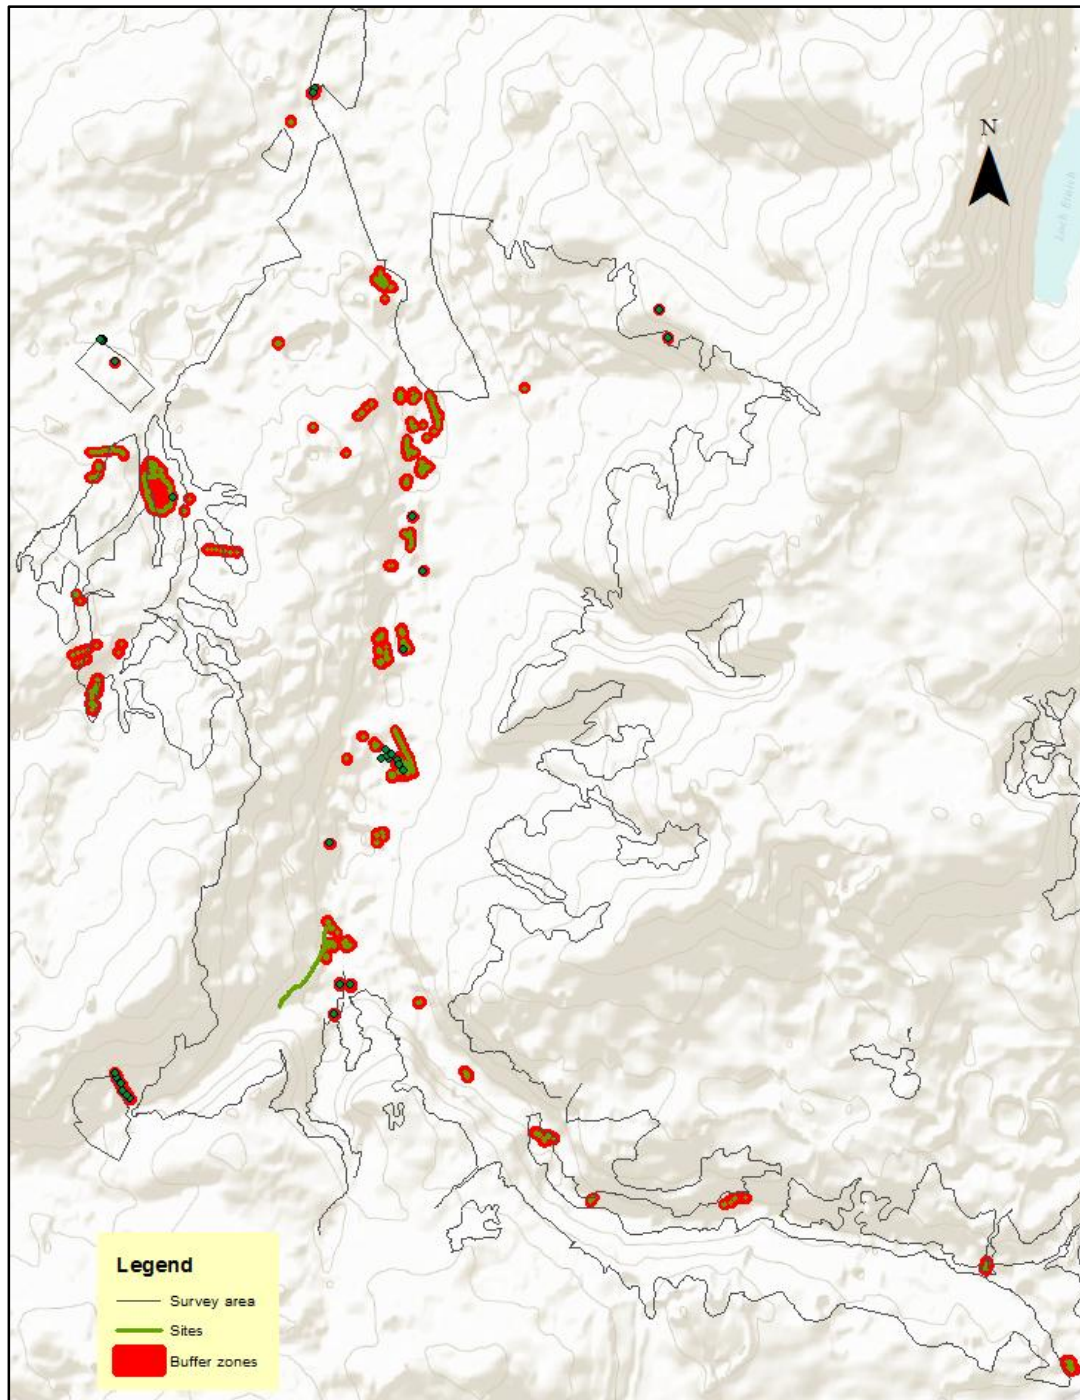
Figure 7 Location of buffer zones around archaeological sites

- A buffer zone of at least 5 metres should be left to each side of shooting butts, boundary dykes and enclosure walls and any new trees setting within these zones should be removed
- Access tracks for vehicles and the erection of any new fence lines should also respect the recommendations set out above
