Dun Borrodale, Raasay

Archaeological Survey Report

AOC 22014
23rd March 2012

On Behalf of:	Forestry Commission Scotland 1 Highlander Way Inverness Business Park Inverness IV2 7GB
National Grid Reference (NGR):	NG 5545 3641
AOC Project No:	22014
Prepared by:	Graeme Cavers
Illustration by:	Graeme Cavers
Date of Fieldwork:	6th to 7th March 2012
Date of Report:	23rd March 2012

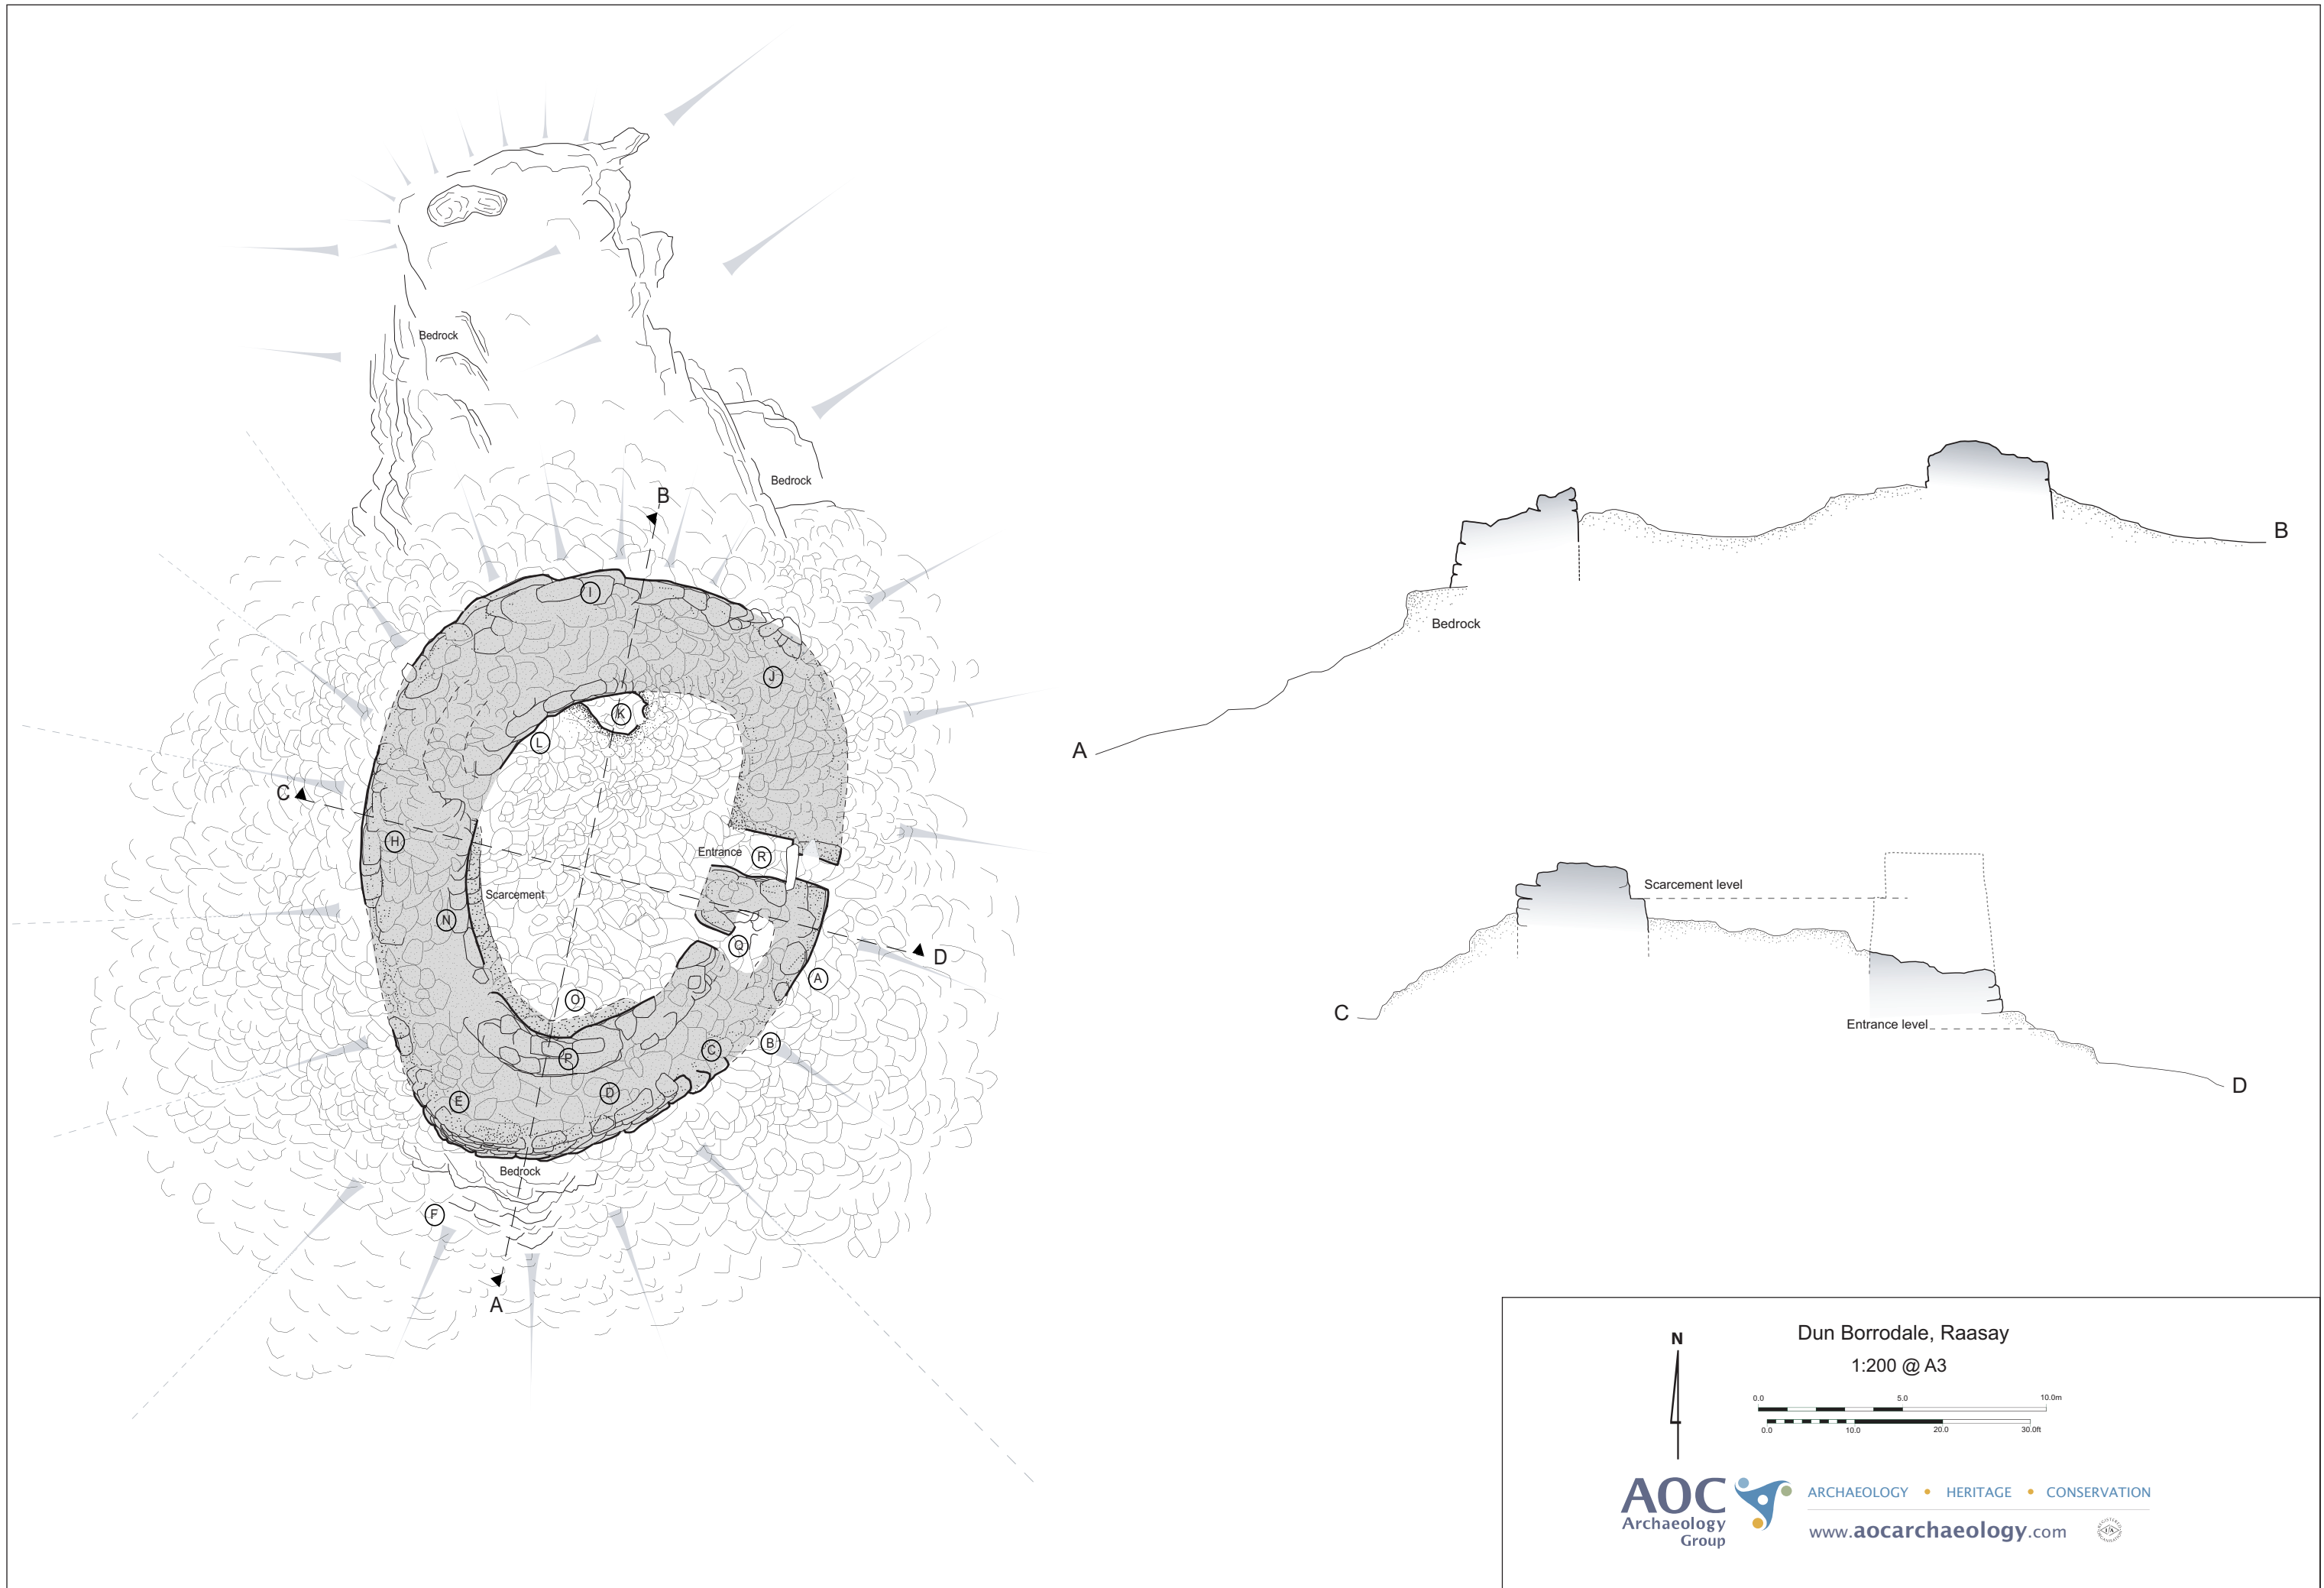
7. The following description refers to Figure 2, and the locations of features are labelled on that plan.
8. The broch comprises a sub-oval enclosure, with a wall which averages over 4m in thickness. Wall face is visible for much of the exterior circuit, although the NE quadrant is very ruinous and the wall face is lost in the rubble. There is a single entrance, in the E.

18. As Mackie considered (2007:845), Dun Borrodale must be sited on steeply sloping bedrock, with the level of the outcrop to the N of the wall just under 5m above that at the level of the entrance passage (see section C-D, Figure 2). Although the bedrock cannot be traced in many places other than at the N and S extents of the monument, the height difference that had to be overcome during construction was considerable. As noted above, it seems likely that the decision to place the entrance at the lowest point on the knoll was a deliberate attempt to accentuate the elevation above the entrance passage. As Mackie considered, the scarcement ledge is c.1m below the level of the bedrock on the northern outer wall face, and projecting this level across the site indicates that the first floor must have been at least 4.5m above the entrance passage level. Allowing for the upper galleries suggested by the remains on the wall head at points D and L, it seems likely that at least a further 2.5m of upper walling has been lost from the wall head. Again, projecting this level across the site leads to a total wall elevation of around 9m above the entrance passage, so that Dun Borrodale must be classed among the true 'broch towers' subgroup of Atlantic roundhouses.

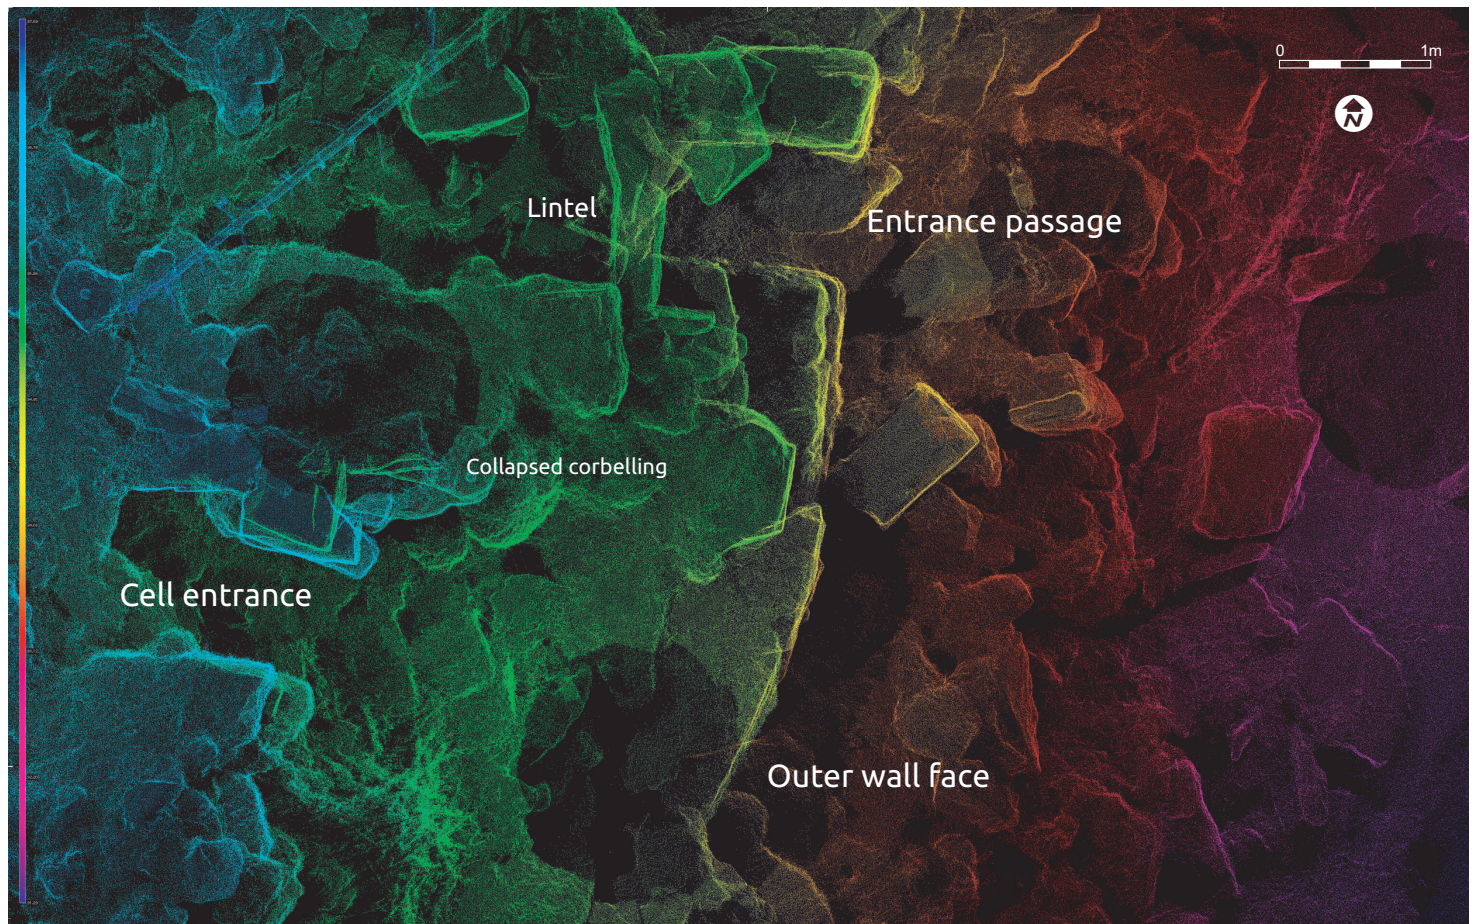
9. At point A, around the entrance, the outer wall face is comprised of very large quarried blocks, some up to 1m across (Plate 2; Figure 3); these heavy courses were evidently necessary to support the area of greatest elevation over the entrance. The entrance passage itself is 0.8m in width and has a door check 1.3m back from the outer wall face, where the passage widens to 0.95m in width. The passage itself is choked with rubble debris (Plate 4), and only a single lintel survives in situ.

17. At Point Q, an intramural cell was entered from within the broch interior (Plates 23-26; Figure 3). The corbelling of the cell is largely collapsed, but still visible standing to a height of c.0.7m. As noted above, it seems probable that the cell gave access to the stairs to the first floor level gallery, though no trace of these is visible in the rubble. The gallery floor level appears to be somewhat higher than the ground level at the entrance, so that the interior must be very uneven, similar in character to that at Caisteal Grugaig, Totaig, where the entrance is placed at the lowest point on the site, and intramural galleries are entered higher up slope.

Figure 3: Orthographic plan image (coloured by elevation) of the entrance and intramural cell, at Points A and B (scale 1:50)

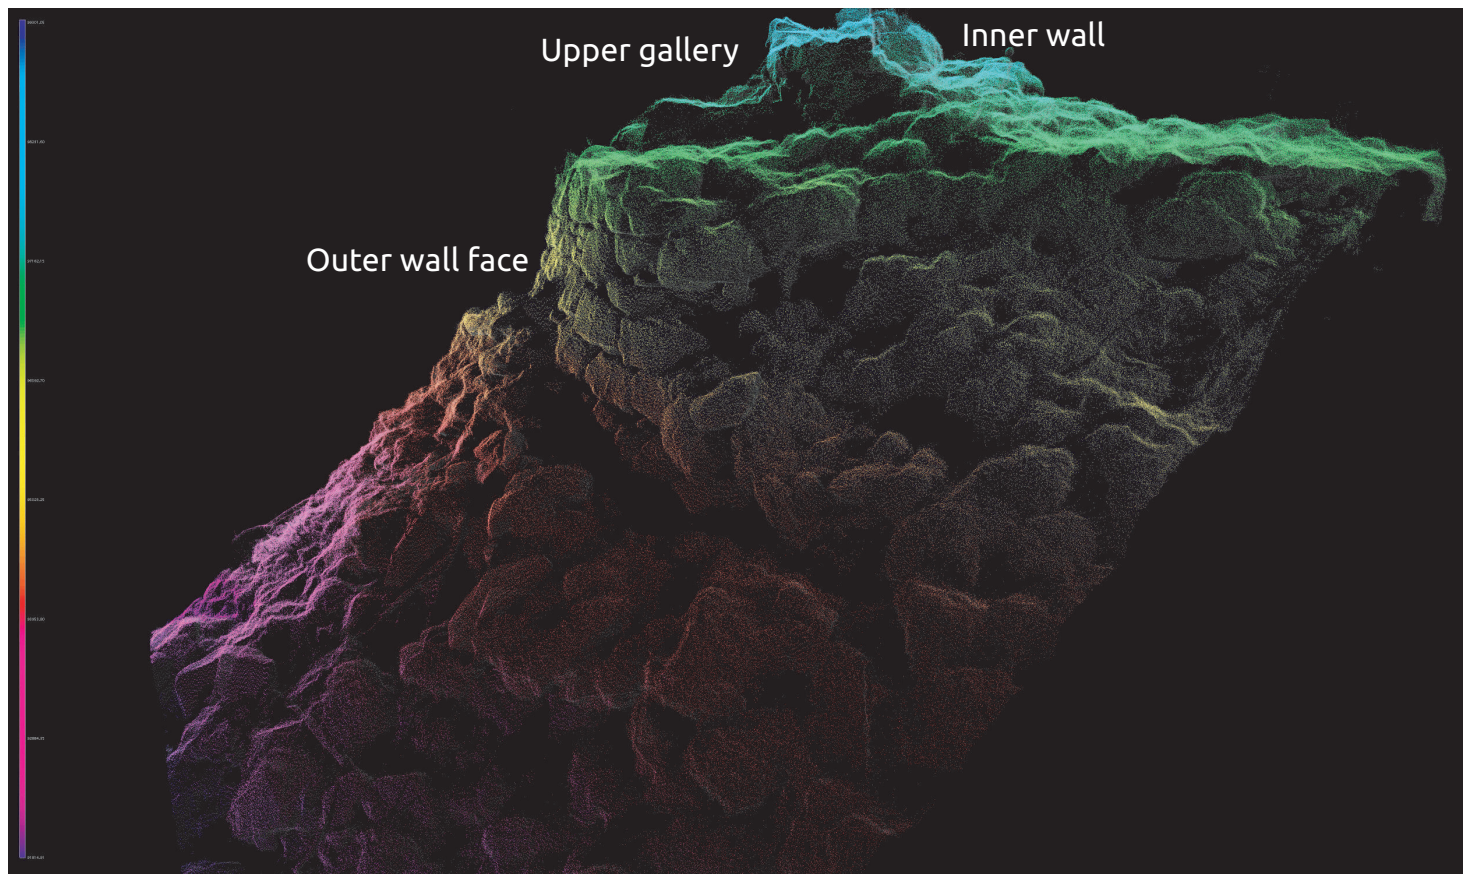
10. The wall face to the S of the entrance at point B is ruinous, and the rubble from the collapse of the wall at this point slopes down the hillside to the E. Where the wall has broken, at point C, the inner and outer walls of the composite broch wall are visible (Plate 5), between which is the intramural space which must have formed the first floor gallery (Plates 6 and 7; Figure 4). Mackie (2007) speculates that the space between Point D and the cell to the S of the entrance passage (described at Point Q, below) may contain stairs to the first floor gallery; these are not visible in the rubble but this seems a plausible suggestion.

Figure 4: Perspective image coloured by elevation of the collapsed wall at Point C, showing the inner wall and upper gallery space (facing SW).

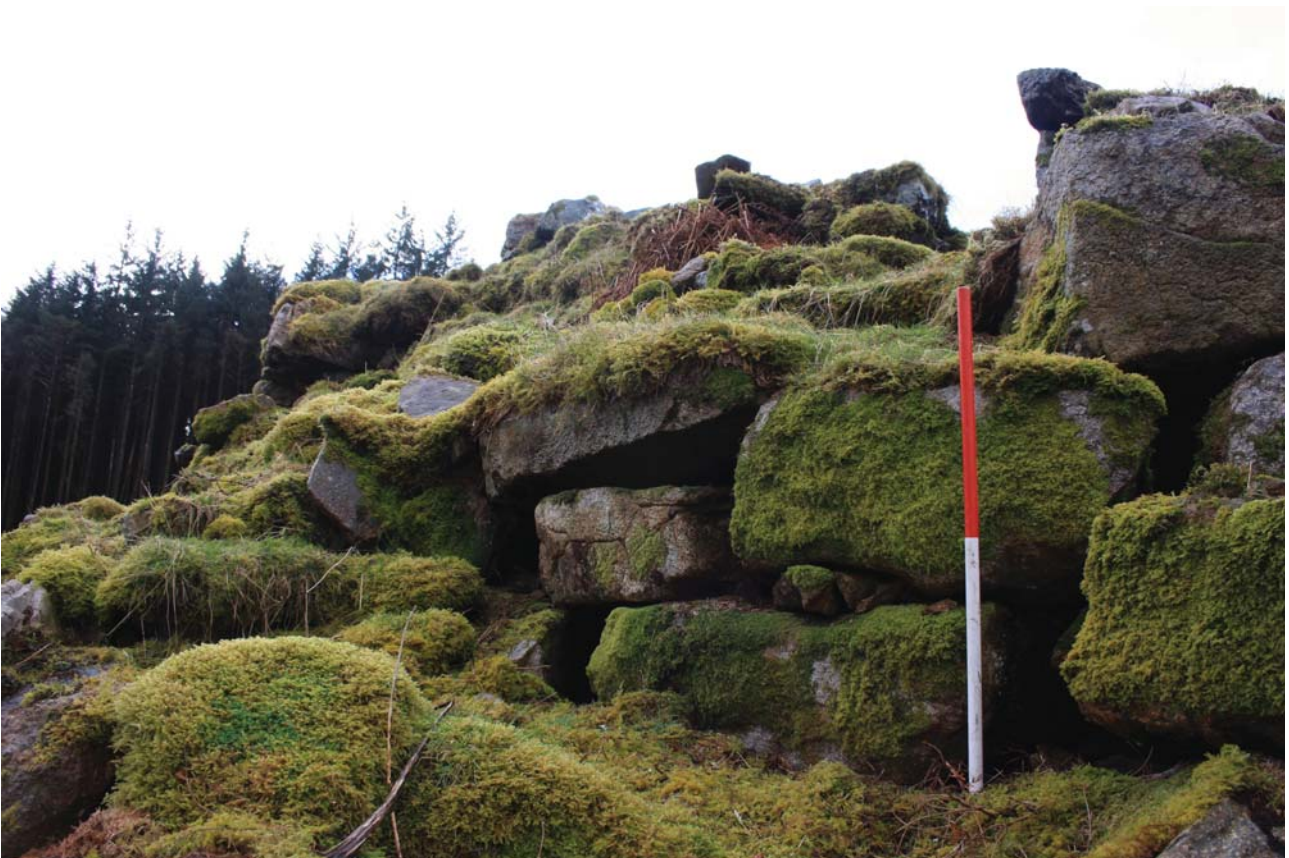
Plate 2: Large quarried blocks in the outer wall face at Point A, facing W

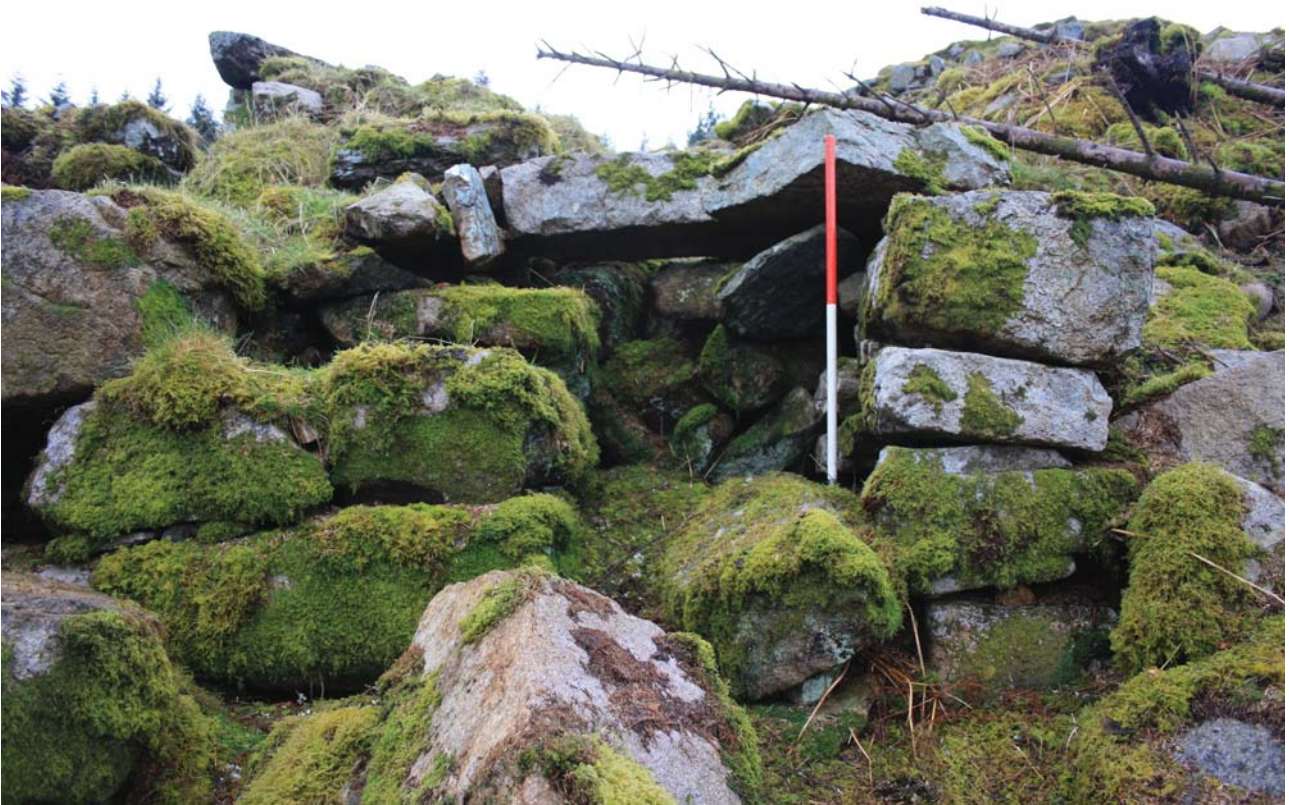
Plate 3: View of the entrance passage, showing the surviving lintel, looking W

20. Three areas would be worthy of future condition monitoring: the surviving lintel over the entrance passage, but more pressingly the surviving corbelling of the intramural cell at Point Q and the exterior wall face at Point E, where several stones are missing. Previous inspection and condition survey of broch structures has indicated that those areas of broch walls immediately adjacent to broken areas (as at Point C and Point J) are most vulnerable to collapse, as pinning stones are lost due to the release of tension in the circuit of the wall.

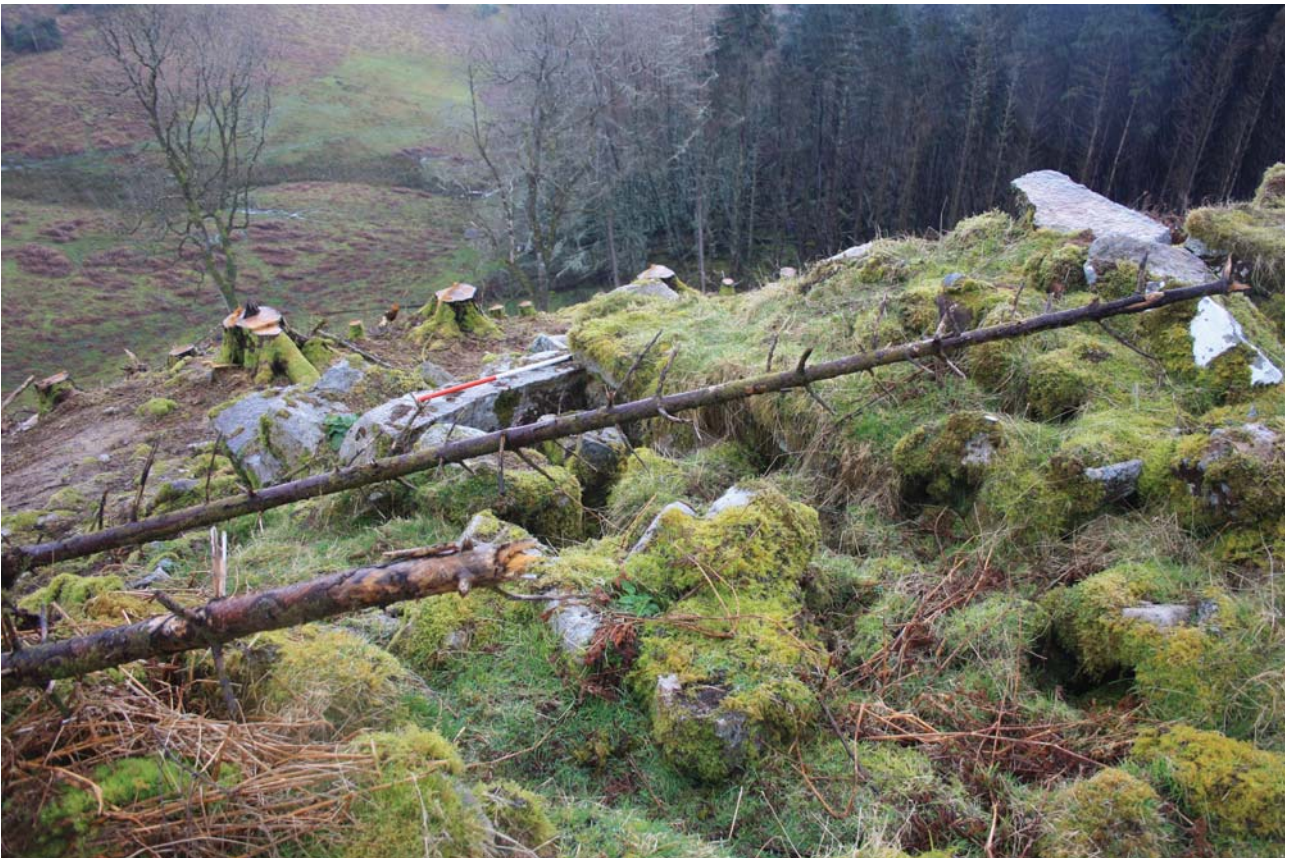
Plate 4: View of the entrance passage from the interior, facing SE

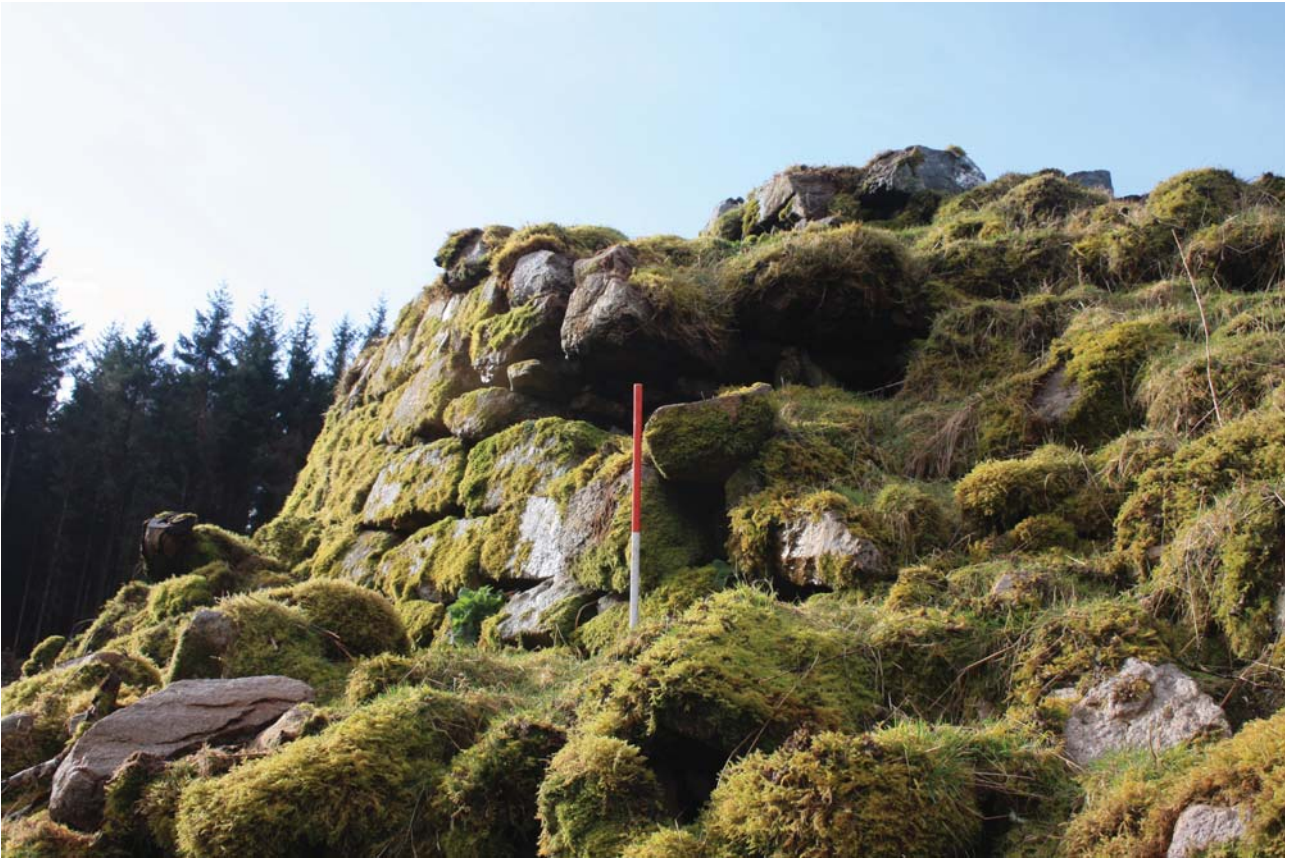
Plate 5: View of the breach in the broch wall at Point C, facing SW

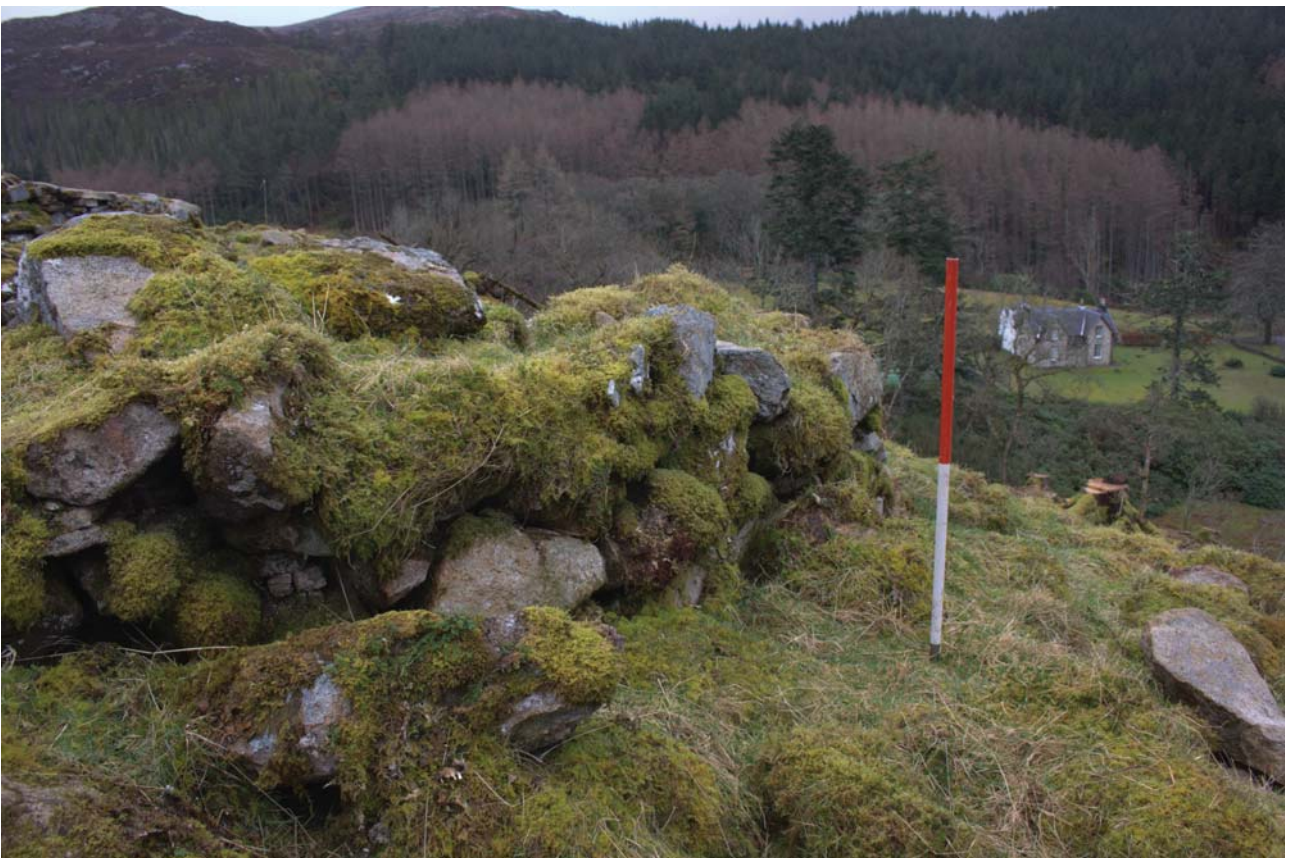
Plate 6: View of the first floor gallery at Point D, looking E.

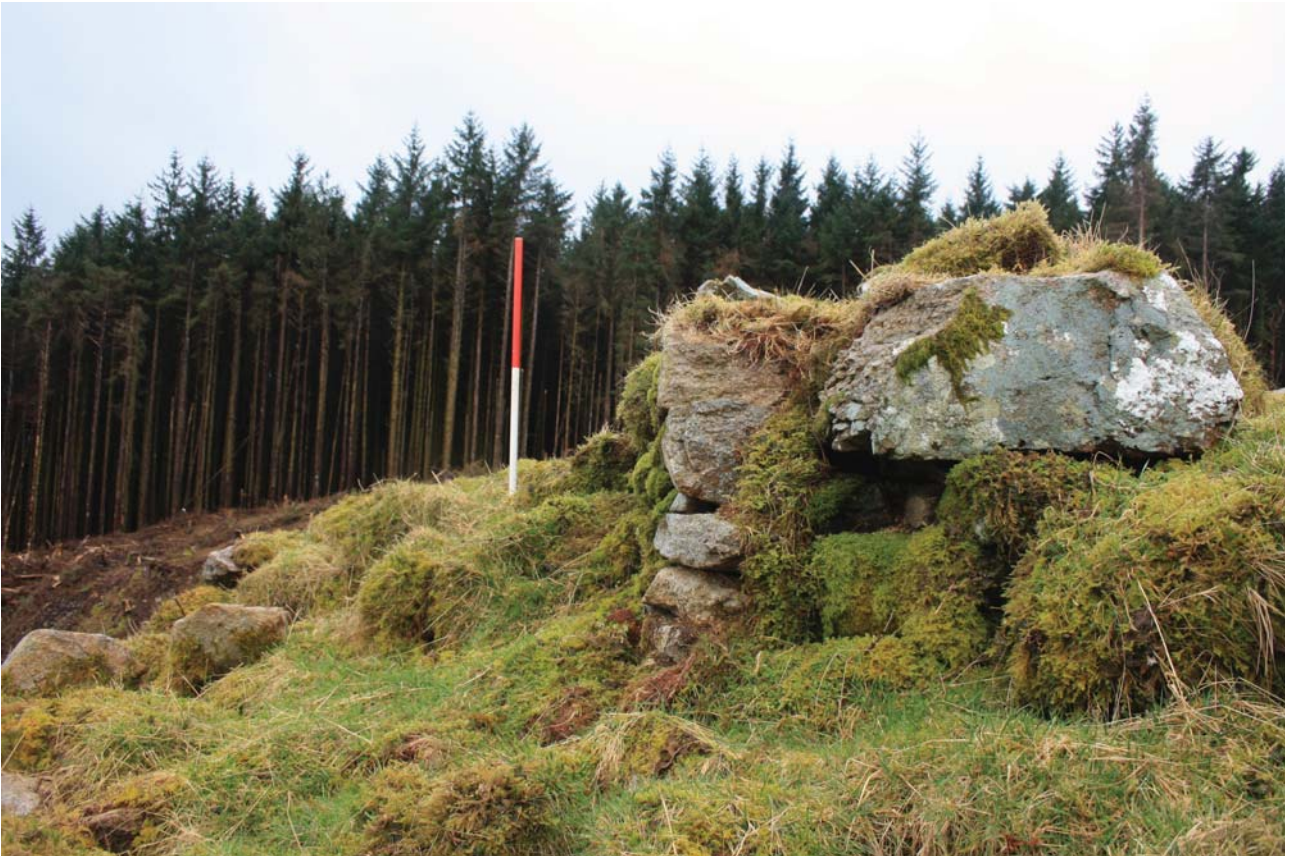
Plate 7: View of the broken end of the inner wall at first floor level, at Point P, looking W

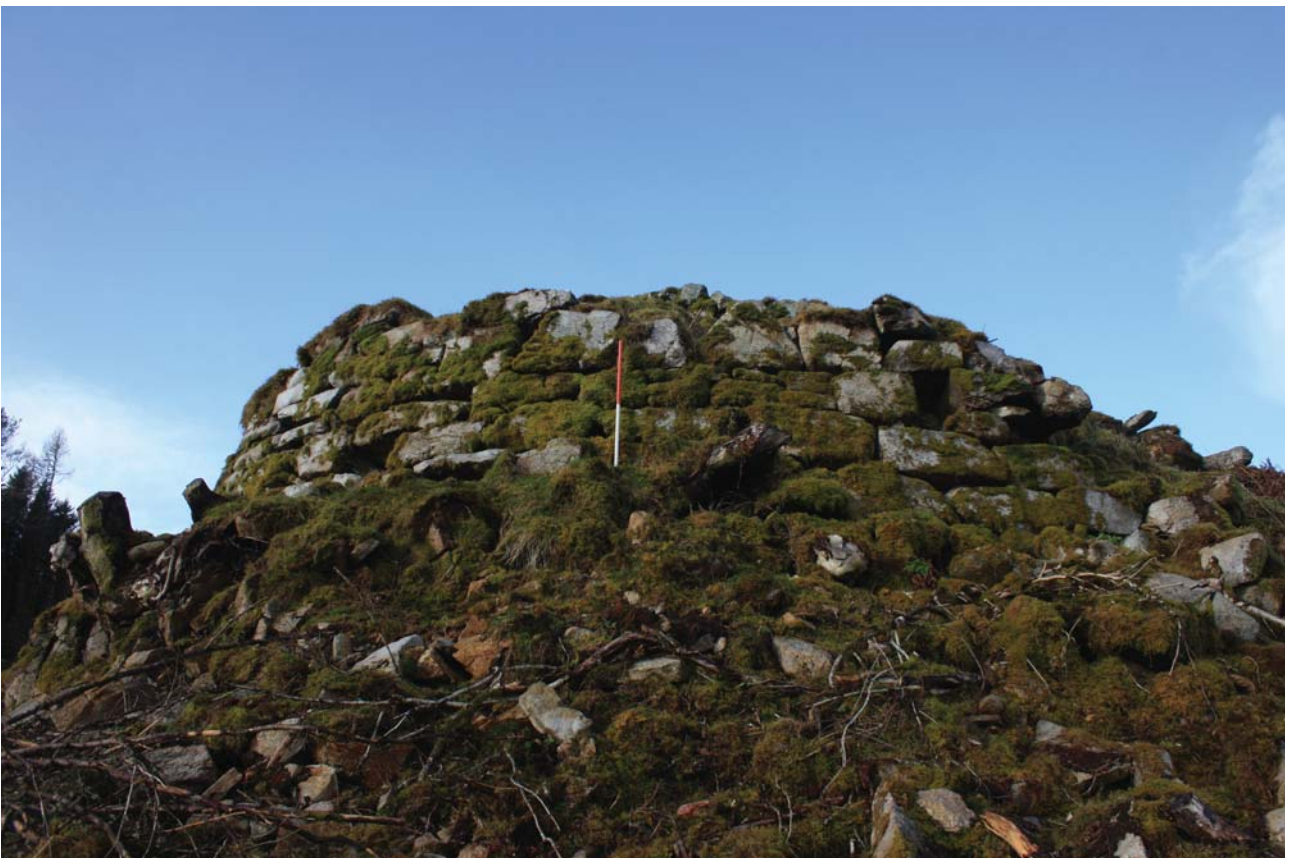
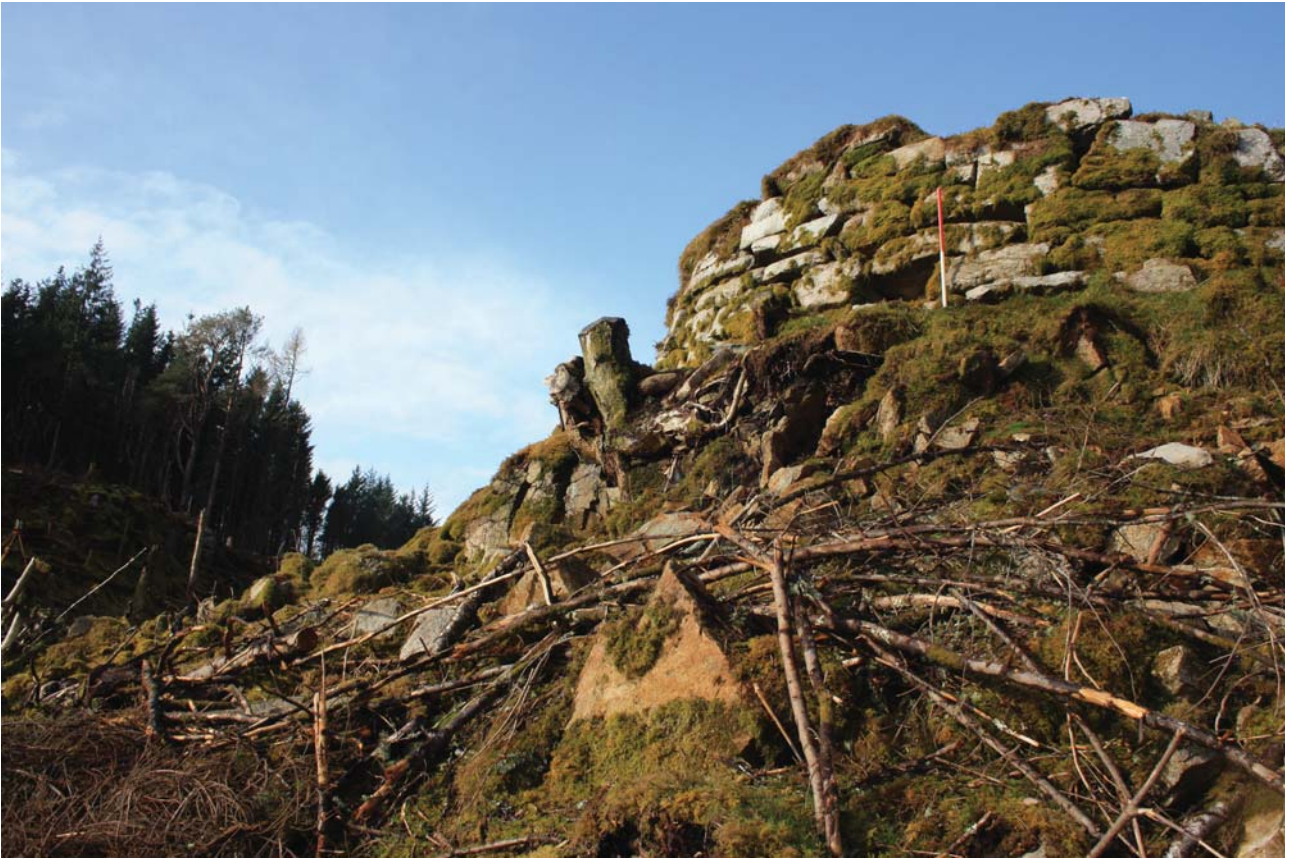
11. Continuing around the exterior of the broch to the S, the wall is preserved to its greatest height at Point E, where the outer wall stands to 2m in 6 courses of blocks averaging around 0.5m across. The wall has a pronounced batter at this point, and steps back from the steep bedrock outcrop on which it is built (Plate 8 and 9). Several of the large blocks have fallen from the wall face at this point, although the structure seems stable (Plate 10 and 11).

Plate 8: Outer wall face of the broch at Point E, looking N

Plate 9: Outer wall face of the broch at Point E, looking NW

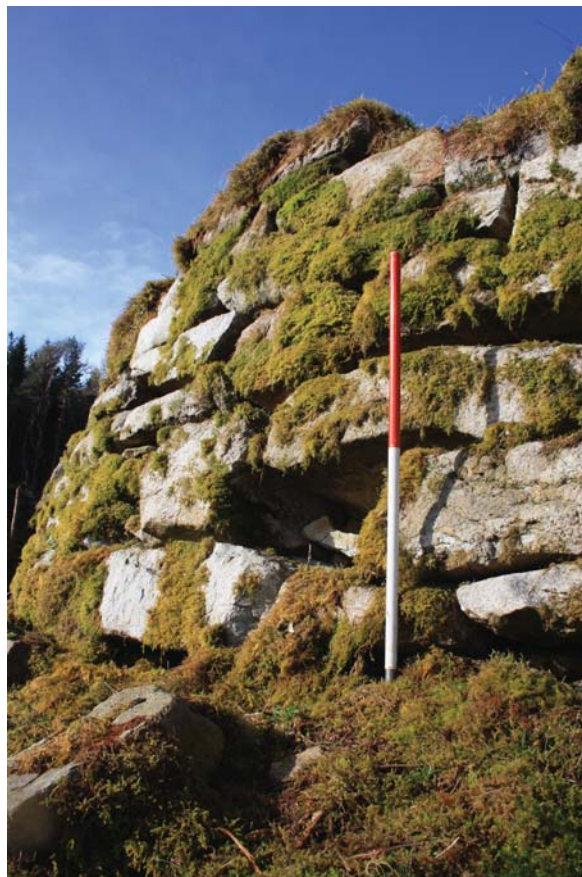
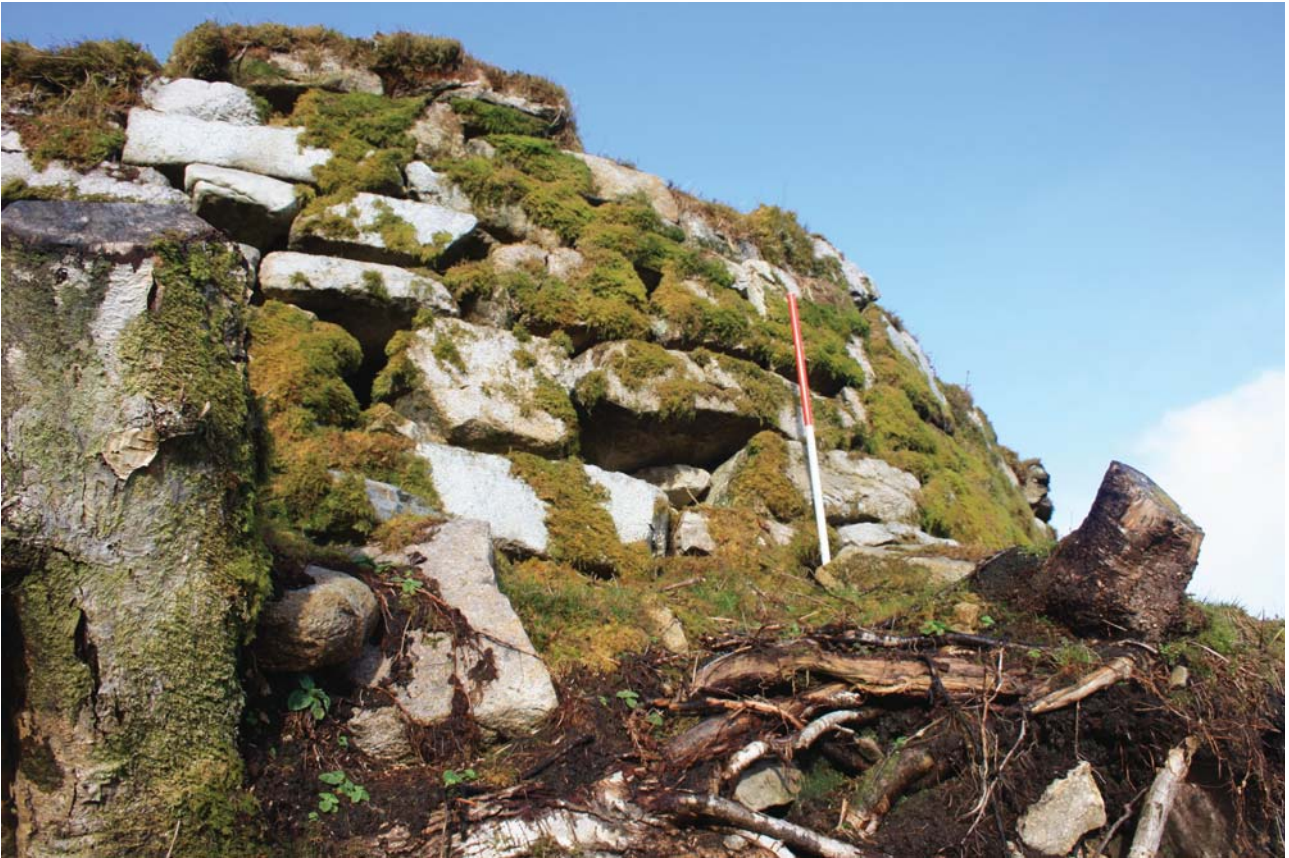
Plate 10: Missing blocks in the outer wall face at Point E, facing N

Plate 11: Missing blocks in the outer wall face at Point E, facing NE

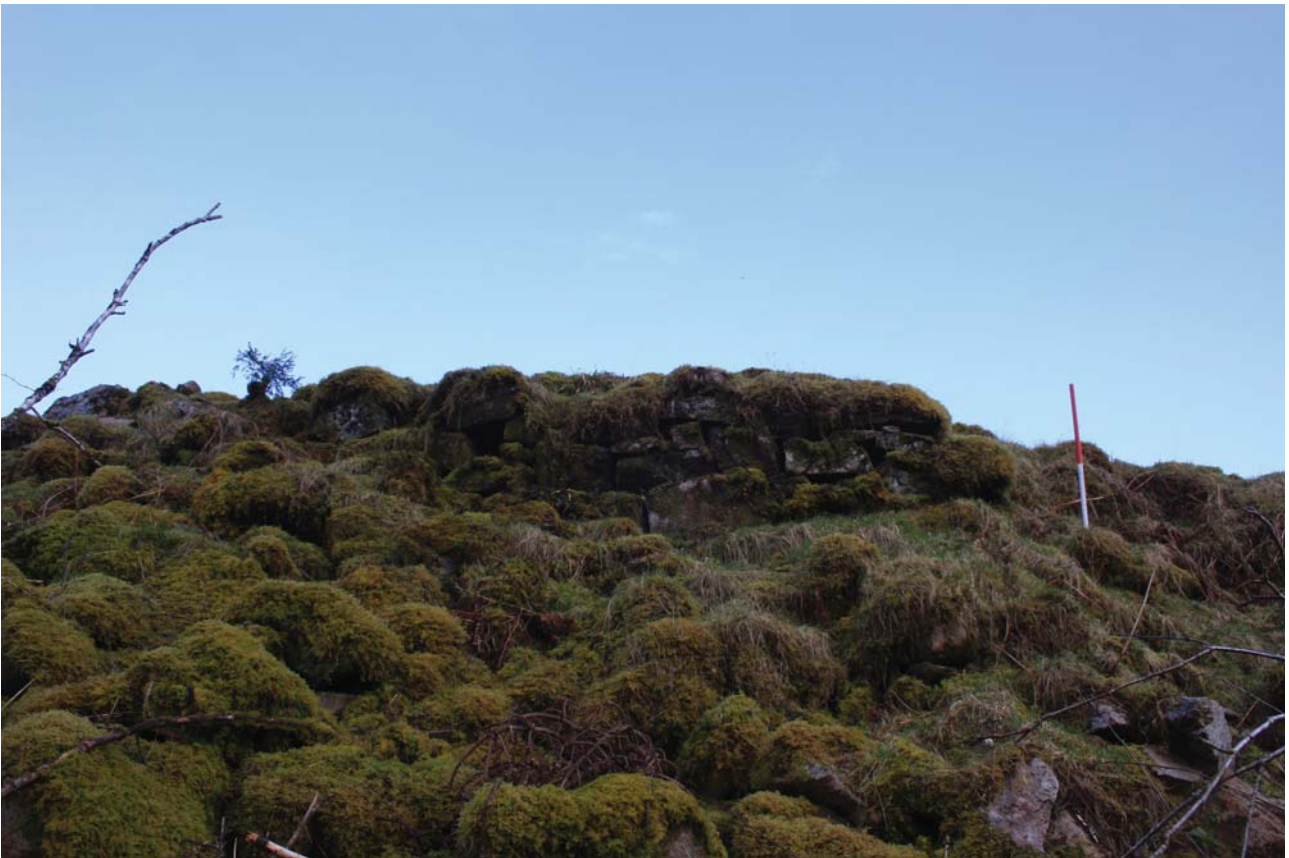
12. The outer wall in the SW quadrant of the broch is largely ruinous and concealed by rubble collapse. At point H the outer face is visible where it stands to three or four courses above the rubble level (Plate 12). The outer wall face at Point I to the north is similarly denuded, where the bedrock is at

Plate 12: Outer wall face at Point H, facing E.

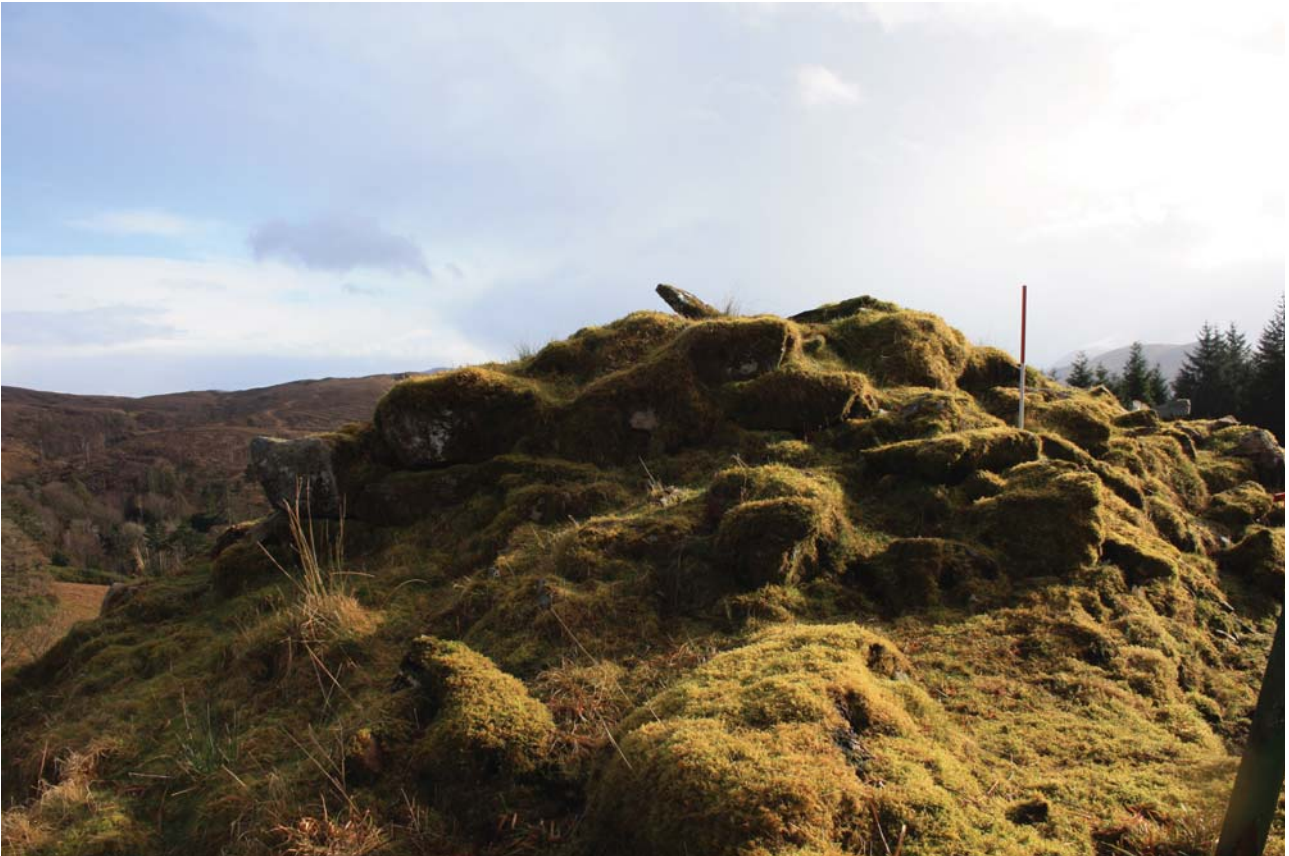
Plate 13: Outer wall face at Point I, facing S

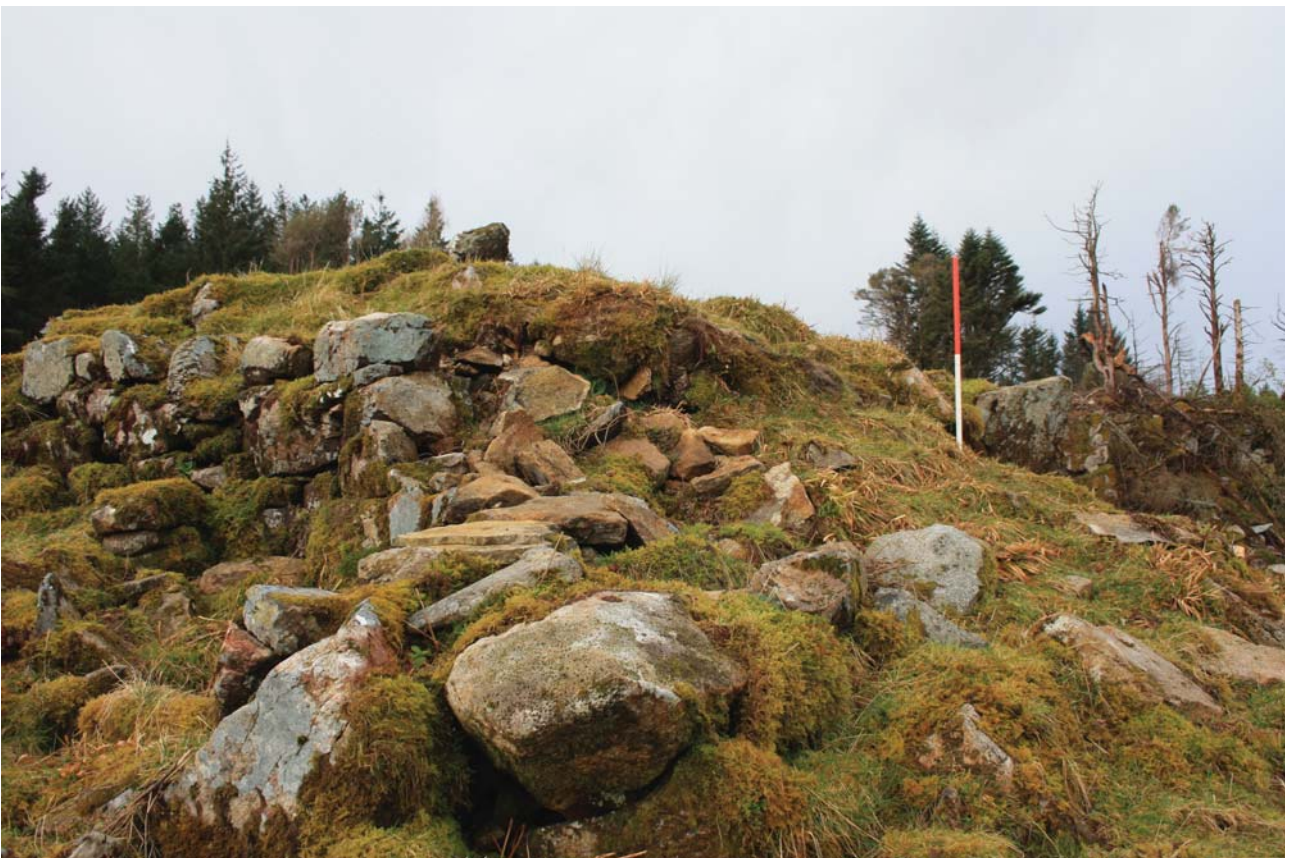
its highest point on the site (Plate 13). The wall in the NE quadrant of the site, Point J, is ruinous (Plate 14).

Plate 14: Ruinous wall in the NE quadrant of the site, Point J, looking W
