Dun Borrodale, Raasay

Archaeological Survey Report

AOC 22014
23rd March 2012

On Behalf of:	Forestry Commission Scotland 1 Highlander Way Inverness Business Park Inverness IV2 7GB
National Grid Reference (NGR):	NG 5545 3641
AOC Project No:	22014
Prepared by:	Graeme Cavers
Illustration by:	Graeme Cavers
Date of Fieldwork:	6th to 7th March 2012
Date of Report:	23rd March 2012

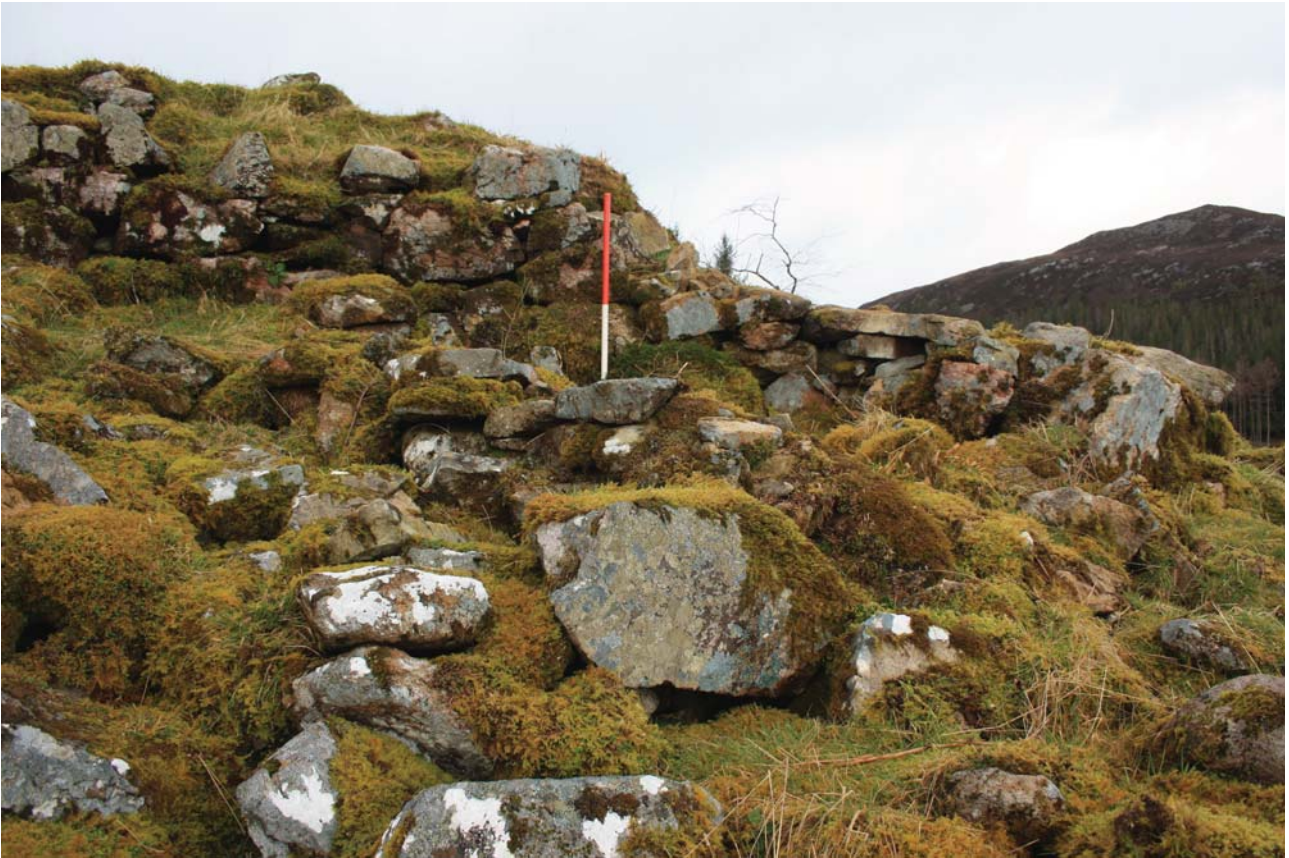
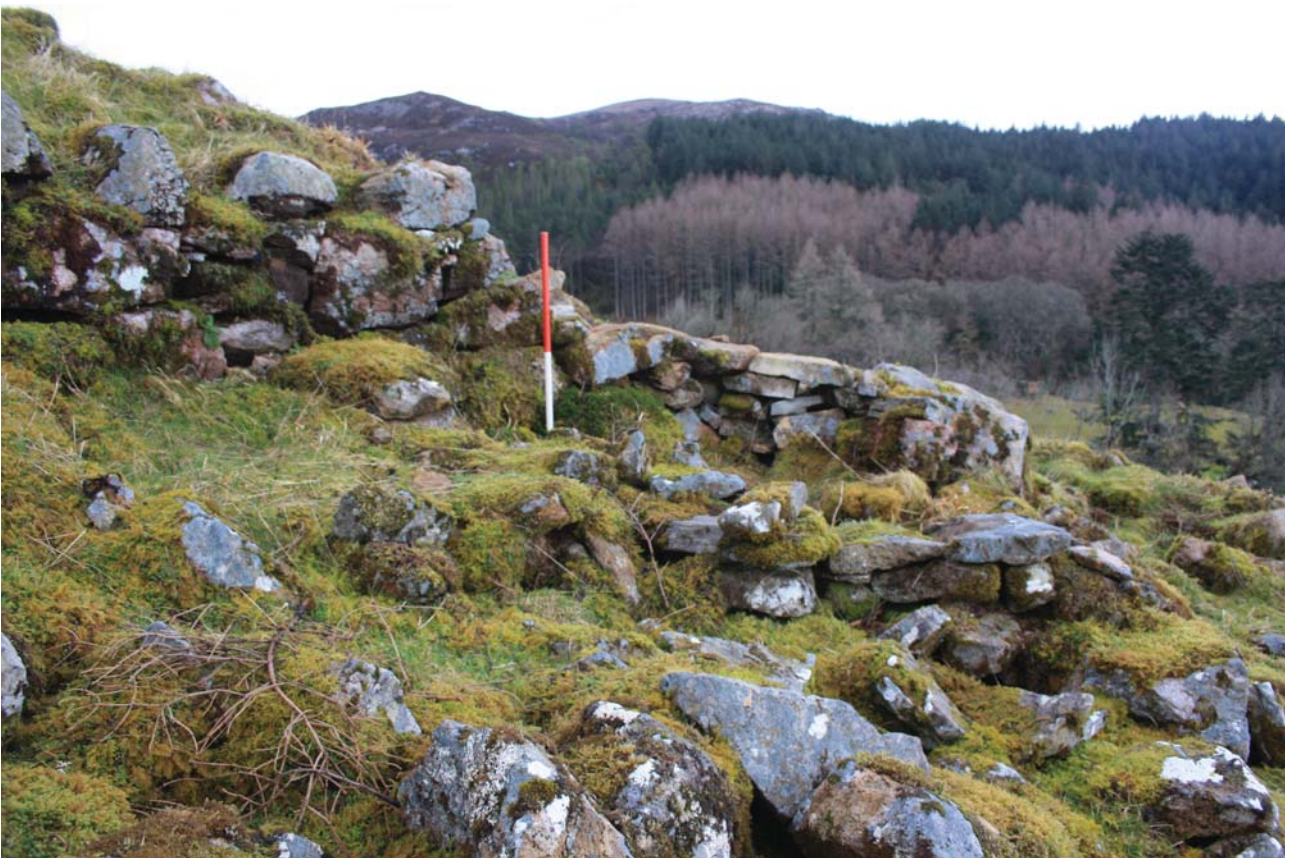
13. In the interior rubble at Point K, a small structure has been built out of the collapse of the broch (Plate 15 and 16); this appears to be of relatively recent origin and is poorly built.

Plate 15: Small structure constructed in the rubble of the broch interior, at Point K, looking N

Plate 16: Small structure at Point K, looking NE

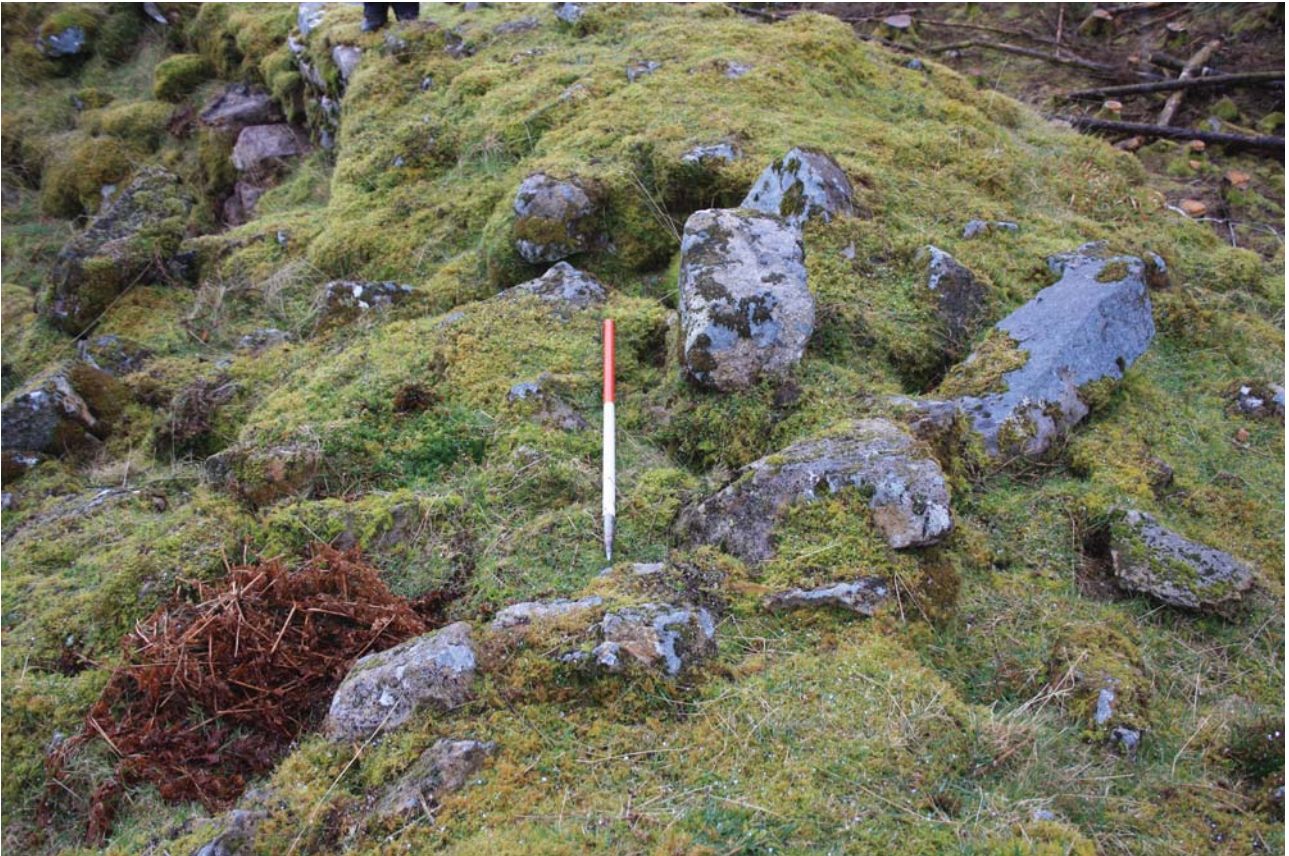
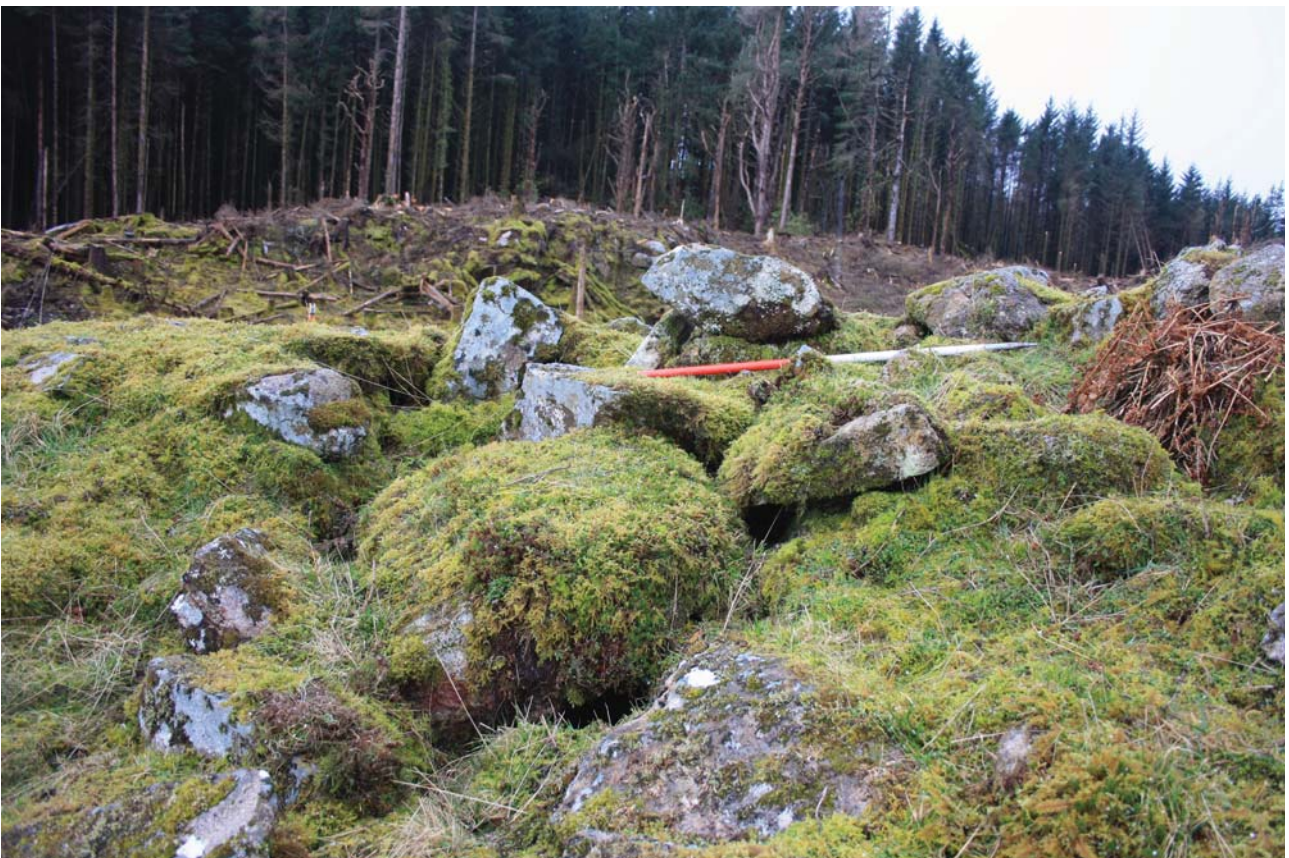
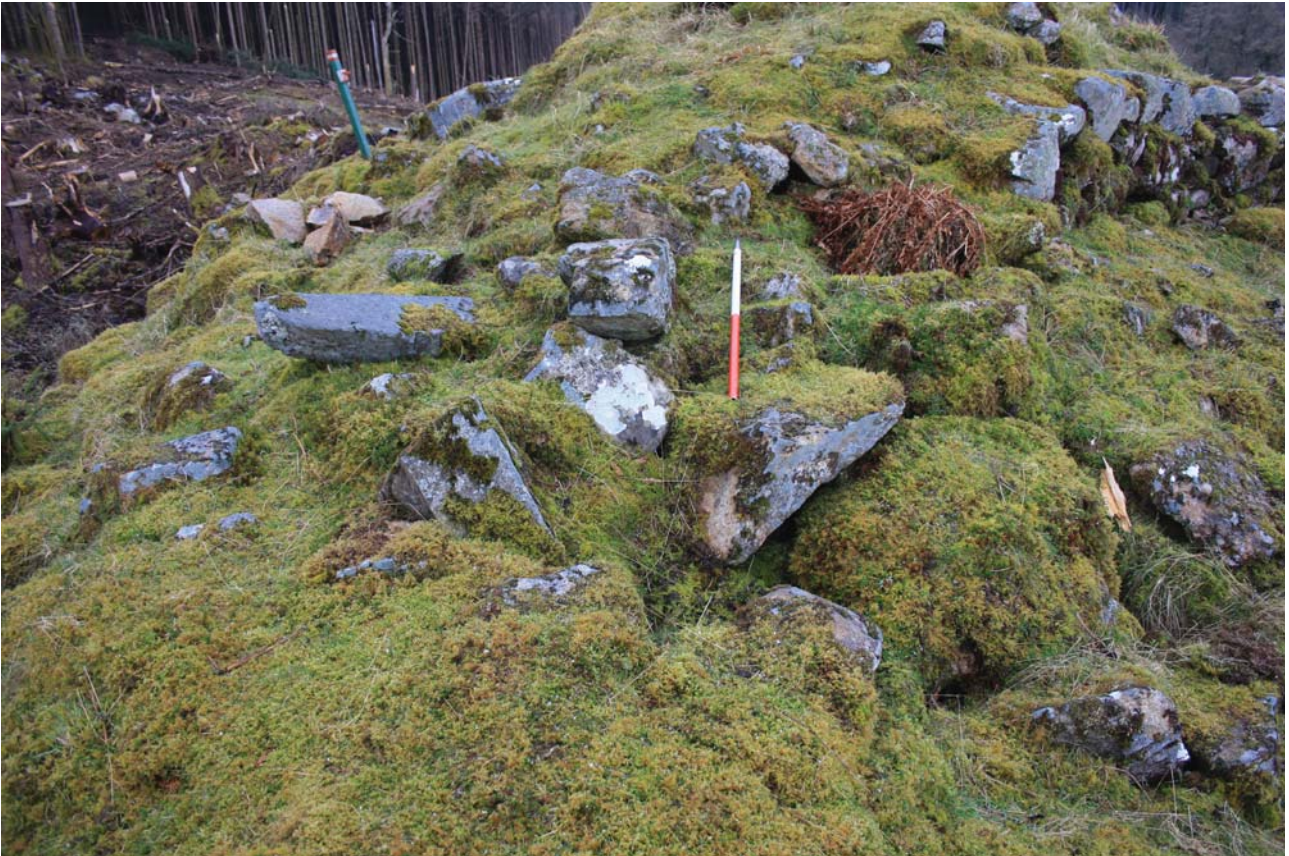
14. At Point L, previous surveyors have suggested the presence of an upper gallery, entered from first floor level. Mackie was not convinced by the evidence for this gallery, but inspection of the stones in this area suggested to the present surveyors that this gallery may indeed be present, accessed from the interior of the broch and curving to the N (Plates 17-19).

Plate 17: Possible upper gallery at Point L; showing possible lintels and corbel stones, looking S

Plate 18: Possible collapsed upper gallery at Point L, looking W

Plate 19: Possible collapsed upper gallery at Point L, looking N

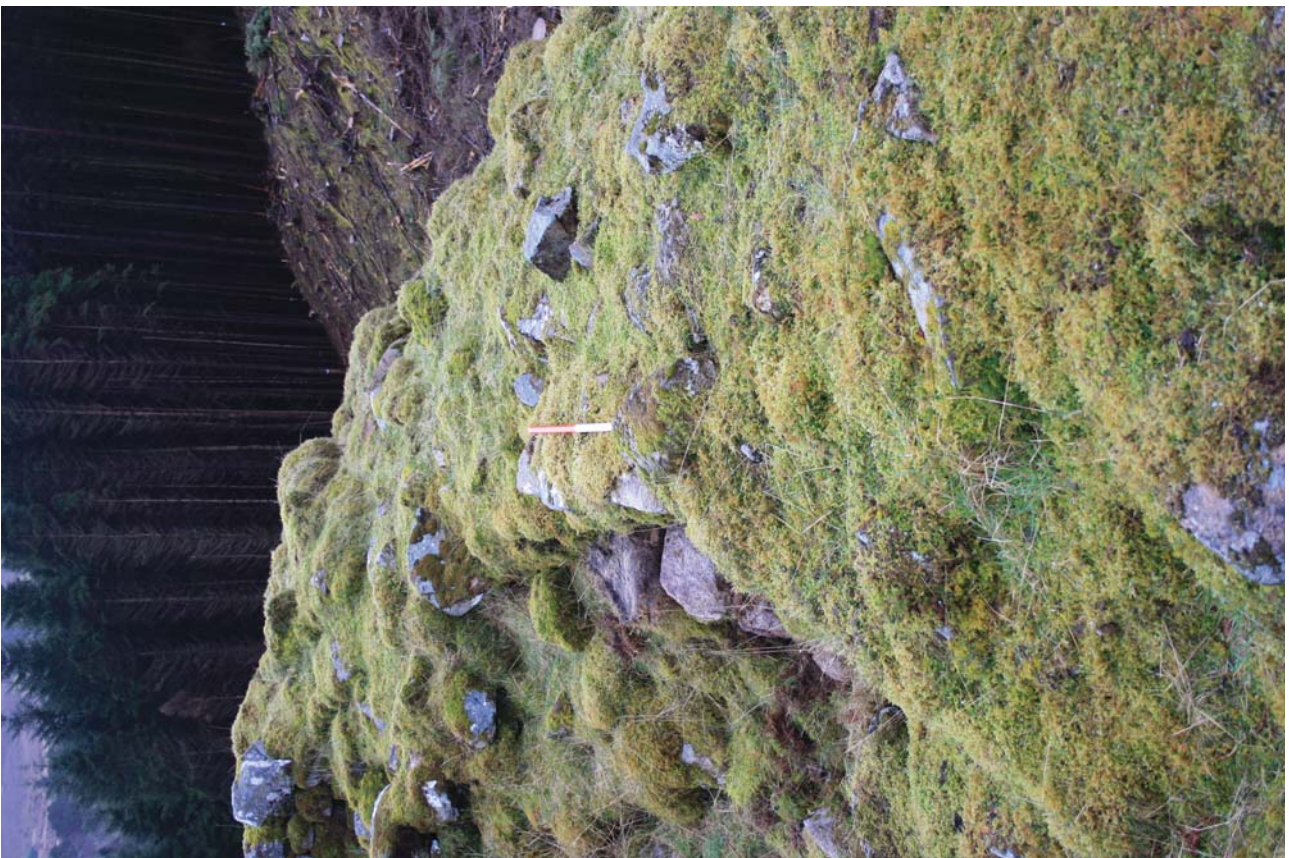
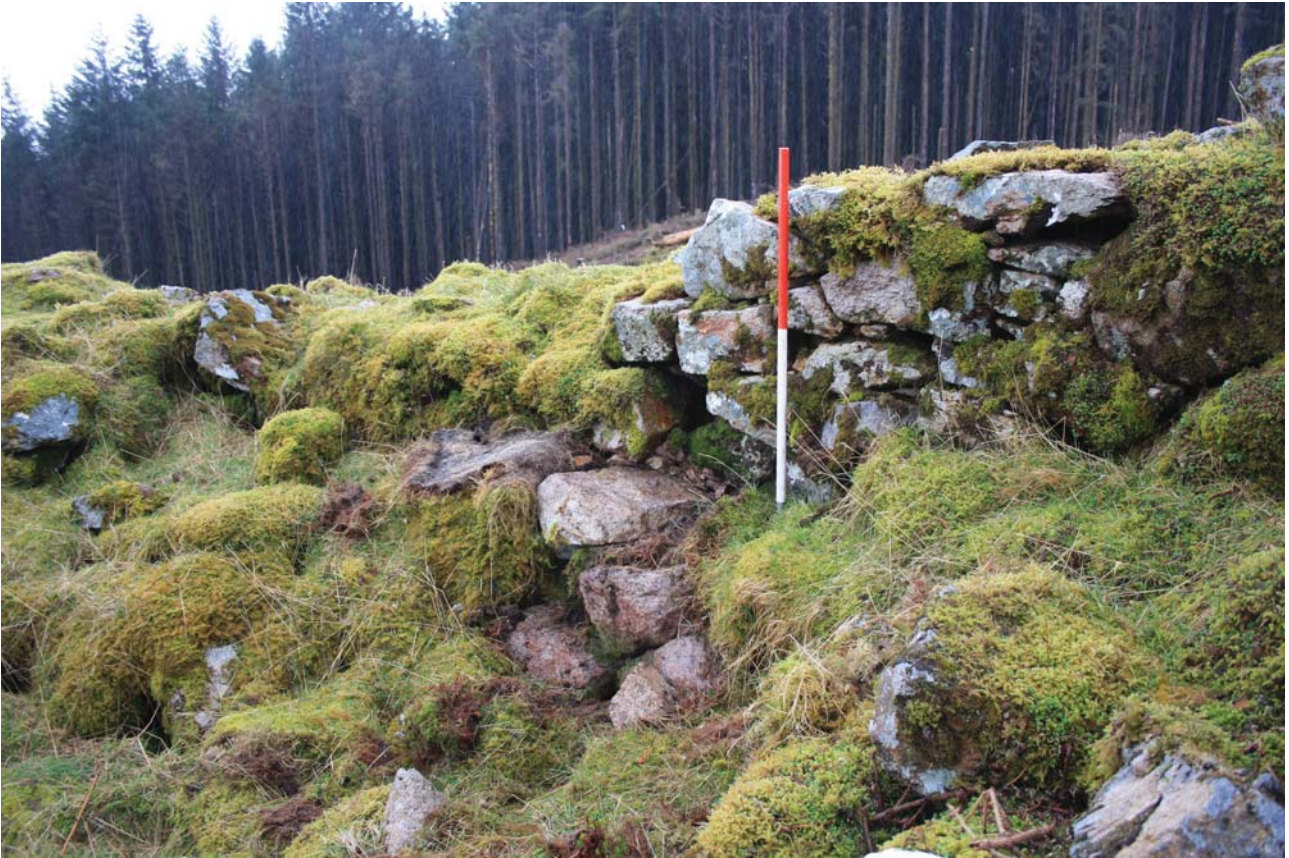
15. At Point N, the scarcement is visible, projecting from the inner face of the broch wall; it is of 'ledge' type and is 0.3m wide where visible (Plates 20 and 21). Previous surveyors have plotted the scarcement ledge running around the S interior wall face of the broch, though this is now largely obscured by rubble collapse.

Plate 20: The wall head at Point N, showing the scarcement on the inside of the broch to the left; facing S

Plate 21: The scarcement ledge at Point N, facing SW

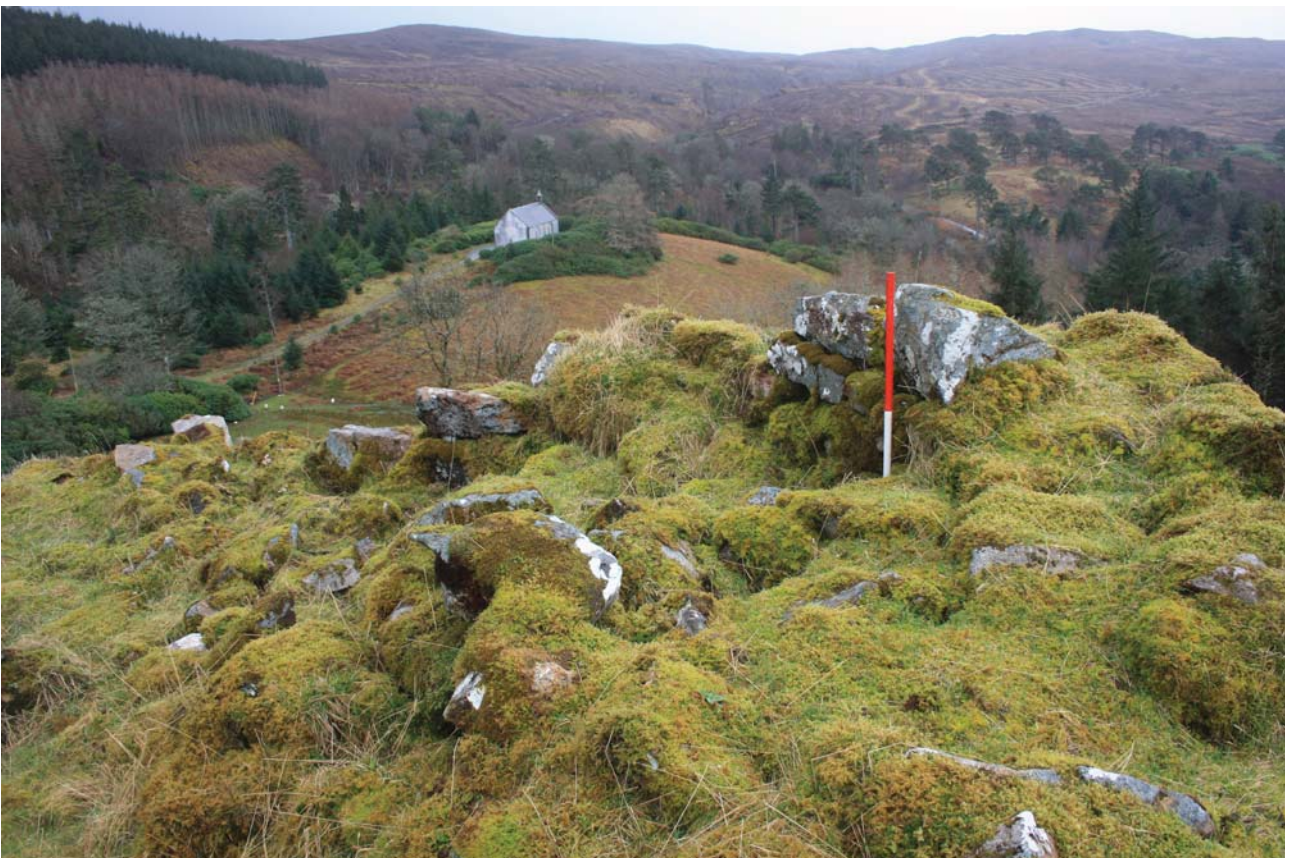
16. The interior wall face stands to its greatest height in the S, at Point O and P (Plate 22), where it stands to 0.9m in height above the level of the rubble collapse; elsewhere it is largely ruinous or obscured by rubble.

Plate 22: The interior wall face at Point P, facing SE

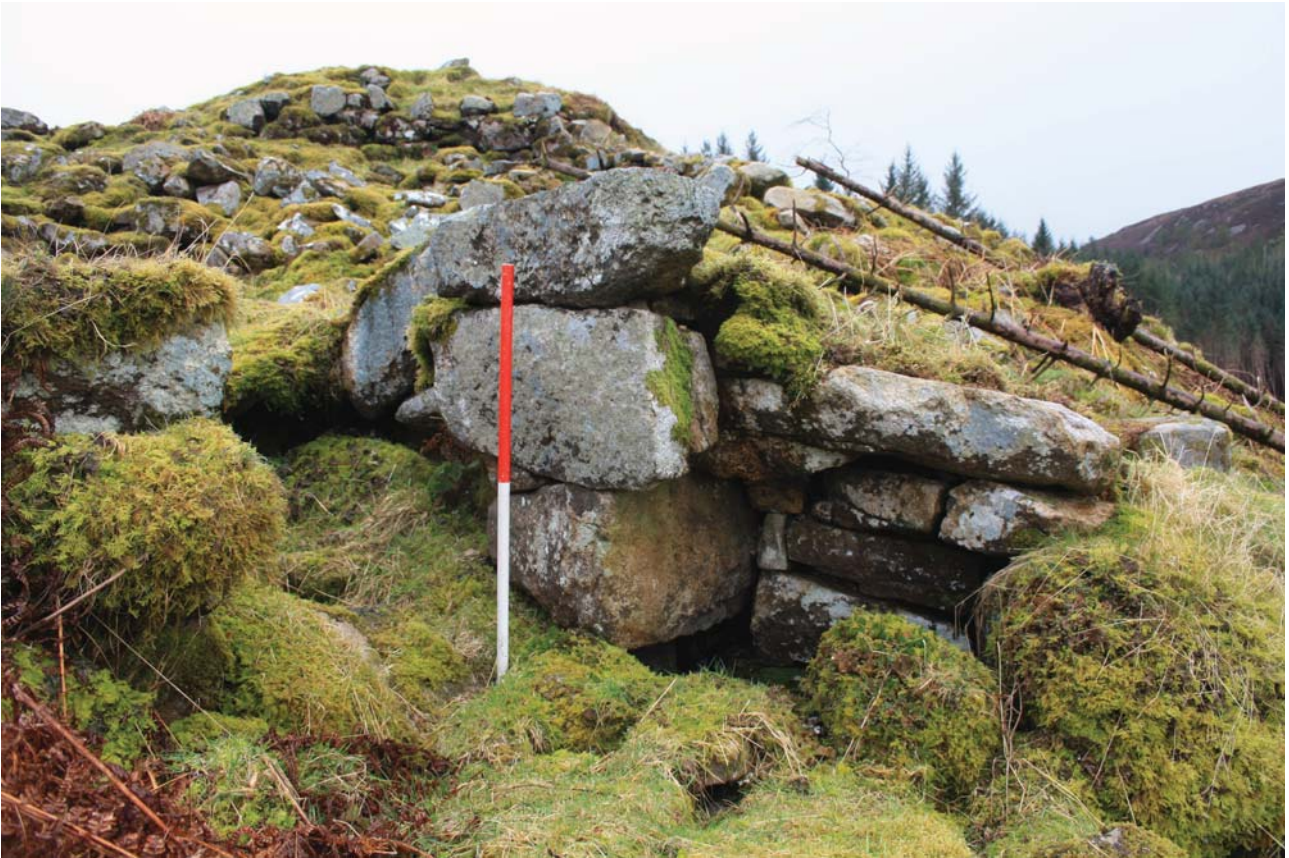
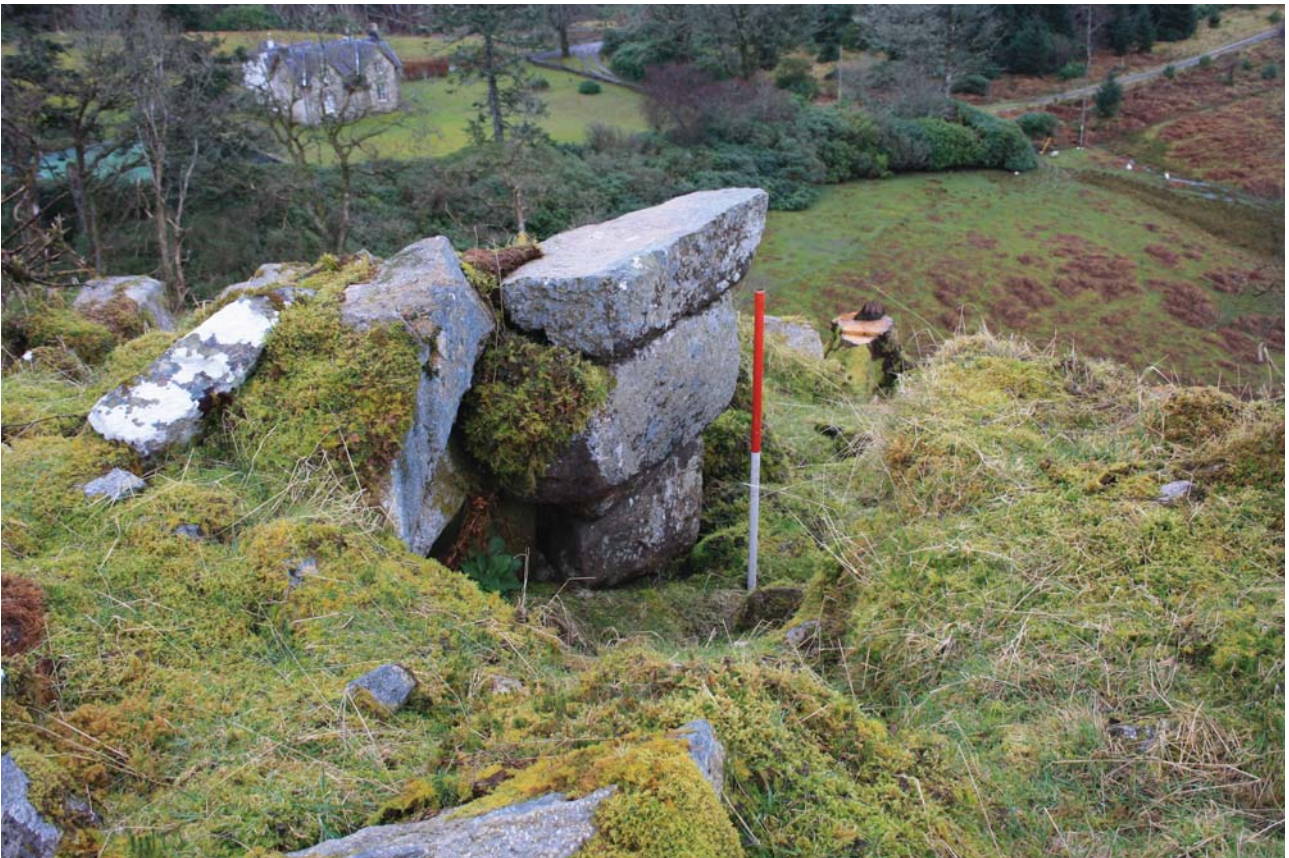
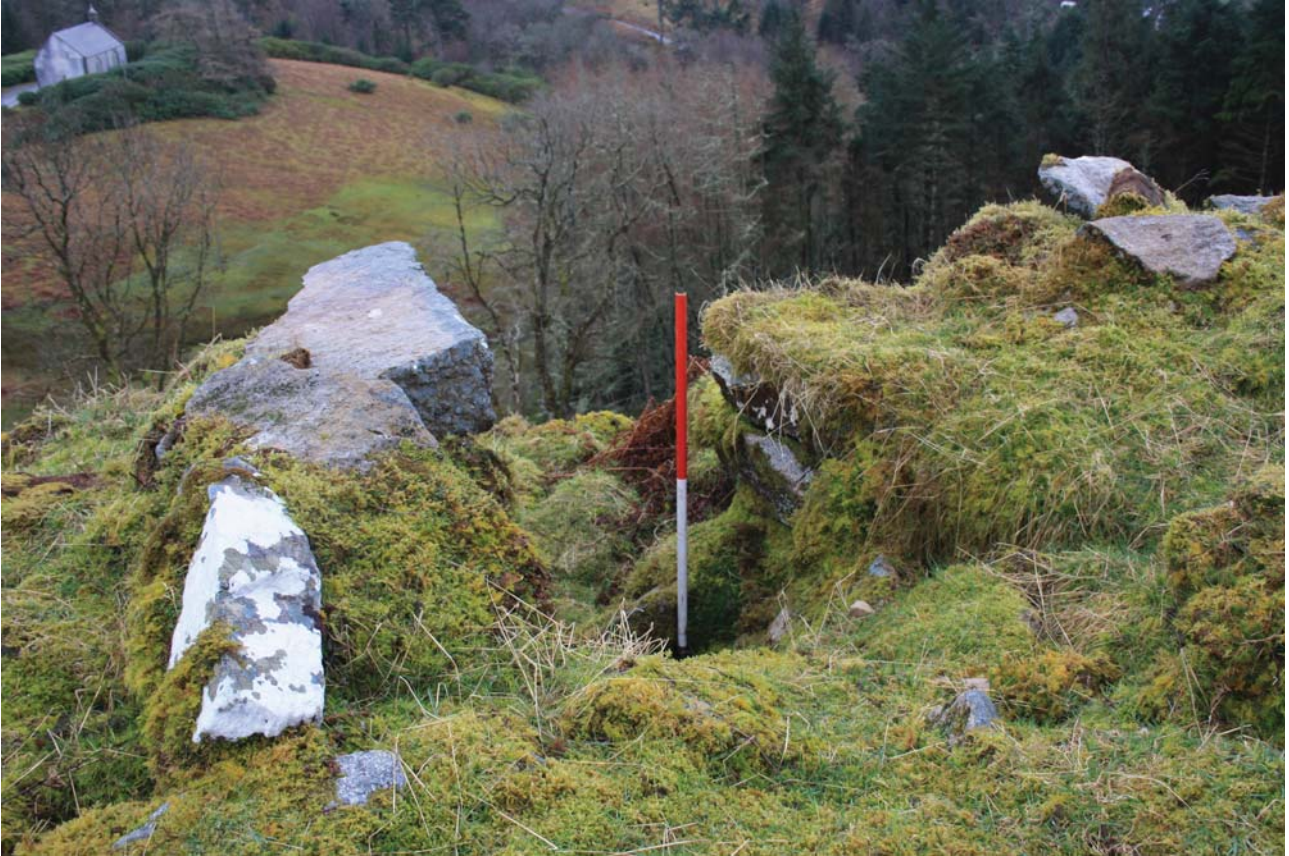
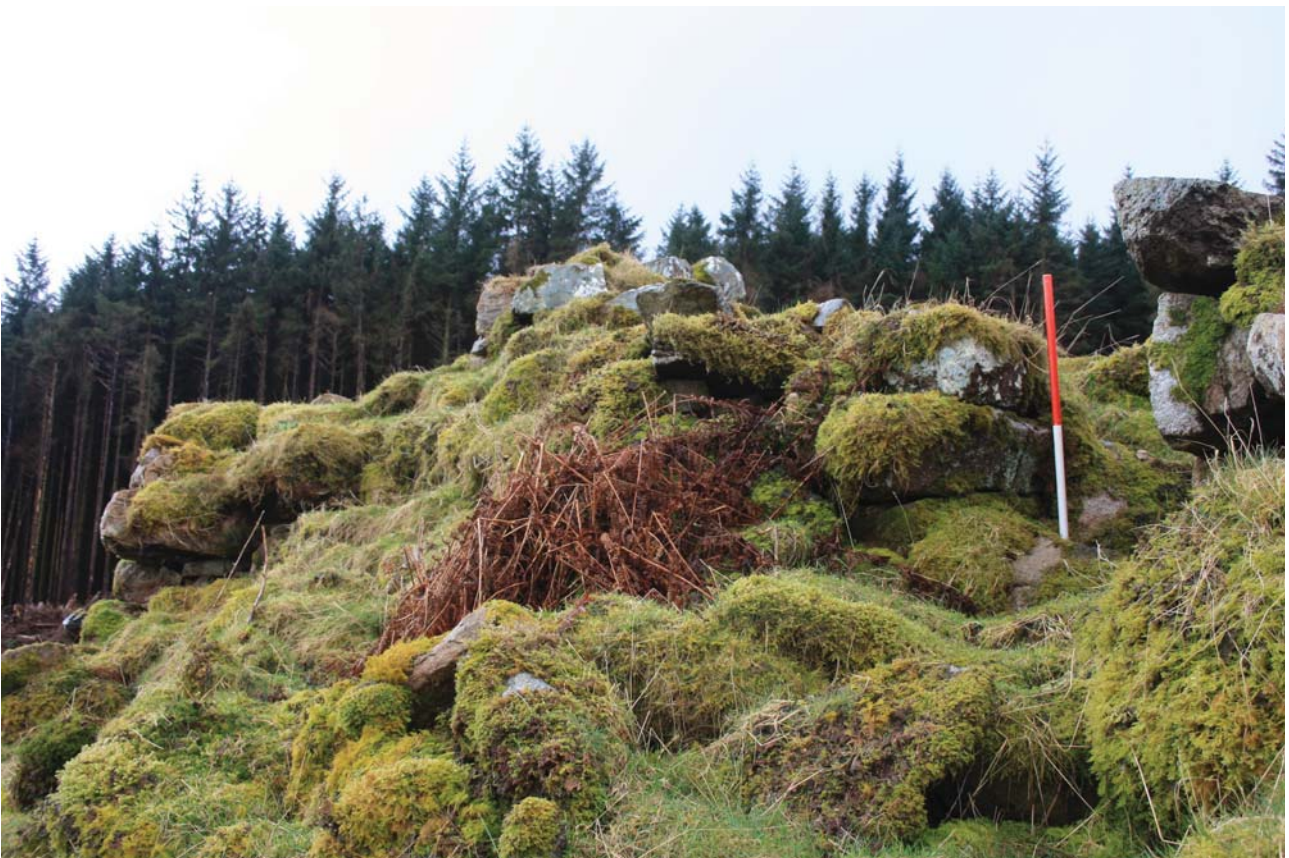
17. At Point Q, an intramural cell was entered from within the broch interior (Plates 23-26; Figure 3). The corbelling of the cell is largely collapsed, but still visible standing to a height of c.0.7m. As noted above, it seems probable that the cell gave access to the stairs to the first floor level gallery, though no trace of these is visible in the rubble. The gallery floor level appears to be somewhat higher than the ground level at the entrance, so that the interior must be very uneven, similar in character to that at Caisteal Grugaig, Totaig, where the entrance is placed at the lowest point on the site, and intramural galleries are entered higher up slope.

Plate 23: View of the entrance to the intramural cell at Point Q, looking N

Plate 24: View of the entrance to the intramural cell at Point Q, looking N

Plate 25: View of the entrance to the intramural cell at Point Q, looking E

Plate 26: View of the intramural gallery at Point Q, facing SW

20. Three areas would be worthy of future condition monitoring: the surviving lintel over the entrance passage, but more pressingly the surviving corbelling of the intramural cell at Point Q and the exterior wall face at Point E, where several stones are missing. Previous inspection and condition survey of broch structures has indicated that those areas of broch walls immediately adjacent to broken areas (as at Point C and Point J) are most vulnerable to collapse, as pinning stones are lost due to the release of tension in the circuit of the wall.
