Beauly to Mossford OHL Replacement

T4-6 Corriemoillie

Archaeological Watching Brief Interim Report

Archaeological Watching Brief

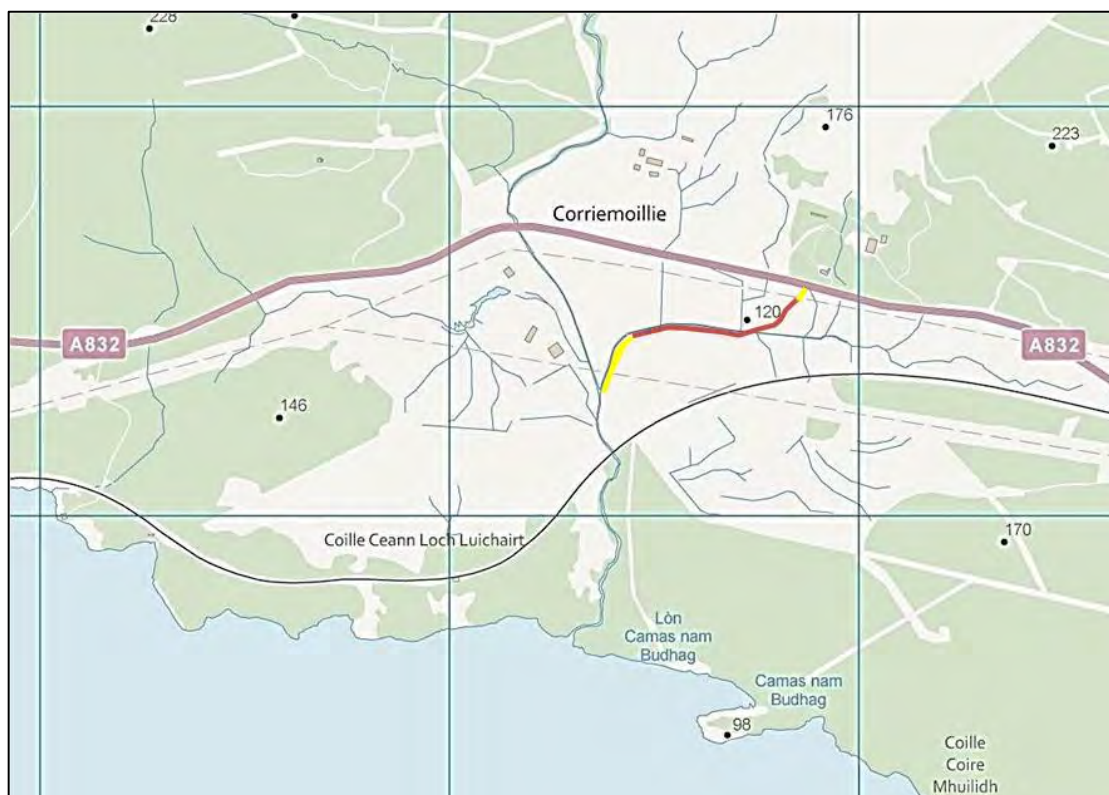
Figure 2: Areas of track observed (in yellow) and floating track (red)

Topsoil was stripped along southern end of the new track and in the splay by the road to the north. The track between these areas was laid as a floating road with no topsoil stripping, and consequently was excluded from the area to be observed (see figure 2). Material to surface the track was quarried from a borrow pit dug into the side of one of the mounds (figure 3).

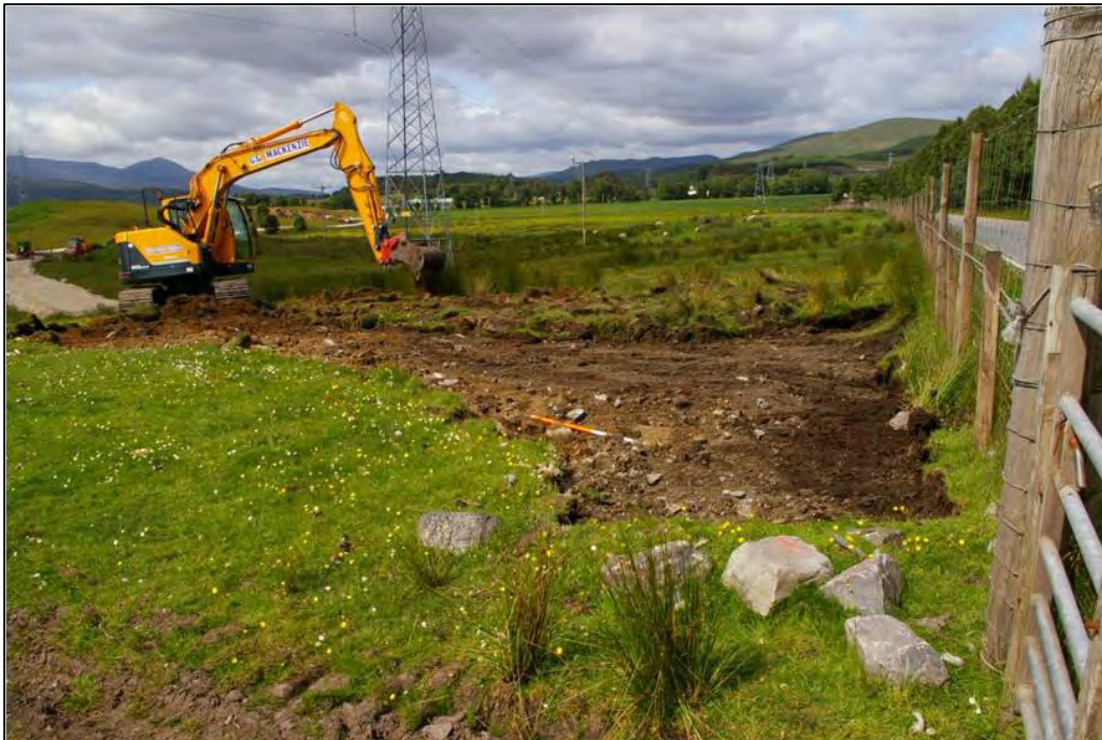
Plate 2: The splay excavation (Photograph 15)

In the extreme north, extending from the gate by the splay southwards for about 16m, topsoil [4] was overlaid by re-deposited material comprising a mix of topsoil and natural. This is almost certainly associated with a borrow pit used during the construction of the modern road immediately to the north, the A832. The borrow pit was subsequently filled with [5] and roughly levelled⁶.
