Knockgranish, Aviemore

Archaeological Mitigation Report (Phase 2)

Report No.	HAS141201
Site Code	AVH14
Client	Colin Bain
Planning Ref	2012-0208-DET
OS Grid Ref	NH 902 147
Date/ revision	03/12/2014
Author	Lynne Mckeggie

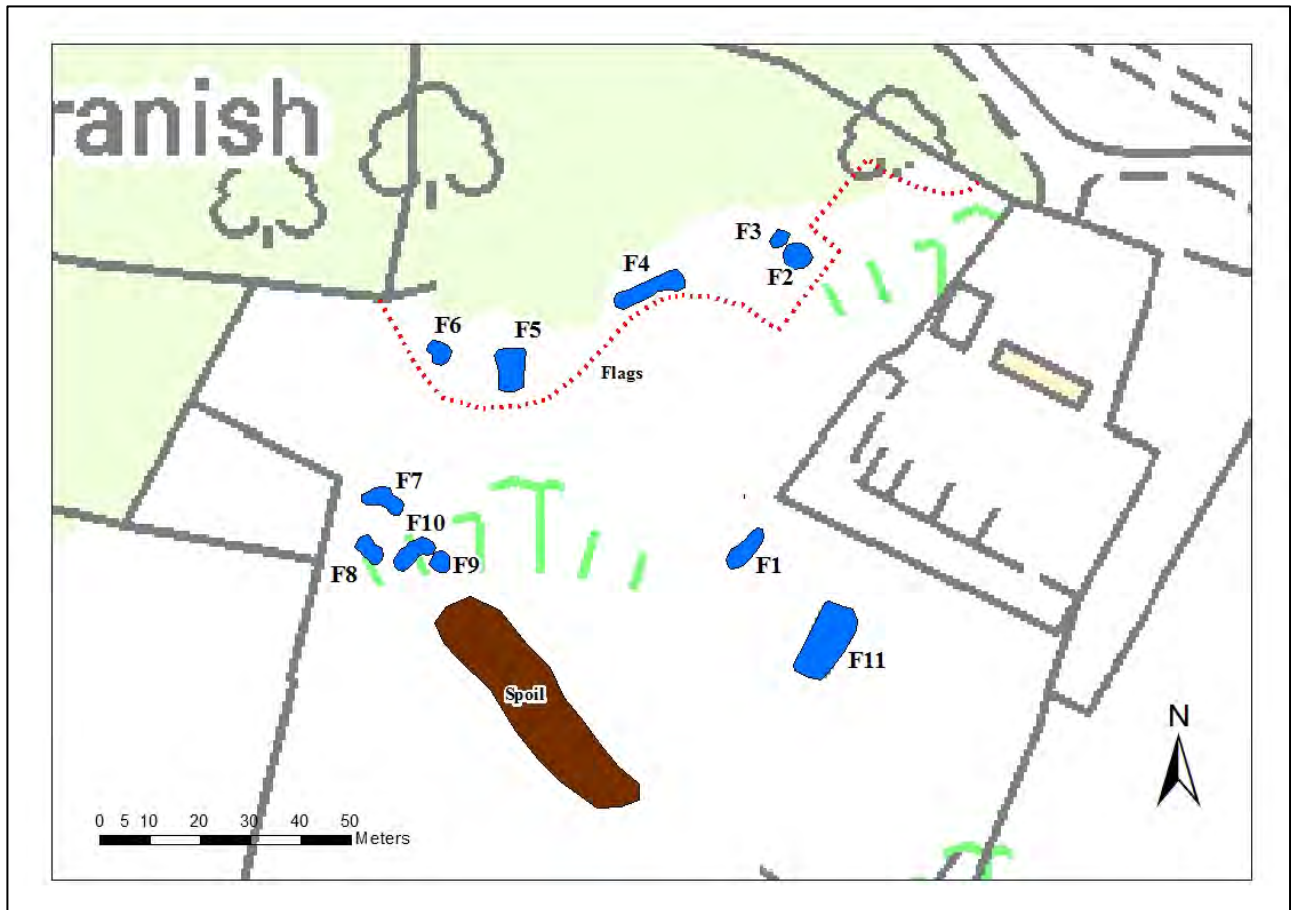
Figure 3: As found, December 2014

Features identified during walk-over survey in 2013 (blue); limit of development as flagged off (red dotted line); client's spoil bund (brown)

The client had already flagged out the development area, so the line was walked with the client to confirm that the previously identified features were outside this. Soil stripping in the car park area had also now taken place and this area had been adjusted to accommodate the features (see Figure 3).

A spoil heap had been set up by the client which will eventually form the sound deflecting bund. It was confirmed that this would be extended to cover field clearance heaps (F7-9). These were identified on the ground with the client and will be safeguarded by placing soil carefully and avoiding driving machinery over them.

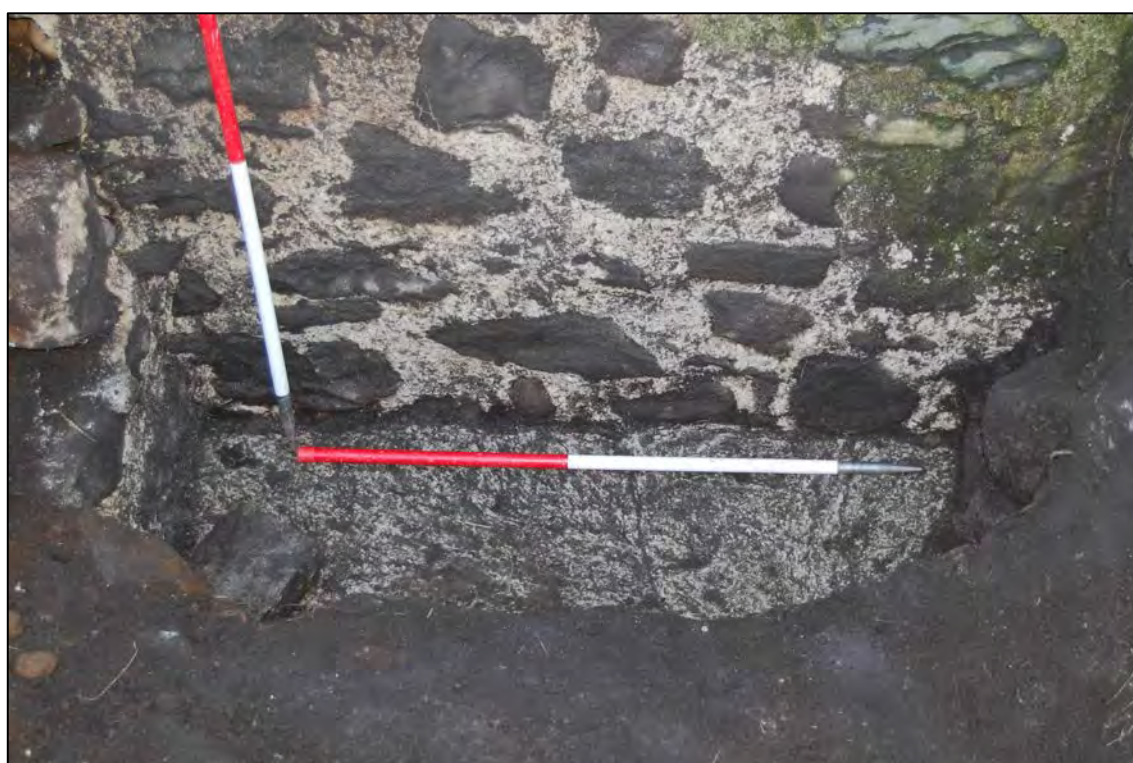
Plate 2: Internal wall and base of cellar (215) [AVG14_4]

The base of the cellar was found to consist of poured lime mortar (215). This was relatively smooth with the occasional depression and was slightly higher on the southern side where slight raised lips suggest the mortar was poured in.

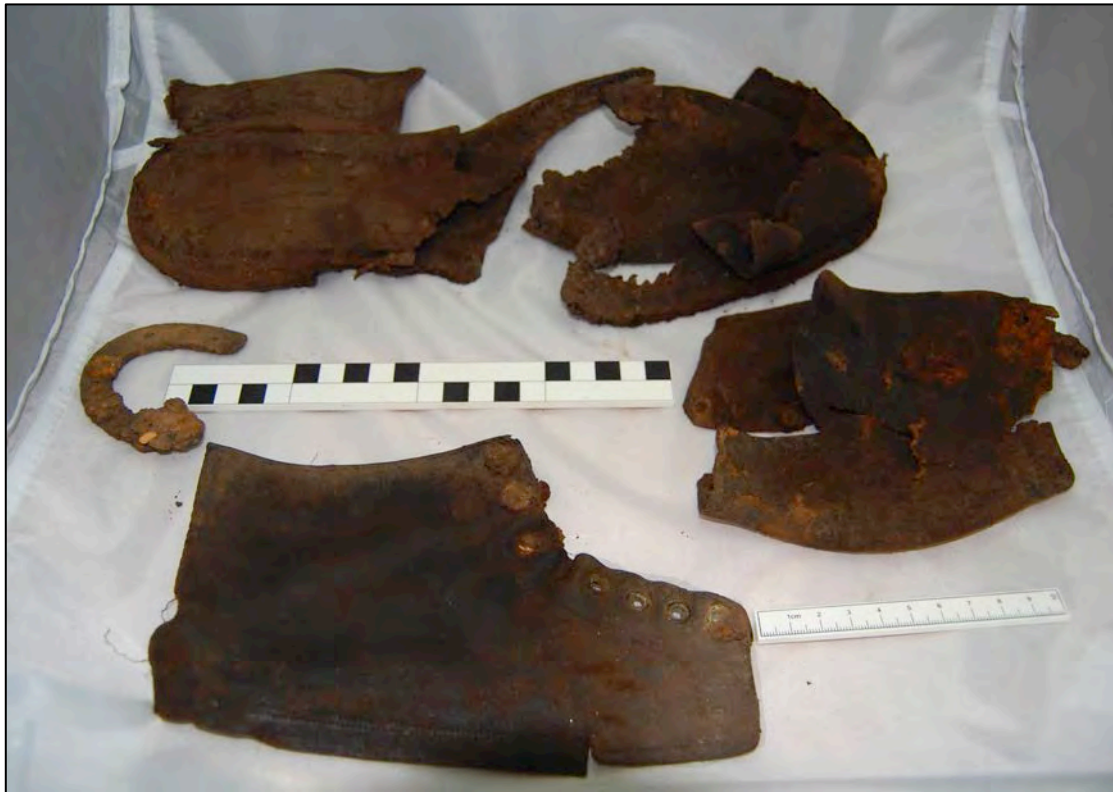
Plate 3: Artefacts 8 and 9 heel plate and leather shoe

Large boulders continued to be found deep down within the cellar deposits (210), along with dark organic rich loam (216) which contained the remains of pieces of wood, wire and parts of a leather shoe (Find no.9; Plate 3). The fragments of wood may be from wooden flooring above the cellar.

Find No.	Trench No.	Context No.	Description
8	2	216	Small metal heel plate, possibly belonging to Find 9
9	2	216	Fragments of leather shoe including portion of sole and heel.
