# Uppat Hydro Scheme, Brora, Sutherland

## Archaeological Walkover Survey Report

AOC 70052  
8<sup>th</sup> July 2015

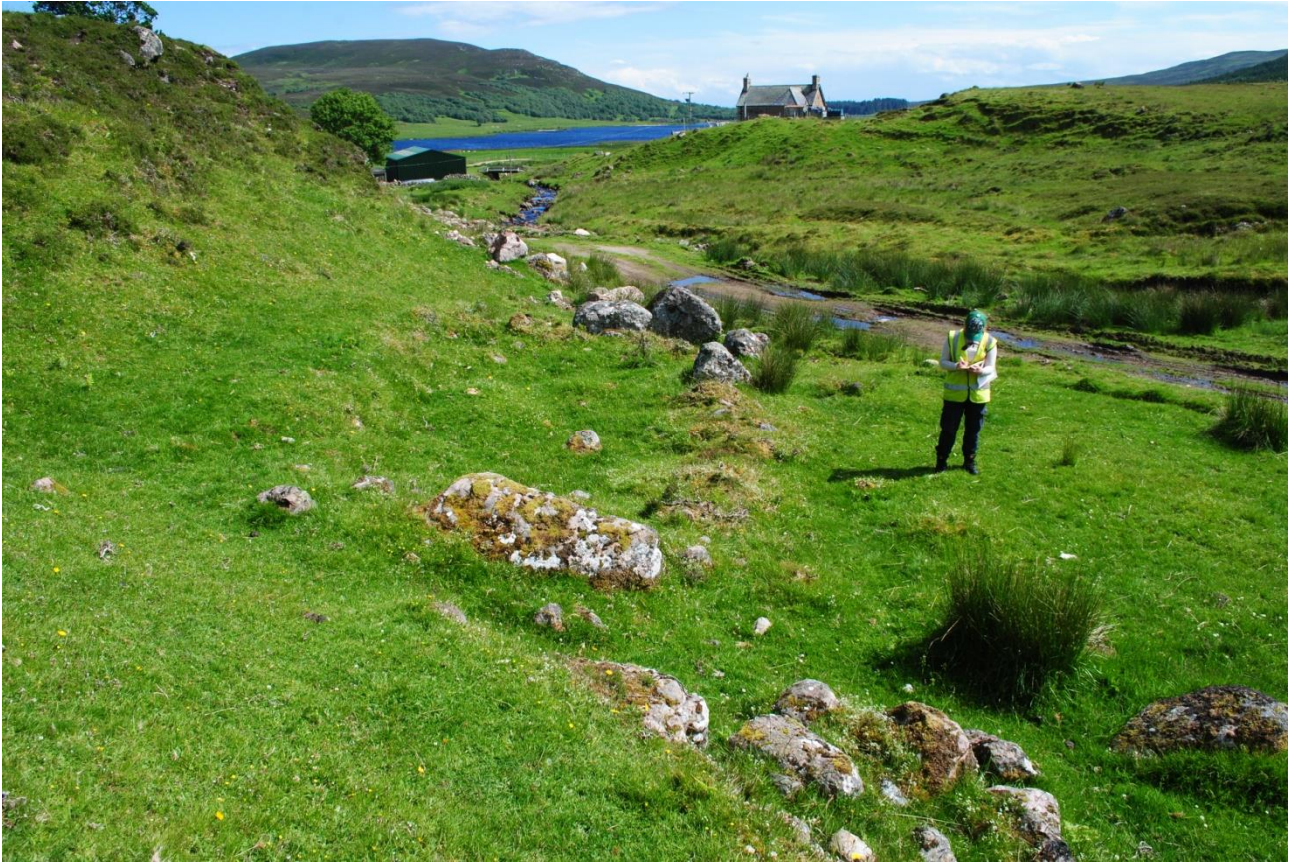
17. Near the eastern end of the access track, past the enclosures and farm buildings at Carrol, Site 1 was recorded. It comprises the footings of a suboval boulder/stone building (Plate 3) situated immediately adjacent to the north side of the track. It had not been previously surveyed, nor is it shown on the First or Second Editions of Ordnance Survey (OS) historical mapping.

*Plate 3 Looking SE over Site 1, a boulder/stone-built structure adjacent to the access track*

- A buffer of 10m is recommended around Sites 1, 10 and 11
  - A buffer of 5m is recommended around Sites 2, 6, 7 and 8.
  - The proposed route should be kept to the south of Sites 1, 6, 7 and 11; the laydown area should be kept between cairns 6b and 6d with the buffer zones maintained

24. The proposed route and laydown area lies close to building Site 1, a possible prehistoric structure Site 11, clearance cairns Sites 6a-6d and boundary dykes Sites 7-8. Given that Site 11 is likely to be a hut circle and that clearance cairns commonly turn out to be more significant monuments (ie burials), it is imperative to ensure they are not damaged or destroyed. If, however, this is unavoidable, excavation and recording of the sites to be breached is recommended in advance of development.

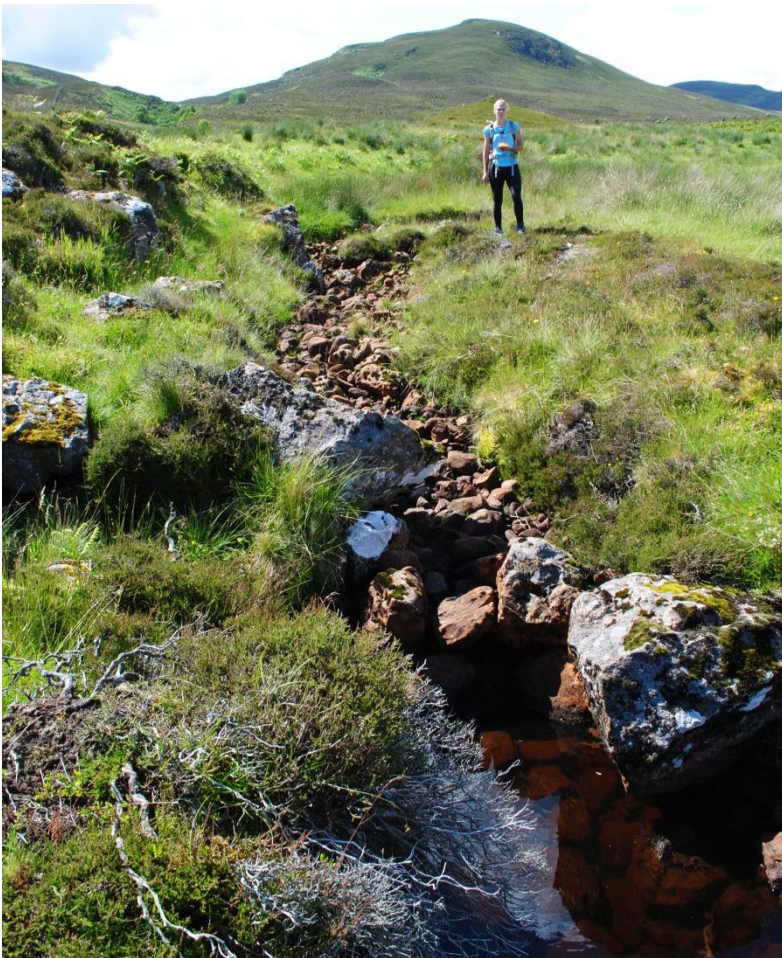
18. Four sites recorded pertain to the two burns. Where the Carrol Burn joins the Allt a Chairn, the site of the ford for the track (Site 3) and a stone-filled channel (Site 4; Plate 4) were recorded. The channel contained compact stone fill with large boulders blocking the east end of it. Another small channel running eastward from Carrol Burn appeared also to have been blocked at the east end of Site 5, a small enclosure bank. A small, slab-built weir, Site 9 (Plate 5), was recorded over the Allt a Chairn at the proposed location for the outfall.

*Plate 4 Looking WNW over Site 4, a blocked-up stream channel*

- If the buffer zones cannot be maintained, an archaeological watching brief is recommended whilst digging in the area between Sites 1-11
23. Site 10 is located well away from the proposed development route and should not be a concern. Sites 3, 4 and 9 do not require a buffer given the type of sites they form, while Site 5 is also located well away from the development and is not a concern. However, several of the sites do lie within close proximity to the proposed access track.

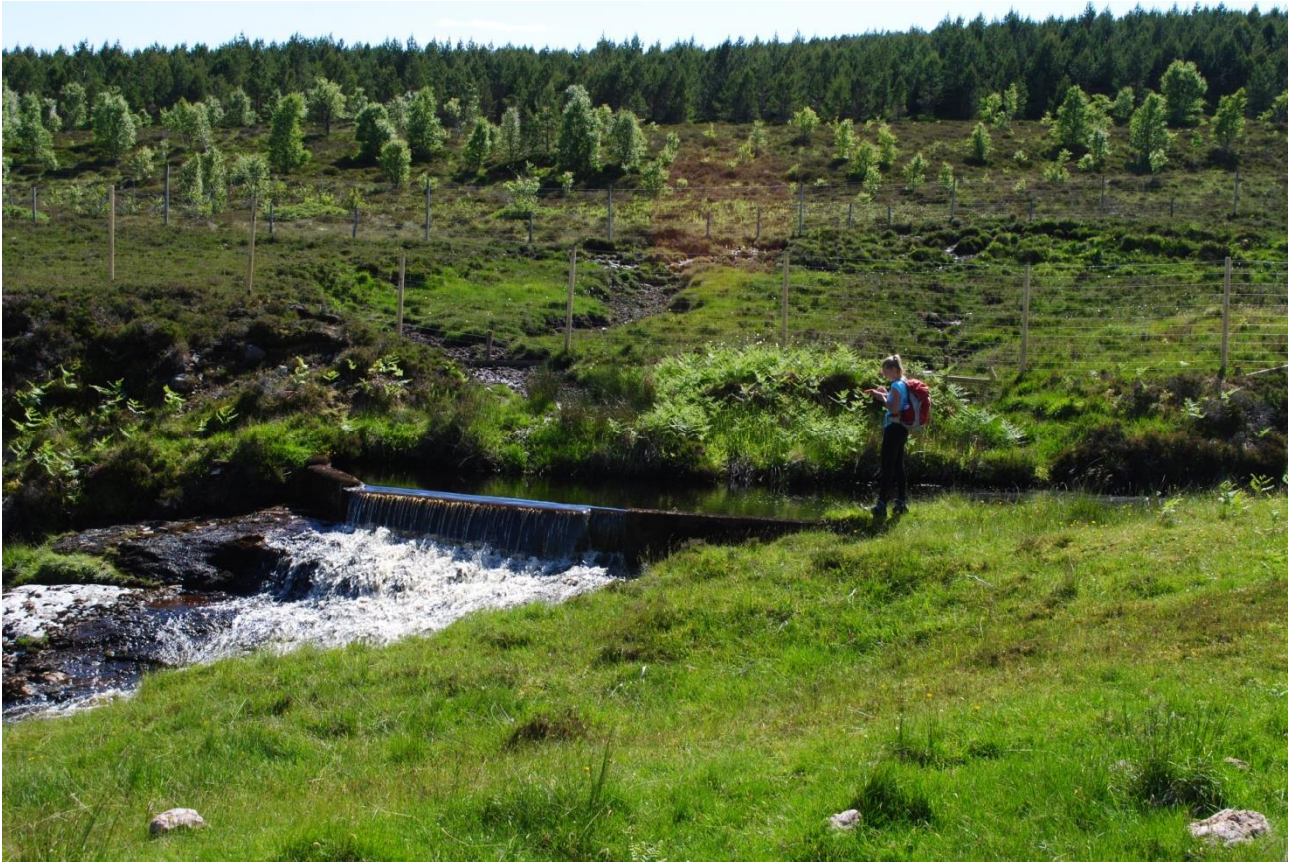
*Plate 5 Looking SSW over Site 8, an existing weir built into the Allt a Chairn*

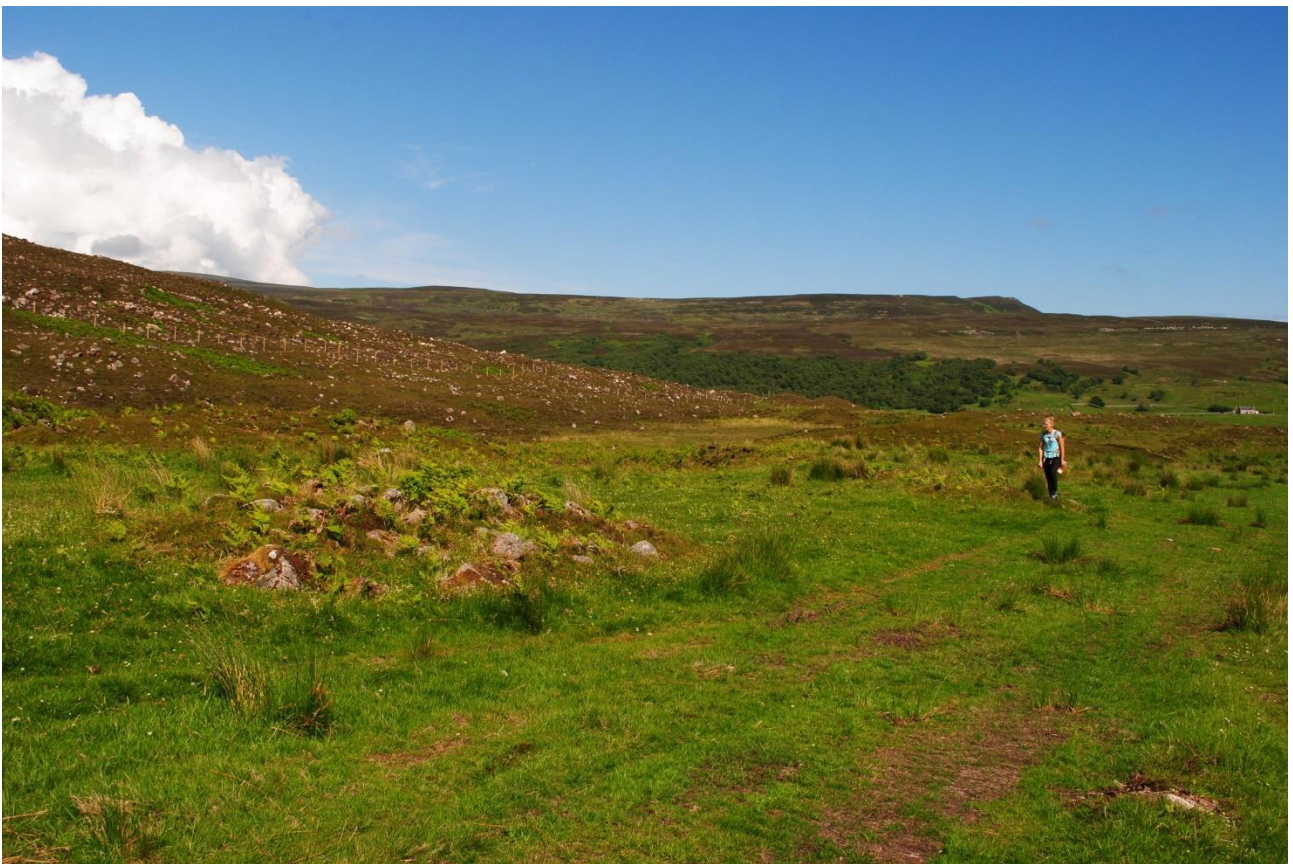
19. Five other sites form the degraded remains of boundary dykes (Sites 2, 5, 7 and 8) or enclosures and field clearance (Sites 6a-6d; Plate 6), associated with post-medieval or earlier settlement. None of these sites are shown on the First or Second Editions of OS historical mapping, suggesting they predate this period.

*Plate 6 Looking E over Site 6b, a cairn, in centre right and dyke Site 7 to left of archaeologist*

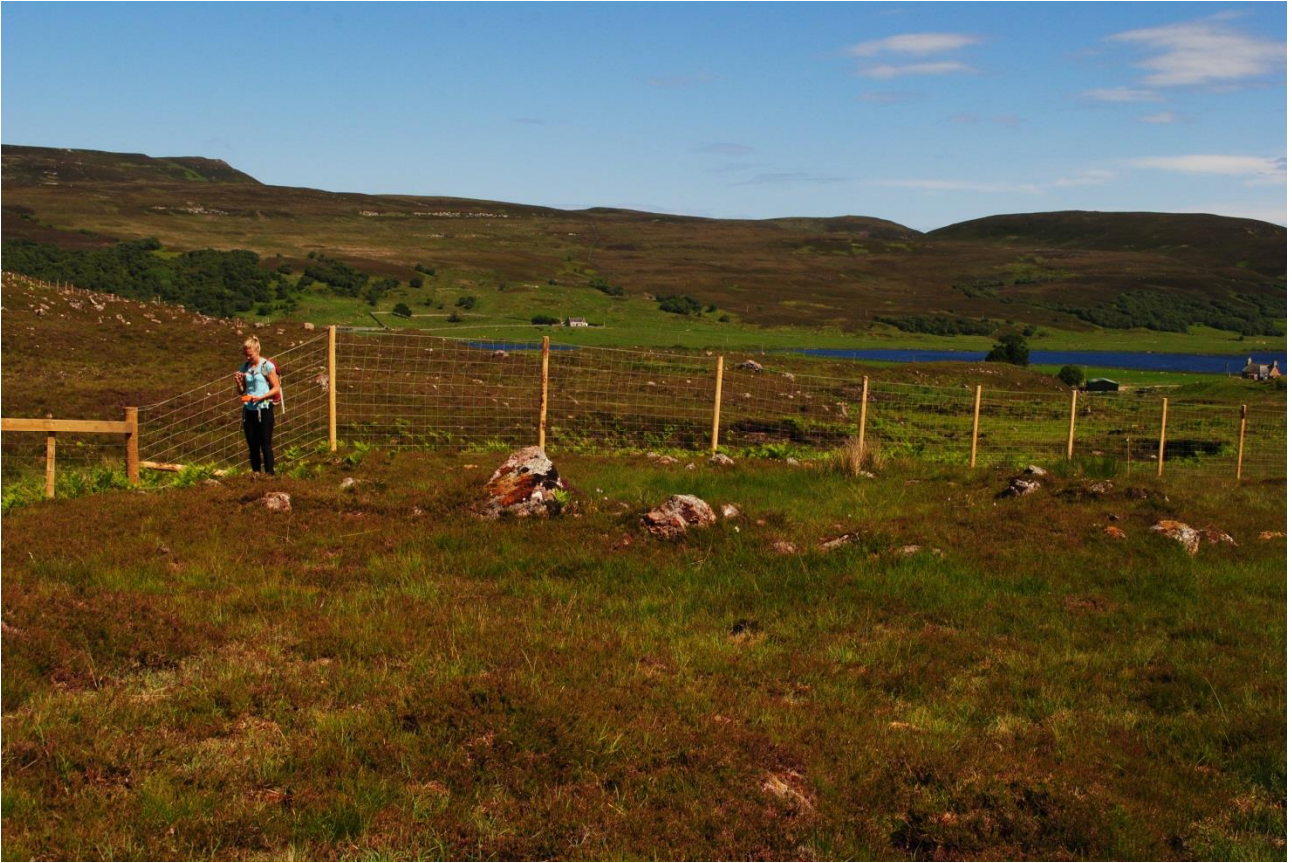
20. A hut circle (Site 10; Plate 7), which had been previously recorded (MHG53866), comprised the circular heather- and grass-covered footings of a stone-built bank with probable boulder/stone inner and outer faces and a rubble core. Located on the south side of Carrol Burn, it may have had an entrance in the southeast. Recent tree planting on the site had clearly marked out the location of the site for protection. On the same terrace to the southeast of the hut circle was a stony, circular platform (Site 11; Plate 8) with large stones visible around the edges. It appeared to form the remains of another structure, a possible hut circle, associated with Site 10. The condition was too degraded to be conclusive about the interpretation.

*Plate 7 Looking SE over Site 10, the remains of a hut circle located N of the proposed route*

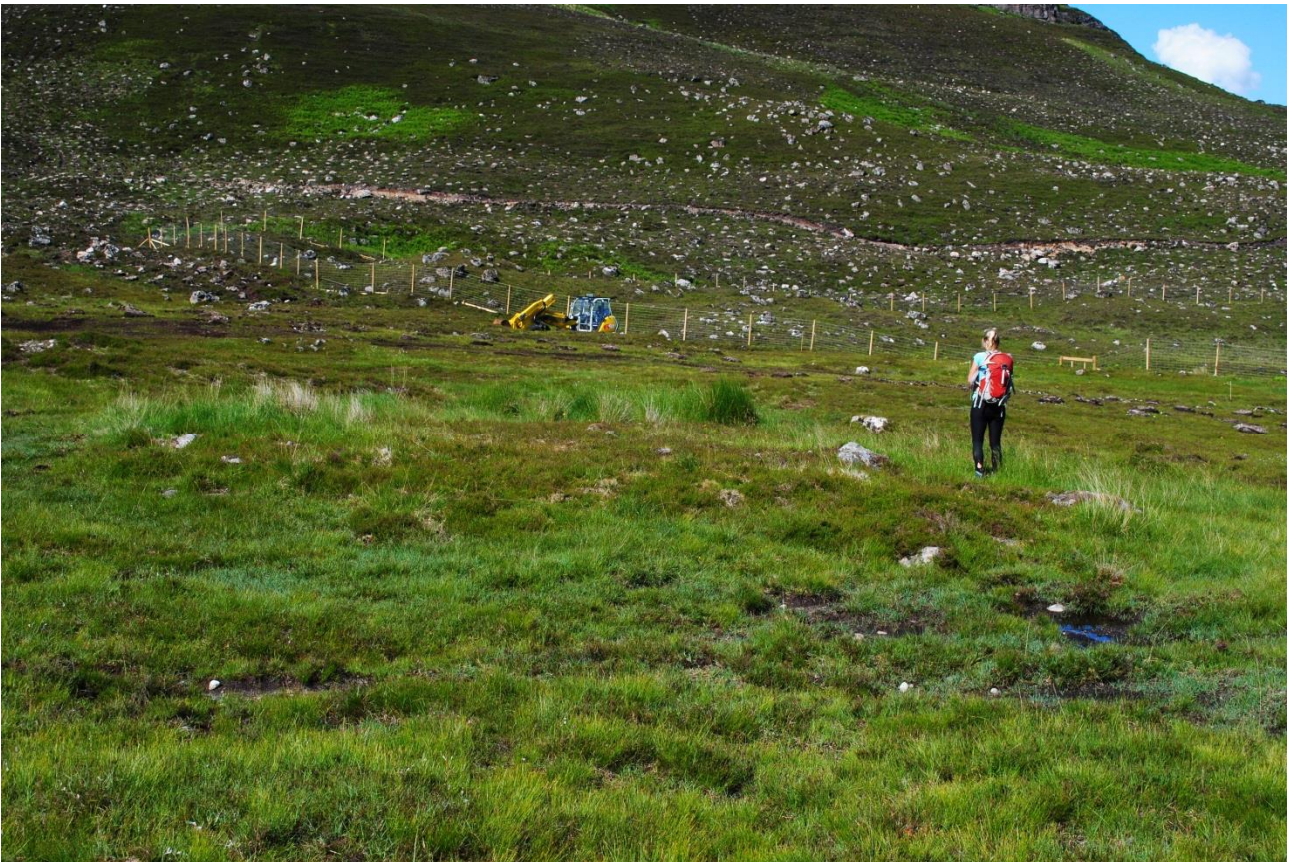
*Plate 8 Looking NE over Site 11, a subcircular platform forming the remains of a possible site next to the proposed track*
