## **Strathan Hydro Scheme, Attadale Estate, Lochcarron, Wester Ross.**

### **Report on Archaeological Survey and Mitigation Recommendations for Gilkes Energy Ltd.**

**by Fiona Baker, Firat Archaeological Services Ltd. 4 December 2015.**

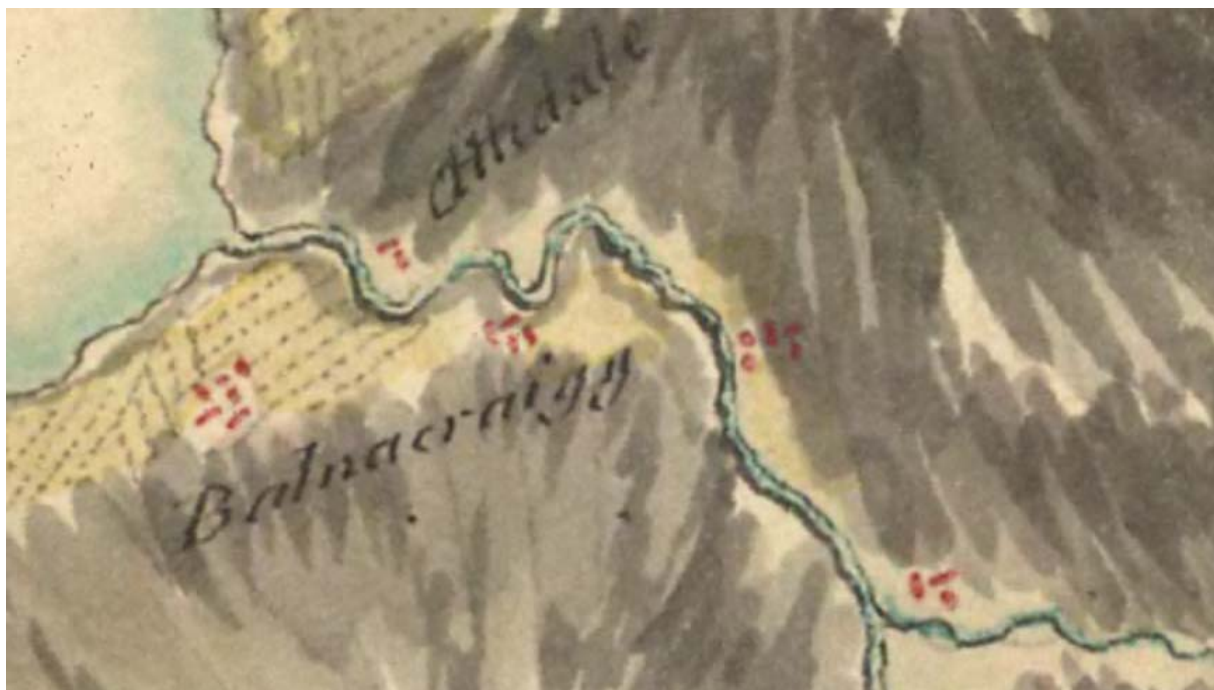
#### **General Wiliam Roy 1747-55 Military Survey of Scotland.**

The small settlement of four buildings shown on the S bank of the River Attadale just above the 'i' of Balnacraig probably represents the settlement remains of Sites 1, 7, 8, 9, 10, 11 and 12.

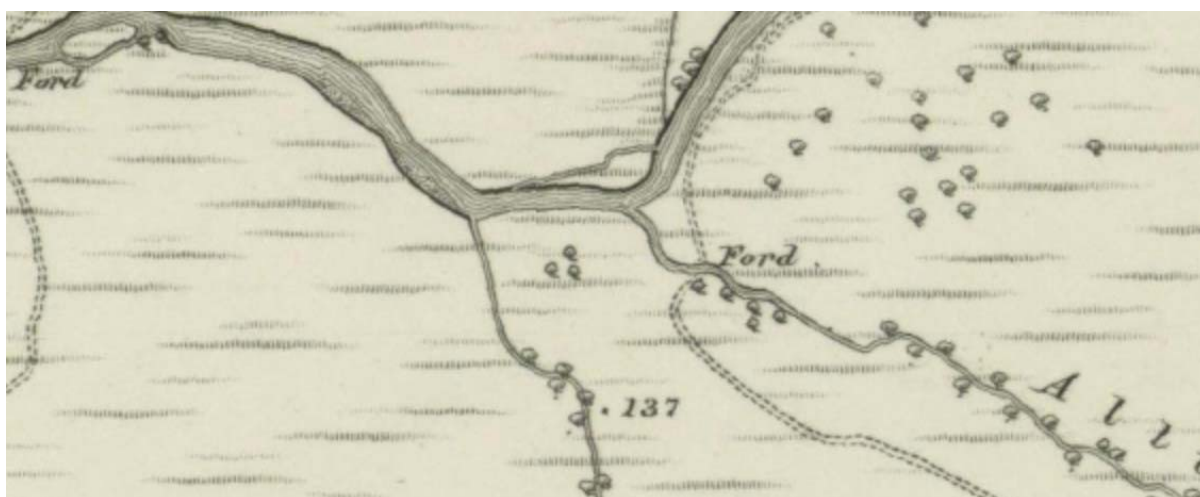
#### **Ordnance Survey First Edition 1875 Ross and Cromartyshire (Mainland) Sheet CX1, 6 inches to 1 mile**

The Ordnance Survey map shows no structures at the Site 1 area at the confluence of the Allt a'Ghiubhais, Allt Odhar and River Attadale.

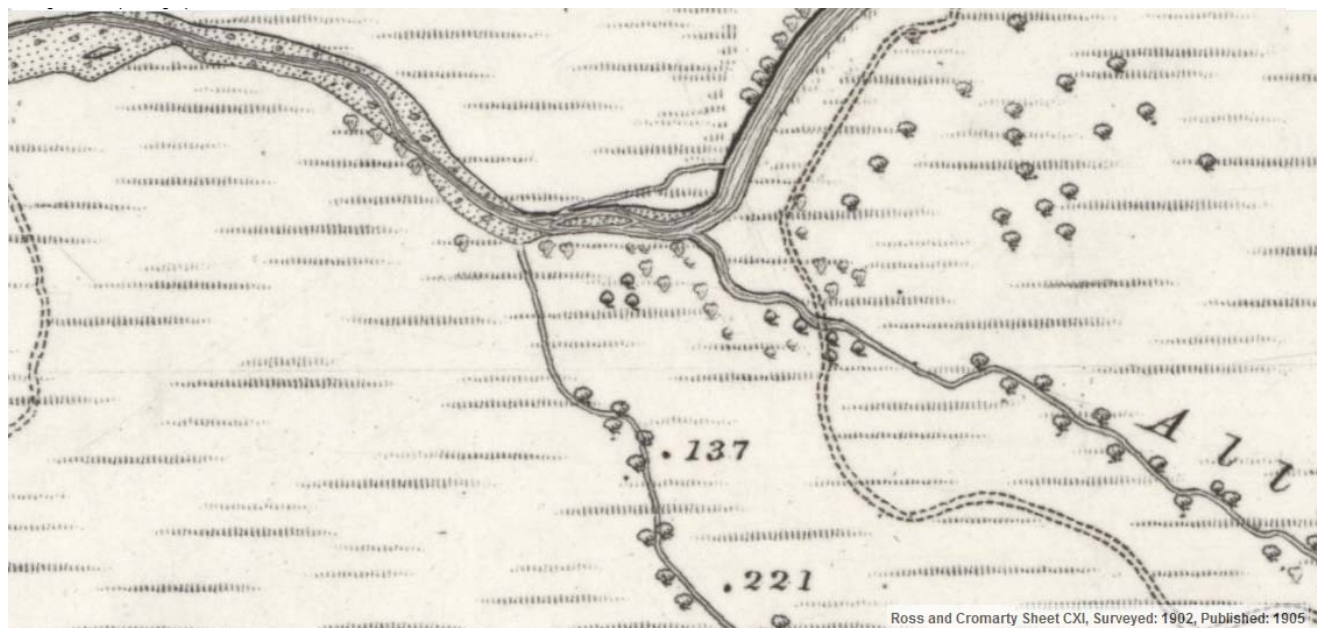
### **Ordnance Survey Second Edition 1902 Ross and Cromartyshire Sheet CX1, 6 inches to 1 mile**

The Ordnance Survey map shows no structures at the Site 1 area at the confluence of the Allt a'Ghiubhais, Allt Odhar and River Attadale.

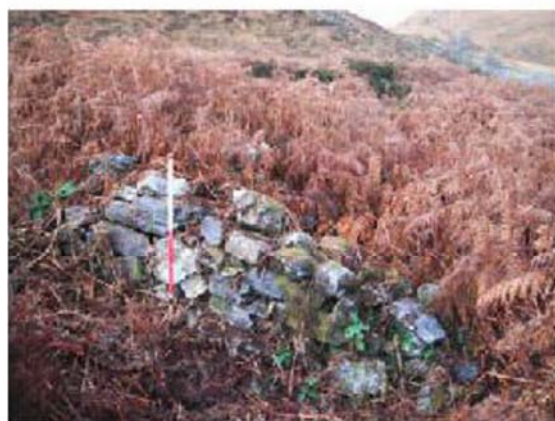
#### Site 5: Building. (Photos 4, 5)

Within an area of thick bracken to the east of the confluence of the Allt a'Ghuibhais and the River Attadale, walling standing to a height of 800mm of a small building aligned NE-SW. Further building remains may be obscured by the bracken. This is most likely a part of the small un-named settlement recorded on Roy's military survey at the head of the strath and likely to have been cleared around 1840. The channelling of water through this area is suggestive of a lade and offers the

possibility that this building or another in this area was a mill.

Photo 4 above: Drystone walling of building, from ESE. PH3 and River Attadale are behind to right.

**Impact Assessment:** This site is situated close to the bridge, immediately East of the Power House.

**Mitigation:** The site could be avoided if the new access road to the new bridge curves round to the South. Further evaluation is recommended prior to construction and, if the site cannot be avoided, excavation may be required.

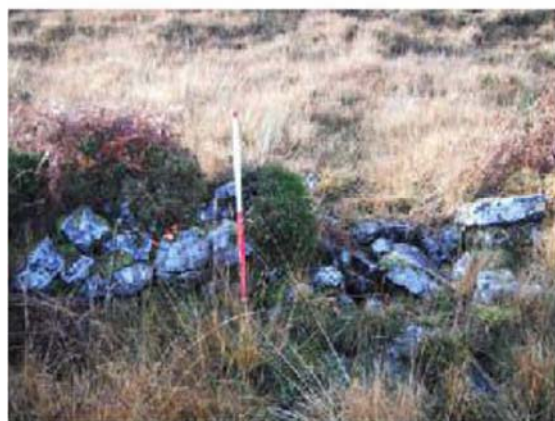
#### Site 6: Turf and rubble dyke.

Sections of rubble or turf and rubble walling follow the west bank of the stream and river to a point where the topography provides a natural barrier. This is interpreted as an animal management feature preventing livestock from crossing the shallow water.

**Impact Assessment:** The greater part of this feature is likely to be removed during construction of the power house and tailrace.

Photo 6: Site 6, Turf and rubble walling, following bank of Allt a' Ghuibhais and River Attadale, from N.

**Mitigation:** Keep damage to a minimum. A watching brief is recommended during removal of this feature.

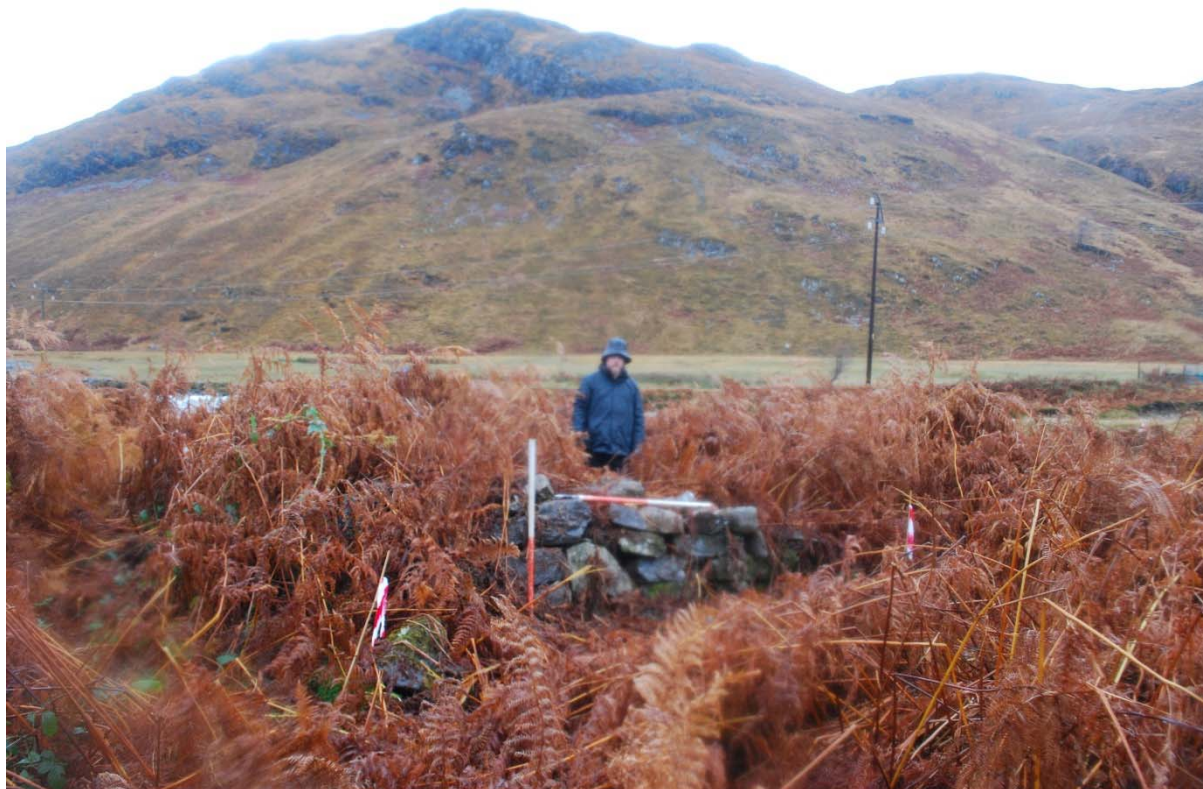
## Site 1      Building

Site 1 is substantial rectangular structure with square corners measuring 9m x 4m overall over walls 0.80m thick. It is aligned NE-SW at 40° and has double skin with rubble core construction and is drystone with no visible mortar. There is an entrance centrally located in the NW wall which is 0.65m wide. The walls stand to a maximum height of 1m at the S corner which has five courses of stonework. The dyke Site 8 appears to curve around to the N wall of the building. On its W side the dyke Site 9 along the edge of the plateau separates it from the Allt a'Ghiubhais. The building, interpreted as a house, is completely overgrown with bracken. Our handheld GPS grid reference +/- 5m is NG 94260 37756.

**Impact of development:** The new bridge BR2, access track and private wire route will probably disturb Site 1 and will in general disturb the settlement area. There is a high risk of disturbing previously unrecognised archaeological features masked by the bracken cover if the route crosses the settlement area. This would potentially cause delay and additional costs for archaeological excavation. If settlement remains are disturbed they would require full excavation before destruction.

**Site 1 rectangular building with Scott in the centre of the interior, view to the N.**

**Mitigation:** Site 1 is quite obvious once you have located its S corner and can be avoided by micro-siting. If it cannot be avoided excavation in advance will be required. A watching brief of the whole settlement area is required. All identified elements should be fenced off with orange plastic fencing (to replace the flagging on canes) which would not only protect the identified sites but increase the visibility and aid interpretation of the overall layout of the settlement. It is recommended that the route of the access track and private wire moves further to the S to avoid the settlement remains. The dense bracken makes site identification very difficult in this area and it is unlikely additional field survey will locate further clear structural remains unless the bracken is cleared or squashed down by heavy snow, though even then the

dense nature of the bracken would still probably conceal elements of the settlement. The best approach is to avoid the structural elements that have been located and for a flexible approach to the final location of the track determined by an archaeological watching brief. It would perhaps be easier to avoid the settlement remains if the track ran S on the W bank of the Allt a'Ghiubhais and the new bridge was located at the confluence of the two burns.

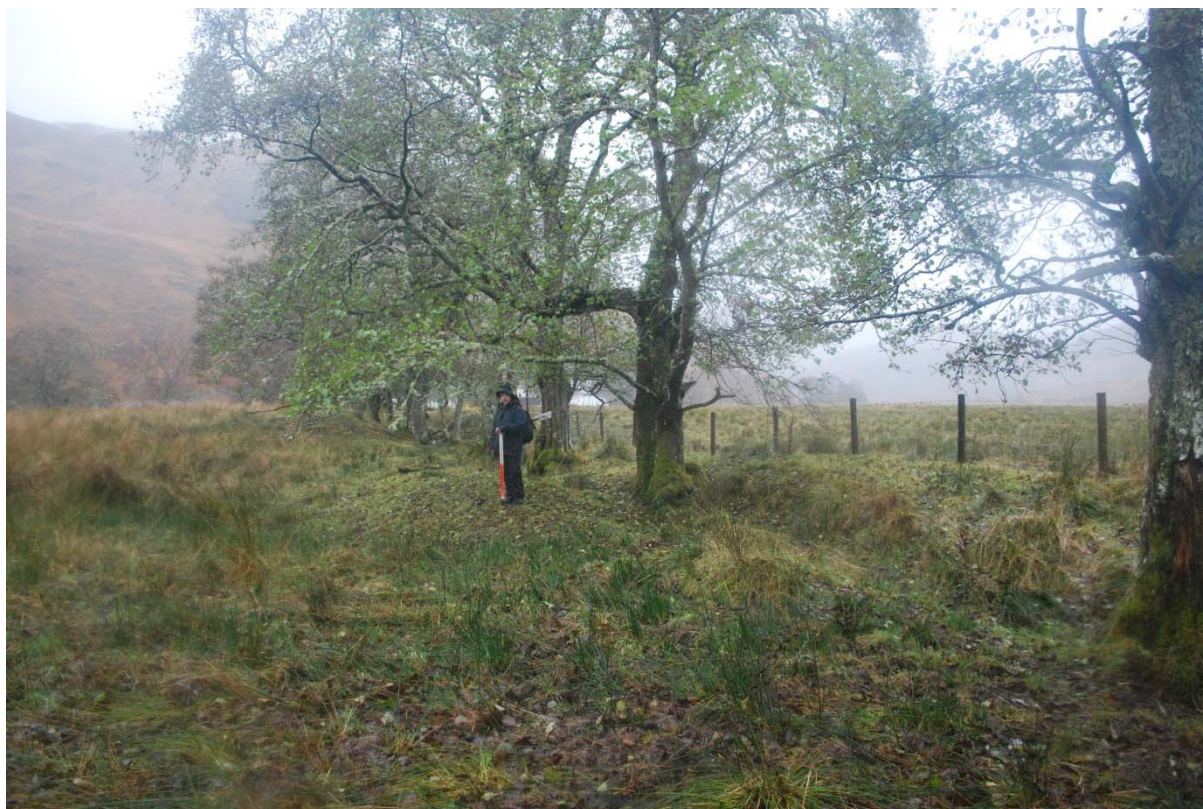
## Site 4      Boundary

A formal boundary aligned NE-SW consisting of two substantial banks with a ditch between them which has been planted with Alder trees. It is possible the Alder trees, which like damp conditions, may have colonised the ditch but they have a linear appearance that suggests deliberate planting. This boundary is shown as a watercourse on the current OS map but it is no longer a running watercourse. However, further N in the field major new drainage ditches have been excavated and have diverted water from this earlier ditch. The quite substantial banks suggest it had been maintained for many years as a canalised drainage feature boundary. The banks representing the original canalisation and subsequent clearance of the watercourse being cast up onto the banks. The banks are up to 4m wide and stand to at least 0.5m high, they have flat tops suggesting they may have been utilised as trackways.

**Impact of development:** The bank and ditch will be cut through by the new access track but damage will be minimal as a gate is already present.

**Site 4 boundary consisting of a canalised burn, now a 'dry' ditch lined with Alder trees, and two substantial banks. View to the NE.**

**Mitigation:** The site has been flagged. Keep new access track to existing gate and avoid trees and earthworks. A watching brief is not required.

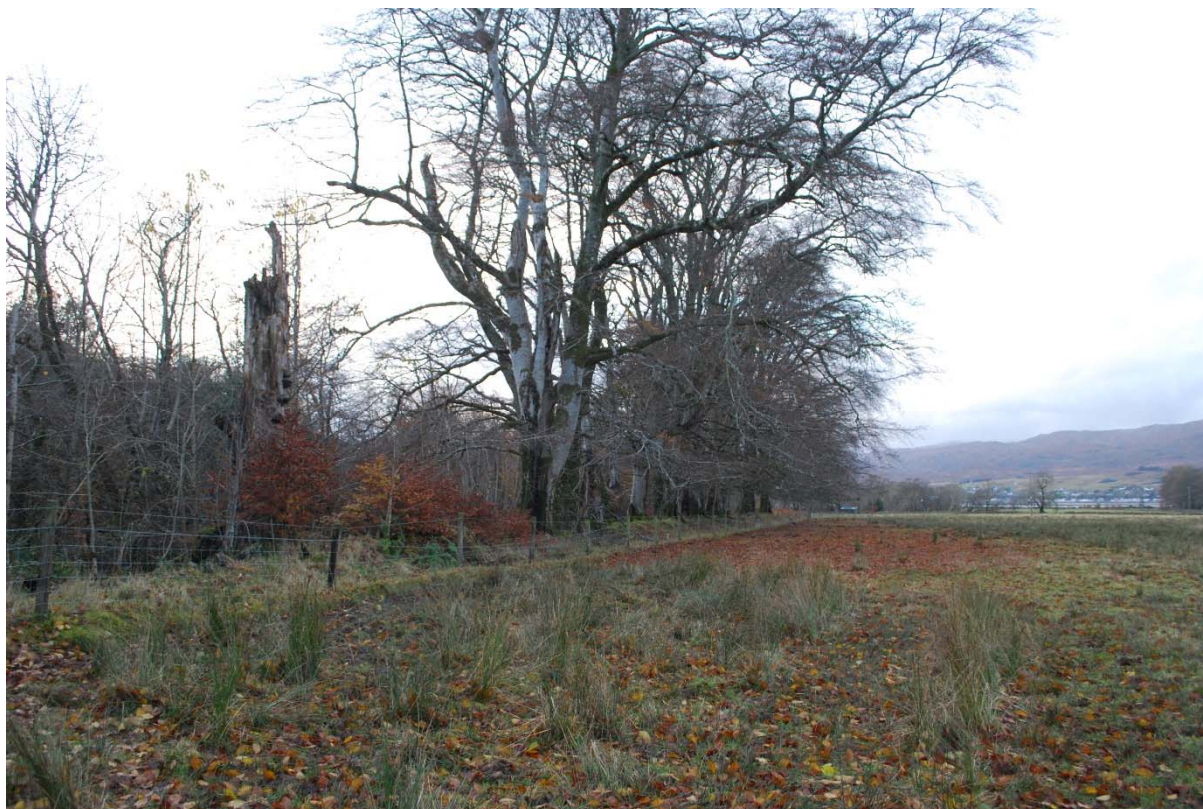
## **Site 5      Boundary**

Planted boundary of beech trees on a turf and rubble bank in the fenced off woodland on the n bank of the River Attadale. It may continue further to the SE but is denuded. Within the woodland on the river bank are another two stone and turf dykes with ditches along their river side running parallel to the river. These may be flood defences. A large bank of river cobbles, which had been created by machine, was also observed and is a more recent attempt to narrow the river and control flooding and overflow of its banks when it is in spate.

**Impact of development:** None. The boundary is fenced off from the location of the new track. There are a few mature trees in the field adjacent to the bank and these should be avoided.

**Site 5 Planted Beech trees on an earth and rubble dyke formal boundary feature, view to the W.**

**Mitigation:** Avoid trees adjacent to the fence line in the field.

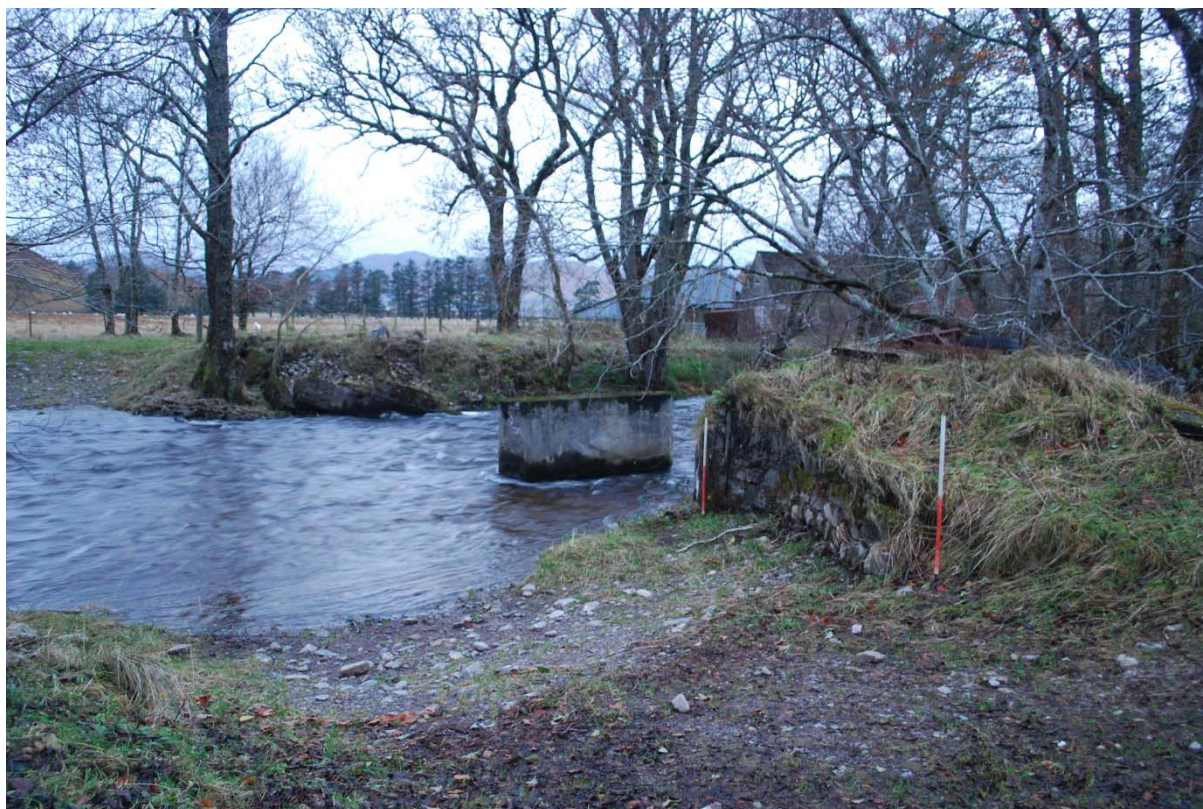
## **Site 6        Bridge remains**

The remains of a bridge comprising splayed cement bonded rubble abutments, concrete springer support pier and a cement cutwater pier in the river. There is a ford on the upriver E side of the bridge remains. The abutment on the S bank was not visited and appears largely washed out on the river side where a concentration of river cobbles was observed but no concrete springer / support pier. Estate materials (gates, fencing etc) are stored on the N abutment.

**Impact of development:** None, adjacent to the new track route which follows an existing track at this point. Ensure the remains are avoided.

**Site 6 Remains of a bridge with a ford on its up-river E side (left of photograph). The abutment on the S side of the river has largely washed out and one pier remains in the river. The buildings on the far (S) side of the river are the Home Farm. View to the W.**

**Mitigation:** Avoid.

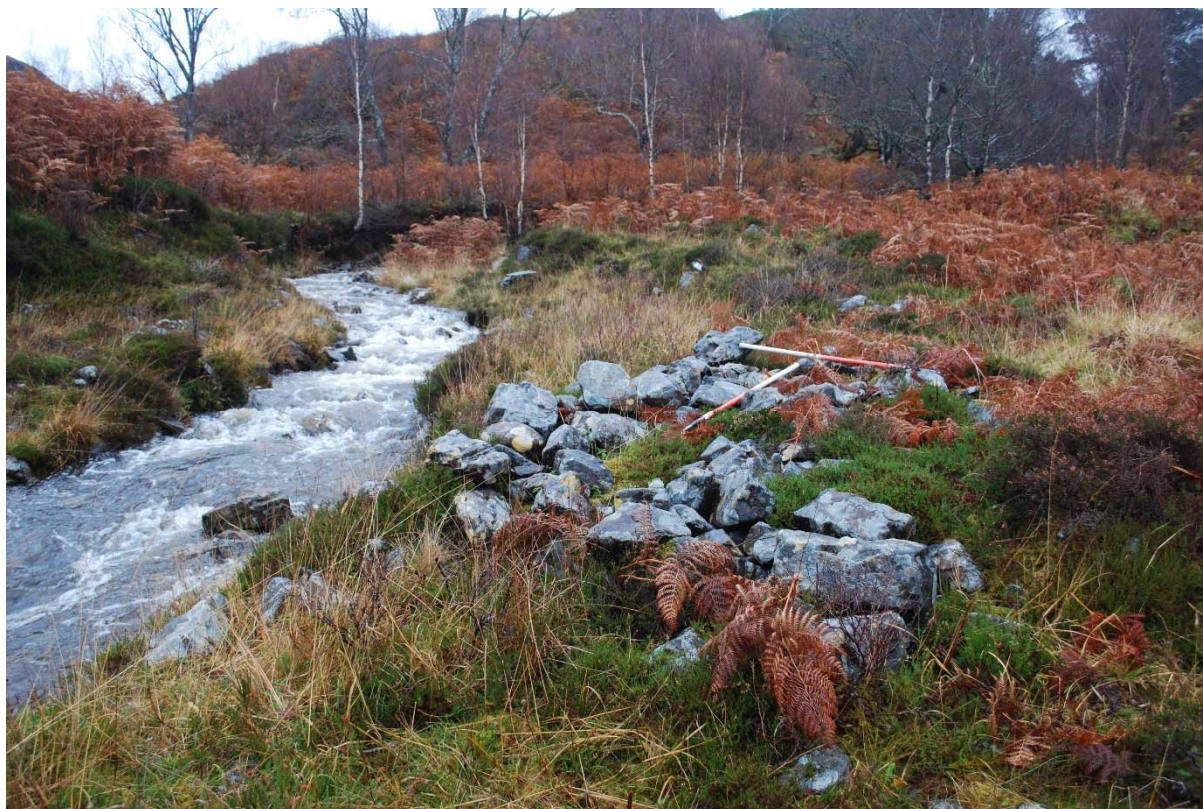
## **Site 7 Building**

A small, collapsed sub-oval drystone structure located on the S bank of the Allt Odhar just above the flood line at about 1m above the edge of the burn. The buildings, constructed of river boulders, measures c. 3m NW-SE x 2.5m overall and the walls appear to be 0.50m thick. The structure stands to 0.4m high. The river boulders, as opposed to cobbles, are good building stones being sub-angular with flat faces and measure 0.40m x 0.20m x 0.15m on average. The structure is overgrown with heather and some bracken but is clearly visible. There is no obvious entrance. The small size of this structure located so close to the burn suggests it might have been a dairy store or a still.

**Impact of development:** This building is avoided by the new track and private wire route. It is not considered to be at risk and a watching brief is not required.

**Site 7 small structure on the S bank of Allt Odhar. View to the ENE.**

**Mitigation:** The site has been flagged but should be fenced off with orange plastic fencing to ensure it is avoided. If it cannot be avoided excavation in advance is required.

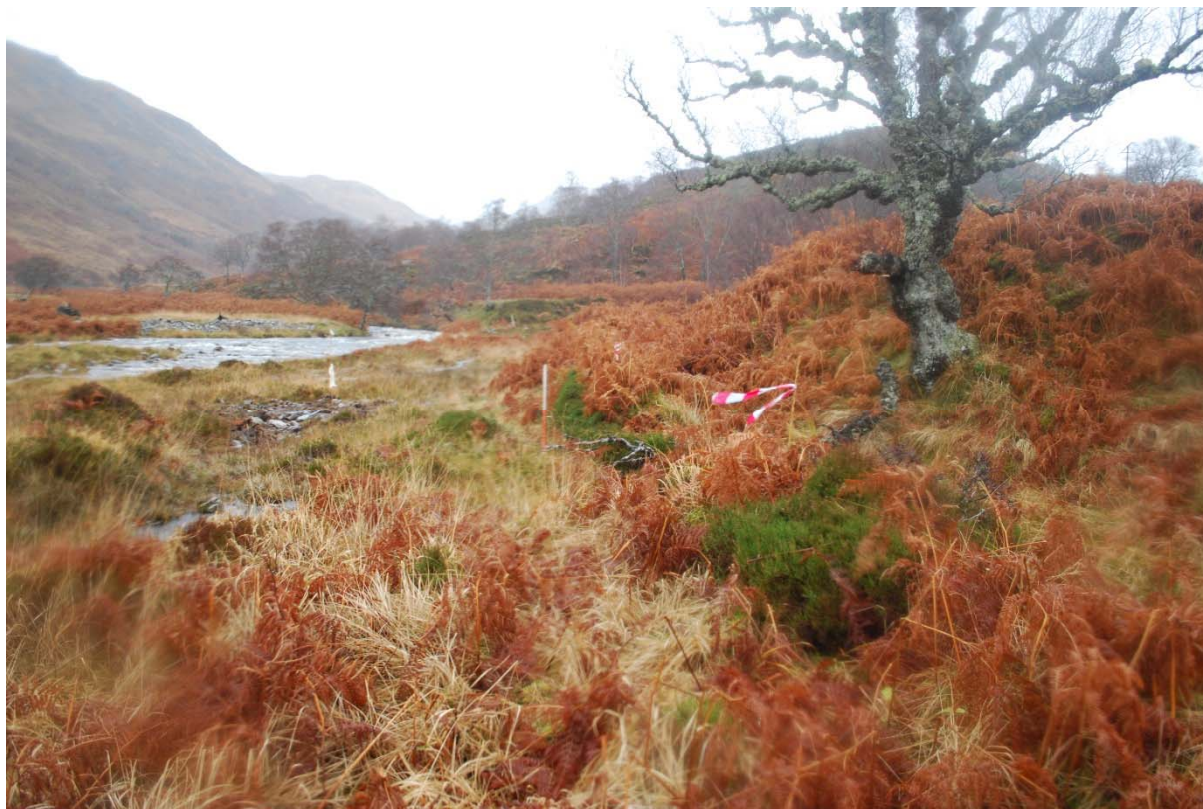
### **Site 8 Stone and Turf dyke**

A quite substantial turf and stone dyke at least 1.5m wide and 1m high. Coursed stone was visible in one or two locations on its interior (S side). The dyke runs E-W along the old (glacial) river bank and separates the higher ground on which the settlement remains (Sites 1, 10, 11, and 12) are located from the lower lying river bank, which is susceptible to flooding. This bank is an enclosure bank for the settlement remains and would have acted as a stock control barrier. The dyke is overgrown with dense bracken. Towards its E end adjacent to Site 10 there is the suggestion of an inner bank running parallel to it and there may be a track or entrance to the settlement here. However, the bracken was too dense to locate features easily or get any useful visual overview of how the various elements that could be identified actually relate to each other.

**Impact of development:** The dyke may be disturbed by the development works, in particular the new bridge.

**Site 8 turf and stone dyke marked by flagging and 1m scale pole running to the E along the edge of the old river bank. View to the E.**

**Mitigation:** See Site 1 recommendations. The dyke should be avoided. A watching brief of the whole settlement area is required.

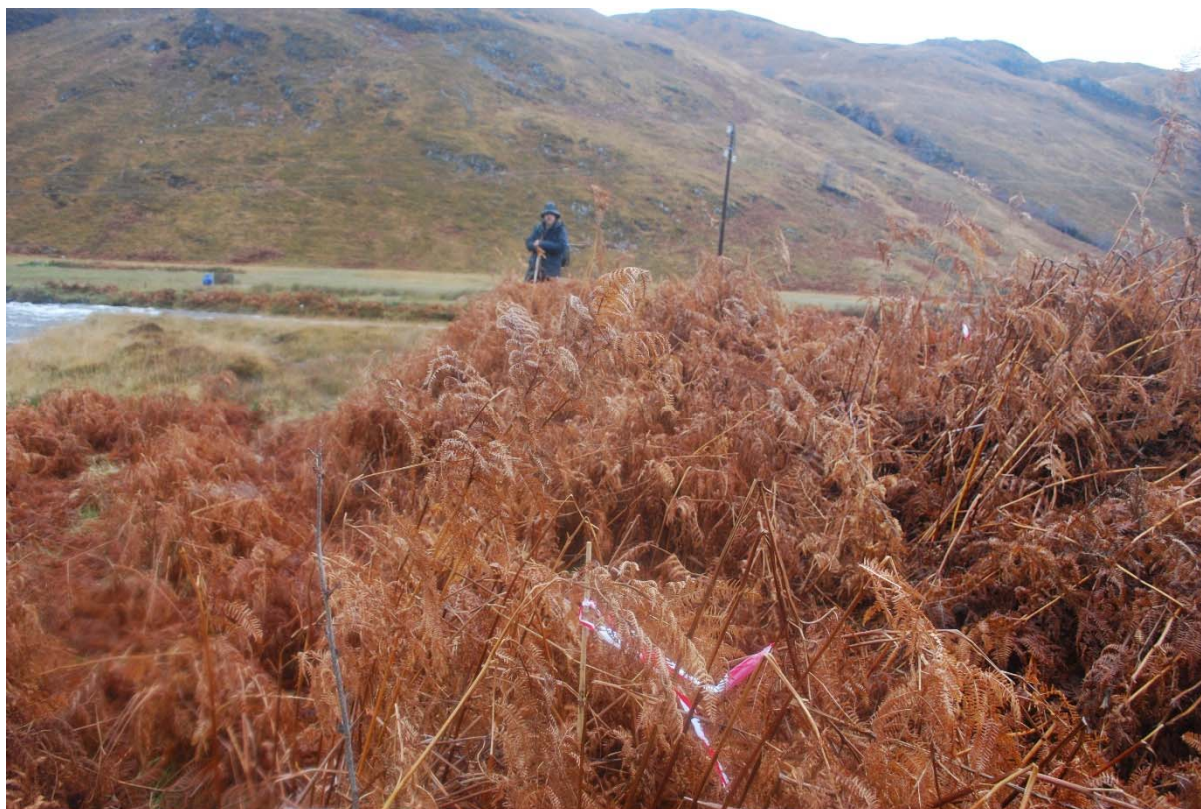
## **Site 9 Dyke**

A turf and boulder dyke running N-S on the E bank of the Allt a' Ghiubhais. And located c. 5m W of Site 1. This dyke is overgrown with bracken and is not easily distinguished from the natural edge but it forms part of the enclosure of the settlement area along with Site 8. The dyke is c. 1m wide and 1m high. It may continue intermittently to the S along the bank of the Allt a' Ghiubhais.

**Impact of development:** The site is at risk of disturbance by construction of the new bridge and the new track and private wire.

**Site 9 turf and stone dyke marked by flagging in foreground and Scott standing on it. View to the N.**

**Mitigation:** See Site 1 recommendations. The dyke should be avoided. A watching brief of the whole settlement area is required.

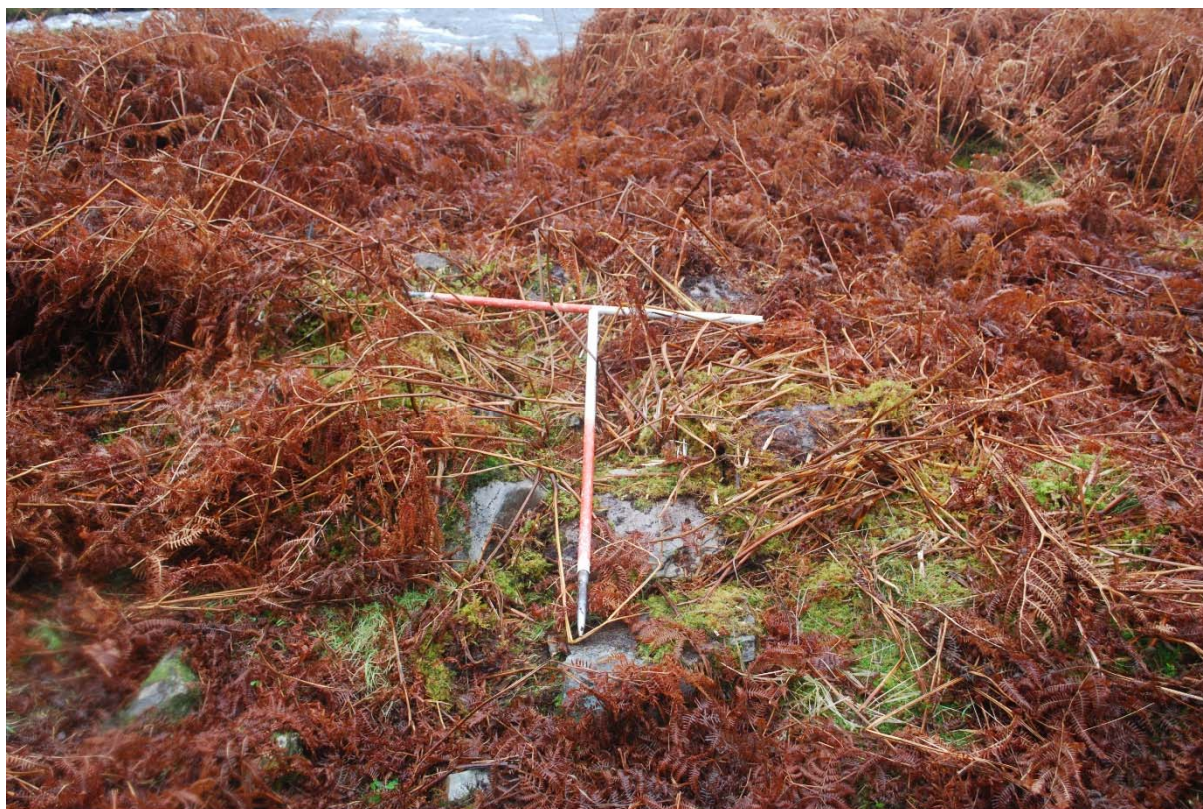
## **Site 10                      Structure, probably corn drying kiln**

A 2m diameter circular setting of boulders with a central depression c. 0.70m diameter and standing to 0.40m high. There is a possible linear extension on the SW side which may be a flue. The site is overgrown with bracken but appears to have very few tumbled stones associated with it.

**Impact of development:** This site would probably be avoided by the new track but is very close to the development works.

**Site 10 probable corn drying kiln with possible flue in foreground. View to the NE.**

**Mitigation:** See Site 1 recommendations. The structure should be avoided. A watching brief of the whole settlement remains is required.

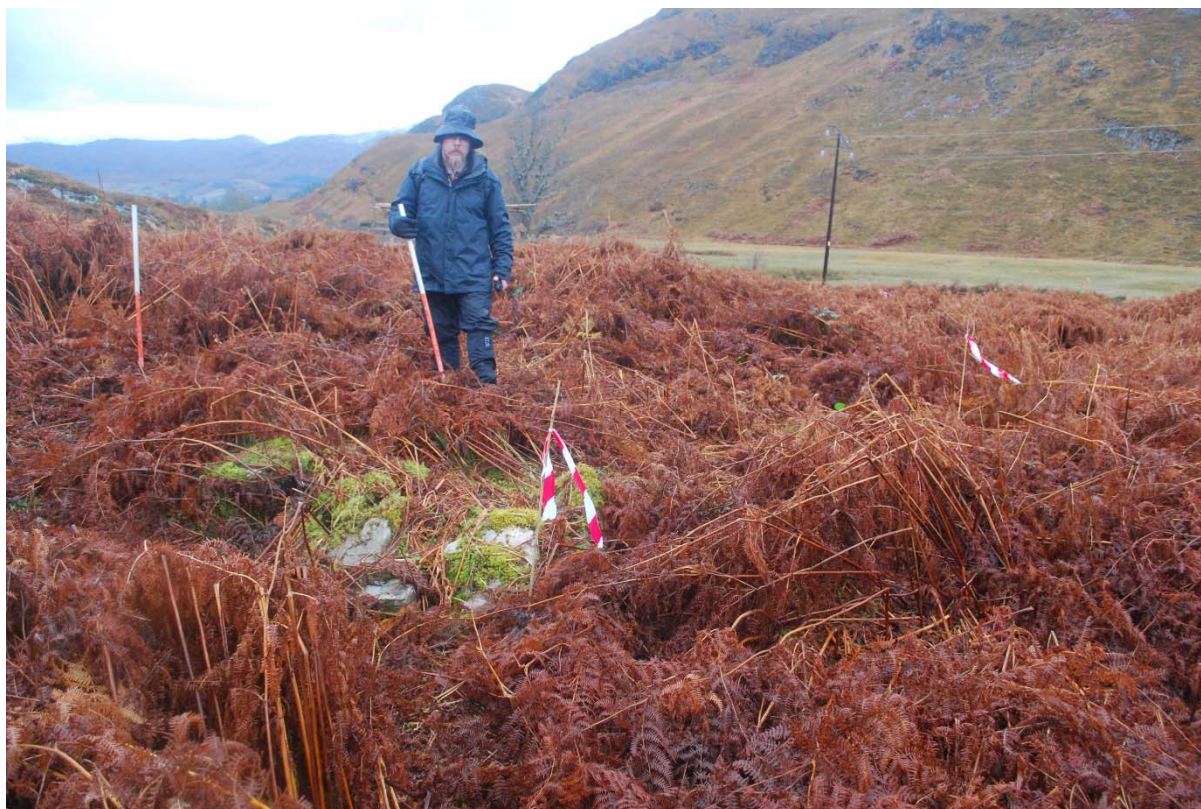
## **Site 11      Structure**

The remains of a rectangular structure represented by one course of stones and standing to 0.30m high. The walls are poorly defined and the E and S walls are most apparent. The walls are 0.50m to 0.70m wide. The site is completely overgrown with bracken and wall lines could not easily be traced by probing with a ranging rod. The site is c. 3.5m N-S x 3m E-W and appears to be aligned NNW-SSE.

**Impact of development:** This site is likely to be disturbed by the new track and private wire route.

**Site 11 structural remains with E end corners marked by flagging and 1m scale pole showing extent of traceable S wall. Scott standing in the interior. View to the NW.**

**Mitigation:** See Site 1 recommendations. The structure should be avoided. A watching brief of the whole settlement remains is required.

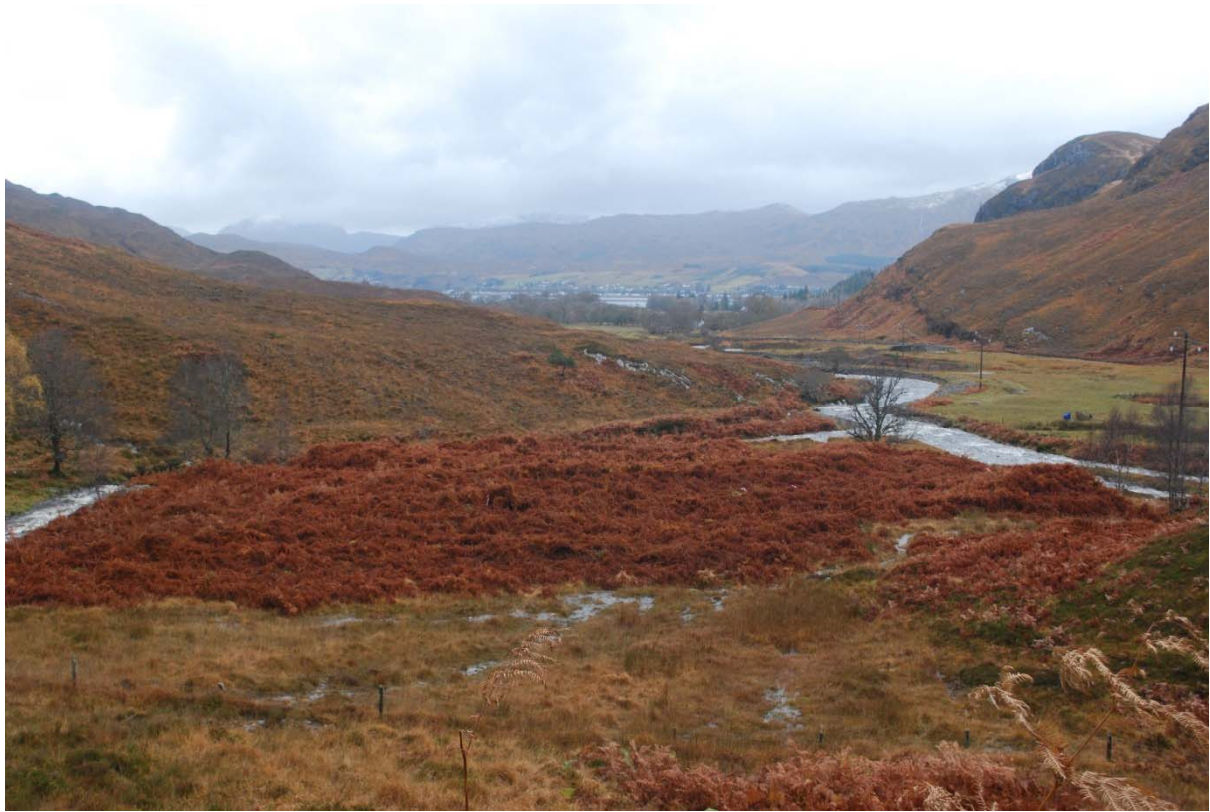
The area is as recorded by Robertson and Dagg but also includes enclosure dykes and other structural elements (Sites 7,8,9,10,11 and 12) suggesting a small fermtoun or clachan. Survey conditions are extremely poor and the area is covered by dense bracken which hampered identification and interpretation of the whole site. Robertson and Dagg commented on the channelled water suggesting a lade and thereby a mill on the site. This is possible and aerial photographs do suggest a managed watercourse. On the ground the western watercourse had clearly been managed and the cutting through the dyke Site 8 at its outflow was quite formal and deliberate rather than eroded. However, Baker and Coulter did not conclusively identify this watercourse as a lade. It is clear that the area was enclosed by earth and stone dykes (Site 8 and 9) and a probable small corn drying kiln (Site 10) is present. The remains of a convincing second building was located (Site 11) some further possible walling and a further possible structure at Site 12. However, the area is a moraine dump so probing for stones that might form wall lines was not entirely convincing. The line of the old river bank is present along the N and W sides of the site and with the exception of the building Site 7 the settlement remains appear to be restricted to the higher land and small plateau island created by the moraine dump.

**General view to the NW over the settlement area covered in bracken and along the strath of Attadale towards Loch Carron.**
