# Run-of-River Hydropower Schemes, Loch Vaich, Strathvaich Archaeological Walkover Survey Report

AOC 70067  
28<sup>th</sup> October 2015

### Archaeological Walkover Survey Report

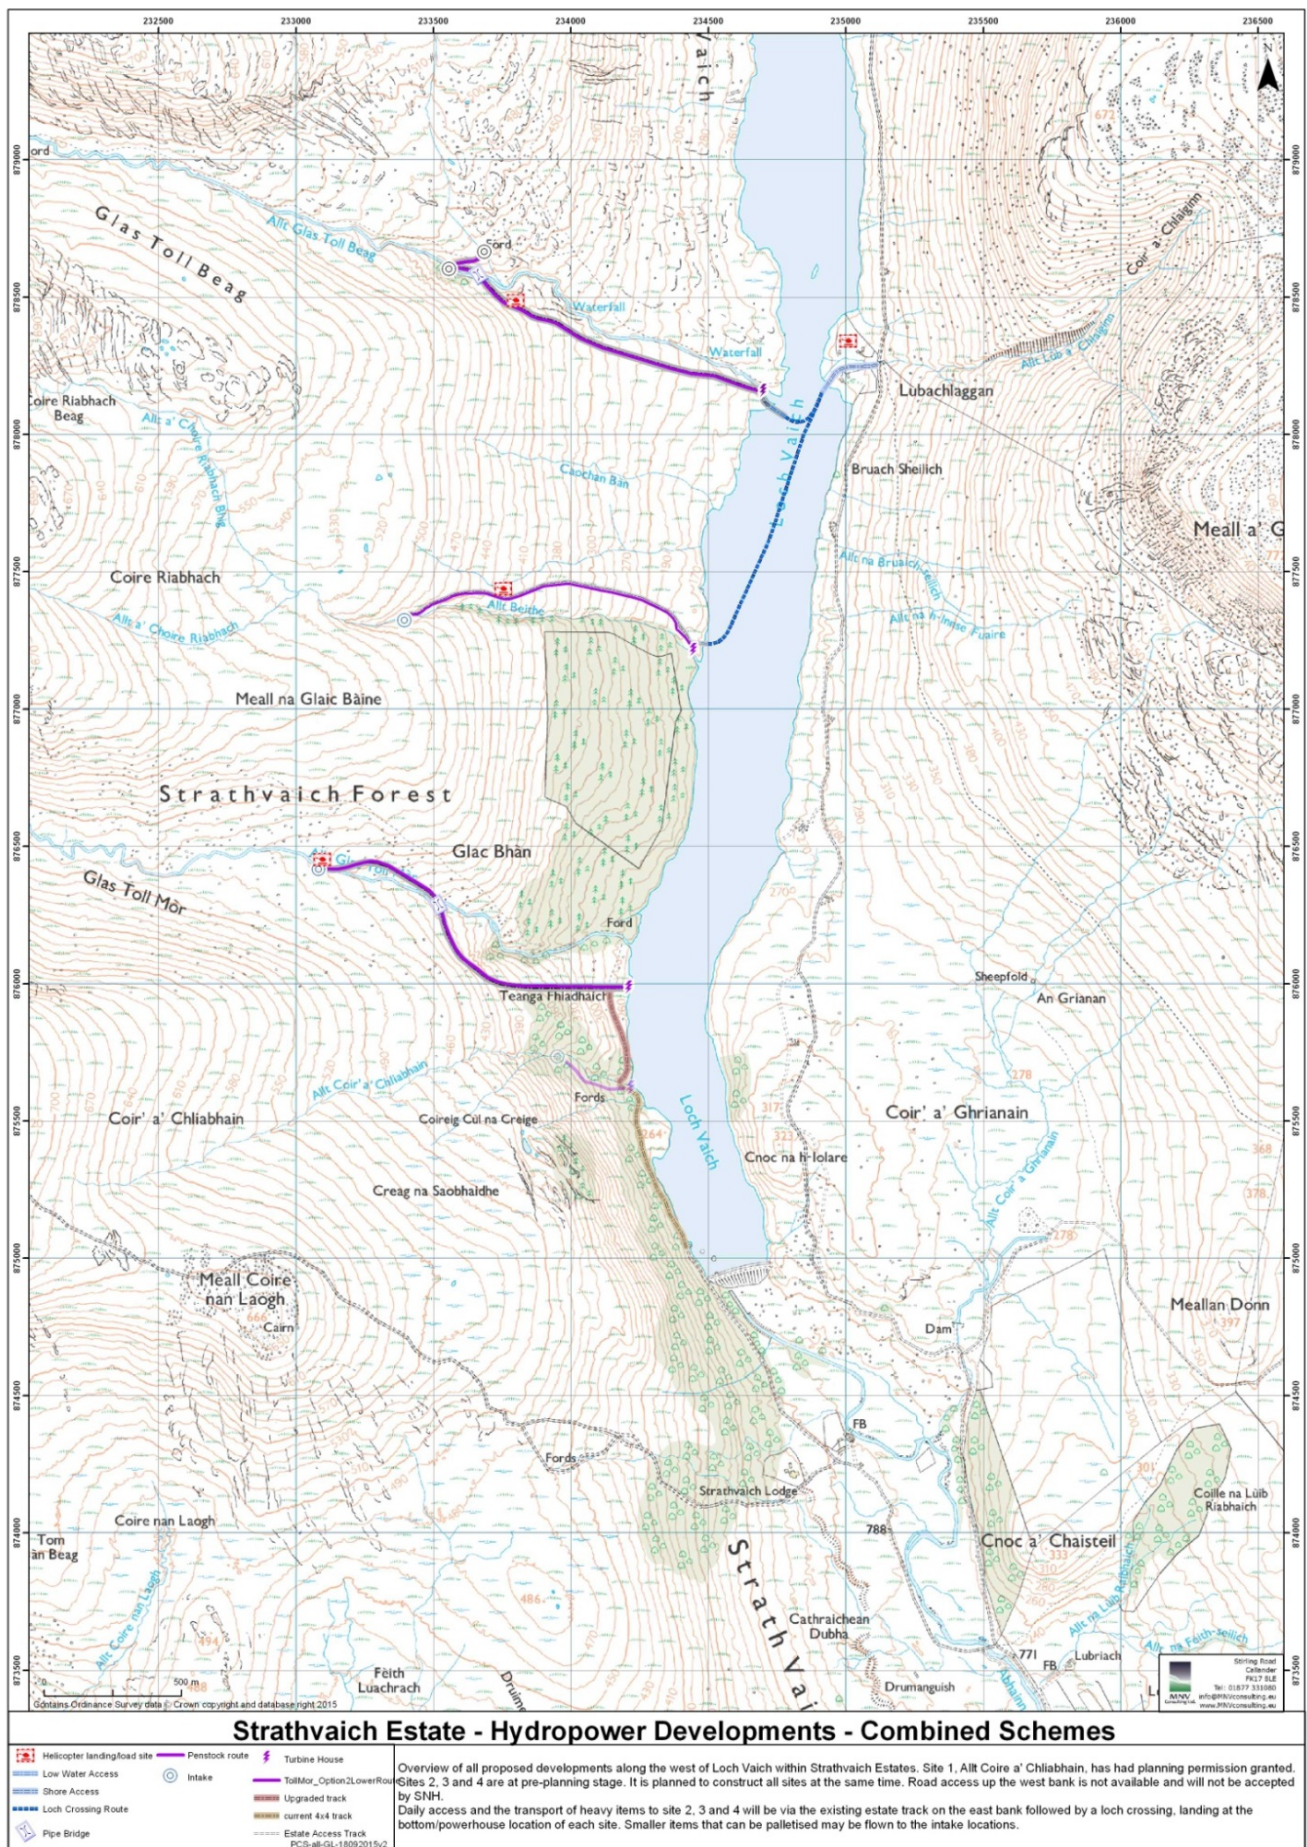
**Figure 1:** Location of the proposed hydropower and access routes (plan provided by MNV Consulting)

2. The development area is centred on NG 3448 7724, approximately 10 miles to the northwest of Garve in Ross-shire, northwest of Inverness (Figure 1). The proposed layout will be located along three stream courses on the west side of Loch Vaich - Allt Glas Toll Beag (Route 1), Allt Beithe (Route 2), and Allt Glas Toll Mòr (Route 3). In addition to the construction of pipelines along the burns, the development will construct improved road access on the track south of the east end of Route 3 and on the track running through Lubachlaggan settlement on the east side of the loch (Figure 1). Construction access to the northern and middle schemes (Routes 1-2) will be made across the loch via boat and by helicopter. The present survey was undertaken to identify any archaeological sites within a proposed corridor around the development areas.

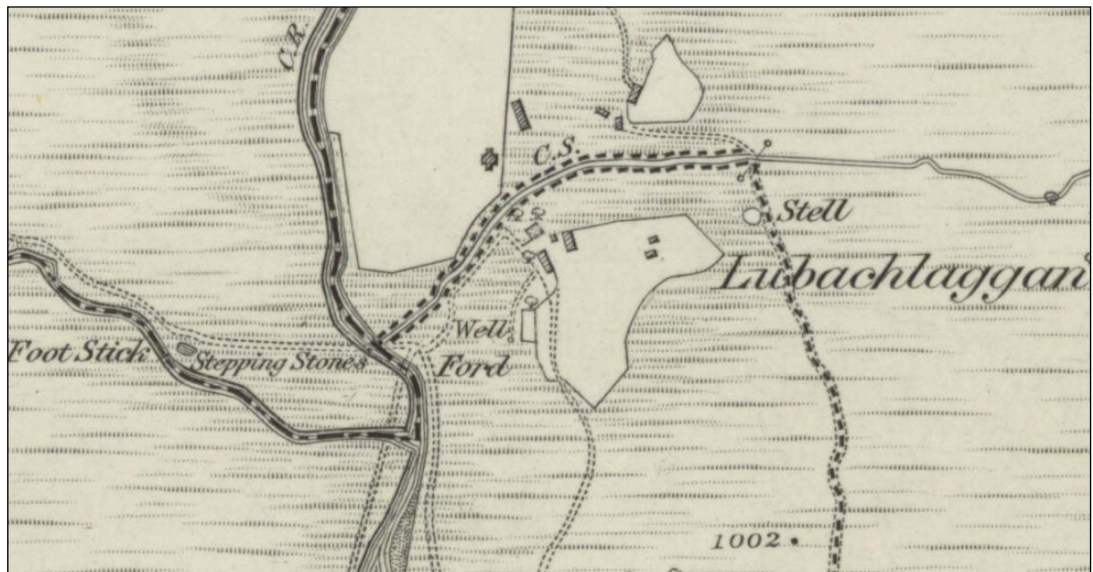
**Figure 3:** Extract from the First Edition OS Map showing Lubachlaggan, 1881 (NLS 2015)

The settlement *Lubachlaggan* is depicted on the 1<sup>st</sup> Edition OS Map to the east of the north hydroscheme (Route 1) on the Allt Glas Toll Beag stream (the stream depicted on the left side of the extract in **Figure 3**). Several roofed buildings can be seen situated across the Allt Lùb a' Chlaighinn stream, with associated enclosures and several marked points of interest, including stepping stones, a stail, a well, and a ford.

Along the Abhainn Srath a' Bhathaich, there are *stepping stones* depicted crossing the burn west of the location of the present bridge. To the south of the stepping stones, a ford is depicted with tracks running along the east and west sides of the burn. A 'foot stick' is also shown to the west

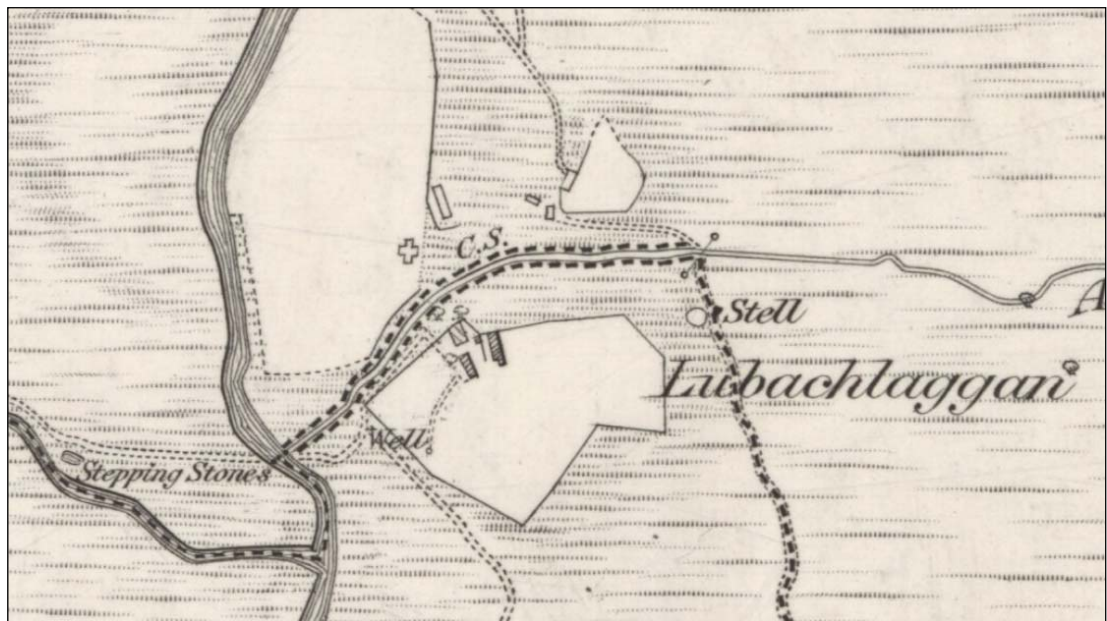
**Figure 4:** Extract from the Second Edition OS Map showing Lubachlaggan, 1903 (NLS 2015)

The buildings to the north of the *Alt Lùb a' Chlaighinn* are abandoned by the time of this map's publication. The buildings to the south are shown as still inhabited. The stepping stones crossing the river are still depicted, but the ford is no longer clearly identified (Figure 4).

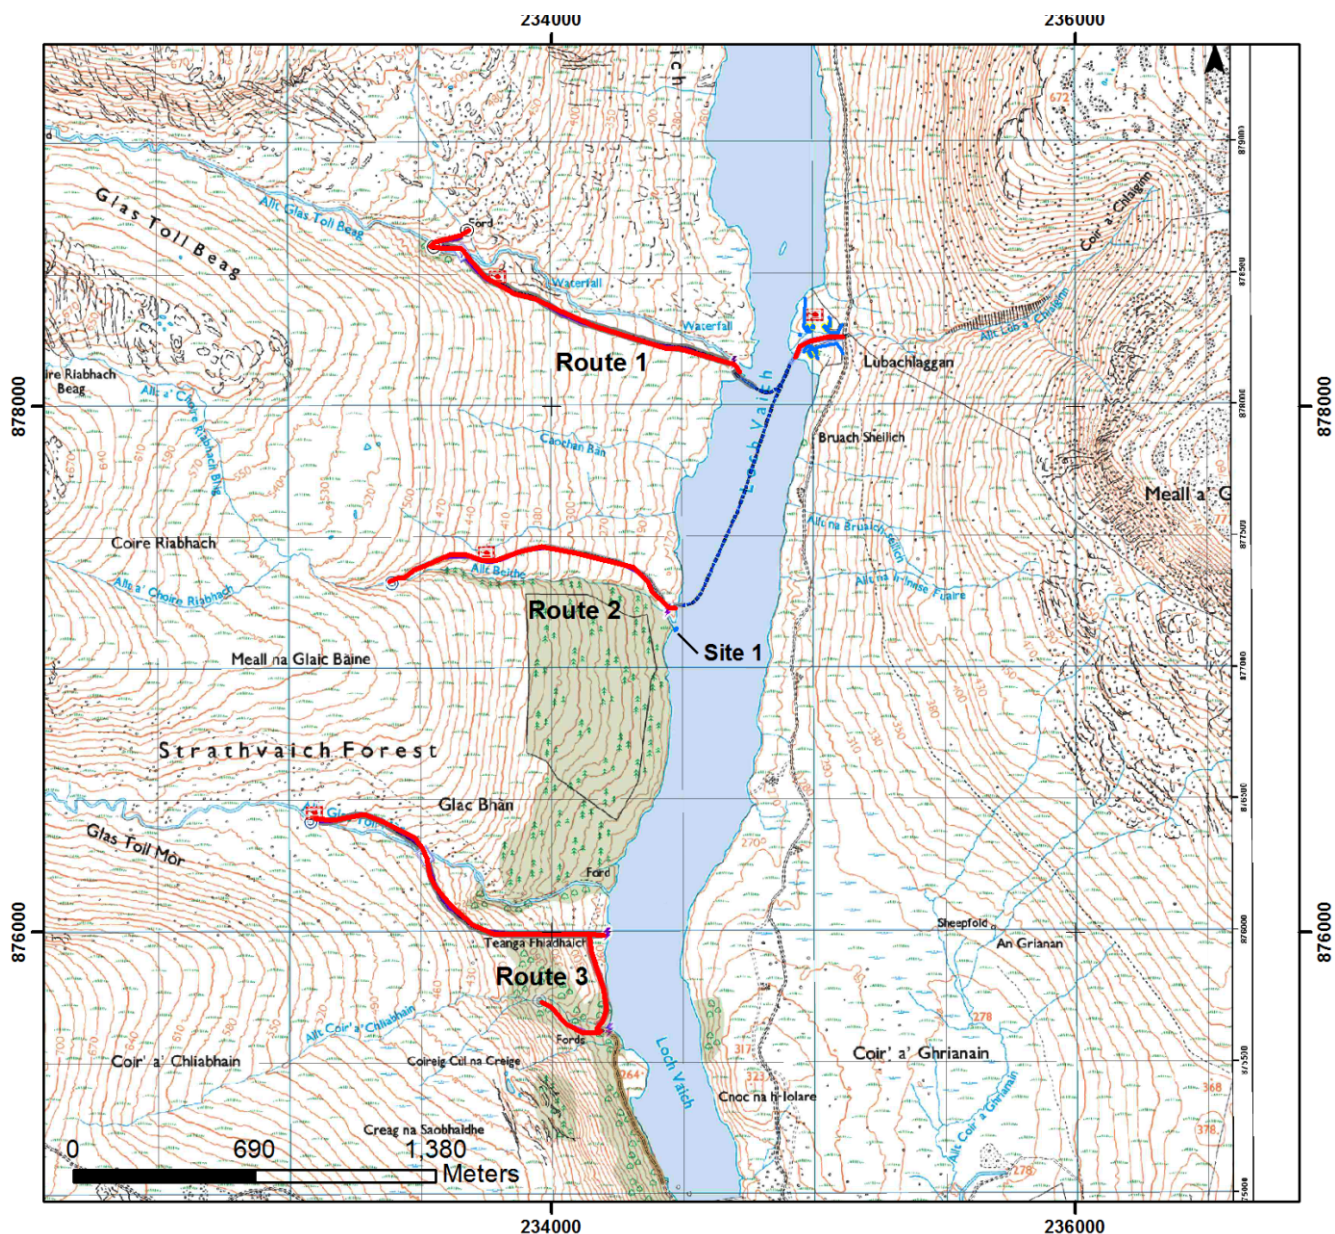
**Figure 5:** Location of the survey routes and archaeological sites

11. The survey routes (Figure 5) were walked over and surveyed on the 23<sup>rd</sup> and 26<sup>th</sup> of October 2015. The weather for the survey was generally good, with cloud cover on the 23<sup>rd</sup> and dry sunny conditions on the 26<sup>th</sup>. The ground conditions were dry underfoot. The survey was carried out by Mary Peteranna, Steve Birch, Sam Williamson and Lindsey Stirling.

12. A corridor of 20-50m around the proposed pipeline routes and access routes (Figure 5) were systematically walked by the archaeologists spaced approximately 15-20m apart. Archaeological sites were recorded using high-resolution digital photography, while sketch survey drawings were produced where necessary. Individual site locations were recorded, using ArcPad GIS software on a handheld Windows Mobile-based Archer Field PC capable of sub-metre accuracy.

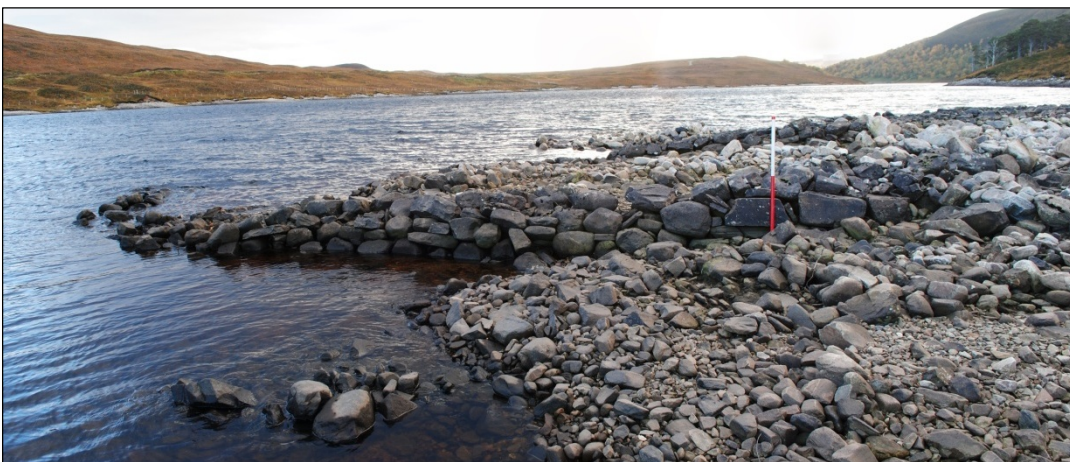
**Plate 3:**  
Site 1, stone-built jetty/boat landing at E end of Route 2, facing S (scale = 1m)

19. Site **1** (Plate **3**) comprises two stone-built jetties built on the west shoreline of the loch. They survive as two alignments of single course walling (up to 3 courses surviving). These are not depicted on any of the available mapping and were certainly built after the dam was constructed and the area was flooded.

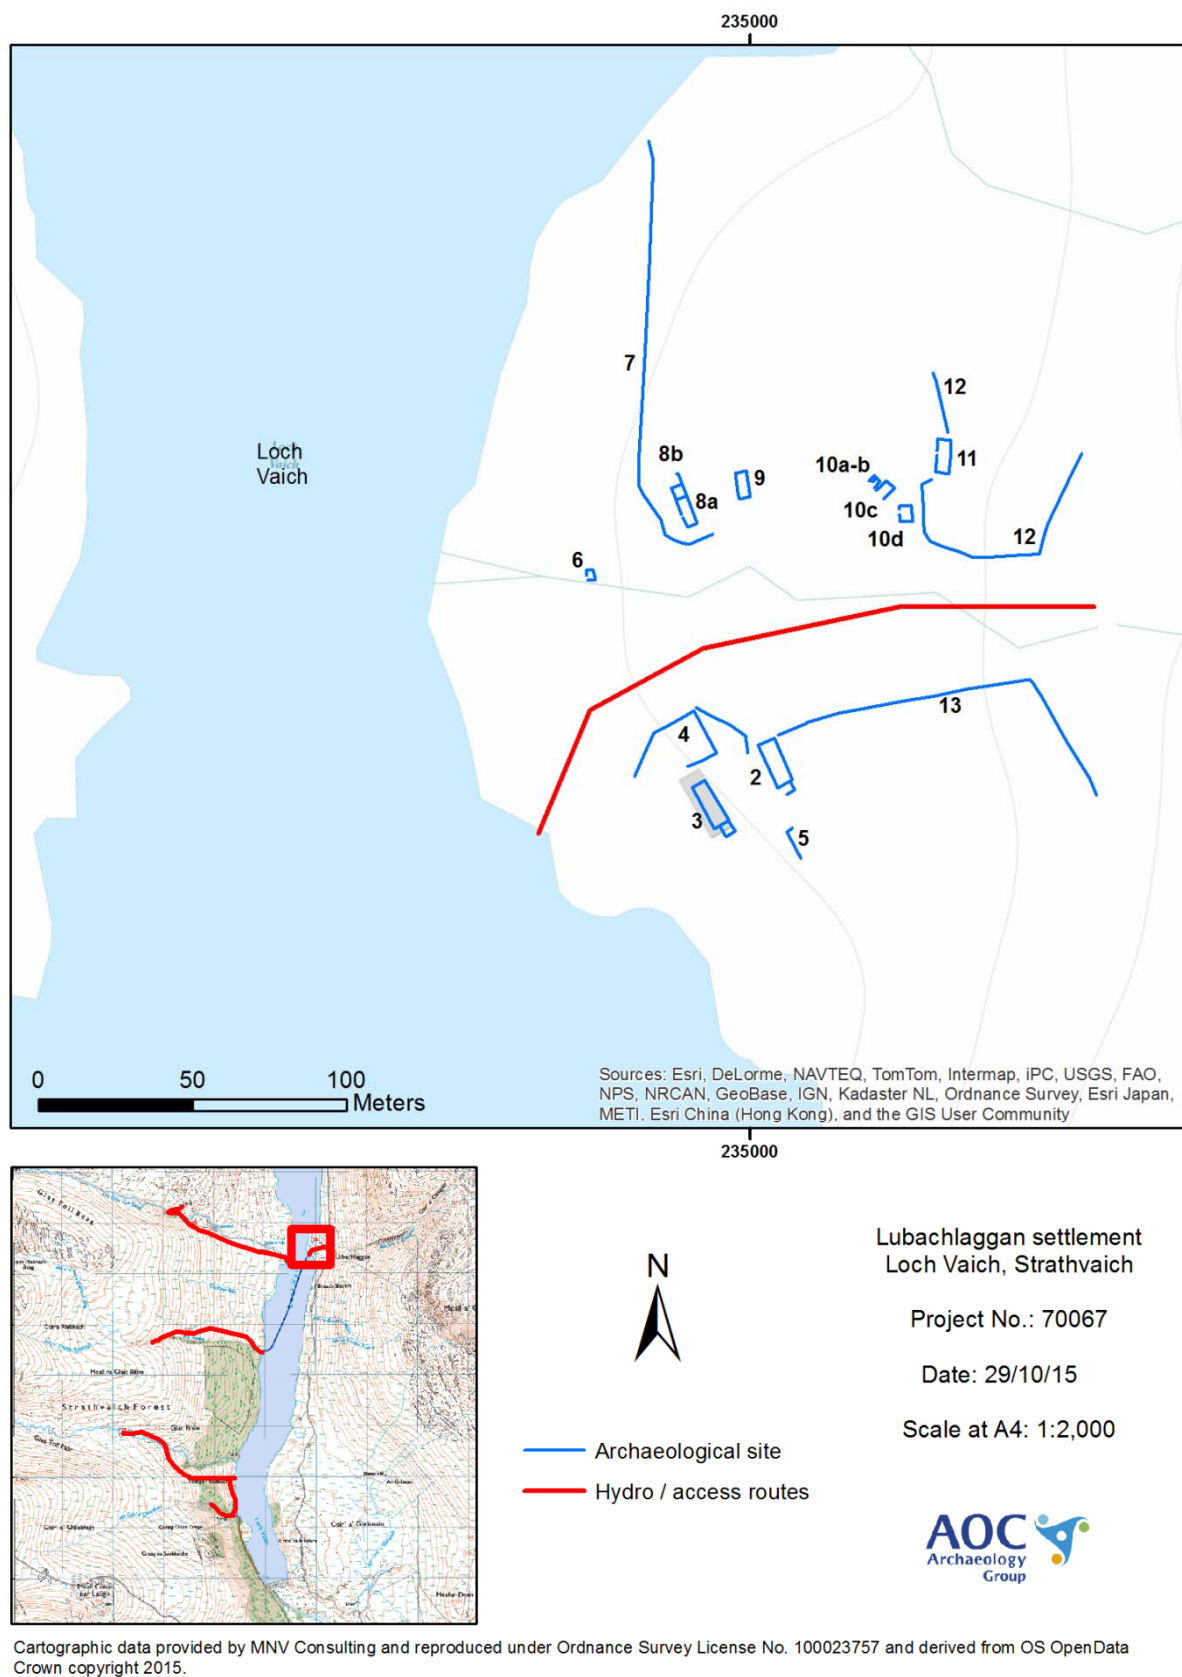
15. The walkover survey recorded 13 archaeological sites (**Figures 6-7**), none of which should be impacted by the proposed work.
16. All but one of the sites recorded form part of the settlement of *Lubachlaggan*, located on the east side of Loch Vaich in the location of a proposed access track for the development (**Figures 5-7**). Although most of the buildings were depicted on modern Ordnance Survey mapping, none of the sites were shown on the Highland HER database or National Monuments Record of Scotland.

17. The settlement of Lubachlaggan, comprising Sites **2-13**, is located opposite Loch Vaich from the north scheme (Route 1) on the east side of the loch. These are typical buildings and structures associated with farmstead settlements, and include a well-preserved roofed house (Site **3**) and byre (Site **2**). The other structural remains within the settlement are in a ruinous condition: a kaleyard (Site **4**), two ruinous buildings (Site **8** and Site **11**), the ephemeral footings of another structure (Site **9**), walls and a boundary dyke (Sites **5**, **12** and **13**) and several revetted stone structures (Site **10**). The access route bisects the settlement sites, with ample space to retain the proposed buffer of 10m from Sites 2, 3, 8, 9, 10 and 11 and the recommended buffer of 5m from Sites 4-7, 12 and 13.

**Figure 6:** Location of archaeological sites recorded during the survey

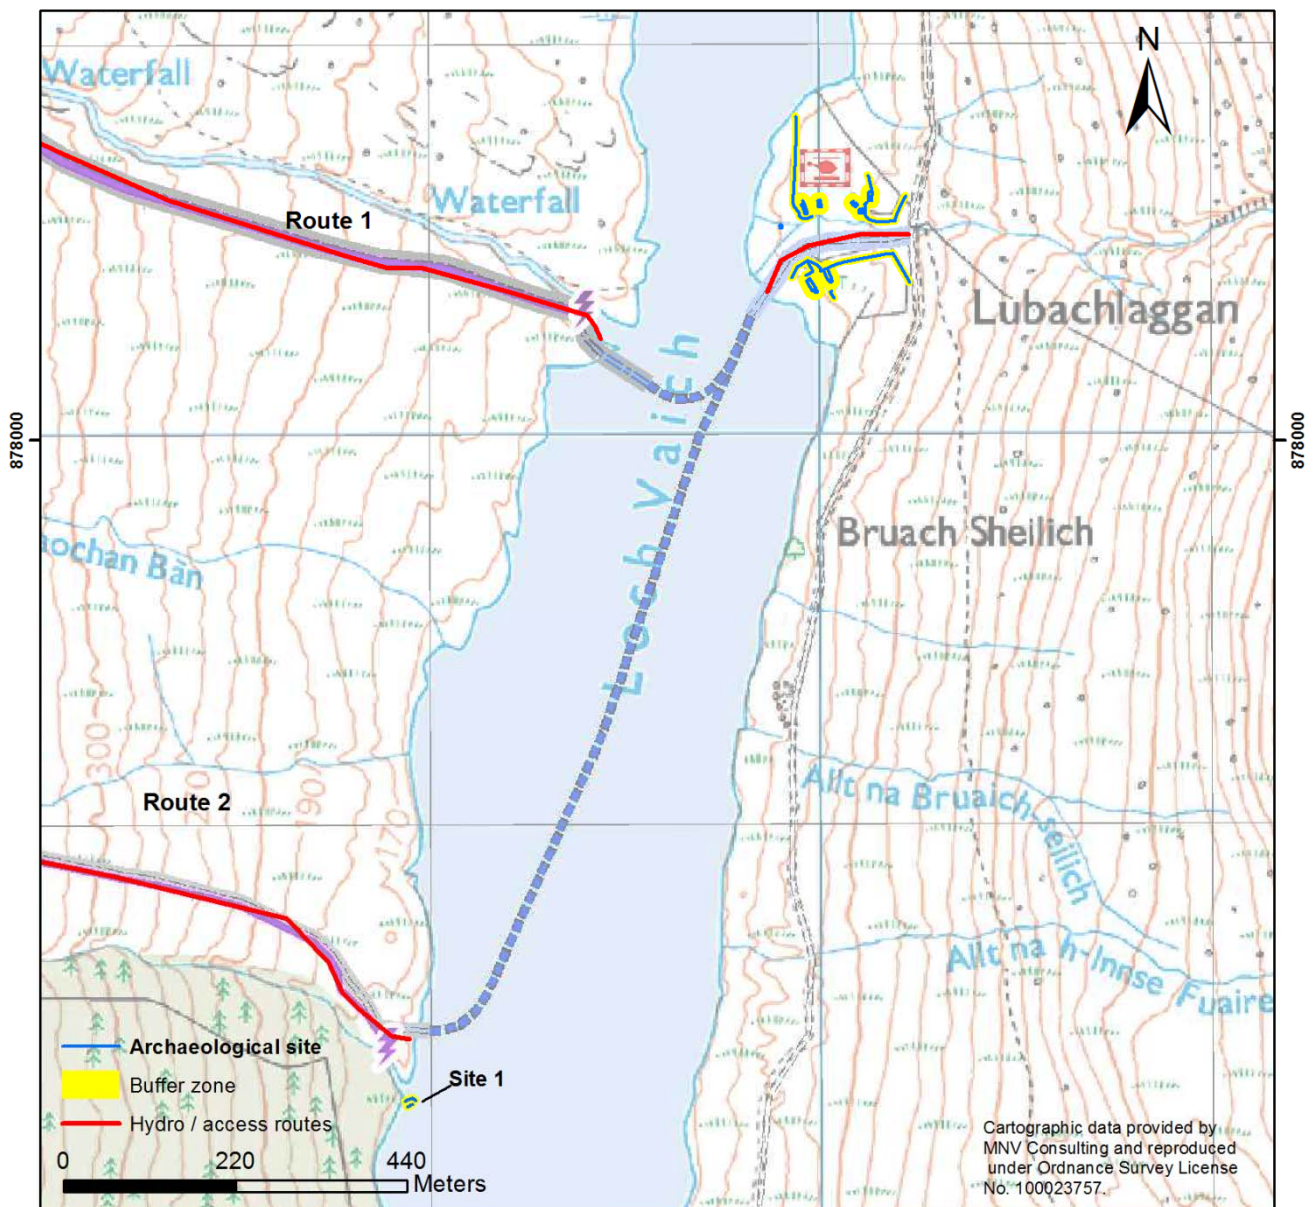
**Figure 7:** Location of archaeological sites and buffer zones

22. The recommended buffer zones for protection of the archaeological sites are shown on the Gazetteer of Archaeological Sites and in the plan (**Figure 7**). According to the proposed hydro scheme layout, it would appear that none of the archaeological sites will be impacted by the development. However, it is recommended that caution be taken during machine movement and equipment staging at Lubachlaggan settlement to ensure that the recommended buffer zones are maintained.

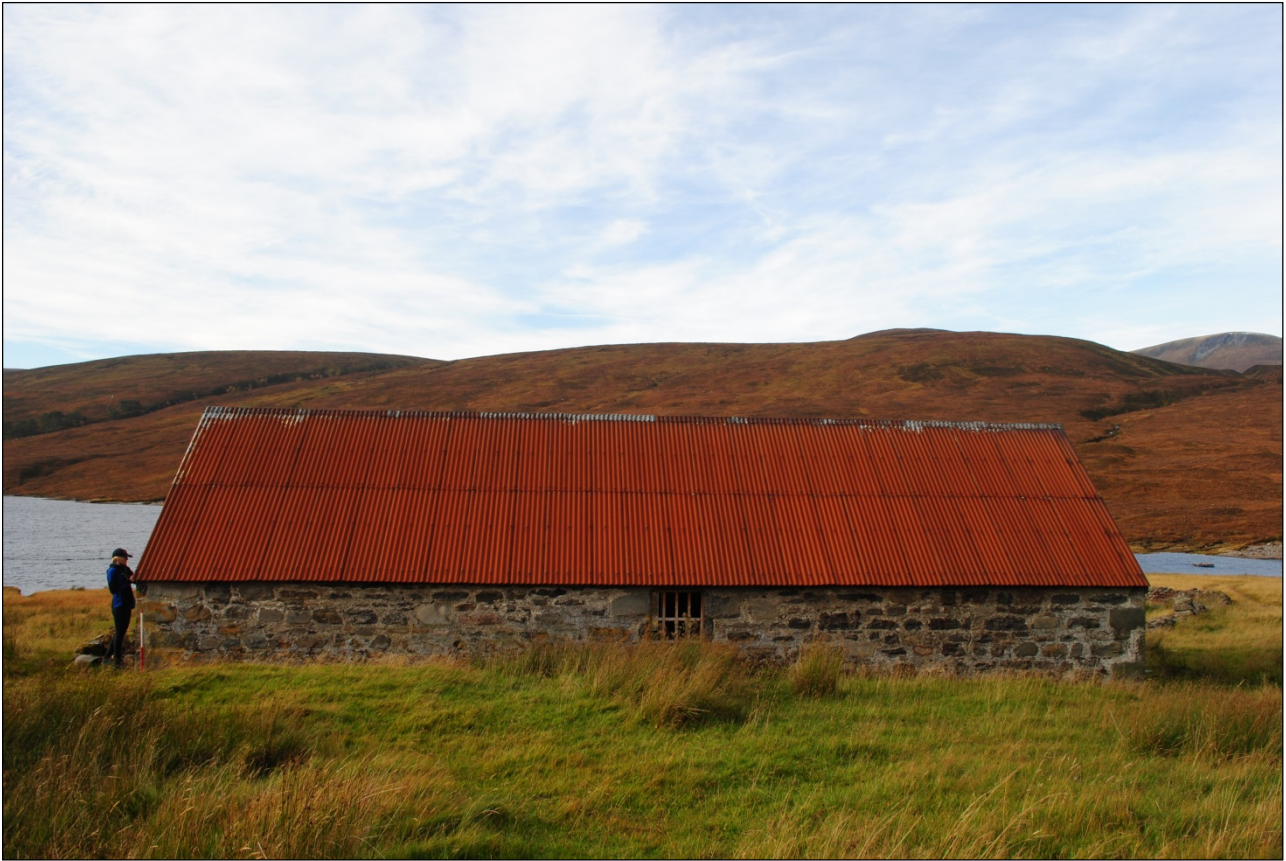
**Plate 8:** Site 2, NE wall of byre, facing SW (scale = 1m)

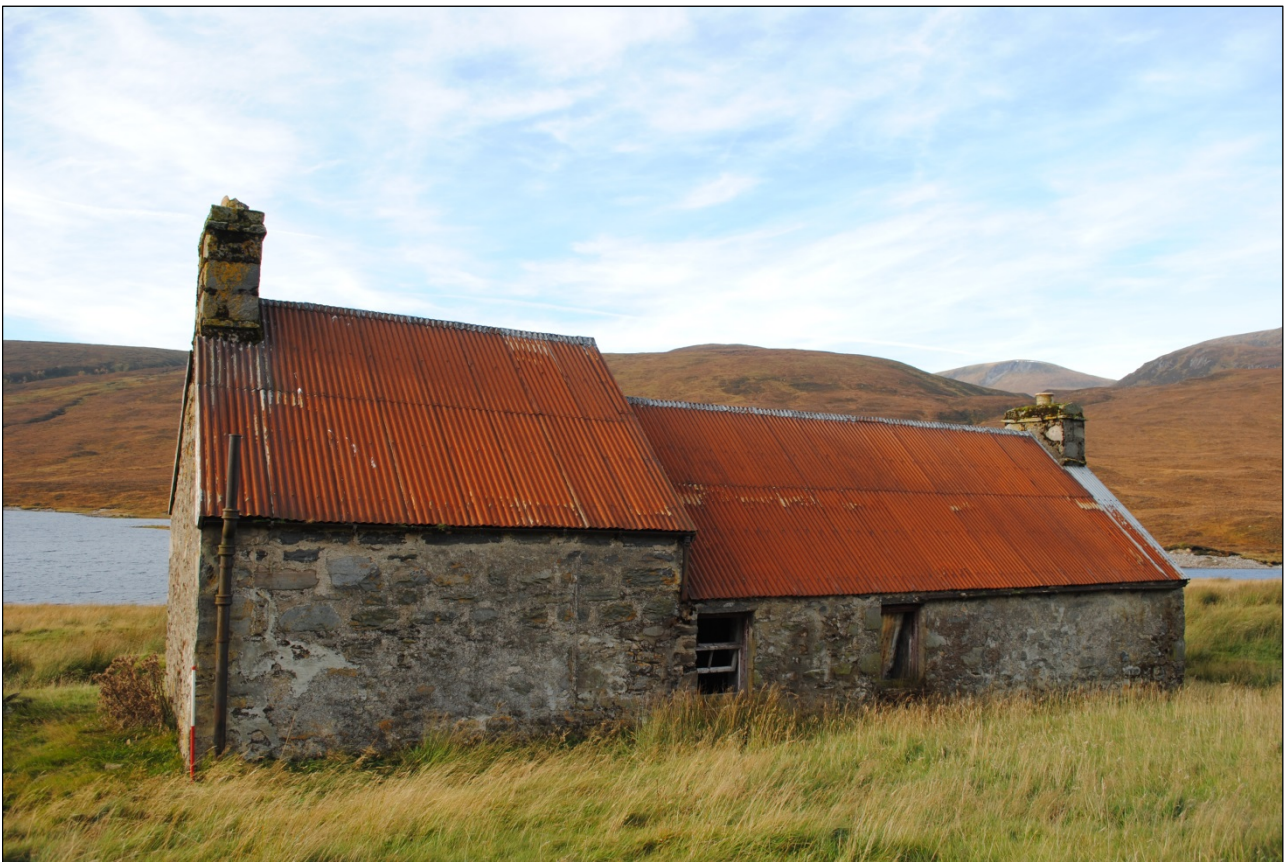
**Plate 9:** Site 3, NE wall of byre, facing WSW (scale = 1m)

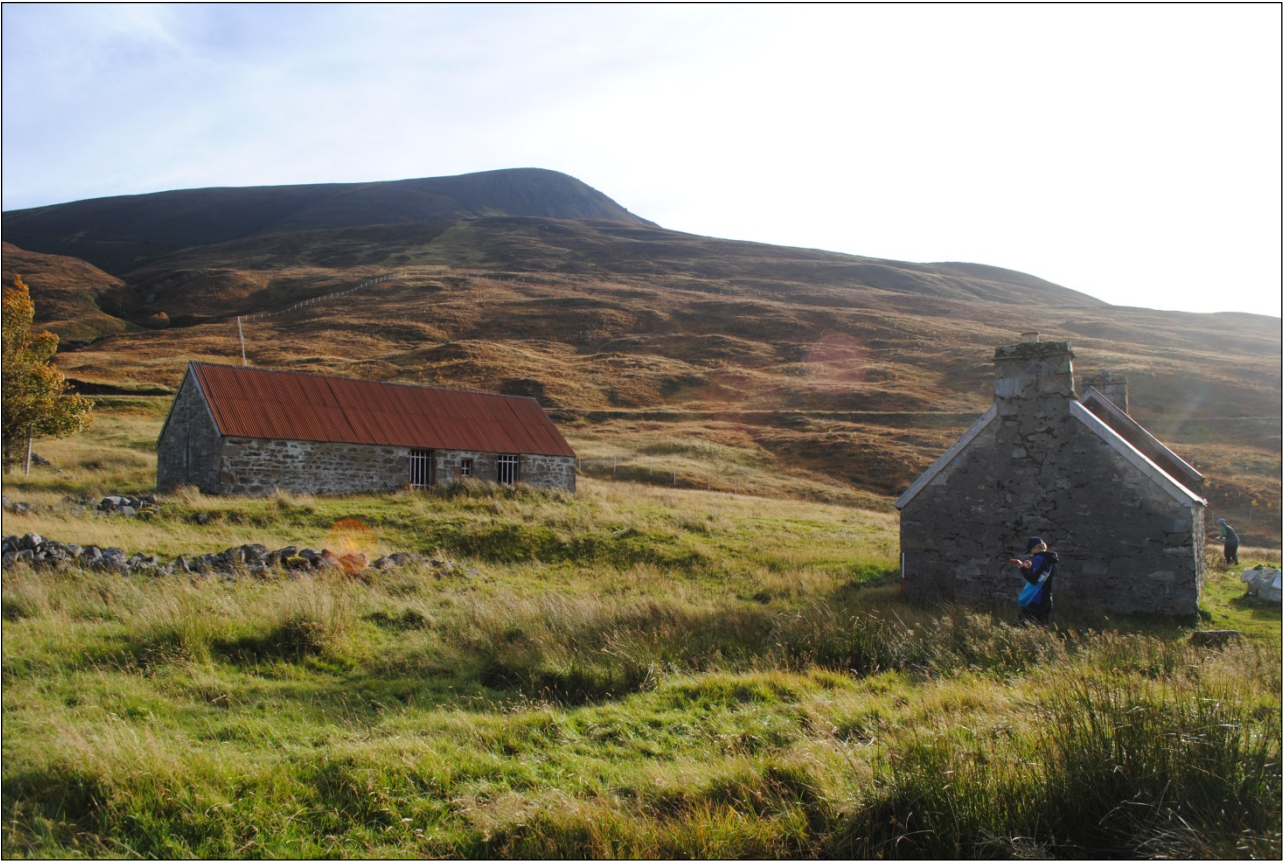
**Plate 10:** House Site 3 (right), byre Site 2 (left) and remnants of enclosure Site 4 in front, facing ESE (scale = 1m)

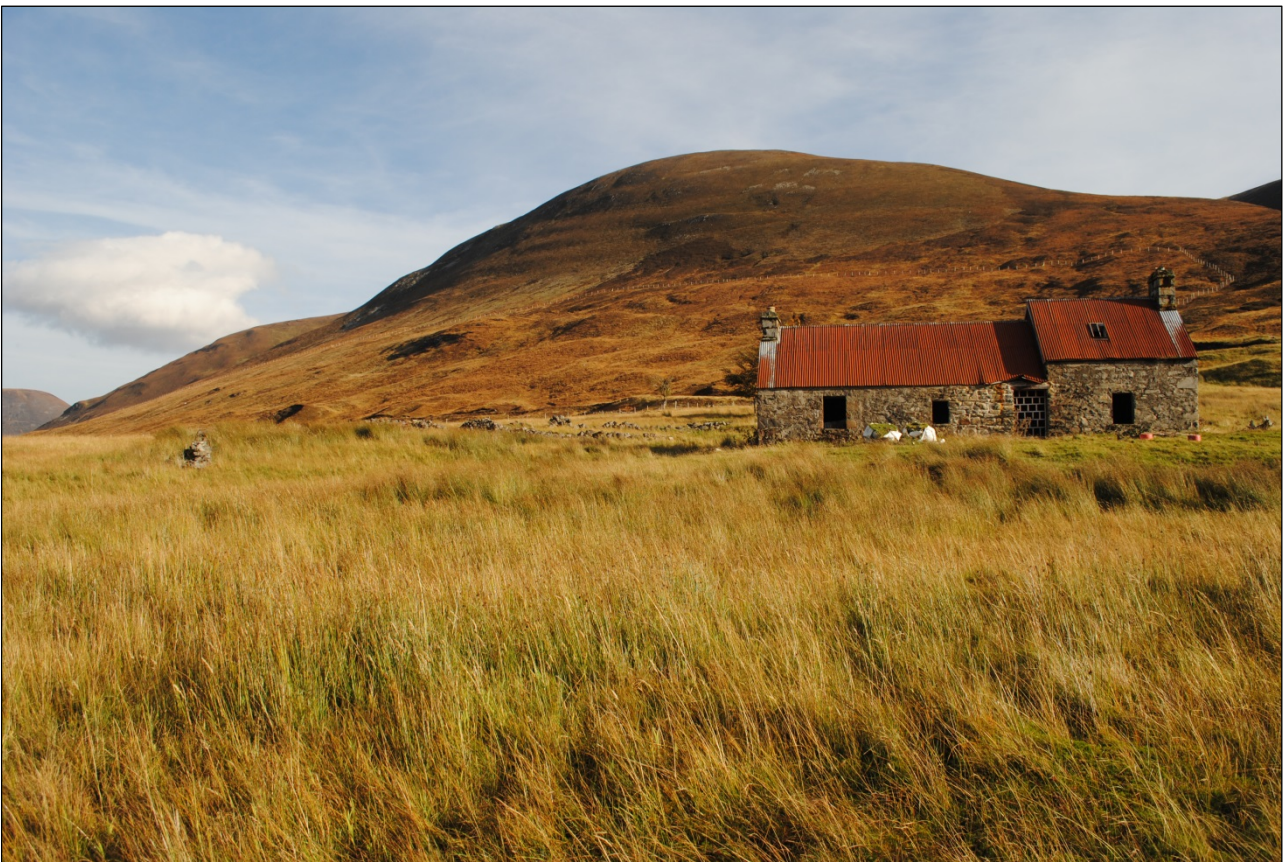
**Plate 11:** House (Site 2) with kaleyard enclosure (site 4) to left, facing ENE (scale = 1m)

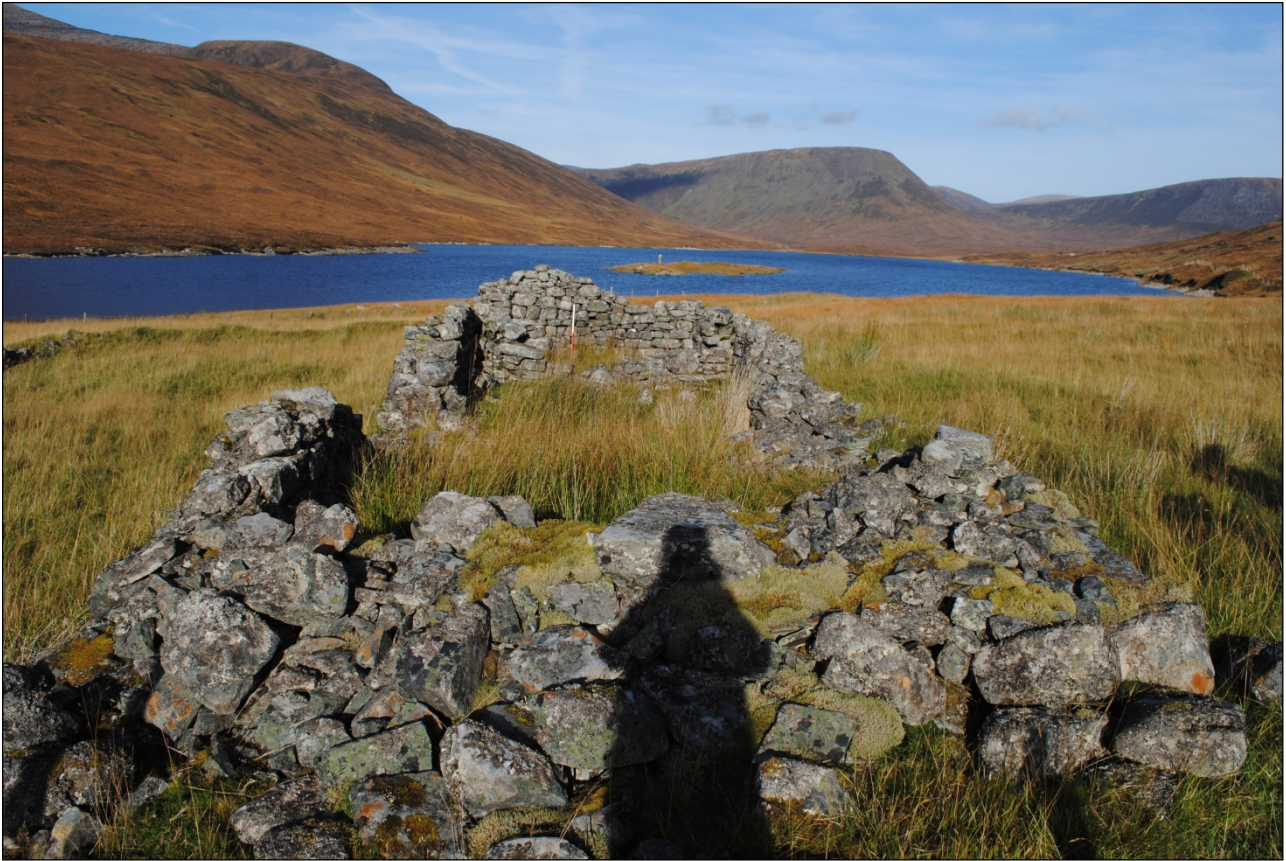
**Plate 12:** Site 8, ruinous stone-built farmstead, facing N (scale = 1m)

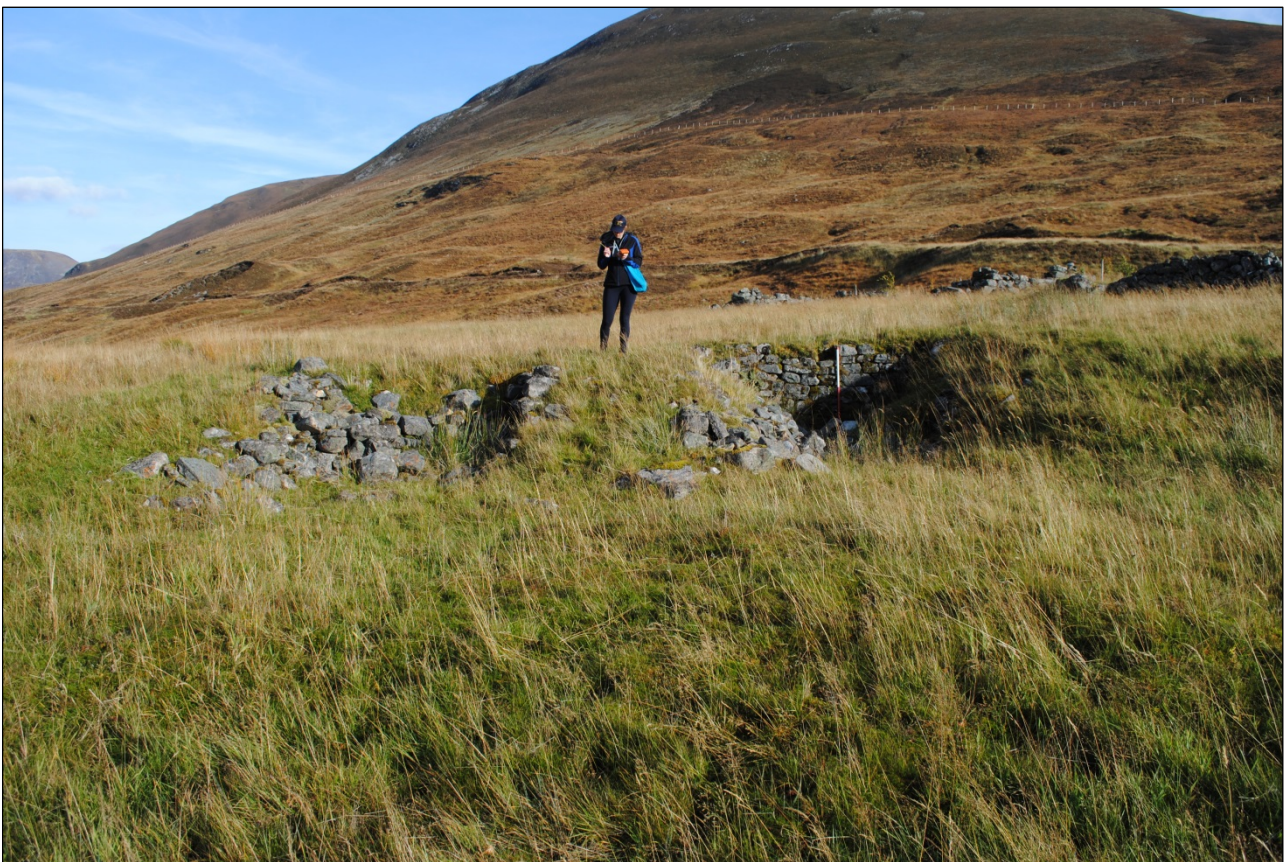
**Plate 13:** Sites 10a-10c, stone-built revetted structures, facing NNE (scale = 1m)

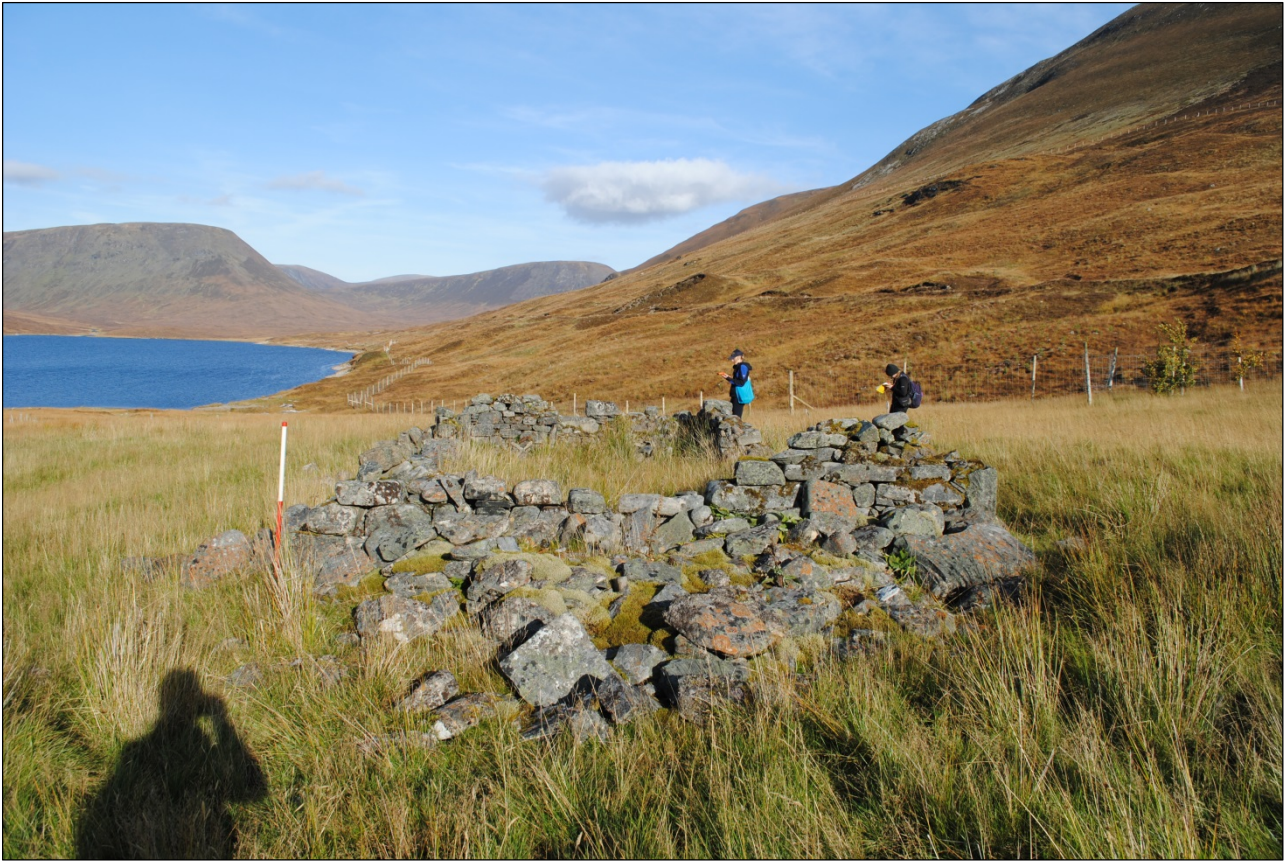
**Plate 14:** Site 11, ruinous stone-built farmstead, facing N (scale = 1m)

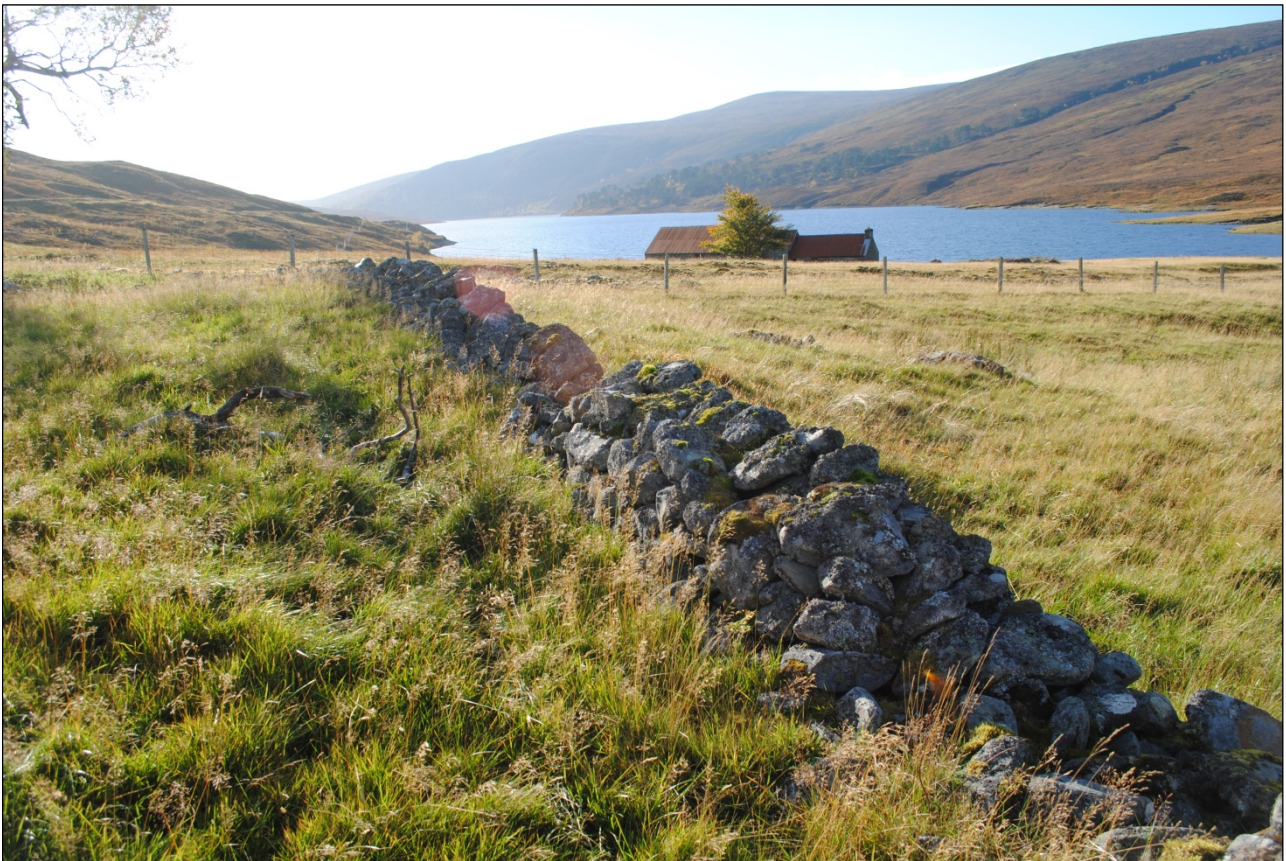
**Plate 15:** Site 12, drystone dyke attached to Site 11, facing SW (scale = 1m)
