## CASTLE ROY

### NETHY BRIDGE

## ARCHAEOLOGICAL INVESTIGATION

SITE CODE: NCR 11  
REPORT CODE: FAS2012 520 NCR457  
NGR: NJ 0065 2192

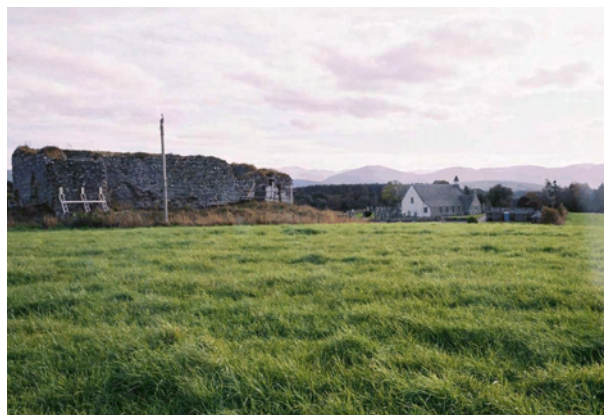
**Plate 1** Castle Roy looking south

Castle Roy is situated beside the B970 on the northern outskirts of the village of Nethy Bridge, approximately 5 miles southwest of Grantown on Spey in the Highlands of Scotland (NGR: NJ 0065 2192). The castle ruin occupies a small hill or mound overlooking the Spey valley (Figure 1; Plate 1). Castle Roy is a Scheduled Ancient Monument (952 NJ 006219).

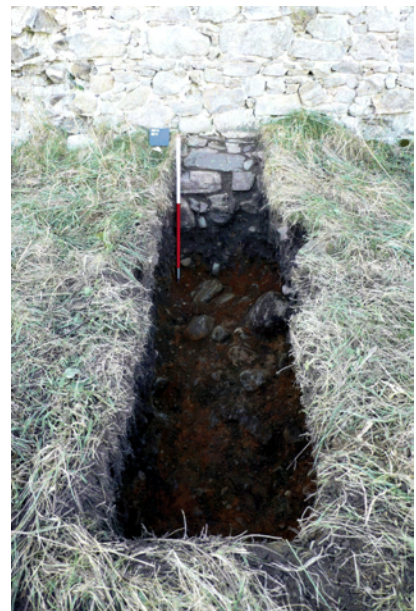
Intervention 2 was located against the exterior of the northeast wall of the castle c.4.5m to the southeast of the entrance (see Figure 2; Plate 2). The trench measured 3.30m x 0.60m and was excavated to a maximum depth of 1.2m below ground level (BGL). The strata encountered and visible in the northwest-facing section consisted of a layer of firm, reddish-yellow sandy silt which lay at the base of the trench, and contained very frequent rounded cobbles, pebbles and gravel inclusions (C1005)(Figure 3; Table 2). C1005 was tentatively identified as a natural subsoil within the confines of the small trench. C1005 was overlain by a c.0.30m layer of brown silty sand allocated C1004 which contained frequent pebbles and gravel, but was otherwise sterile. C1004 was overlain by a similar deposit of dark grey silty sand containing frequent gravel, pebbles and cobbles (C1002), sealed in turn by a layer of turf forming the current ground surface (C1000).

**Plate 2** Intervention 2, F1 C1003 (scale 1.0m)

C1002 was found to abut the foundation of the northeastern castle wall (F1, C1003)(Table 3). The foundation consisted of three fairly rough courses of unbonded angular masonry splaying to form a 50° chamfer. The foundation was found to be c.0.60m deep and overlay C1004 which may therefore represent a buried topsoil.

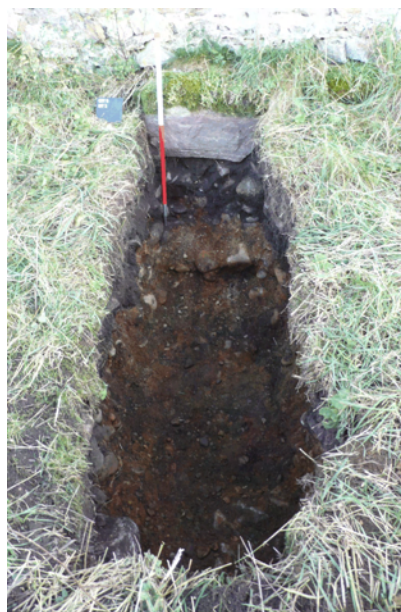
Intervention 3 was located against the exterior of the northwest wall of the castle (see Figure 2). The trench measured 2.75m x 0.60m and was excavated to a maximum depth of 1.10m BGL (Plate 3). The strata defined in the southwest-facing section consisted of the layer of firm, reddish-yellow sandy silt (C1005) also observed within Intervention 2, which formed the base of Intervention 3 where it was seen to contain very frequent rounded cobbles, pebbles and gravel inclusions (see Figure 3). C1005 was more confidently identified as a natural subsoil within Intervention 3. C1005 was then overlain by a c.0.50m layer of dark grey sandy silt, C1007, which contained frequent rounded cobbles, pebbles and gravel, along with occasional small fragments of old red sandstone at the southeastern end of the trench, but was otherwise sterile. C1007 was sealed in turn by a layer of turf (C1000).

**Plate 3** Intervention 3, F2 C1006 (scale 1.0m)

C1000 was found to abut the foundation of the northwestern castle wall (F2, C1006). The foundation in this part of the castle was found to consist of a single course of very large angular blocks of masonry projecting c.0.20m from the elevation of the wall. The foundation was found to be c.0.40m deep, overlying C1004.

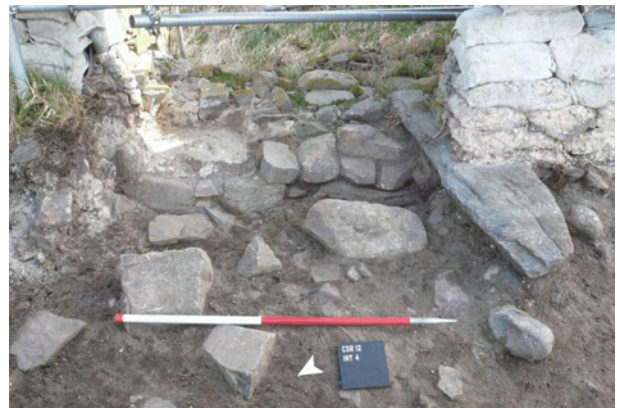
The removal of C1000 and C1007 revealed structural evidence relating to the form of the garderobe turret. A large slab of stone was found to project from the exterior elevation of the castle wall by

c.0.50m directly beneath the southwestern edge of a fragment of barrel vaulting c.2.0m higher in the elevation (Figure 4; Plate 4). Immediately to the northeast of this slab, a large imprint in the mortar at the base of the wall, and the position of a large stone block beyond the wall indicated the former position of a similar stone slab to the northeast. These two stone slabs (F3 C1008) appear to have provided the foundation for two short walls projecting approximately 0.5m beyond the exterior elevation of the castle and coincide with a small projecting barrel vault above. It seems likely that a further stone slab would have spanned between the surviving slab and the parallel slab evidenced by the mortar imprint to form the end wall of the turret and a convenient low opening for the flow of effluent.

**Plate 4** Intervention 4, F3 C1008 (scale 1.0m)

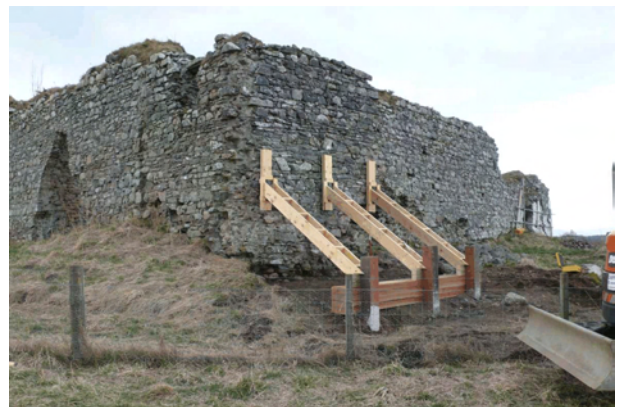
A watching brief was maintained during groundworks associated with the temporary propping and subsequent underpinning of the northwest foundation of the two-storey tower on the northern corner of the castle during March 2012. The initial de-turfing of the area was followed by the excavation of a 5.0m x 0.5m x 1.0m deep trench for the installation of three substantial timber uprights to support the temporary shoring system (Plate 5). Once the shoring had been constructed, the area around the northeastern foundations of the tower was excavated to a depth of approximately 1.0m below the former ground level to allow the foundations to be repaired.

**Plate 5** Intervention 5 showing temporary supports

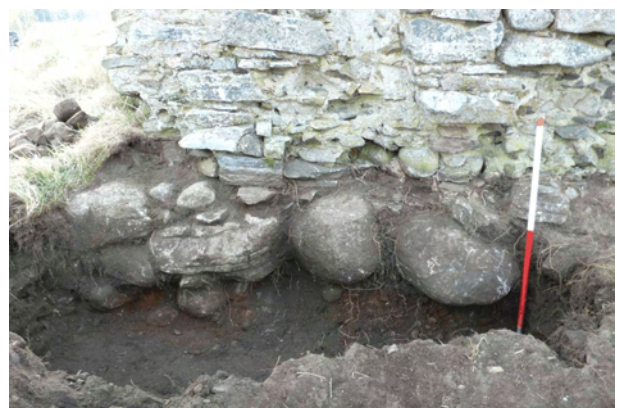
The foundations of the tower (F4 C1009) were found to consist of irregularly coursed unbonded rubble including a number of very large rounded blocks (Plate 6). The irregular and frequently voided foundations was offset approximately 0.30m from the face of the elevation above and varied from 0.6m to 0.8m in depth.

**Plate 6** Intervention 5, F4 C1009 (scale 1.0m)

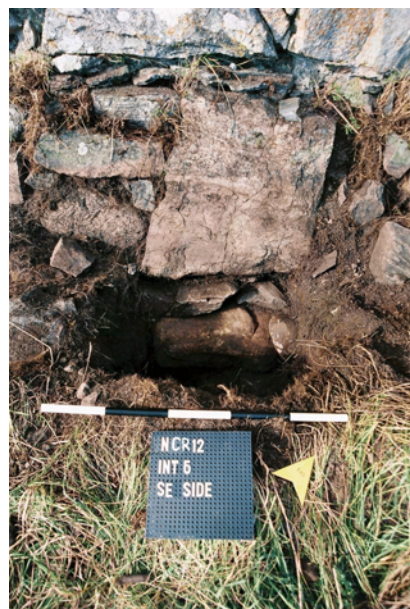
As part of the visual inspection of foundations, a localised testpit was excavated against the exterior of the southeast wall to prove the depth of foundation make-up. The foundations were found to consist of unbonded angular stonework down to 0.35m below ground level and somewhat shallower than the northeast and northwest foundations (F5 C1010)(Plate 7).

**Plate 7** Intervention 6, F5 C1010 (scale 0.50m)
