Bhlaraidh and Beinneun Wind Farm Grid Connection Works, Highland

Archaeological Mitigation Works

Report No. 3521

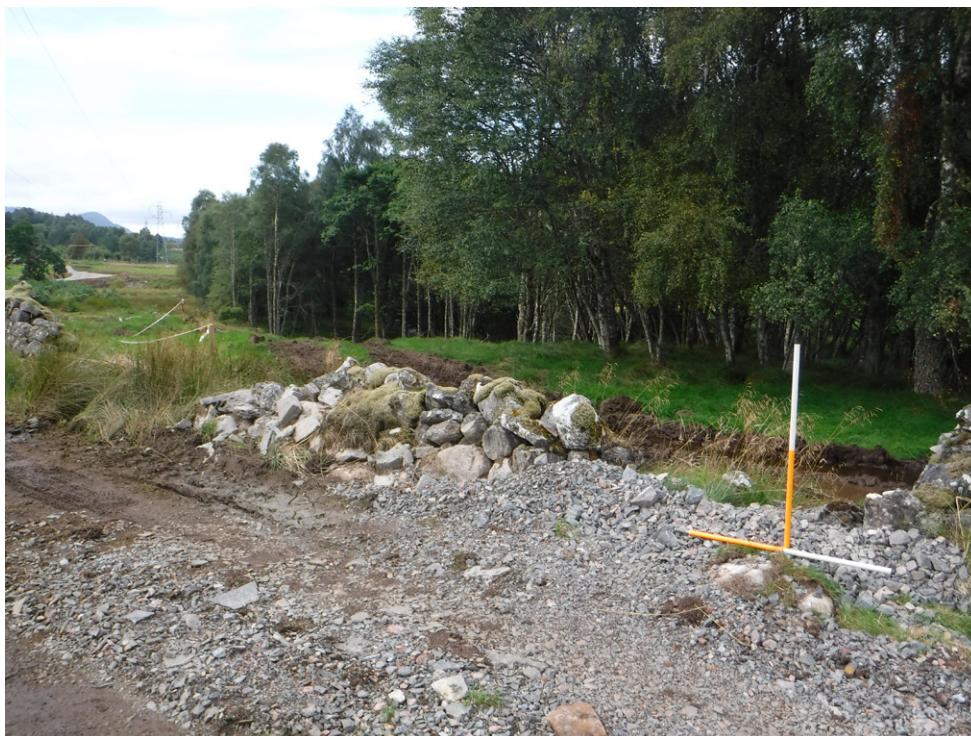
Fig. 3 - Watching Brief: Pre-Excavation of Site 80 / Wall 003

Site 80, a drystone wall (**003**) and adjacent trackway relating to the Inverwick estate, was partially removed for access track emplacement at Inverwick (see Fig. 1 and Figs 3-5). The wall section was located at NH 32573 13704 on the northern edge of the existing trackway. Although the wall was reduced, the associated trackway remained in situ with the improved access track floated over it.

Wall **003** was a denuded moss-covered drystone wall comprising unworked granite stones of varying size. A 10m section of this wall was removed for access track construction with approximately 60% of the wall section already in a semi-ruinous condition prior to the commencement of ground works.

The wall foundations comprised large (0.4m by 0.4m) boulders. The wall measured up to 1.2m in height by 0.75m wide, with 4 lower courses, a levelling course of flatter stones and an upper course of capping stones. No date is ascribed to the wall and

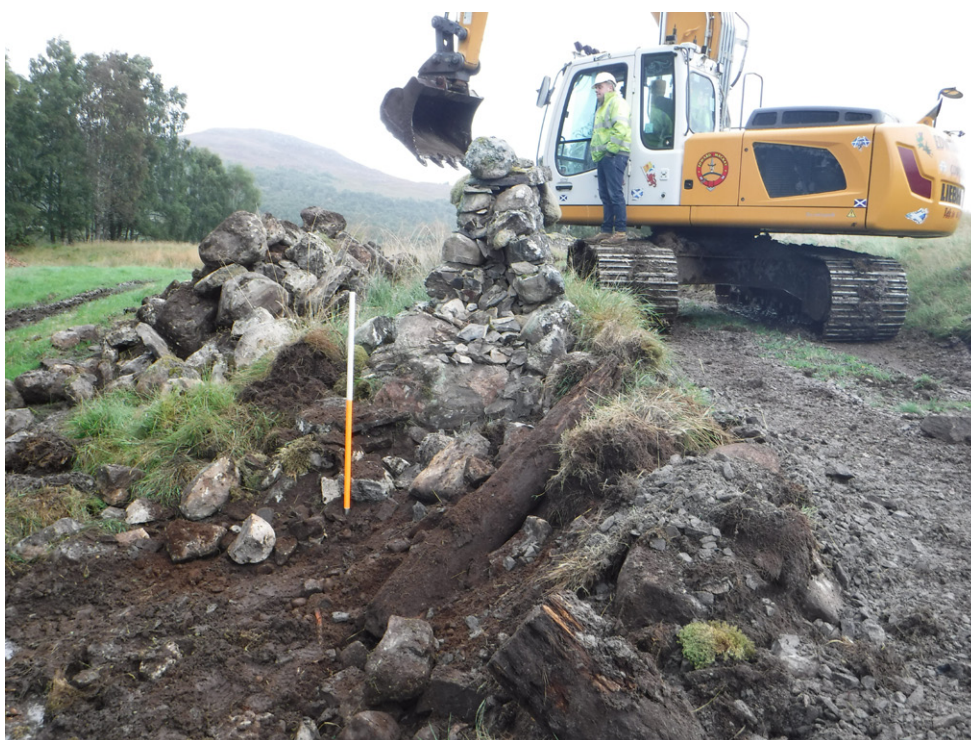
Fig. 4 - Watching Brief: South-west-facing section through Site 80 / Wall 003

trackway in the Site Gazetteer but it seems that the wall is likely contemporary to the formation of Glen Moriston Estate.

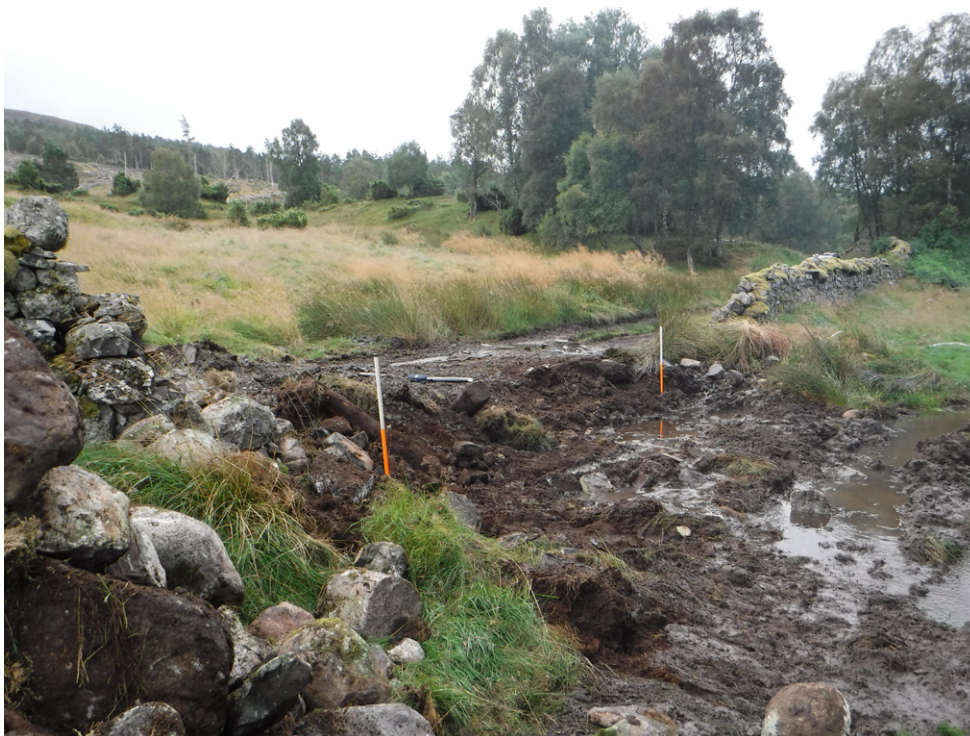
Fig. 5 - Watching Brief: Post-excavation shot of Site 80 / Wall 003 removal, looking south

The adjacent track was a rough compacted stony track measuring 4-5m in width with a central muddy/grassy bank and wheel ruts from repeated modern use.

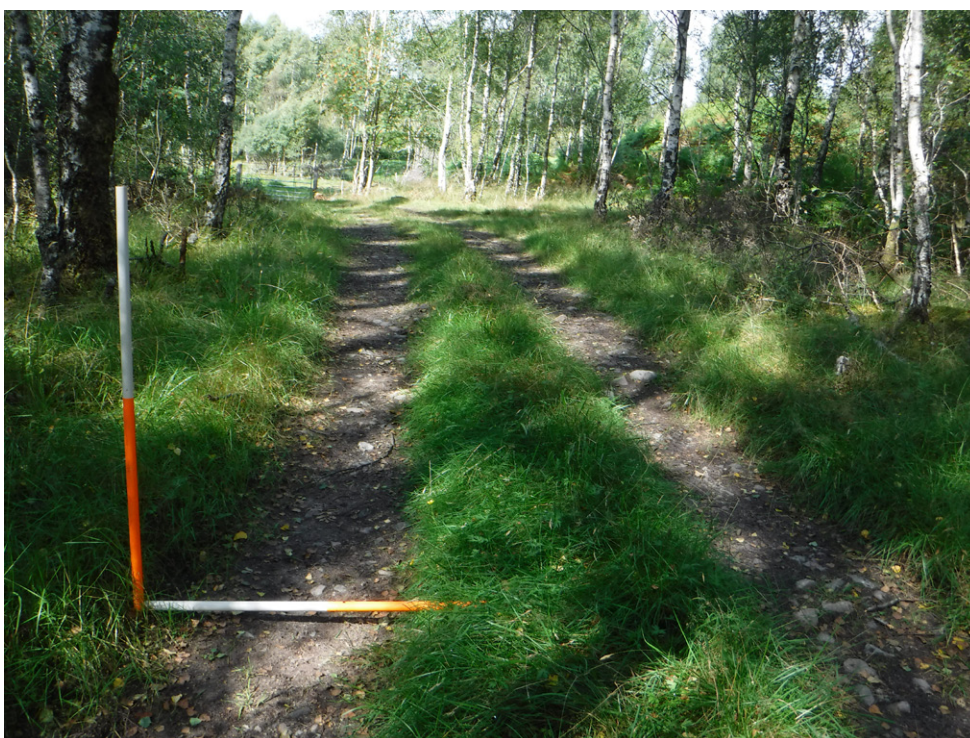
Fig. 6 - Walkover Survey: Photo of Old Military Road at Glenmoriston, looking north-west (north end)

The access route to FM102 (see Figs 2 and 6) comprised a portion of trackway along the potential route of an Old Military Road (Site 14).

The track runs through mixed forestry starting from 50m north east of the Ceannacroc Bridge and running north-west to the location of FM102. It continued beyond FM102 into rough pasture and moorland. The inspected section was from NH 22795 10805 to NH 22672 10902.

The track was slightly overgrown with a small central grassed bank and comprised small to medium rough compacted stones elsewhere. There were no signs of culverts or ditches along this track way section. The junction with the southern road was extremely muddy and waterlogged and as it left the forestry to the north west, the track became muddied again and difficult to decipher. It would seem that the best survival, along the stony section, may be have been formed relatively recently, perhaps to access the Hydro Station nearby. It is unlikely that the pre-existing military road would have survived this road-maintenance activity.

No further mitigation was required on this portion of the access route.
