Construction of a 2m wide trail path between Glendoe and Loch Tarff

Archaeological Walkover Survey Report

AOC 70238

30th October 2017

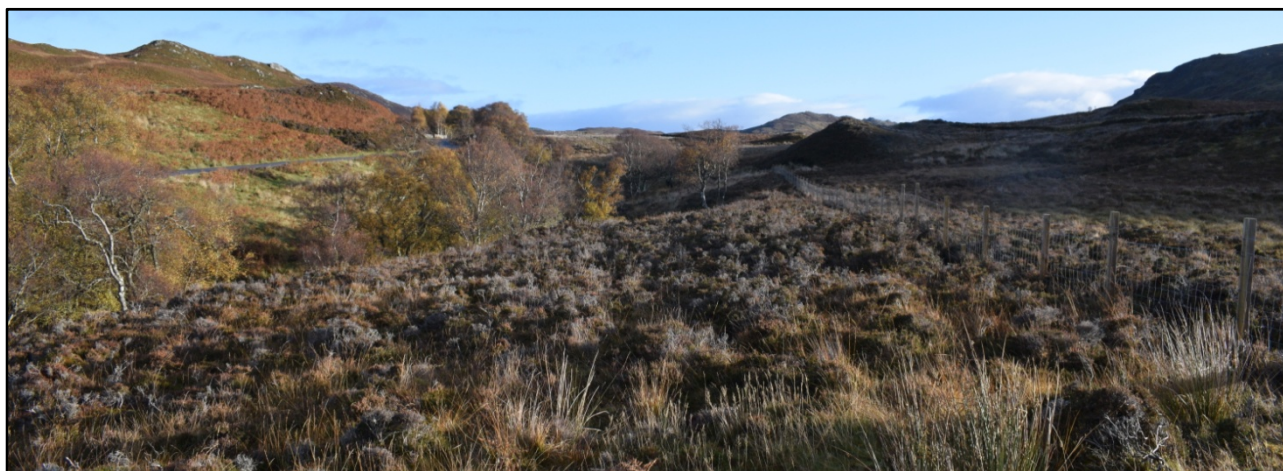
Plate 1: An example of the terrain crossed by the proposed path route, looking NE towards Loch Tarff

- 2.1 The proposed footpath is located to the north and south of the B862, which runs from Dores to Fort Augustus, from Loch Tarff before leaving the road and striking off generally in a south-westerly direction (**Figure 1**; NGR NH 41647 09111 (centred)). This route runs through a variety of terrain including the roadside and undeveloped open rough grassland and moorland with some open woodland (**Plate 1**).

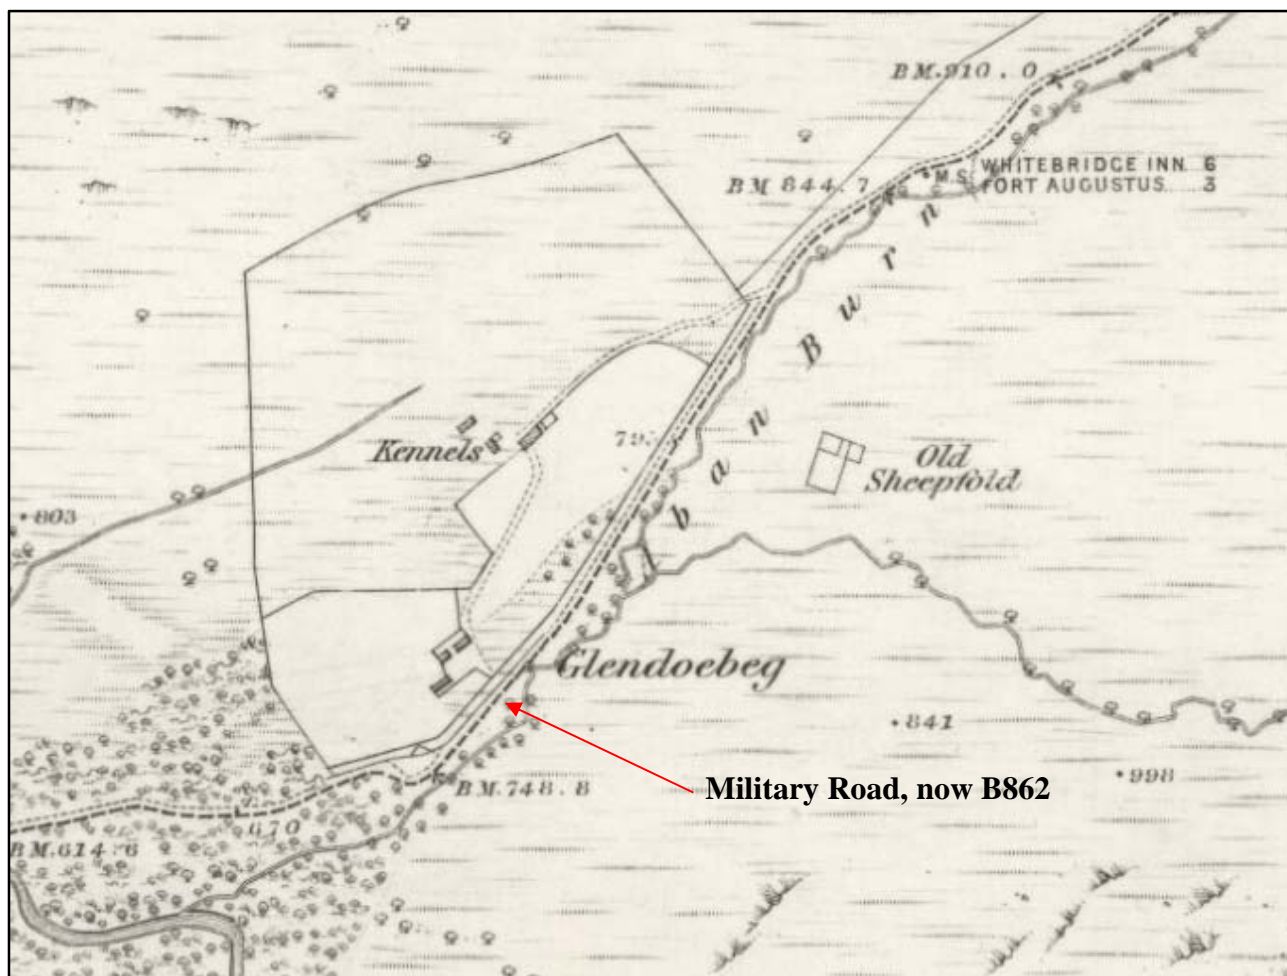
The Military Road is still depicted. A track is shown at the northeast end of *Loch Tarff*. The sheepfold has reduced in size slightly. The two enclosures at *Glendoebeg* have merged into one large area within a larger enclosure. There are four roofed and one unroofed structure together with one roofed and one partially roofed structure marked as 'Kennels' (**Figure 3**).

Figure 3: Extract from the OS 2nd edition 6-inch-to-the-mile map

- 5.5 Although close to the east side of the proposed path route, the sheepfold depicted on the historical OS mapping (**Figures 2-3**) is still in use and was therefore not recorded as an archaeological site.

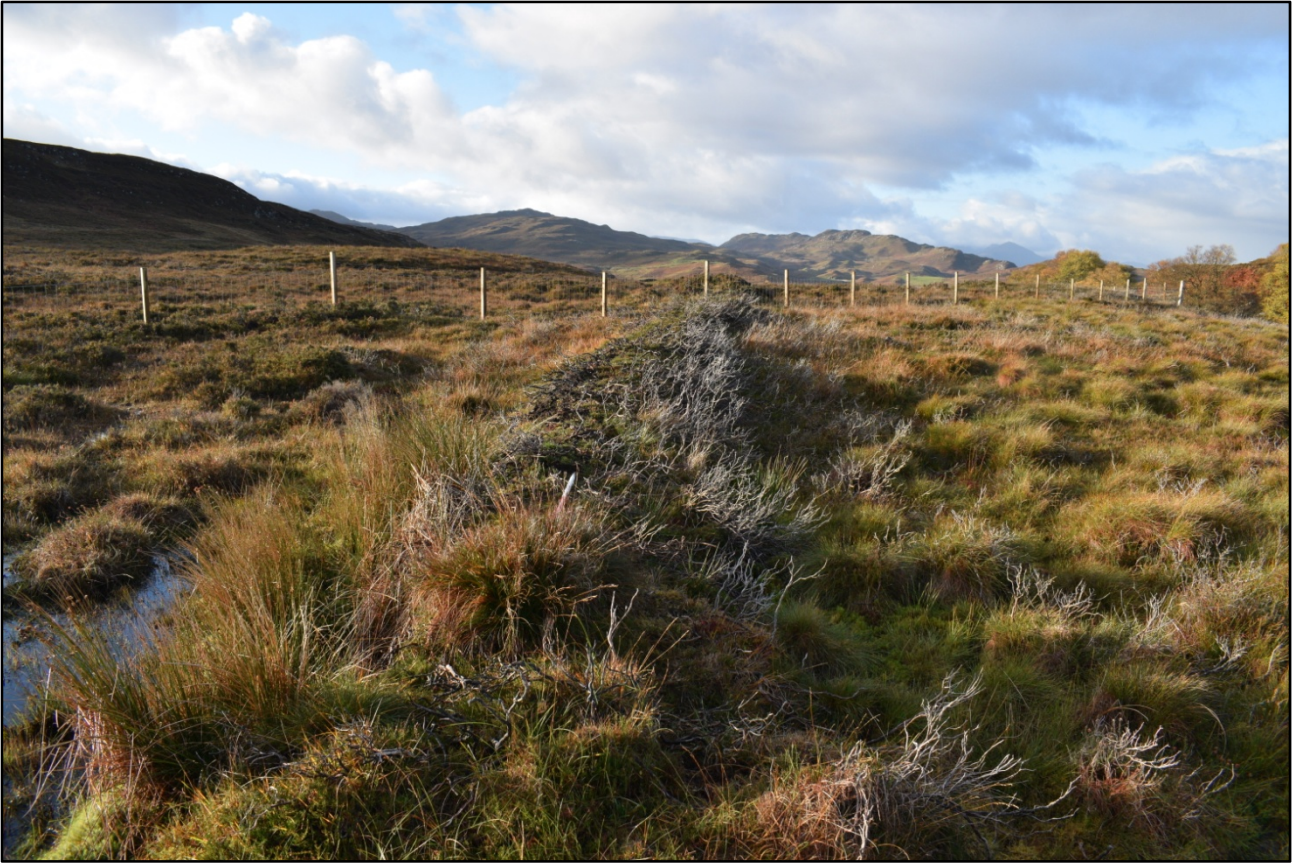
- 5.2 **Site 1** comprised a moss- and heather-covered turf dyke standing up to 0.6m high and spread to 1.5m wide (**Plate 2**). **Site 2** consisted of a group of large, grass-covered stone cairns situated close to the base of the slope on the south side of the B862 (**Plate 3**). They range from about 7m in diameter to approximately 12m in length. They are located within a close cluster in a small, flat field. The function of the cairns is unclear, and their large size may suggest that they represent activity other than field clearance – and one possibility is that they represent the remains of prehistoric burial cairns.

Plate 2: Moss- and heather-covered dyke (Site 1), facing SW

- 6.1 The present survey covered a 10-20m corridor around the route and the results represent the sites found in close proximity to the proposed footpath route. Based on the maps provided ahead of survey, Sites 1, 2, 3 and 6 are shown in line with the proposed path route. It is recommended that the footpath location be routed to avoid any direct impacts on these sites. A buffer of 5m is recommended for Sites 1 and 3. A buffer of 10m is recommended for Site 2, due to its potential prehistoric significance. The condition and minimal significance of Site 6 does not warrant any mitigation measures.
- 6.2 If it is not possible to re-route the pathway to avoid the sites, it is recommended that any groundworks in these areas be carried out under archaeological supervision.

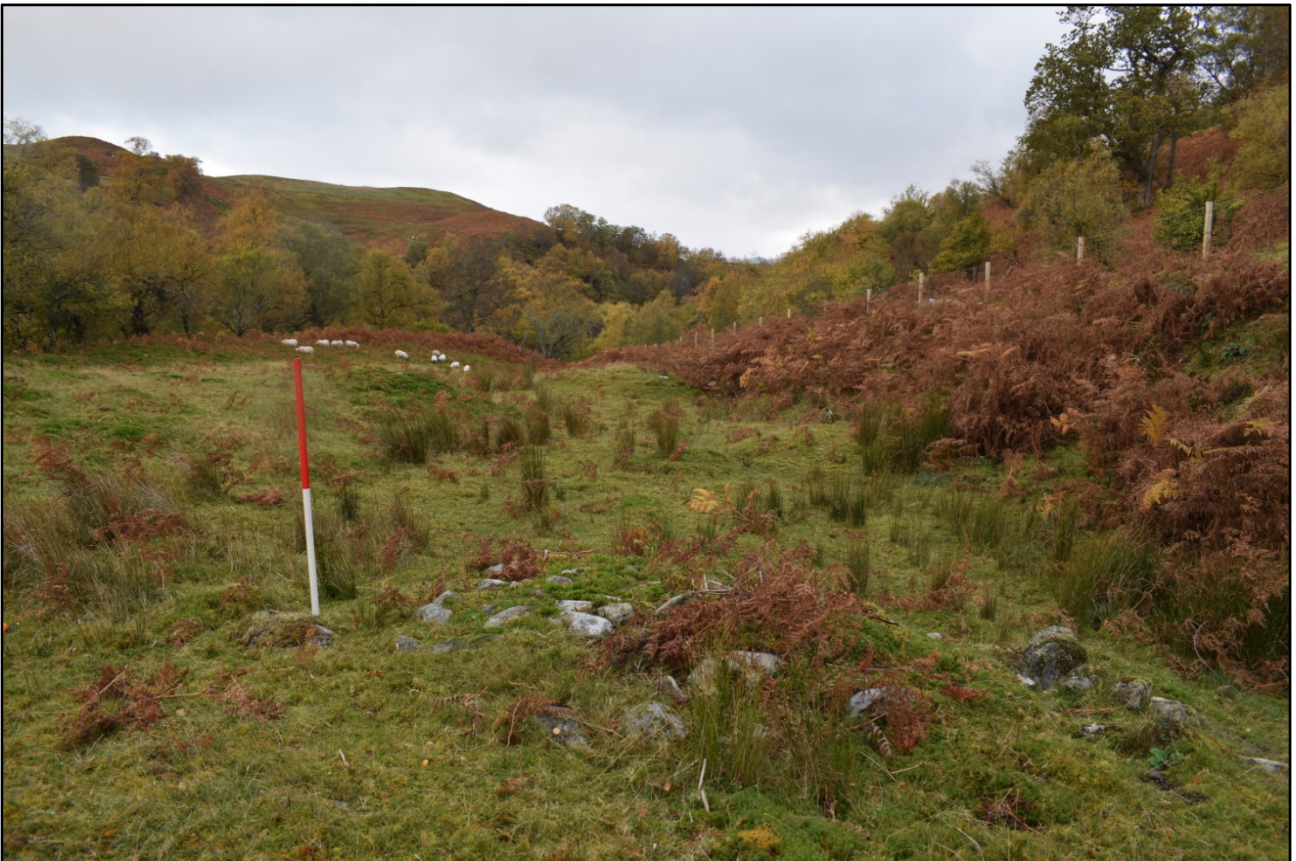
Plate 3: One of the clearance cairns at Site 2, facing W

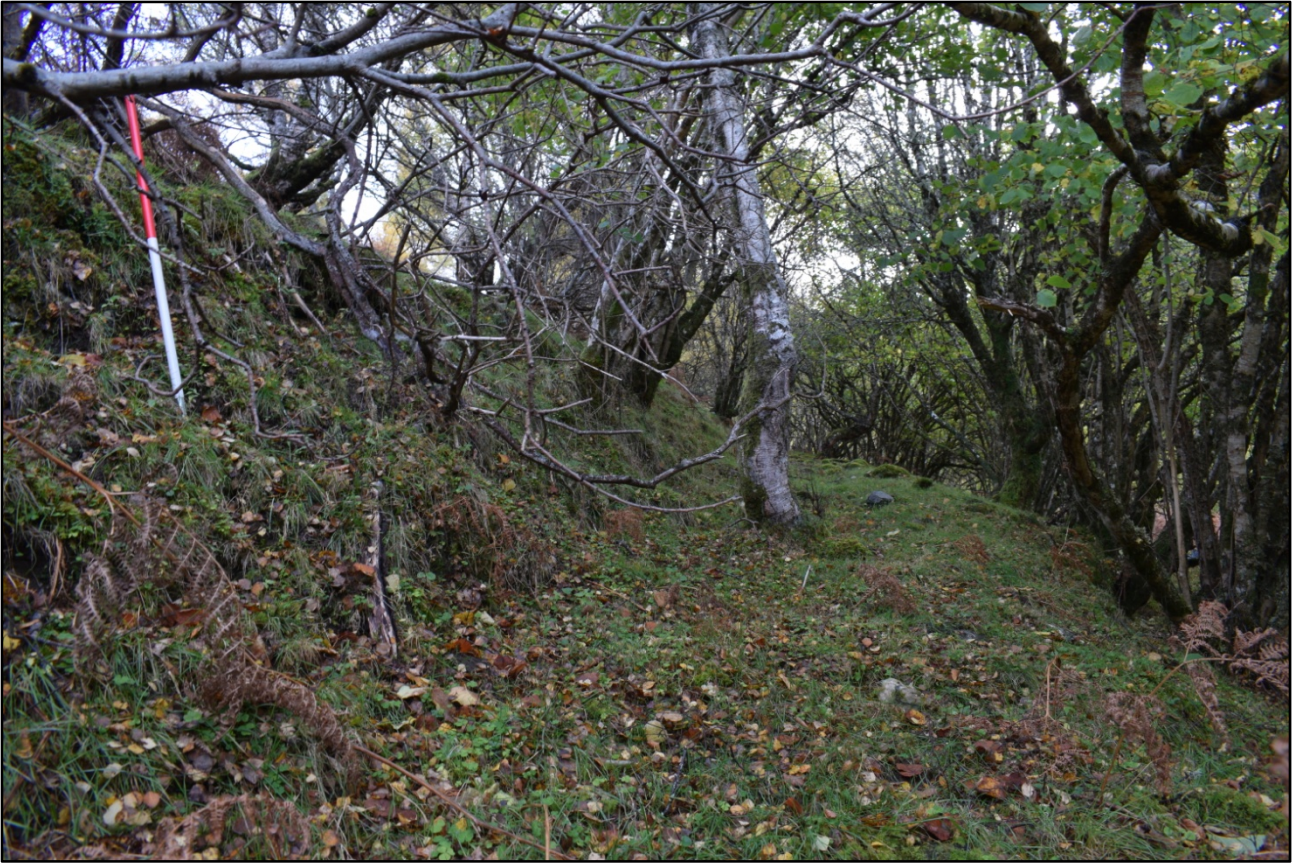
- 5.3 Two relict tracks (Sites **3** and **6**) were also recorded. **Site 3** (**Plate 4**) is the most substantial of the two, measuring approximately 1.5m wide with a stone wall revetted into the hillside on its north side and was located close to the bridges crossing the Allt Doe, suggesting that it was part of or associated with Wade's Road. The old bridge was over the Allt Doe was visited and it was noted that there is quite considerable damage to its structure at the northeast end (**Plate 5**). **Site 6** (**Plate 6**) is likely an old farm track, approximately 2m wide and leading from the B862 towards the settlement complex (Sites 4 and 5).

Plate 4: Relict track, Site 3, with revetted wall on its N side, facing ESE

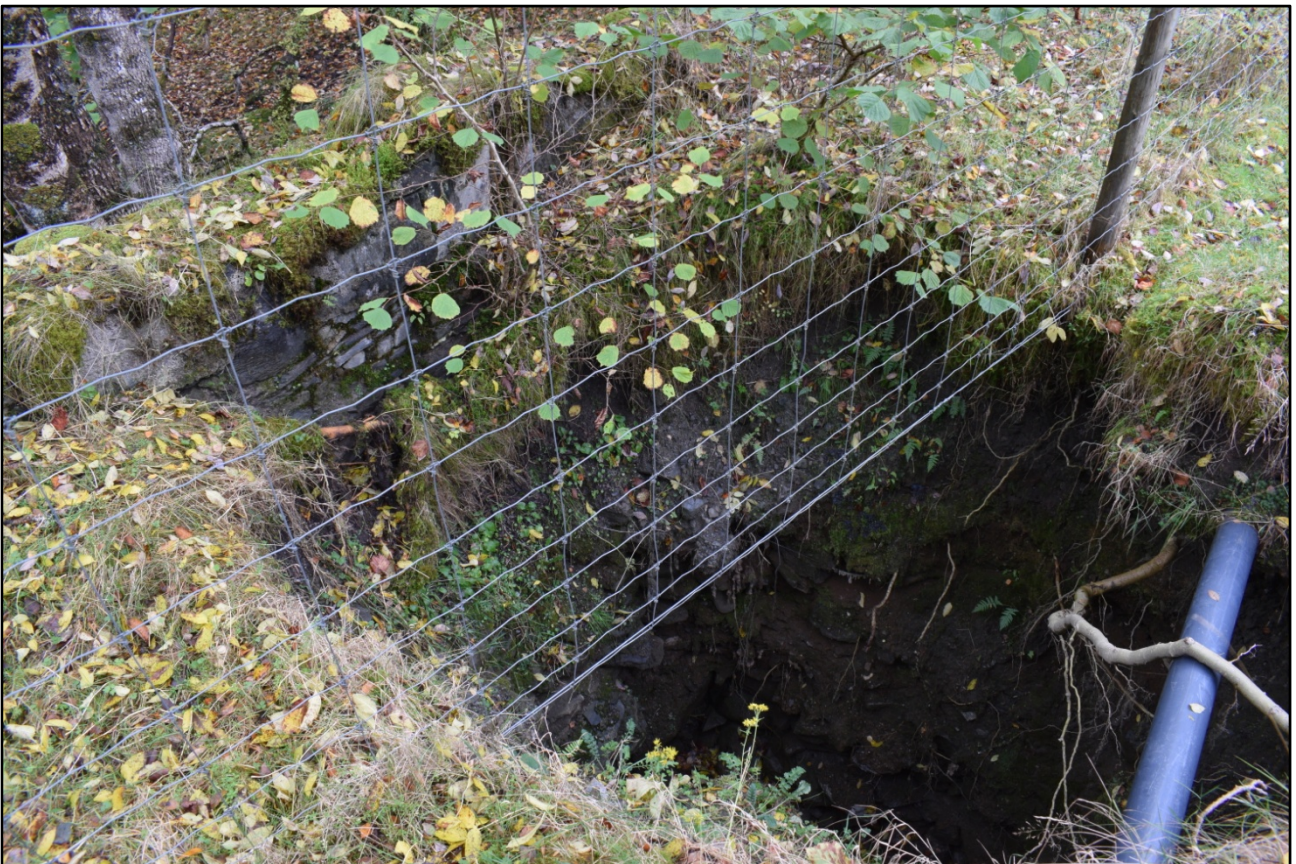
Plate 5: Damage to the old bridge crossing the Allt Doe

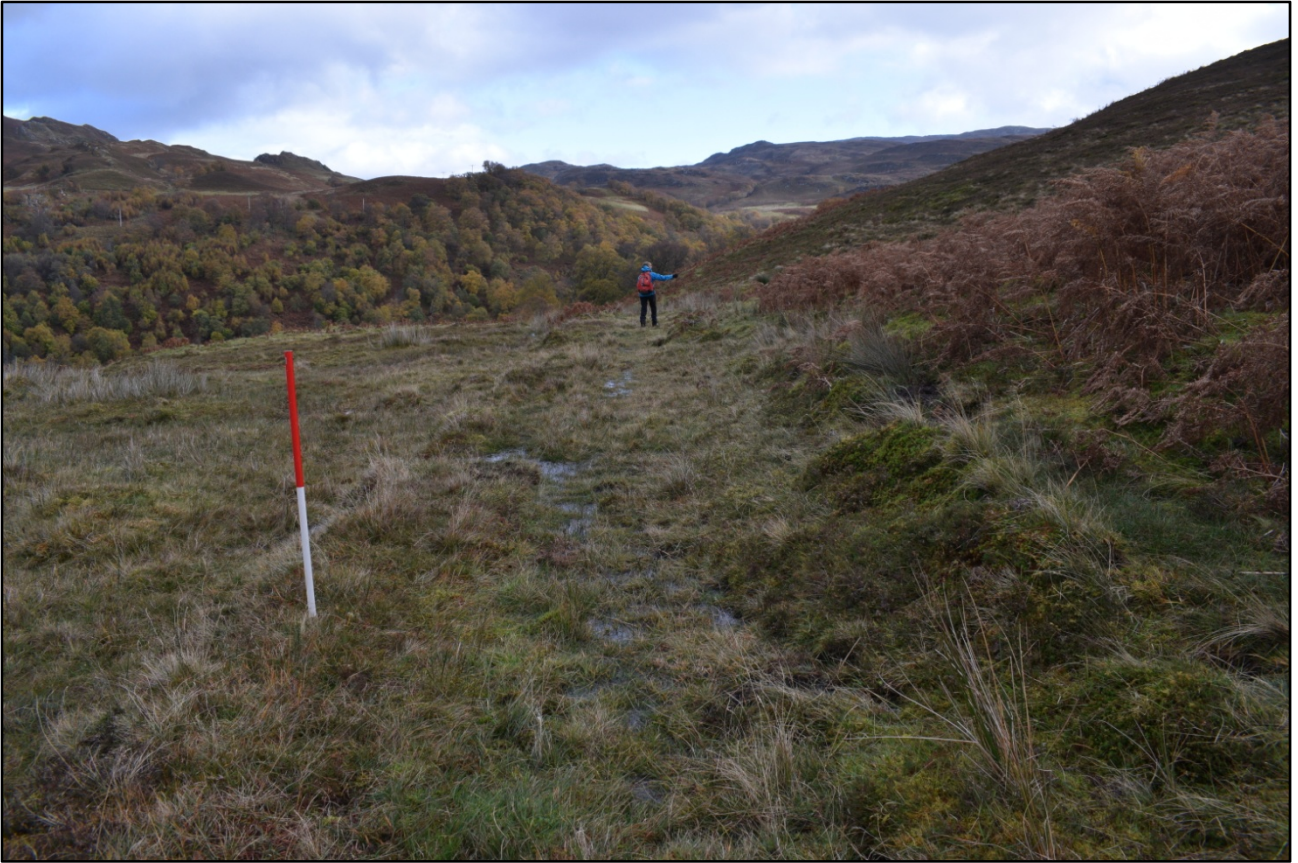
Plate 6: Relict track (Site 6), facing E

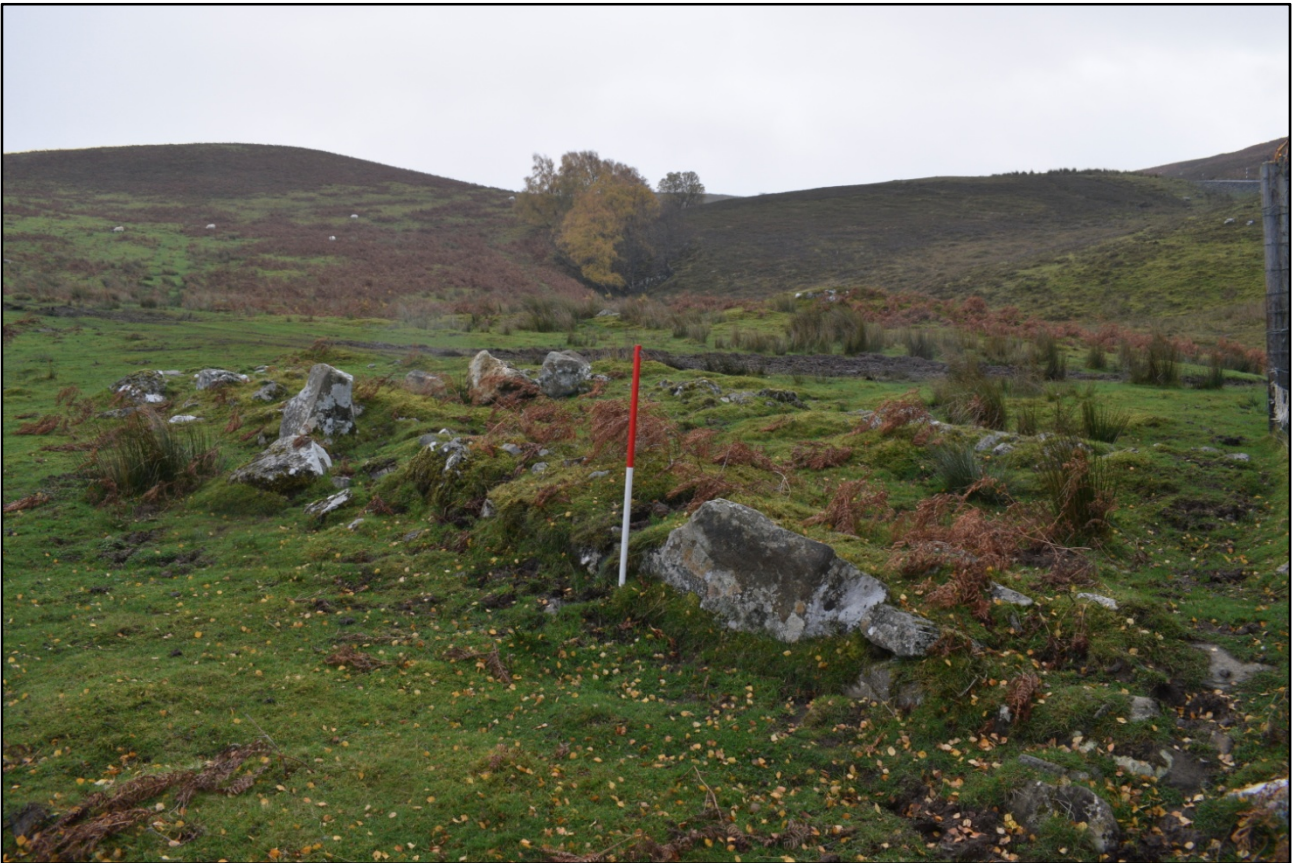
- 5.4 At the southwest end of the route, **Sites 4** (**Plates 7-9**) and **5** (**Plates 10-11**) formed two discrete settlements and enclosure complexes within close proximity to one another. Unfortunately, a modern farm track had been cut through enclosure 5c. Neither of these sites is depicted on the historical mapping, which suggests that they were in a much degraded state by the time of the first survey in 1871 and, as such, likely date to the early 1800s. The detailed site gazetteer and photograph register are set out in **Appendix 1** and **Appendix 2** respectively.

Plate 7: Structure 4a, facing SE

4a	Structure	Turf and stone structure under grass and bracken, measuring 12m E-W by 3m internally. Walls spread to 1m wide and up to 0.5m high. Constructed with some large boulders and slabs, with smaller stones between. Tumbled stone on all sides.	E-W	Very degraded	Post-medieval	240339	808596
4b	Structure	Turf and stone structure under grass and bracken, measuring 11m NW-SE by 3m internally. Walls spread to 0.8m wide and up to 0.4m high. Constructed with large boulders and some smaller stones. More degraded at the SE end.	NW-SE	Very degraded	Post-medieval	240350	808607
4c	Structure	Very degraded turf and stone structure under grass, measuring 8m WNW-ESE by 2.5m internally. Walls spread to 0.7m wide and up to 0.3m high. Some large boulders visible in the construction.	WNW-ESE	Very degraded	Post-medieval	240377	808599
4d	Enclosure	Turf and stone enclosure, approximately 16m N-S by 14m, under grass and bracken. Walls spread to 1.5m wide and up to 0.5m high. Walls on the N and E sides are better preserved.	N-S	Very degraded	Post-medieval	240362	808573

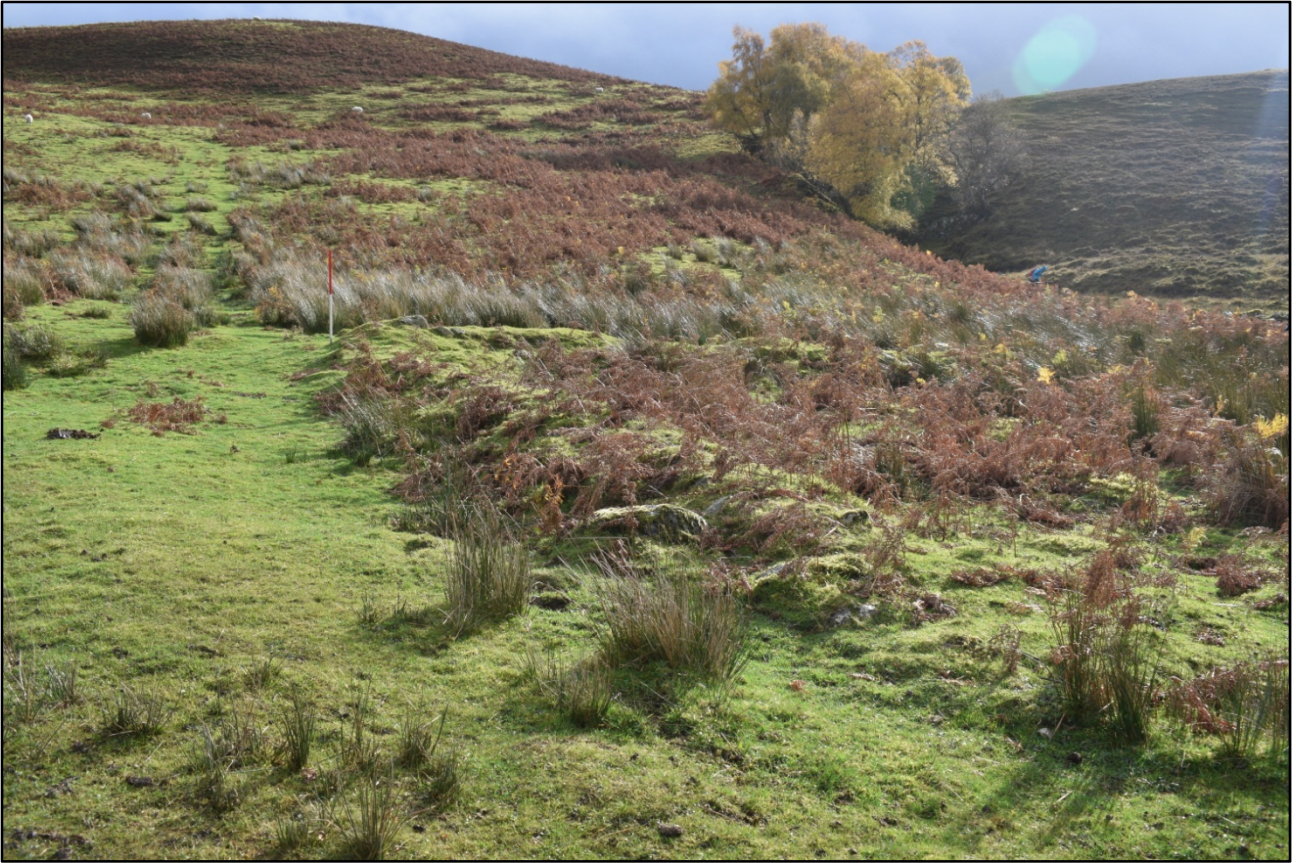
Plate 8: Structure 4d, turf and stone enclosure, facing SE

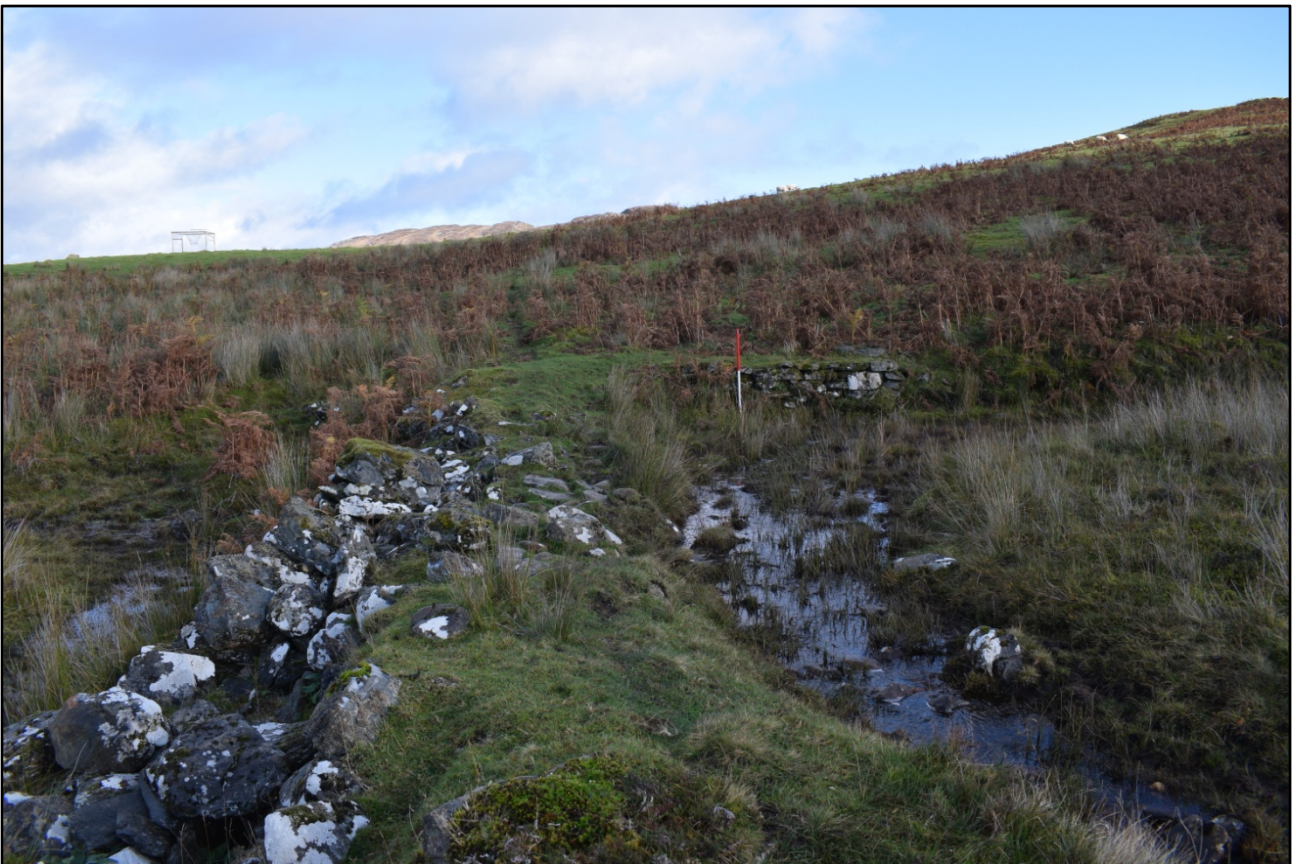
Plate 9: Structure 4e, a stone wall and bank by a stream, facing NE

Site No.	Type	Description	Alignment	Condition	Period	Easting	Northing
4e	Wall/Bank	Stone wall and bank of loose stone beside the stream; possibly used to divert its course. Stone bank measures c.3m wide and is partly under grass. At its SE end is a 4m long section of coursed stone wall, aligned NW-SE, perpendicular to the stone bank. It may continue further under the grass and bracken.	NW-SE	Very degraded	Post-medieval	240375	808553
5a	Structure	Very degraded stone structure under grass measuring 9m NW-SE by 2.5m internally. Walls spread to 0.7m wide and up to 0.3m high. Possibly double faced construction using large stones.	NW-SE	Very degraded	Post-medieval	240302	808584
5b	Structure	Turf and stone structure under grass measuring 12m NE-SW by 3m internally. Walls spread to 1.5-2m wide and up to 0.5m high with only very few stones visible on the surface. Enclosure (5c) attached on the SE side.	NE-SW	Very degraded	Post-medieval	240307	808571

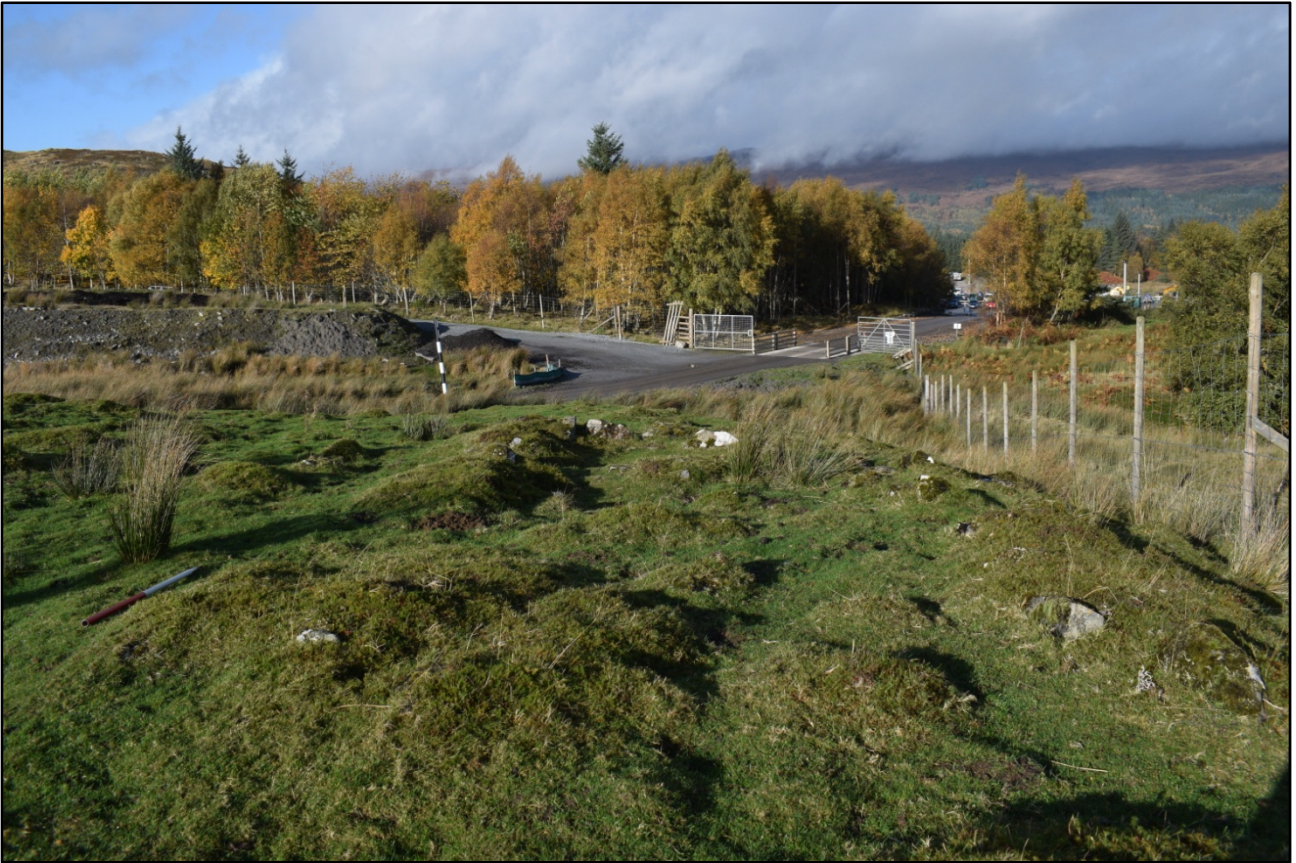
Plate 10: Structure 5a, facing NW

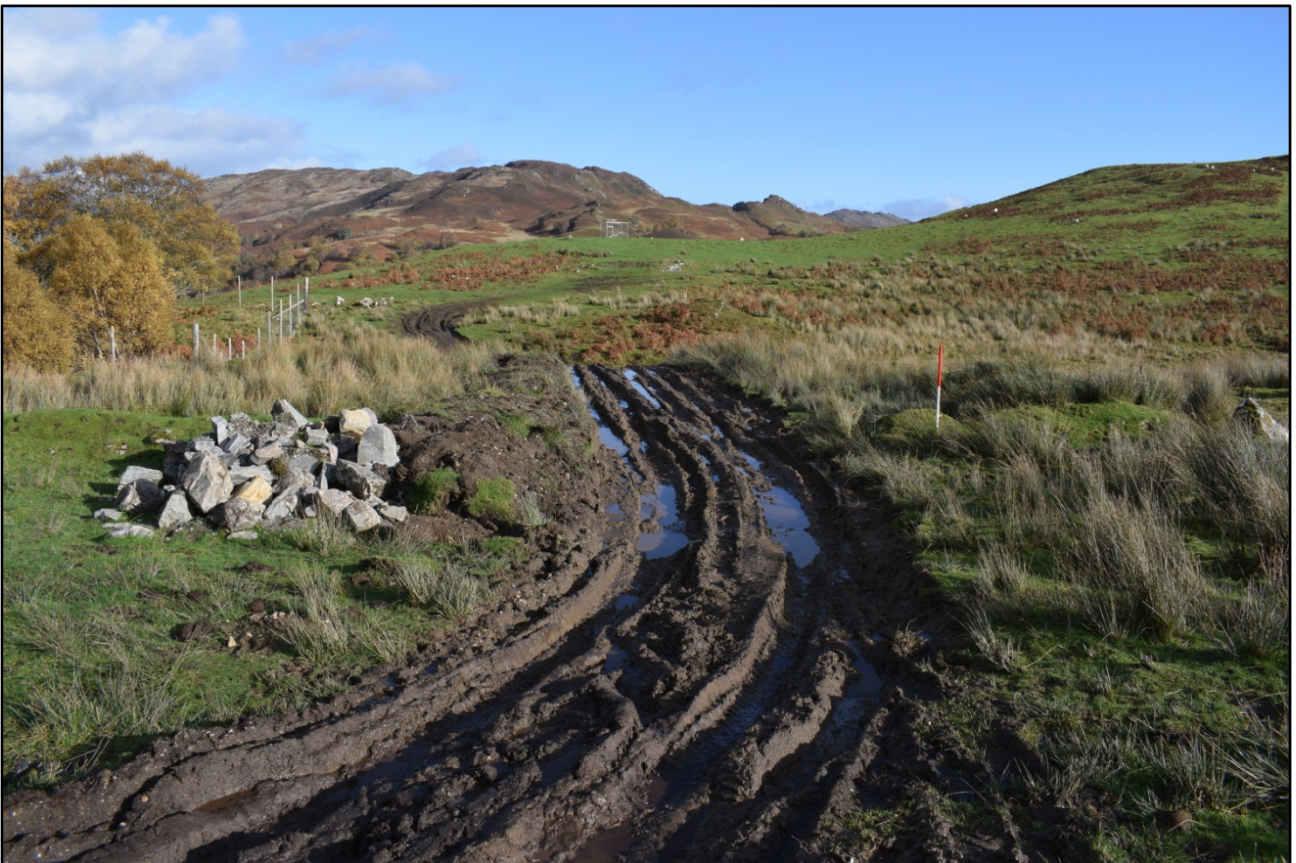
Plate 11: Structure 5c, enclosure with modern track cut through, facing NE

5c	Enclosure	Turf and stone enclosure, approximately 19m NW-SE by 16m, under grass and rushes to SE side of structure 5b. Banks spread to 1.5m wide and up to 0.5m high. Has been severely truncated through the centre by an estate dirt track.	NW-SE	Very degraded	Post-medieval	240317	808551
6	Track	Relict track, approximately 3m wide with low turf banks along each edge up to 0.3m high.	ENE-WSW	Very degraded	Post-medieval	240564	808774
