Cromdale Church, Cromdale, Grantown

Archaeological Metal Detecting Survey & Watching Brief

Final Report

HAS Report No.	CAC17-2
Site Code	CAC17
Client	Scottish and Southern Electricity Networks
Planning Reference	N/A
OS Grid Reference	NGR NJ 0667 2898
Date	8 th November 2017
Author(s)	Emma Malone & Andrew Young MCIfA

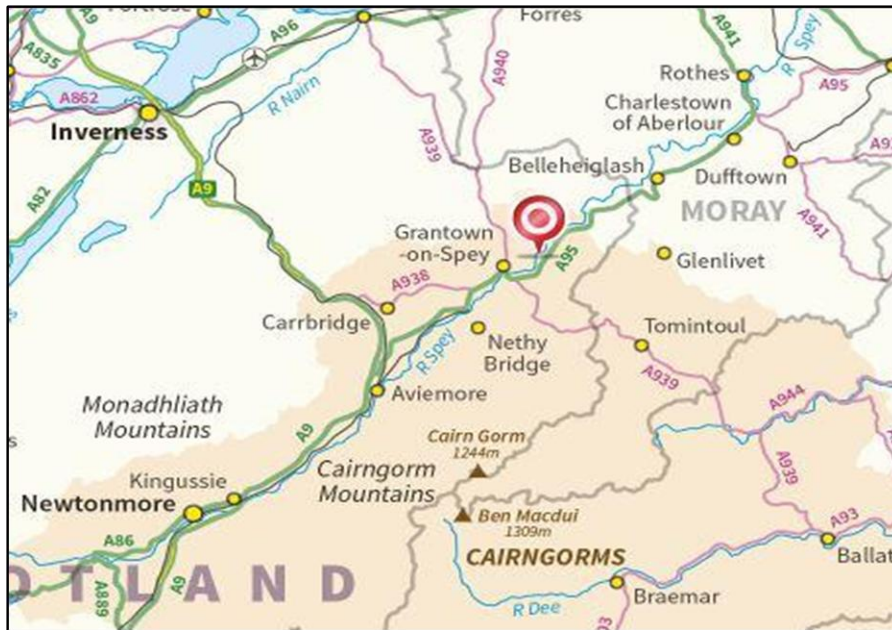
Figure 1: General Site Location

The route of the new underground electricity supply to Cromdale & Advie Church is located within the churchyard and an adjacent field located immediately to the southeast (Figures 1, 2 and 3). The site also lies within the designated area of Cromdale Battlefield (BTL20), which is centred at approximately NGR NJ 067 289. The study site and the entire curtilage of the Grade B Listed Cromdale Church and burial ground (MHG6824 and 31374) is located approximately centrally within the designated battlefield area whilst the adjacent Old Parish Manse (MHG15358), built in 1834, is also Grade B Listed.

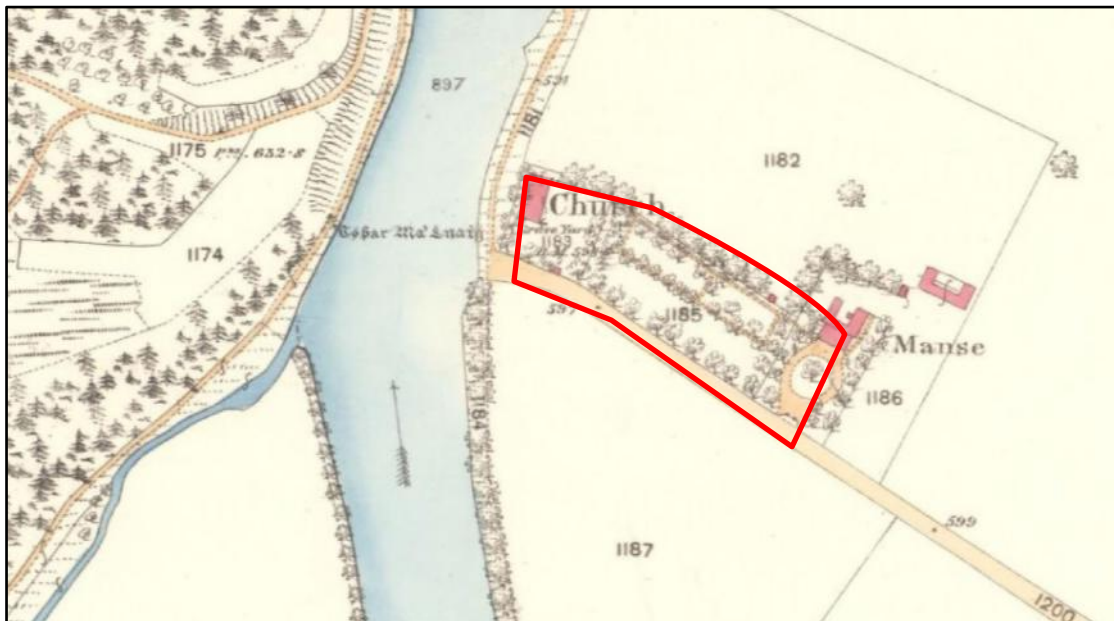
Figure 5: Extract from the 1st edition OS 25" map surveyed 1874 with the boundary of the study area.
Cromdale, Inverallan & Advie XXXIII.2

The 1st edition 25-inch map shows the church as a rectangular building with churchyard to the east. There are formal gardens between the church and the manse to the south east (see Figure 3). There

is also a small, square, roofed building that is depicted just to the north of the ‘formal garden’ wall (DBA7). This lay in the direct path of the proposed underground cable route.

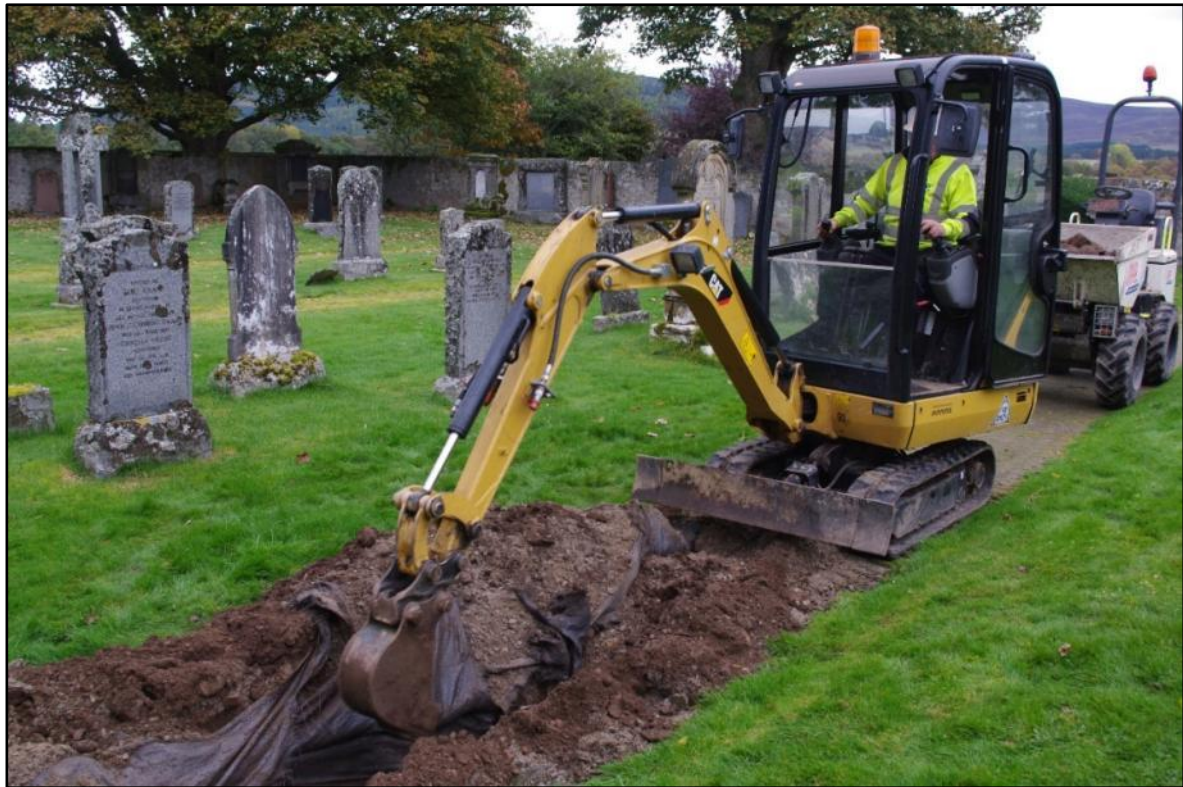
Photograph 1- Trench excavation along the church yard path

The cable trench was opened using a narrow four-inch ditching bucket attached to a small tracked excavator. The narrow bucket afforded enough room for the cable trench to be opened without opening any more ground that was necessary. Underneath the church yard path was a layer of geotextile fabric, which was peeled off and left to the side for repositioning during backfilling. Tree roots marred the progress within the field.

The topsoil directly beneath modern geotextile along the churchyard path consisted of loosely compacted dark brown sandy silt, friable with frequent large angular and rounded stone inclusions measuring up to 0.45m in length. The topsoil revealed in the field was texturally quite similar except slightly darker due to decaying leaf matter from the surrounding trees shed seasonally and creating a rich organic mulch. The natural substrate was not revealed in the churchyard but was in the field where it consisted of a dark yellow/orange fine sand. The trench cut through a modern post-war midden (judging from the bottles and fire-place fragments uncovered) close to the field boundary wall (Figure 6), which had likely been fly-tipped there within the last 50 years. The collection (Photograph 5) was not deemed to be archaeologically significant due to its relatively modern date and was not retained.

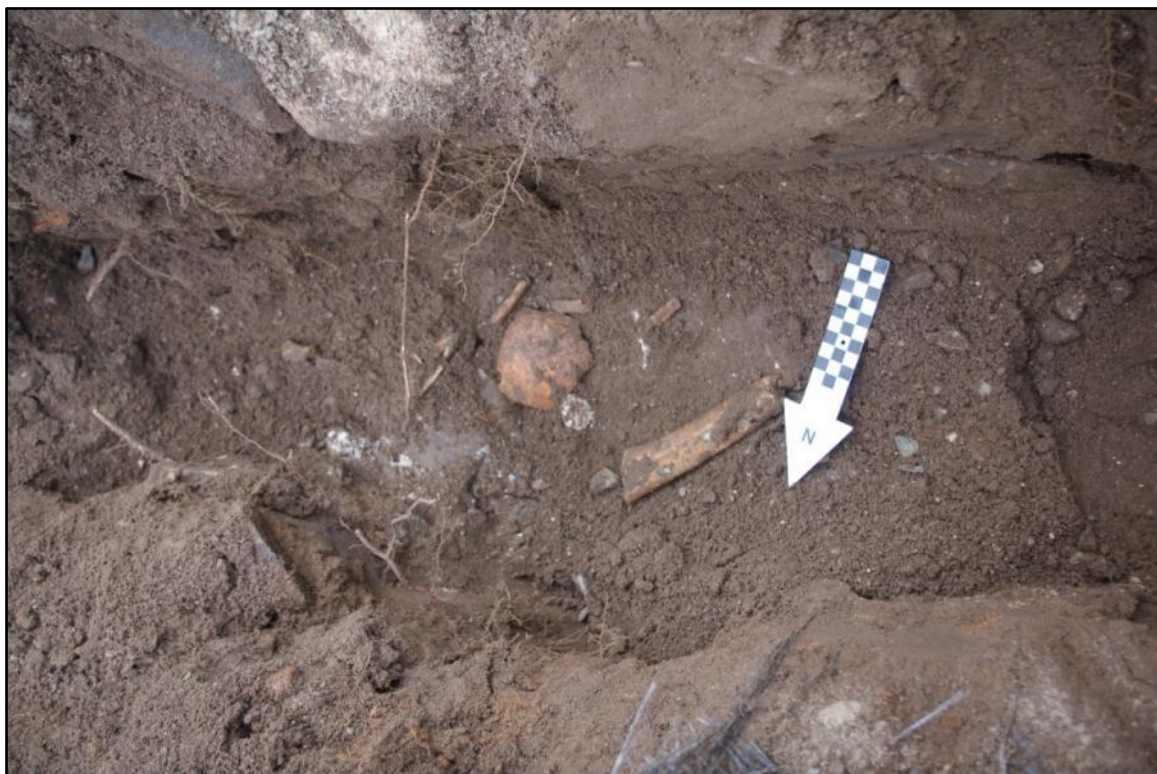
Photograph 2 – Human bone revealed in the churchyard trench (scale in cms)

Occasional fragments of disarticulated human bone were revealed in the section of the trench opened through the gravel path in the church graveyard. The remains were mostly revealed at a depth of 0.45m, considerably shallower than anticipated. Their presence at this shallow location might be attributed to animal burrowing activity or material reworked as a result of several hundred years of grave digging. The grave markers located closest to the line of the trench were of mostly mid-19th century date. The human remains were fragmentary, and included a small piece of cranium, a small rib bone, pieces of ulna / radius and one vertebrae bone. No associated artefacts or items of coffin furniture were revealed.

No significant buried archaeological features or deposits were revealed during the course of the watching brief. The small number of disarticulated human bones identified in the church yard were to be expected – the remains were noted and re-interred in their exact discovery location.

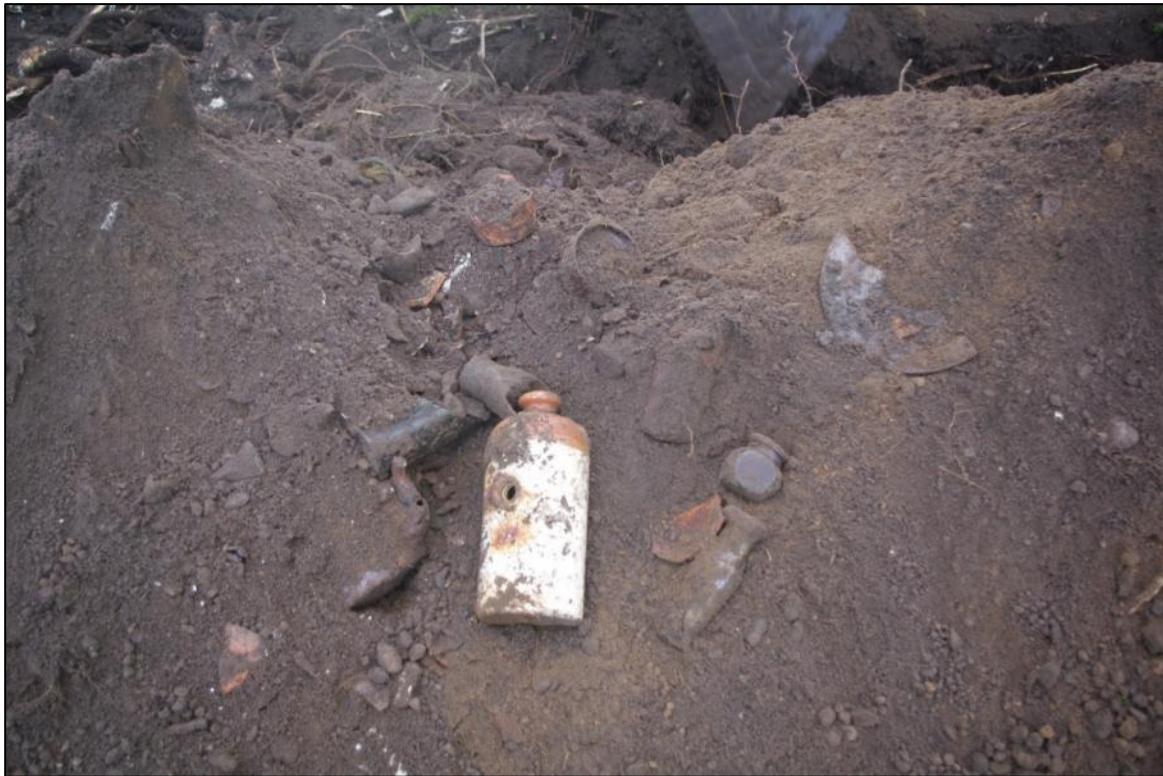
Photograph 5: Modern finds from the field trench spoil

No significant archaeological finds were uncovered during the watching brief. Modern (post 1940s) household waste including stoneware and glass (Photograph 5) was identified although the objects were not deemed to be archaeologically significant and were not retained.
