The crofting township of Big Sand

Centred on NG 75284 79229

Big Sand Township

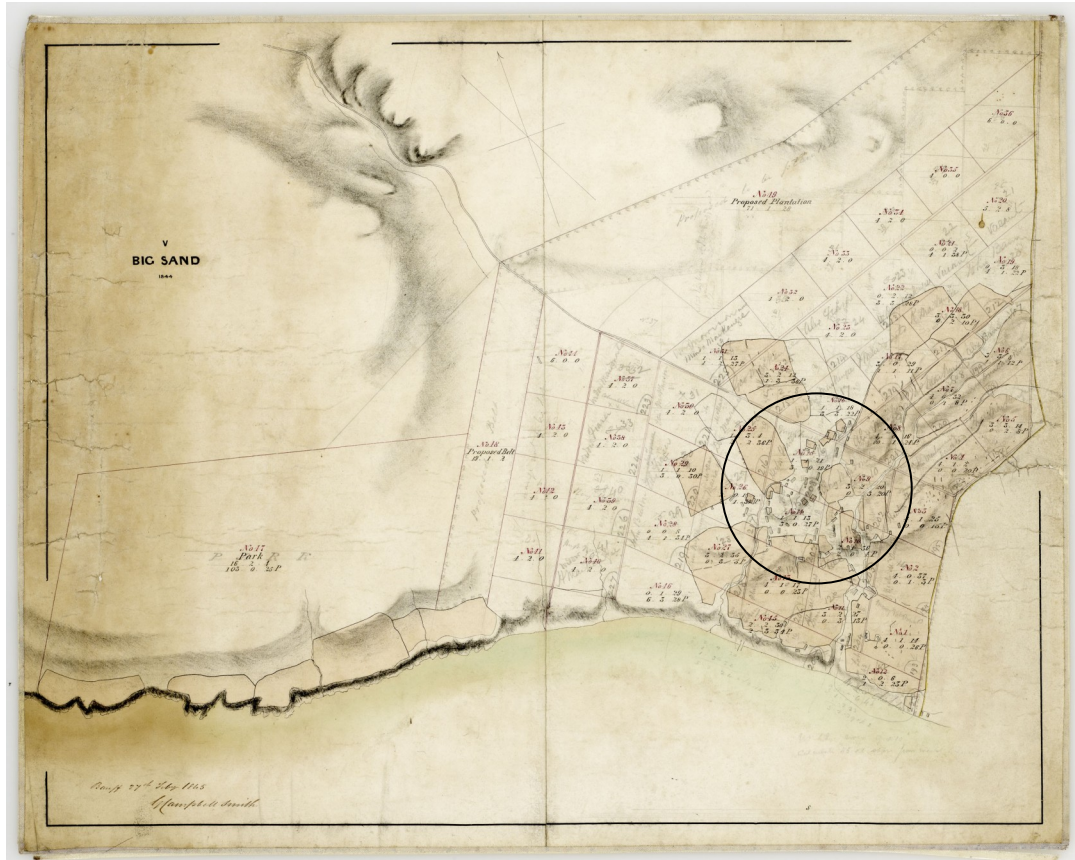
The Gairloch Estate Map of 1845 shows a sizeable cluster of buildings already in the area.

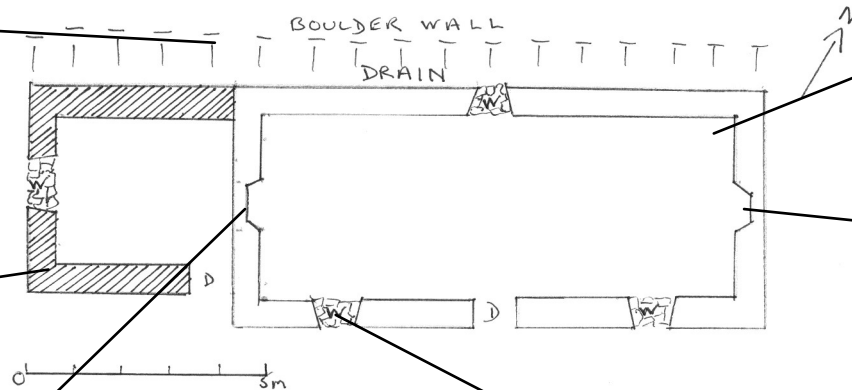
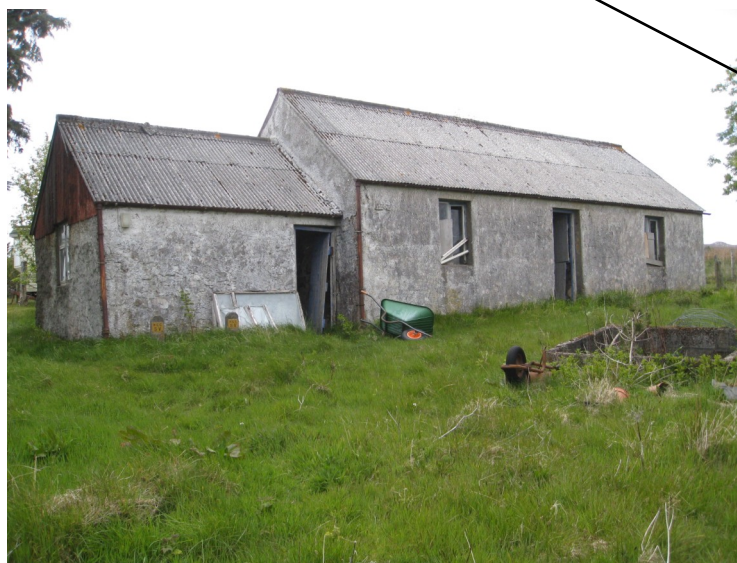
Croft house with attached byre at 3 Big Sand, Gairloch. NG 75550 79113 GPS ,elevation 29m ,surveyed 18-05-12

**Croft House with attached barn on Croft 3 Big Sand, Gairloch.
NG 75550 79113 GPS elevation 29m surveyed 18-05-12**

This croft house is first shown on the 2nd OS map. It faces S and is situated on croft 3 on a gently sloping area of ground. The site is fairly well drained but has a drain with retaining wall to the rear to take water away from the building.

It is traditionally constructed with chosen and dressed local sandstone that has been layered with snecking between the larger stones.

It has the traditional design of two windows and a door to the front, and a single window to the rear, the direction of the prevailing wind.

The barn/byre to the W has been attached at a later date.

The walls and gable ends of the building have been raised when the building was reroofed. This can be seen quite clearly in both the stonework and mortar.

There are two fireplaces with substantial lintel stones.

The exterior of the building has been covered with a rough thin harling.

The building is about to undergo extensive renovation.

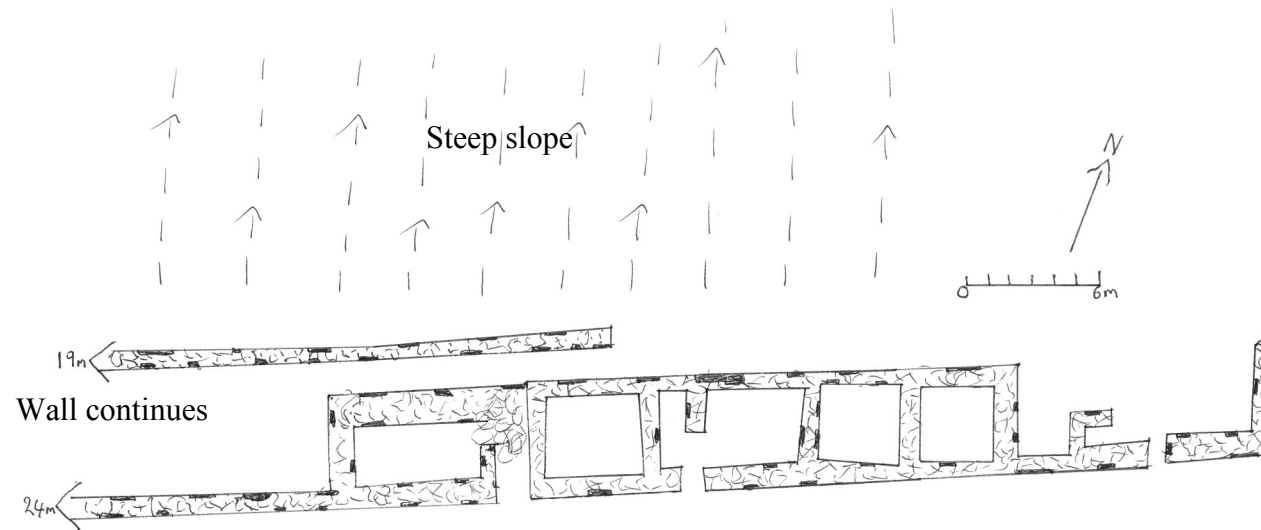
Ruin situated on croft 8 Big Sand. NG 75655 79275 elev 44m Plane table survey 06-06-2012

This ruin is situated along the ridge between two steep slopes. It is shown as roofed on the 1st OS but remains now as low footings up to a height of 0.5m.

The footings are constructed with boulders and a few chosen stones. The purpose of the building is unknown, although it is known locally as 'Larach Taigh Seumas' or the ruins of James house. It is not the typical construction style of the area.

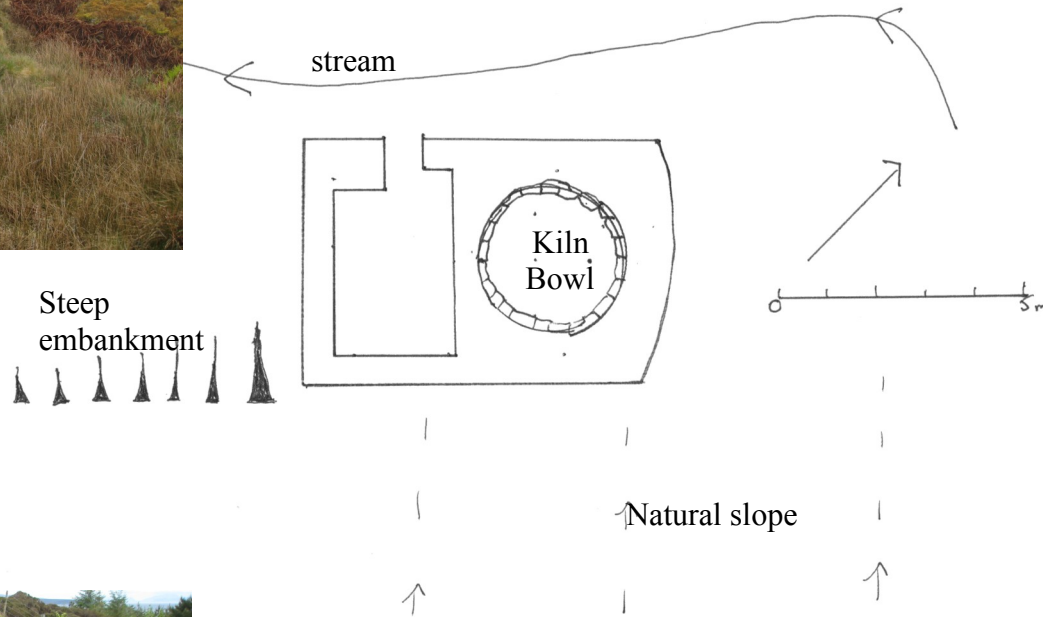
Corn drying kiln, croft 10, Big Sand, Gairloch. NG 75394 79116 elev 34m

Looking S across stream to Kiln

This kiln is set into a bank of the stream that runs NE to SW through the township. The slope to the W of the kiln has been artificially graded.

The kiln is of solid construction, made with boulders and chosen stone that is layered, to a remaining height of 1.76m.

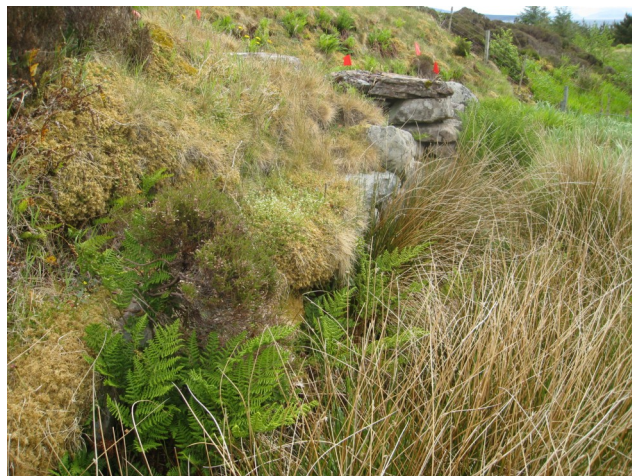
The kiln bowl

The bowl is 2m in diameter, and walls range in width from 0.6 to 1.0m. There is an attached kiln barn and visible

lintel over entrance to flue.

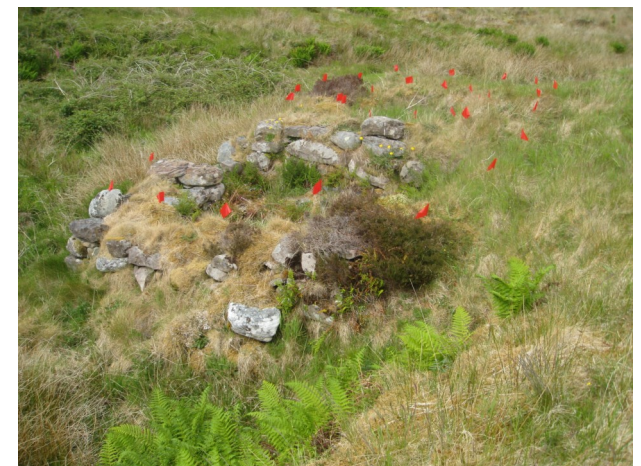
It is shown as roofed on the 1st OS, but in living memory was only used as a rubbish dump.

Looking from slope down on to kiln barn and bowl

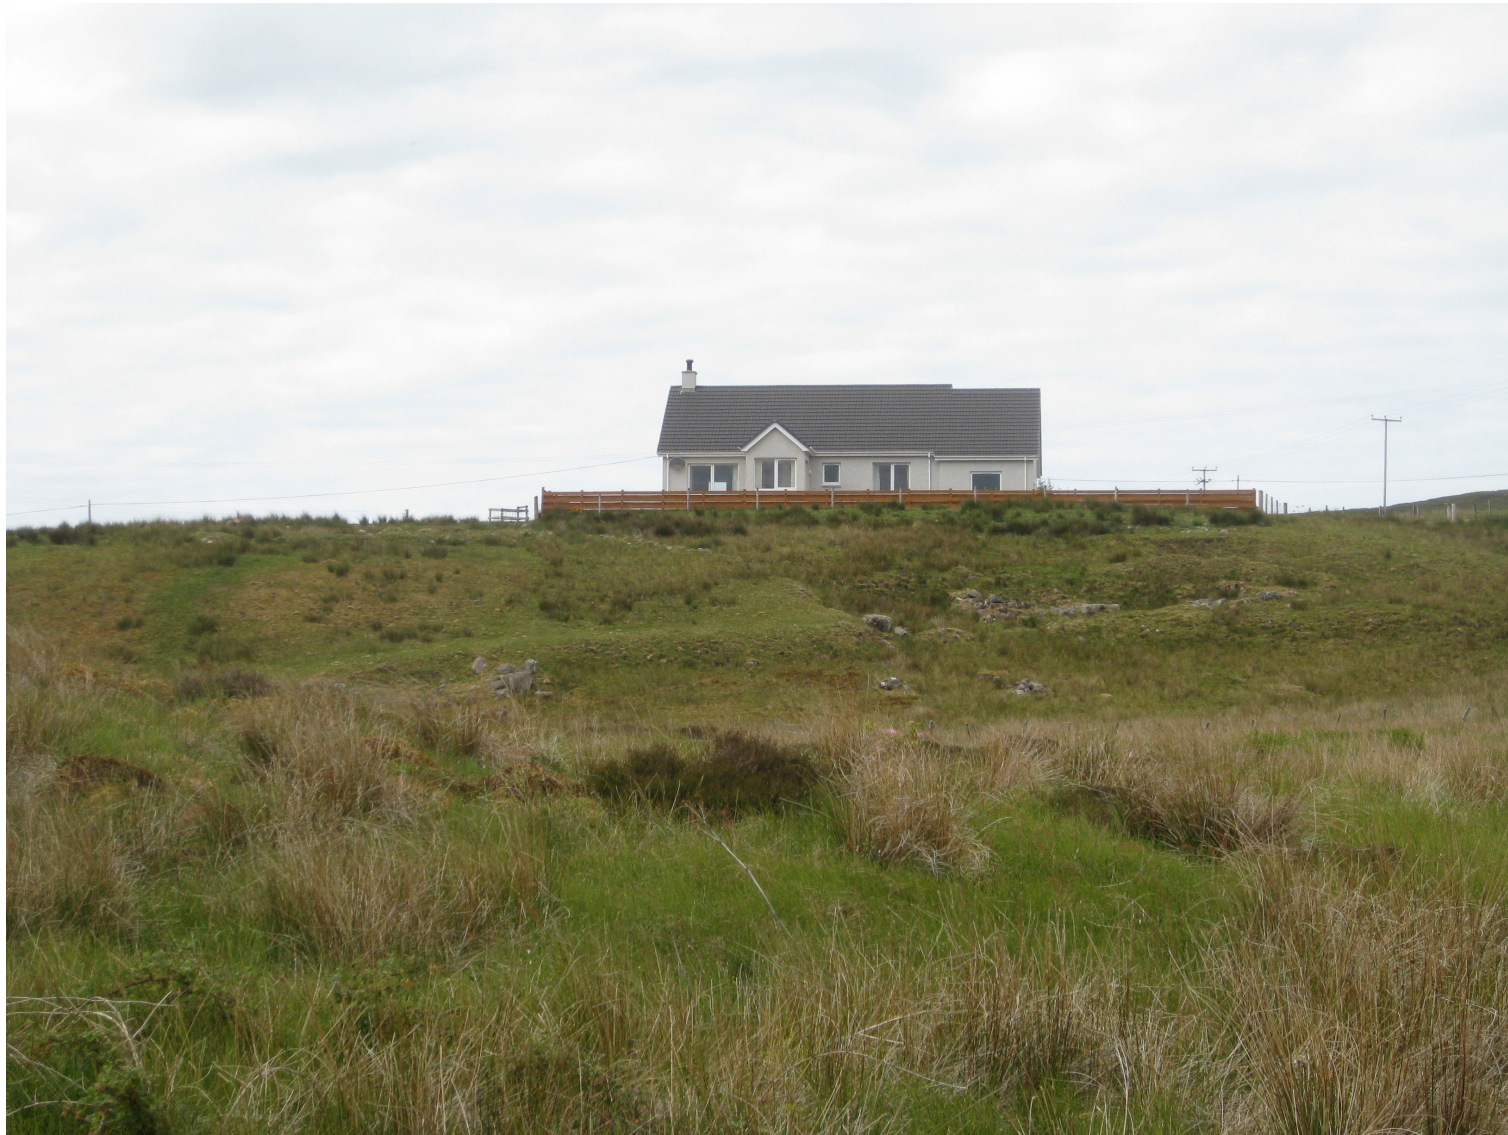
Looking across to the old settlement area on Croft 10 and 11 Big Sand Crofting Township. This shows features 45—48
