# An Archaeological Survey of **Gruinard Island**

Centred on NG 94418 94047

Jim Buchanan and Anne MacInnes

The survey took place as part of a study of the island for Gairloch Museum and its history is documented within the report.

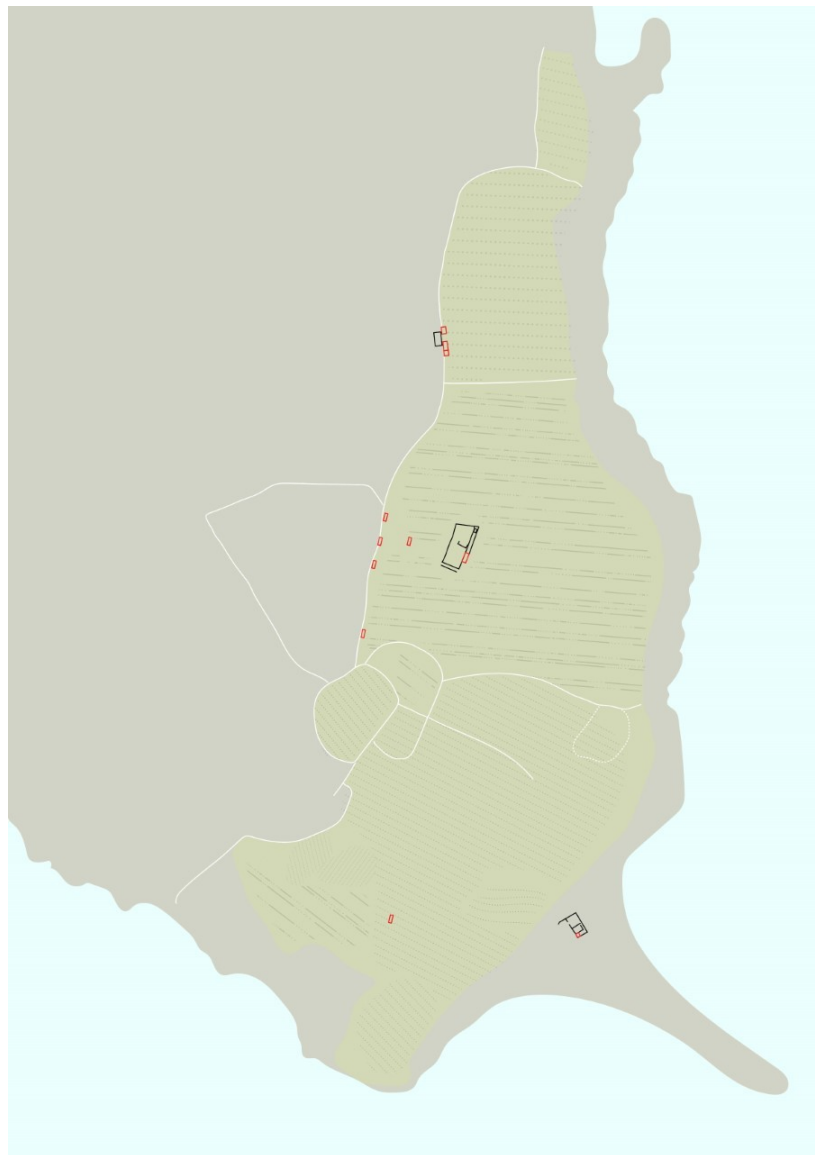
This blanked out aerial shows the cultivated areas very clearly. The report indicates that there did not seem to be many people living permanently on the island so perhaps people travelled the short distance from the mainland to utilise the sheltered SE part of the island to supplement their acreage. What appears to be a type of head dyke would have separated the cultivated areas from any grazing livestock.

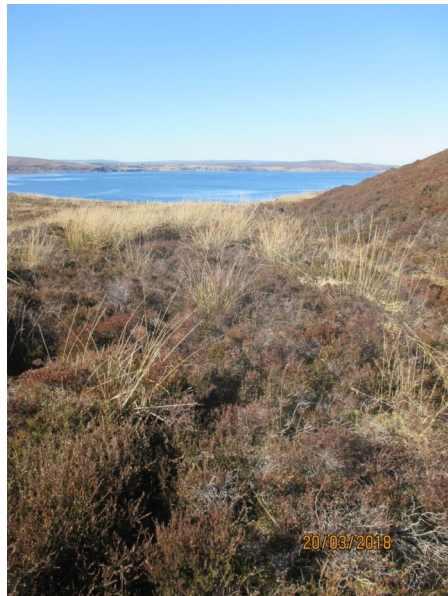
3. NG 94517 93256 The remains of a turf and stone dyke that curves around the base of a hillside.

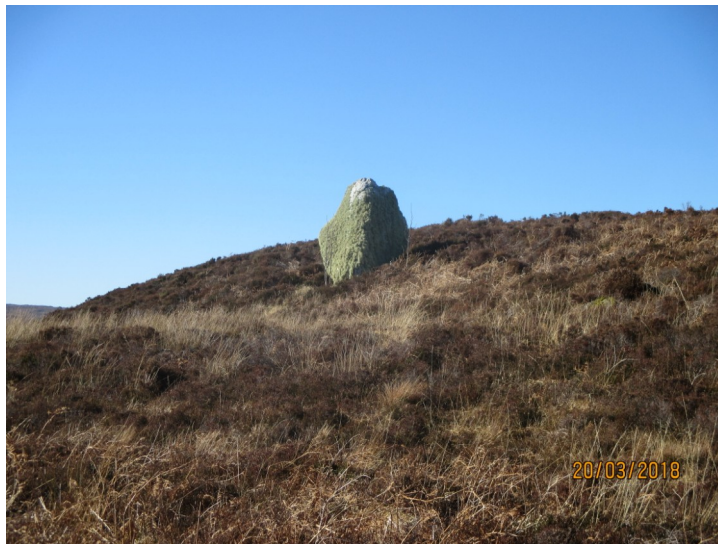
4. cont.

4. NG 94477 93354 A large lichen covered boulder that stands out from the hillside. A probable erratic but could be a standing stone connected with prehistoric settlement? It measures 3.5 x 2.5m

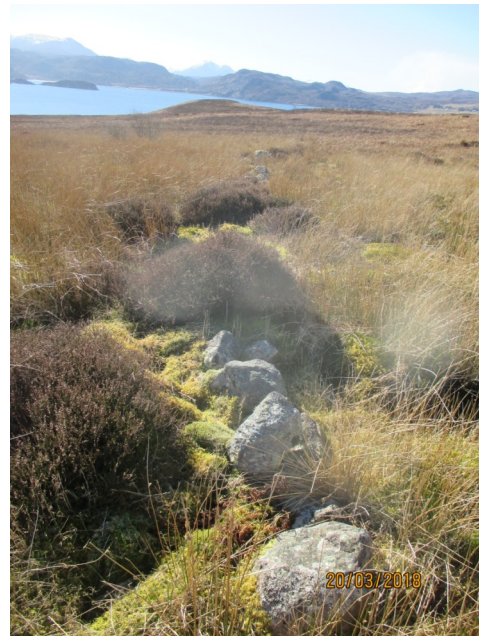
5. NG 94502 93375 A field dyke

Some of the dykes comprised a line of large single boulders instead of constructed turf and stone dykes. A distinct difference.

It is possible that these dykes, which were often on curving enclosure boundaries were much earlier, and associated with earlier roundhouses that have since been destroyed by subsequent building and land improvement. The deep moss made it impossible to investigate further.

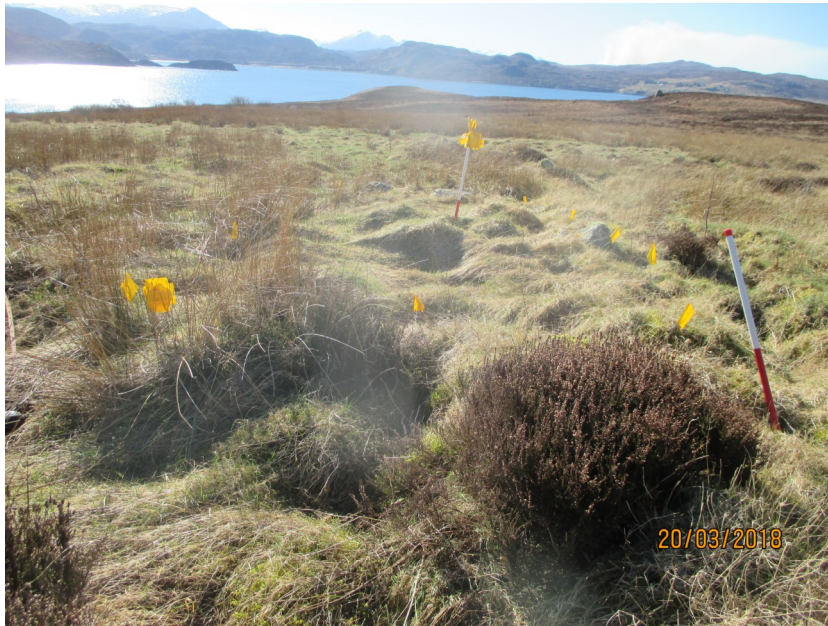
8. NG 94587 93564 Footings of a building measuring 6 x 2.5m

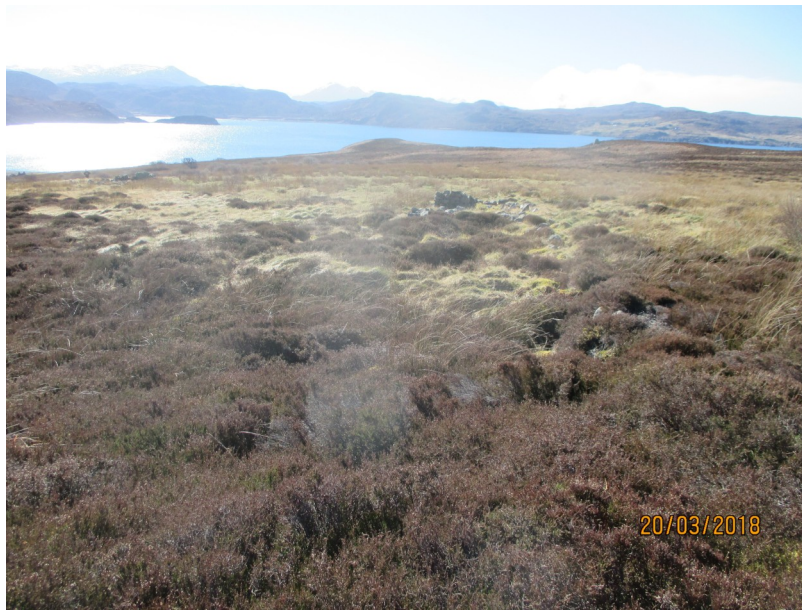
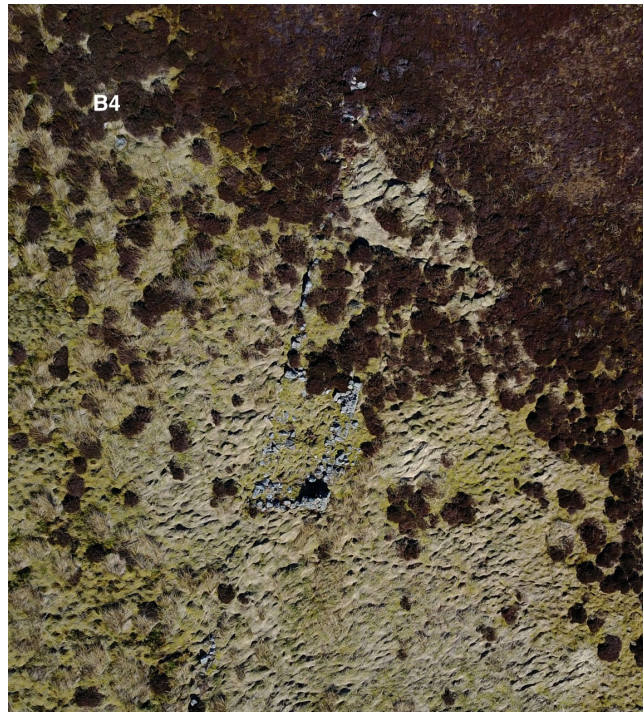
9. NG 94601 93595 Footings of two adjoining buildings measuring 8 x 4m and 9 x 4m

Drone shot of the ruin.

Both images illustrate the thick deep covering of moss, grass, and heather. Note how the wall construction differs from the single large boulders previously seen. These walls have an inner and outer facing and are made with smaller boulders. It was difficult to establish features like entrances due to the tumbled nature of the ruins and vegetation cover.

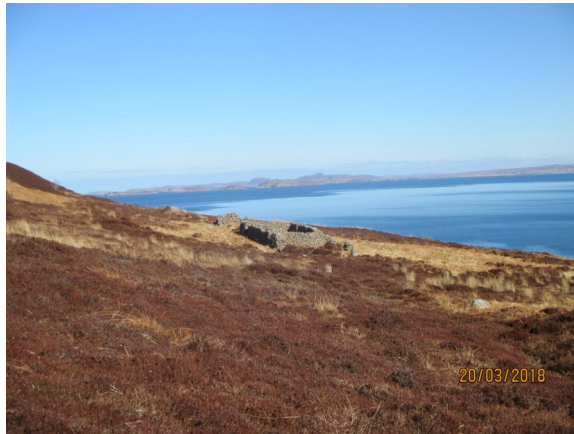
10. NG 94679 93783 Footings of what appear to be a barn/byre with a central unroofed area adjoined by a house measuring 30 x 4.5m overall. There is a midden downslope from the barn/byre and an enclosure upslope. The walls are upstanding to a maximum height of 2m.

Approaching the ruin from the NW

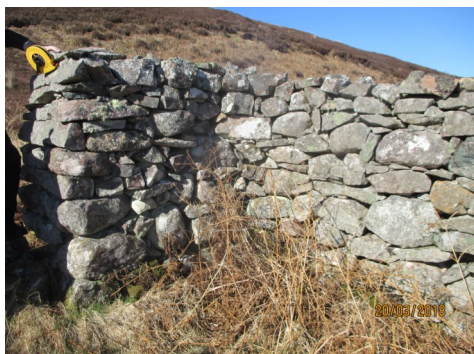
The house shown in this photo was constructed with chosen and shaped stones. The stones were layered and had snecking to make it watertight.

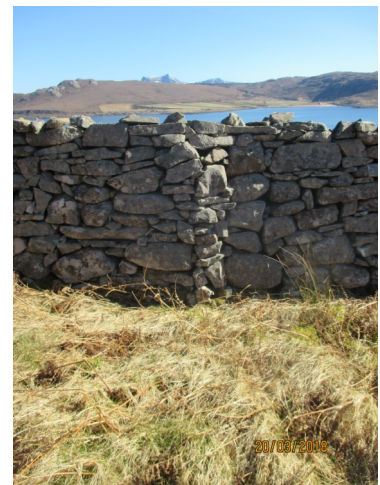
The barn was a phased building with rougher construction and had rounded inner corners. It had two entrances.

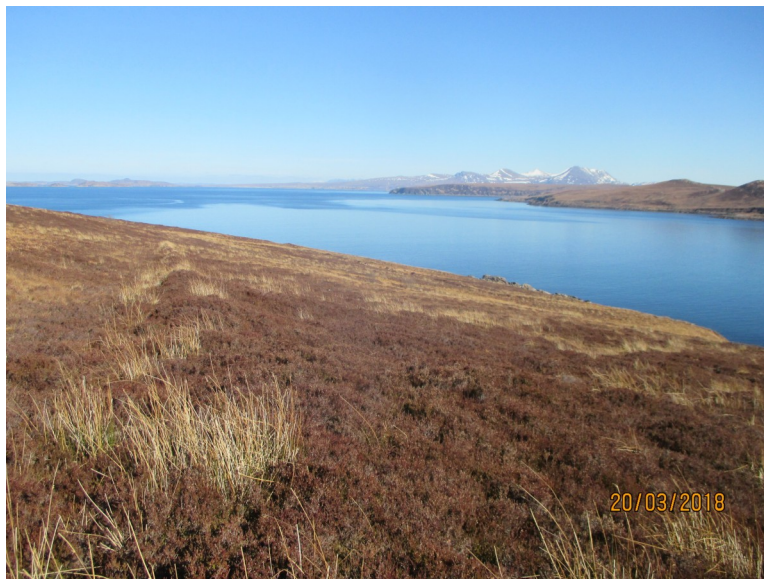
11. NG 94684 93856 Continuing wall of turf and stone leading from feature 10, SE down towards the sea.

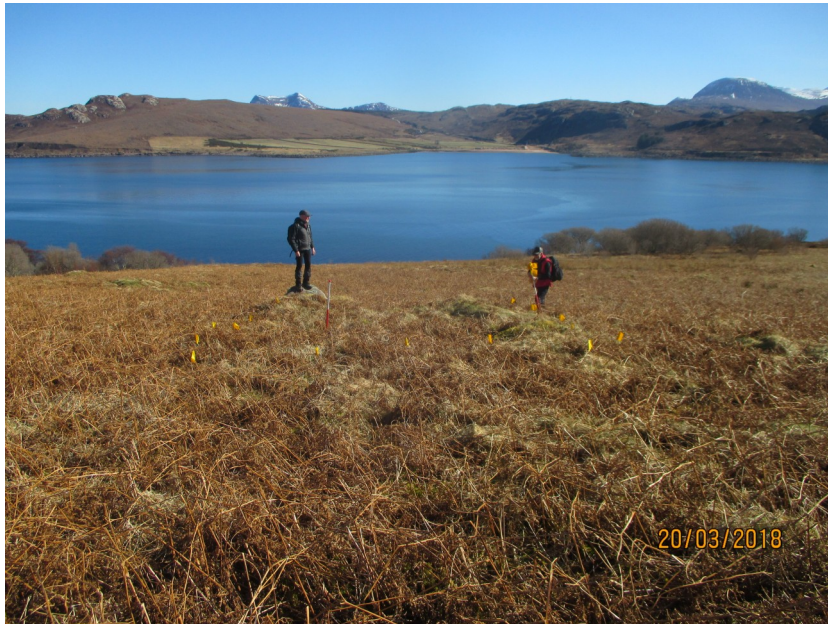
12. NG 94712 93697 Footings of building measuring 7.5 x 5m

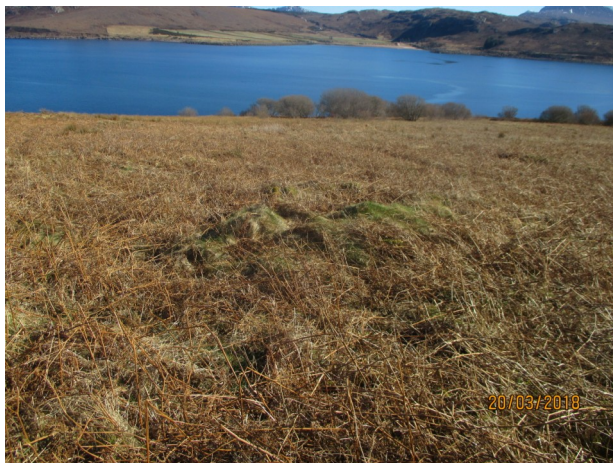
13. NG 94715 93654 Footings of building measuring 3 x 4m

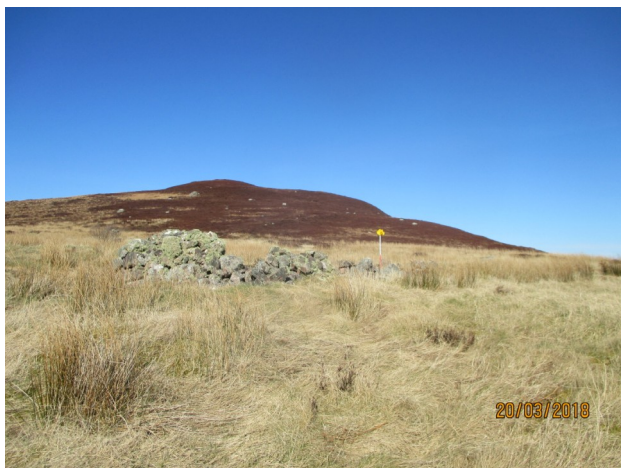
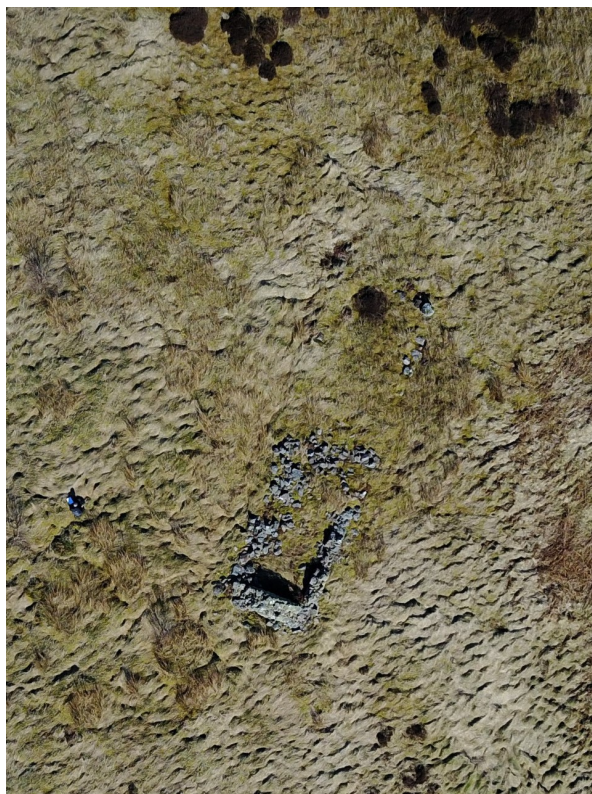
14. NG 94623 98556 Ruins of three adjoining buildings measuring 16.5 x 4.3m

A drone shot of feature 14 showing the layout of the buildings

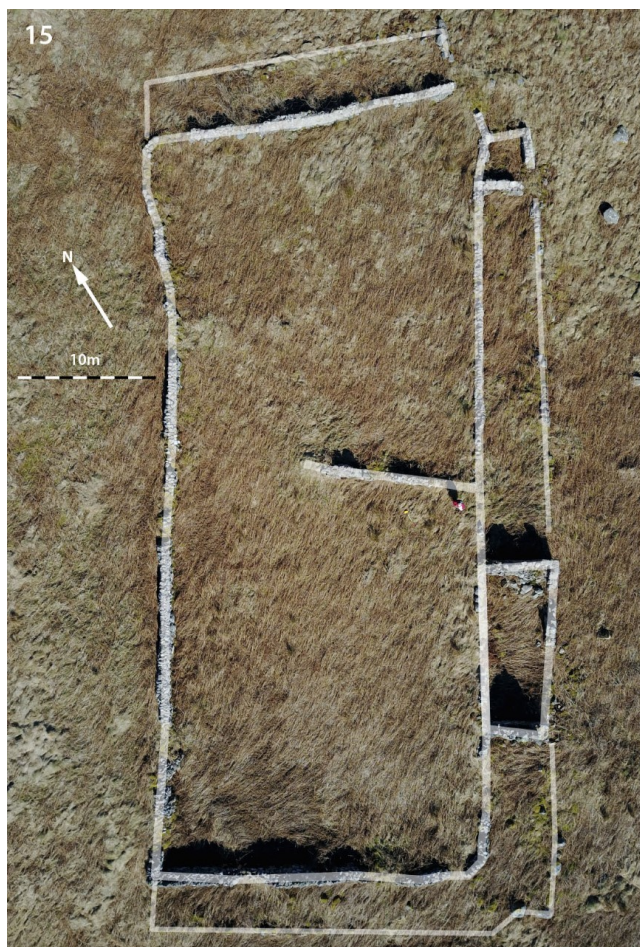
15. NG 94686 93547 Ruin of walled enclosure with house and outbuildings built along three sides.

Enhanced drone shot showing ground plan of the ruin.

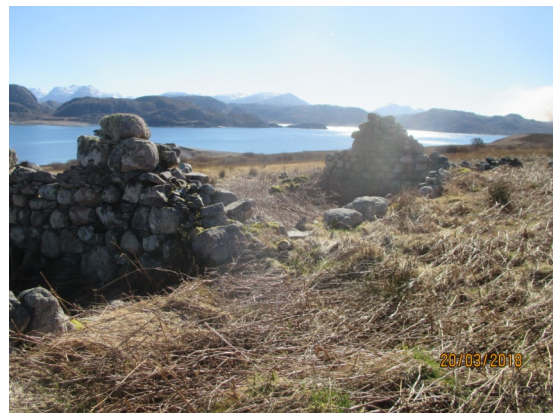
The house, note the layered stones in walls

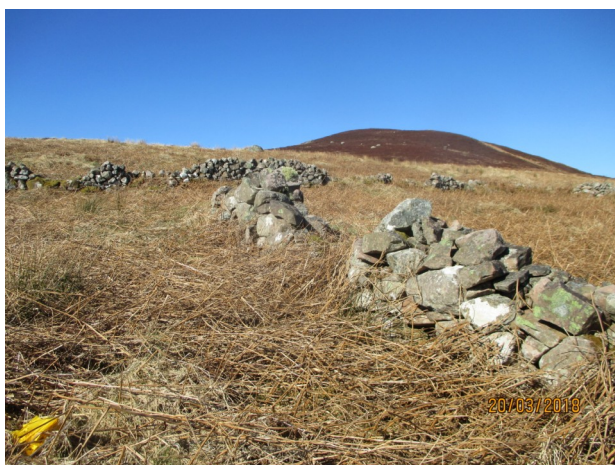
The enclosure to rear of house is higher

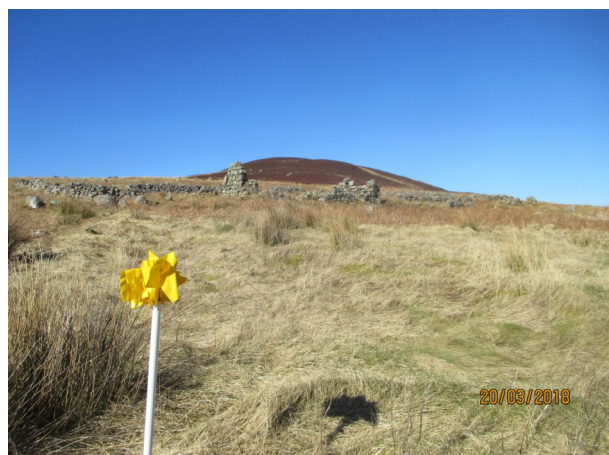
The rough enclosure walls

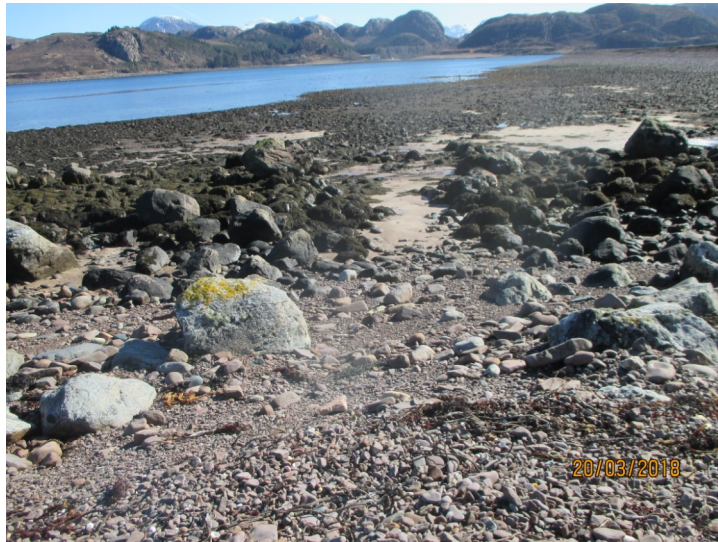
16. NG 94844 93192 A slipway for landing boats

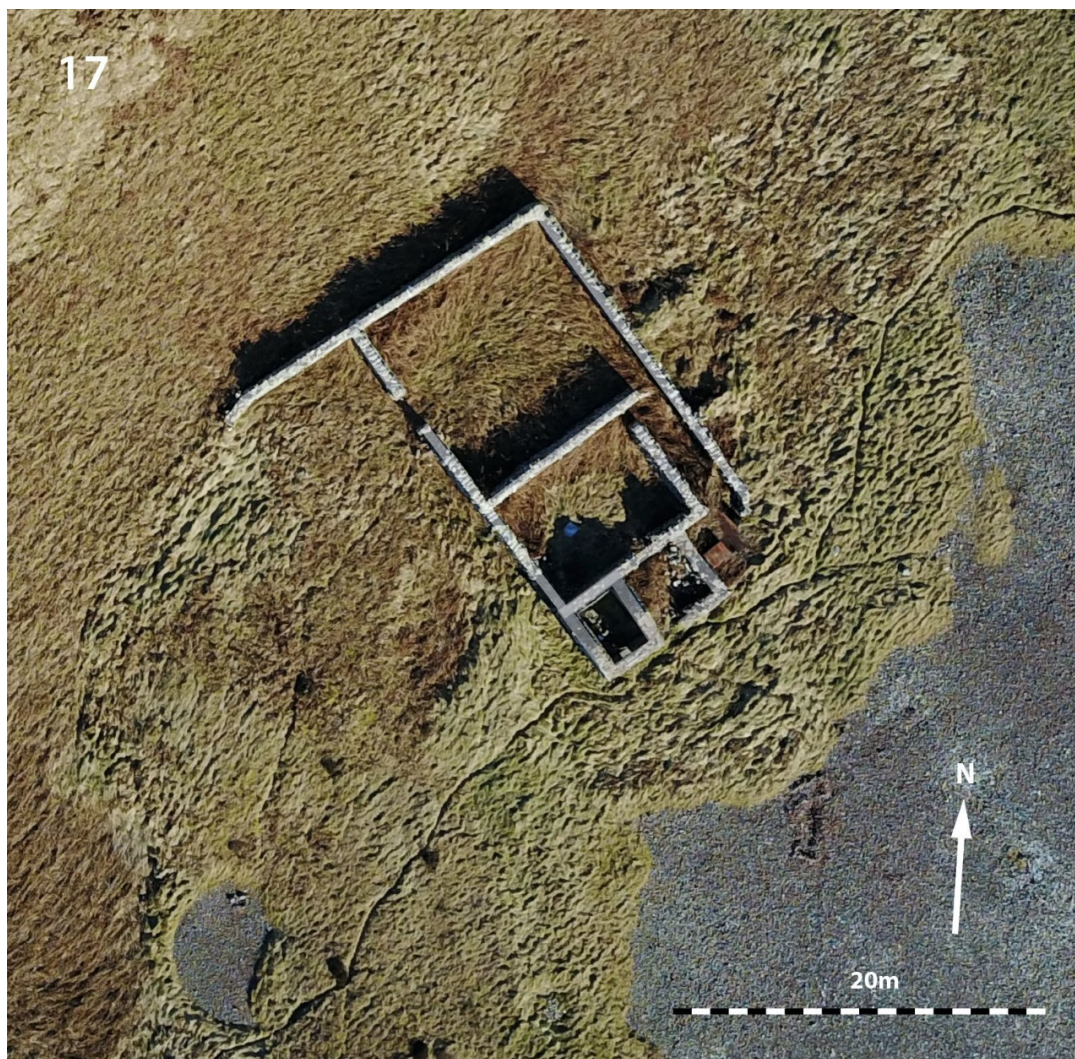
17. NG 94772 93113 Ruin of known shepherds bothy with adjoining fank and dipper. Also used by the MOD during anthrax experiments.

Enhanced drone shot showing layout of ruin

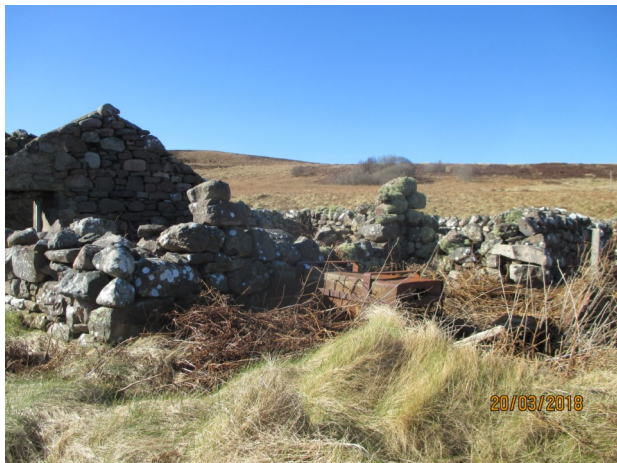
Showing the dipper in the foreground

The building has been altered but the construction is of dressed stone that is layered with lime mortar used in the walls and a cement cap on the skews.

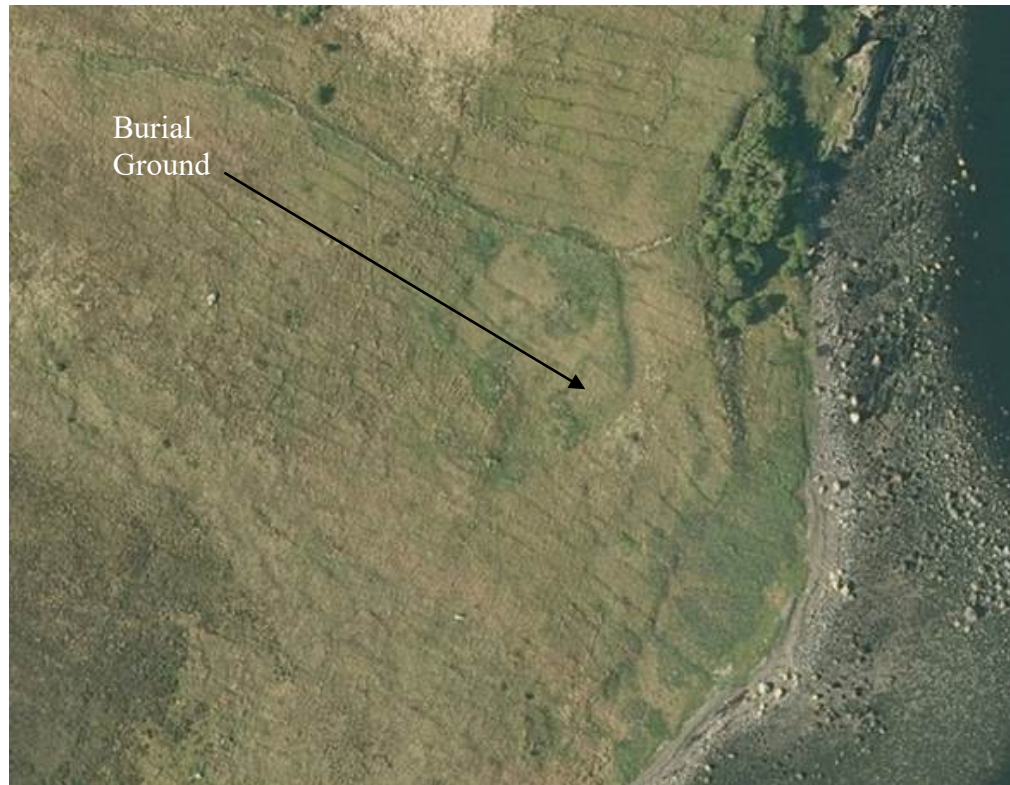
18. NG 94848 93316 Burial ground.

Investigation found a ruined stone dyke heavily mossed over enclosing an area measuring 9 x 14m. On probing and removing some of the moss we discovered about a dozen stones placed at regular intervals within this area. Four were in a row, parallel to the boundary wall.

The stones were also carefully chosen, not just cobbles off the beach. There was quartzite, mica schist, patterned sandstone, and a stone with quartzite nodules through it. No engravings were found on the stones but this is not unusual.

We concluded that this was the noted burial ground.

View from the burial ground looking S. The outline of the low stone walls can be seen in the foreground.

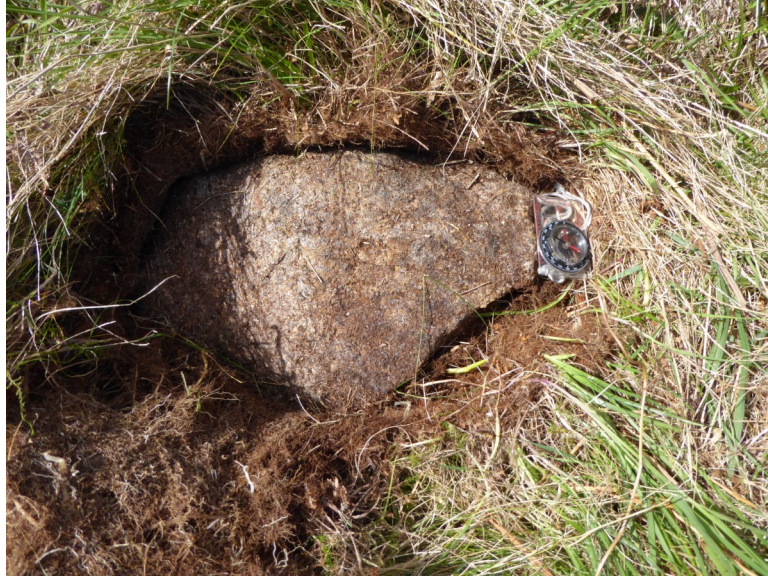
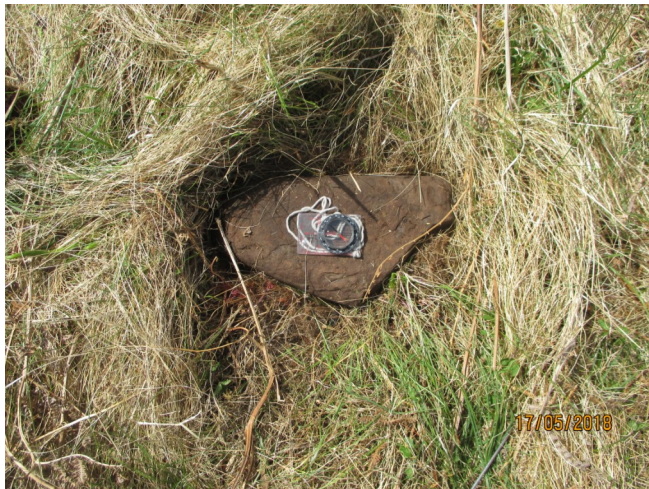
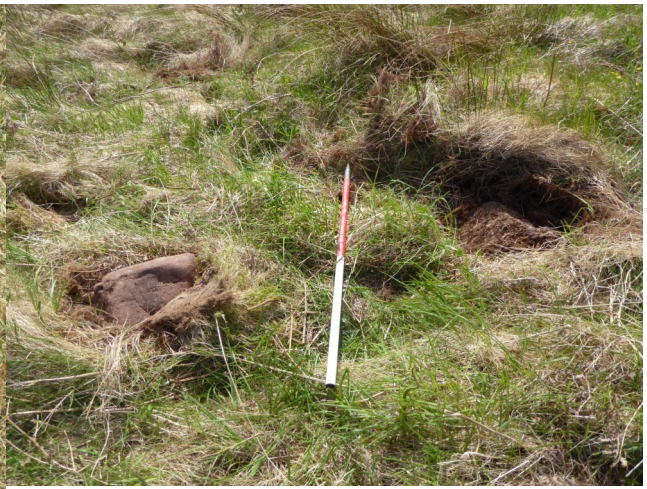
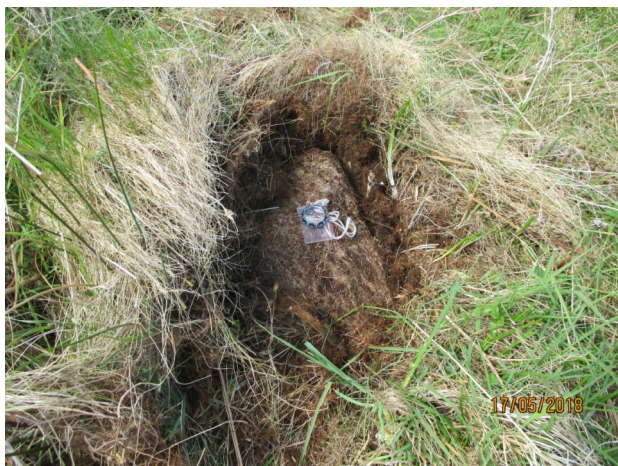
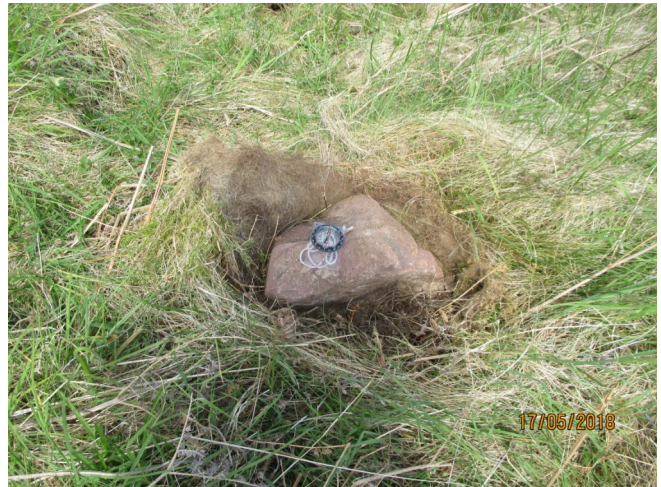
Some of the stones in the burial ground.

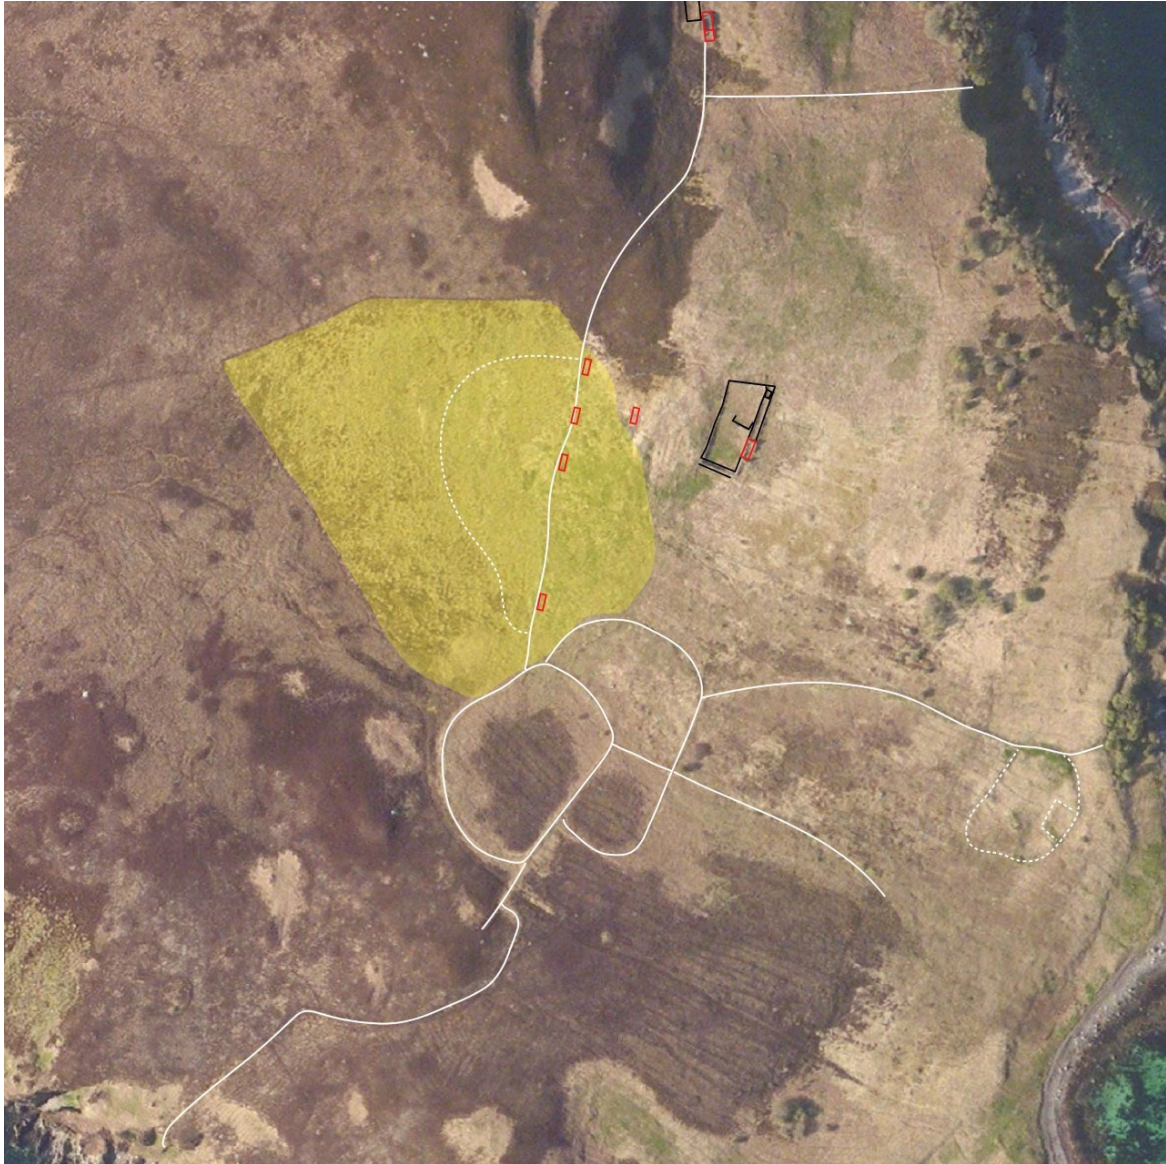
Following the research into the anthrax experiment on Gruinard and after looking at maps and diagrams, it was noted that the marked experimental area treated with anthrax matches an area with distinct colouration change in the vegetation.

The above aerial photo has the area marked in pale green.

In an attempt to remove the anthrax spores, the area was first of all burnt during the war and then treated with Formaldehyde in 1986 ( see report )
