Knocknagael Substation, Inverness: Cable Undergrounding Works (2nd line)

Watching Brief

| Report No. | HAS111002 |

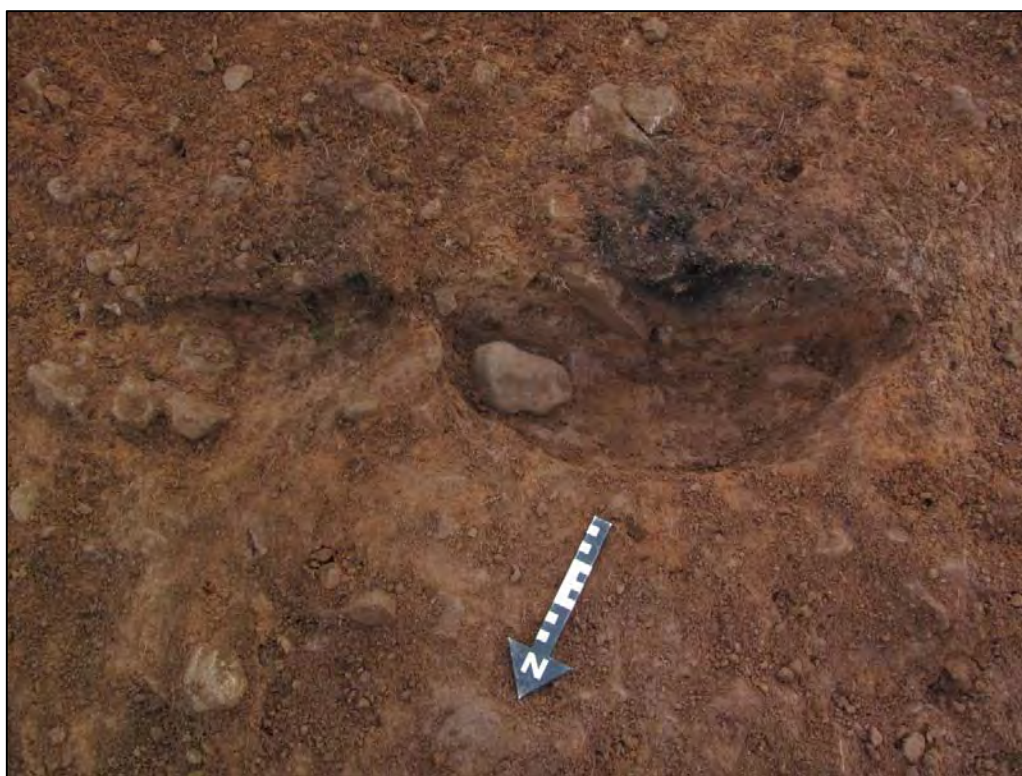
Plate 1 Features F1 (left) and F2 (right)

0.2 x 0.15 x 0.1m. Hollow with no defined cut; not archaeology: apparently root action (Plate 1)

0.2 x 0.2 x 0.07m. Hollow with no defined cut; not archaeology: apparently root action (Plate 1)

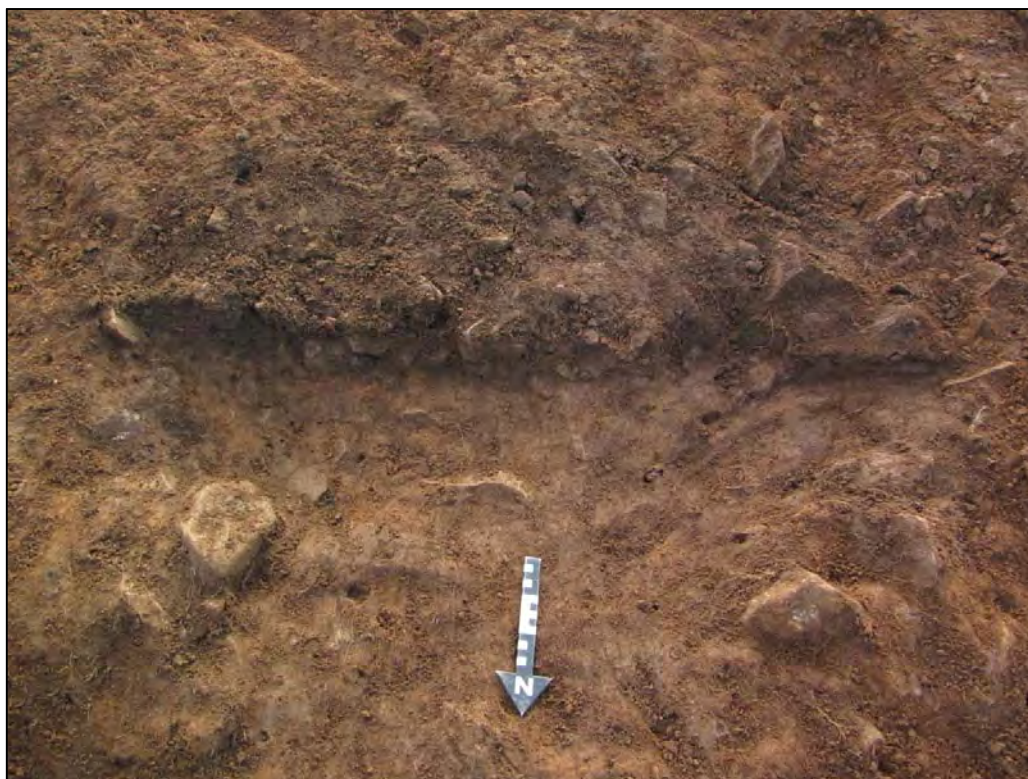
Plate 2 Feature F4

1.2 x 0.6 x 0.03m. Hollow with no defined cut; charcoal flecks: apparently root action and / or scrub burning (Plate 2)

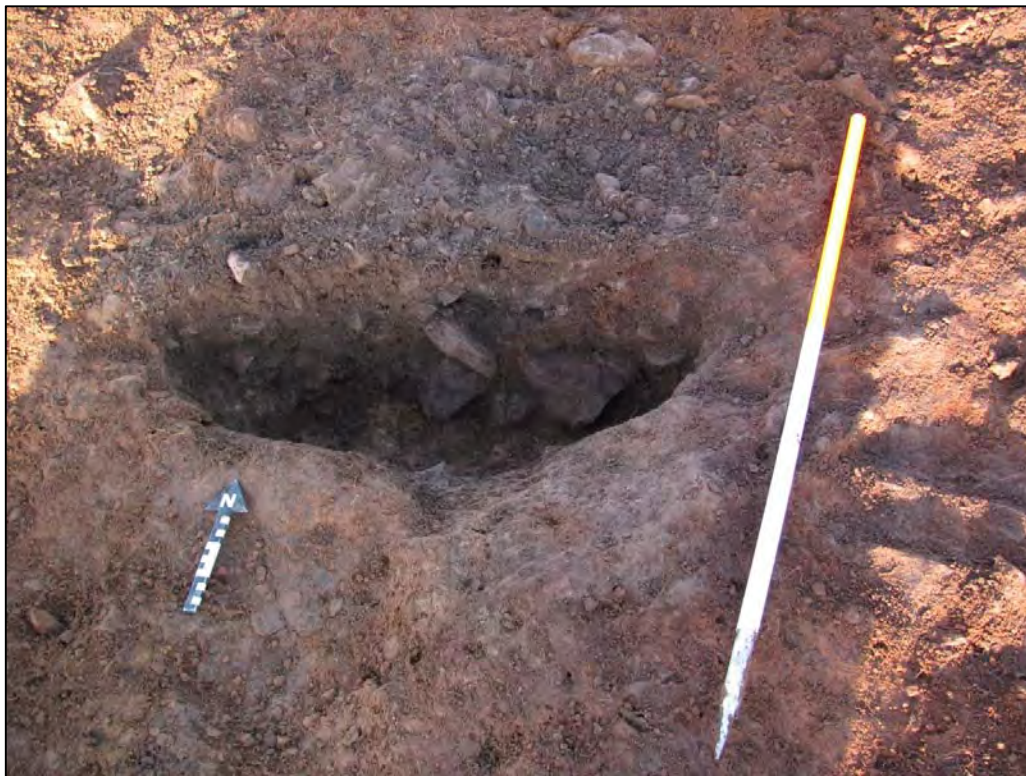
Plate 3 Feature F7

1 x 0.8 x 0.35m Pit; charcoal + flat stones, especially on E. A cut feature, but with no dating evidence (Plate 3).

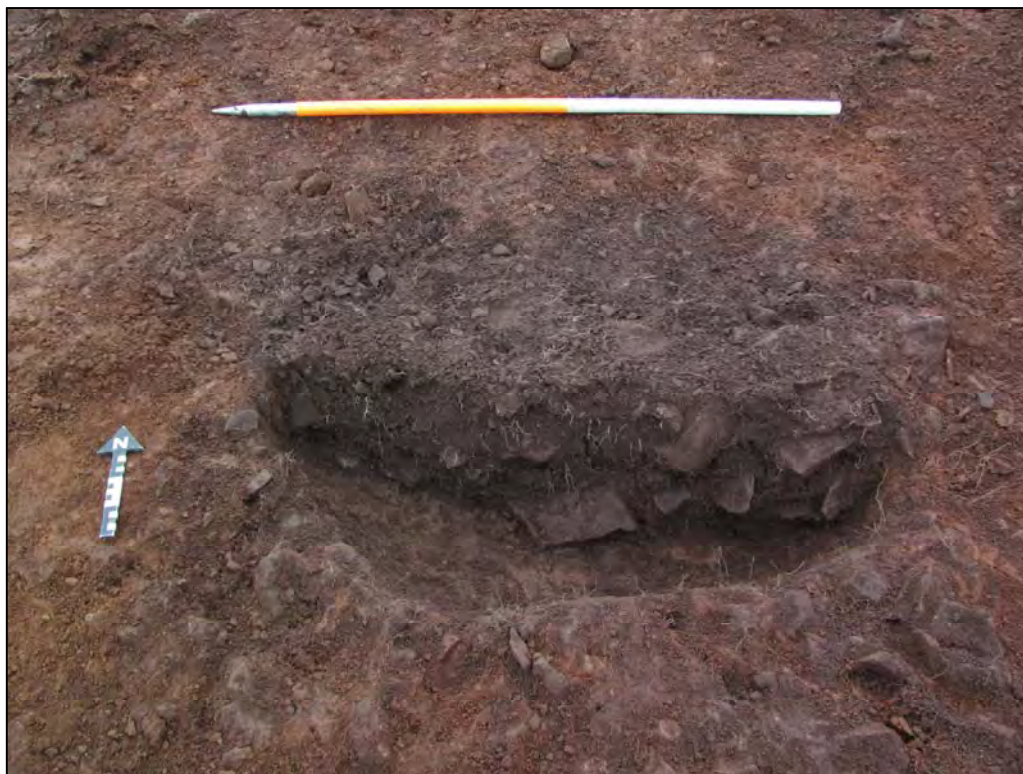
Plate 4 Feature F8

1 x 0.7 x 0.3m. Pit: approx oval, steep sided with slight curve to base, containing mid-dark brown soil with many stones. Some rounded stones c. 10-15cm. diameter around edge of cut. Poor definition and no dating evidence. Possible root bowl.

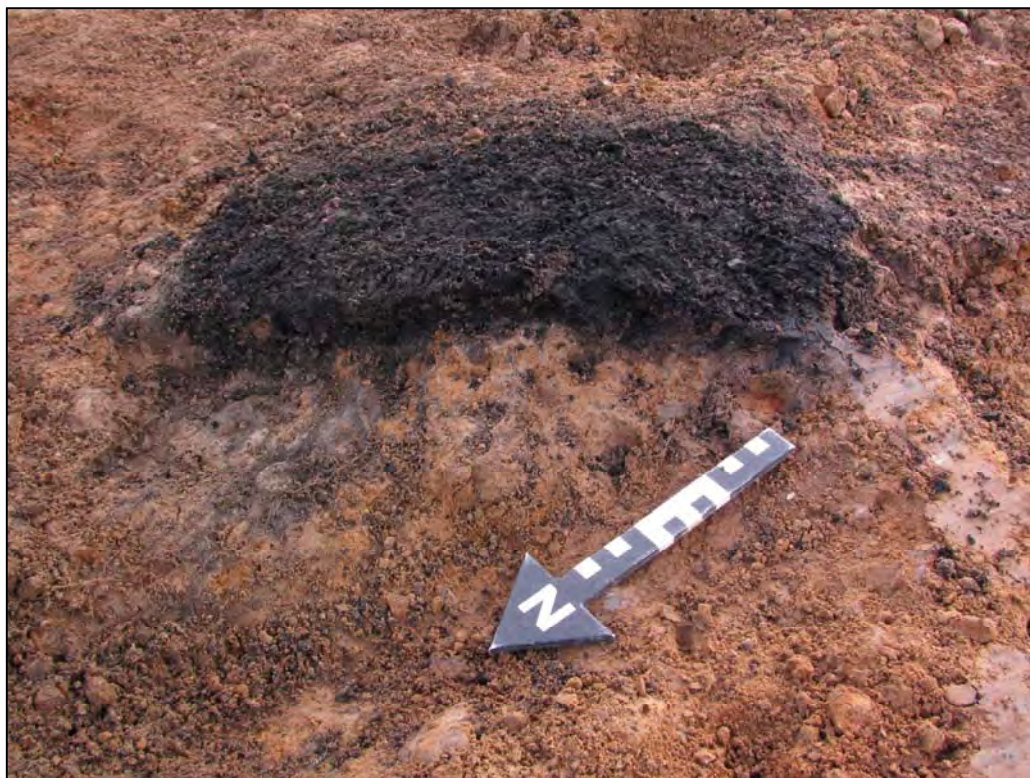
Plate 6 Feature F18

0.35 x 0.35 x 0.07m. Pit: well defined where visible but damaged by digger so full recording not possible; cut into yellow hard clay subsoil; fill of peat with charcoal. Similar to F15.

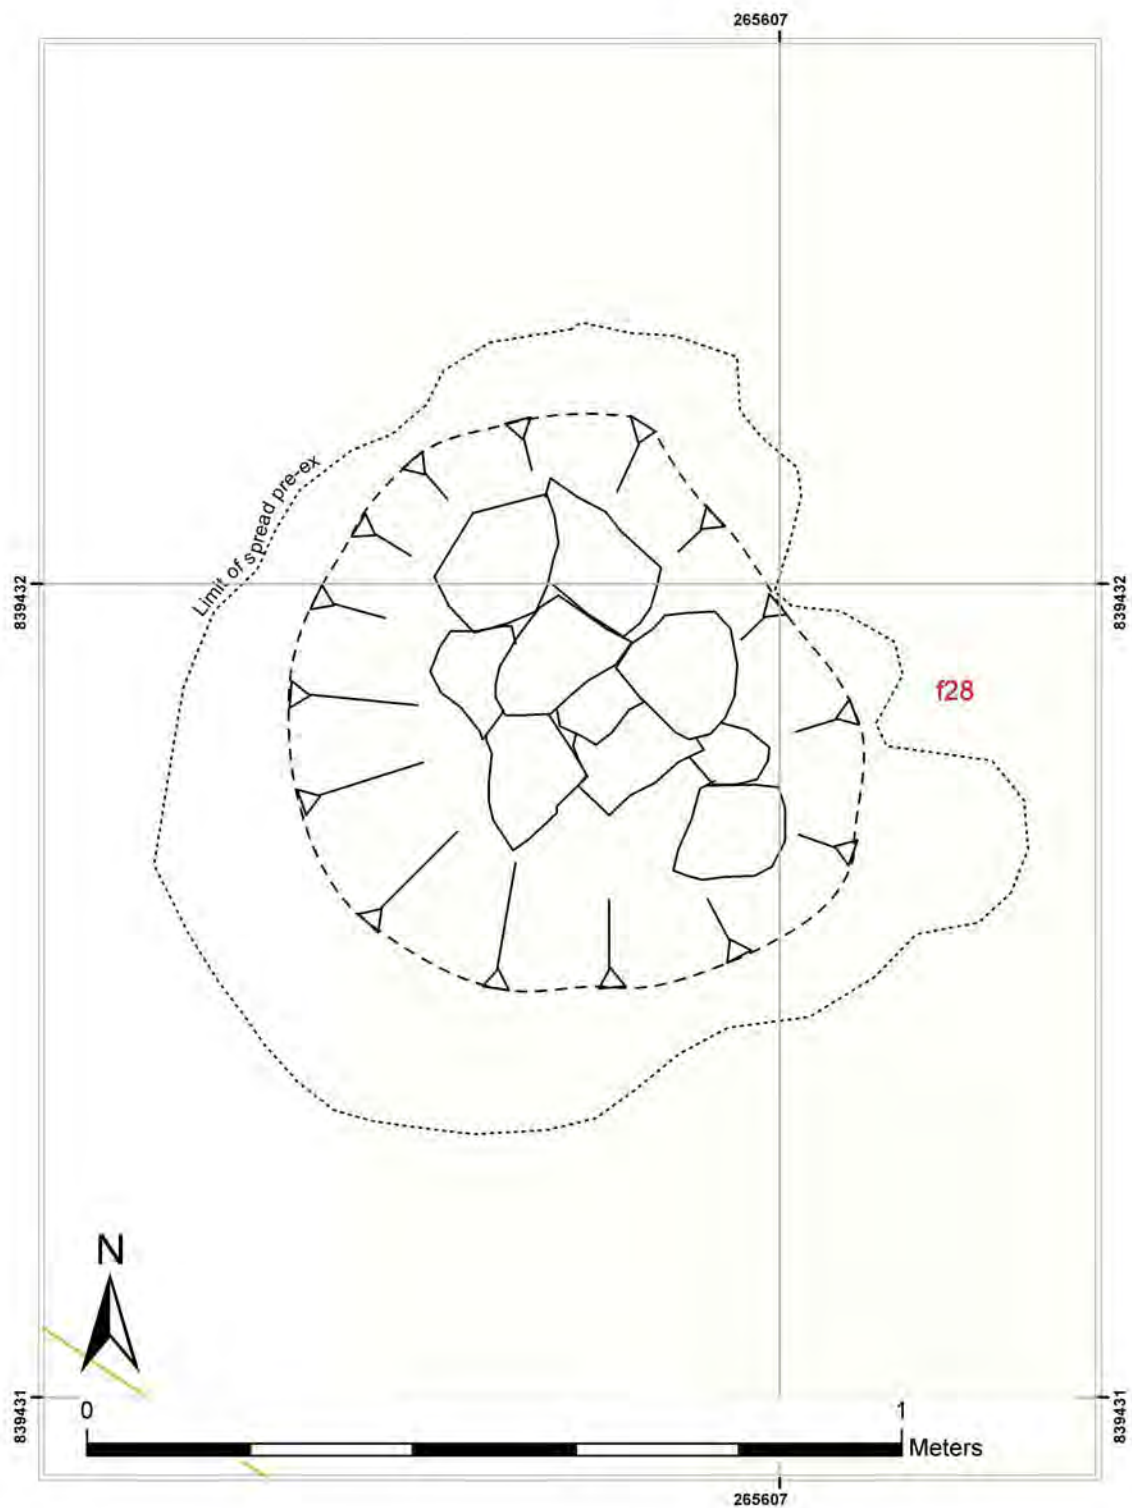
Figure 2 Feature F28

0.9 x 0.9 x 0.1m. No defined cut. Charcoal rich deposit overlies hearth stones in hollow. No dating evidence. (Plate 7 below).

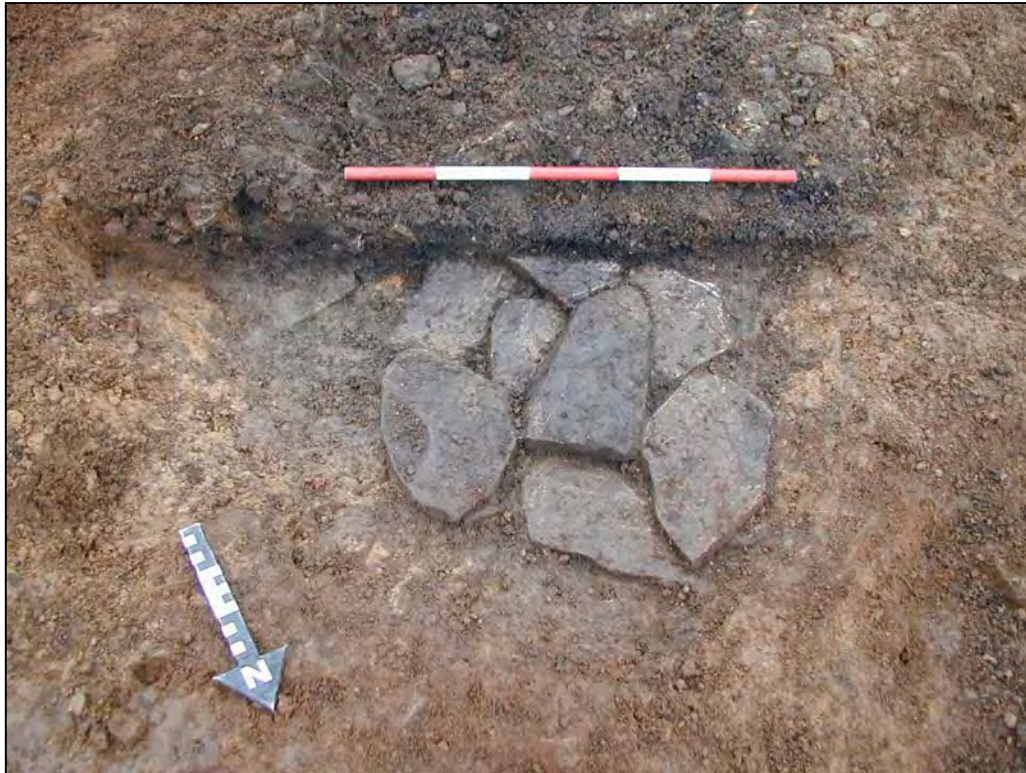
Plate 7 Feature F28

Apart from Feature F28, very little archaeology was found during this watching brief, despite the presence within the wider area of a number of significant sites. There was some scattered evidence of 19th -20th c. manuring as might be expected. No dating evidence was recovered. All features were very shallow, and most of the pits and hollows were probably produced by root action and / or post-medieval scrub clearance. The linear features appear to be the result of modern deep ploughing or pan-busting activity. There are no recommendations for follow-up work.
