Alness Academy, Alness

Archaeological Watching Brief

Data Structure Report

August 2018
AOC Project Number: 24012-3

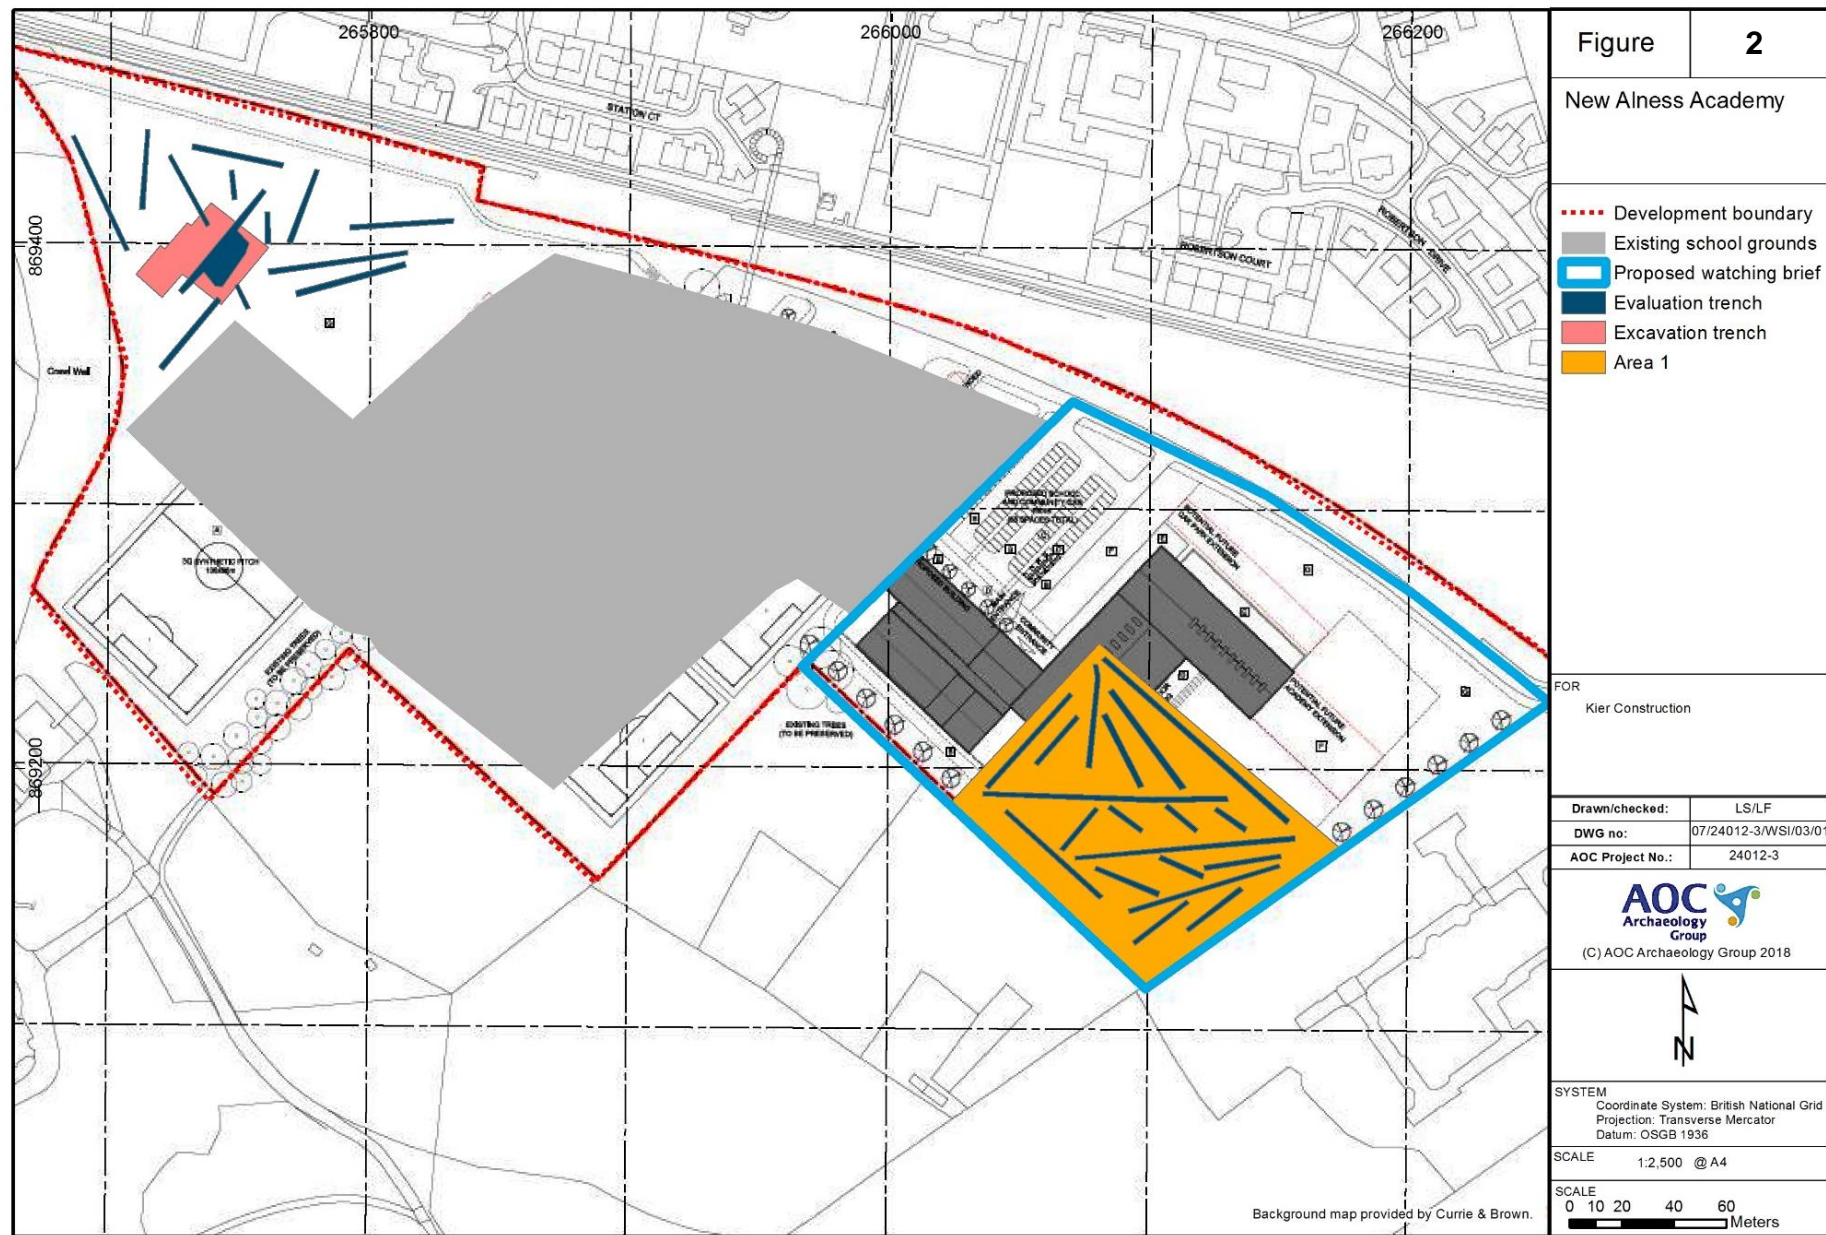
Figure 2: Previous archaeological evaluation and watching brief area

- 2.2 The archaeological watching brief requirement has arisen due to the proximity of the development to significant prehistoric archaeology. A trial trenching evaluation was carried out at the site in September and October 2017 (**Figure 2**). The trenches in the southeast area did not reveal any archaeological features, most likely due to landscaping work carried out in the 1980s and 1990s. However, the northwest area contained several groups of archaeological features (Stirling and Williamson 2017). As a result of the evaluation, an archaeological excavation was carried out in November 2017 (**Figure 2**). Overall, 143 features, mostly pits, were uncovered, representing the truncated remains of prehistoric occupation. Detailed information can be consulted in the Data Structure Report (Stirling 2017).

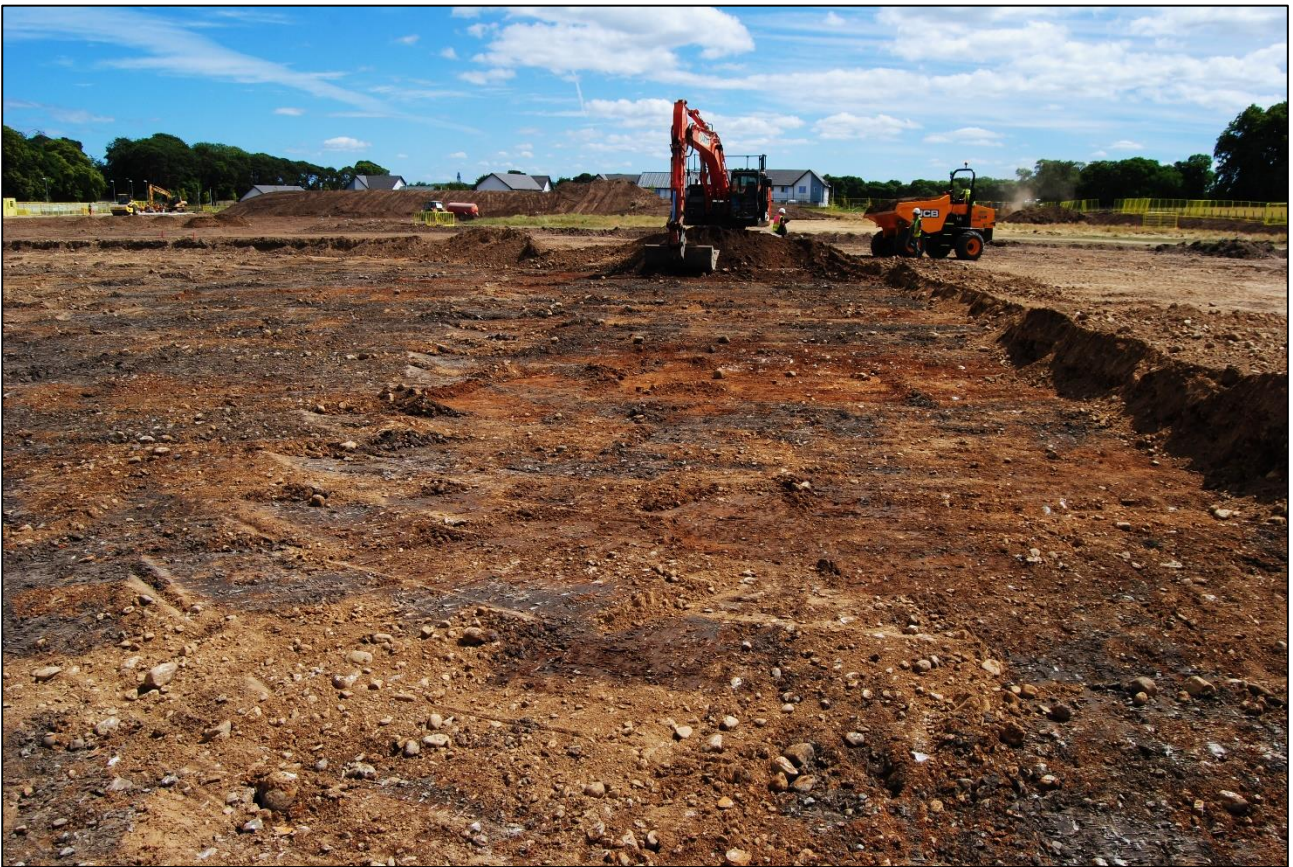
Plate 4: Stripping an area of made ground, facing SE

- 6.1.4 Topsoil varied in depth between 0.3m – 0.5m across the site. The natural subsoil generally consisted of bright or pale orange gravel, with patches of compact dark gravel and was overlain by a deep (0.8 - 1m) mixed deposit of topsoil and redeposited natural to the south, where the ground had been made up to form a level sports field.

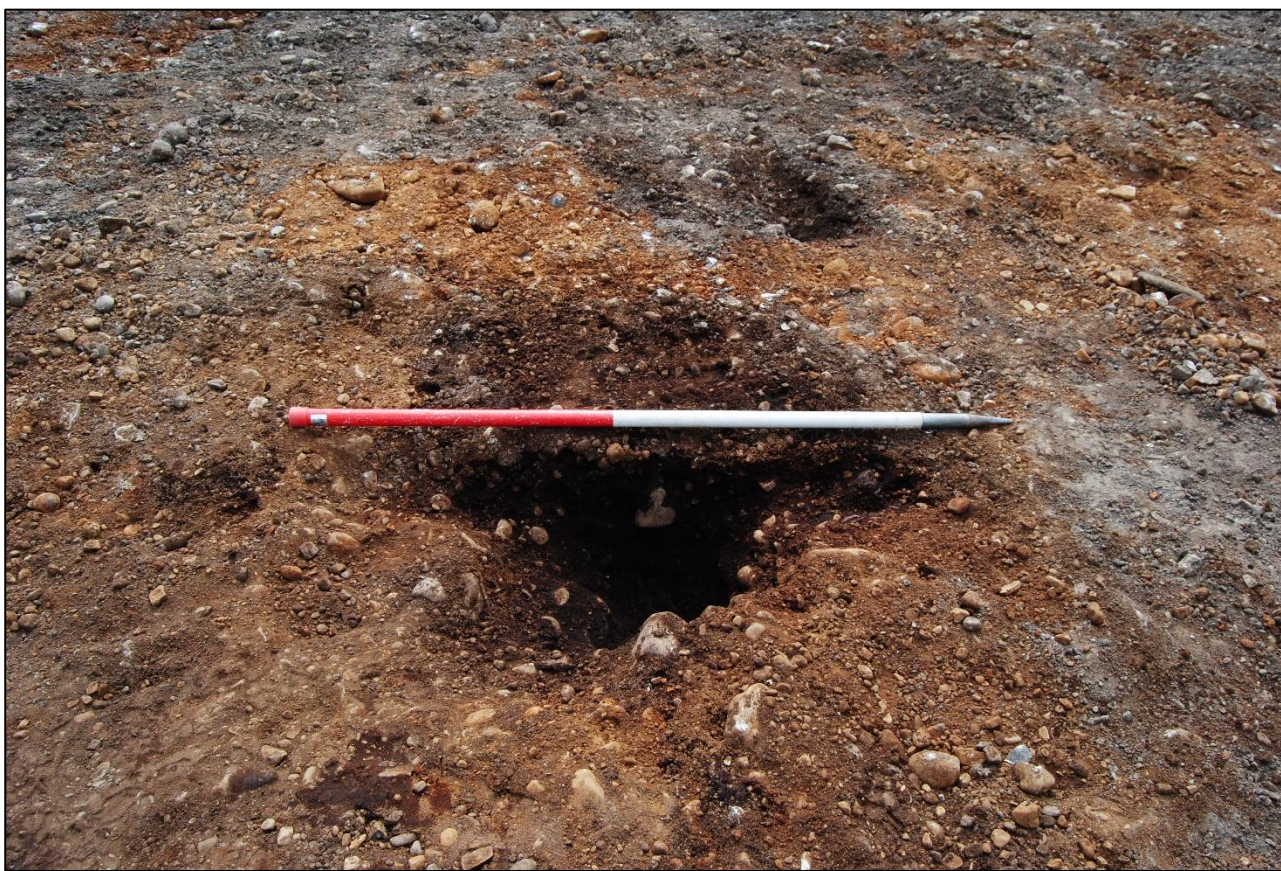
Plate 6: NE-facing section of pit/natural feature [004], facing SW

- 6.1.3 Three possible pits were recorded during the watching brief (**Plates 6-8**). Pit [004] consisted of a circular, bowl-shaped cut with ill-defined edges measuring 0.8m diameter with a depth of 0.22m (**Plate 6**). Pit [004] contained fill (005), a compact dark blackish brown silty sand with gravel and stones. Pit [006] consisted of a circular, bowl-shaped cut with ill-defined edges

measuring 1m in length, 0.7m in width with a depth of 0.2m (**Plate 7**). Pit [006] contained fill (007), a dark blackish brown compact silty sand with gravel and stones. Pit [008] also consisted of ill-defined edges, with gently sloping sides leading to flat base measuring 0.5m in length, 0.4m in width with a depth of 0.06m (**Plate 8**). Pit [008] contained (009), a dark blackish brown compact silty sand with gravel and stones. The pits were similar in terms of characteristics and sterile fill, and likely represent natural silted hollows or features, or are possibly related to extensive landscaping works on the site.

- 7.1 Approximately 6000m² was stripped of topsoil during the watching brief. Three possible pits recorded probably relate to modern landscaping or may be natural in origin.
- 7.1 Despite the development area being located within close proximity to significant sub-surface prehistoric archaeological deposits, no finds or archaeologically significant features were uncovered. The area has been subject to extensive landscaping works related to the cut and fill creation of level sports pitches. No further work is recommended.
