**REPORT  
TO  
SCOTTISH & SOUTHERN ENERGY**

**FORT AUGUSTUS  
TO  
GLEN QUOICH  
OVERHEAD POWER LINE**

**WALK-OVER SURVEY  
SEPTEMBER 2013**

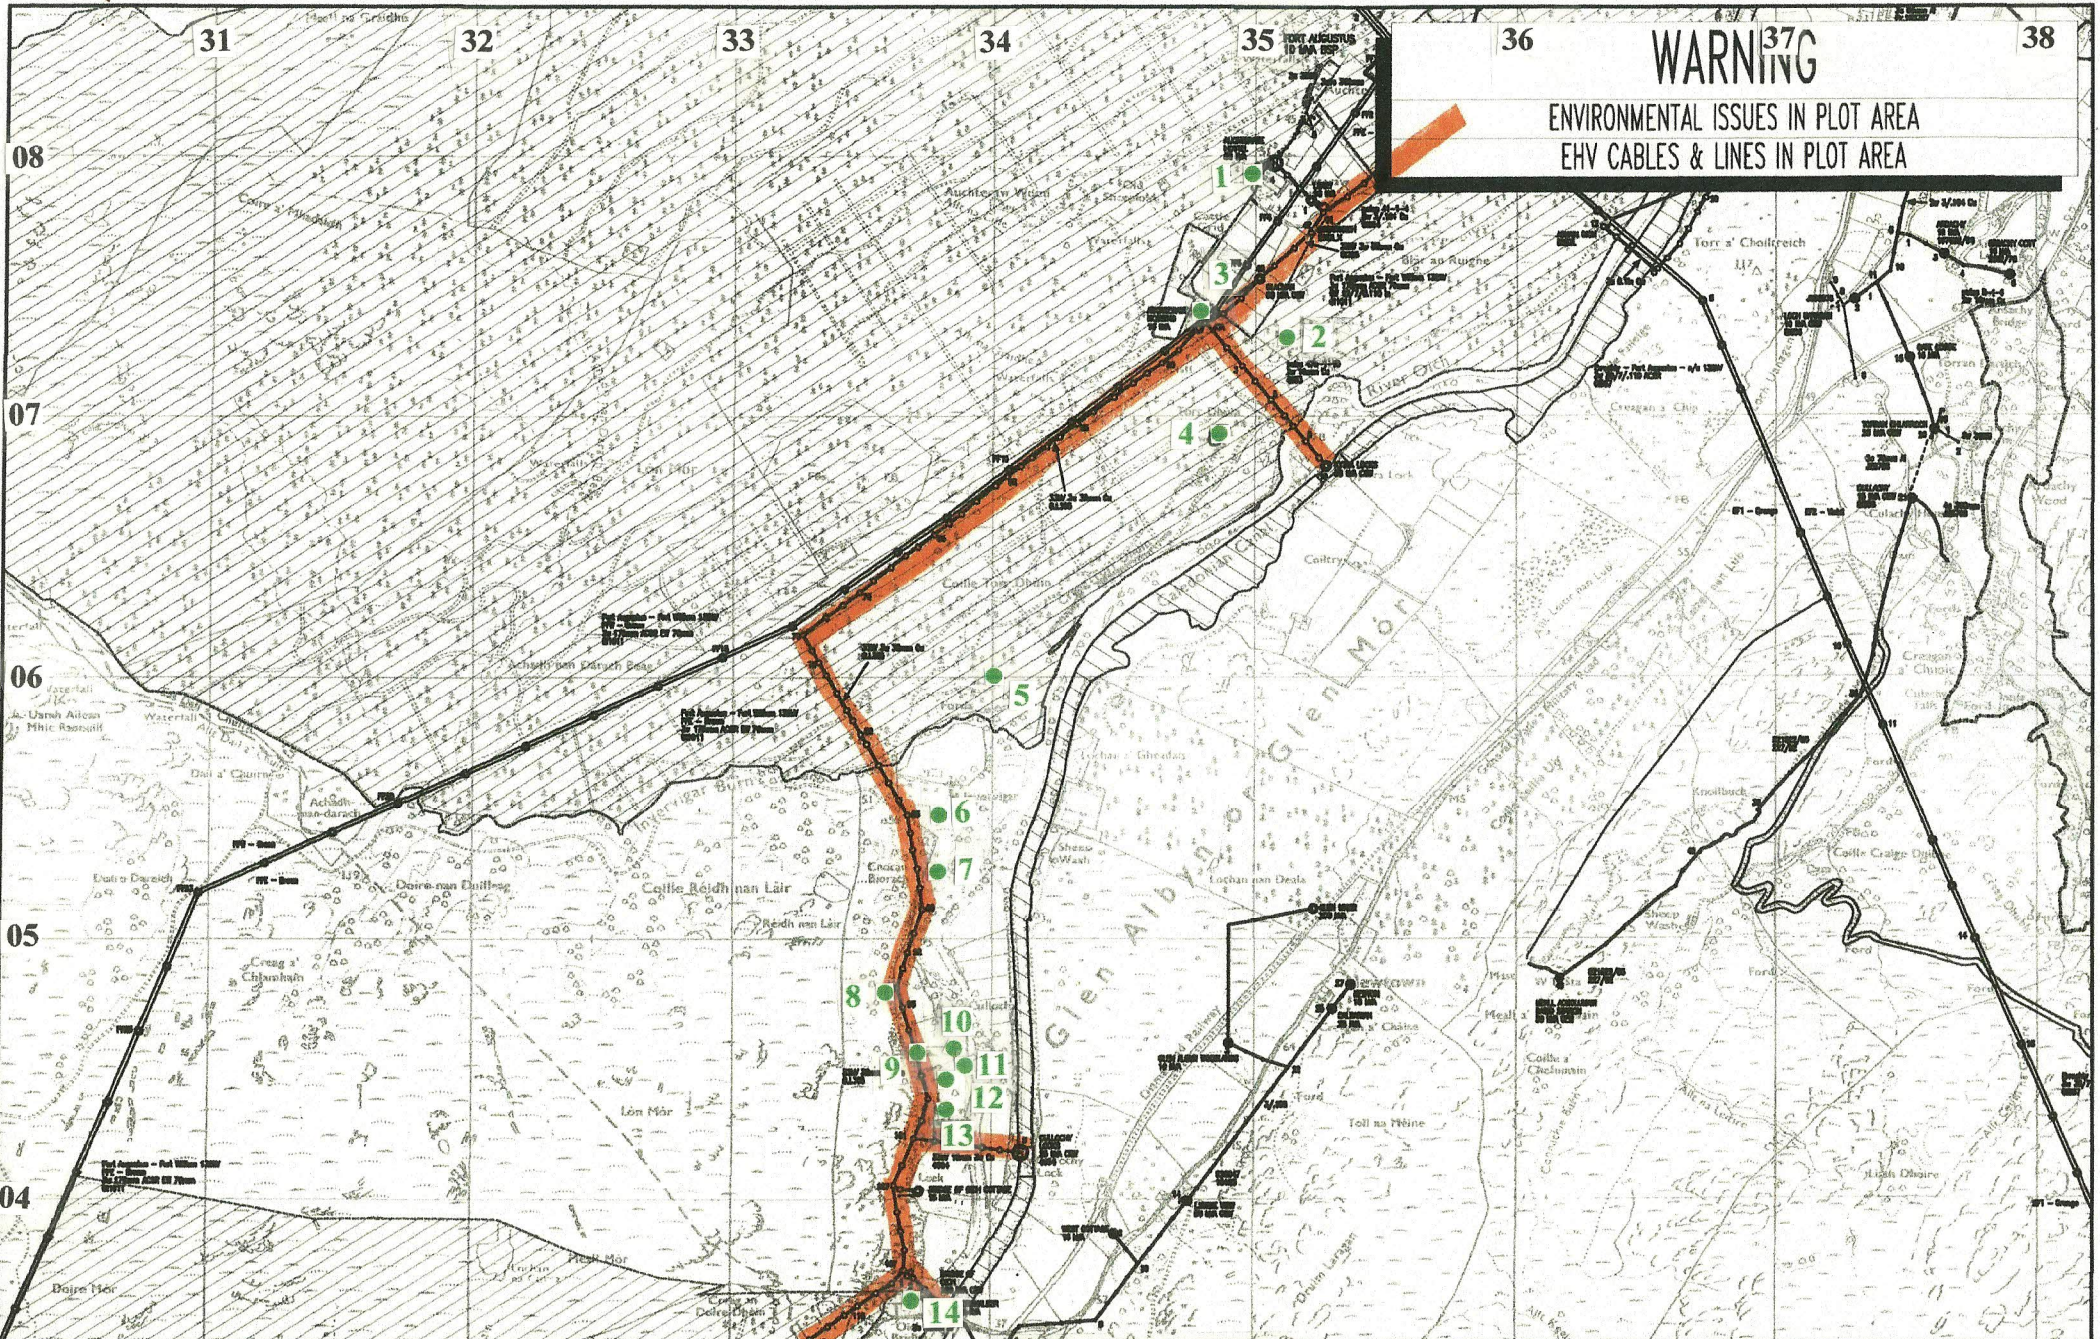
## MAP 1

Most of the sites noted in this area (Sites 6-14) are sufficiently far from the power line as not to be threatened by its refurbishment. However, there is one exception, Site 8 (NH30SW 15),

which sits directly adjacent to an extant pole at the north end of a pasture field and close to a small stream (see photos 1-3). The site, centred on NH 33656 04826, comprises the sparse remains of a building measuring approximately 11m north/south by 5m wide over grass-covered, drystone rubble walls of which only one to two courses survive. This is a two-roomed building, the south one being very small and was perhaps a store.

Site 8 is probably the more vulnerable of the two structures, an existing pole sitting directly against the west side of the building. As a consequence, it is recommended that any work carried out there should avoid direct contact with the remains of this structure. If the pole is to be replaced at Site 8, it is suggested that the new one is erected some distance from these fragile remains.
