DRUMMONDHILL, INVERNESS, HIGHLANDS

HBR (LEVEL 2) AND
TRIAL TRENCH EVALUATION
PLANNING REF. 17/02387/SCRE

commissioned by Tulloch Homes Ltd

March 2018

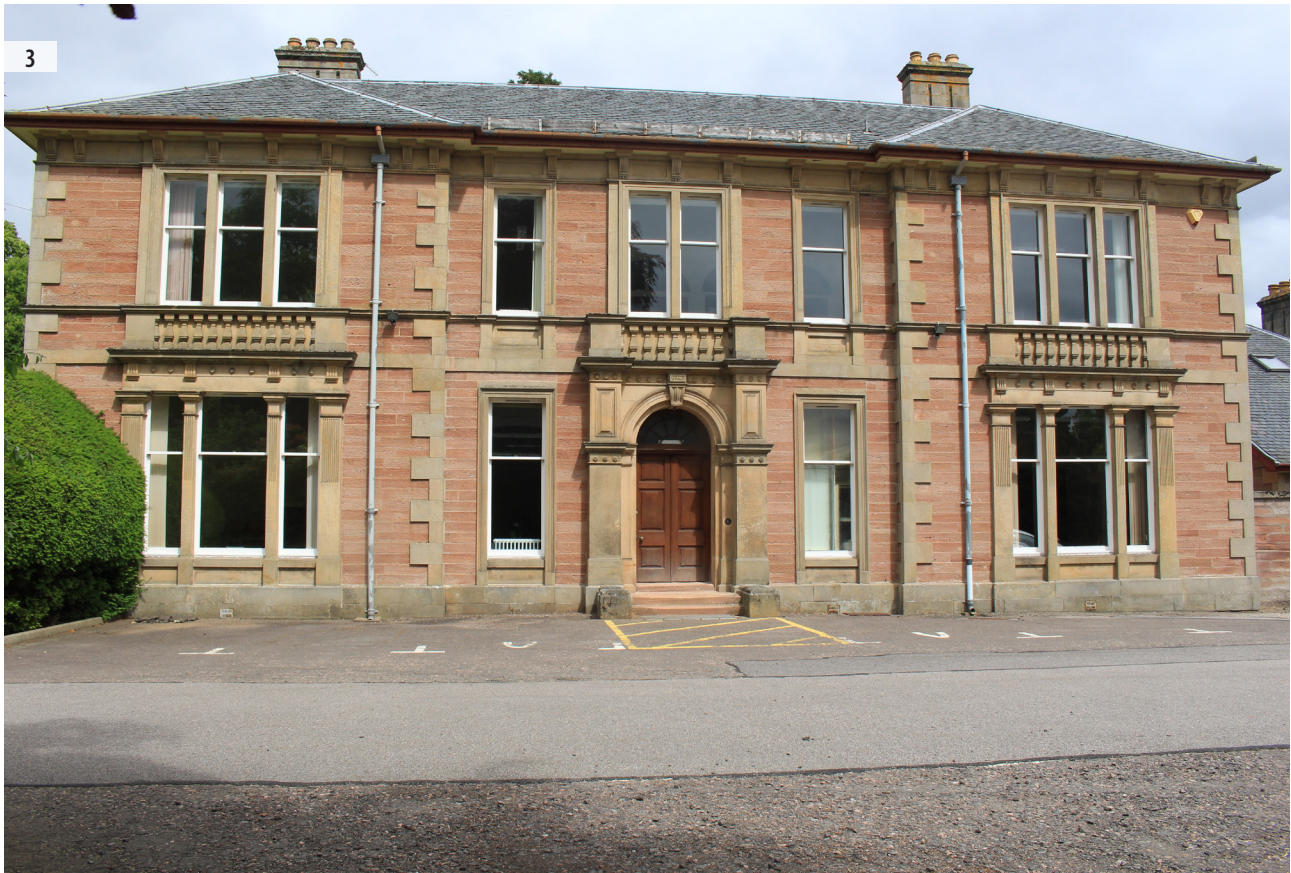
The Villa was constructed circa 1890 and comprises a large two storey five bay symmetrical Italianate villa with piended roof (Illus 3). The building had recently been in commercial use as offices and this was evidenced by the predominately modern interior of

ILLUS 3 View of the south facing elevation of the Villa ILLUS 4 View of the extensions to the east end of the Villa

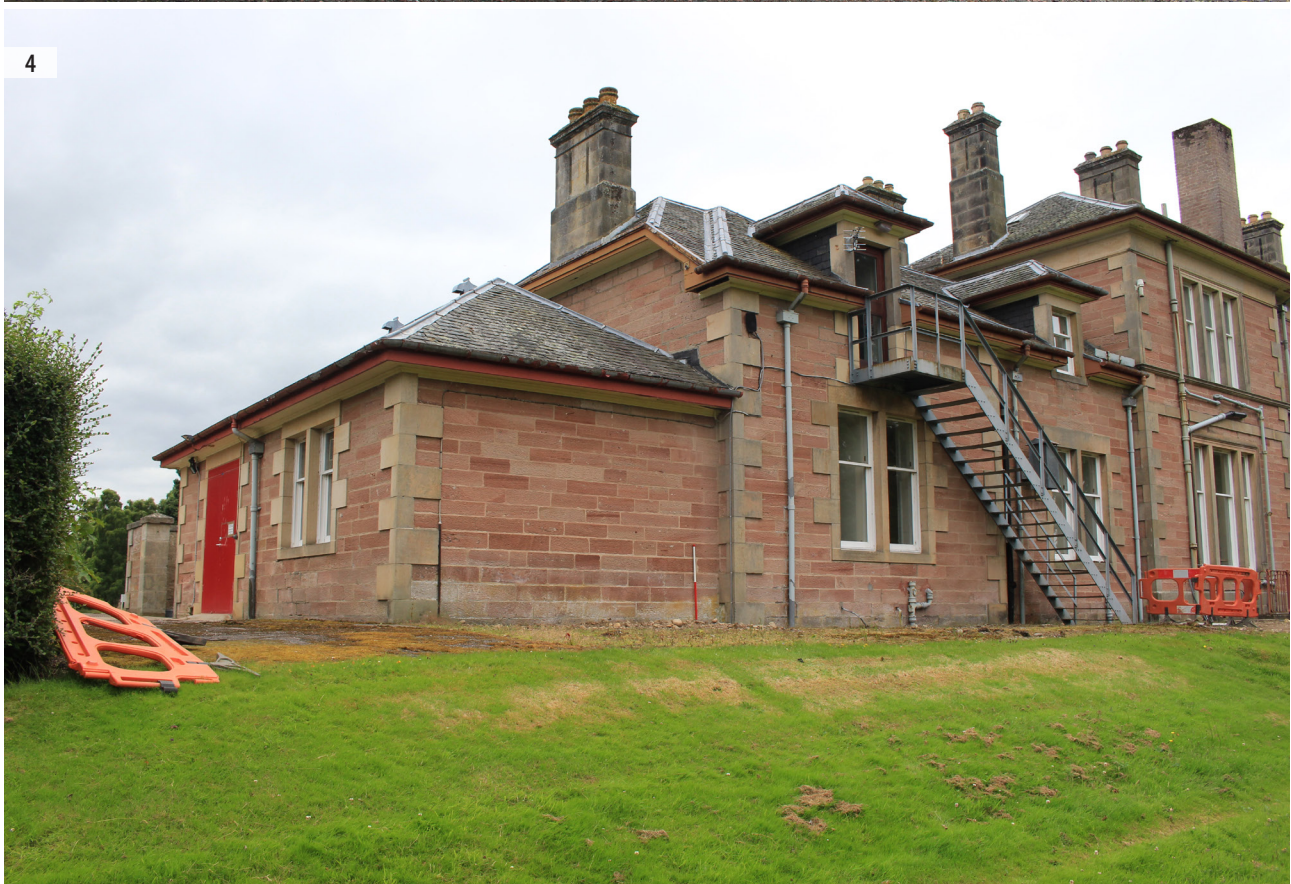
the building. The building as a whole comprises three phases of construction with the two storey Villa representing the first phase. A single storey dormered extension was then added to the east side of the Villa (Illus 4). This in turn was followed by a further single storey extension that wrapped around the east and south elevations of the second phase extension.

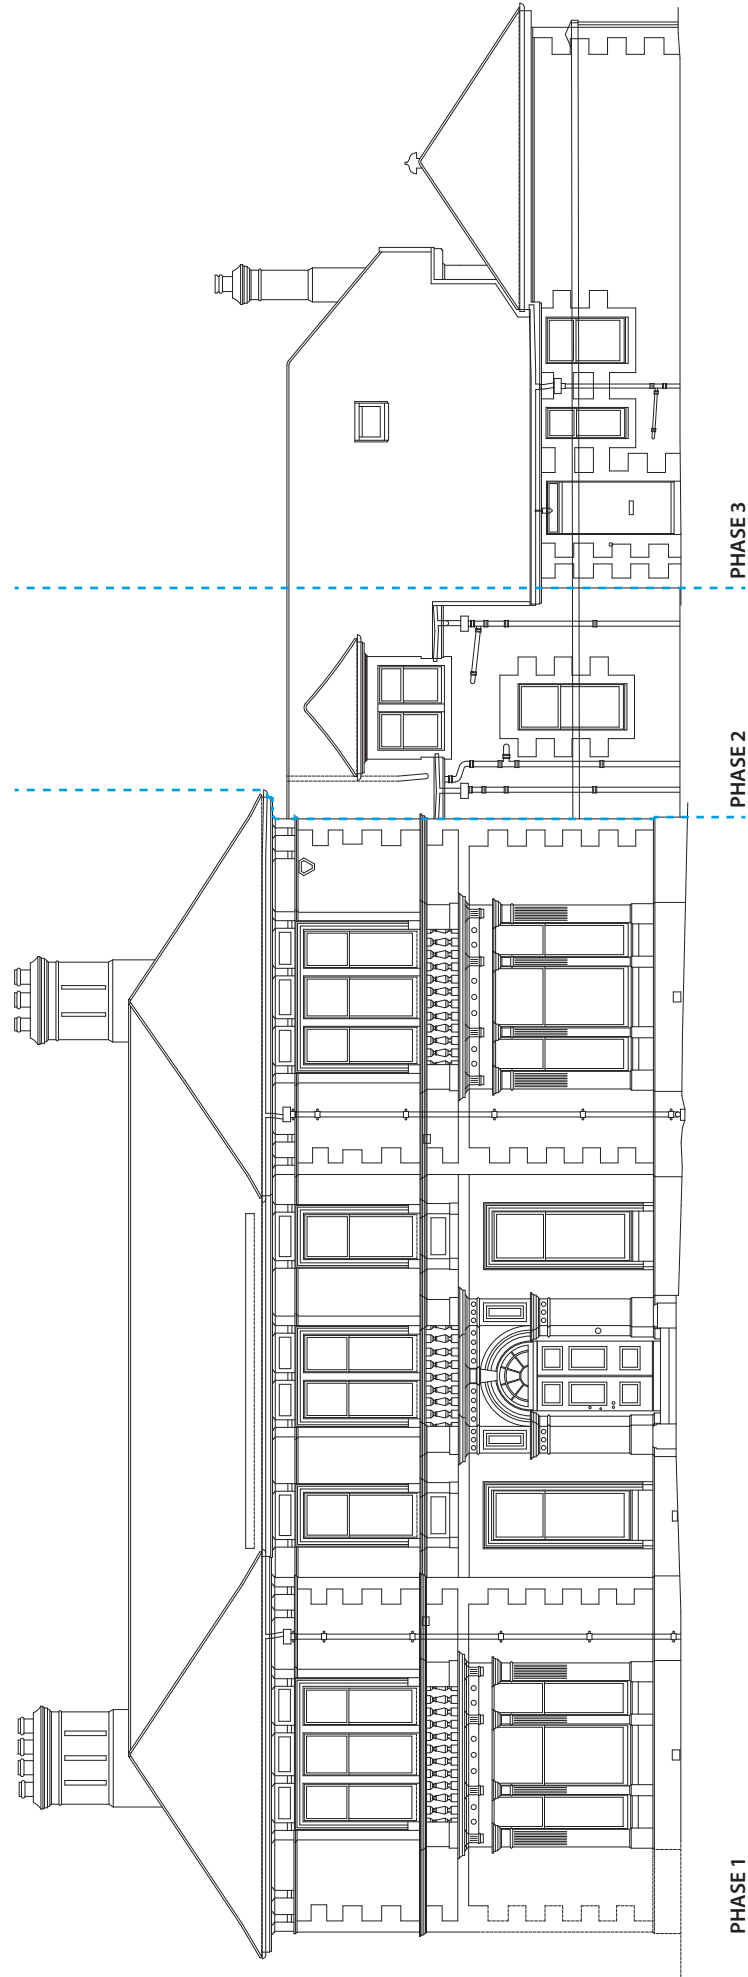
ILLUS 5 Measured survey of the south facing elevation of the Villa

The predominant design of the stonework of the building comprises coursed and tool-marked pink sandstone masonry with light yellow sandstone window surrounds and ashlar quoins. The main south facing façade of the Villa (Illus 5) presents the most ornate elevation of the building. It displays a central decorated entrance flanked by advanced symmetrical outer bays to each side. The entrance has a single-leaf panelled door with an overhead fanlight set in an ornate raised pilastered stone surround that incorporated a round-headed and key-stoned arch with a ballustered apron above. The initials WB+MJF are carved into the key-stone (Illus 6) representing the names of William Burns and his wife, Mary Jane Fraser. The entrance is flanked by single-light windows that display raised architrave surrounds. This design is repeated on the upper floor windows that flank a bi-partite window positioned above the entrance. The advanced wings have raised quoins to each side and three-light mullioned windows to each floor. The ground floor window mullions are pilastered with decorated cornice supporting a further ballustered apron. The upper floor windows are simpler in design copying the architrave surrounds of the central window bays. The elevation includes light yellow ashlar band and string courses to the first floor and a bracketed eaves course, the dentils of which display carved decoration.

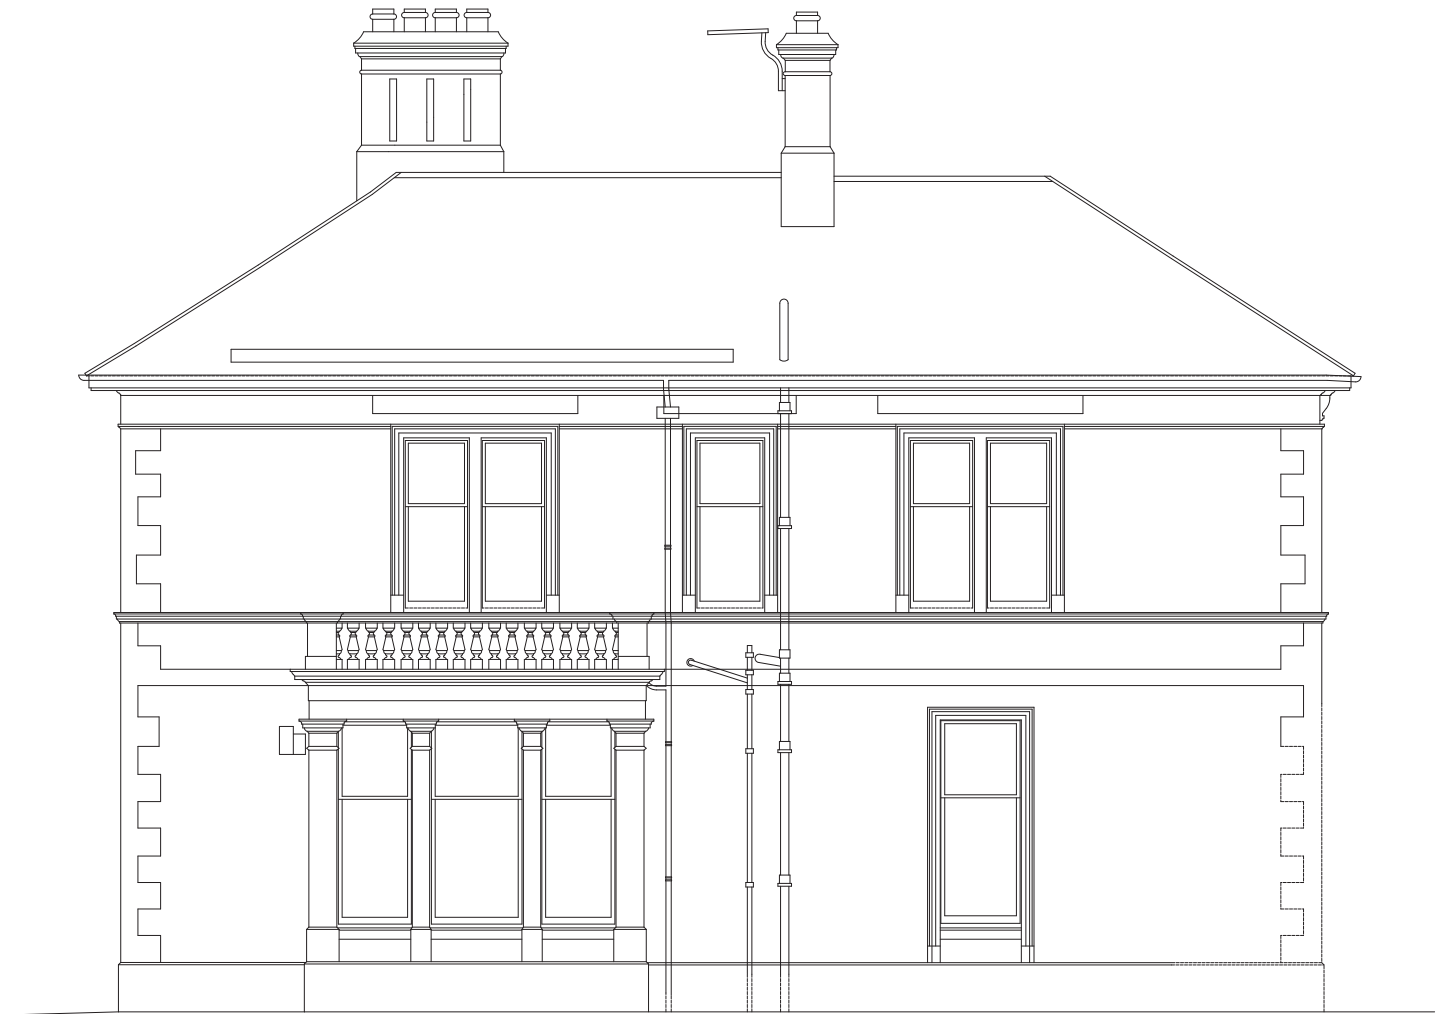
ILLUS 9 Measured survey of the west facing elevation of the Villa

The west external elevation (Illus 9) is asymmetrical although is similar in decorative style to the rear elevation of the house (Illus 10). To the north side is a ground floor canted three light window bay with pilastered mullions and a ballustered balcony above. The ground floor also has a single-light window bay to the south side. The upper floor has a central single-light window flanked by two-light windows to each side, all designed with the same stone architrave surrounds. The upper floor windows also include a raised moulded string course lintel.

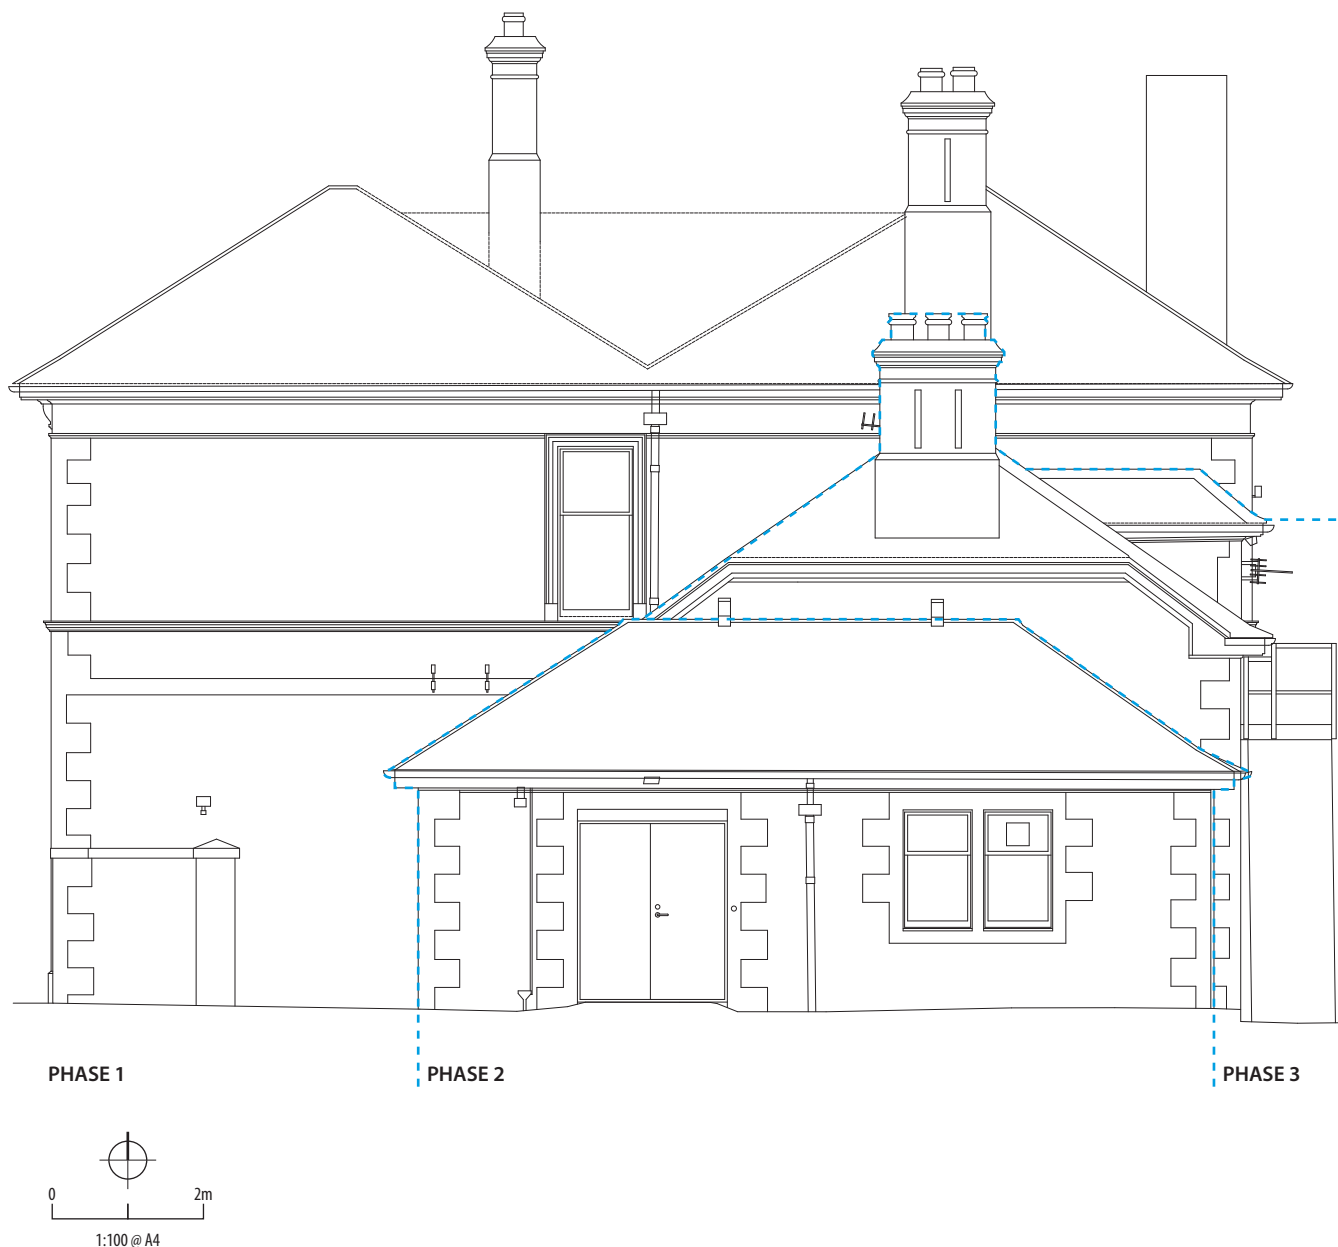
ILLUS 11 Measured survey of the east facing elevation

The northern half of the east elevation (Illus 11) has been masked by the later phase extensions leaving only the southern half of the elevation exposed (Illus 12). This revealed a single-light window bay to each floor, each window offering different designs. The upper window surround submits to the same design displayed on the other elevations whilst the ground floor window has a raised in-out ashlar surround. This is identical to the window design in both the first and second phase extensions, suggesting it was probably inserted during the construction of one of these phases.

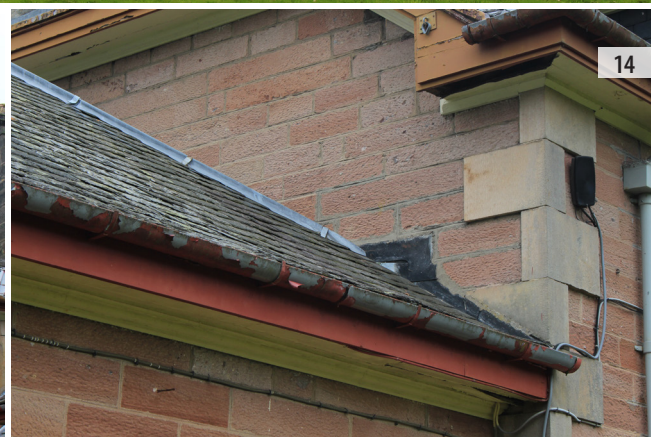
Both the later phase extensions are constructed to the same basic design as the Villa with coursed pink sandstone walls and yellow ashlar sandstone window surrounds and raised in-out quoins. The design differed slightly in the window surrounds. In the extensions these are all raised in-out ashlar in design rather than the architrave style found on the Villa. The second phase extension, constructed onto the east side of the Villa, is a single storey asymmetrical building with a half-hipped slate roof and dormer windows to the north and south elevations. The eastern half of the south elevation and most of the east elevation is masked by the third phase extension as it wraps around this end of the building. The eastern bay of the two bay north elevation of the second phase extension (Illus 13) is advanced and includes raised quoins to each side. One of the two dormer windows on this elevation has been converted into a fire escape door with a steel staircase attached to the outside of the building. All that is visible of the exposed south elevation is the single-light ground floor window and the dormer window above. To the north side of the east elevation the top north corner of a possible window or door surround was identified above the roofline of the third phase extension (Illus 14), although it was not clear what was represented here.

ILLUS 14 Detail of the possible masked window opening

on the east elevation of the villa extension

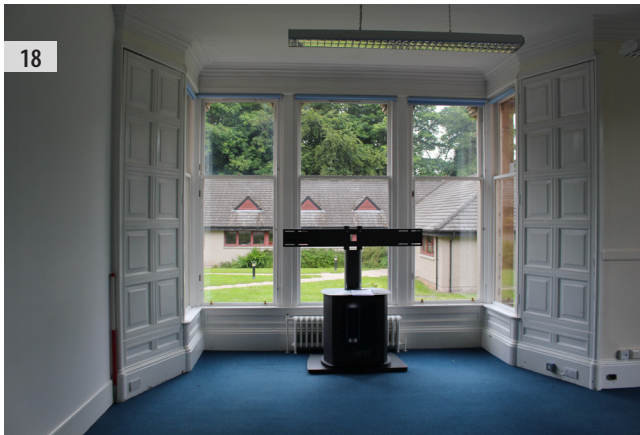
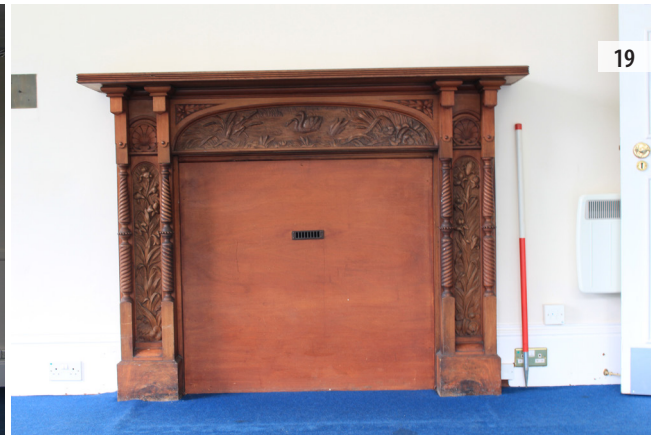
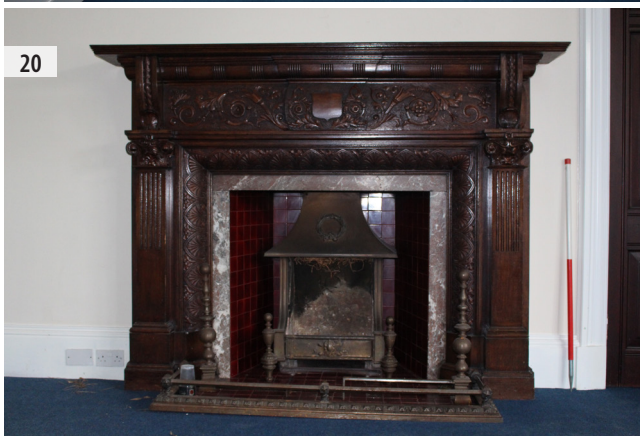
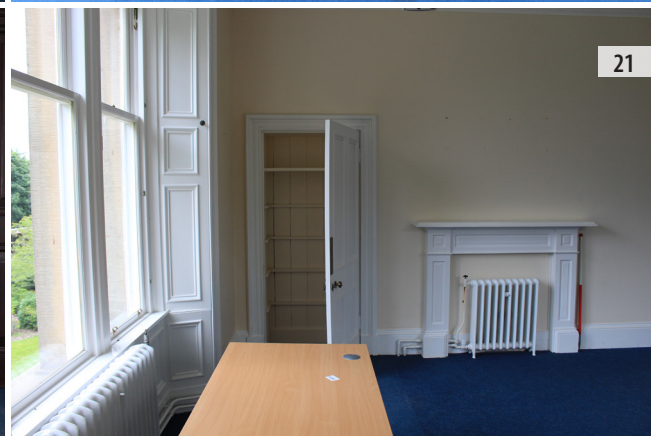
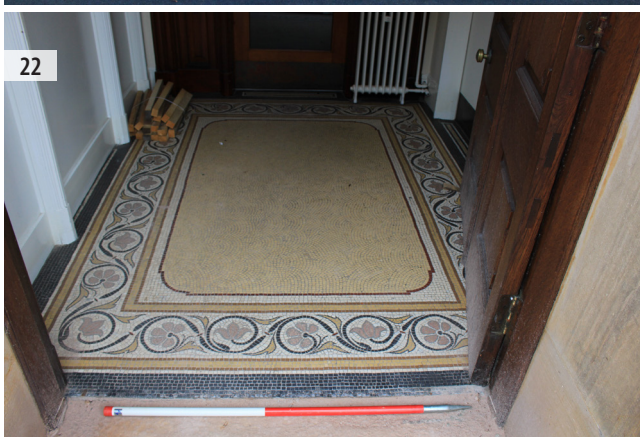
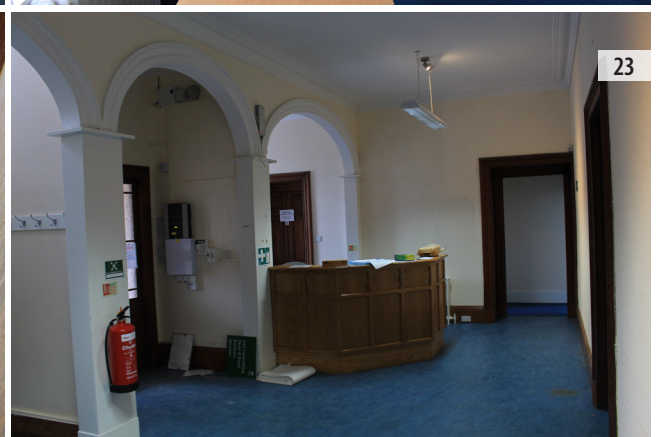
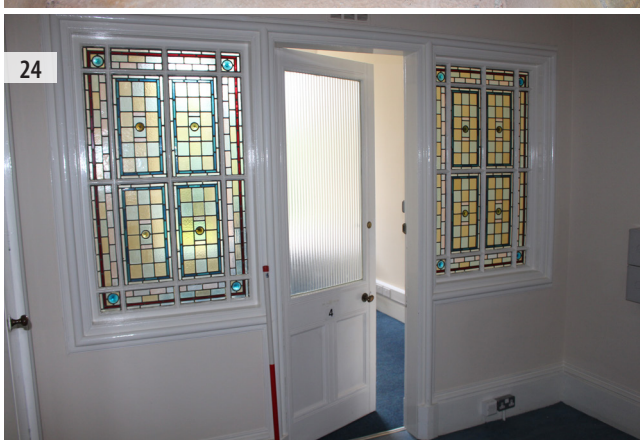
A recurring design feature identified throughout the rooms of the initial phase villa was the square timber panelling design found on all the recessed window surrounds. The two canted window bays in Rooms 5 and 6 displayed more extensive versions of this panelling (Illus 18). This design was also seen on many of the timber fireplace surrounds throughout the villa although the fireplaces in Rooms 5 and 6 are much more elaborate. In both cases the fireplace surrounds are highly decorated with floral carving predominant (Illus 19). The fireplace in Room 6 also includes an inset marble surround and red tiling fascia and floor (Illus 20). The fireplace surrounds in Rooms 21 and 22 on the upper floor also display a slightly higher level of decoration than was found elsewhere in the Villa (Illus 21).

Further original features include the mosaic floor located in the vestibule (Room 1) of the main entrance (Illus 22). The mosaic has a decorated floral design to the outer margins of the area. A timber and glass panelled inner door leads to the lobby (Room 2) from the

vestibule. A number of arcaded openings are present in the lobby which are repeated on the upper floor foyer (Room 17) (Illus 23). One of the arcaded openings leads to the main dog-leg staircase leading up to the first floor level. Some of the rooms (Rooms 6 and 8) on the ground floor provided evidence of the original layout of the villa whilst others had been altered. Modern partition walls divided Rooms 3, 4 and 5 with the remains of an original dividing wall projecting from the east and west walls of Room 2. A new dividing wall had also been inserted between Room 7 and a later phase staircase (Room 9), the original window in Room 7 continuing into the north wall of the staircase. An ornate glass panel partition wall is presented on the entrance to Room 7 although it was not clear if this was an original feature (Illus 24). The majority of the upper floor rooms seem to represent the original layout although a modern partition wall between Rooms 20 and 21 is a later alteration.

ILLUS 18 Detail of the window panelling in Room 5 **ILLUS 19** Detail of the fireplace in Room 5 **ILLUS 20** Detail of the fireplace in Room 6 **ILLUS 21** Detail of the fireplace in room 21 **ILLUS 22** Detail of the mosaic floor in the vestibule entrance **ILLUS 23** Arcaded openings in the Lobby **ILLUS 24** Detail of the partition wall entrance to Room 7

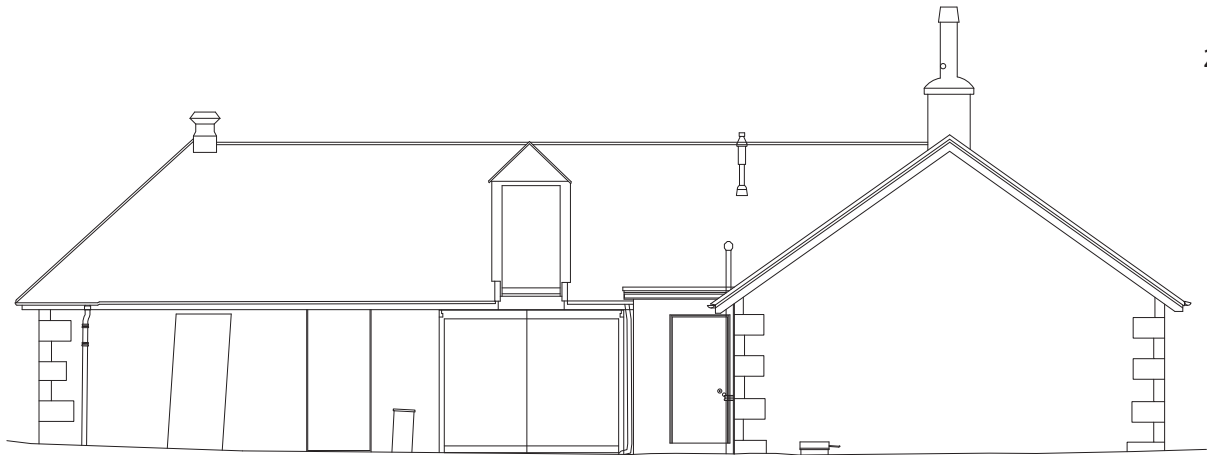
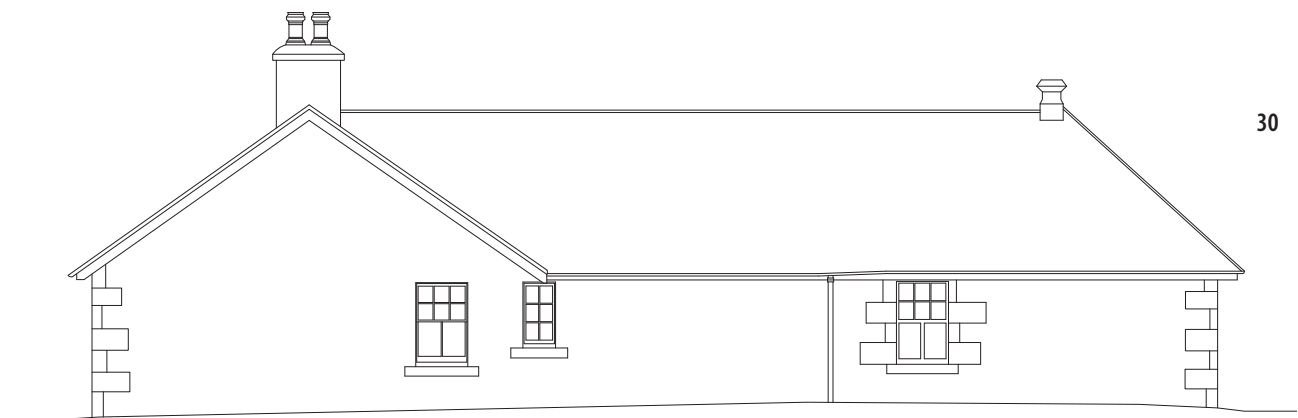
ILLUS 29 Measured survey of the south elevation of the Lodge **ILLUS 30** Measured survey of the north elevation of the Lodge

The stable block included a double timber door with a further dormer loading door above on the south facing elevation (Illus 29) plus a single timber door further to the west. The slate roof was hipped at the west end with three further windows on the north facing elevation (Illus 30).

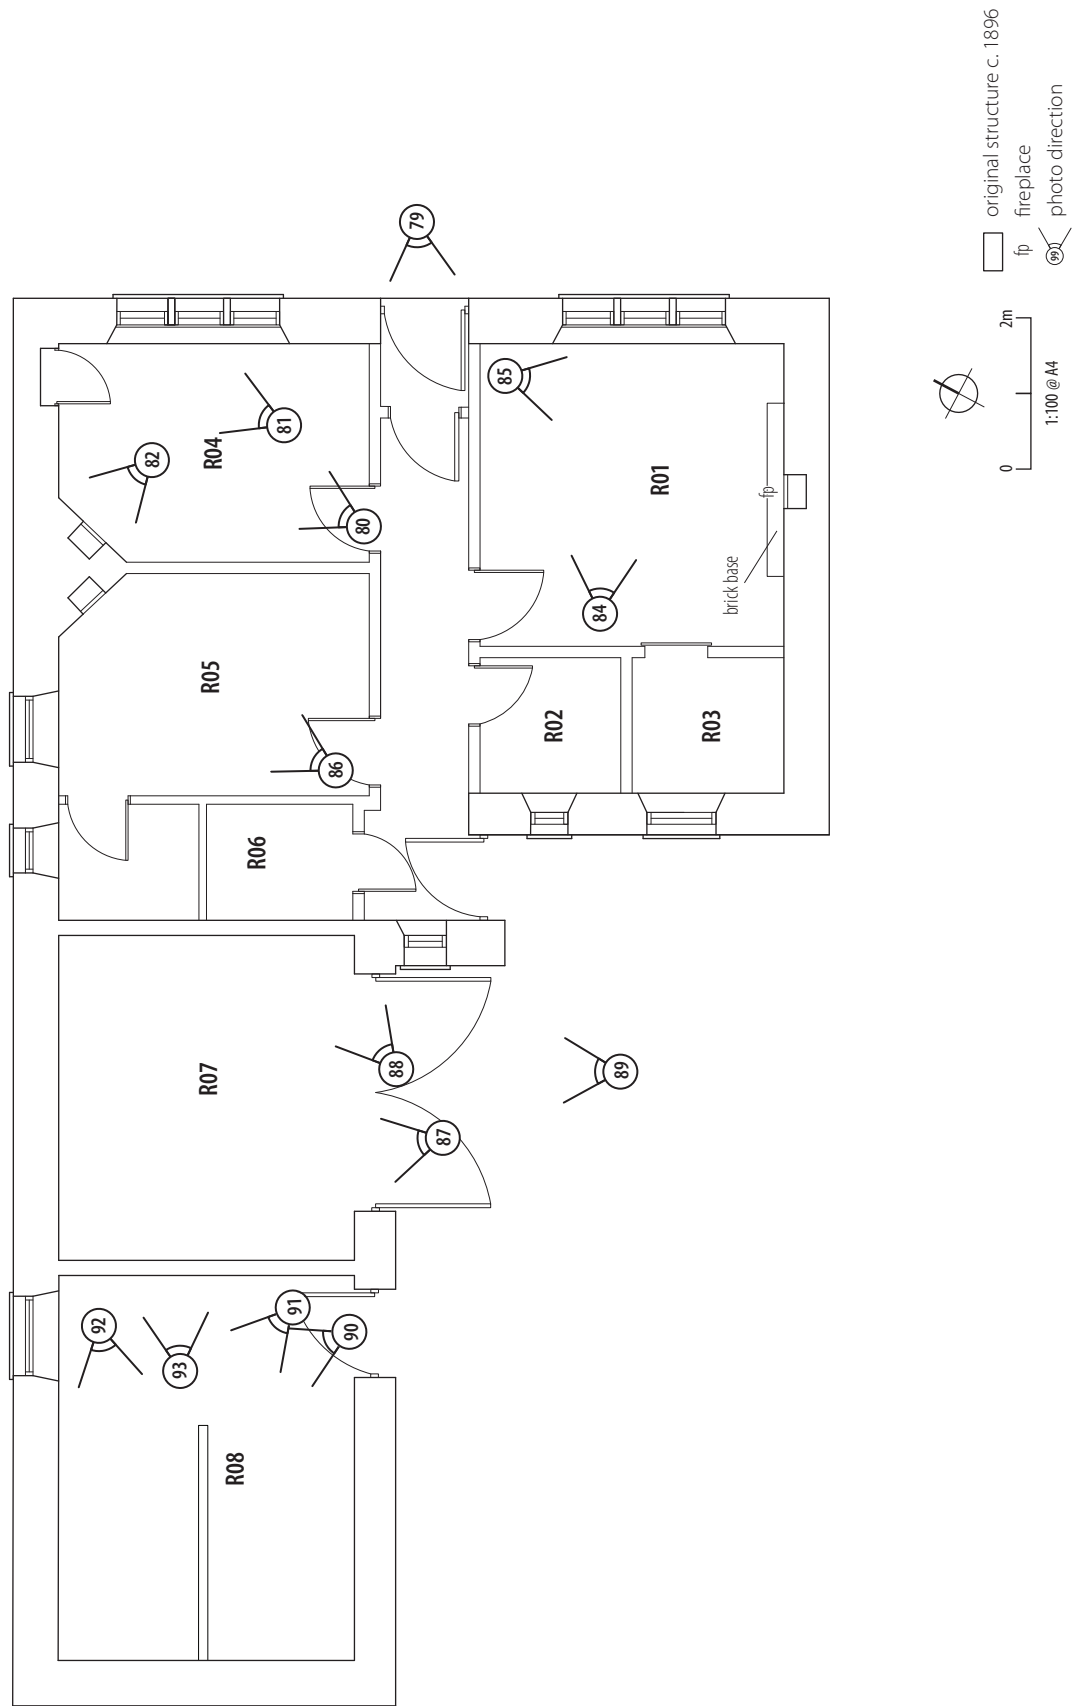
ILLUS 31 Plan of the Lodge and stables

The internal configuration of the house comprised three large rooms, a kitchen, a bathroom and two small storage rooms (Illus 31). The house had been fully modernised throughout with carpets, painted plaster walls and ceilings and modern fittings. The three fireplaces in rooms 1, 4 and 5 had been blocked although the plain timber surrounds survived. The stable block comprised two rooms divided with a timber partition wall. The east wall of the garage (Room 7) was constructed of brick with the stone wall exposed to the north. The stable (Room 8) included two stalls with a timber partition and wainscot panelling on the side walls (Illus 32). Both stalls incorporated iron feeding troughs to the west end although it was not clear if these were original. A timber ladder was located in the north-east corner of the room leading up to an attic storage space.

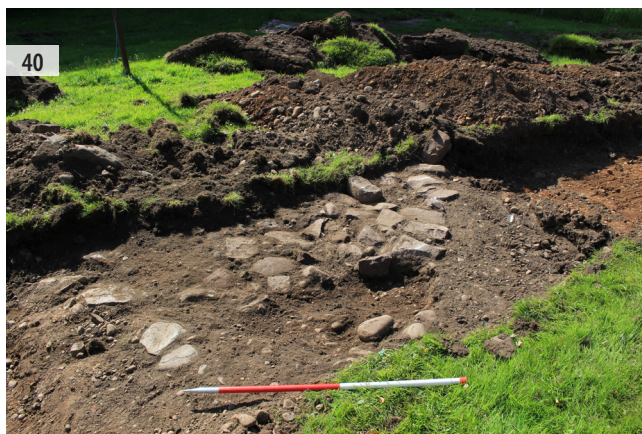
ILLUS 40 Detail of stone paving [1002]

Trench 1 was excavated in two halves due to a centrally located field boundary to the north side of the Lodge. Some subsidence was evident before trenching with the trench excavation revealing the existence of a modern drainage ditch running from the lodge across the trench. The only feature recorded within the trench was a stone constructed path [1002] (Illus 39). This was located 2m north of the drainage ditch, aligned north-west/south-east. This path comprised a single course of poorly sorted stone slabs with no visible bonding material identified. Some evidence of disturbance was clear on the south-western edge. The path ran towards the corner of the Lodge, suggesting it related to this building. In addition, it ran towards a break in the field boundary to the north-west.

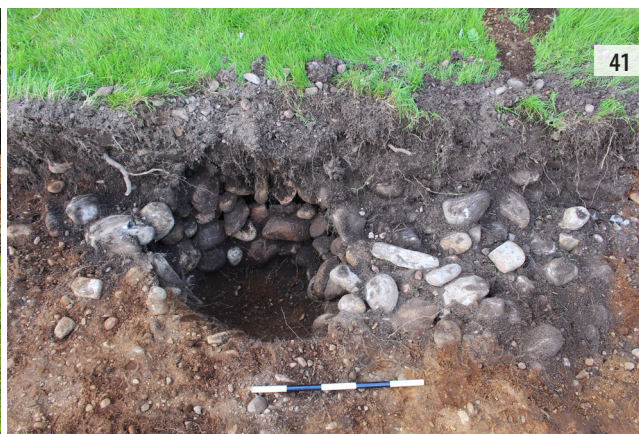
ILLUS 41 Detail of the cobble-filled soak-away pit [5002]

A single cobble-filled pit [5002] was located at the northern end of Trench 5 (Illus 40). The exposed extent measured 1.7 x 0.55 x 0.48m although the pit continued beyond the western edge of the trench. The steep sided pit contained a concentration of rounded cobbles within a loose dark grey sand matrix. The loose fill indicating the pit was most likely a 19th or 20th century feature such as a soak-away relating to field drainage, however no dateable material was present.
