Laggan Water Main

Archaeological Survey

December 2006

Report No.	HAS070309
Site Code	HAS/ LWM06
Client	Halcrow Group Ltd
Planning Ref	N/A
Report Date	21 March 2007
Authors	Mary Peteranna and John Wood

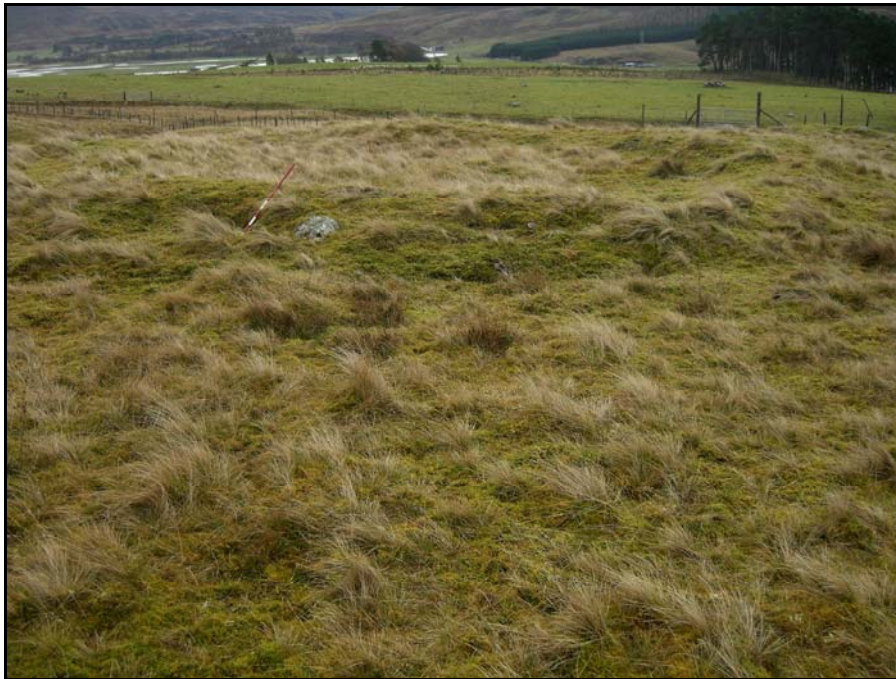
Figure 4 Feature [1]

Feature [1] (SMR NN69SW0022) was clearly visible (See Fig 4 below). Although the grid reference has been slightly relocated from the previously recorded position as a result of this fieldwork, it was safely clear of the area to be dug for the pipeline trench. The landscape west of Feature [1] is covered by multiple small clearance cairns, but all are well clear of the trench.

Both these features were marked with canes and yellow tape, and the areas of interest were discussed with the site agent from Scottish Water. Because the proposed trench was approximately 0.30 m wide, the areas of interest are clearly out of danger from destruction. An area east of Feature 1 and an area west of Feature 2 were marked off to safeguard them. There is ample room on the site for the trench to remain well clear of these features and they are not in danger of being destroyed.

1. The client was advised to avoid the marked-off areas around Features [1] and [2] to help ensure their preservation.
2. No further action is proposed along the proposed pipeline trench.

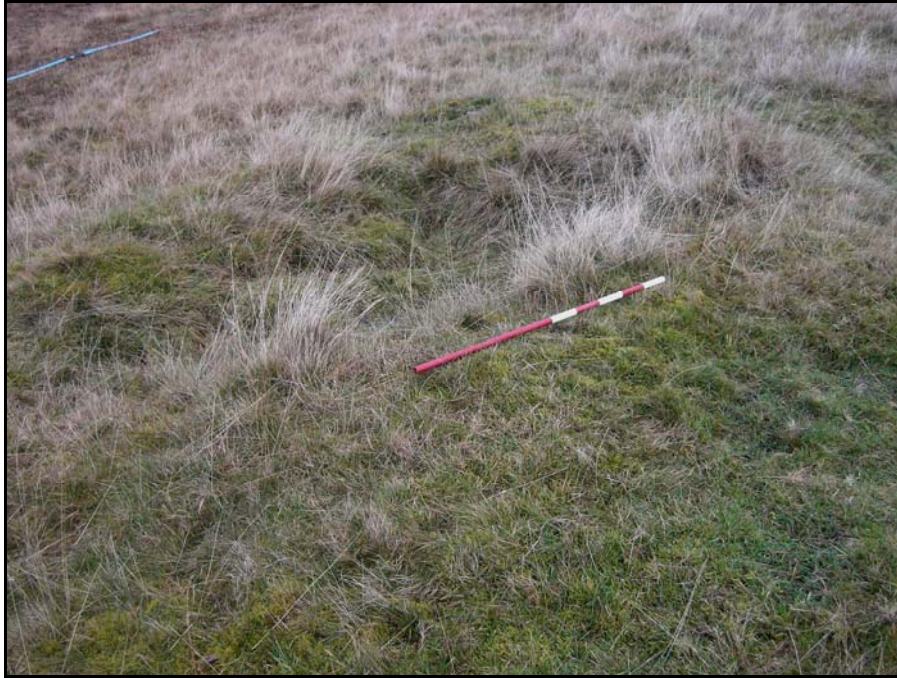
Figure 5 Feature [2]

Feature [2] had not been recorded previously. It was located between the trench line and the river, approximately 75 metres from the Water Treatment Works. The structure was sub-circular, measuring approximately 5 metres by 3.5 metres, and interpreted as a possible corn kiln (See Fig 5).
