New Access Track at Land 100m NE of Ash Cottage, Struy, Strath Glass, Inverness-shire

Archaeological Walkover Survey Report

May 2020

AOC Project Number: 70494

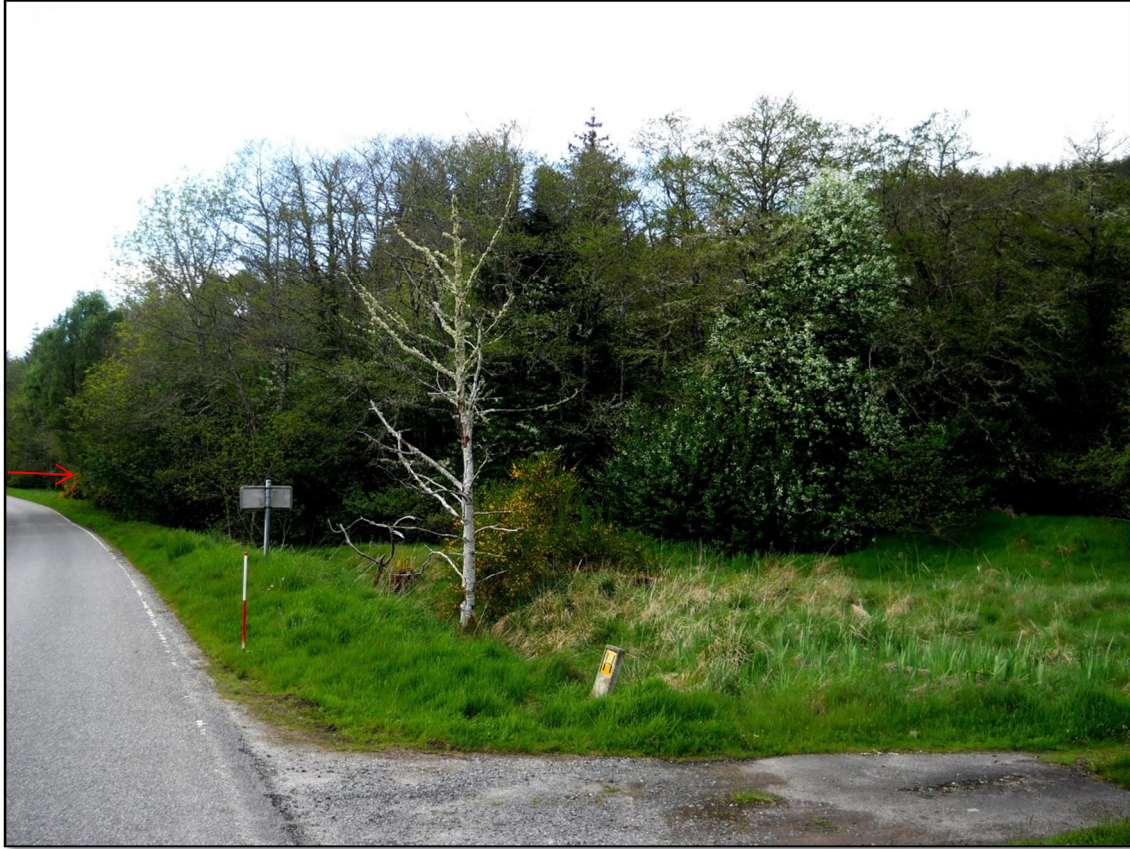
Plate 1: View SW over the roadside section of the survey area and access to the old school (red arrow shows access point for track)

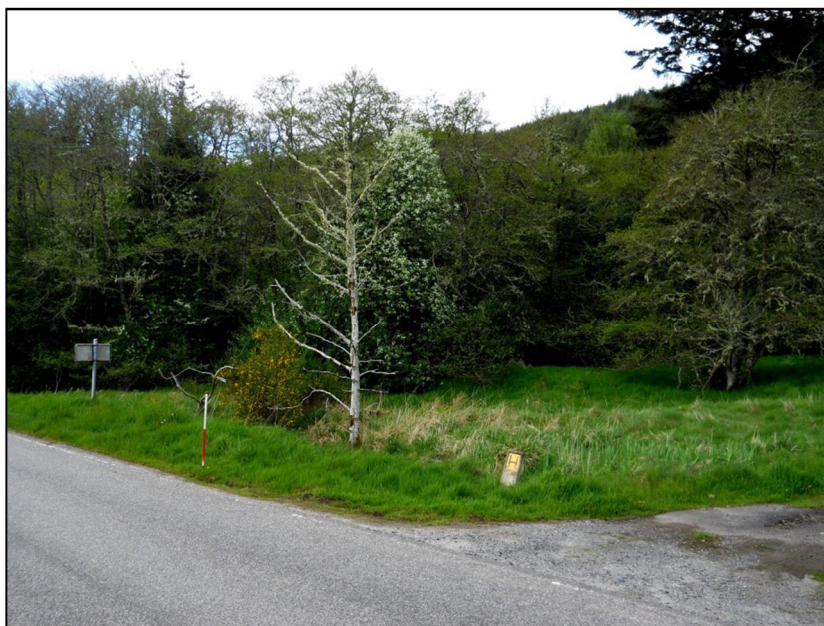
Plate 2: View WSW over the NE sector of the survey area and access track to old school

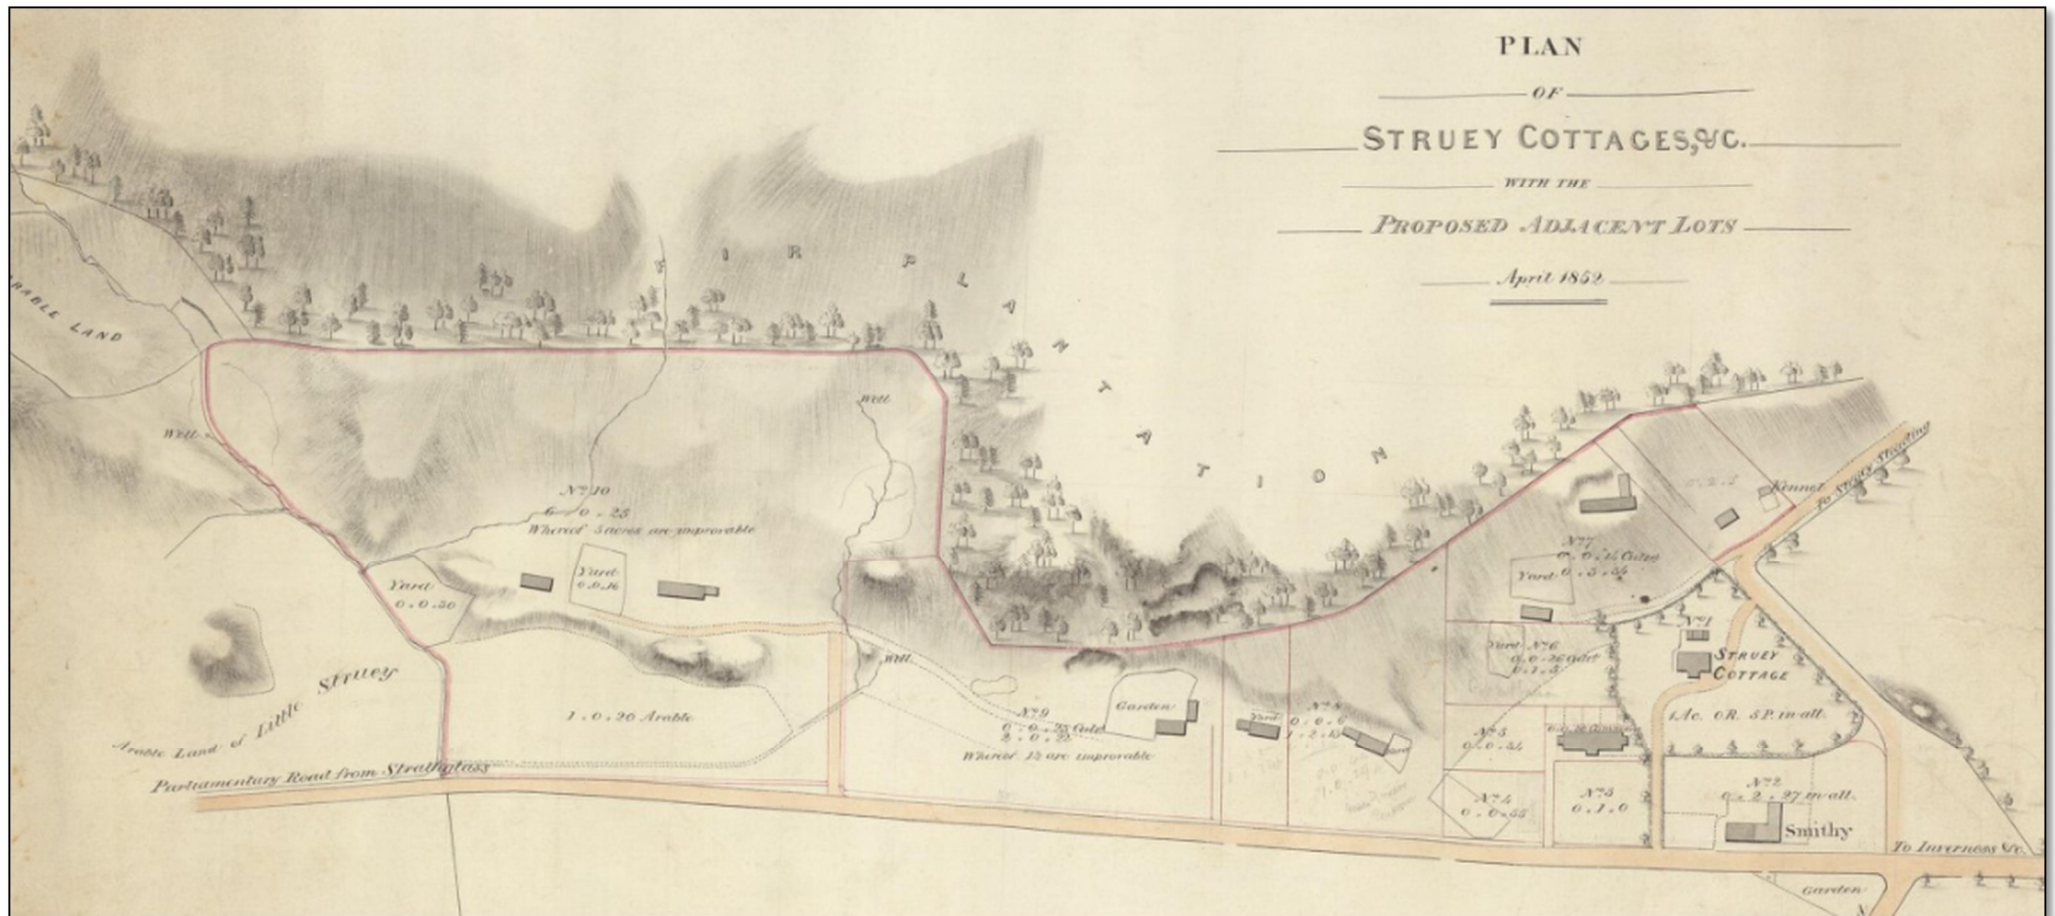
This Lovat Highland Estate map (**Figure 2**) shows the lower section of the survey area under arable lands, with a major boundary shown passing through the area, dividing the main settlement of Struey from the arable lands of Little Struey. A small enclosure is shown extending off the NNE side of the boundary, with two roofed structures and a second small enclosure located between them. A track is shown running NE from the second enclosure and providing access to the two buildings. The building closest to the major estate boundary (shown in pink) and located between the two yards is in the approximate position of the Old Schoolhouse shown on the 2nd Edition OS map sheet (**Figure 5**).

Figure 2: Plan of Struey Cottages with the Proposed Adjacent Lots, 1852 – Lovat 281 – after Lovat Highland Estates and North of Scotland Archaeology Society (© NLS Edinburgh)

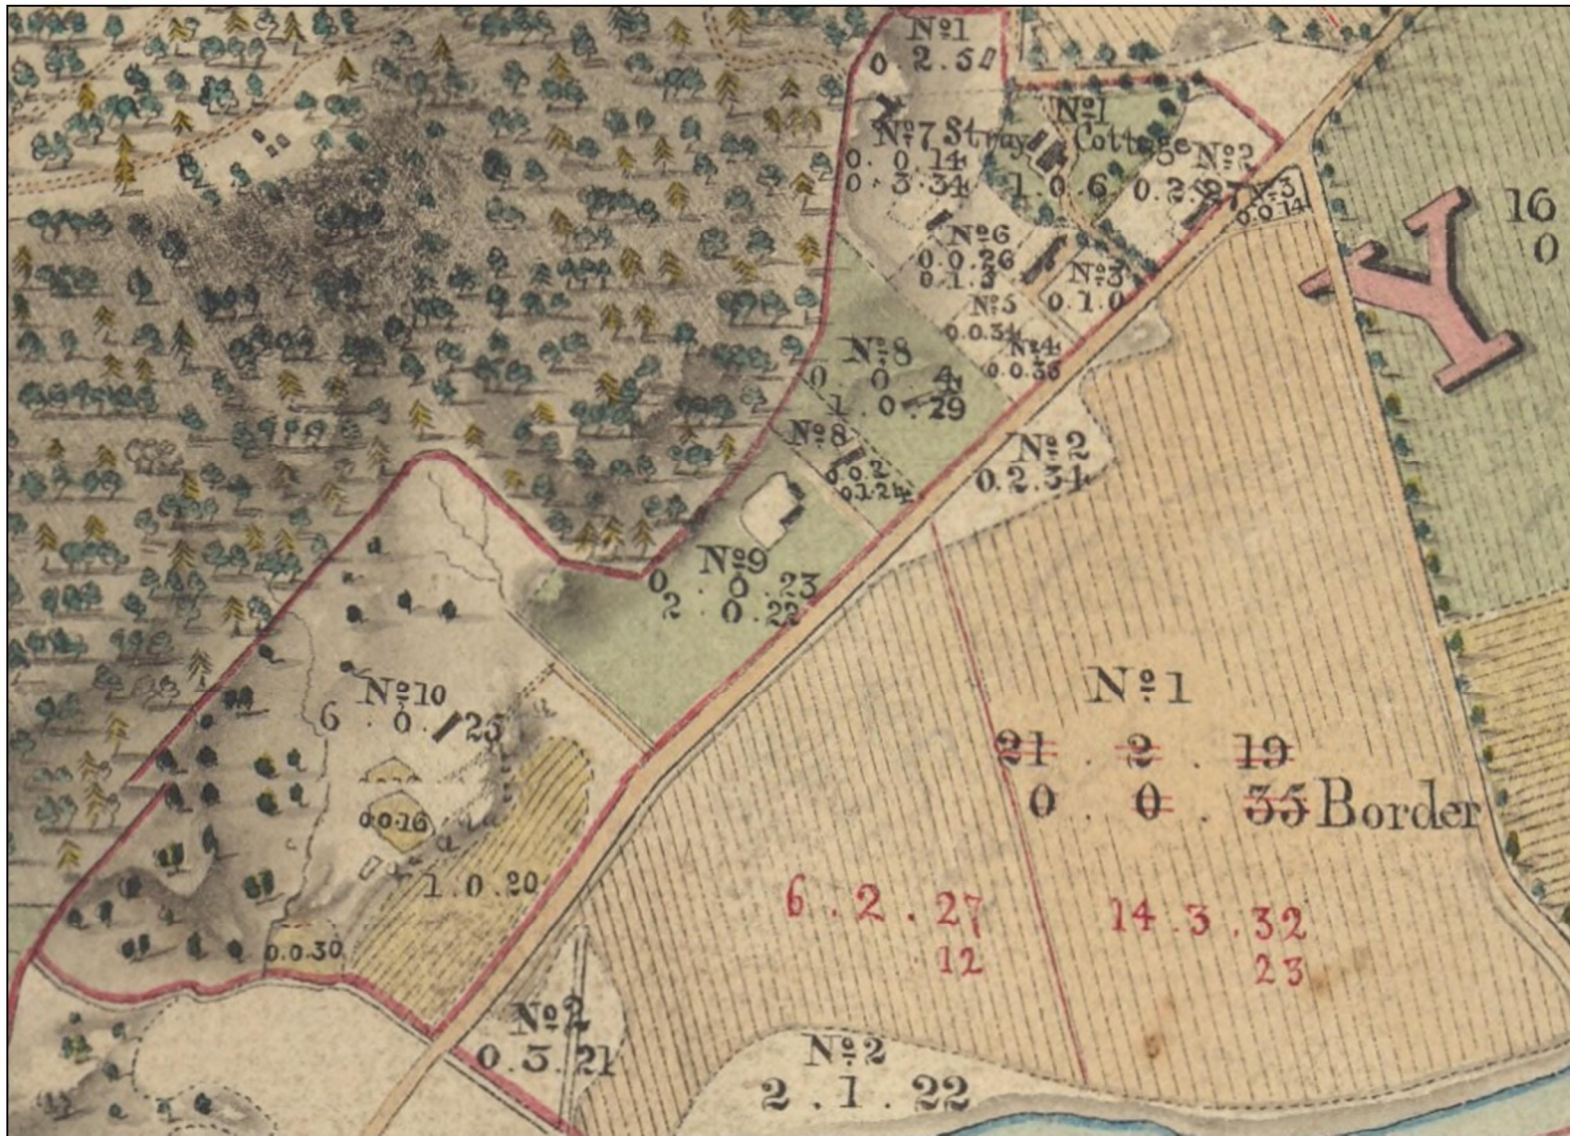
This estate map (**Figure 3**) shows similar detail to (a) above, although the south westerly of the two structures is now shown abandoned and without a roof.

Figure 3: Extract from 'Plan of Estate of Struy Situated in the Parish of Kilmorack, the Property of the Right Hon Lord Lovat', 1853 – David Gordon – after Lovat Highland Estates and North of Scotland Archaeology Society (© NLS Edinburgh)

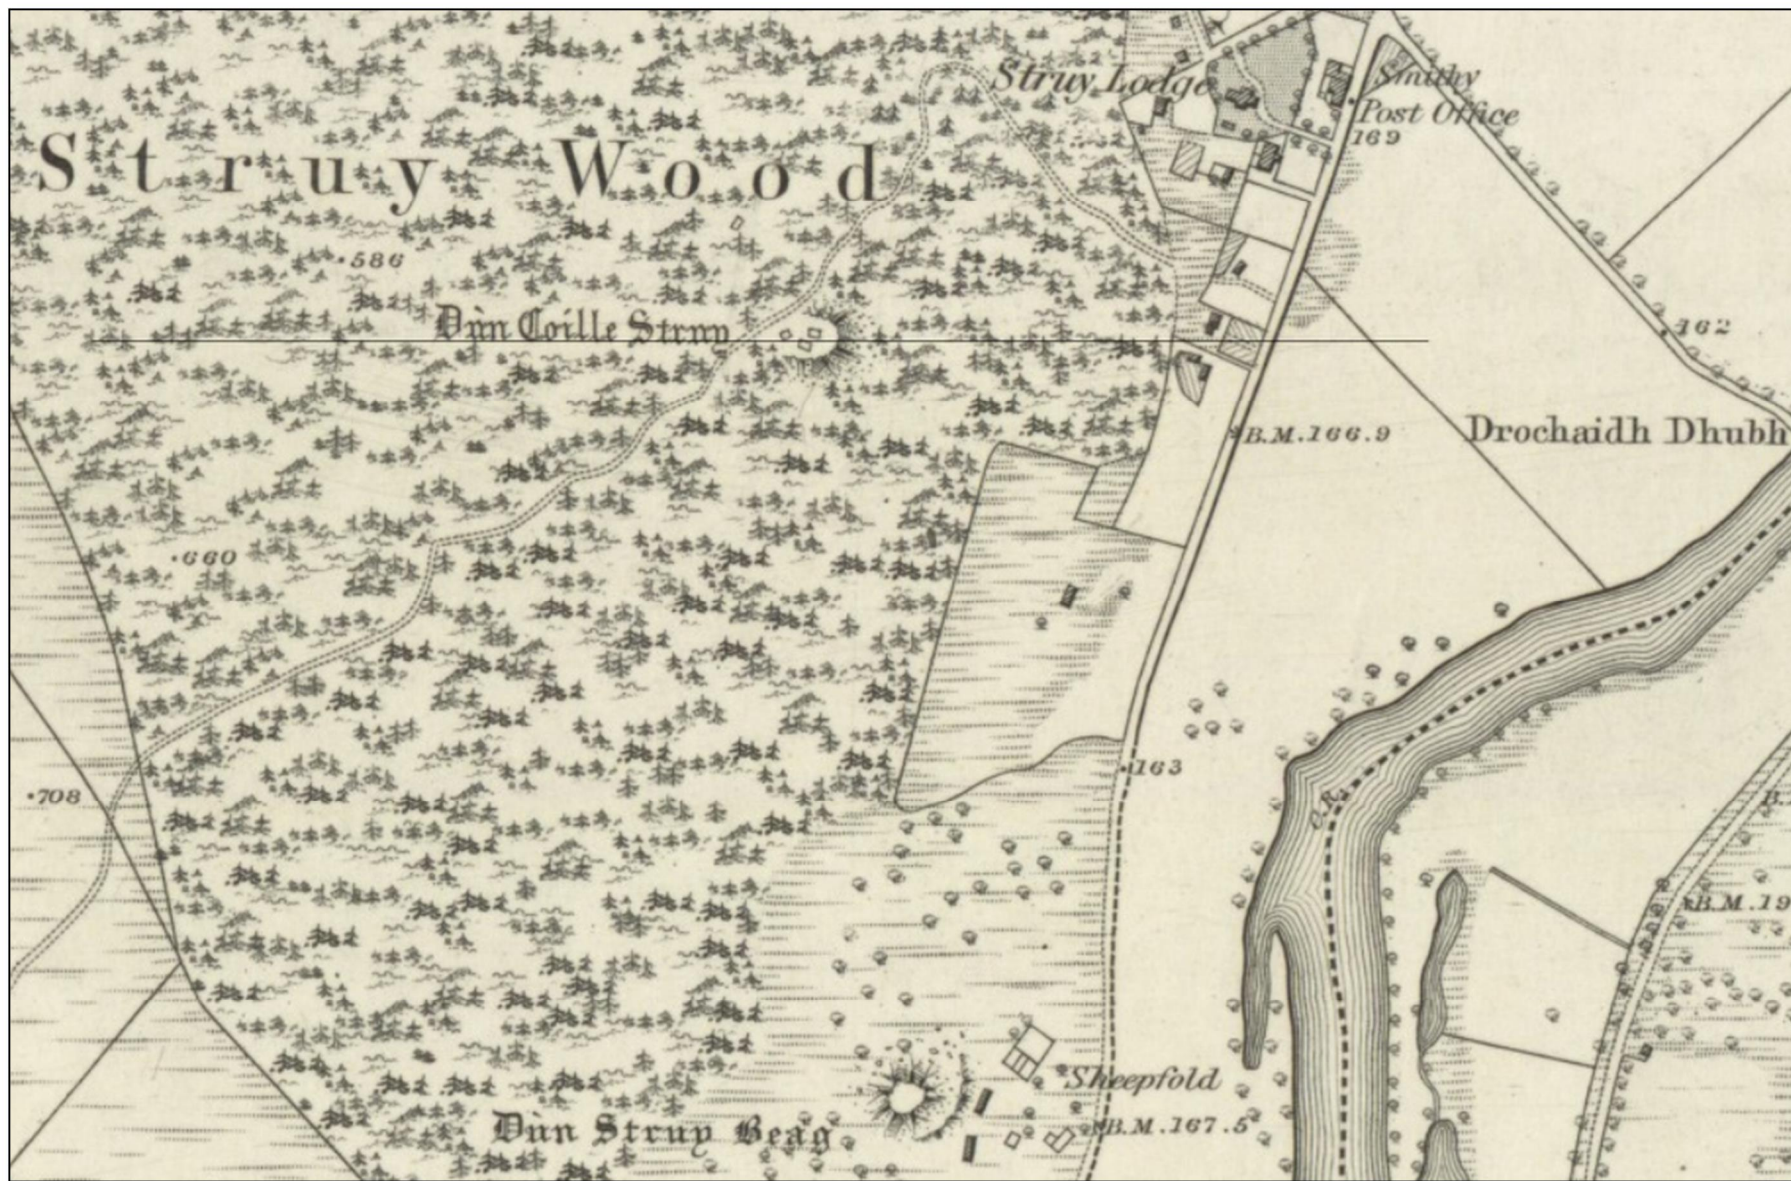
The map excerpt (**Figure 4**) shows open ground, defined by the major boundary to the SW, but does not show the roofless and abandoned structure shown in estate map (b) above. The roofed structure to the NE is still shown. The area shown to the NE of the boundary is depicted as open ground, while that to the SW is shown under open deciduous woodland.

Figure 4: Extract from the First Edition Ordnance Survey map, 1872 (© NLS Edinburgh)

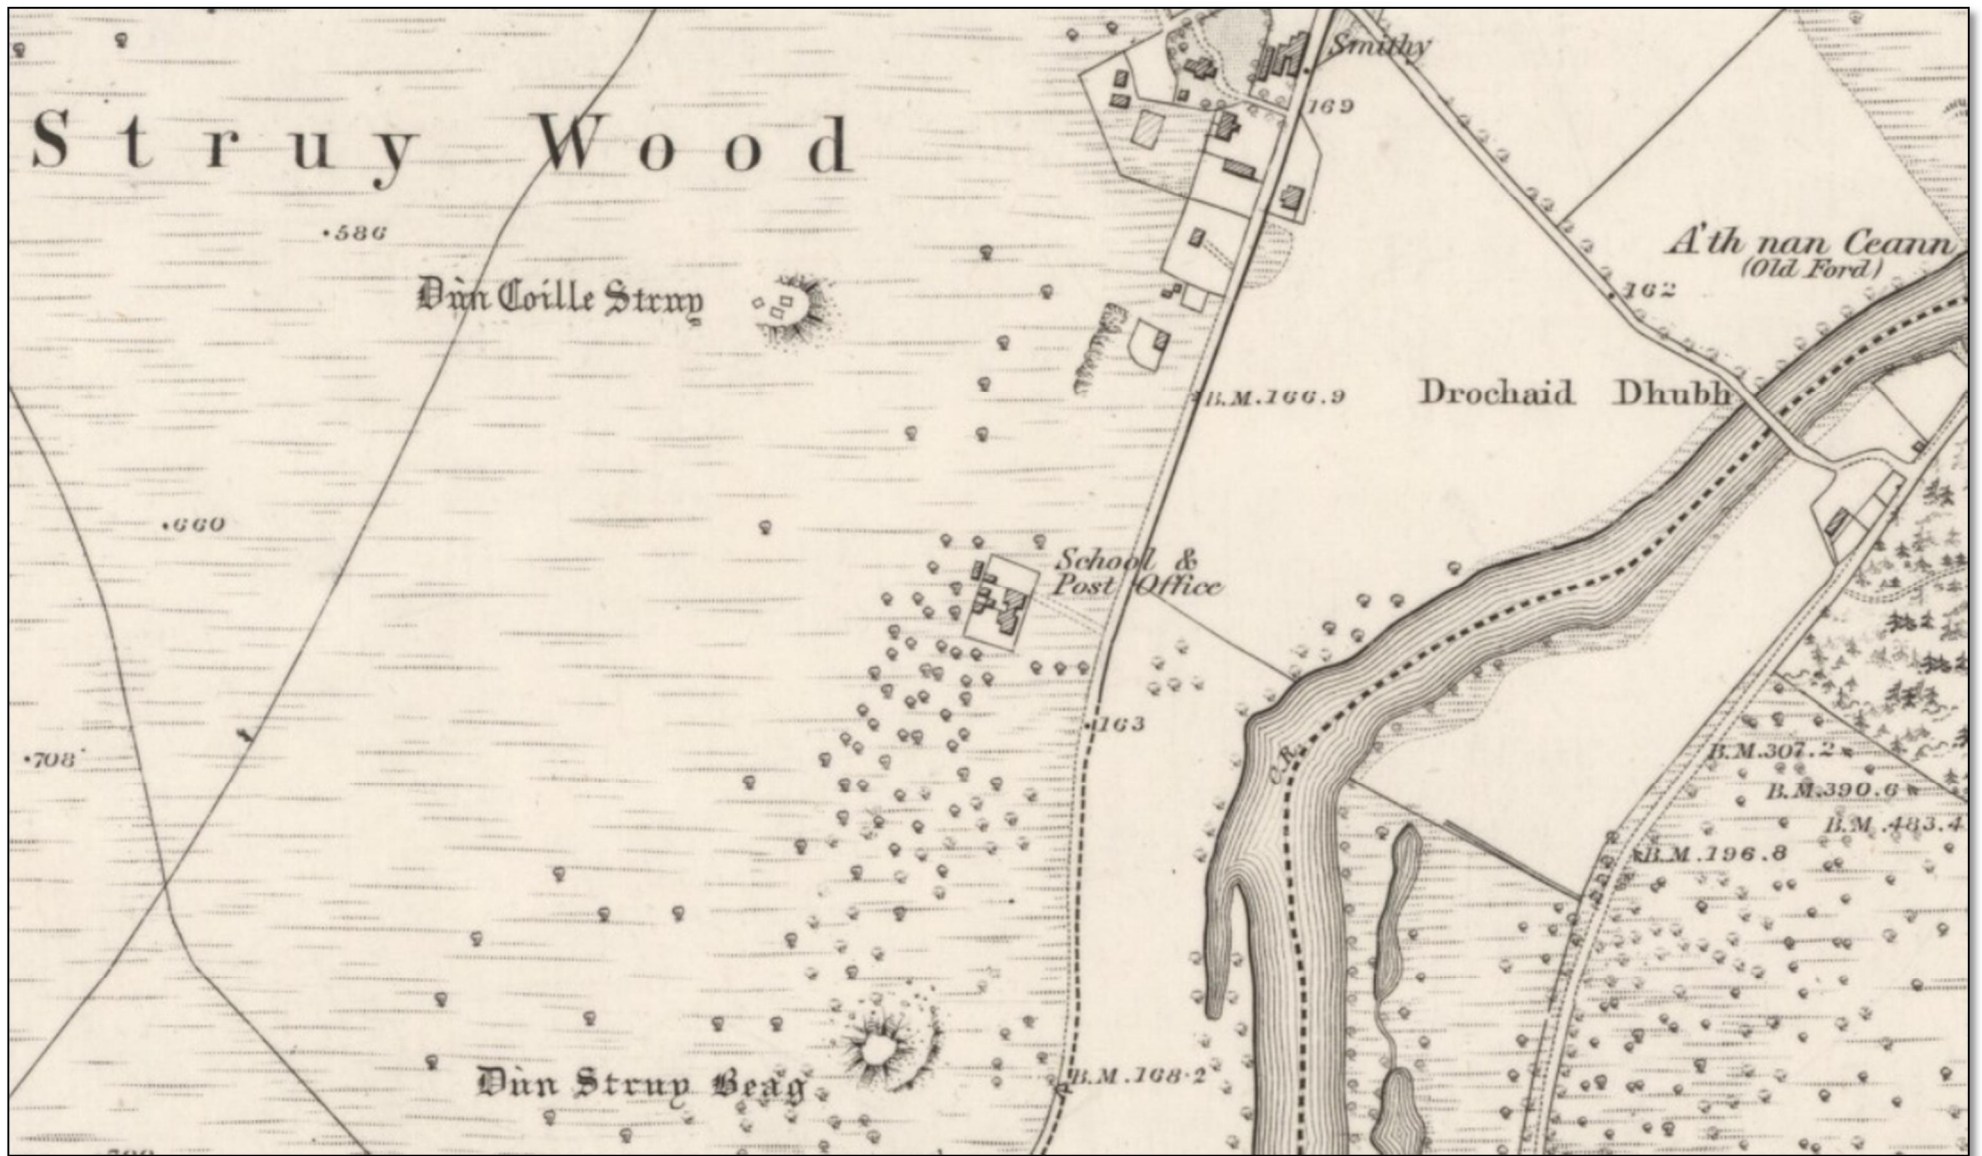
On the 2nd edition OS map (**Figure 5**), the school and post office is shown at the end of a short track leading off the NW side of the main road. The remainder of the survey area is shown under open deciduous woodland.

Figure 5: Extract from the Second Edition Ordnance Survey map, 1901 (© NLS Edinburgh)

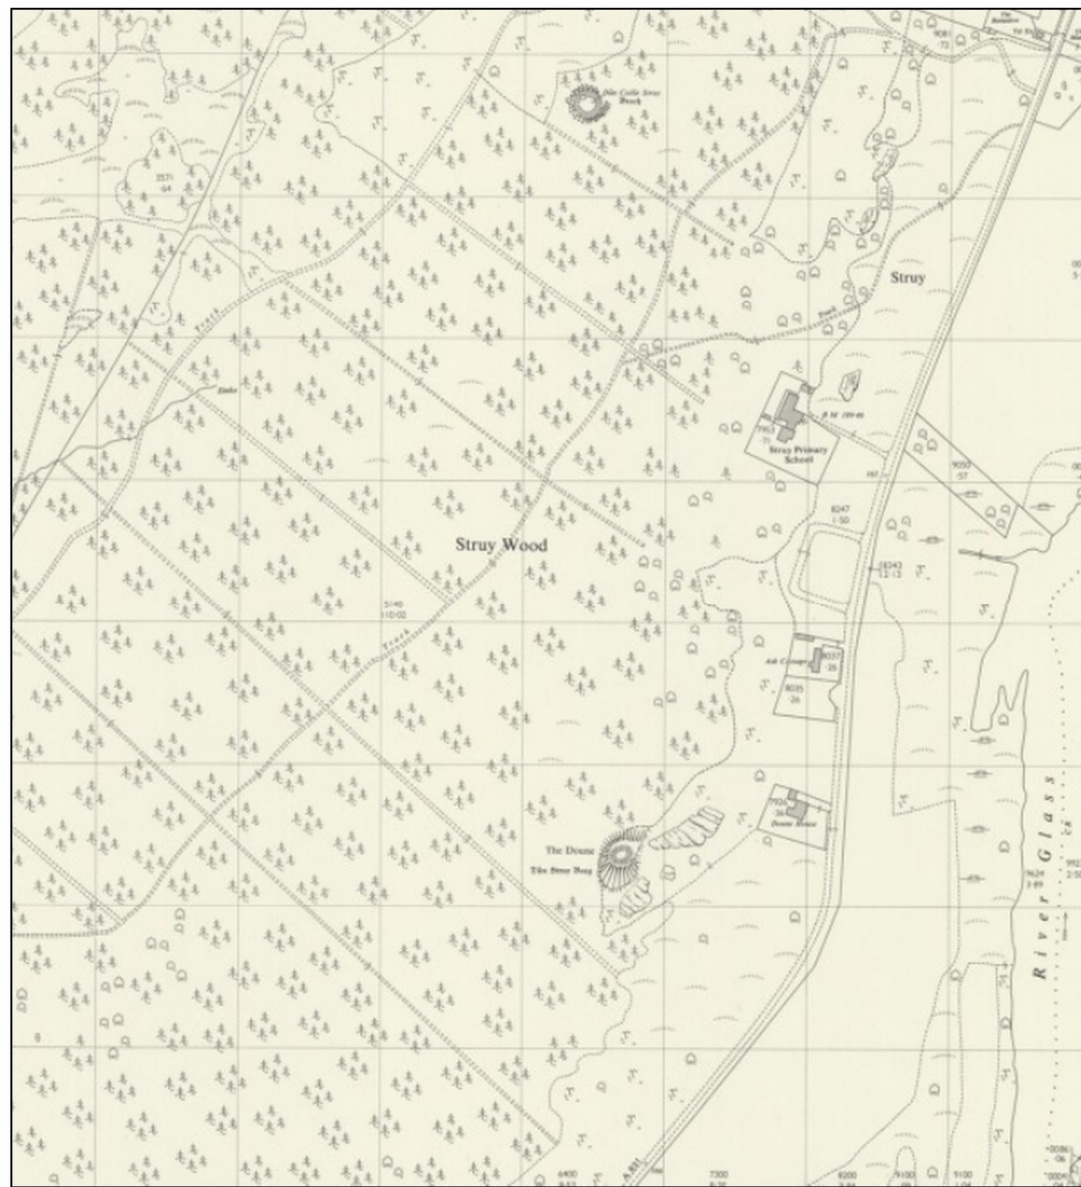
The 1966 map excerpt (**Figure 6**) depicts the Struy Primary School, while Ash Cottage and its associated garden/enclosure are shown at the SW end of the survey area. Narrow tracks link the school and Ash Cottage, along with other settlement and Dun Struy Beag. The most striking feature on this map is the u-shaped layby-type feature running off the NW side of the A831 road. This is the main feature recorded within the survey area (see Section 5).

Figure 6: Extract from the 1:1250 Ordnance Survey National Grid Map NH3939-A, 1966

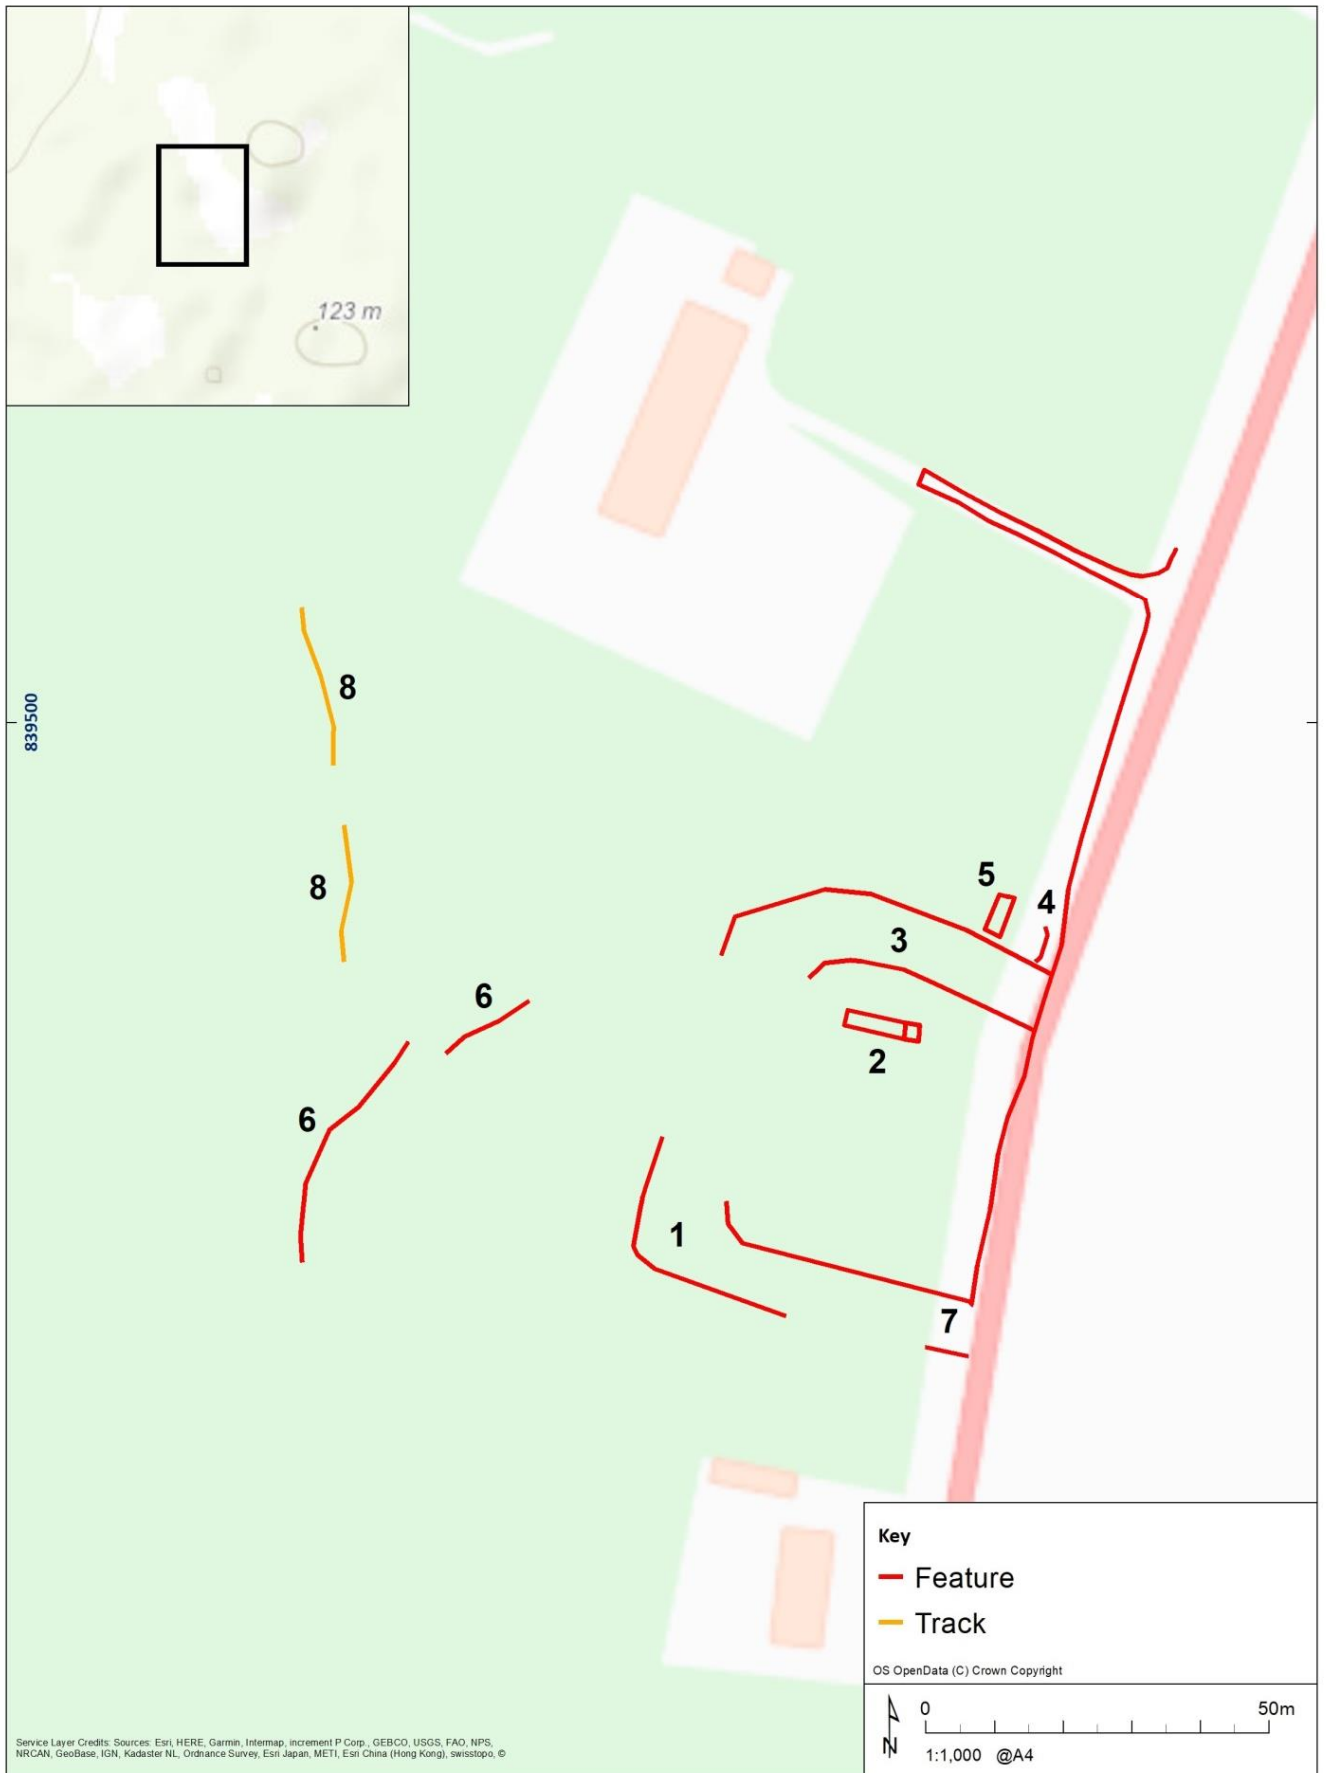
Figure 7: Survey results and site numbers

- 5.1 The walkover survey was undertaken on 26th April 2020 in generally sunny conditions with some cloud, and excellent light levels. The results are shown in **Figure 7** with full details of the survey photographs and the archaeological sites in **Appendices 1 – 2**. The landscape within the lower SE half of the survey area comprises low-lying and undulating ground covered with deciduous trees, low shrub, long grasses, nettles and bluebells. The area also contains some small open glades within the trees, while the area also includes some wet ground. To the NW, the ground rises sharply below mature coniferous woodland, with shallow ravines and valleys with small braided stream courses. The areas below the conifer trees contain little understorey vegetation, but have been heavily disturbed in the past by afforestation activities including the planting of trees. However, this area also includes small, open glades containing small shrubs, deciduous trees and grasses . especially adjacent to the stream courses.

- 5.2 The majority of the sites and features recorded during the survey are located on the lower, level area of ground under deciduous woodland. These include a roughly u-shaped, flat-topped platform (**Sites 1, 3 and 7**), which is in places revetted with stone. The stone contains relatively modern rubbish including corrugated iron sheets, scrap metal, and the degraded remains of a wheeled trailer. The u-shaped feature runs off the road and corresponds to the detail shown on the Ordnance Survey Grid Map NH 3939-A (**Figure 6**); a former layby that housed caravans and temporary accommodation for people working on the construction of hydro-electric dams and their associated infrastructure during the latter half of the 20th century (Phil Lycett *pers comm*).

- 6.2 The main group of sites including the layby platform and associated drainage features most likely relate to a temporary occupation site for people working on the Affric-Beaully hydro-electric scheme. The NE arm of the layby was constructed on the SW side of boundary dyke Site 6 (outside the boundary of the Struy Township) and destroyed most of this feature in this area. The stream running down the side of the old dyke and layby platform here runs under a culvert (Site 4) below the A831 road, while the concrete slab (Site 5) was used to bridge the stream immediately to the N of the layby. The layby is depicted on the plan of recorded sites (**Figure 7**) with numbers 1, 3 and 7.

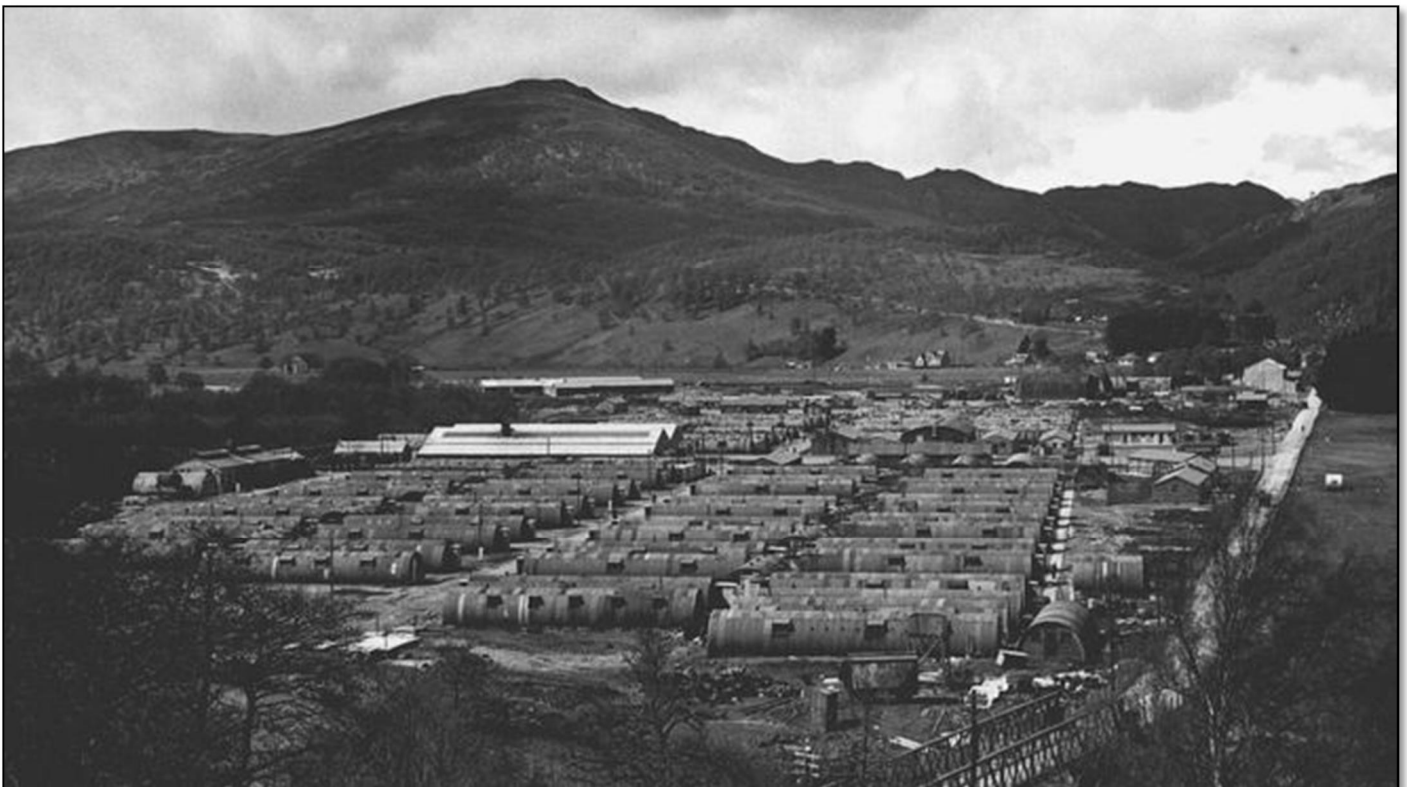
*Figure 8: Workers camp at Cannich at the time of the hydro-electric construction works c.1948-50
(© Strathglass Heritage Association)*

- 6.3 During the second half of the 20th century the dawn of hydro-electric power saw the construction of dams, power stations and tunnel networks in the surrounding glens and along Strath Glass. With the coming of the hydro scheme life in Strathglass, and in particularly Cannich, was changed significantly. Previously the village only had a scattering of small dwellings. Suddenly in the late 1940s the population increased greatly, with an influx of workers resulting in the population swelling to over 2000 at its peak. Cannich was the site of the main camp that housed the construction workers (**Figure 8**), with much of the temporary accommodation focused on old Nissan huts previously used in concentration camps during the Second World War. Permanent housing was also required for the people who would maintain the scheme long after the construction workers had gone.

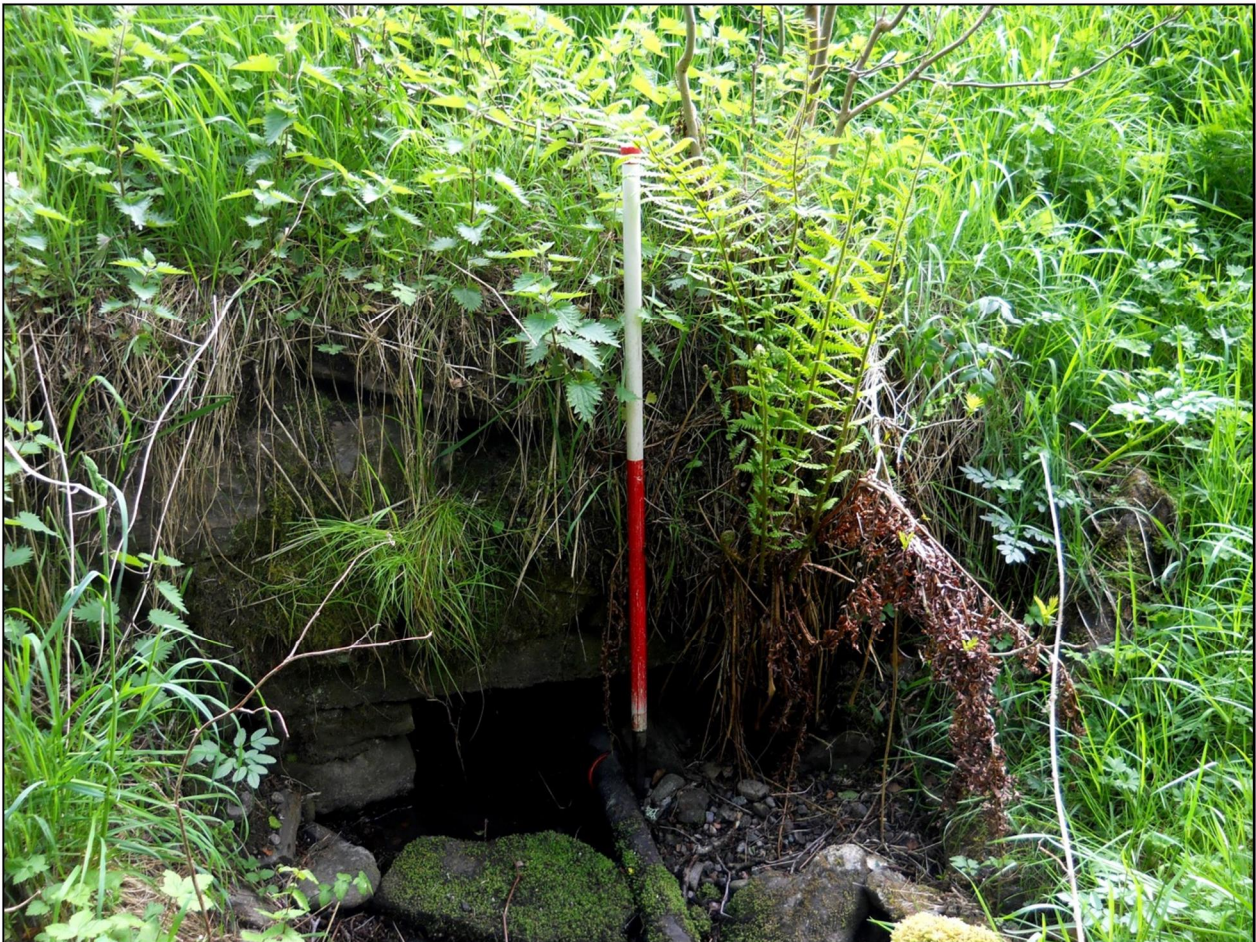
- 5.3 During periods of wet weather, especially during the winter months, this low-lying area of ground adjacent to the layby is prone to flooding. Attempts to alleviate these issues included the excavation and construction of a series of drains within the u-shaped area of ground. Features associated with the drainage infrastructure include a drainage channel and square, concrete-lined access chamber (**Site 2**) with drainage pipes accessible in its base; and a long concrete slab (**Site 5**) bridging a shallow stream channel running around the perimeter of the layby platform (to the NE of Site 3). Just to the ESE of the concrete slab (Site 5), the water from the shallow stream course enters a stone-built culvert (**Site 4**) running below the A831 road.

Plate 3: Stone culvert (**Site 4**) and iron pipe running under A831 road

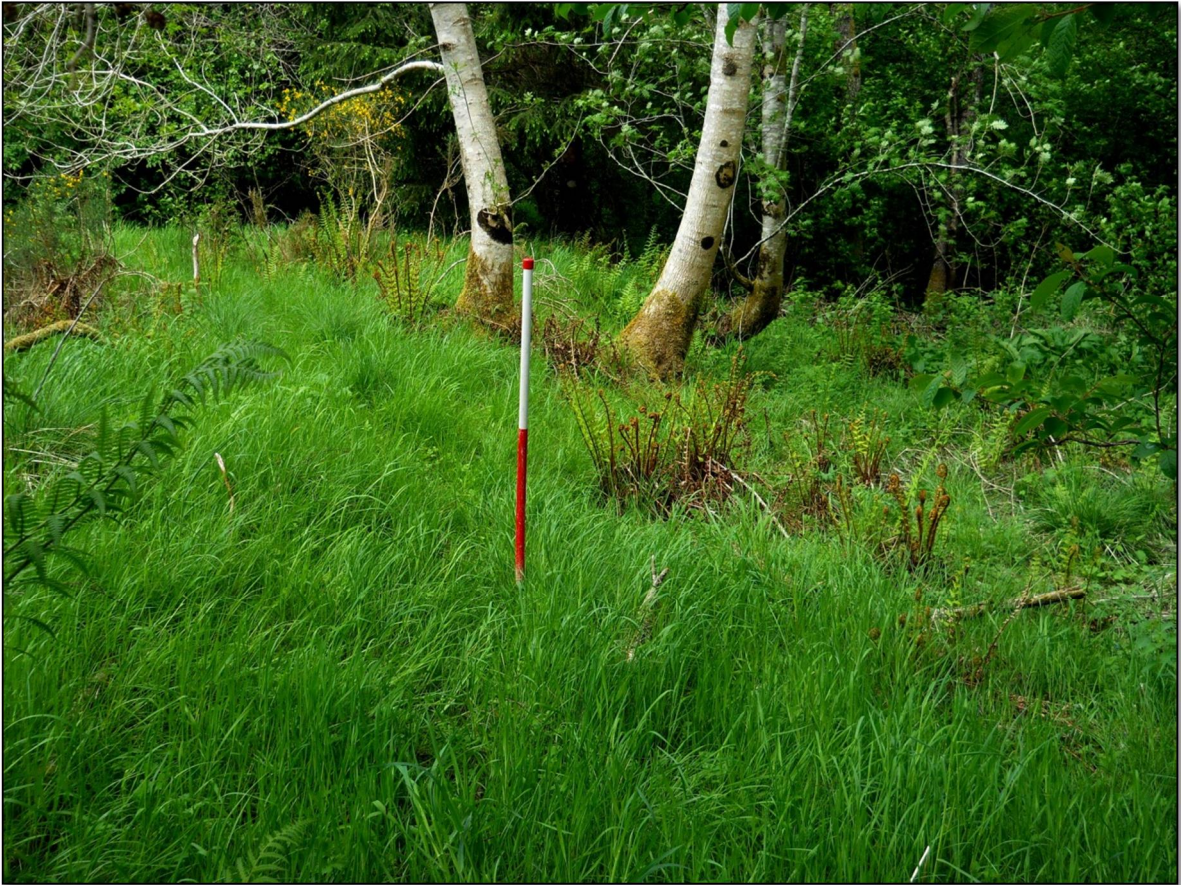
Plate 4: View W showing N edge of layby platform falling into low-lying ground

- 6.4 The proposed first section of the access track running WNW off the A831 road and the turning area segment running SSW, generally follow the course of the NE half of the u-shaped layby (**Site 3**). The utilisation of this raised feature, with its underlying stoney base, avoids the wet ground conditions within this low-lying sector of the survey area. The proposed access track will directly impact on this feature, but due to its relatively recent construction, it is recommended that no further archaeological input is required. The use of the raised layby feature will also negate any impacts on the surrounding/underlying natural ground surface and any potential buried archaeological features or deposits; although it is highly unlikely that settlement remains exist in this area.

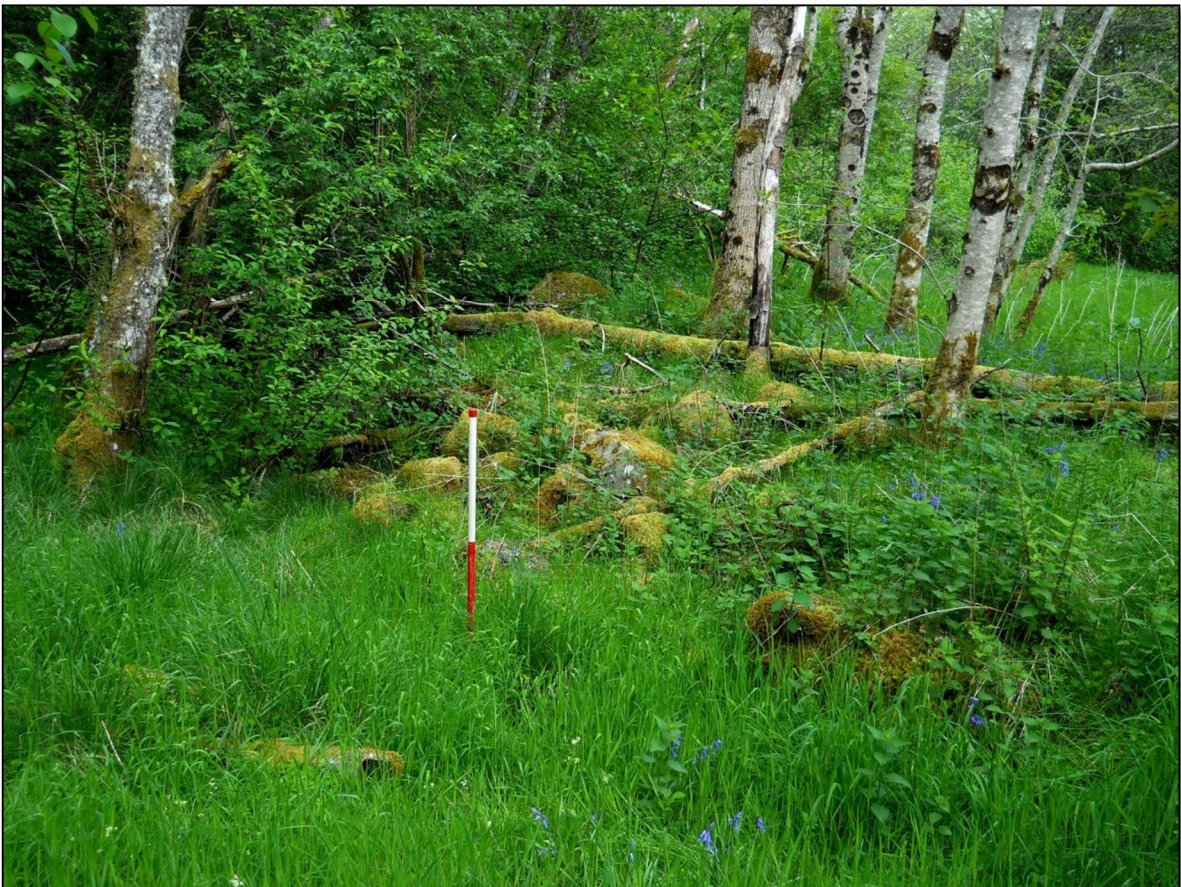
Plate 5: View N showing stone-revetted outer edge of the layby platform

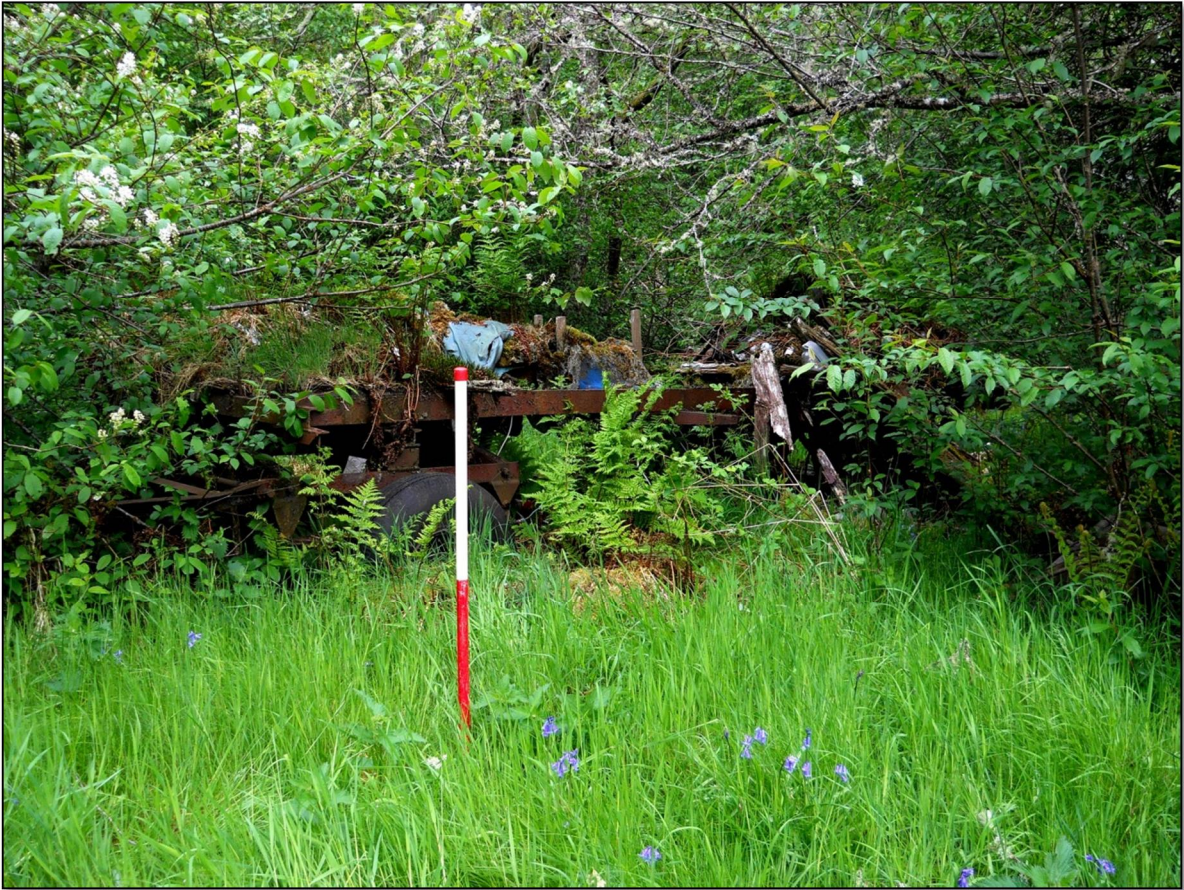
Plate 6: Old wheeled trailer and associated rubbish located at edge of u-shaped layby feature

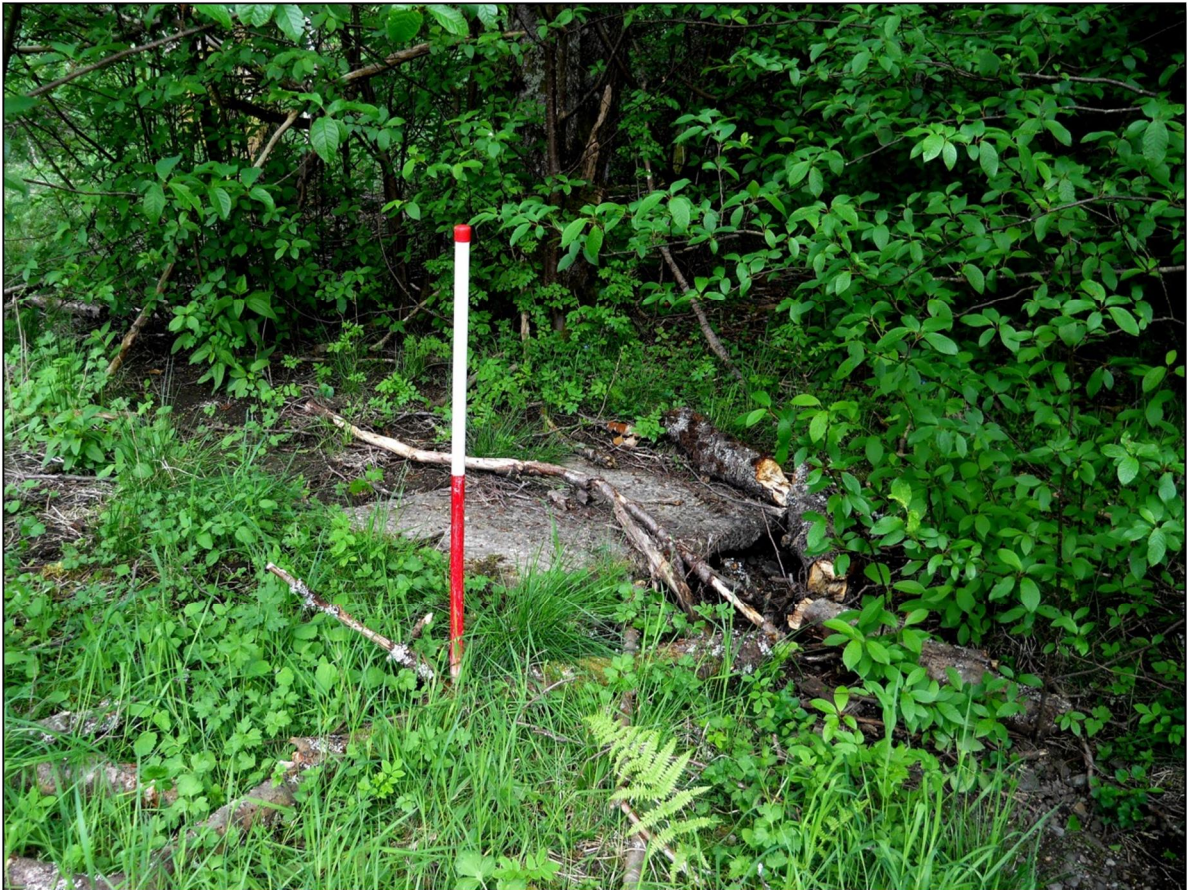
Plate 7: Concrete slab (Site 5) bridging shallow stream course – looking N
