New Access Track at Land 100m NE of Ash Cottage, Struy, Strath Glass, Inverness-shire

Archaeological Walkover Survey Report

May 2020

AOC Project Number: 70494

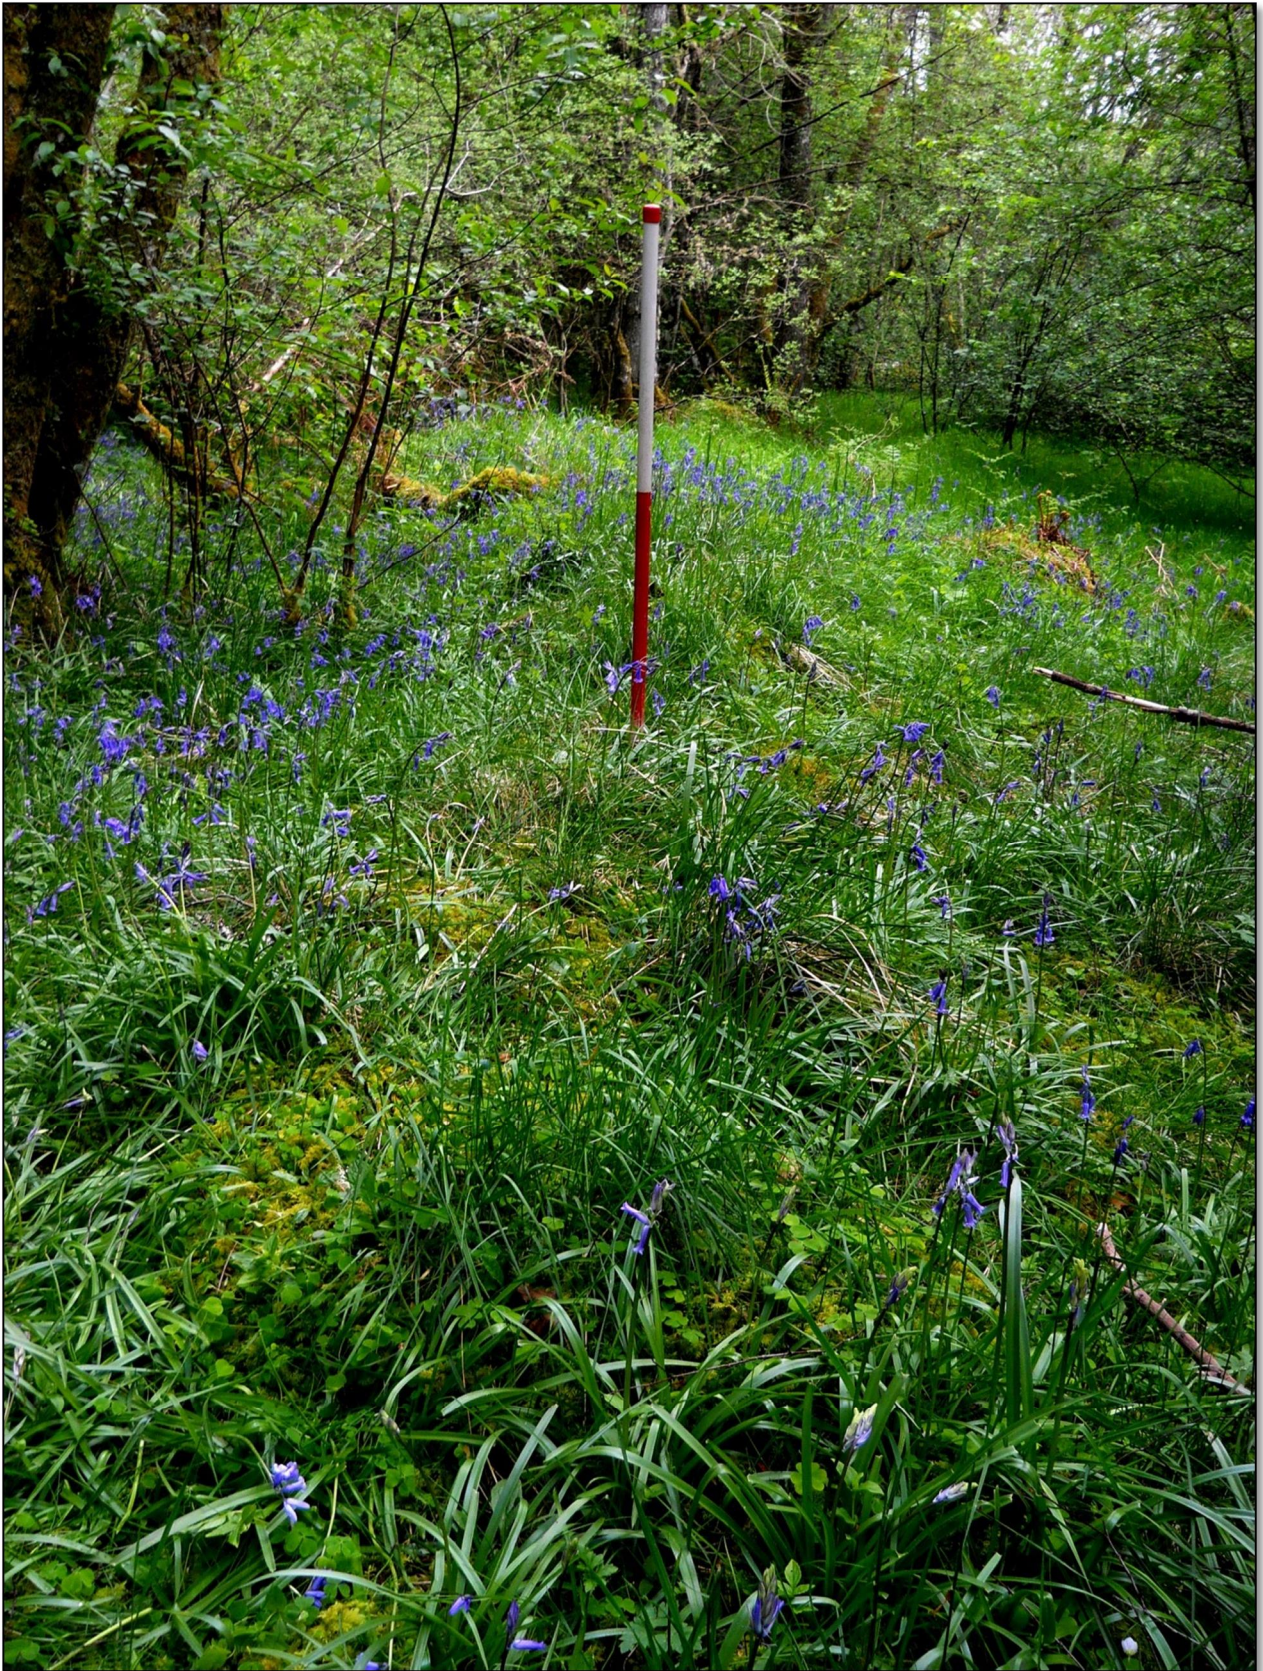
- 5.4 Located at the W side of the low-lying area of ground, the very-degraded remains of a drystone dyke was recorded (**Site 6**). This has been truncated at the east termination by

attempts to divert the stream courses running off the slopes to the W, and by the construction of the NE arm of the layby platform. The dyke runs to the SW up steepening and undulating ground into the conifer plantation. A part of the dyke survives here running up the sides of a shallow ravine, but generally the feature has been heavily disturbed by the original planting of the conifer plantation, and through the actions of tree roots. It appears that the dyke runs along the former boundary for Struy, as marked on the Lovat Estate maps (**Figures 2 and 3**) and on the First Edition Ordnance Survey map sheet (**Figure 4**).

Plate 8: Drystone dyke (Site 6) looking NE

- 6.5 The proposed continuation of the new access track to the WSW to the T-junction, along with the extended track spurs to the SW and NE, will impact on the drystone dyke (**Site 6**) and footpath/track (**Site 8**). It would prove difficult to re-route the proposed access track around the dyke, as both the dyke and the track follow the easiest-angled ground that leads into the conifer plantation. If the alignment of the track cannot be moved to avoid these two features, then it is recommended that they are subjected to these minimal impacts. These are quite extensive, linear archaeological features, so other sections will be preserved in-situ. The tracking of vehicles used to access this landscape and for construction purposes should also be directed along routes that will cause minimal impact to these features.

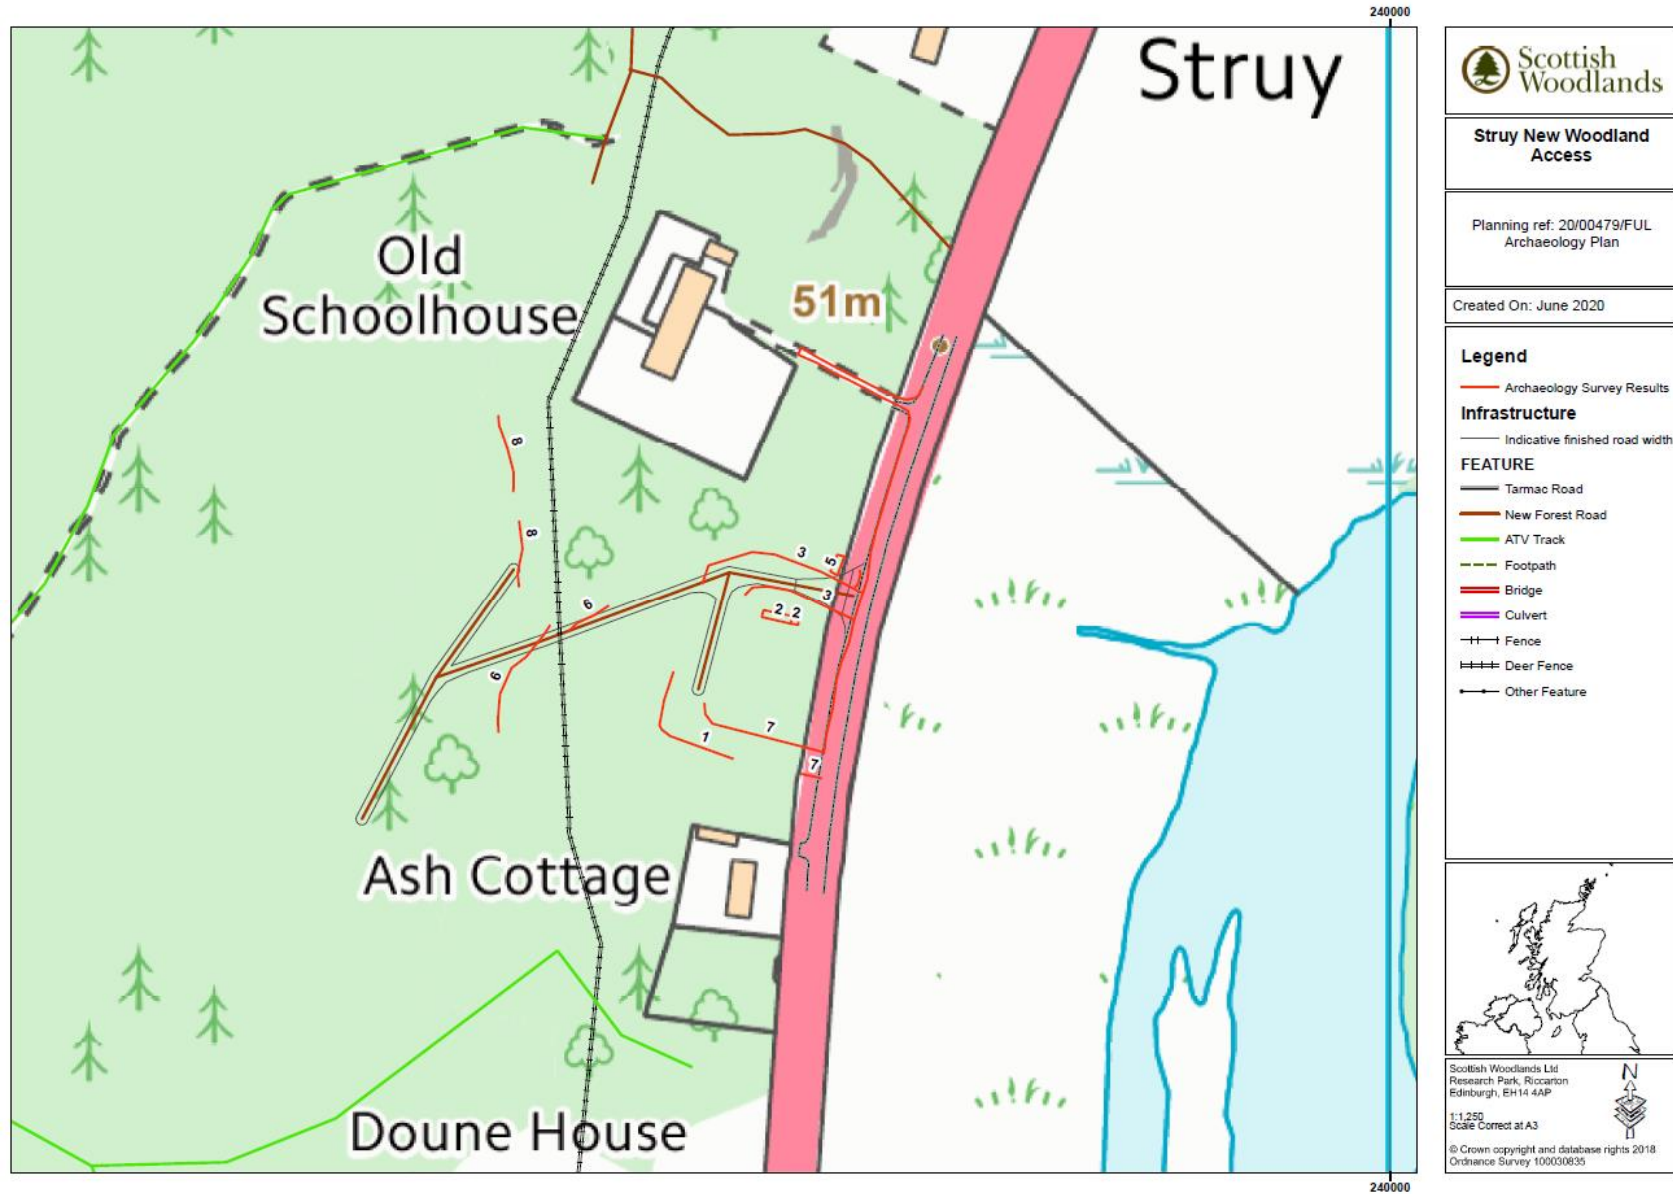
- 6.4 The proposed first section of the access track running WNW off the A831 road and the turning area segment running SSW, generally follow the course of the NE half of the u-shaped layby (**Site 3**). The utilisation of this raised feature, with its underlying stoney base, avoids the wet ground conditions within this low-lying sector of the survey area. The proposed access track will directly impact on this feature, but due to its relatively recent construction, it is recommended that no further archaeological input is required. The use of the raised layby feature will also negate any impacts on the surrounding/underlying natural ground surface and any potential buried archaeological features or deposits; although it is highly unlikely that settlement remains exist in this area.

Figure 9: Plan showing proposed access track in relation to recorded archaeological sites (Ben Taylor, Scottish Woodlands)
