High Mingarry Woodland Creation and Management

Lochshiel Estate, Moidart, Lochaber

Archaeological Desk Based Assessment and Walkover Survey

Client	Lochshiel Estate & Miller Harris (Kirn Ltd)
National Grid Ref	NM 68852 70132 (Centred)
Site Code	MINGARRY20
WCAS Report Number	118/MINGARRY/20
Author	Steven Birch
Date	10-09-2020

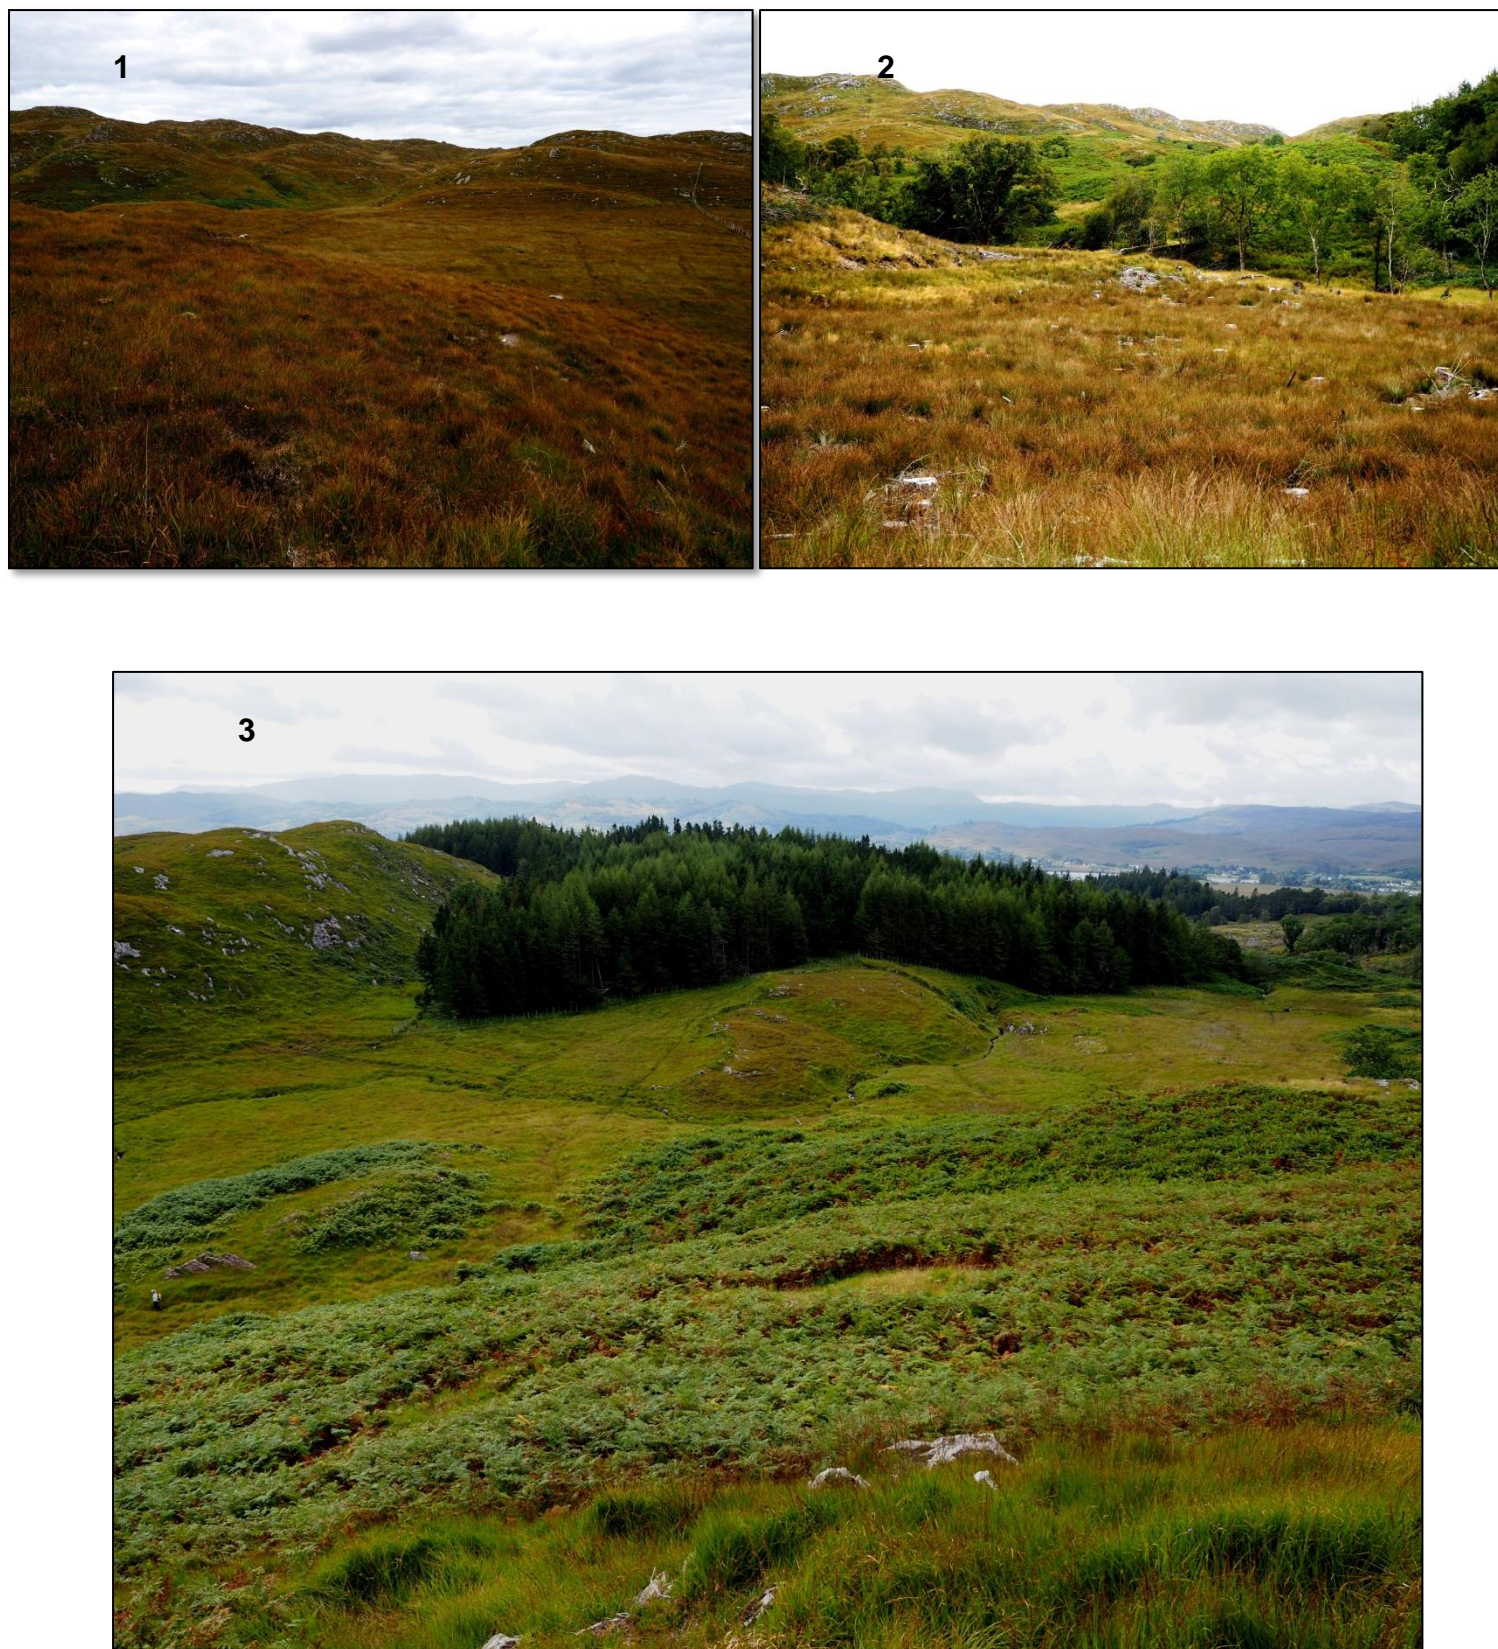
Plate 1 – Looking NNW over the section of survey area, located to the N and NE of Area 1; **Plate 2** – View N over low-lying area within east sector of Area 2, with Bridge (Site 3) over Mingarry Burn; **Plate 3** – View SSE over Area 3 (foreground), Mingarry Burn and N end of Area 1 under conifer trees. The deep bracken in the foreground covers elements of the settlement remains of High Mingarry

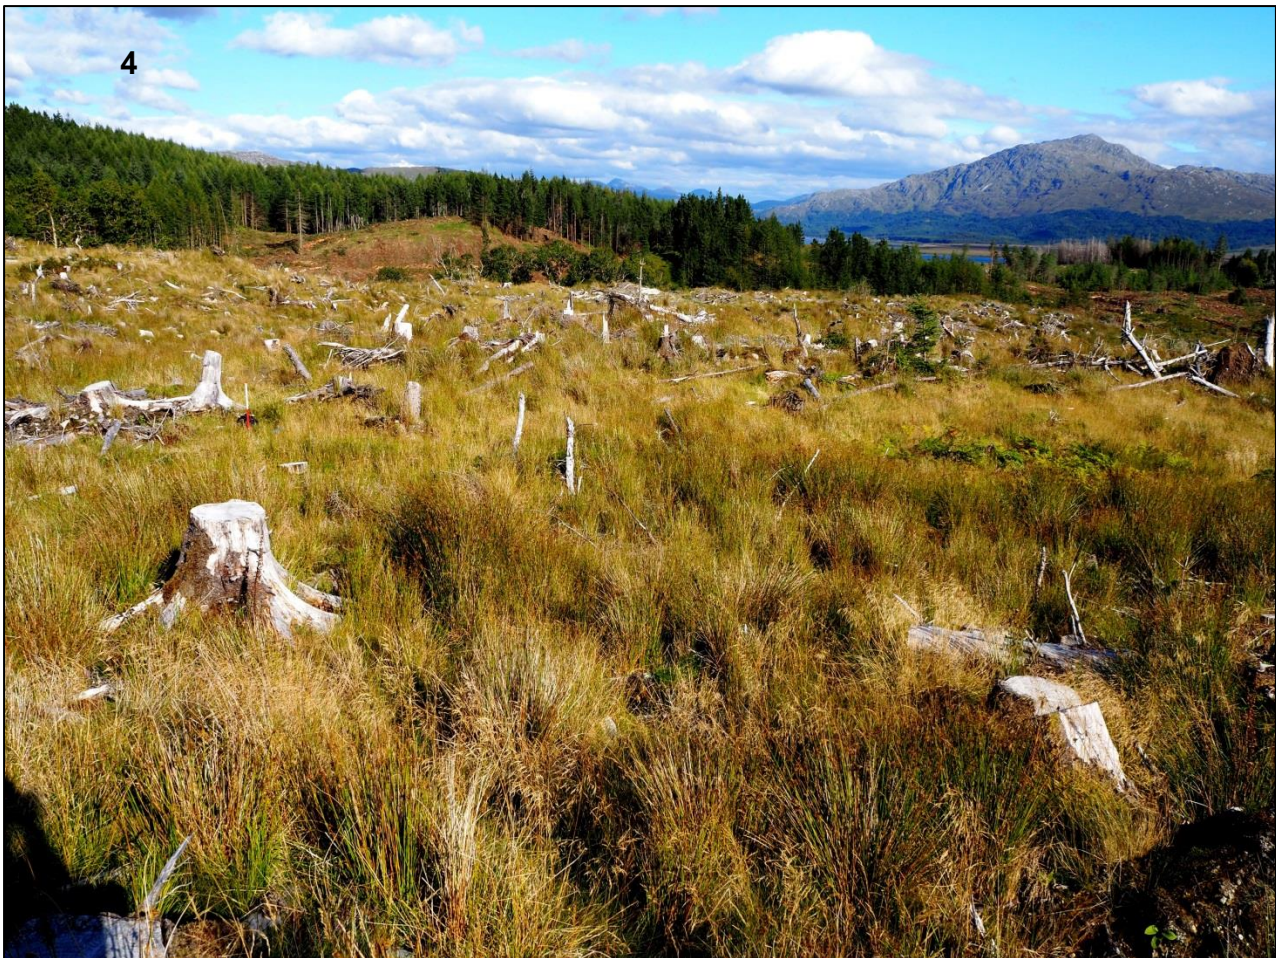
Plate 4 – Looking E over Area 2 (clear-felled ground) to Area 1 under conifer plantation, where felling is taking place, with Loch Shiel and Ben Resipole at top right

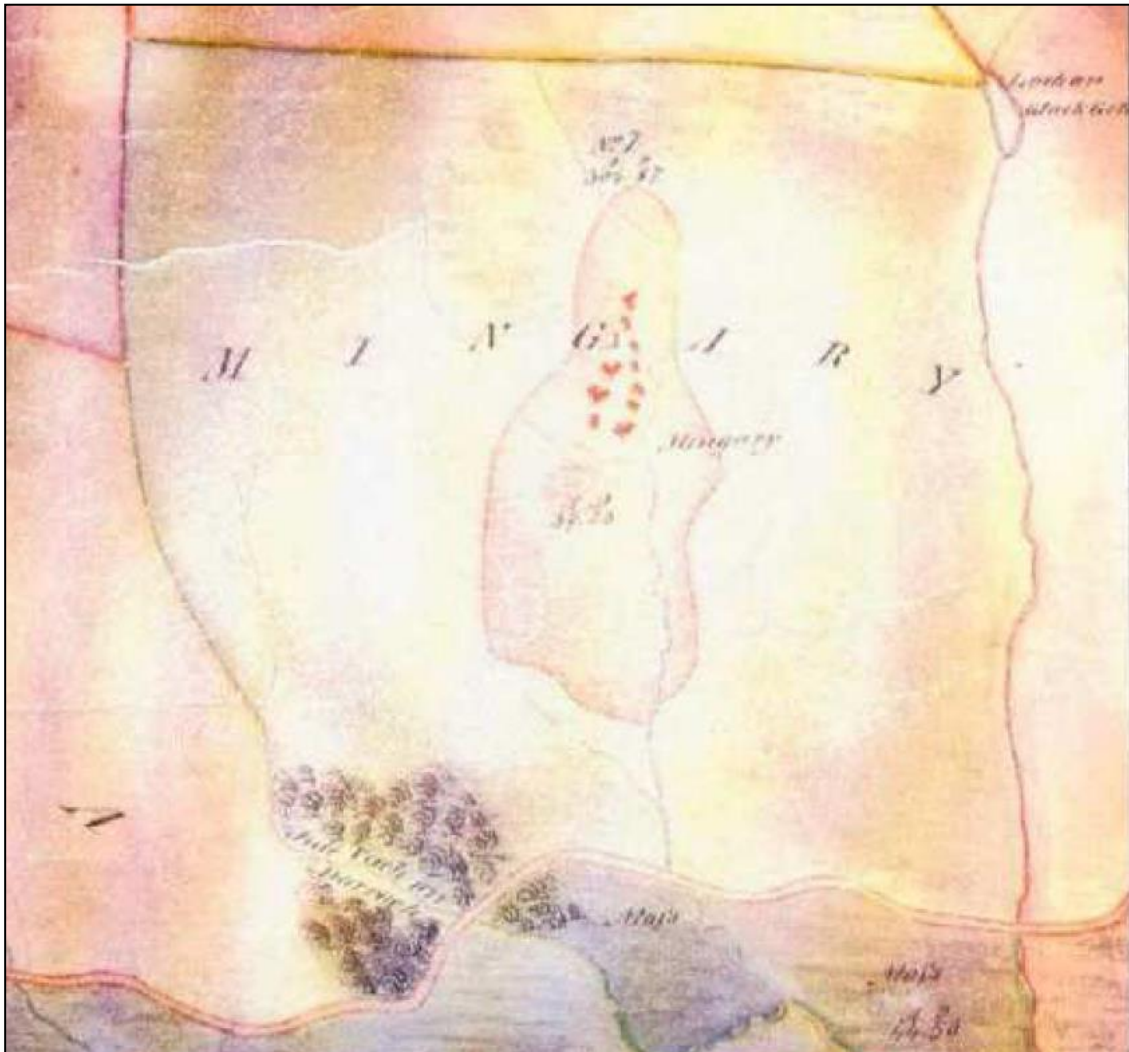
Figure 4 – Excerpt from the Lochshiel Estate map, c. 1811

This small section of the Lochshiel Estate map shows the layout of the buildings at High Mingarry and the associated major boundaries of the township (Figure 4).

However, the Lochshiel Estate map of c.1811 (Figure 4) clearly shows the settlement at High Mingarry, depicted as two converging rows of buildings located on the west side of the Mingarry Burn, enclosed by a wandering head-dyke. At this time, estate records indicate that the settlement was shared between nine tenants and their families, but by the time of the 1841 Census the number of houses had increased from 11 to 13, with a total of 76 people.

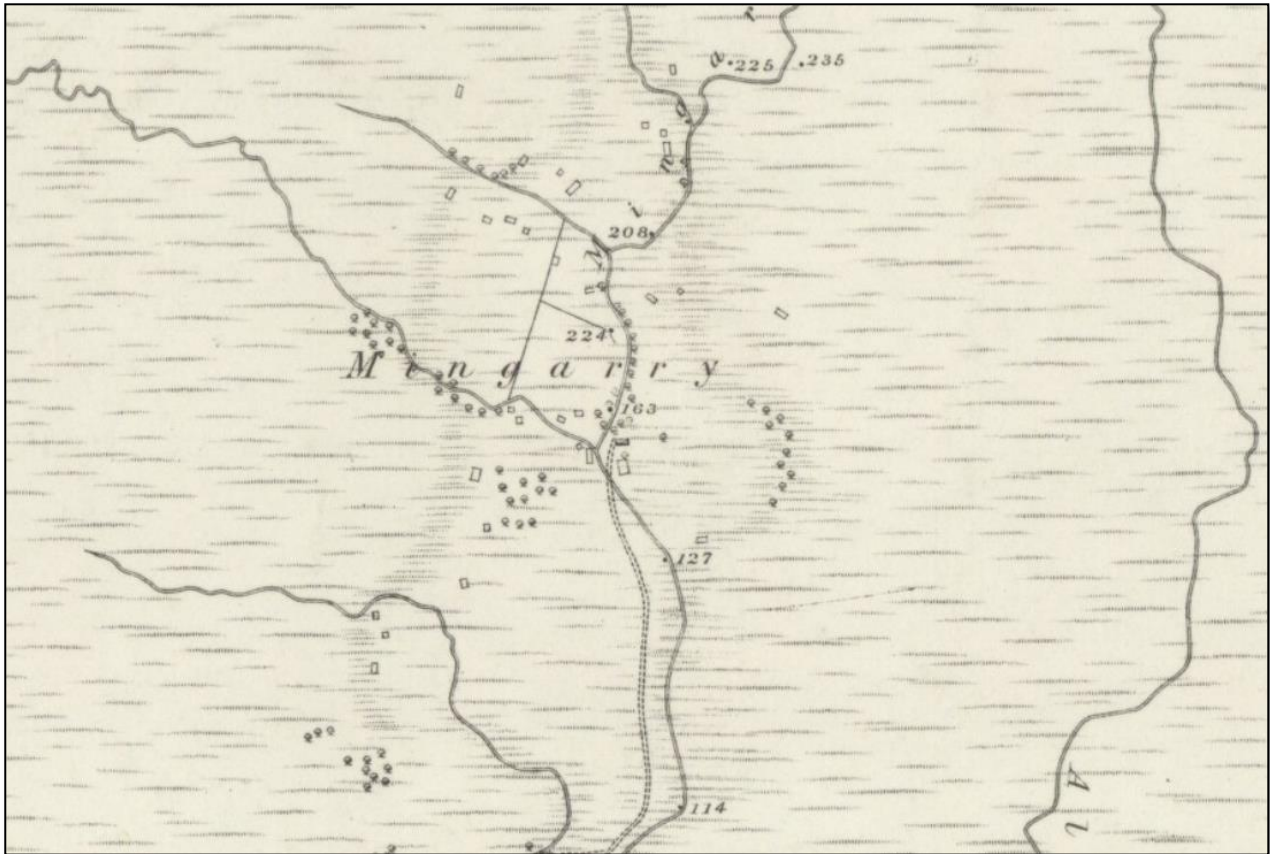
Figure 5 – Excerpt from the 1st Edition 6 inch to the mile OS map sheet (Surveyed: 1872-73) © NLS Edinburgh

At the time of the survey for this Ordnance Survey map sheet, only one building is shown to be roofed and potentially occupied – located at the end of the access track. At least 33 structures are shown to be unroofed and unoccupied.

Seven buildings are shown to the east of the Mingarry Burn, with the remainder located to the west of the stream course (Figure 5). Two field boundaries are shown to the west of the Mingarry Burn, which uses two of the stream courses as additional natural boundaries. This settlement arrangement may relate to the record of Mingarry in the 1871 Census, which lists only two houses occupied by families whose head was farming just 2 acres. These were likely to have been crofts and may be depicted on the map by the two fields.

At the time of the survey to gather data for the 1st Edition Ordnance Survey map sheet (Figure 5), it is obvious that most of the buildings at High Mingarry had been abandoned. Indeed, the 1861 Census records confirm this, with only two potential houses and associated crofts being occupied. We cannot be certain at what time the settlement was initially established, but it appears in lists of Estate rentals for 1691-1771 and is named as *Mengary*. Jannsen's map *Lochabria* of 1659 also shows the potential settlement, as *Megarie* (Figure 2).

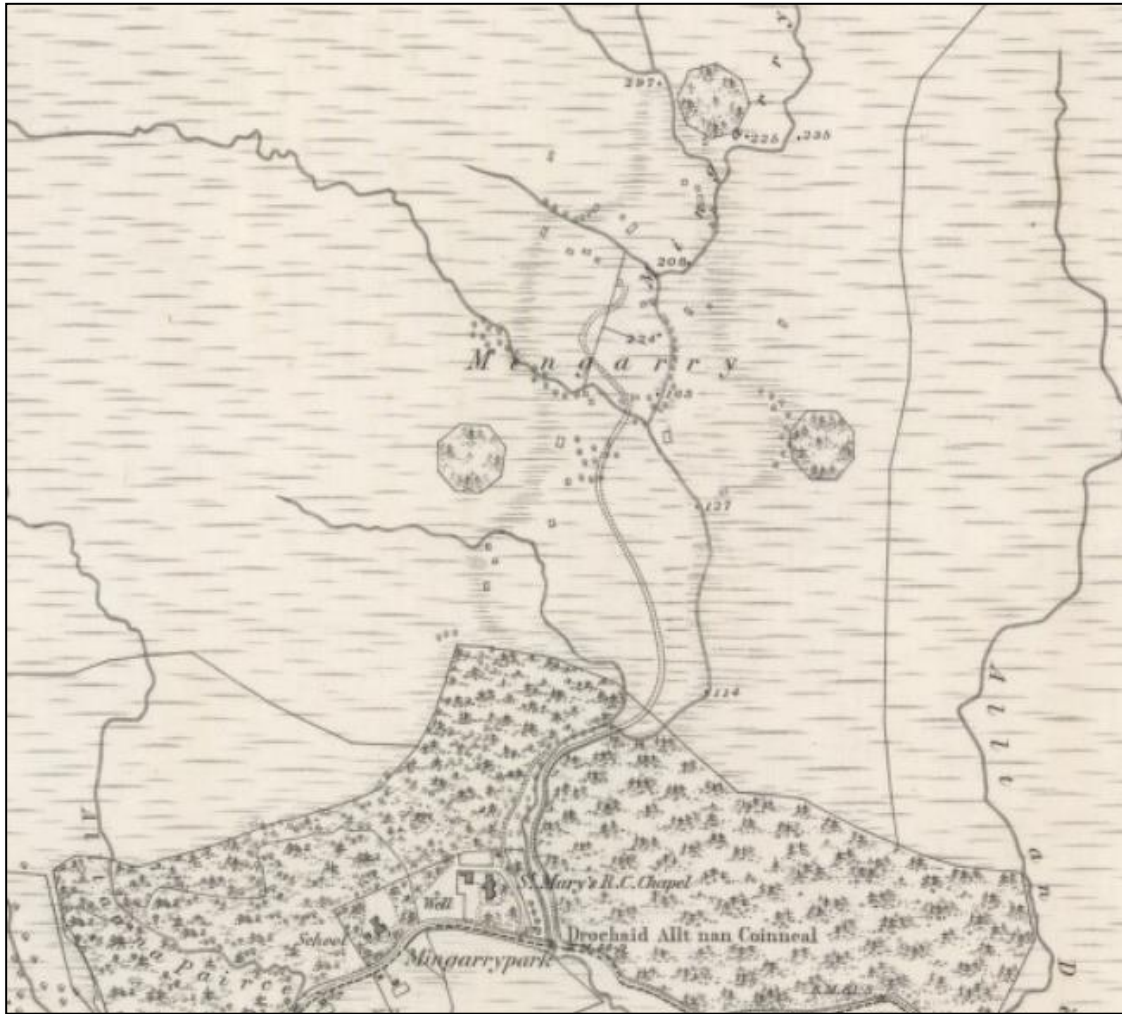
Figure 6 – Excerpt from the 2nd Edition 6 inch to the mile OS map sheet (Revised: 1899) © NLS Edinburgh

The settlement at High Mingarry appears to be deserted by the time this revision to the Ordnance Survey map sheet has been made. The map shows a total of 29 unroofed buildings, along with the two field boundaries shown on the 1st Edition map sheet. One major change noted on this revision is the alignment of the new track leading into the area of the old settlement, which has also been extended further north, to the west of the Mingarry Burn. The map sheet also shows the construction of a bridge over the burn, just before it emerges out of the woodland, at the southern end of the old settlement. Also of note, are the three distinctive octagonal-shaped enclosures containing trees (Figure 6). The improvements to the track and these additional features most likely correspond with the ownership of the Lochshiel Estate by Lord Howard of Glossop.

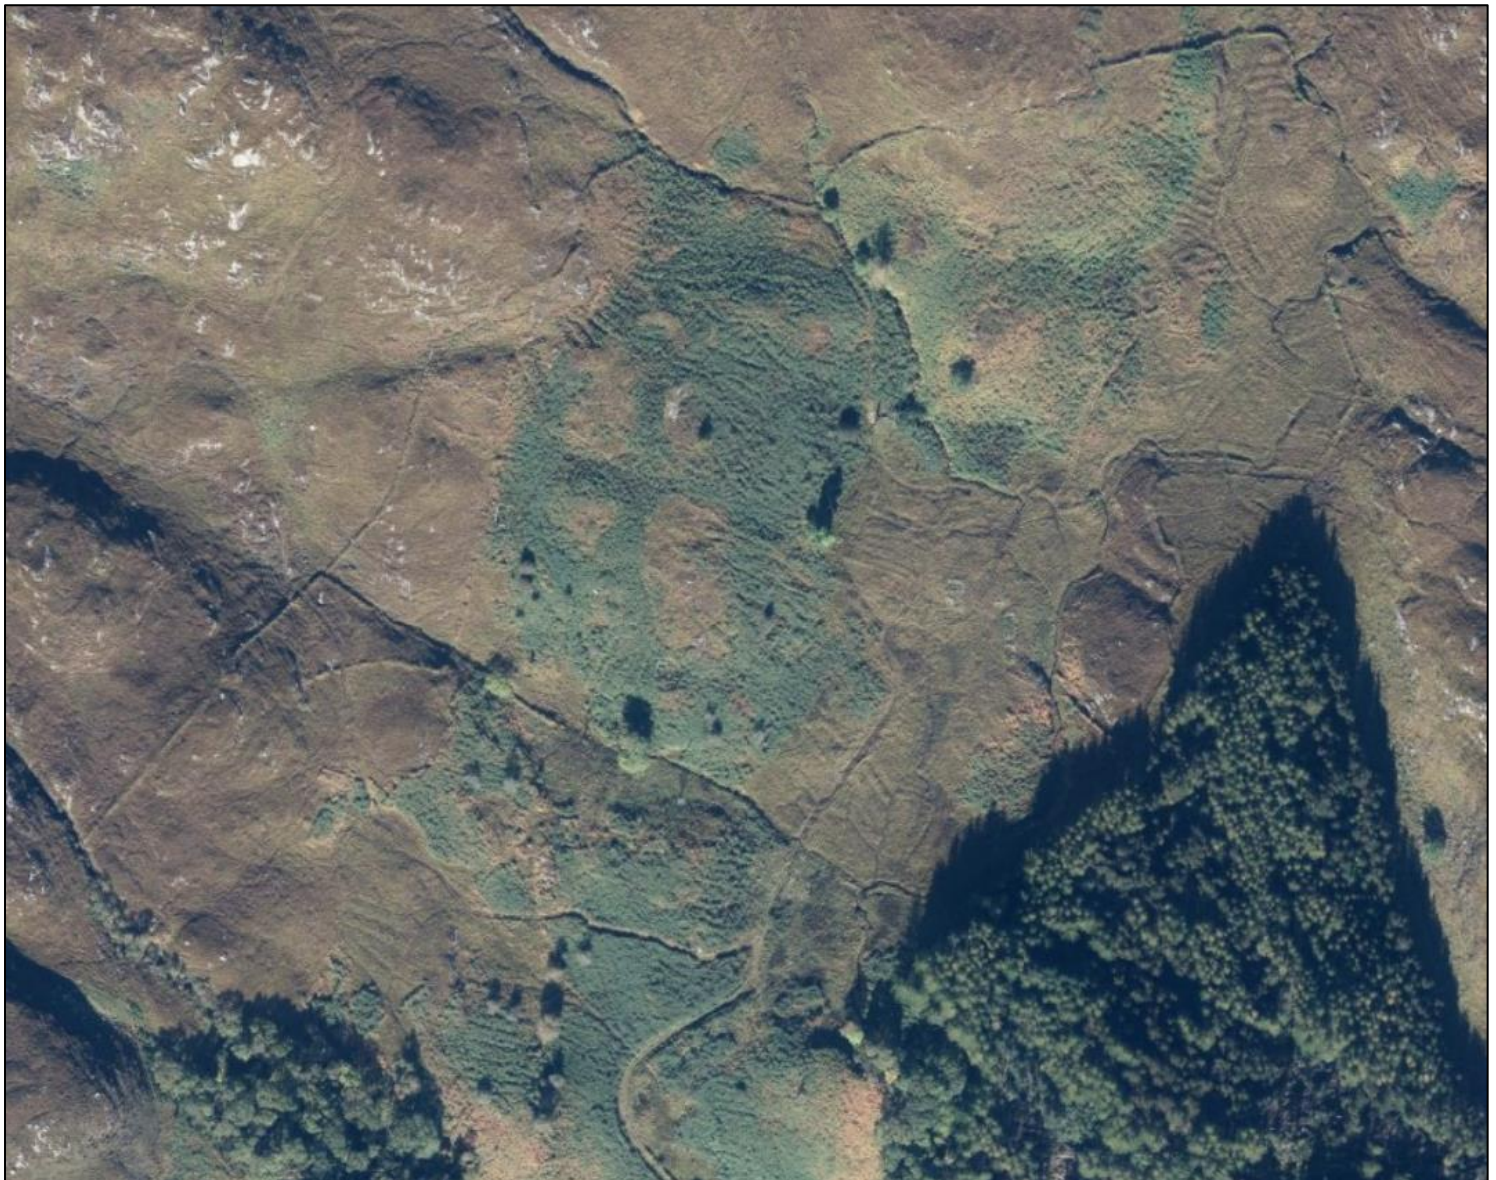
Figure 7 – Aerial image of the NW sector of the survey area (Area 3) showing multi-period field boundaries, relict rig and furrow cultivation, and buildings. The settlement remains continue into the conifer plantation (Area 1) on the right (OS Online Mapping)

The images show a complex of field boundaries, enclosures, cultivation remains and buildings centred on the settlement of High Mingarry. Most of the imagery corresponds with the results of the archaeological survey carried out by the Moidart History Group, and with the additional data gathered as a part of the survey informing this Data Structure Report.

It proved difficult to recover detail in some sectors of the survey area due to standing trees and dense bracken stands.

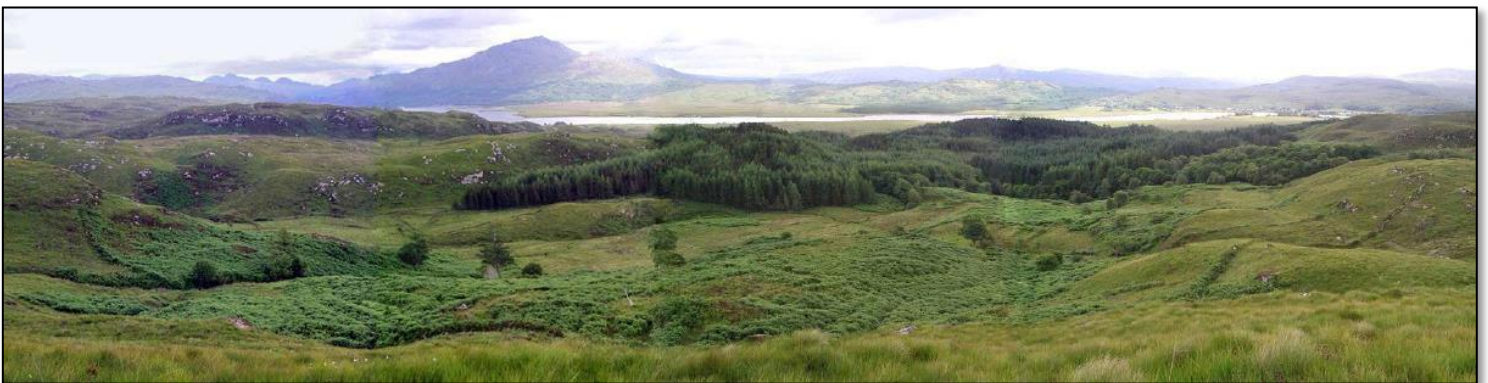
Plate 5 – Looking SE over the High Mingarry Township to Loch Shiel and Ben Resipole

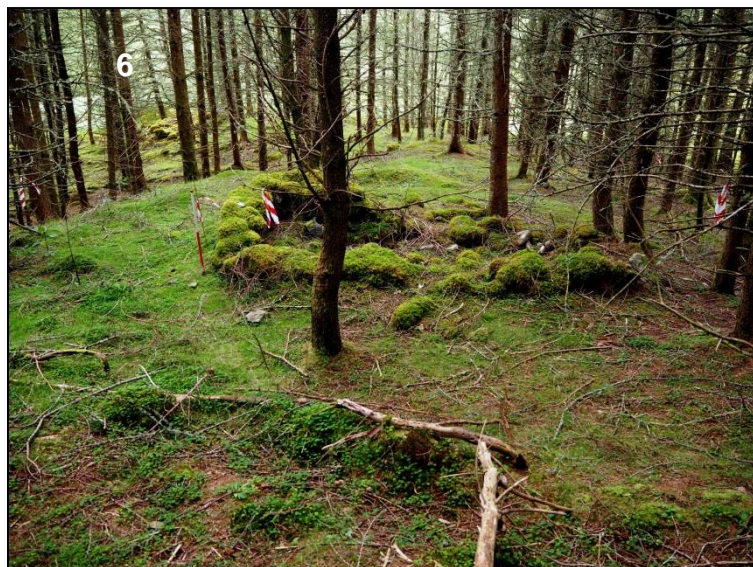
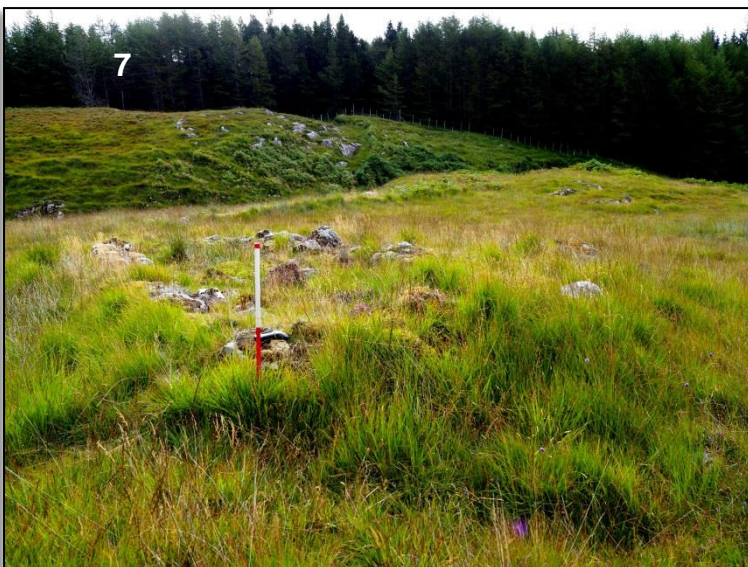
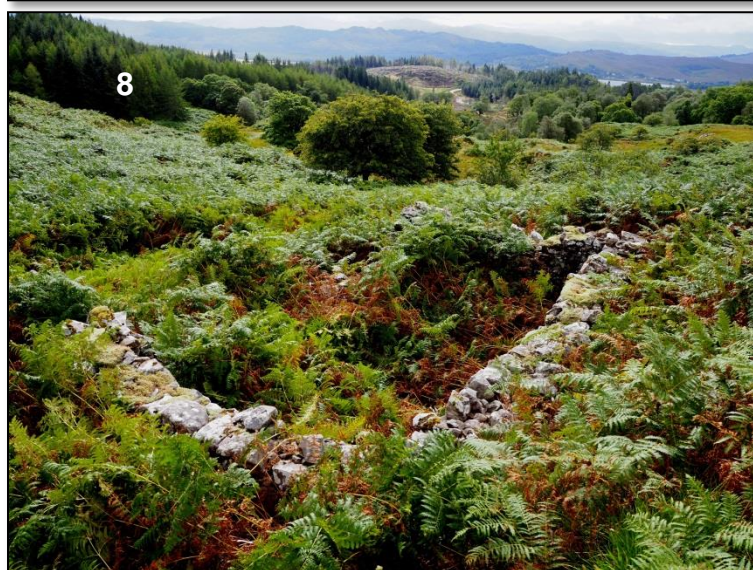
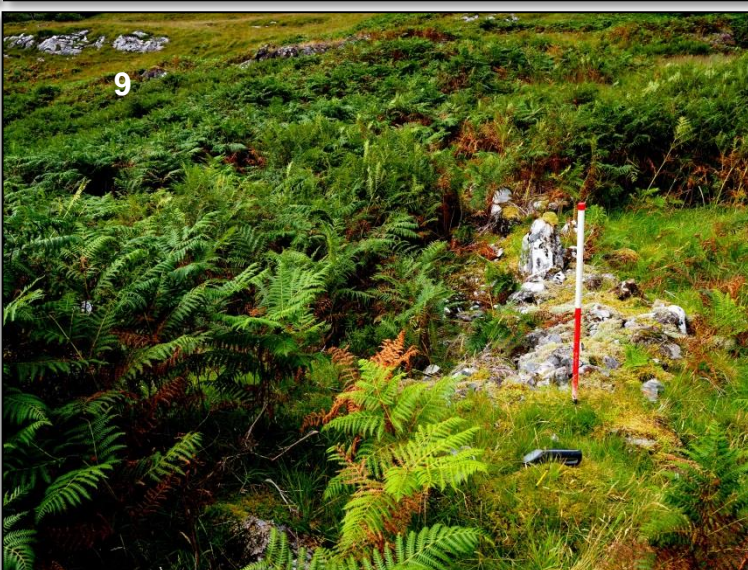
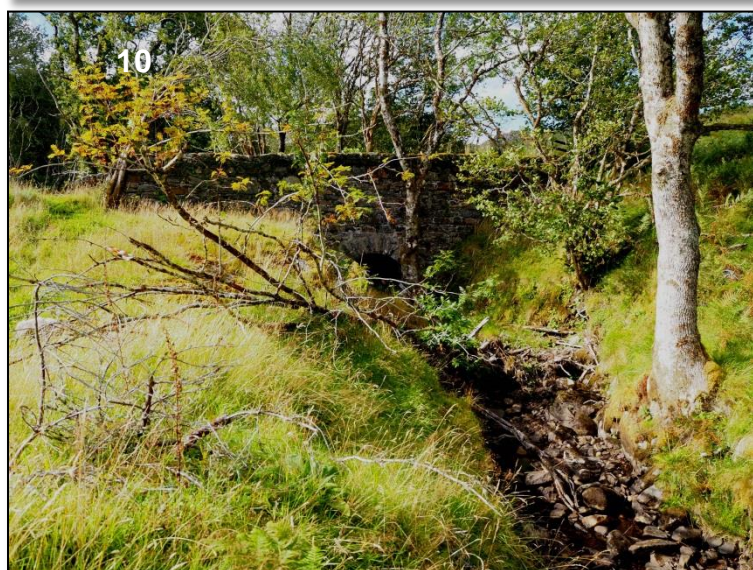
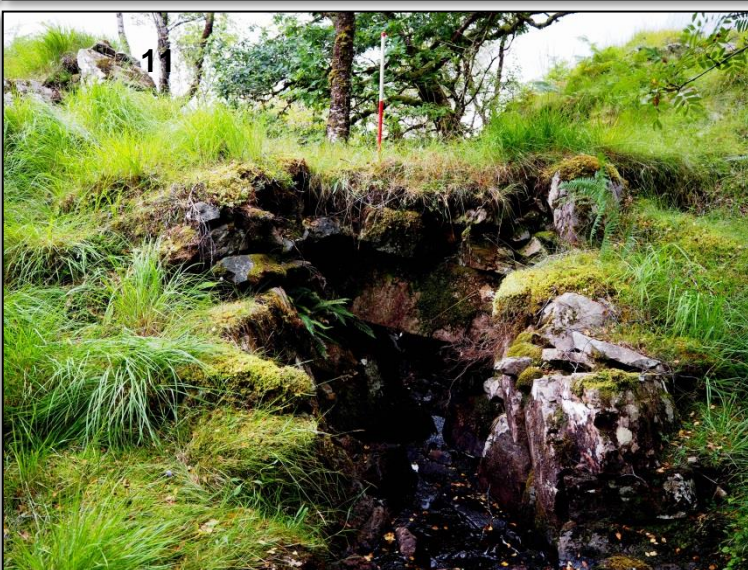
Plate 6 – View W over Site 13 (Area 1); **Plate 7** – Looking ESE over Sites 32 and 31 (Area 3); **Plate 8** – Site 43 located under dense bracken (Area 3); **Plate 9** – Side wall of building (Site 51a) under bracken stands looking W (Area 3); **Plate 10** – Bridge Site 3 spanning Mingarry Burn (Area 2); **Plate 11** – View SE to bridge Site 84 over tributary of Mingarry Burn (Area 3)

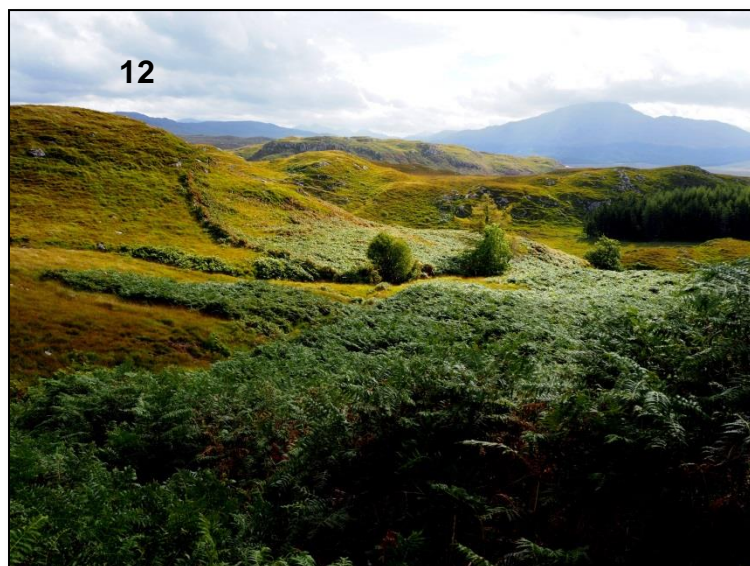
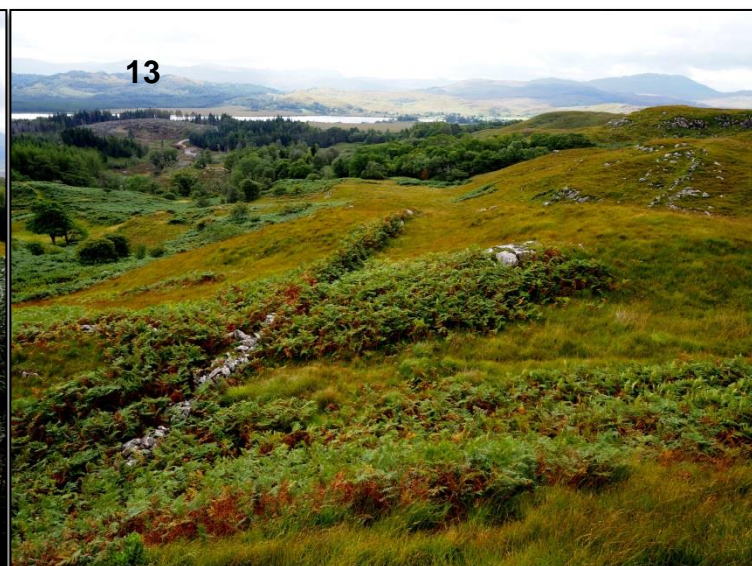
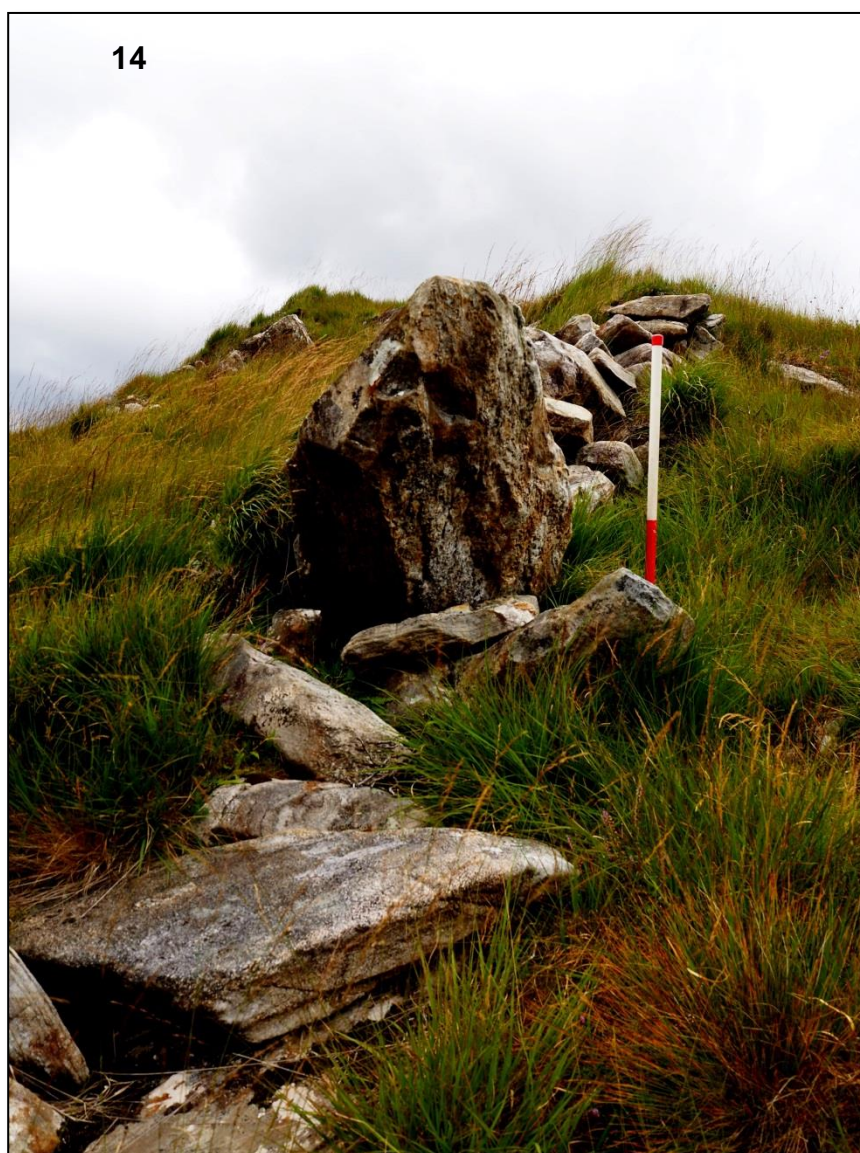
Plate 12 – View E over High Mingarry showing head dyke (Area 3); **Plate 13** – Looking SSW to head dyke and distinct terraces of High Mingarry (Area 3); **Plate 14** – View SSW of head dyke (Area 3)

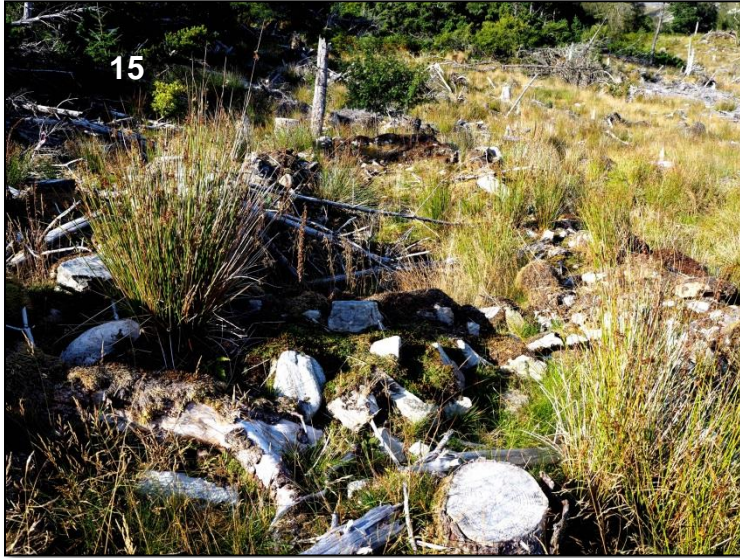
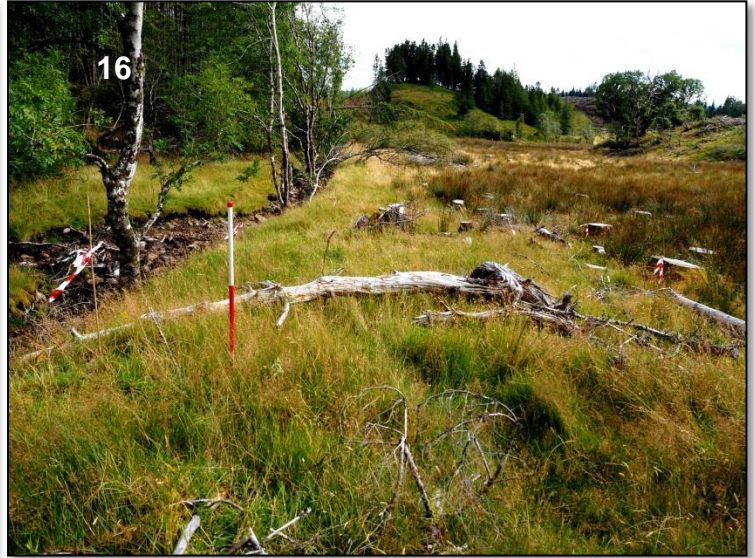
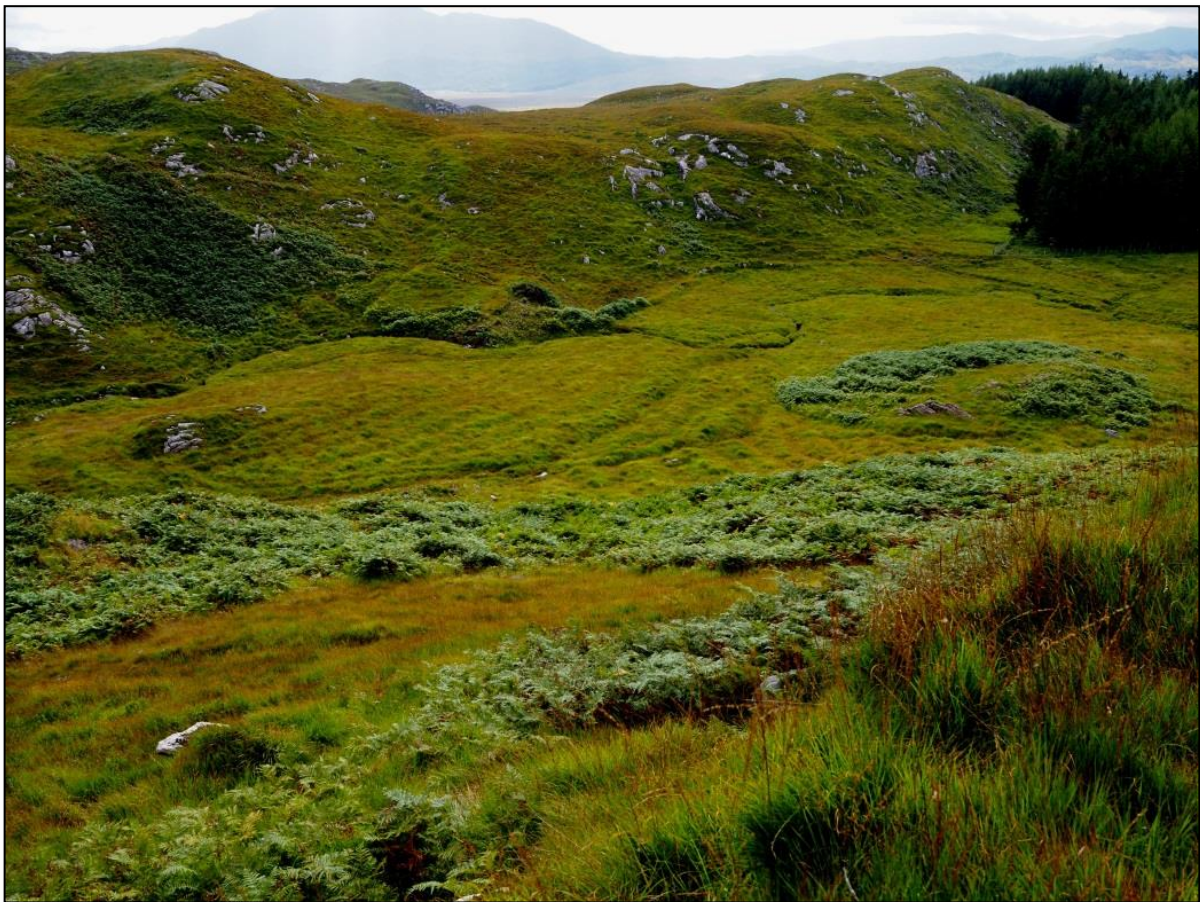
Plate 15 – View N over Site 61 in felled area (Area 2); **Plate 16** – Looking SE over junction of Areas 1 (left) and Area 2 with Mingarry Burn and very degraded buildings (Sites 71 and 72); **Plate 17** – Relict rig and furrow cultivation at the N end of Area 3
