# Nairnside Farm, Cawdor

## Archaeological Evaluation & Photographic Survey Data Structure Report

AOC 70542

*March 2021*

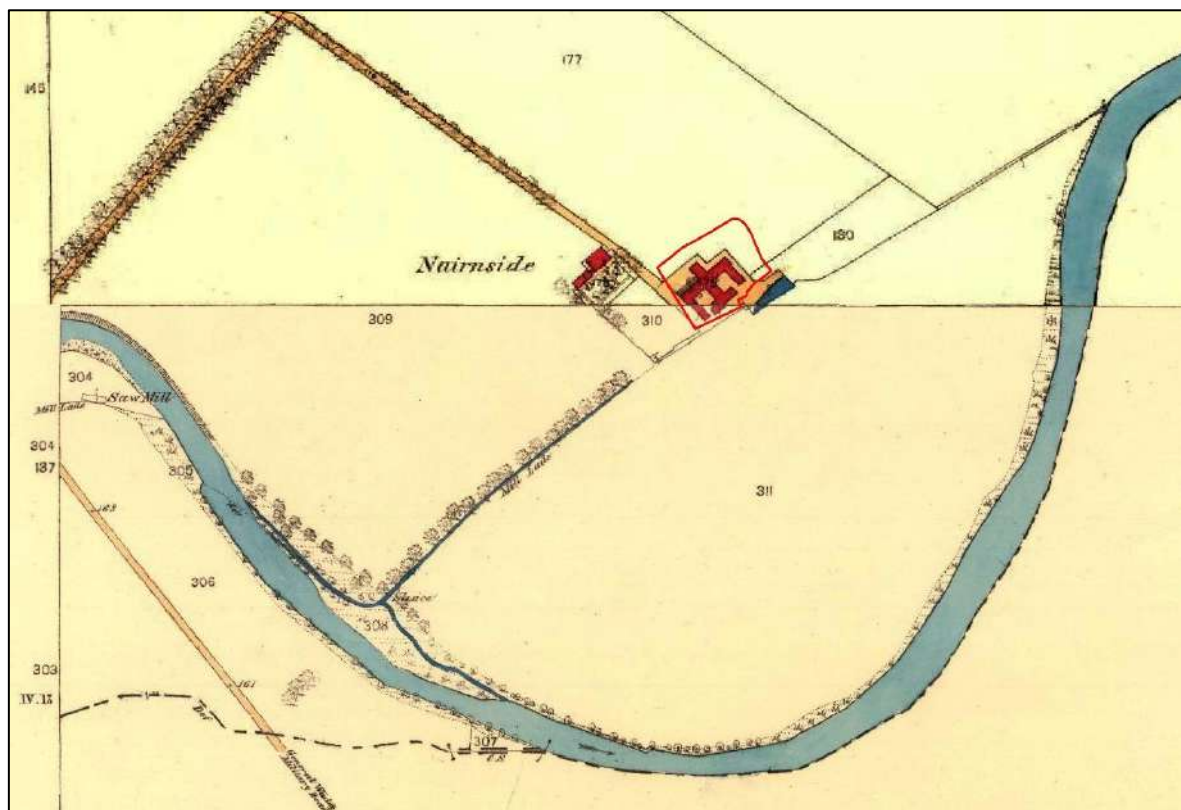
Figure 2: Excerpt from the 1<sup>st</sup> edition 25-inch OS map, 1868-9, highlighting the development site (Reproduced with the permission of the National Library of Scotland)

This map depicts a large E-shaped farm building located at the development site (**Figure 2**). The building is set within open fields, with a mill lade running to the southwest.

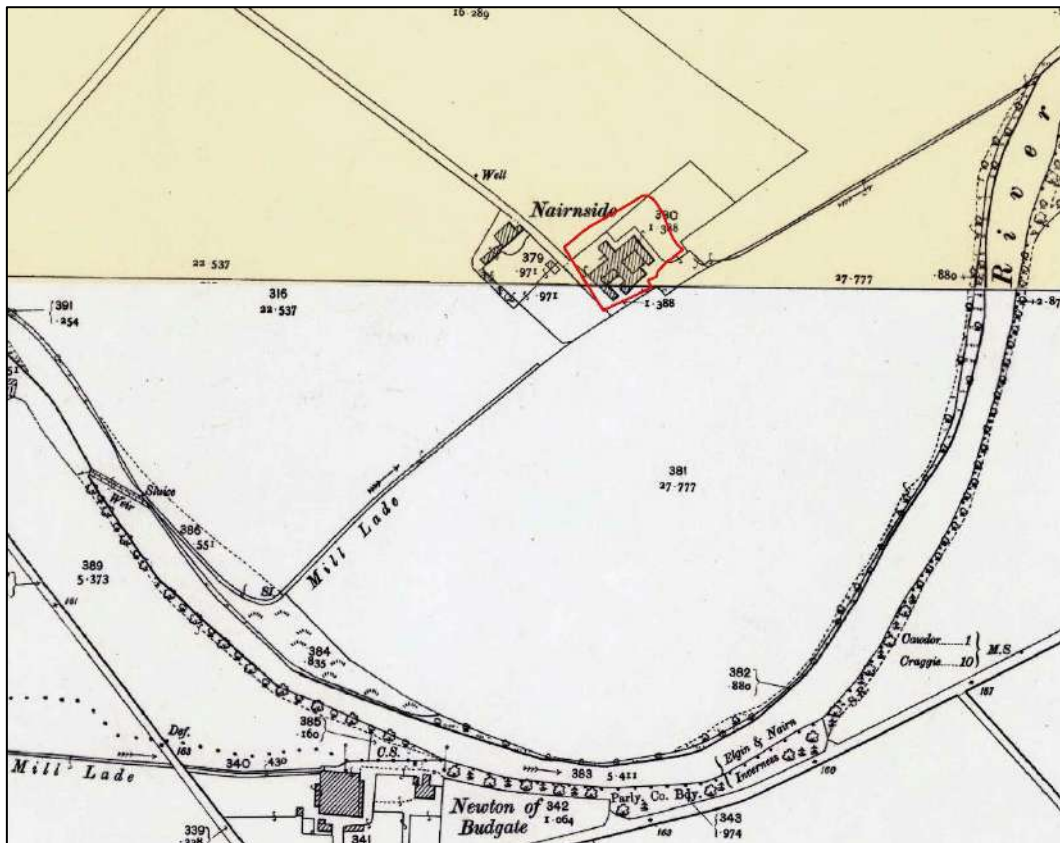
Figure 3: Excerpt from the 2<sup>nd</sup> edition 25-inch OS map, 1904, highlighting the development site (Reproduced with the permission of the National Library of Scotland)

This map shows the main E-shaped building at the development site, but also indicates that further roofed buildings have been added within the courtyard areas (**Figure 3**).

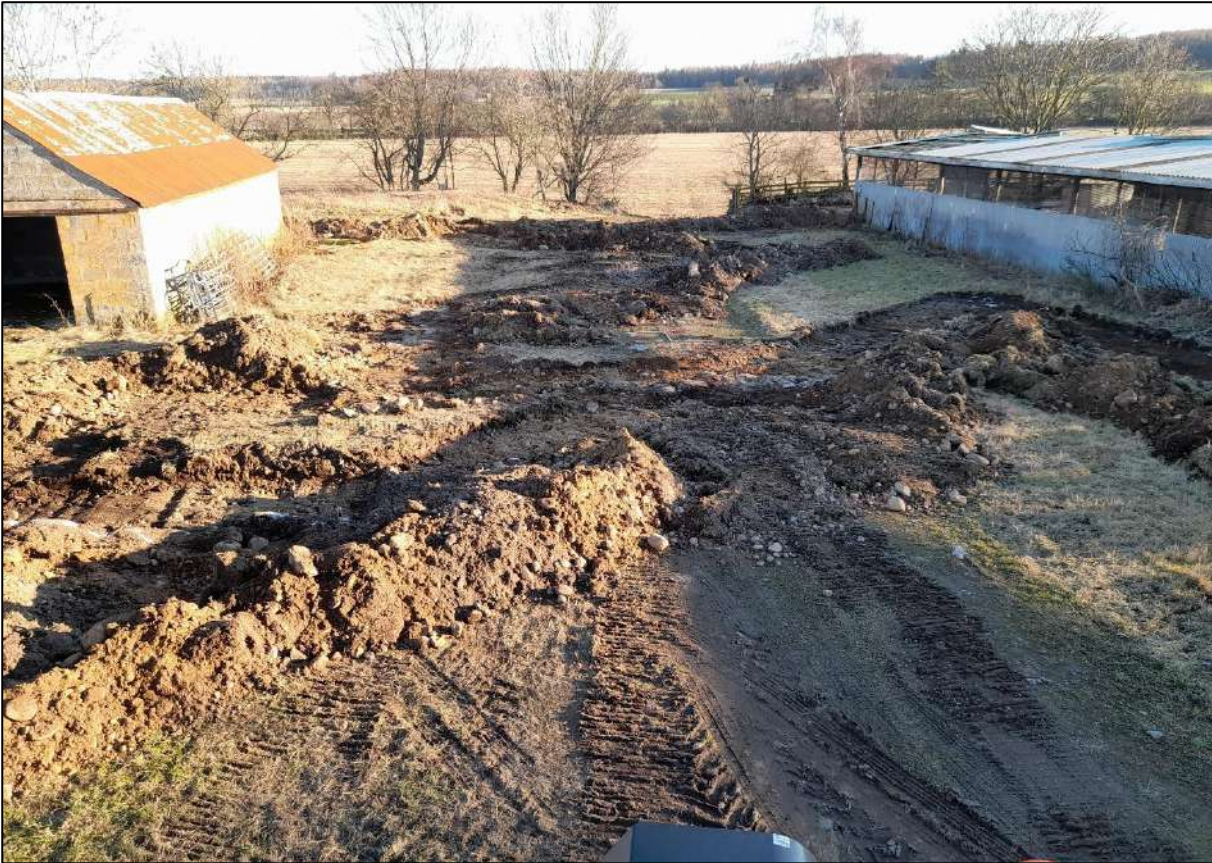
*Plate 1: General view of the development site showing Trenches 2-7*

- 6.1.1 The archaeological trial trenching evaluation was carried out between 1<sup>st</sup>-3<sup>rd</sup> March 2021 (**Plate 1**). Eight trenches were excavated and a total of five archaeological features were identified (**Figure 6**). The features included two rubble field drains, one stone deposit, and the extensive remains of previous post-medieval building walls. Topsoil across the site was generally a shallow (0.09m-0.45m deep), dark brown, loamy silt over natural subsoil of mid orange-brown sand and gravel with frequent stones. A small amount of post-medieval ceramics, glass, iron and leather objects were recovered (**Appendix 3**).

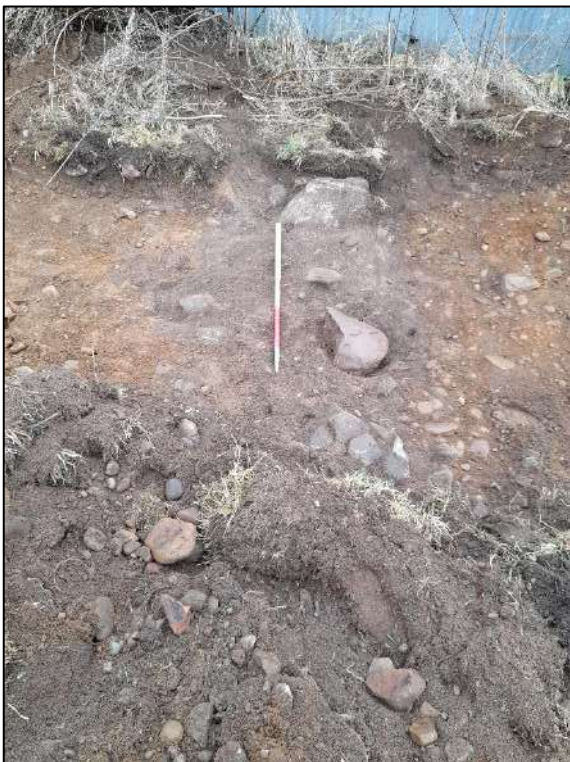
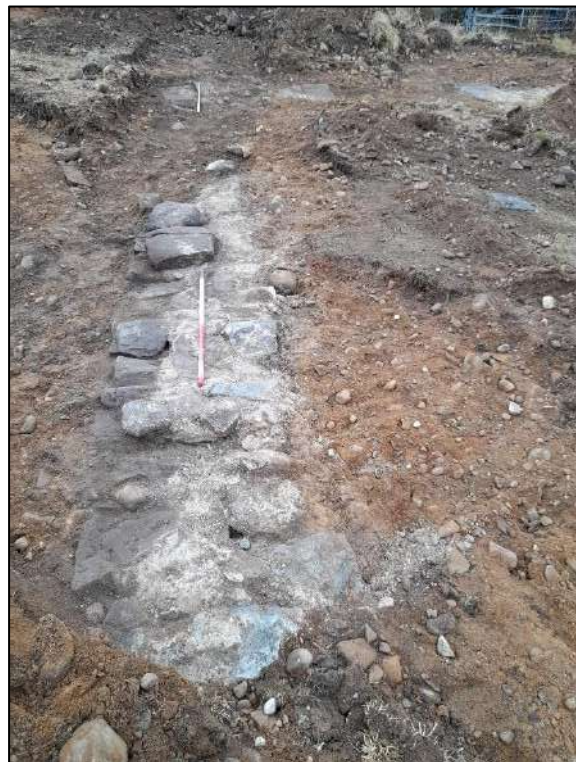
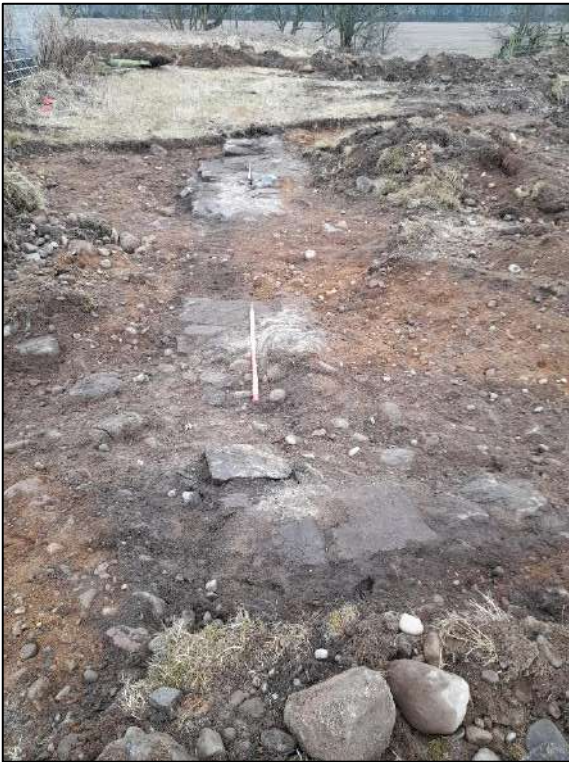
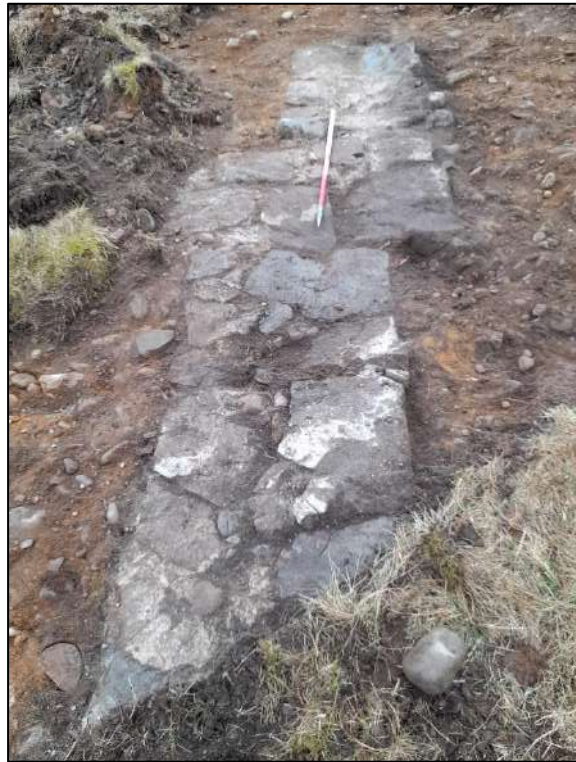
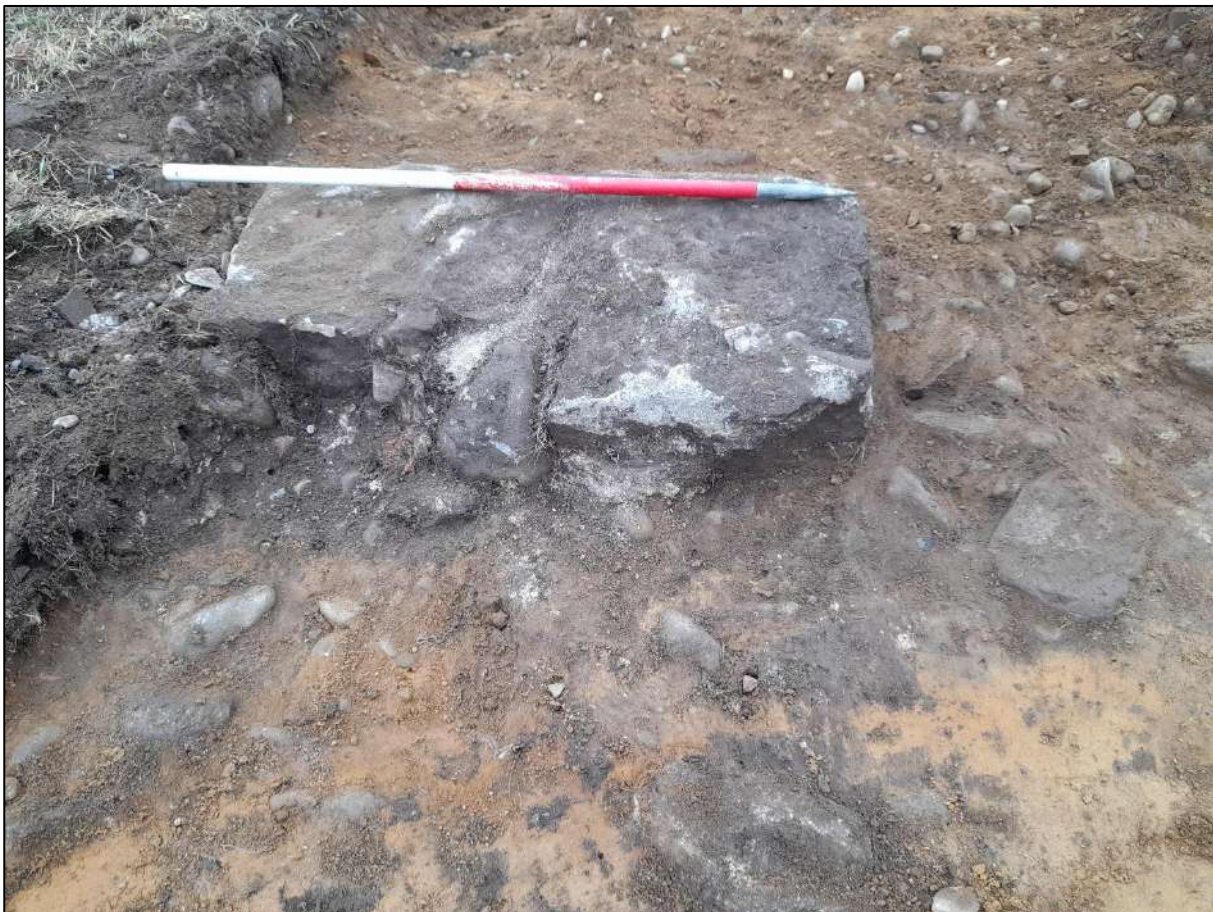
*Plate 2: Wall [008a]*

*Plate 3: Wall [008b]*

Plate 4: Wall [008c]

Plate 5: Wall [008d]

Plate 6: Wall [008e]

- 6.1.2 Wall [008] comprised a stone wall constructed primarily with large flat stones, bonded with light-coloured mortar (**Plates 2-6**). It survived in fragmentary sections [008a-e] within Trenches 2-5 and 7 and measured overall 0.4-0.48m wide and up to 0.13m deep. Overall it formed a large L-shape indicative of two building walls aligned northeast-southwest and northwest-southeast, which joined at the northern corner (**Figures 7, 8**). The walls were truncated in several places by modern services.

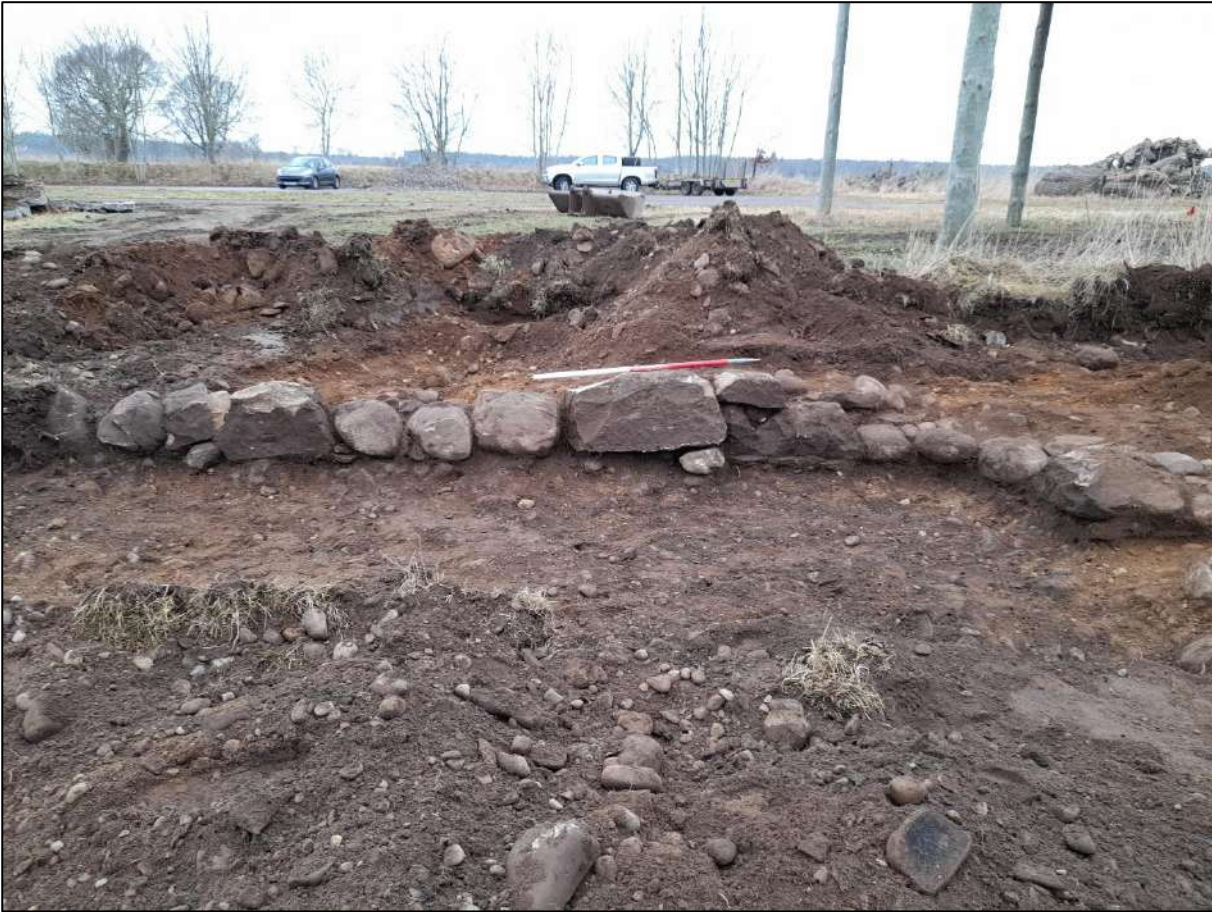
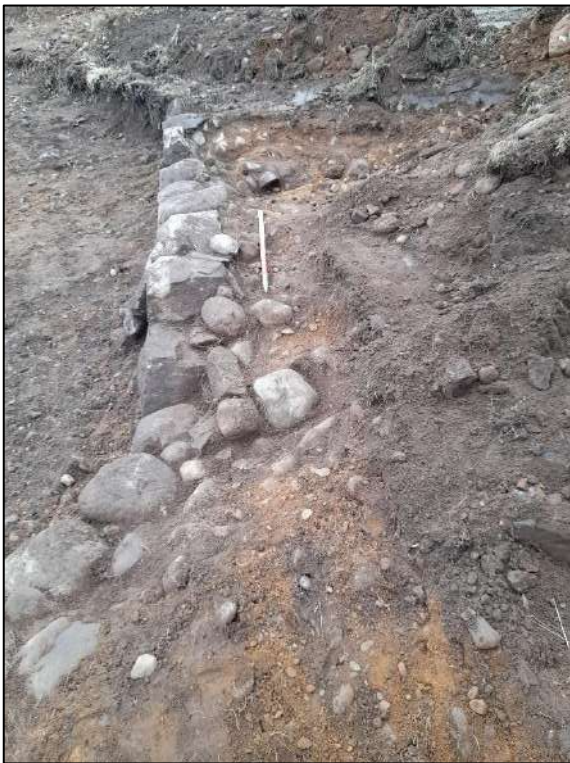
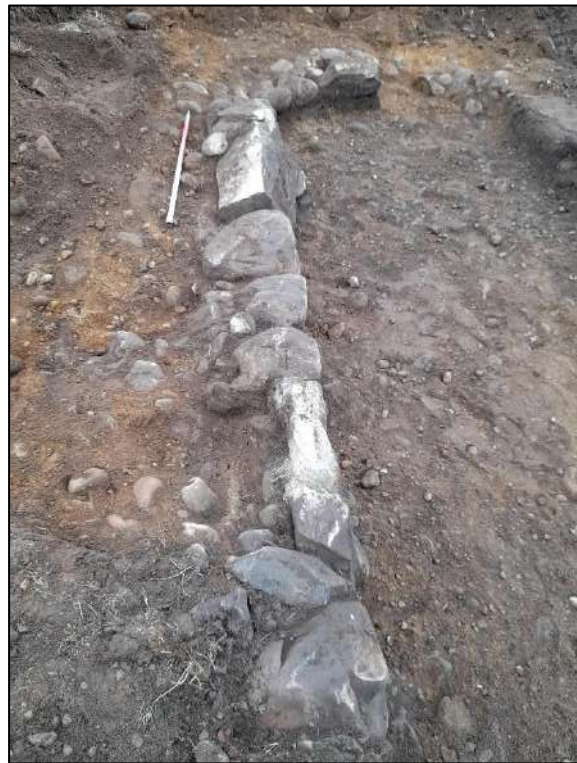
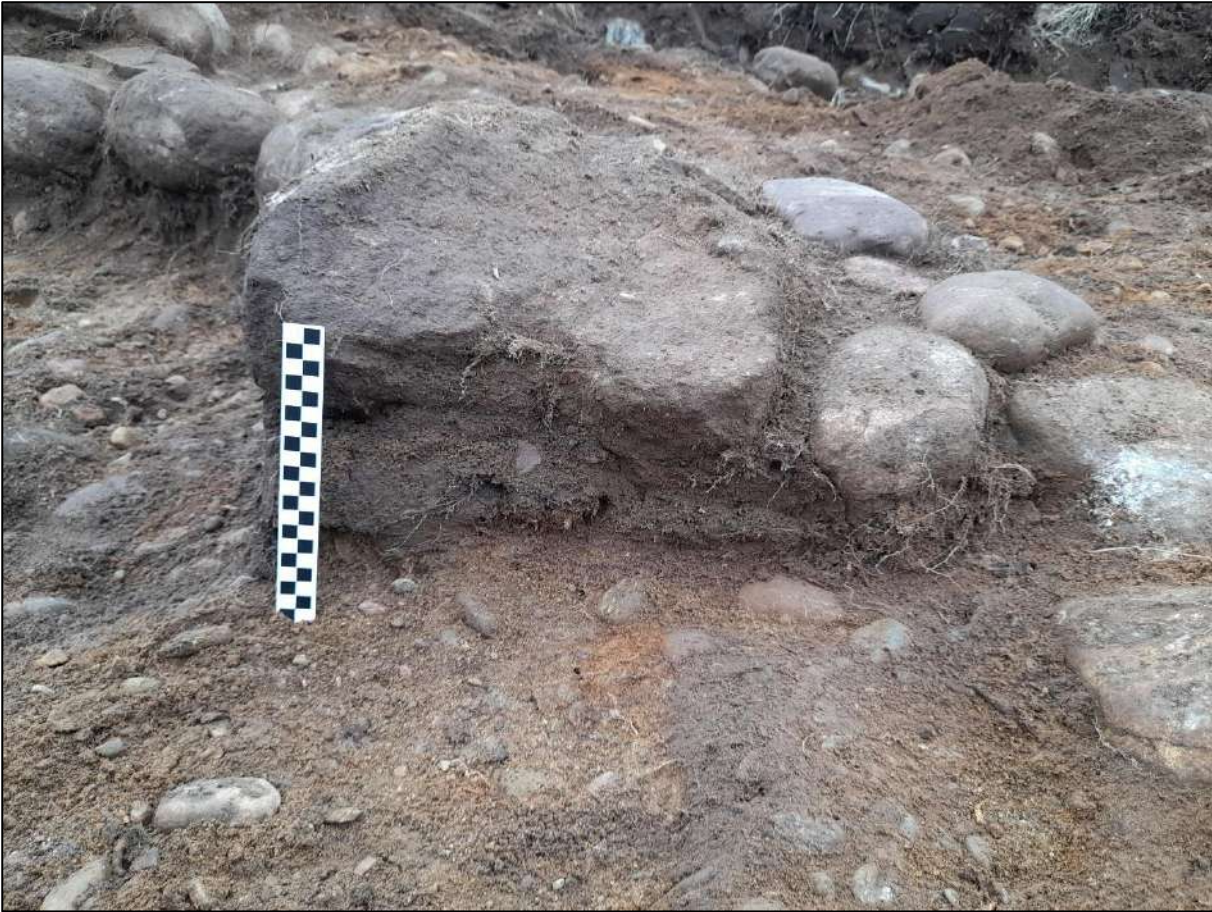
Plate 7: Wall [011] in Trench 6

Plate 8: Wall [011] in Trench 6

Plate 9: Wall [011] in Trench 7

*Plate 10: SE-facing section of wall [011]*

- 6.1.3 Wall [011] comprised a stone wall constructed from roughly-shaped, mixed large and small stones with no evidence of mortar (**Plates 7-10**). It survived in Trenches 6 and 7 and measured on average 0.4m wide and 0.45m high. It consisted of two curving alignments (NE-SW and NW-SE) which adjoined at the southern corner (**Figures 7, 8**). Wall [011] appeared to respect and curve around the possible building formed by wall [008] and around the north end of existing farm Building C, suggesting it may have been a stone retaining wall. It is possible that parts of wall [011] have been used as foundation stones for Building D.

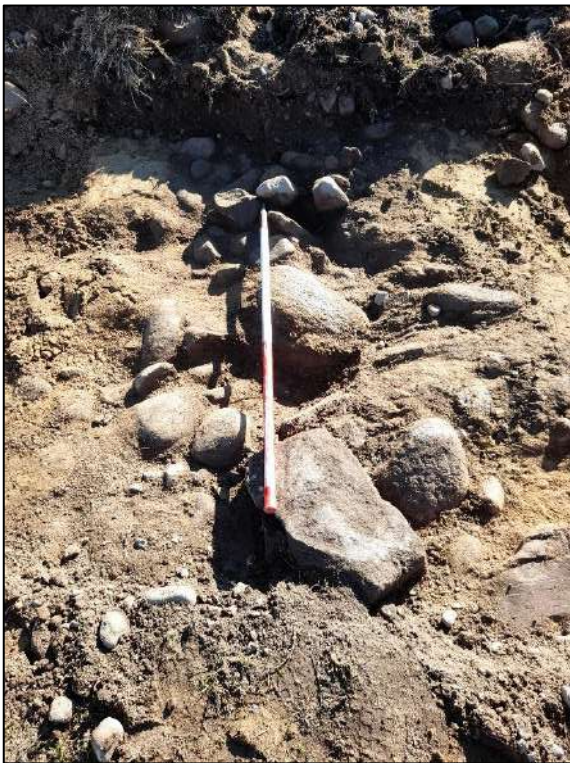
*Plate 11: Field drain [005]*

- 6.1.4 Features [003] and [005] consisted of rubble-filled drains found within Trenches 1 and 2 respectively and measuring between 0.39m-0.73m wide (**Plate 11**). Both were probably associated with the previous post-medieval building.

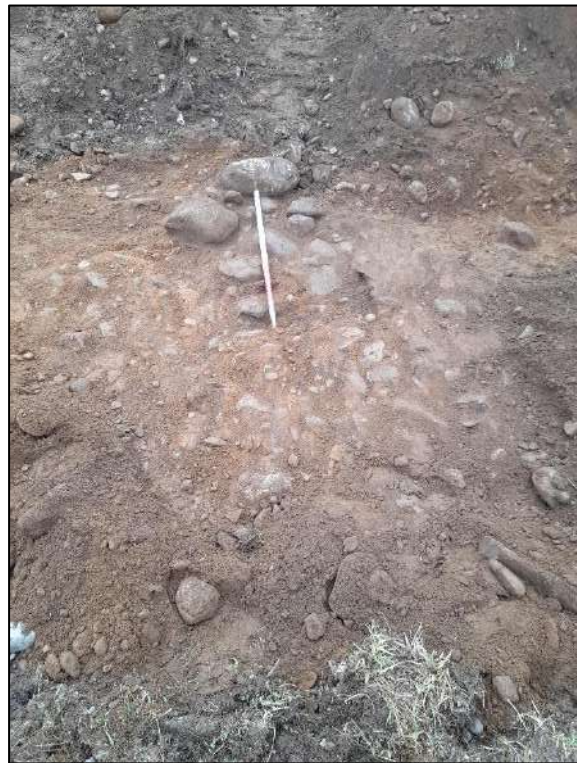
*Plate 12: Stone deposit [013]*

- 6.1.5 Feature [013] comprised an amorphous deposit of stones below the topsoil in Trench 8 (**Plate 12**). There was no structure to the stone pile, suggesting it was a general clearance pile likely associated with the post-medieval structure or its demolition.
