Castletown Mill, Castletown, Caithness

Standing Building Recording

Buildings Archaeology Ltd

November 2022

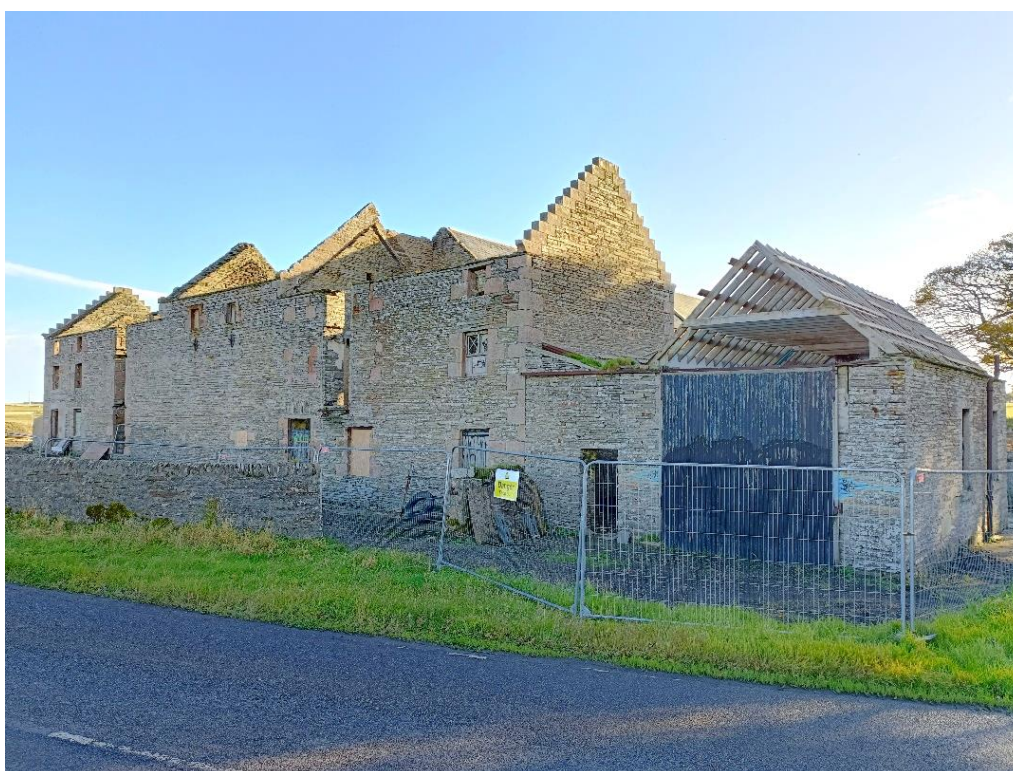
Figure 6: View of Castletown Mill c.1818 range from the north

The c.1818 range is a three storey building constructed in grey coursed Caithness rubble with large local red sandstone alternate quoins and margins and Mey flagstone lintels; the two end gables of the main range are crowstepped (see Figure 7). Today roofless, pictorial evidence reveals this range

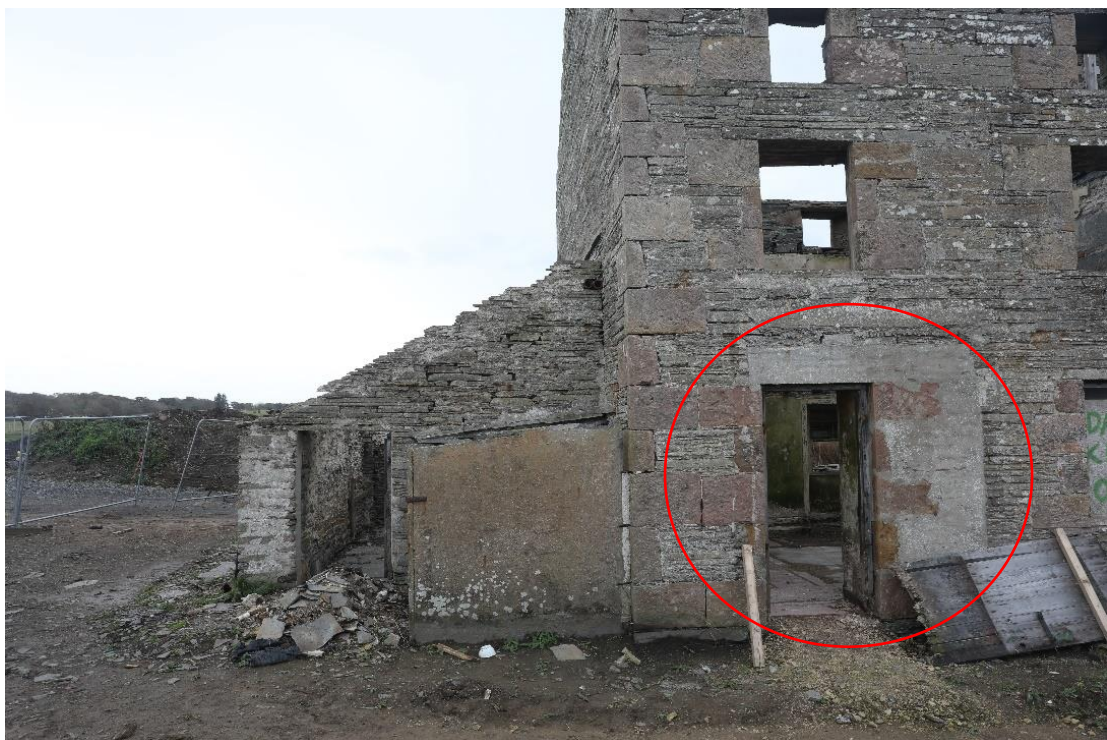
The bays to the east of the central drying kiln comprised of the Miller's House and a grain store. The fenestration is mainly symmetrical and originally consisted of 6/6 sliding sash windows to the Miller's House and shuttered openings to the grain store. Today most of these windows are all largely empty and either blocked or covered. The Miller's House (which occupied the two easternmost bays) had an off centre entrance and early photographs show where a porch over the door once stood, indicated now by a concrete scar (see Figure 8). A basic lean to extension built of Caithness rubble and with a small window opening and a coal store constructed with large Caithness flagstones have been built against the eastern gable of the Miller's House. These additions are now roofless.

Figure 8: Front (northern) elevation of Miller's House showing a rectangular concrete scar where a porch once stood

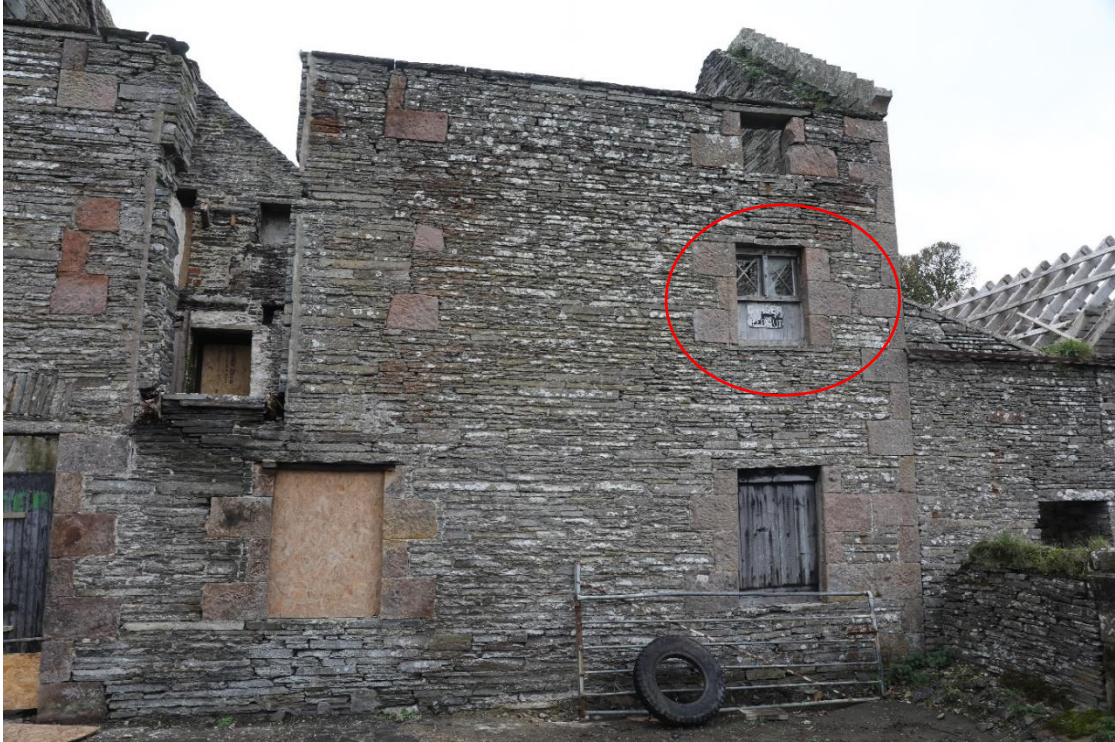
The bays to the west of the central drying kiln comprised of the mill and most of the windows in the mill appear to have been either shuttered or 6/6 sliding sash windows, although most are now removed or blocked. First floor window W28 (see Figure 9) in this bay displays an unusual configuration where the window had four lights with crossed glazing bars (the two lower lights are now boarded over externally).

Figure 9: Unusual window with cross shaped glazing bars in westernmost bay of original c.1818 range.

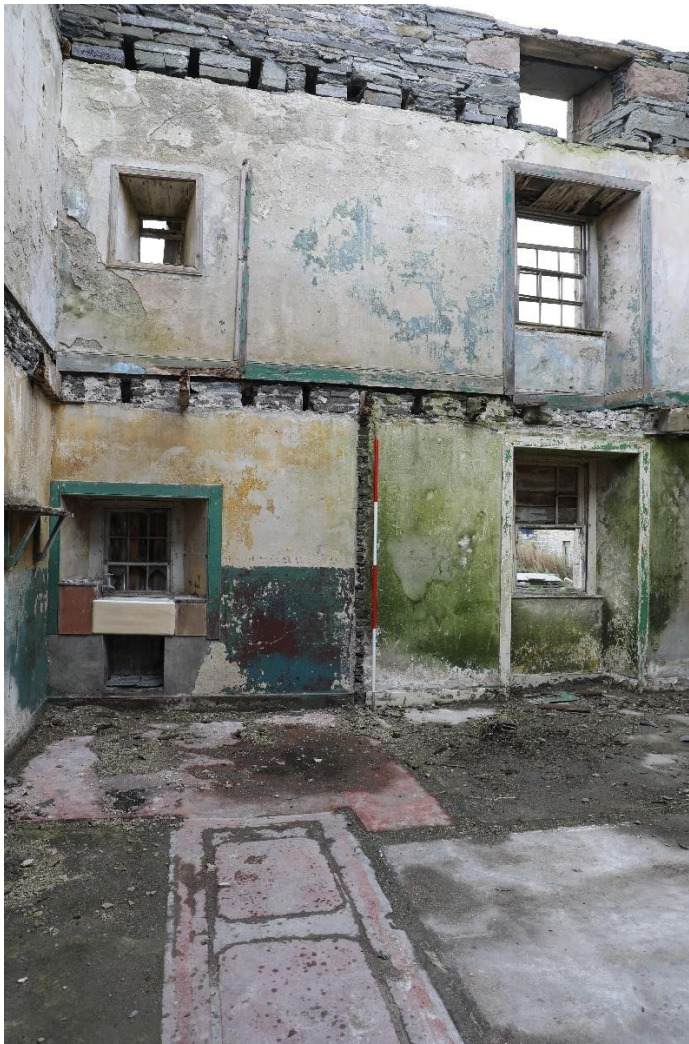
part of the building the ground floor gives an indication of the original plan form of the Miller's House (see Figure 10).

Figure 10: Photograph showing evidence of internal partitions surviving in the floor surface of the Miller's House.

There is evidence of a staircase that rose to the first floor opposite the front door and three downstairs rooms. Within the front (southern room) there was a range (living kitchen) immediately behind this room a room with a fireplace (parlour) and next to this behind the stairs a room with a sink in the windowsill (possibly the scullery). At first floor level there is evidence of wall partitions in the transverse wall and two fireplaces (see Figure 11). There is a door opening (D29) in the western interior wall between the second floor of the residential accommodation and the grain store (see Figure 11). This floor and doorway were not accessible from the Miller's House but via the drying kiln building (Calder Hill, 2010).

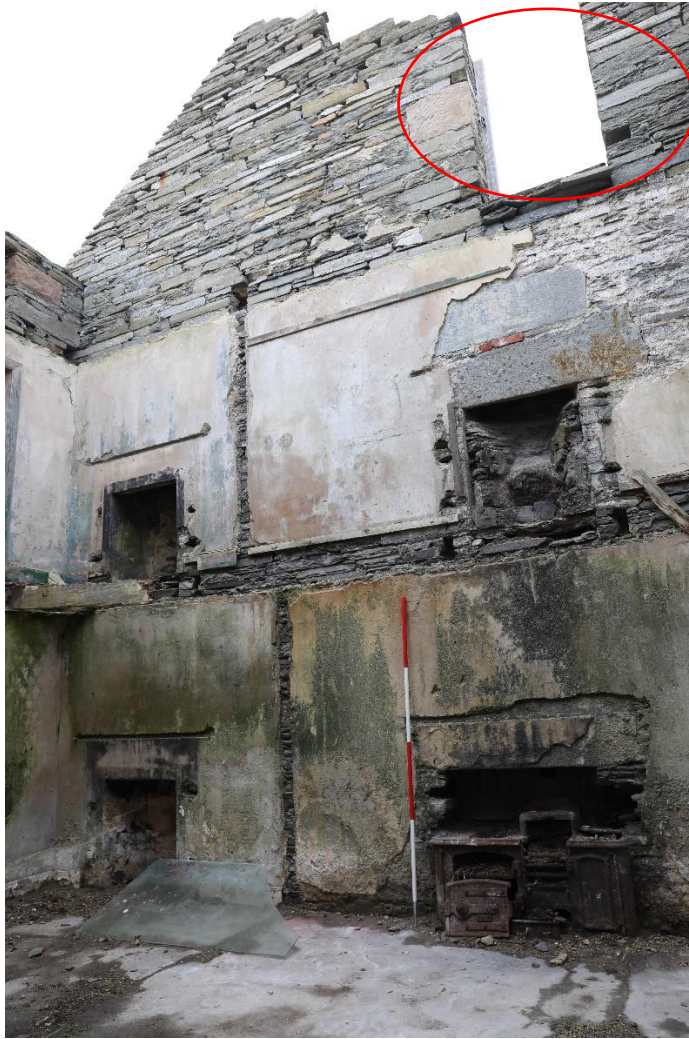
Figure 11: Western interior wall of Miller's House with 2nd floor door opening to Grain Store 1.

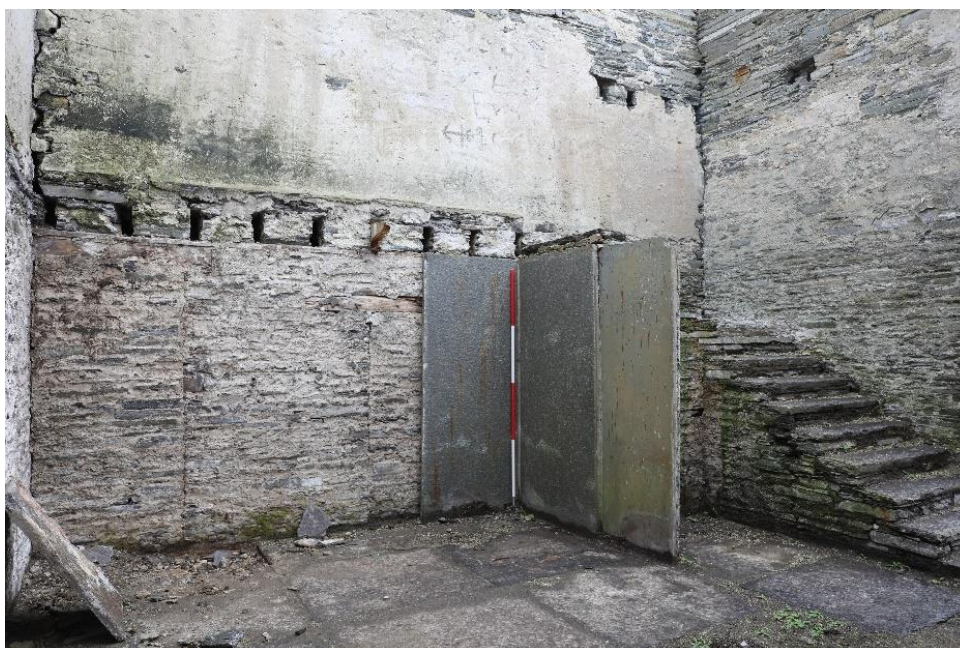
The walls were all finished with a limewash finish and the ground floor was formed of Caithness flags. Within this room are a set of stone stairs against the northern wall leading to a low first floor, now lost, but for which the joist holes survive. A later right-angled screen constructed of large Caithness flagstones is built out from the wall at ground floor level (see Figure 12). Within the western and southern walls there is evidence of blocked openings (D14 & 15). There was access to both the Drying Kiln and the Miller's House from the second floor via interconnecting doors (D28 & 29).

Figure 12: Interior of Grain Store 1 with stairs

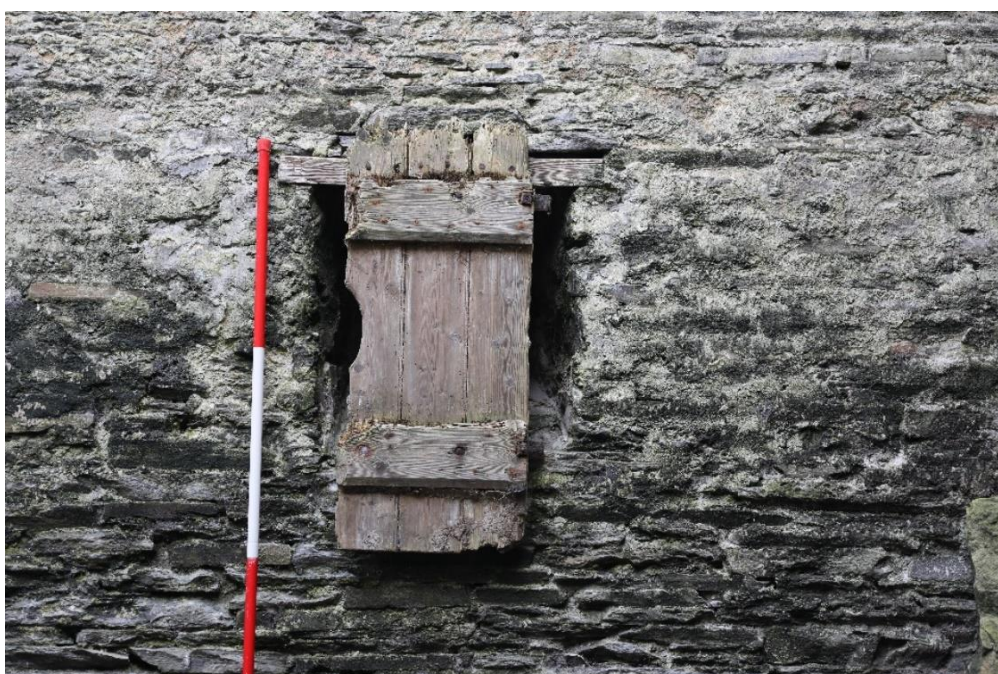
The walls are all finished with a limewash finish and the ground floor is formed with Caithness flags. There is access at ground floor from this room to the later southern range and through into the mill. Ground floor window openings survive on the northern and southern walls, now blocked or boarded with W3 retaining the partial remains of an internal fitted shutter (see Figure 13).

Figure 13: Remains of a shutter to ground floor window W3.

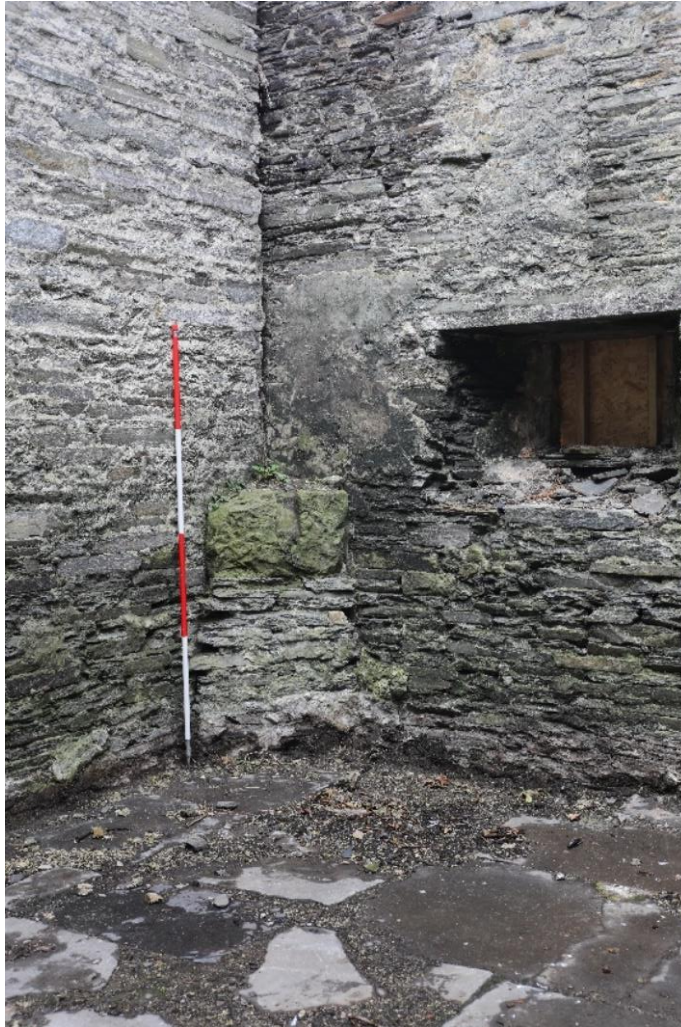
Figure 14: Detail of stone pillar with carved angled socket

There are shadows visible in the limewashed walls and wall structure which may indicate where machinery was attached to the walls. Built into the four corners of the room are low angled stone pillars each topped by a substantial stone capping with a carved angled socket, presumably fixing points for a structure that was housed in this room (see Figure 14).

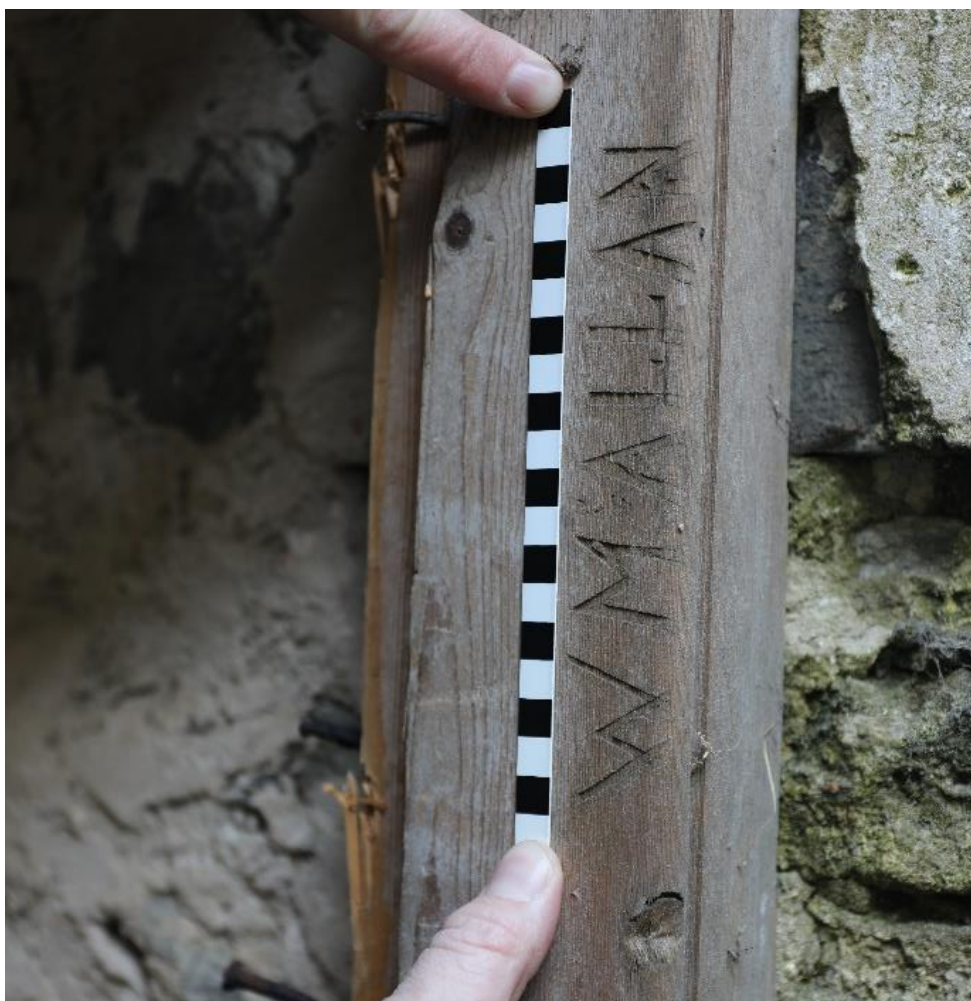
Figure 15: Detail of graffiti “W McAllan” carved into door jamb of D16

At the top floor there is evidence of an interconnecting door between the neighbouring residential accommodation and the mill building. These doors are located on a level with the drying floor (now removed) which was “floored in 0.46m square cast iron tiles carried on iron cross members” (Calder Hill, 2010). The position of the drying floor is indicated by a gap/ building scar infilled with loose bricks. There is also evidence of vents at second floor level. The metal rods from the ties between the front and rear facades are visible at upper floor level. In the jamb of the connecting door between this range and the later southern range (D16) there is a name carved into the woodwork (see Figure 15).

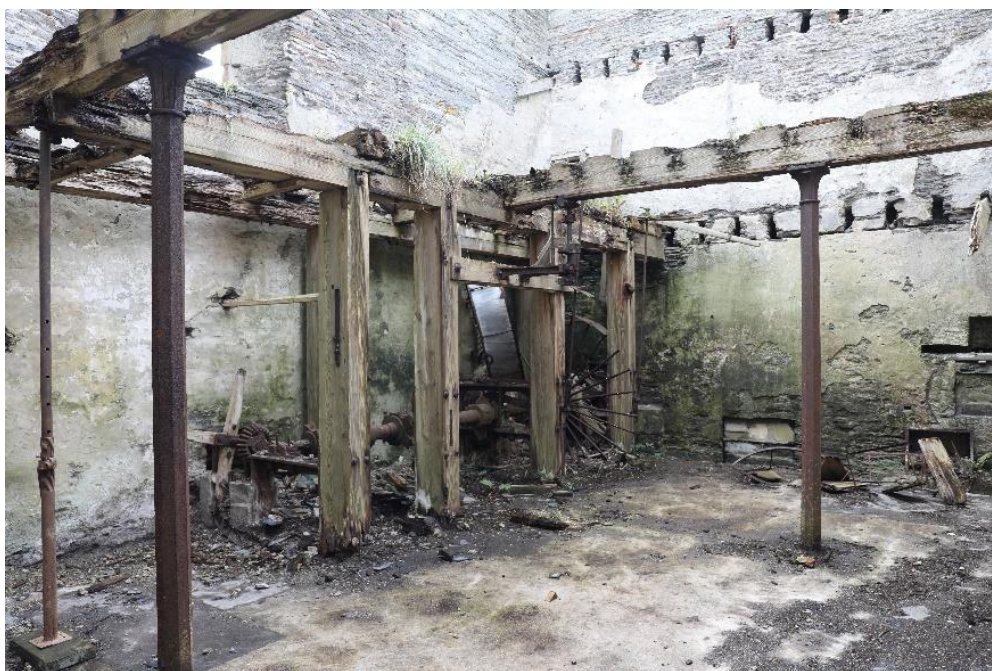
The walls are all finished with a limewash finish and the floor is concrete. The mill would have been accessible from the front and rear facades as well as from Grain Store 1 and the later rear range. There are remnants of the mill workings within this room although most have been moved or removed (for detailed description and interpretation see Calder Hill, 2010 and Howdle, 2019) (see Figure 16).

Figure 16: General view of remaining mill workings

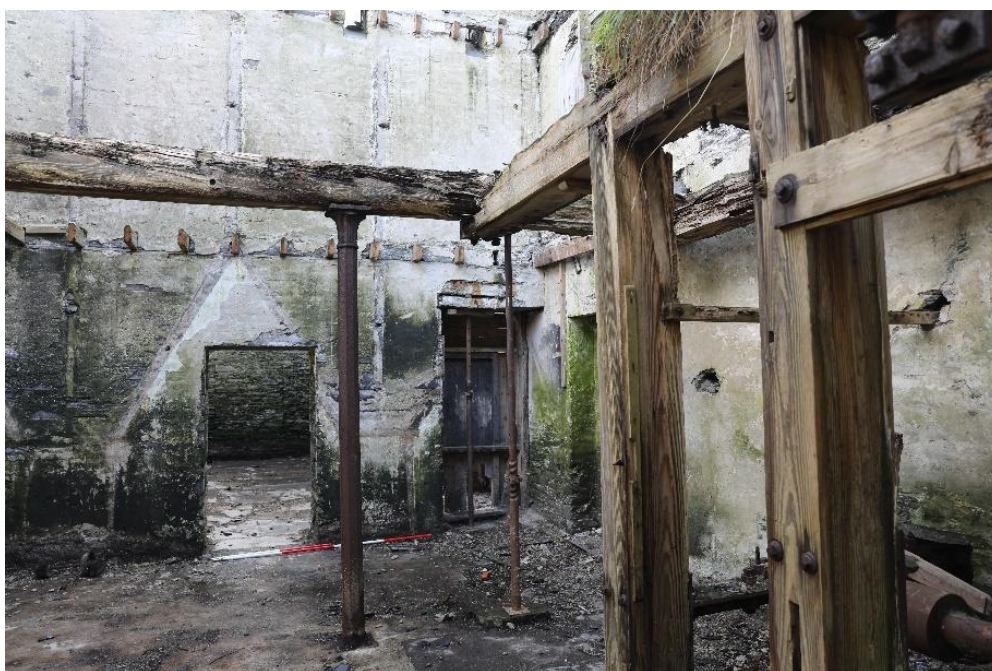
There are shadows on the eastern internal wall where silos were situated (see Figure 17 and Figure 18).

Figure 17: Wall detail showing shadows where silos were attached

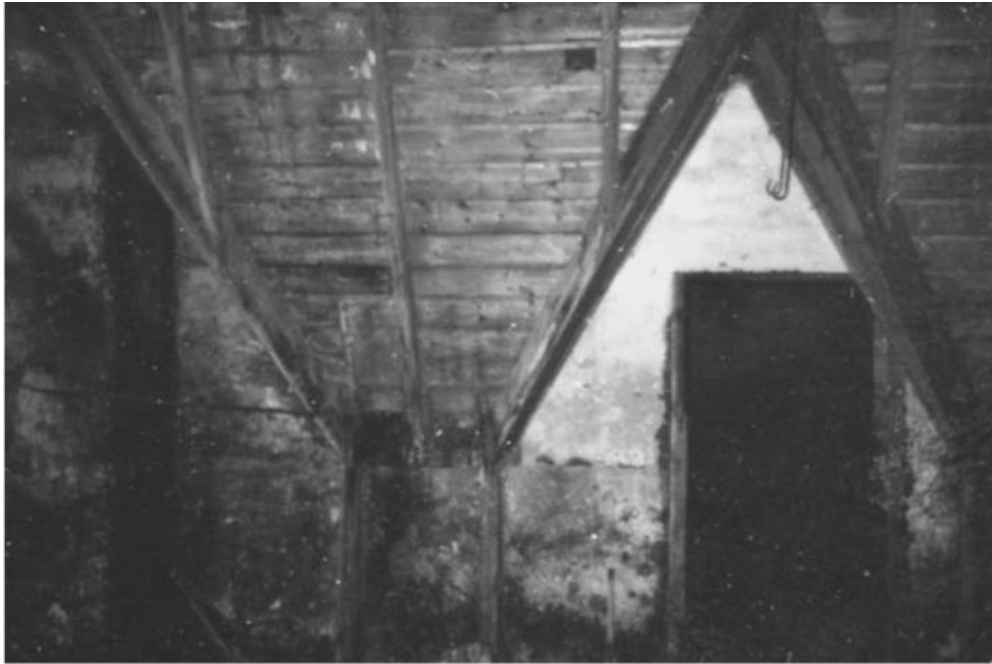
Figure 18: Photograph from 1991 from Historic Environment Scotland's Canmore website showing the same location with silos attached (<https://canmore.org.uk/site/96746/castlehill-mill>).

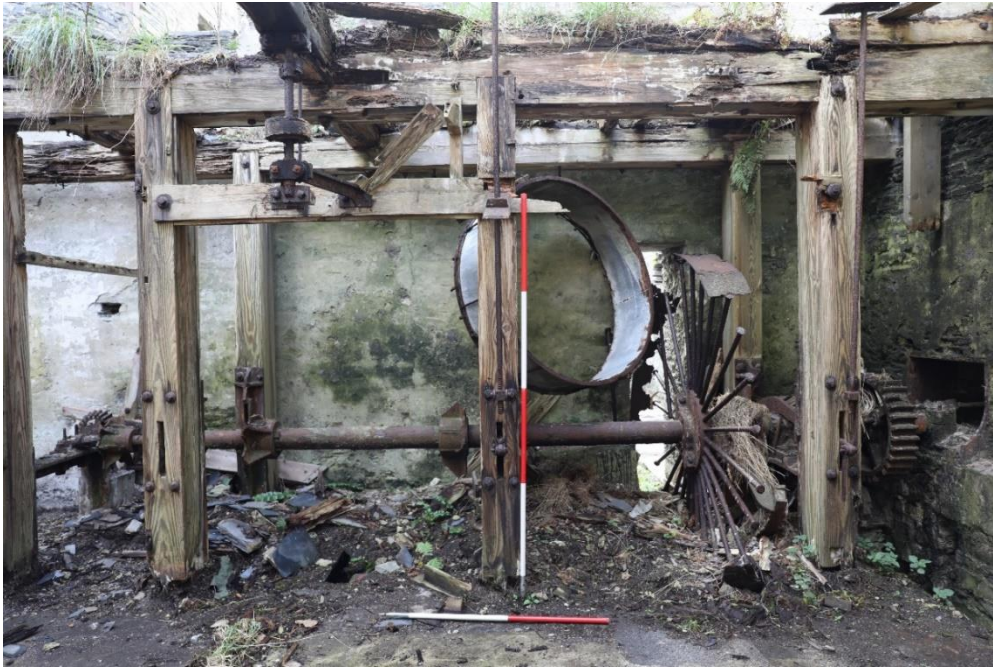
Two decorative cast-iron posts remain which support first floor joists and a scar on the northern wall indicates the location of a staircase rising to the first floor which cut across the ground floor window. A timber frame remains where the mill workings were housed (see Figure 16) and large apertures in the western wall are presumably indicative of lost features or fixings for machinery. In the floor at the western end of this room a shallow pit has been partially infilled with debris and in the southern extremity is a pit within which a drive shaft and parts of a wheel remains (see Figure 19).

Figure 19: Remains of wheel and drive shaft

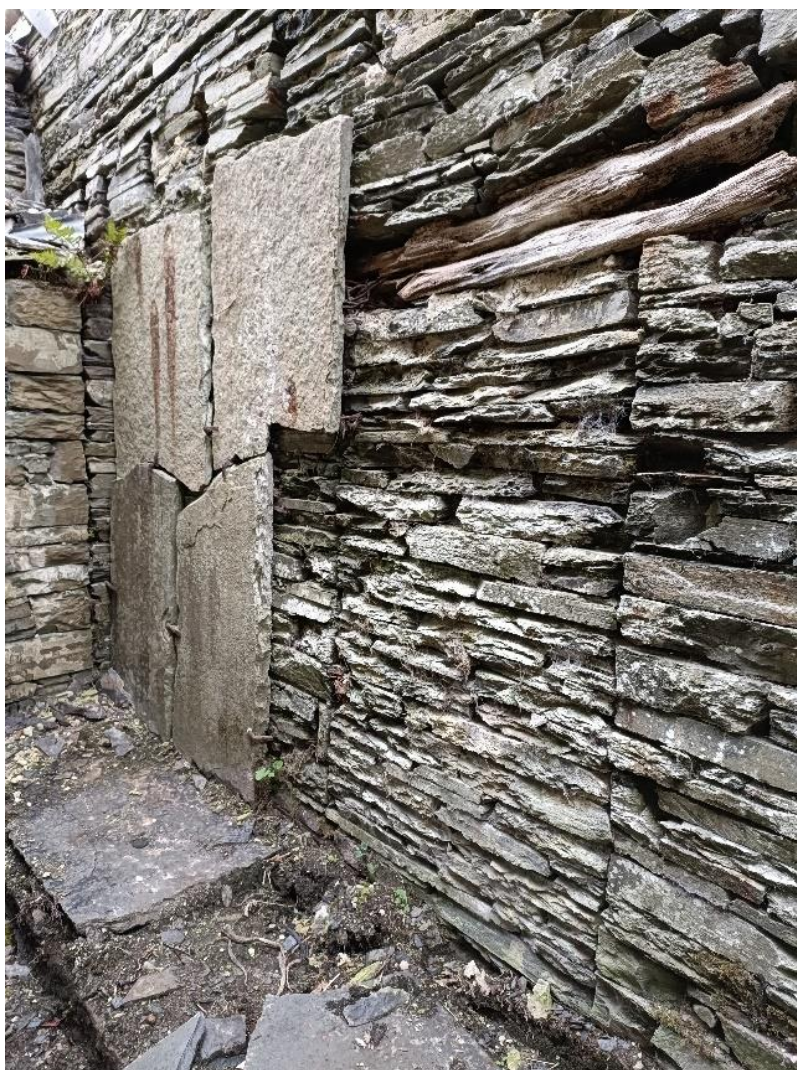
Very little remains in either of these structures. Within the wheel-house there is evidence of an infilled pit today. A large opening in the south façade may have accommodated the water trough from the mill lade (Adams Napier Partnership Oct 2021). There is evidence that the structure was once roofed with the remains of corrugated iron still visible. The western wall of the wheel-house has evidence of earlier blocked windows (W67 & W68) which are partially covered at the southern end of the building by large Caithness flagstones lining the wall (see Figure 20).

Figure 20: Detail of internal wall of wheel-house with earlier blocked windows and Caithness Flagstone lining

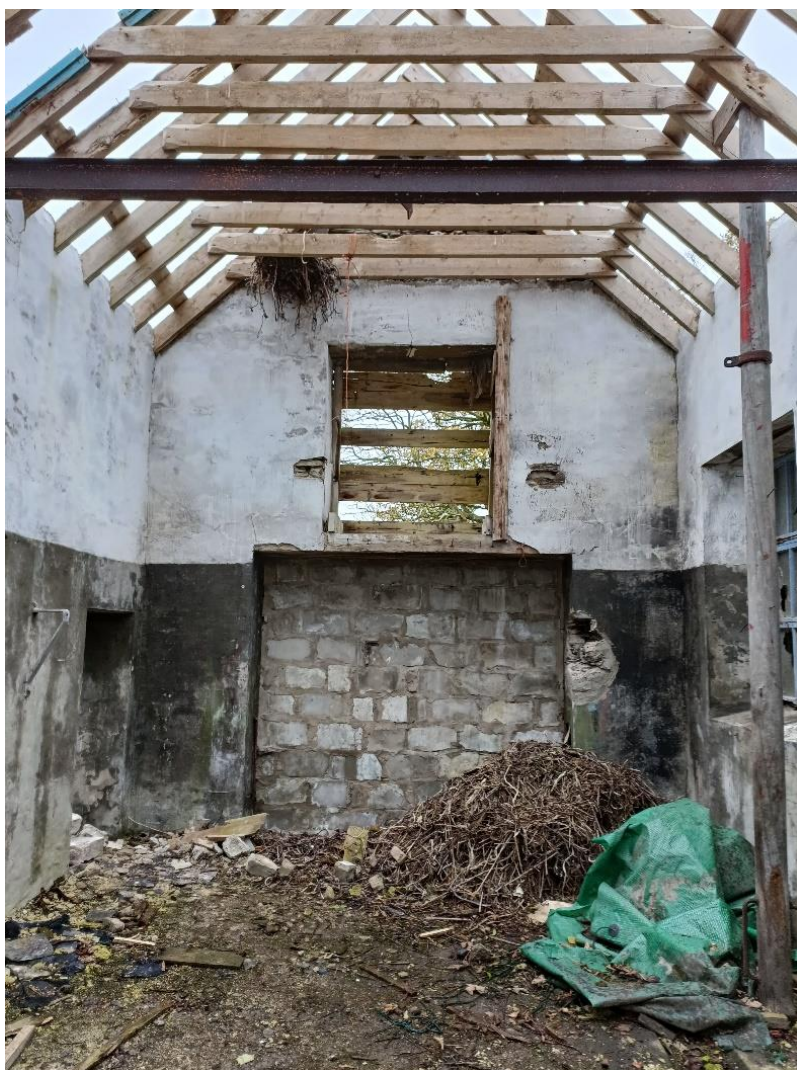
The internal walls of the slaughterhouse are covered in a cementitious mortar and painted, and the floor is concreted. The remains of the timber gabled roof structure remain, formed by twenty one common rafters and a central I-beam. There are large central doorways to the north and south elevations both now blocked (see Figure 21). The room contains debris, which hides the floor but a channel, possibly for drainage, can be seen running along the western side of the building.

Figure 21: General internal view of slaughter-house looking south

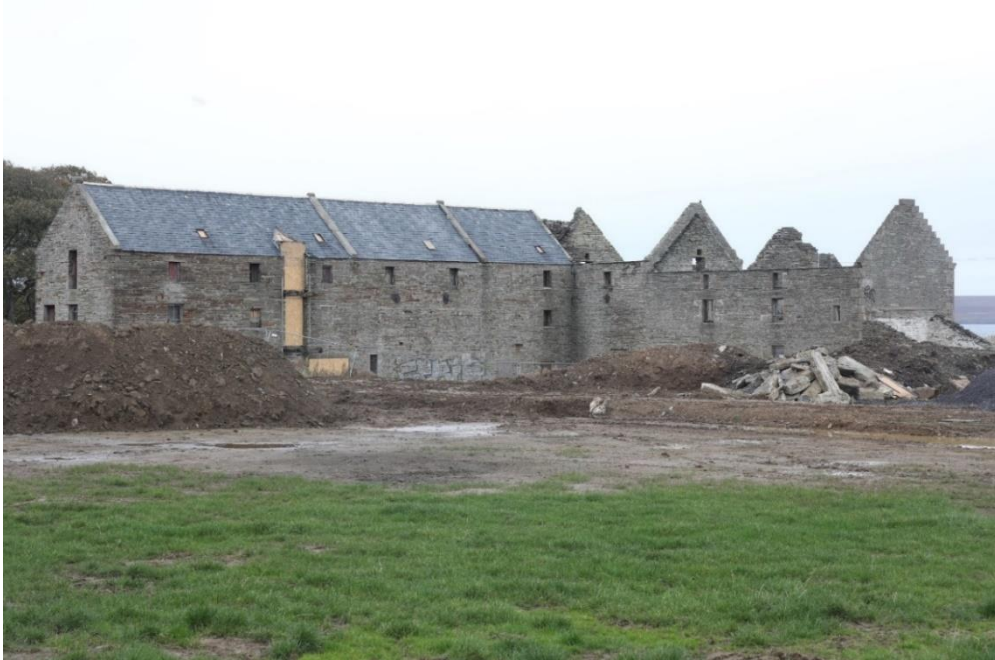
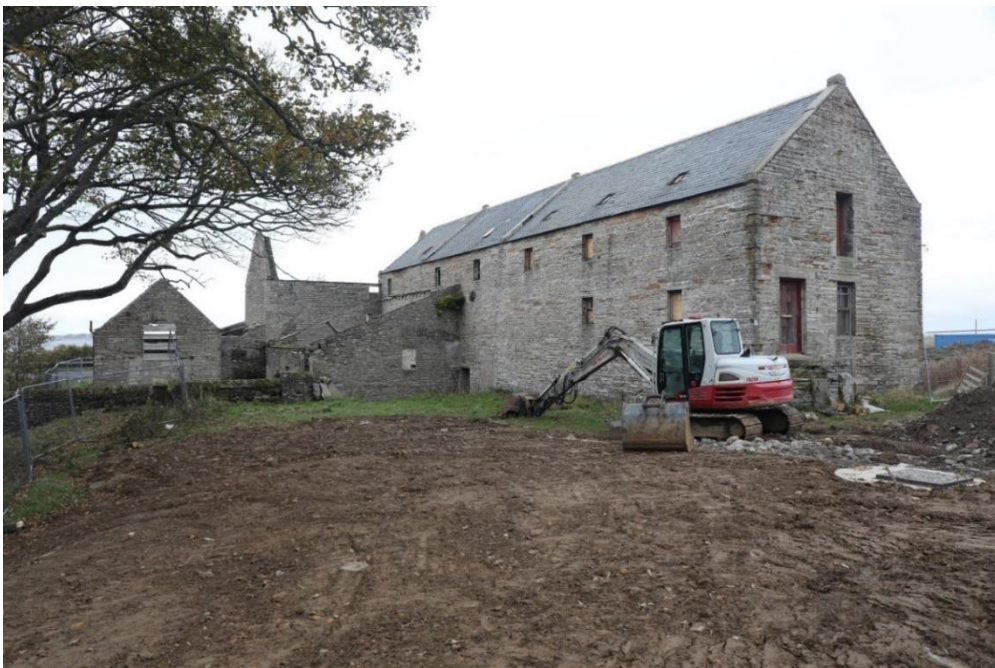
Figure 22: Eastern elevation of 1888 range

Figure 23: Western elevation of 1888 range

The mill was extended southwards in the late 19th century with a large 3 storey 6 bay range added at right angles and almost centrally to the earlier range (See Figure 22 & 23). It contained a second kiln, grain stores and an office.

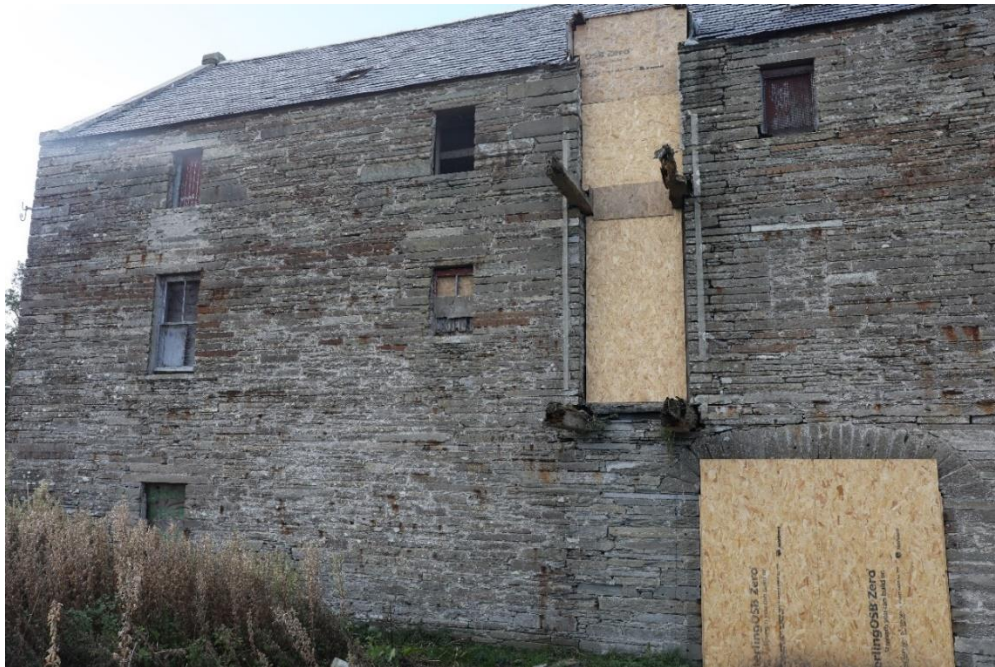
This range is constructed of grey coursed Caithness rubble with no red sandstone margins or quoins; the window openings have flagstone lintels. There are the remains of a gabled chute to the eastern façade (see Figure 24). The roof is finished with Welsh slates and raised gables with smooth skews, associated with internal cross walls protruding through the roof. There are four rooflights to either side of the roof. The windows of this range are mainly blocked but appear to have been shuttered except for three 4/4 late 19th century sliding sash windows at the southern end of the first floor (W34, 35 & 36 see Figure 25) and a 20th century 2/6 metal top opening casement window (W16) to the ground floor (see Figure 26). There was an entrance at ground floor level and a double entrance under an arched flagstone lintel on the eastern facade and there was a first floor entrance via a forestair to the southern gable. There were two doors on the western elevation at ground floor level. There are two oval pattress plates visible on either side of the range. A prominent scar on the eastern elevation indicates where an extension has been removed (see Figure 27). The range still contains all three floor levels.

Figure 24: Remains of chute or sack hoist

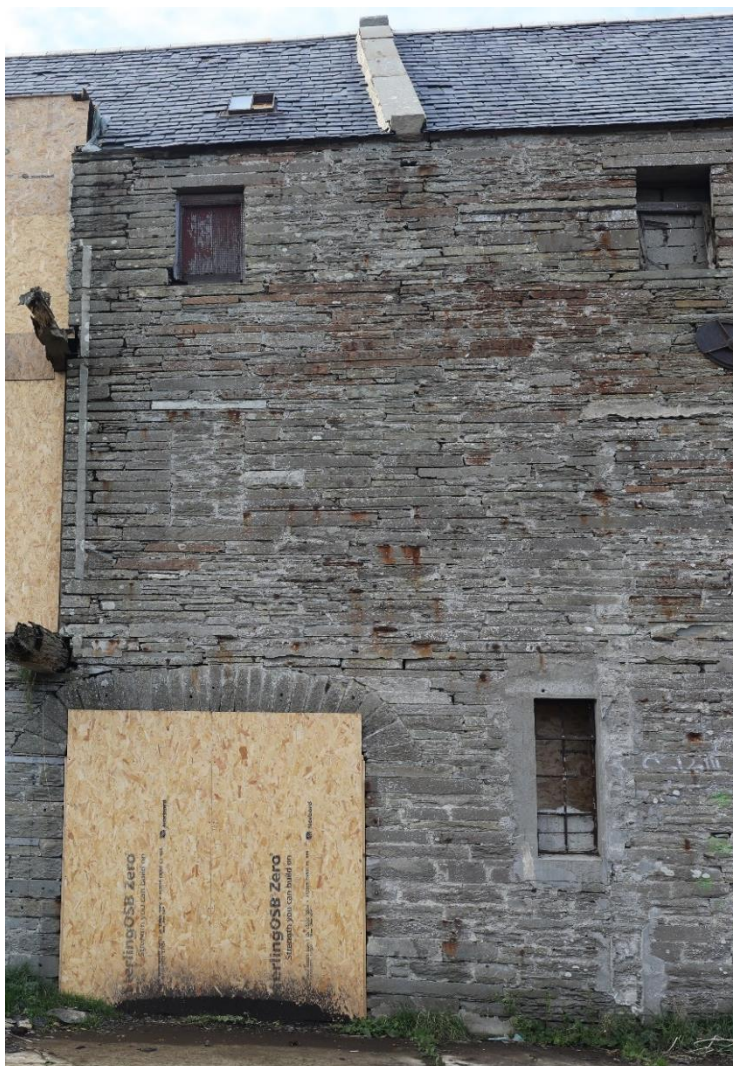
Figure 26: Remains of a 20th century metal window in the eastern elevation

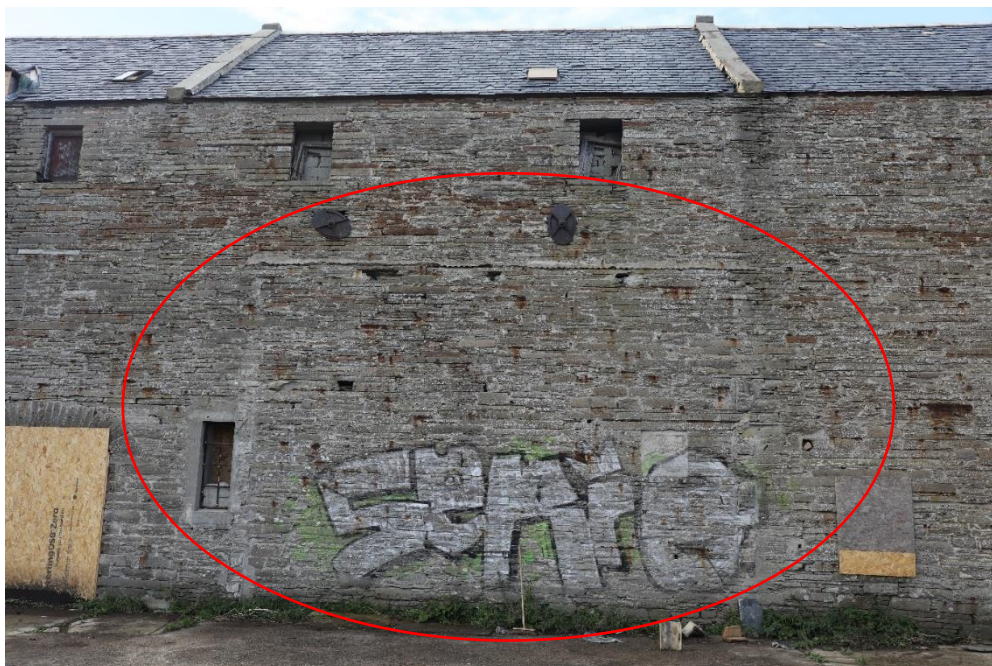
Figure 27: Evidence of former extension to eastern elevation

been demolished, however a roof and wall scar can still be seen from this (see Figure 27 above). The 1940s laundry buildings to the eastern perimeter of the site are also shown on the 1967 OS map.

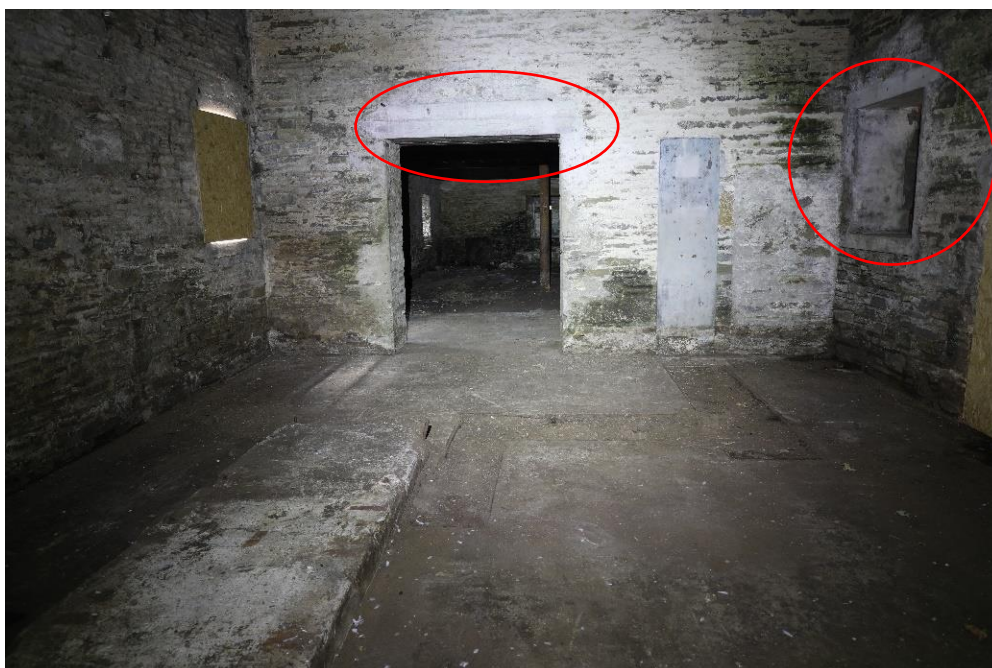
This room is open to the roof and has a limewash finish to its walls and a concrete floor with evidence of fixing mounts and channels (see Figure 29). There is evidence of later alterations having been carried out to some of the door and window openings (D21 and W13) which have had concrete lintels inserted (see Figure 29).

Figure 29: Grain Store 2 showing channels and fixing points in floor (alterations to openings highlighted)

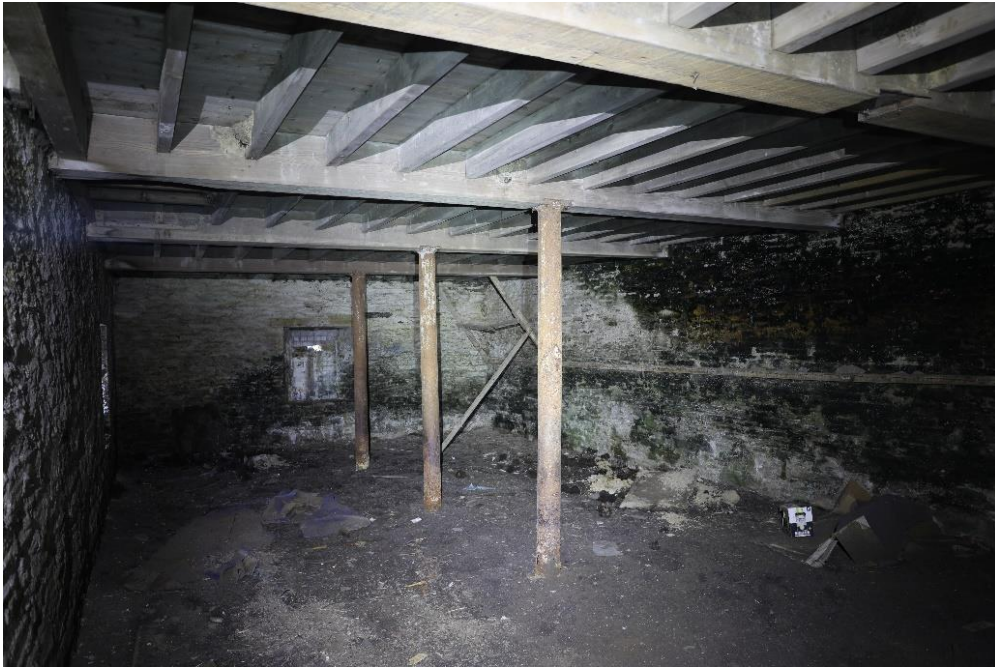
The room is partially subterranean, the end of the building being cut into the rising land to the south. The room contains debris, which hides the floor. Three plain cast-iron columns support the upper timber floor (see Figure 30). There is a double opening to the exterior courtyard and two blocked windows in the eastern and southern walls. A metal door allows access to the drying kiln.

Figure 30: Grain Store 3

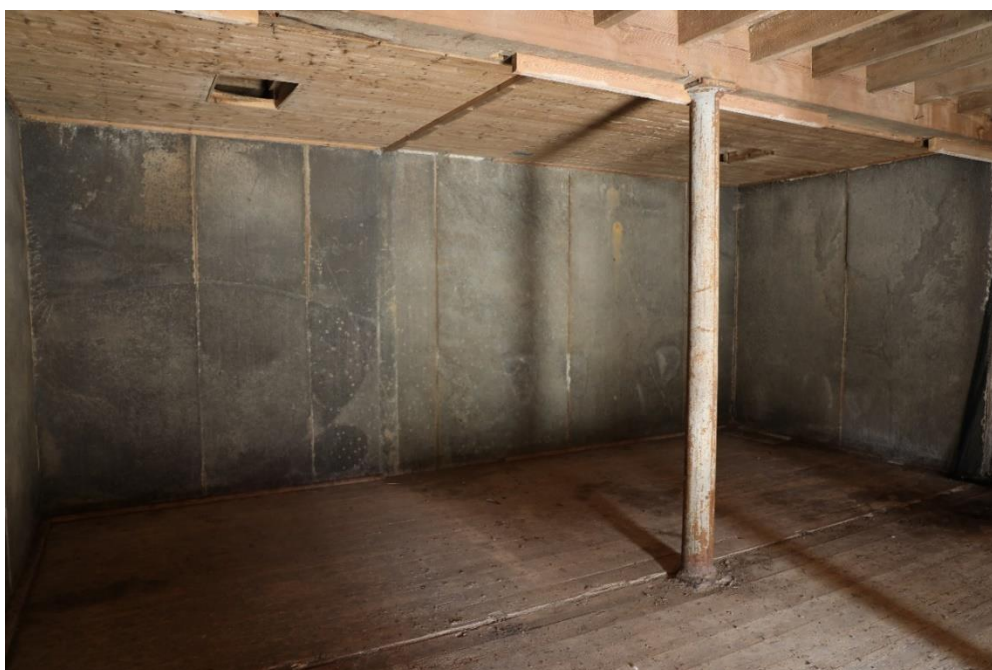
Grain Store 5 is accessed at first floor level via an external forestair on the southern gable. Lime washed walls and timber floor to most of room. The far end of the room (wall backing on to the kiln) has been lined out with large Caithness flagstones and the ceiling and floor have been double boarded. This has been suggested as a “girnal” - a storage place for meal or oats (pers comm, W MacMac, 07.11.22) (see Figure 32). There are four plain cast-iron columns supporting the upper floor level. At the opposite (southern) end the walls have been boarded in tongue and groove and there is a projecting partial wall protecting the area from drafts from the door. There is a blocked fireplace on the southern wall (see Figure 33). This area has been suggested as an office (pers comm, W MacMac, 07.11.22). A timber stair rises to the second floor on the eastern side of this room.

Figure 32: Grain store 5 “girnal”

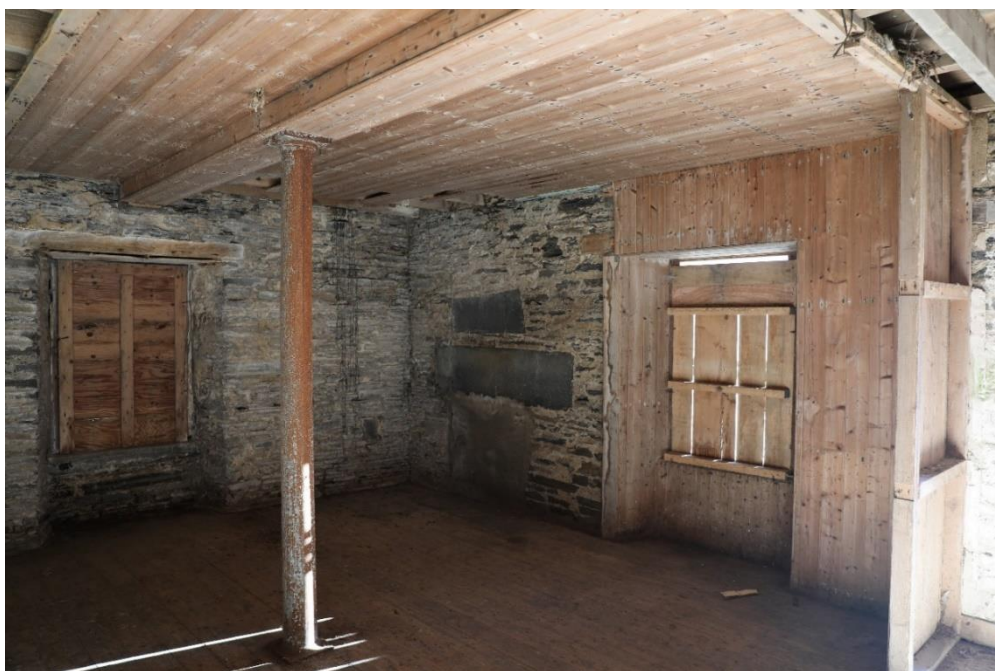
Figure 33: Office area Grain Store 5

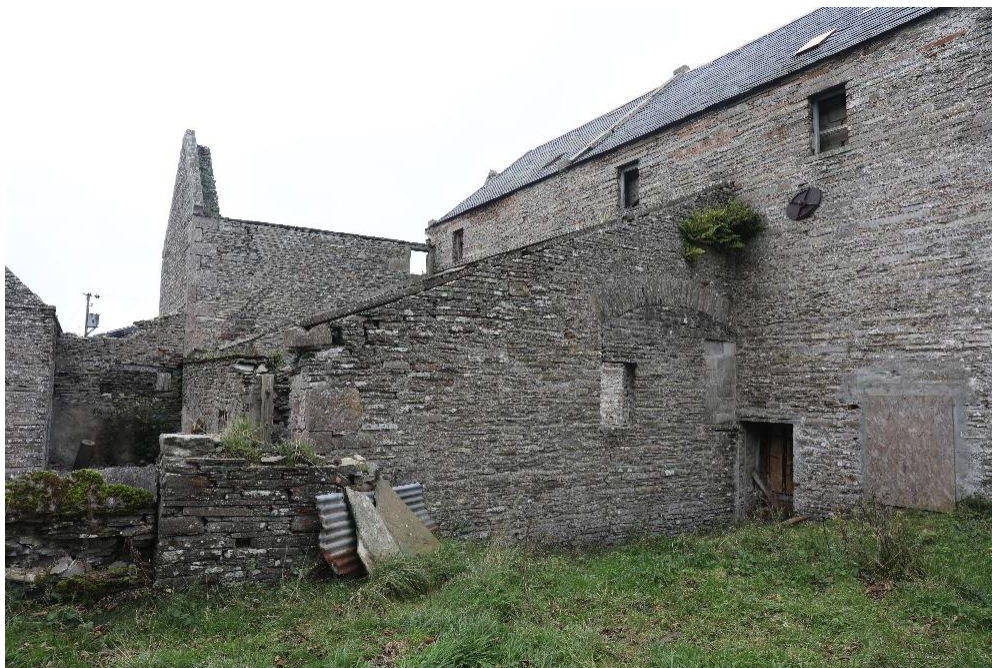
Figure 34: Sawmill extension

A rear single storey extension located in the southwest re-entrant between the original mill and the later rear extension, constructed of coursed Caithness rubble and now roofless (see Figure 34). There was a large opening on the southern gable end of the building with an arched flagstone header which has been blocked and had later windows inserted. Blocks of dressed red sandstone have been reused in the end of the gable wall. There is a window on the western elevation and a door opening. This building has become known as the sawmill after the RAF utilised this part of the complex during WWII to install a drive to power a sawmill (Calder Hill 2010).

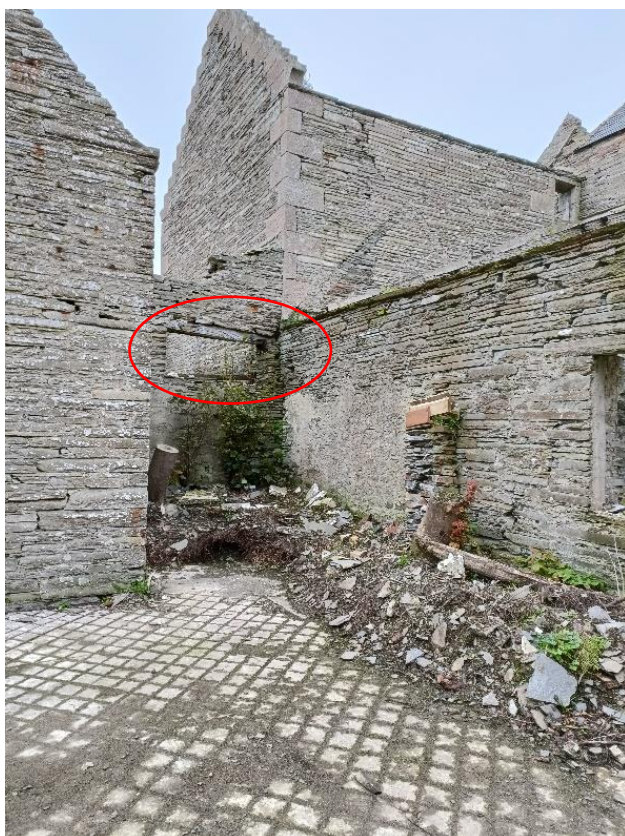
Figure 36: Remains of the wheel-house wall where a wooden trough ran water from the lade into the mill wheel.

The lade ran from a small mill pond south-west of the mill via an underground channel and then into a trough lined with flagstones. The lade then ran into a wooden trough, carried on dry stone piers, into the wheel-house (Calder Hill, 2010) (see Figure 36). The lade and the remains of the stone lined channel can still be seen at the south-western perimeter of the site (see Figure 37). The perimeter of the site is partially surrounded by a rubble wall (see Figures 38).

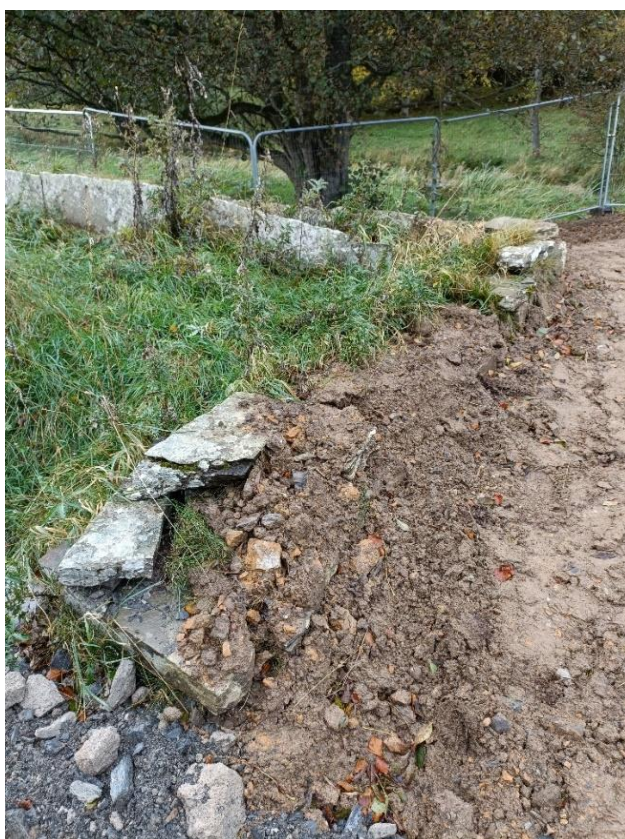
Figure 37: Remains of the stone lined lade
